## Building Inspection Report

Inspection Date: Mon, 30 Mar 2026

Property Address: 6 Heather Grove, Cheltenham VIC 3192,  
Australia

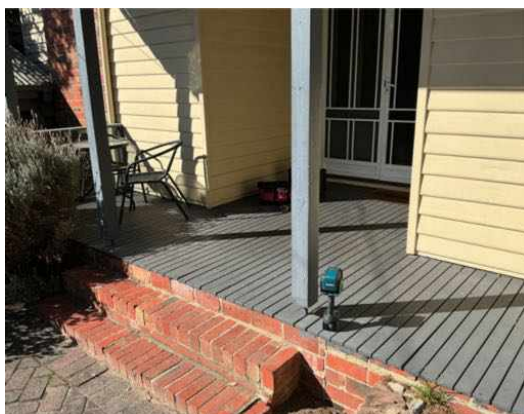
#### Defects 1.01

Building:	Main Building
Location:	Deck front and back
Finding:	External Timber Balcony or Deck - Structural Stability
Information:	The load capacity of the external balcony or deck could not be verified during the inspection, the fencing surrounding the deck is also deteriorated.

External timber structures are also constantly exposed to weather elements and can deteriorate in an accelerated manner, ongoing assessments are required.

It is highly recommended that a Structural Engineer further assess the external timber balcony or deck to inform the client of its load capacity. Regular maintenance inspections by competent practitioners is needed.

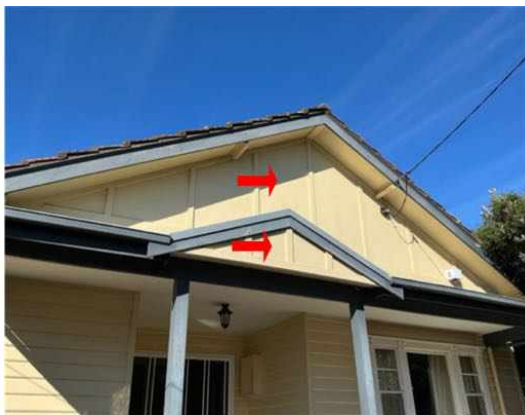
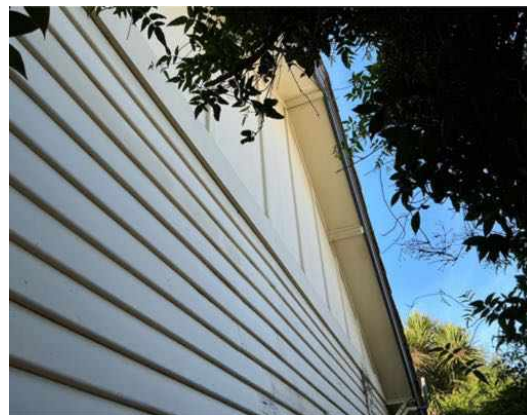
#### Defects 1.02

Building:	Main Building
Location:	Gable ends

Finding: Asbestos - Suspected ACM Identified on Site  
 Information: Reporting on Asbestos is outside the Scope of this Report. This suspected defect is highlighted as a caution only. We suspect, based on our experience in the building industry, that there is a higher risk of the identified building element containing asbestos.

As Asbestos Reporting is outside the scope of this report, we advise that you consider a separate Asbestos Inspection and Condition Audit, which can include the taking of samples for definitive confirmation of the presence of Asbestos.

In the interim, the client is advised to act with caution, especially when considering any damage to building materials general wear and tear renovations extensions demolition and general maintenance activities due to the suspected presence of Asbestos.

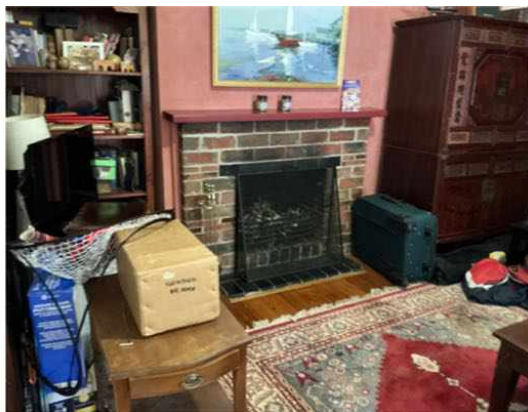
### Defects 1.03

Building: Main Building  
 Location: Lounge Room  
 Finding: Fireplace  
 Information: It is beyond the scope of this inspection report to comment on fireplaces, we recommend a professional chimney sweep check the safety of this fireplace prior to use.

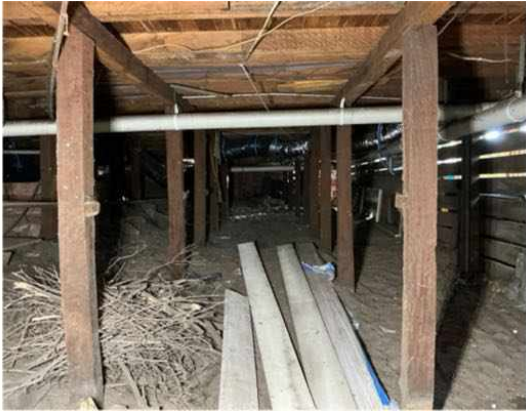
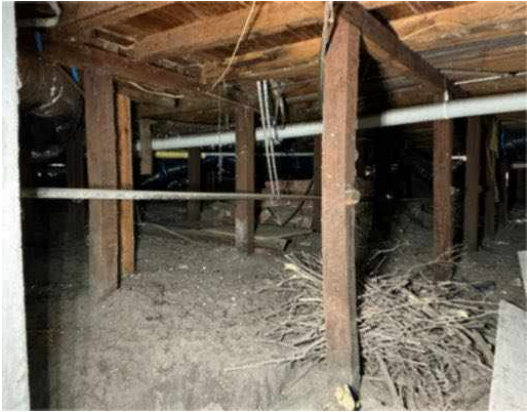
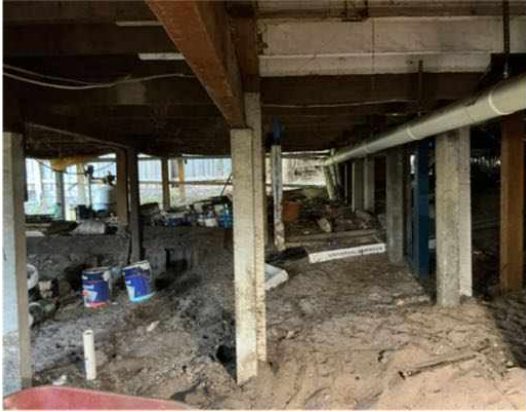
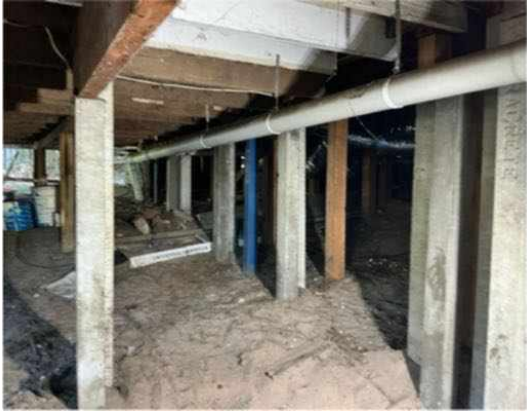
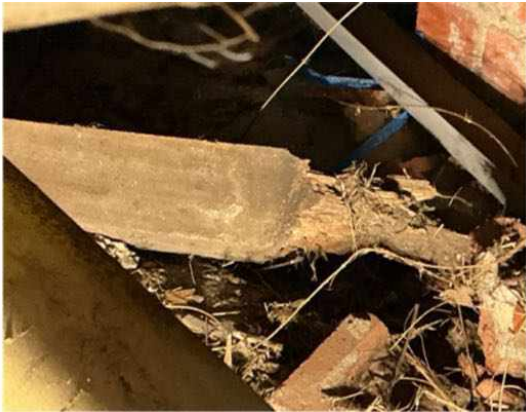
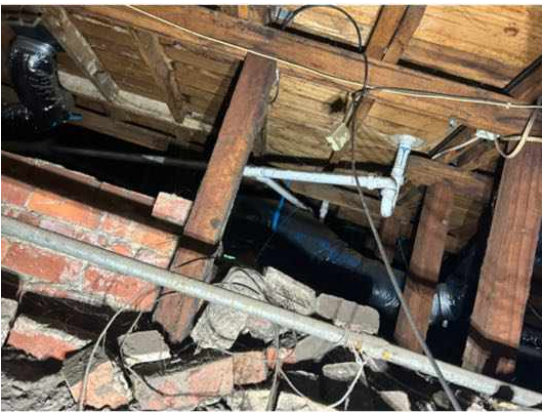
### Defects 2.01

Building:	Main Building
Location:	Subfloor
Finding:	Timber stumps - Suspected deterioration
Information:	It was noted that the property has timber stumps. Inspection of the condition of the timber stumps - below the surface of the ground - is excluded from the scope of this report. However, it is suspected that several timber stumps are deteriorating, evidenced by secondary defects such as uneven flooring, visually-observable subsidence or major cracking within the property. Even without these secondary defects, deteriorated stumps may still be present.

Where timber stumps are failing, a high degree of maintenance or even replacement of stumps may be required in the short- to medium-term future. It is probable that there is some degree of wood rot or deterioration beginning to occur in areas that are currently inaccessible for inspection. Timber stumps are no longer used in current building practices due to their susceptibility to wood rot and deterioration over a prolonged period of time.

The client should be prepared that in purchasing a property with timber stumps, that the need to restump the property in the short- to medium-term future is highly likely, which involves expensive works.

The major defect is the timber stumps that were found to the subfloor area, timber stumps have the propensity to rot in the ground and will need to be replaced in the short term. This may prove costly to potential purchasers

A registered builder specialising in re-stumping may be appointed to provide a more invasive inspection of the timber stumps and provide estimates on any works that may be required.

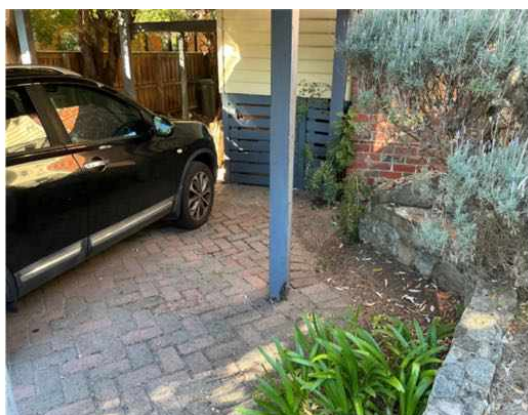
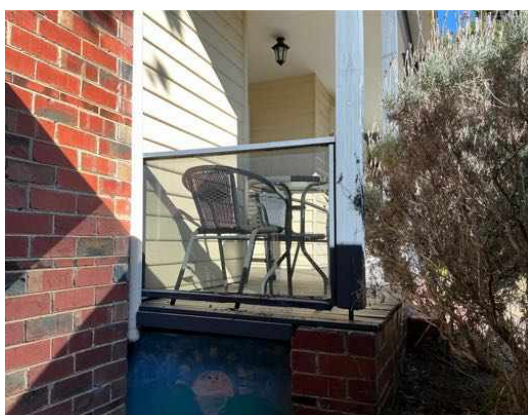
## Defects 3.02

Finding: Wood rot

Information: This building element shows evidence of wood rot. Wood rot, also known as Fungal Decay, occurs when timbers and other cellulose building materials are exposed to damp conditions on an ongoing basis. This could be the result of exposure to weathering over a prolonged period of time, or the attraction of excessive moisture from other abutting building materials. Contributing factors also include poor air ventilation in the area.

Wood rot is often associated with general damp problems and is evidenced by a 'musty' smell or mould and mildew occurring on surfaces. If left unmanaged, damp conditions can lead to further health problems and the decay of timbers will continue.

Early intervention and regular maintenance, particularly of exterior timbers, will prolong the useful life of these building elements. Prior to any works being performed, the cause of the moisture that has created the visible wood rot should be identified and addressed in a suitable manner. Replacement of affected timbers may then be a necessary step in protecting surrounding building elements from such deterioration.

A qualified plumber may be appointed to assess the cause of excessive moisture and to provide advice on any remedial works as required. A qualified carpenter or

registered builder may also be required to replace affected building materials.

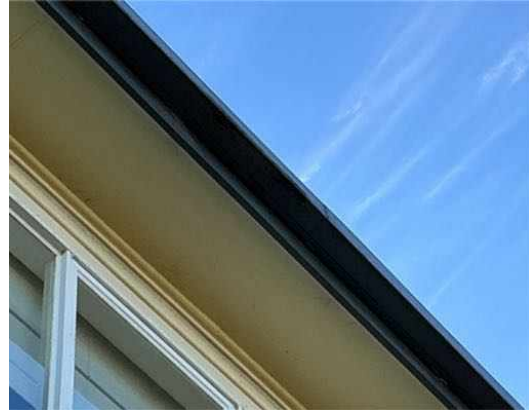
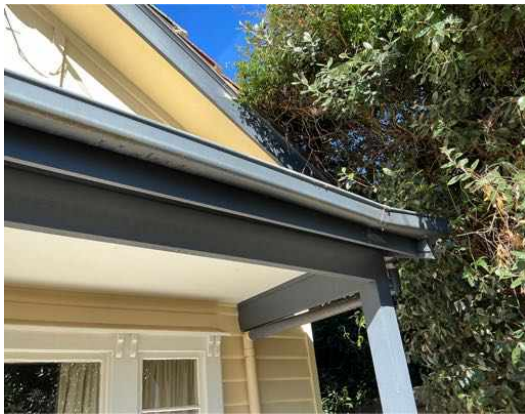
### Defects 3.03

Building:	Main Building
Location:	All Areas
Finding:	Roof plumbing - Rusted or deteriorated
Information:	The roof plumbing has areas of rust and corrosion. It is suspected that this has been caused by blockages, resulting in pooling or standing water, that have prematurely rusted elements of the roof plumbing.

Rusted roof plumbing will generally develop holes and leaks that can affect other building elements with poor drainage of storm water. Poorly drained roof areas will also lead to damp conditions surrounding the base perimeter of the building which, if left unmanaged, can lead to a range of secondary building defects.

Repair and/or replacement of rusted roof plumbing is highly required in order to reinstate the roof drainage system to a fully operational level. To further maintain these areas, gutters should be cleaned frequently, allowing the avoidance of any partial blockages.

A licensed plumber or specialist roof restoration company should be appointed to undertake these works. It is advised that such works be completed as soon as possible to prevent any further damage and deterioration.

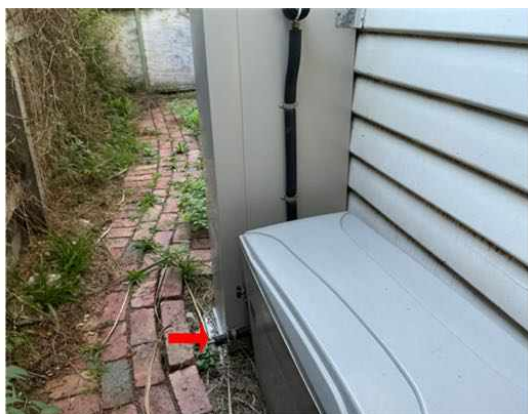
### Defects 3.04

Building:	Main Building
Location:	Exterior walls - right side
Finding:	HWS Overflow - Not Connected
Information:	The Hot Water System (HWS) overflow was found to be disconnected from storm water drainage and is creating excessive moisture in the surrounding area.

These damp conditions can lead to secondary defects such as rot, rust or corrosion of associated building elements, the formation of fungal decay, or even the creation of potential slip hazards. When coupled with poor site drainage, pooling of water may also attract termite activity to this area.

It is highly recommended that a licensed plumber be appointed to connect the HWS overflow in order to prevent such an environment from being created. These minor works should be carried out as soon as possible.

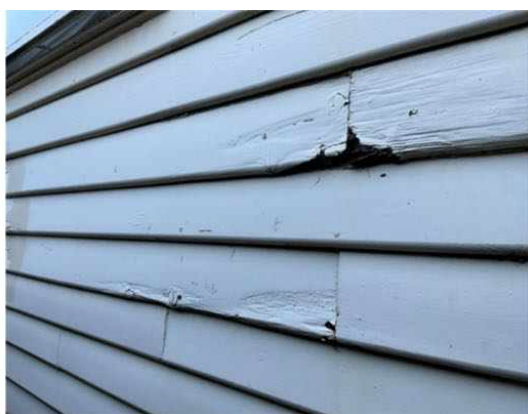
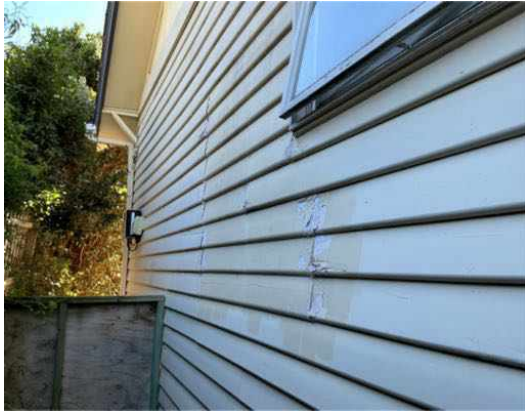
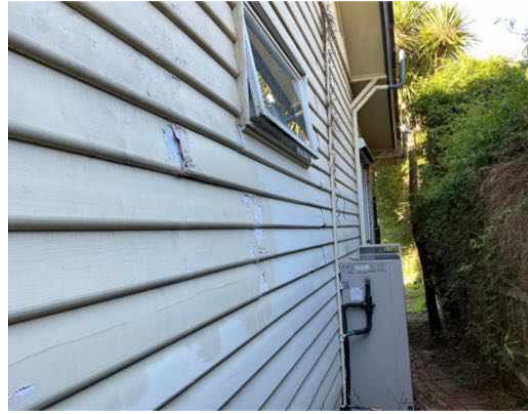
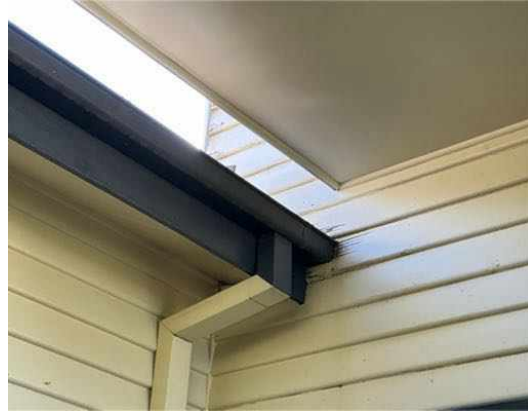
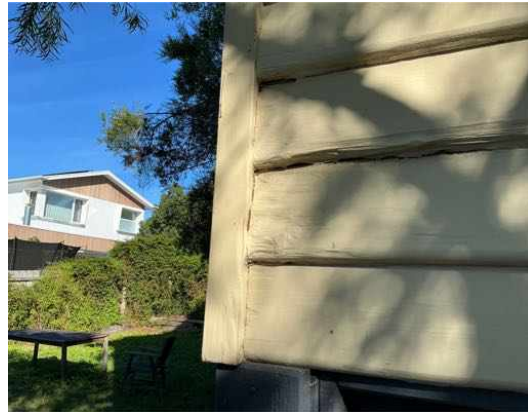
### Defects 3.05

Building:	Main Building
Location:	All Areas
Finding:	Weatherboards - Rotting
Information:	The external weatherboards show signs of fungal decay (wood rot) in several sections. This wood rot is suspected to have developed over a prolonged period of time due to frequent weather exposure, which is expected in a property of this age and condition

Weatherboards are sealed and protected by paint and other sealants. When these sealants deteriorate over time, they allow water penetration to the weatherboards, causing wood rot. If left unmanaged, the wood rot is likely to develop further, possibly necessitating major repair or replacement works in the long-term future.

To maintain the condition of the external wall cladding, any severely affected weatherboards should be substituted as soon as possible with pre-treated replacements. Where weatherboards have rotted due to excessive moisture other than rain penetration, the cause of the moisture should be identified immediately by a licensed plumber. A qualified carpenter should be appointed to repair and replace rotting weatherboards.

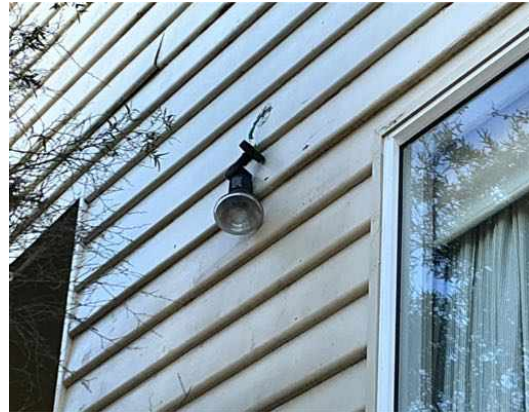
### Defects 3.06

Building:	Main Building
Location:	Rear Elevation
Finding:	Light fitting - Damaged
Information:	The light fitting in this area was found to be damaged at the time of inspection. Damage occurs generally when the building materials have aged and decayed, but may also be indicative of impact damage to the building element (accidental or deliberate).

Left unmanaged, the fitting is unlikely to cause further damage to surrounding building elements. However, the broken light fitting may expose electrical works, and may create a minor safety hazard if there is potential contact with persons in the area.

Repair and/or replacement of the damaged fitting is advised. A Licensed electrician should be appointed to repair/replace the light fitting at the client's discretion.

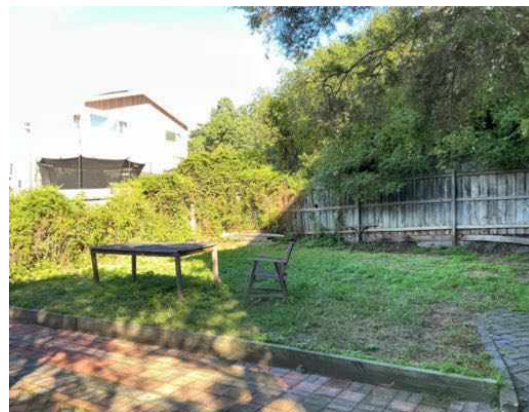
### Defects 3.07

Finding: Fencing - Deteriorated

Information: It was noted at the time of inspection that sections of the fencing throughout the property have deteriorated. Typically fencing deteriorates due to age and or wear, rot and or rust which is generally expected for a structure of this age, due to prolonged exposure to weather conditions. Sometimes inadequate installation or maintenance can be to blame.

If left unattended, it is likely that further damage will occur. It is suspected that repair of several elements of the fencing may be required however replacement may be a consideration of the client also.

A licensed fencing contractor should be appointed to provide further advice and perform rectification works as necessary.

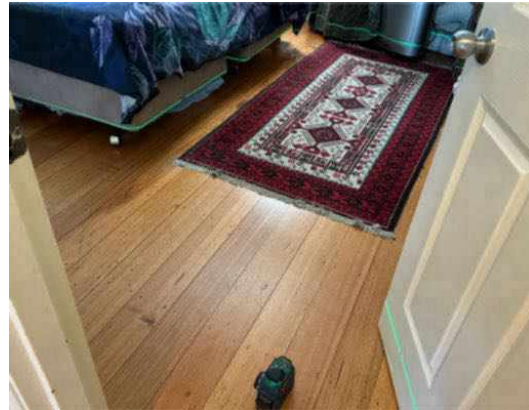
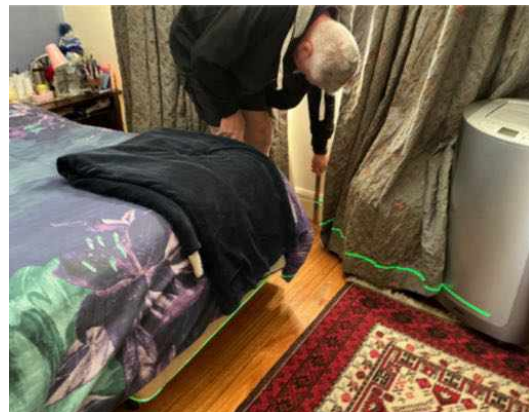
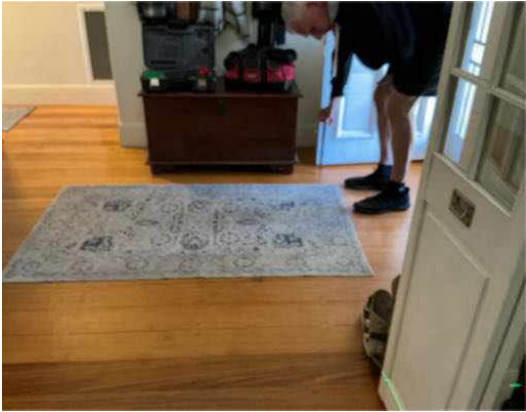
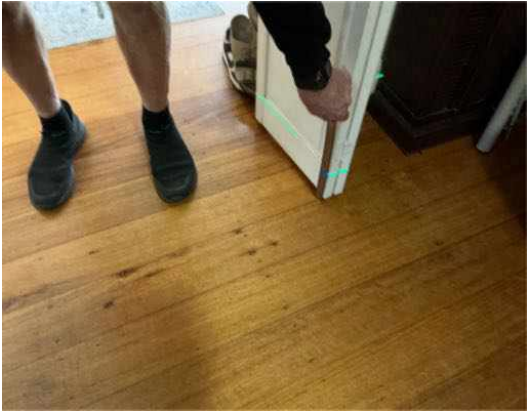
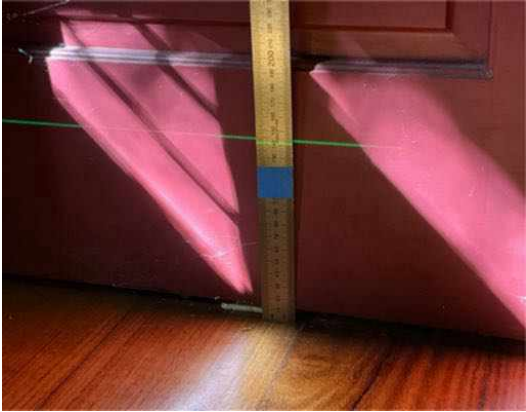
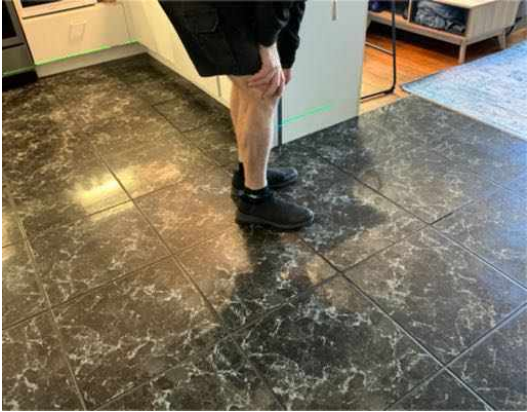
### Defects 3.08

Building: Main Building  
Location: All Areas  
Finding: Flooring - Uneven  
Information: The internal flooring in this area is out of level and uneven. Uneven flooring is likely to indicate minor defects such as expected movement of the foundations of the property, but may also indicate subsidence of the associated subfloor stumps.

It is advised that the flooring be closely monitored to identify any further movement. Where flooring remains relatively unchanged for an extended period of time (i.e. several months), it is likely that this defect has been caused by expected movement of the foundations of the property.

However, where flooring is uneven further, potentially invasive inspection of the subfloor structures and stumps in this area is required. In this case, works to repair are likely to be required, and would be carried out by a registered builder specialising in re-stumping.

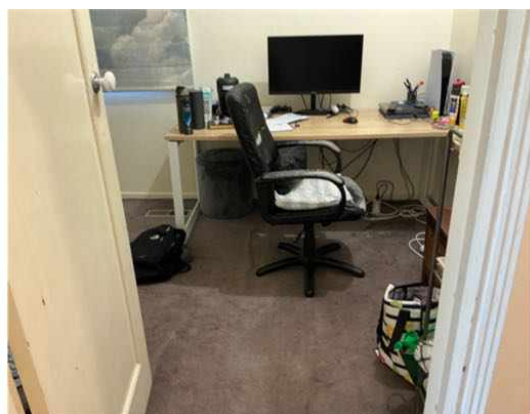
Defects 3.09

Building: Main Building  
Location: All Areas  
Finding: Floors - bouncy  
Information: The internal flooring in this area was identified as being bouncy at the time of inspection. A bouncy floor surface generally presents as a discernible change in level as they are walked across, in noisy or creaking flooring, or in consequent movement of surrounding furniture and fixtures.

Bouncy floors generally indicate that the floorboards or the subfloor structures are coming loose from the joists that they are installed on. Bouncy flooring may also be the result of gaps between flooring and stumps or joist structures, which require packing.

The client is advised to seek quotations for required repairs from a Registered Builder specialising in re-stumping. The potential resolution may range from packing gaps in subfloor structures through to replacement of subfloors stumps and refixing of flooring.

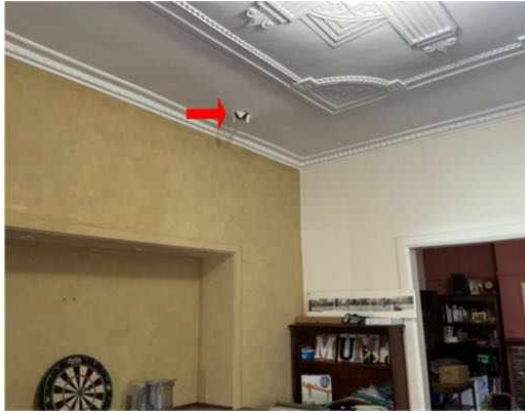
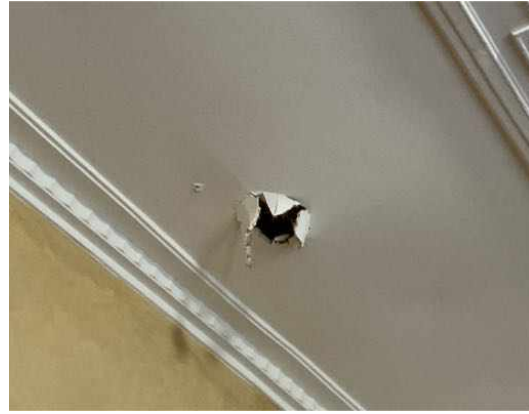
### Defects 3.10

Building: Main Building  
Location: Dining Room  
Finding: Building element - Damaged  
Information: Evidence of damage was identified to the ceiling plaster in this area, a qualified plasterer and or painter should be engaged in order to repair this damage.

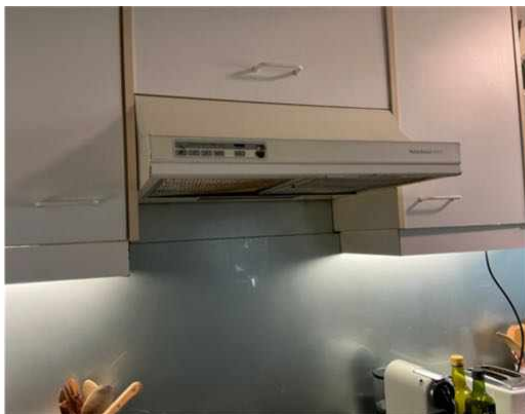
### Defects 3.11

Building:	Main Building
Location:	Kitchen
Finding:	Rangehood -not working
Information:	the range hood was not working at the time of inspection.

Without a functional fan, a build-up of grease and evaporative moisture is likely to accelerate deterioration of the range hood and associated flue. This potential build up may also create a minor fire hazard, particularly if left uncleaned.

A licensed electrician should be appointed to replace the fan on the range hood to restore it to a fully operational state.

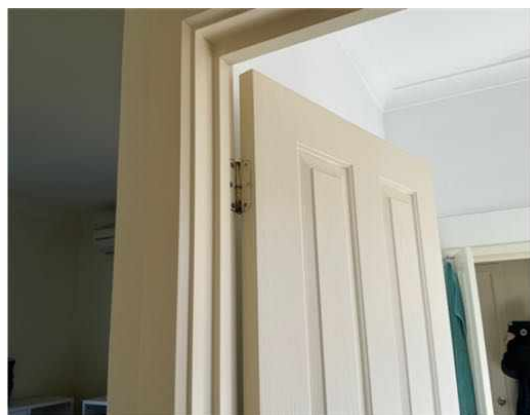
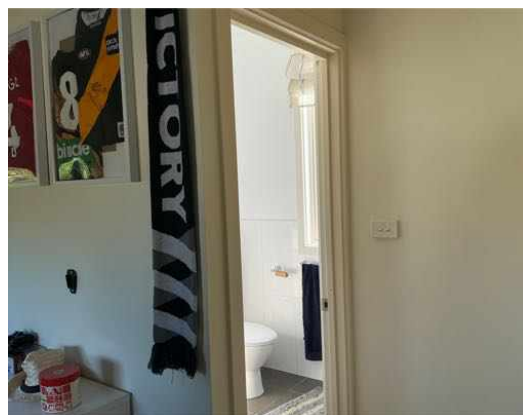
### Defects 3.12

Building:	Main Building
Location:	Bathroom
Finding:	Door - Loose hinges
Information:	Doors that are not level and fully operational were found. Upon further inspection, it was noted that the hinges to the door has deteriorated over time and, as a result, has come loose from their original fixing. To improve operation of the affected door, a general handyman may be appointed to replace the faulty hinges. Such works should

be completed at discretion of the client.

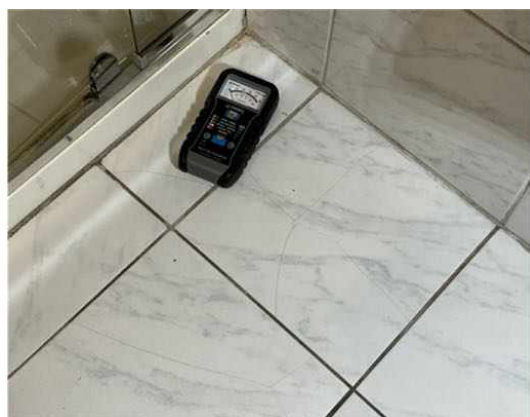
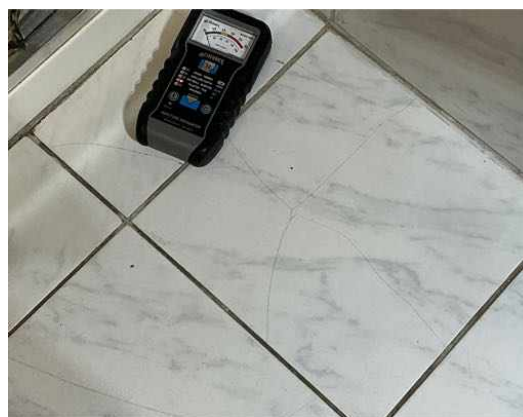
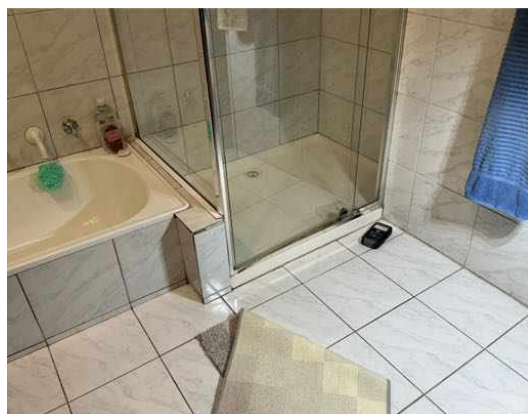
### Defects 3.13

Finding: Floor tiles - Cracked

Information: Cracking in the floor tiles was evident in this area at the time of inspection. It is suspected that this cracking has occurred as a result of the floor being uneven and lacking a solid or suitable foundation for the tiles to be laid on. Settlement in the floor foundations may also have caused movement and resulted in the cracking of tiles in this area.

Cracked tiles throughout the household detract from the overall appearance of the affected areas, as well as creating potential for water penetration to adjoining building elements. If left unmanaged, water damage may occur as a result of constant water penetration over a prolonged period of time.

While not considered a matter of urgency, replacement of cracked floor tiles is advised as a solution. A tiling contractor or general handyperson may be appointed to perform these works at client discretion. Where cracks become more numerous, consultation with a registered builder specialising in re-stumping may be required.

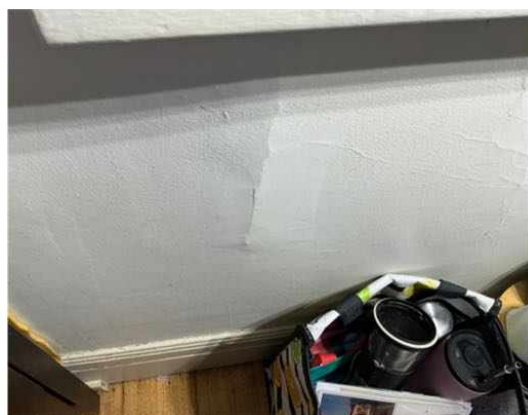
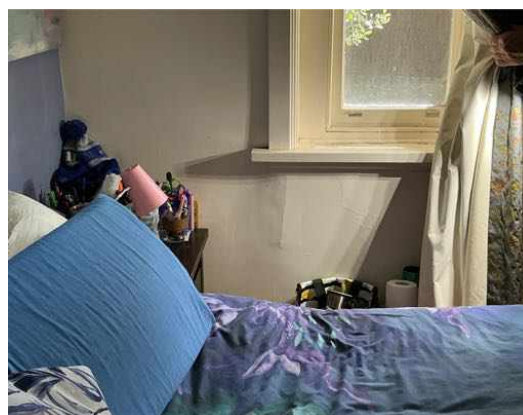
### Defects 3.14

Building:	Main Building
Location:	Bedroom - Master
Finding:	Cracking - Damage Category 2 - Noticeable (up to 5mm)
Information:	Noticeable cracks are a common occurrence as a result of many primary defects. Such causes may include age, general wear and tear, expected building movement, general expansion/contraction of building materials in different weather conditions, and/or minor failings in the installation or application of building materials.

Noticeable cracks may result in minor sticking or jamming of associated doors and windows, which require easement. However, noticeable cracks are easily filled and repaired. A plasterer can be consulted to install an expansion joint at this point to allow for this movement during different weather conditions.

Monitoring of all cracking should be conducted frequently. Always contact a building inspector should cracks widen, lengthen, or become more numerous. Additionally, your building inspector should also be contacted if associated building elements such as doors and windows become more difficult to operate over time.

Relevant tradespeople, such as carpenters, painters and plasterers, should be appointed to perform remedial works, as deemed necessary.

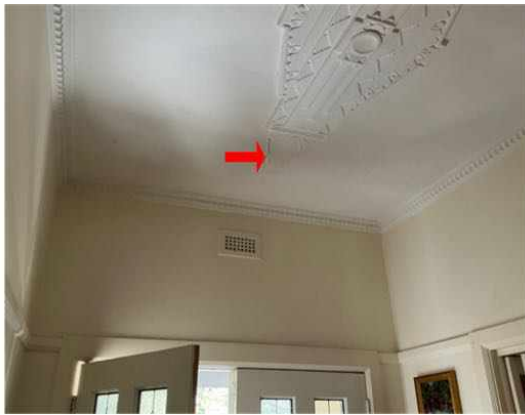
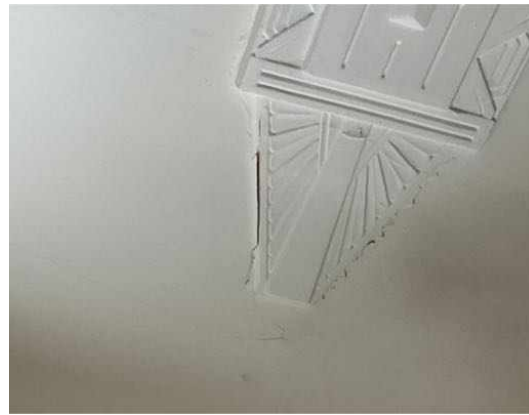
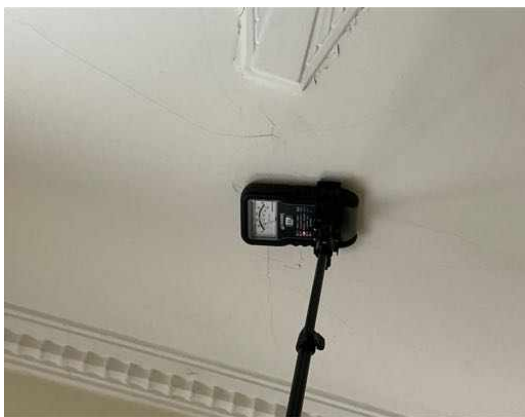
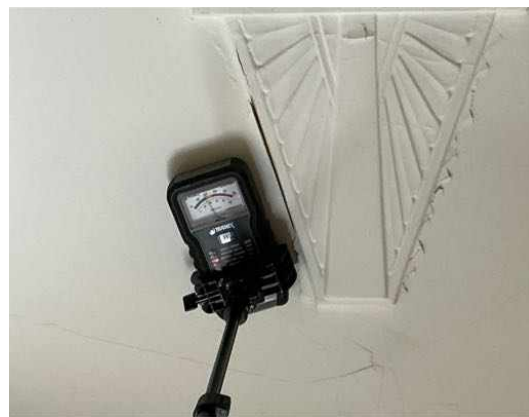
### Defects 3.15

Building: Main Building  
 Location: Entry  
 Finding: Painted surface - Bubbling  
 Information: Sections of paint in this area was found to have bubbled and deteriorated. Paint bubbling is generally an indication of excessive moisture in the area, that is currently hidden by the painted surface.

The presence of excessive moisture can have major implications on associated building elements if left unattended. While only seemingly minor at this stage, the damage cannot be determined due to the paint obstructing any further inspection of the damage.

It is highly advised that the affected paint be cleaned to allow a further, more invasive inspection by a licensed plumber. Failure to act on this defect may necessitate major works in the future.

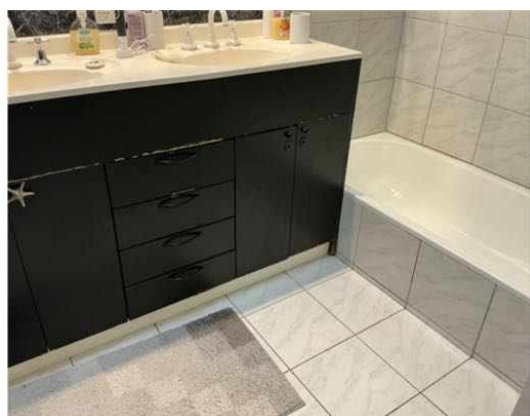
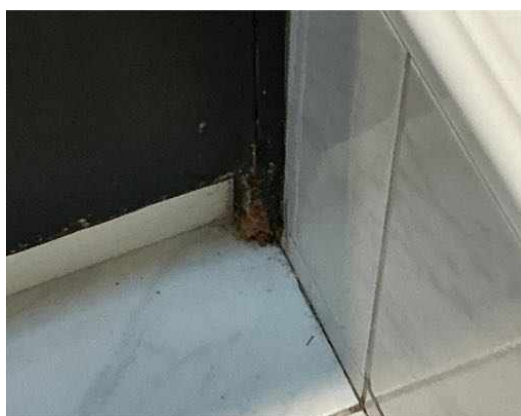
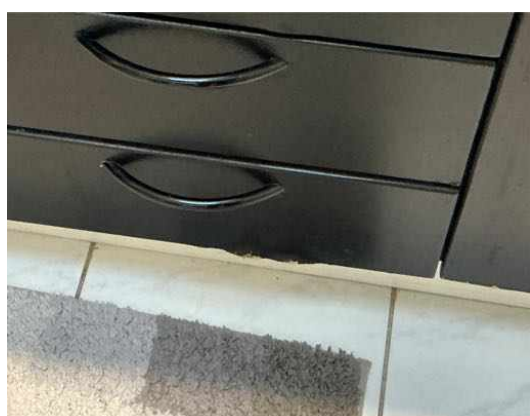
### Defects 3.16

Building: Main Building  
 Location: Bathroom  
 Finding: Building element - Swollen  
 Information: Swollen building elements generally indicate that the building materials have been affected by excessive moisture over a prolonged period of time, and have swollen as a

result. The formation and development of mould/fungi or mildew is also a likely consequence of excessive moisture, which may pose major respiratory issues for occupants, particularly the elderly, the very young and those with existing illnesses and could be potential health safety hazards. In these cases an appropriately qualified inspector/tester should also be contacted for advice and/or technical assistance.

The structural integrity of swollen building elements can not be guaranteed, and further damage is likely to develop if left unmanaged. Excessive moisture is likely to lead to the development of secondary damage to any associated building elements, which may necessitate major repair works if prolonged.

Rectification of the cause of the water leak should be addressed prior to any remedial works to the swollen building elements. A licensed plumber should be appointed immediately to identify the cause of the leak and provide advice on remedial works as necessary. Repair and/or replacement of swollen building elements should be conducted as a matter of urgency by a registered builder or qualified carpenter.

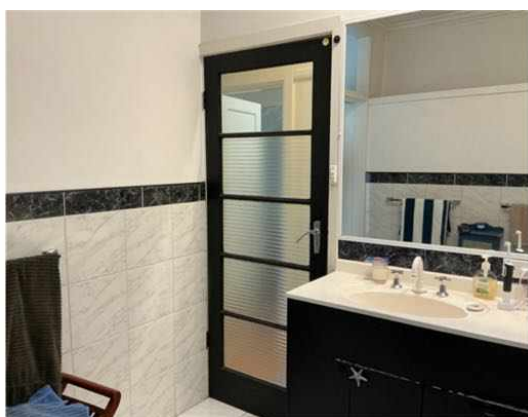
### Defects 3.17

Building:	Main Building
Location:	Bathroom
Finding:	Door handle - Not latching
Information:	It was noted that the door in this area was not latching during operation at the time of

inspection. Whilst detracting from the functionality of this building element, this minor defect may also be a security risk, and may therefore have serious implications if left unattended.

It is suspected that this defect has occurred due to minor issues with the associated hinges. Such damage is identified as general wear and tear, which is expected for building elements of this age.

A qualified carpenter or general handyperson may be appointed to perform rectification works as necessary, at client discretion. If left unattended, further functional impairment is likely to occur.

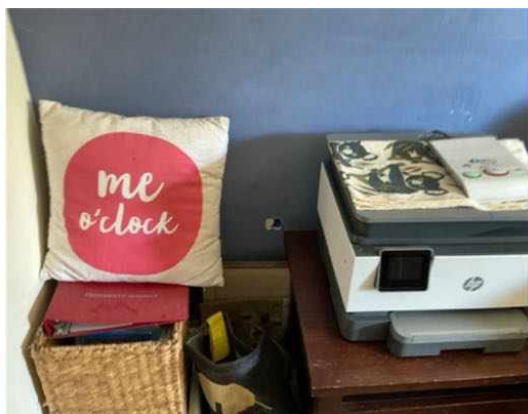
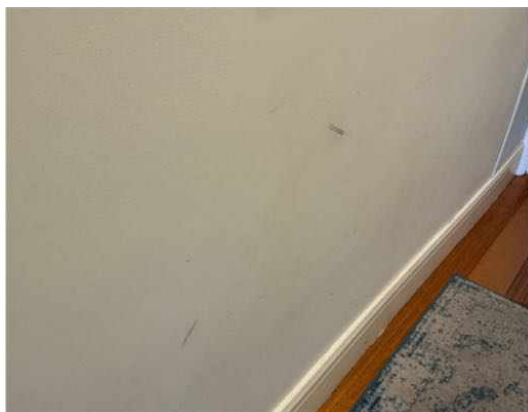
#### Noted Item

Building: Main Building  
Location: Interior exterior  
Finding: Deteriorated elements  
Information: It was identified that many items around the home have suffered from environmental effects and wear and tear with replacement required.

Secondary defects are likely if the issue is not addressed.

Elements such as bolts and structural brackets may require the services of a builder where replacement is required other wise a carpenter or handy man can attend to the more general replacement requirements such as loose hinges, door handles, damaged plaster fixtures etc.

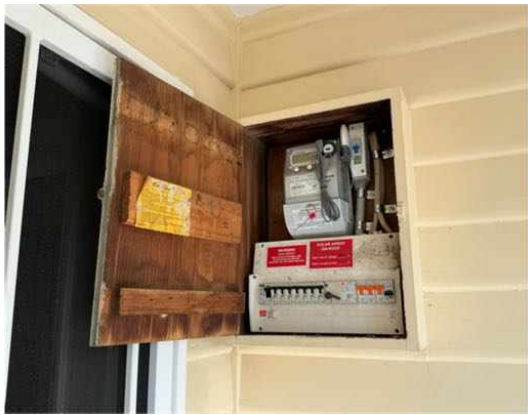
### Noted Item

Building: Main Building  
 Location: Electrical Switchboard  
 Finding: Termite Management System - no evidence of a chemical installation  
 Information: The application of a post-construction chemical termite barrier is highly recommended for all properties, particularly if live termite activity has been found on the site previously. Such barriers are highly effective in preventing termite attack on any timber building elements throughout the property.

The client may consider gaining further advice from a pest controller as to the costs and procedures involved with this application. It is recommended that obtaining such advice be a short-term priority.

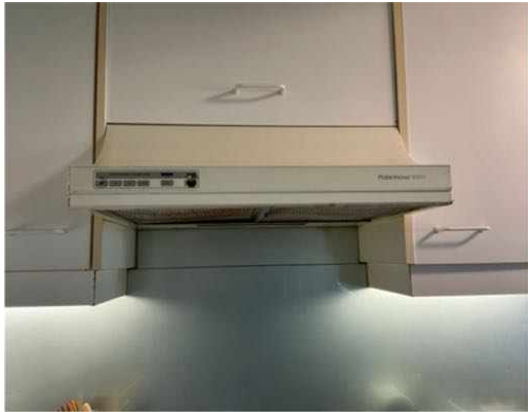
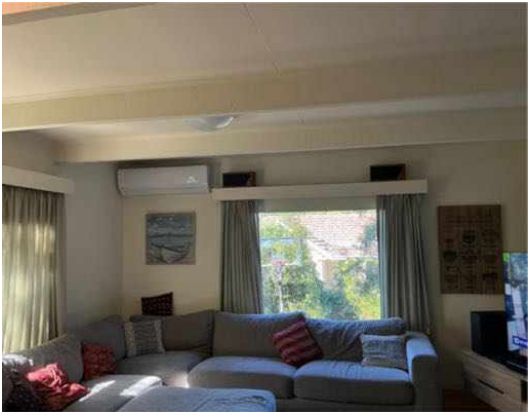
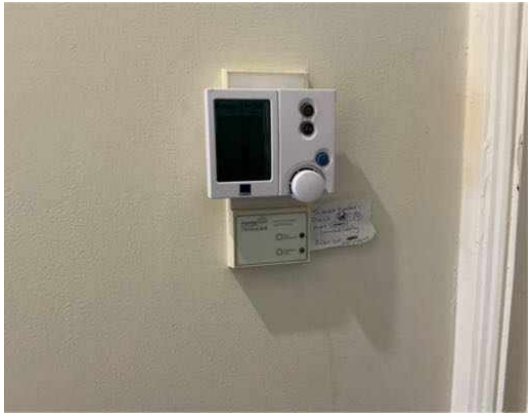
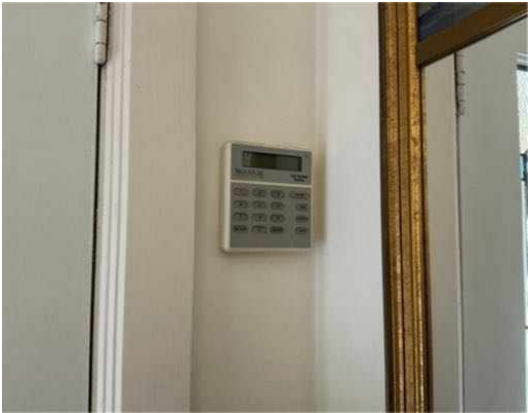
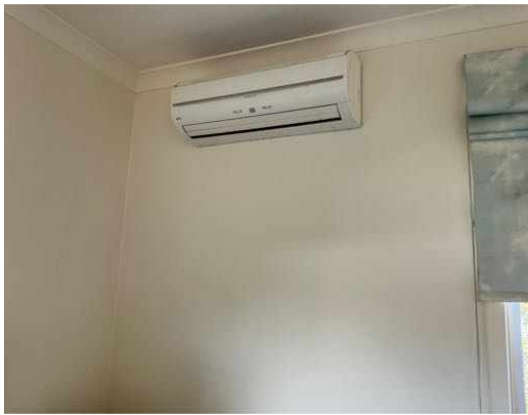
**Noted Item**

Building: Main Building  
Location: All Areas  
Finding: Warranty - Expired  
Information: Where appliances are beyond their warranty period, the owner should be prepared to meet the cost of replacement or repair of the item at any time. The operation of the appliance can not be guaranteed and further inspection by an appropriately qualified tradesperson may be required.
