# Building and Timber Pest Inspection Report

Inspection Date: Tue, 10 Mar 2026

Property Address: 25 Quinn St, West Tamworth NSW 2340,  
Australia

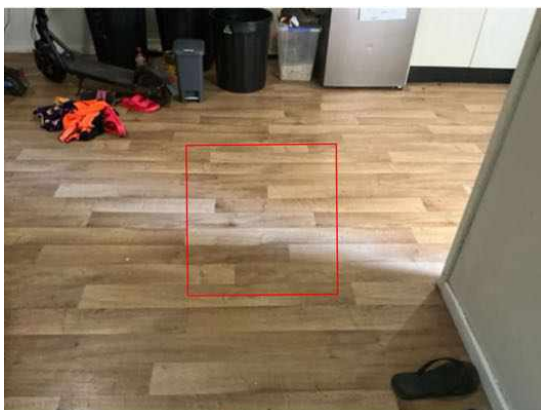
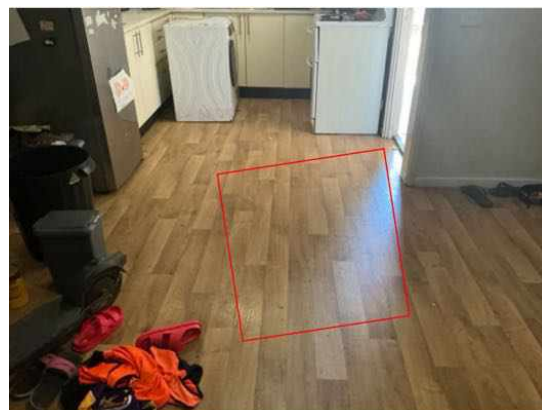
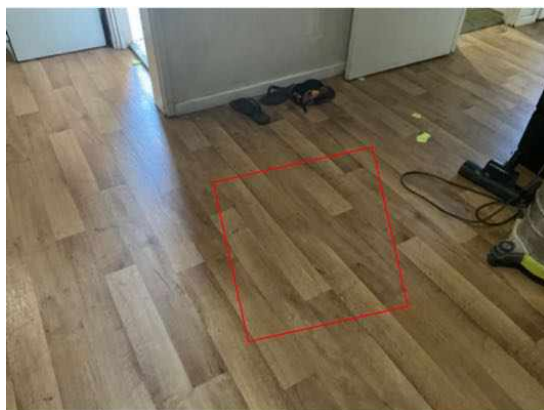
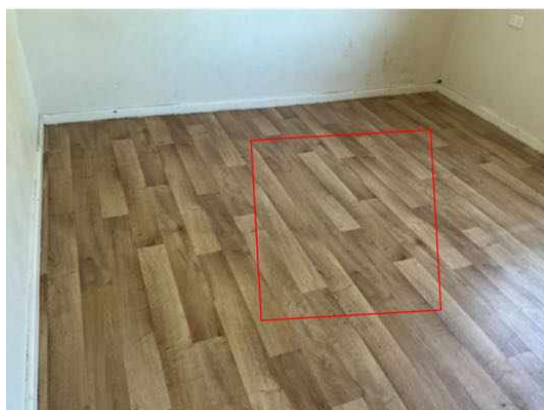
Building: Main Building  
Location: All Internal Areas  
Finding: Flooring - Severe Unevenness  
Information: The internal flooring within this area was observed to be significantly out of level and uneven. The degree of unevenness is considered excessive and is well beyond what would typically be expected from normal settlement or minor movement in a building of this age.

The severity of the floor deflection strongly suggests that there may be movement or failure within the supporting subfloor structure. This may include settlement of footings, movement or deterioration of subfloor stumps/piers, or deflection of supporting floor beams and joists.

Flooring exhibiting this level of unevenness is indicative of an underlying structural issue rather than minor cosmetic settlement. The condition is considered substantial and warrants further investigation.

A thorough inspection of the subfloor structure should be carried out by a suitably qualified structural engineer or experienced building contractor. Investigation should include assessment of the supporting piers, stumps, beams and footings to determine the cause of the movement. Rectification works may be required and could involve structural repairs of the affected area by a suitably qualified builder.

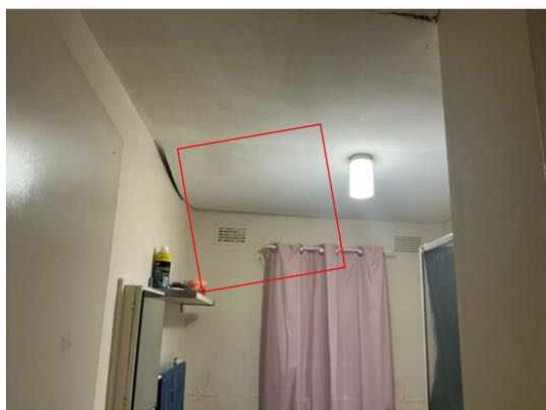
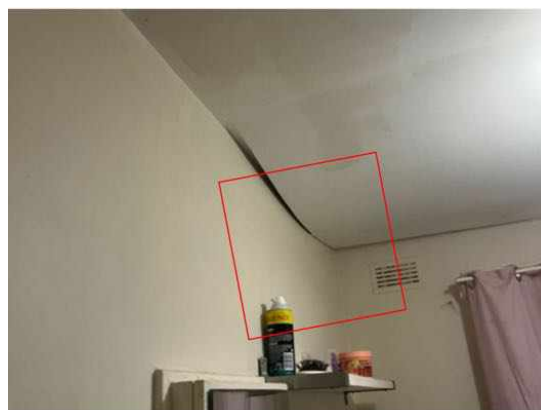
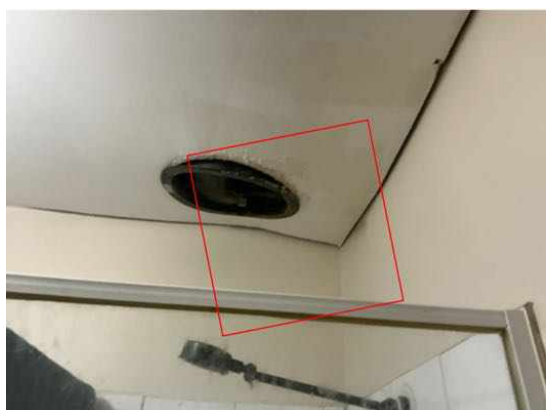
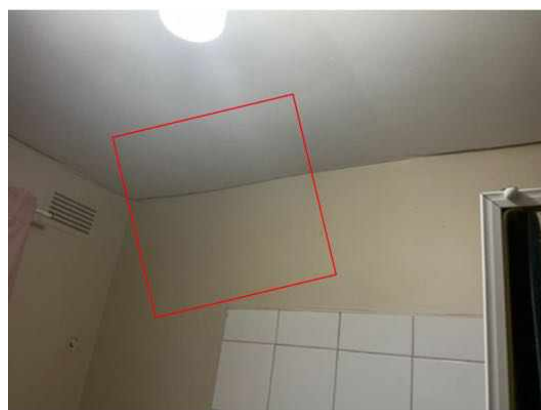
## Finding 2.02

Building:	Main Building
Location:	Bathroom
Finding:	Water Damaged Ceiling - Severe
Information:	The bathroom ceiling lining has been significantly affected by water ingress and is showing extensive deterioration across the entire ceiling area. The plasterboard ceiling lining is visibly sagging and breaking down, indicating prolonged exposure to moisture. It is understood this condition may have originated from a previously connected water storage system located within the roof space.

Plasterboard ceiling linings that have been saturated with water lose their structural integrity and can progressively deteriorate. The extent of sagging and material breakdown observed indicates that the ceiling lining has been compromised and may be at risk of further failure or collapse. Prolonged moisture exposure within ceiling cavities may also contribute to mould growth, deterioration of insulation, corrosion of fixtures, and potential impacts to adjacent structural timbers and electrical components.

The condition is considered significant and requires immediate attention.

The client should arrange for a suitably qualified contractor to inspect the roof space and confirm the source of the previous water ingress has been permanently rectified. The affected ceiling lining should be removed and replaced, and the ceiling cavity

inspected for any associated moisture damage, mould growth, or deterioration of building materials. Any affected insulation, electrical components, or structural elements should also be assessed and rectified as required.

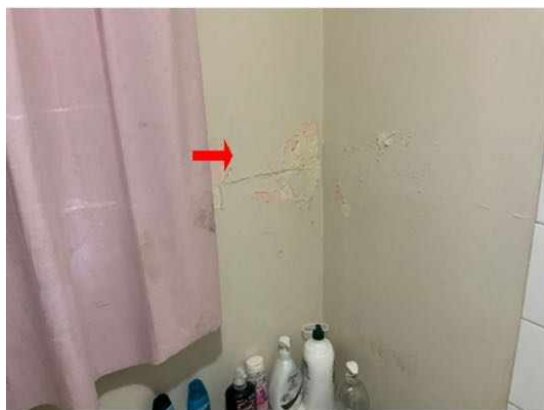
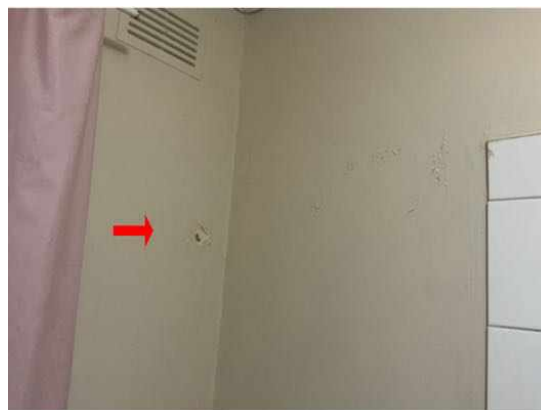
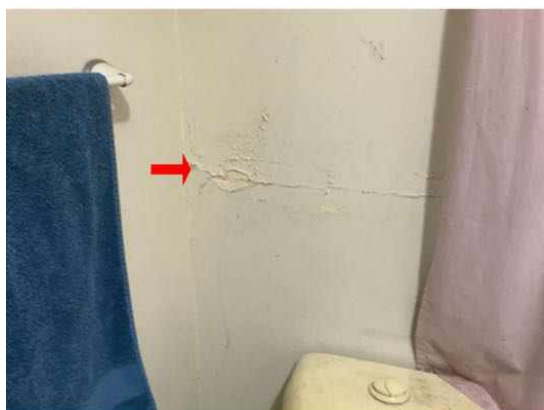
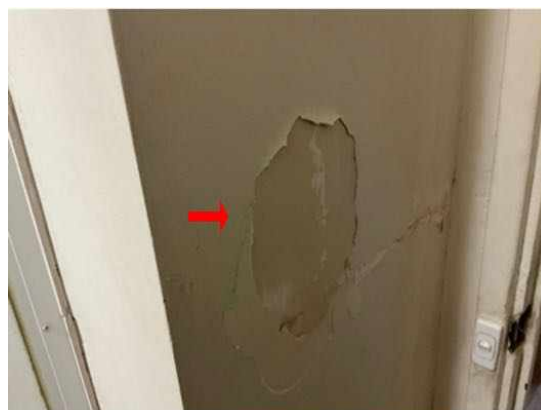
### Finding 2.03

Building:	Main Building
Location:	Bathroom
Finding:	Painted surface - Peeling
Information:	Sections of paint in this area was found to have peeled and deteriorated. Paint peeling and or bubbling is generally an indication of excessive moisture in the area, that is currently hidden by the painted surface.

The presence of excessive moisture can have major implications on associated building elements if left unattended. While only seemingly minor at this stage, the damage cannot be determined due to the paint obstructing any further inspection of the damage.

It is highly advised that the affected paint be cleaned to allow a further, more invasive inspection by a licensed plumber. Failure to act on this defect may necessitate major works in the future.

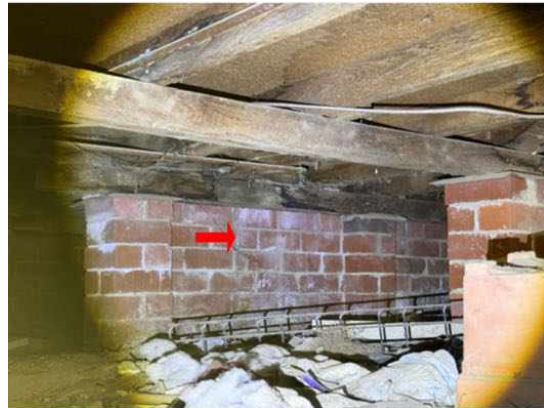
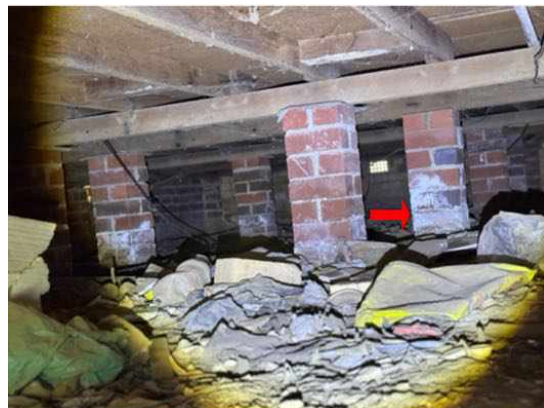
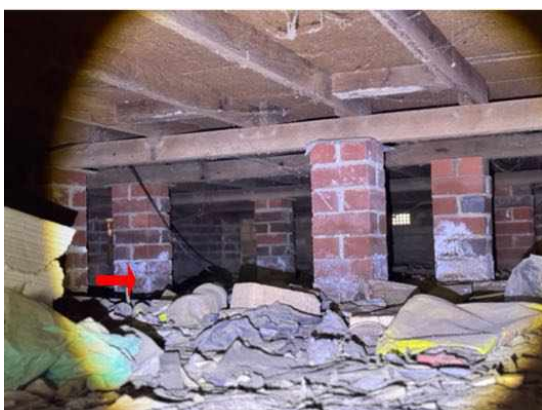
### Finding 2.04

Building:	Main Building
Location:	Subfloor
Finding:	Subfloor Moisture/Efflorescence - Present
Information:	Evidence of moisture staining and salt deposits (efflorescence) was observed to several brick piers and masonry elements within the subfloor area. Efflorescence occurs when moisture moves through masonry materials and deposits mineral salts on the surface as it evaporates.

The presence of efflorescence indicates that moisture is migrating through the masonry, which may be associated with ground moisture, inadequate subfloor drainage, or limited ventilation within the subfloor space.

It is also recommended that the adjacent wet areas within the dwelling be further investigated, as leakage from internal plumbing fixtures or wet area waterproofing failures may also contribute to elevated moisture levels within the subfloor space. Additionally, the rear external wall does not appear to have any visible drainage provisions, which may allow rainwater to accumulate against the structure.

During periods of heavy rainfall, surface water may migrate along the ground and potentially flow beneath the dwelling, contributing to the moisture conditions observed within the subfloor area.

Prolonged moisture conditions within subfloor areas may contribute to deterioration of masonry materials, corrosion of metal components, and may increase the risk of timber decay or termite activity if moisture levels remain elevated.

The client should monitor the subfloor area for ongoing moisture presence and ensure adequate subfloor ventilation and site drainage are maintained. If excessive moisture persists, further assessment by a suitably qualified contractor may be required to determine the source and implement appropriate moisture management measures.

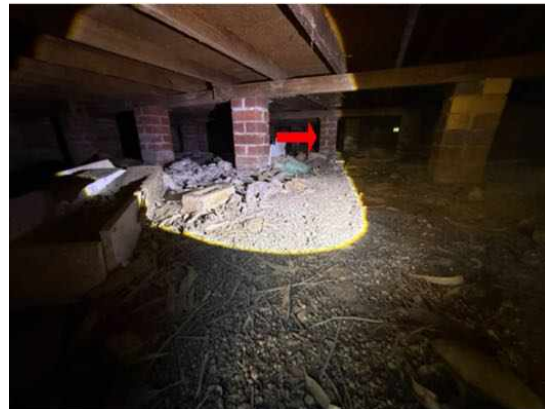
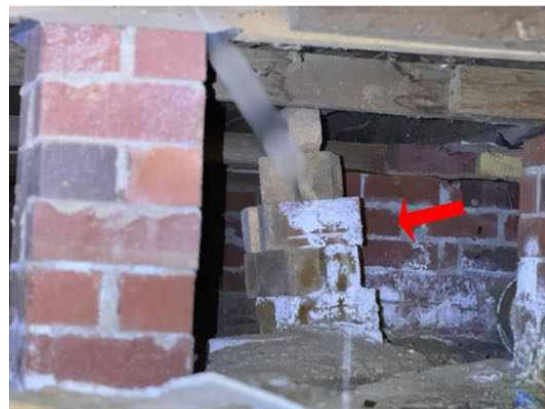
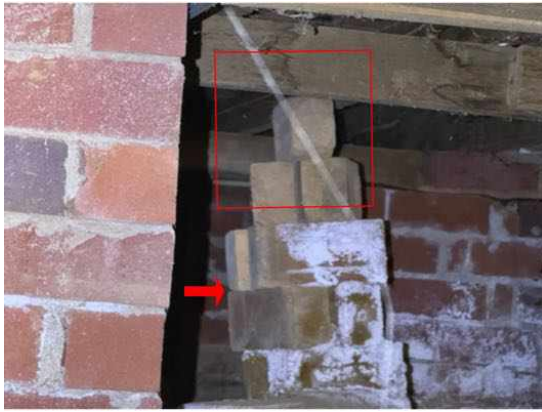
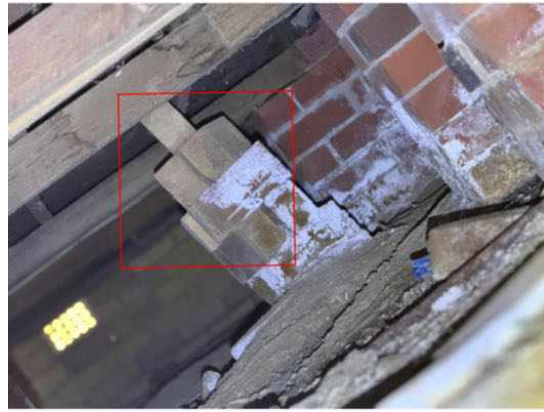
### Finding 2.05

Finding: Subfloor Brick Piers - Unstable or Deteriorated

Information: The brick piers supporting the subfloor structure are exhibiting signs of instability, suggesting that their structural integrity has been compromised. This may be the result of ground movement, deterioration of mortar joints, or other underlying structural issues. Such conditions can accelerate the degradation of the piers and pose a risk to the overall stability of the structure.

The brick piers are suspected to be failing in their intended structural function, which may lead to a variety of significant and minor building defects. If left unresolved, further and potentially severe damage to both the piers and the subfloor structure may occur.

It is essential that a Registered Builder, preferably with expertise in subfloor repairs and re-piering, be engaged without delay to assess the condition of the brick piers and recommend appropriate remedial works. This defect requires immediate attention and should not be left unaddressed.

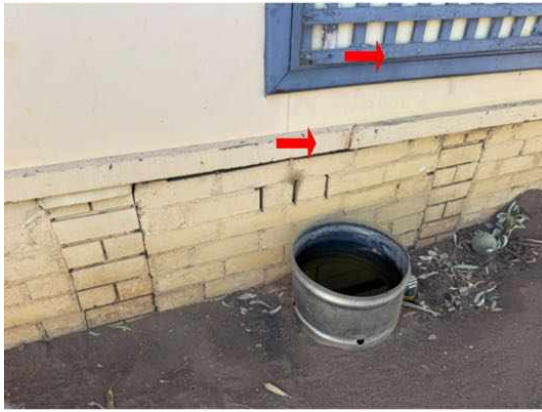
### Finding 3.01

Information: External timber elements around the property were observed to be showing signs of general wear and tear, including surface deterioration, fading, and early signs of weather exposure. These conditions are commonly caused by prolonged exposure to sunlight, moisture, and temperature fluctuations, which can lead to cracking, splitting, or degradation over time if not properly maintained.

It is recommended that all external timber be inspected and maintained to ensure ongoing protection. This may include sanding, sealing, or repainting affected sections. Regular maintenance will help preserve the timber's integrity, extend its lifespan, and prevent more extensive damage in the future.

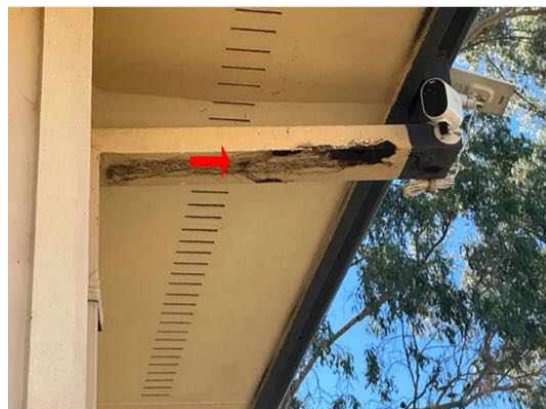
### Finding 3.02

Building:	Main Building
Location:	All External Areas
Finding:	Gutter/Fascia Damaged/Deteriorated
Information:	The damage of the gutters or fascia has occurred on the front left hand side of the facade as shown in the photos.

Breakage and deterioration occurs generally when either the metal/timber has aged and decayed with excessive moisture, or as a result of damage (accidental or deliberate).

Repair and/or replacement of the gutter is advised to ensure that additional secondary defects do not arise as a consequence. Such works are necessary, as all building elements play a key role in the operation and function of the overall structure and its performance.

A licensed roof plumber should be appointed immediately to repair or replace the damaged gutter prior to any subsequent damage being caused.

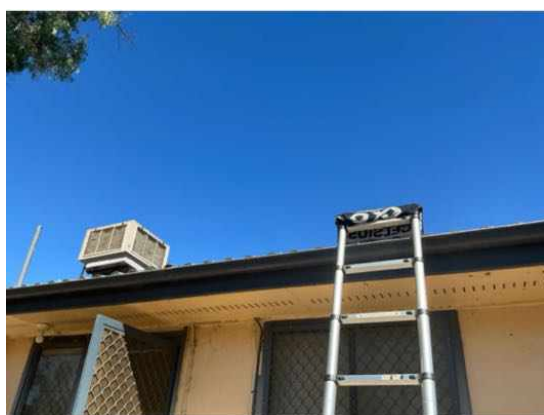
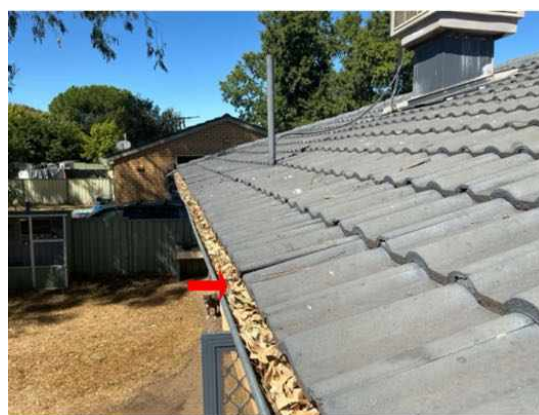
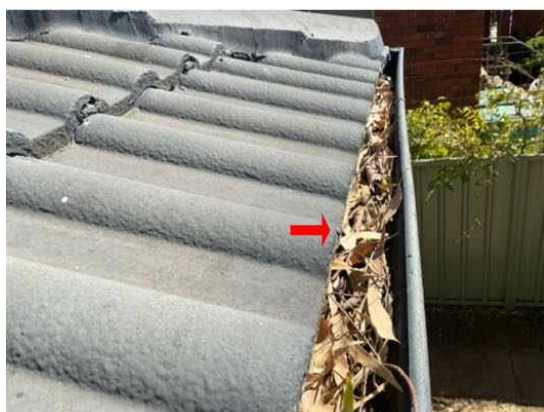
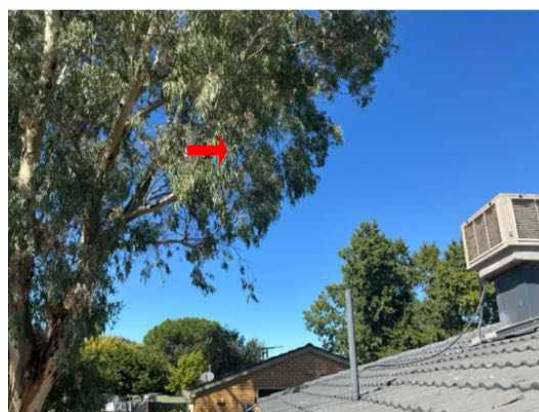
### Finding 3.03

Blocked gutters are likely to lead to high levels of moisture in the affected areas. Such moisture will not only cause rust and decay of the associated building materials, but can also provide conditions that are conducive to termite and timber pest activity. Blockages in gutters should therefore be removed immediately to ensure dry conditions are maintained.

Consult a Licensed Plumber for further specific advice on remedial works that may be required. In the interim, it is highly advised that blocked gutters be removed by the homeowner or a general handyperson as a matter of urgency.

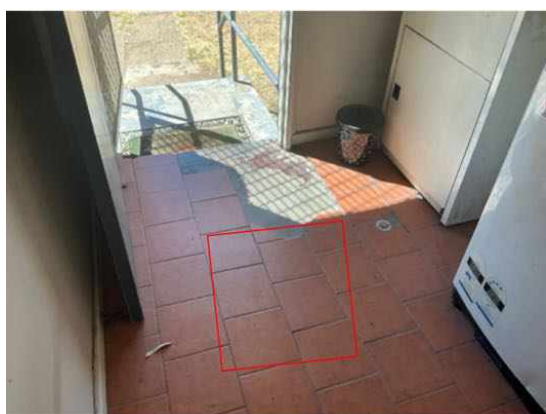
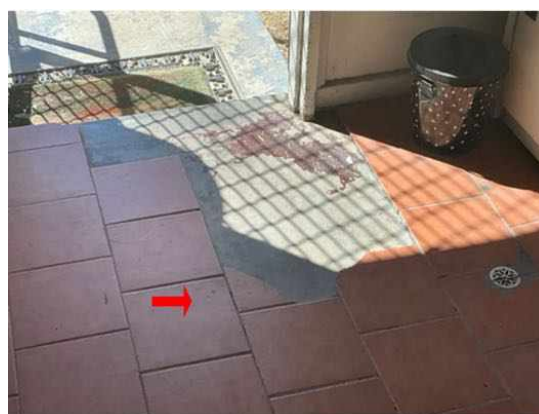
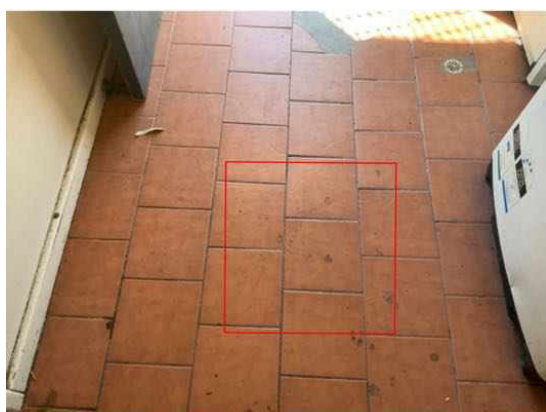
### Finding 3.04

Building: Main Building  
 Location: Laundry  
 Finding: Tiles - Drummy  
 Information: Drummy tiled areas were identified at the time of inspection. The term 'drummy' refers to tiles that have become detached from their fixing, despite otherwise being in

relatively good condition. Such defects are generally caused by physical or moisture damage to the area. Drummy tiled areas may also be a direct result of poor workmanship during the construction process.

Tiled areas may swell and shrink with changes in air humidity if the area has sustained moisture damage. Any exposure to moisture is capable of causing tiled areas to become drummy and/or cracked over a prolonged period of time. Drummy tiled areas generally require removal and replacement of affected tiles, with adequate sealant and grouting.

Specialist trades are available for these types of services. A registered builder may be required to undertake works if damage is extensive or if secondary building defects have resulted. Otherwise, it is advised that a tiling contractor be appointed to perform works as necessary. Immediate action is recommended to ensure that no further damage is sustained in the affected area.

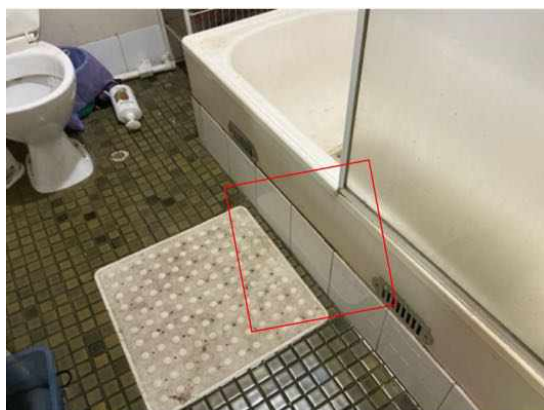
### Finding 3.05

Building:	Main Building
Location:	Bathroom
Finding:	Missing Tiles - Bath Hob
Information:	The bath hob was observed to have only a single row of tiles installed at the lower section adjoining the floor. The remaining surface of the bath hob appears unfinished

Exposed substrate materials in wet areas may be vulnerable to moisture penetration and deterioration over time. Inadequate or incomplete finishing of surfaces surrounding baths may allow water to enter wall or framing cavities, potentially leading to damage to surrounding building materials and finishes.

The client is advised to inform the builder and request that the bath hob be properly finished with suitable waterproofing and tiling in accordance with standard wet area construction practices to prevent moisture ingress and ensure a durable finish.

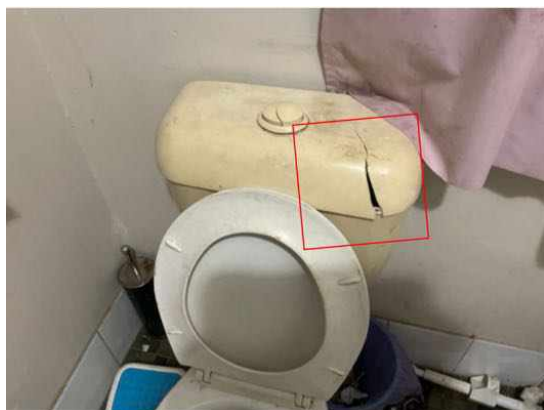
### Finding 3.06

Building:	Main Building
Location:	Bathroom
Finding:	Damaged/Deteriorated
Information:	Breakage occurs generally when the building materials have either aged and decayed, or as a result of damage (accidental or deliberate).

Repair and/or replacement of these materials is advised to ensure that additional secondary defects do not arise as a consequence. Such works are necessary, as all building elements play a key role in the operation and function of the overall structure and its performance.

A relevant tradesperson should be appointed to repair or replace the affected building element prior to any subsequent damage being caused.

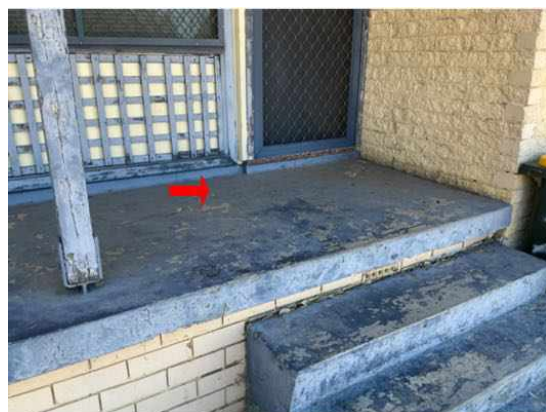
The concrete porch/patios are providing a concealed entry point at the time of the inspection. Where the location of the porch is retrospectively installed against an external wall this will provide a concealed entry point for termites.

The client should consider gaining further advice from a timber pest technician as to treatments required in this area. It is recommended that obtaining such advice be a short-term priority.

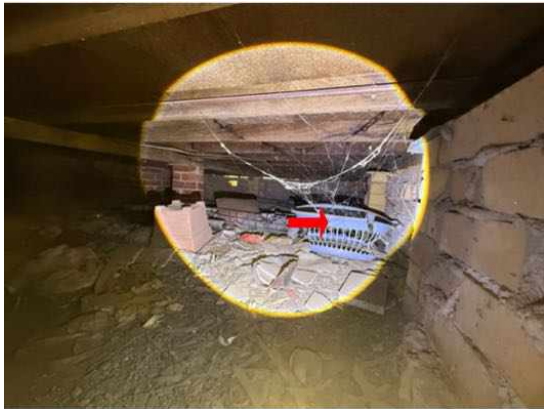
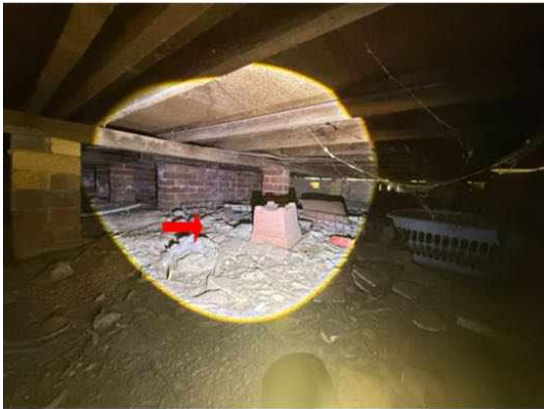
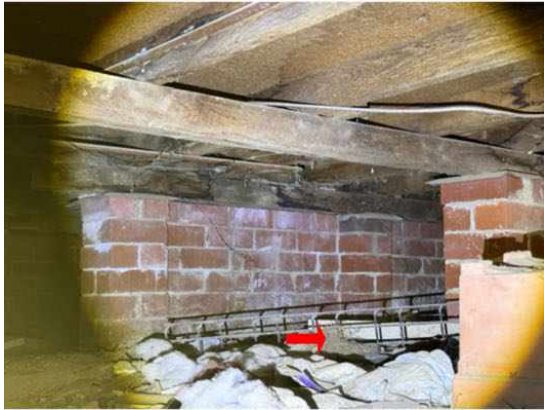
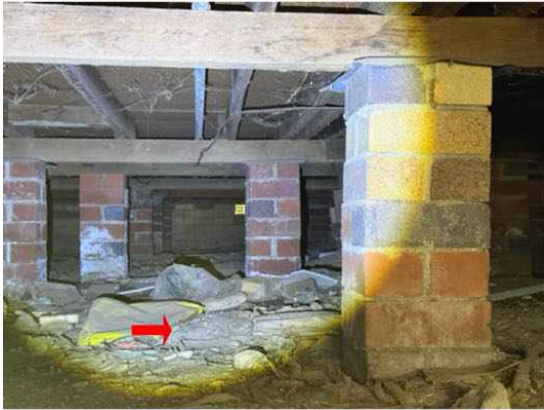
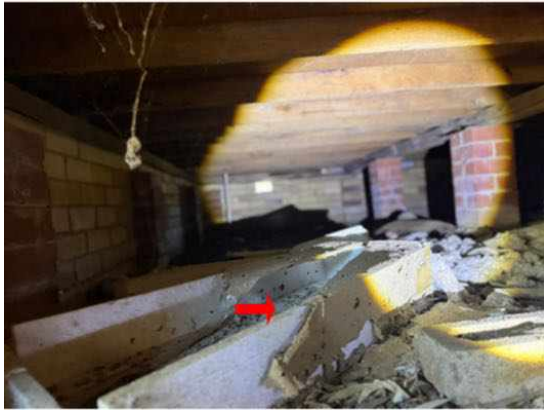
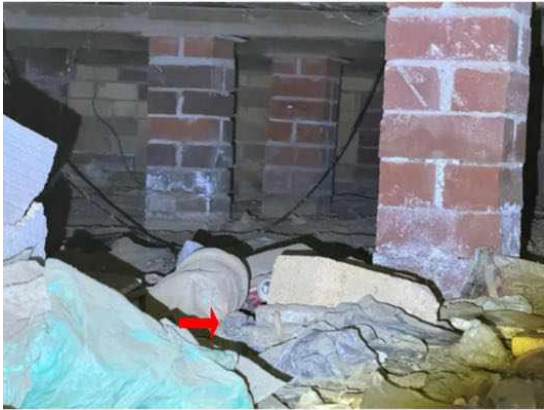
Building:	Main Building
Location:	Subfloor
Finding:	Stored Items - Subfloor
Information:	At the time of inspection, various stored items and leftover building materials were observed within the subfloor area of the dwelling. Subfloor areas are required to remain clear and unobstructed to allow for adequate ventilation, routine inspection access, and to prevent the accumulation of moisture and pests.

The storage of materials and general items in this space can obstruct air flow, potentially contributing to poor ventilation and the buildup of damp conditions, which may lead to timber decay, mould growth, or termite activity. Additionally, stored items can conceal defects or damage within the subfloor, delaying their detection and rectification.

It is recommended that all stored items and debris be removed from the subfloor area to maintain compliance with good building practice and to preserve the structural and environmental integrity of the subfloor space.
