## Building Inspection Report

Inspection Date: Tue, 18 Nov 2025

Property Address: 1 Derwent Ave, Margate TAS 7054,  
Australia

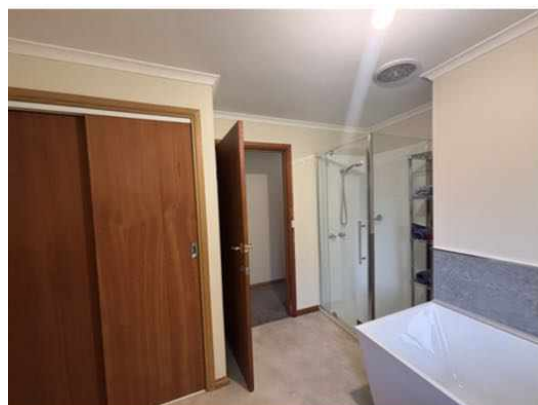
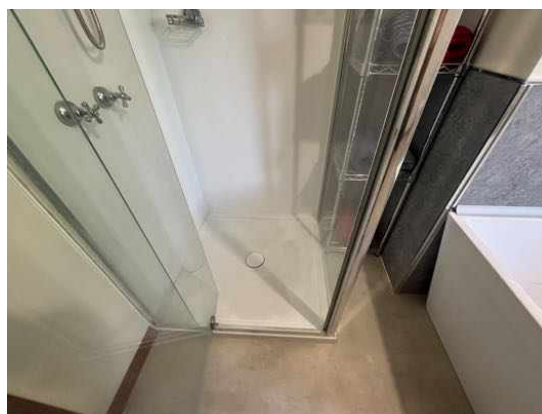
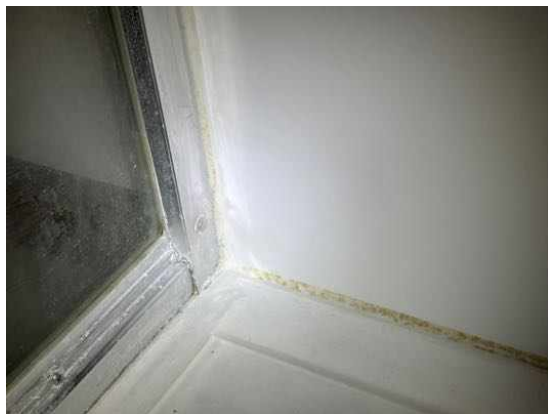
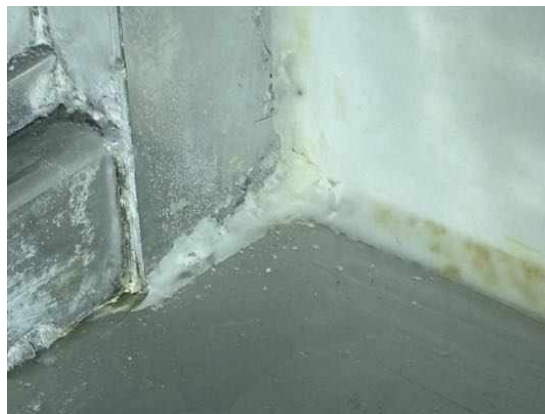
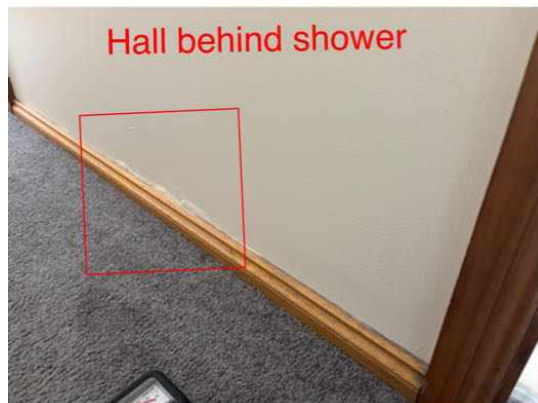
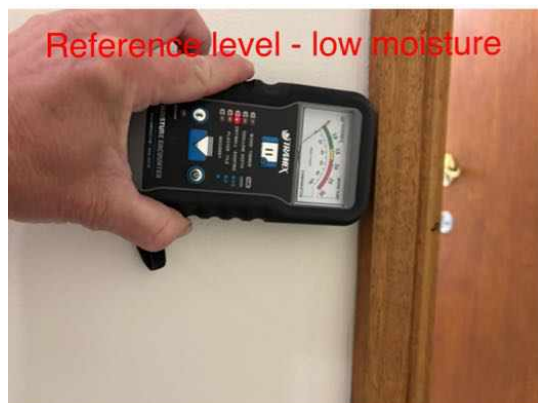
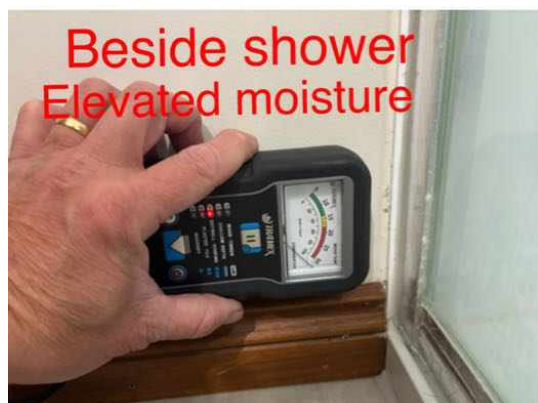
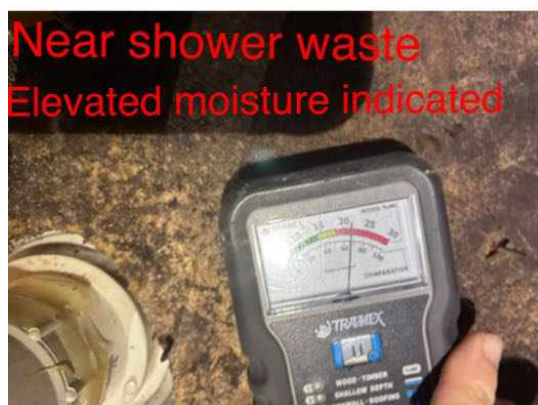
#### Defects 2.01

Building: Main Building  
Location: Bathroom  
Finding: Bathroom - water leak  
Information: In the main bathroom there were elevated moisture readings to the floor around the outside of the shower. The plasterboard beside the shower has elevated moisture readings. There is some deteriorated silicone inside the shower. There are also elevated moisture readings to the hallway backing onto the shower. Inspection in the subfloor shows there is leaking from under the shower base and elevated moisture readings. In the subfloor there is also water staining and mould to the flooring underneath the shower, the room next door and the hallway. Water was dripping from the shower waste.

If not rectified, water will continue to ingress and may lead to further water damage and deterioration of the surrounding building elements if the water proofing membrane is not intact or absent. However our non invasive inspections is unable to determine the adequacy of the water proofing membrane. Tiles, grout and sealents are used to protect building materials to ensure that they are water-tight and prevent water penetration to the associated structures.

Leaking showers x 2. Both showers have major defects in that they have been leaking into the subfloor and adjacent rooms and walls to some extent. Recommend client engage a Lic Builder (who specialises in bathrooms) to investigate and rectify, as soon as possible.

Recommend client engage a Lic Builder (who specialises in bathrooms) to investigate and rectify, as soon as possible.

This will likely require partial demolition and reconstruction of this bathroom.

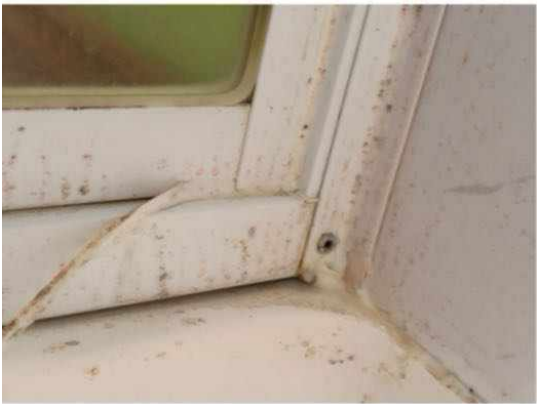
## Defects 2.02

Finding: Ensuite - water leak

Information: There is water damage and elevated moisture readings to the plasterboard beside the shower and on the bathroom and bedroom side of the wall. There have been some silicone repairs. There is elevated moisture outside of the shower to the vinyl. In the subfloor there is extensive water staining and mould to the under side of the sheet flooring. The shower silicone has deteriorated. The ensuite shower door is binding on the bottom, it may be able to be adjusted at the mounting points. The subfloor access under here was quite tight and pipes prevented moisture checks to the entire affected area. There was also some mould in the bottom of the cupboard that backed onto this bathroom, that may be related.

If not rectified, water will continue to ingress and may lead to water damage and deterioration of the surrounding building elements if the water proofing membrane is not intact or absent. However our non invasive inspections is unable to determine the adequacy of the water proofing membrane. Tiles, grout and sealants are used to

Recommend client engage a Lic Builder (who specialises in bathrooms) to investigate and rectify, as soon as possible.

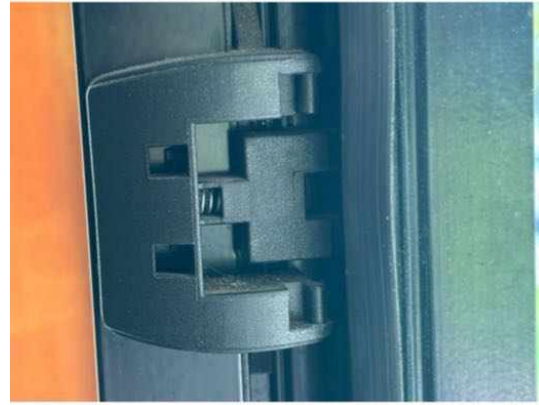
### Defects 3.01

Building:	Main Building
Location:	Front Living Room
Finding:	Window latches damaged
Information:	The window latches in the front 2nd living room are damaged and not easy to open.

Windows provide ventilation to the adjoining area and should be at a fully operational level to ensure user comfort. Restricted function of the window may also pose as a potential safety hazard if required for emergency egress from the building.

Generally, factors such as general age of the building element and a lack of maintenance are the usual causes for this type of defect.

Recommend client engage a Handy Person to rectify at clients convenience.

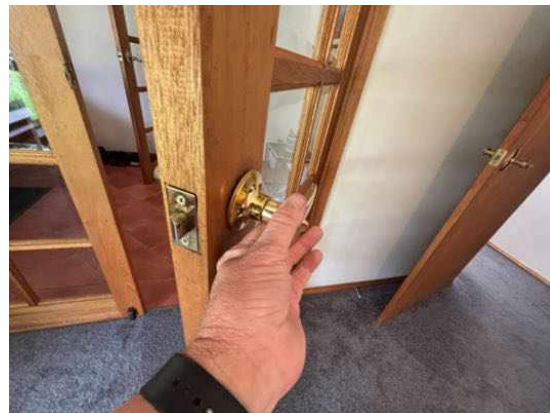
### Defects 3.02

Building: Main Building  
 Location: Entry foyer room  
 Finding: Door handle loose  
 Information: In the entry foyer room the door handle is loose. This impedes the function of the door.

Generally, factors such as general age of the building element and a lack of maintenance are the usual causes for this type of defect.

Recommend client engage Handy Person to rectify at clients convenience.

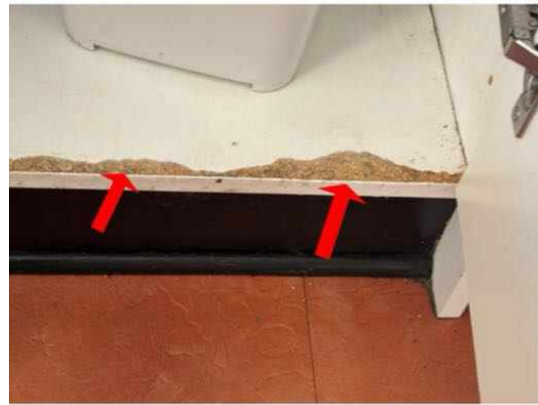
### Defects 3.03

Building: Main Building  
 Location: Kitchen  
 Finding: Laminate damaged to kitchen cabinet  
 Information: In the kitchen there is damage to the laminate of the cabinet under the kitchen sink.

Recommend client engage a Handy Person to paint at clients convenience to prevent moisture ingress.

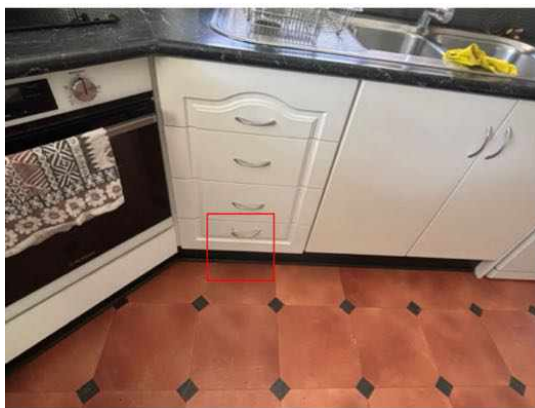
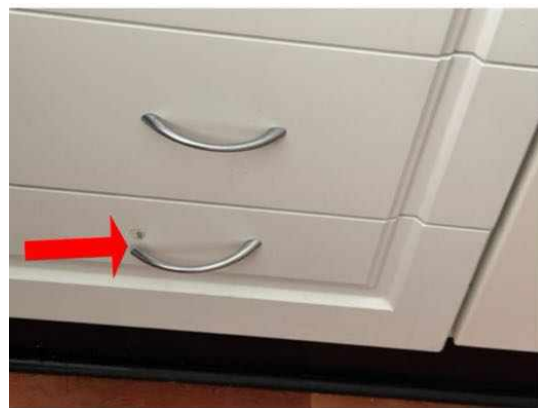
### Defects 3.04

Building: Main Building  
 Location: Kitchen  
 Finding: Draw handle loose  
 Information: In the kitchen the draw handle was loose. This impedes the function of the draw.

Recommend client engage Handy Person to rectify at clients convenience.

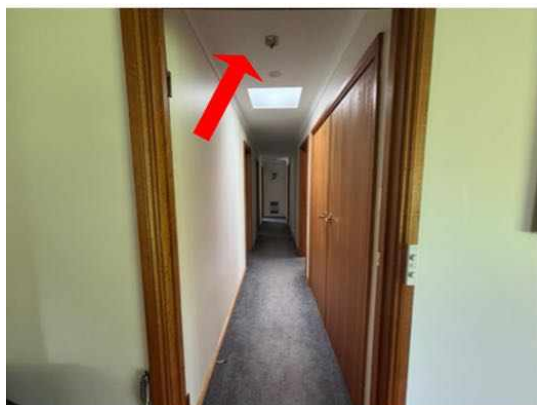
### Defects 3.05

Building: Main Building  
 Location: Hallway  
 Finding: Smoke Alarm  
 Information: For your information, the smoke alarm in the hallway has only a base attached to the ceiling, the smoke alarm has been removed.

experience in the building industry, that the absence of smoke detectors, or their poor condition, should be addressed as a matter of urgency to improve occupant safety.

Always ensure sufficient working and suitable smoke detectors are installed prior to occupying any building. Additionally, it is advised that all smoke detectors be tested by the homeowner on a monthly basis.

Modern building standards would require hard wired and interconnected smoke alarms. This older property is not required to have this, but I still recommend that you install smoke alarms to meet these current standards. Recommend client engage a Lic electrician to install prior to occupation.

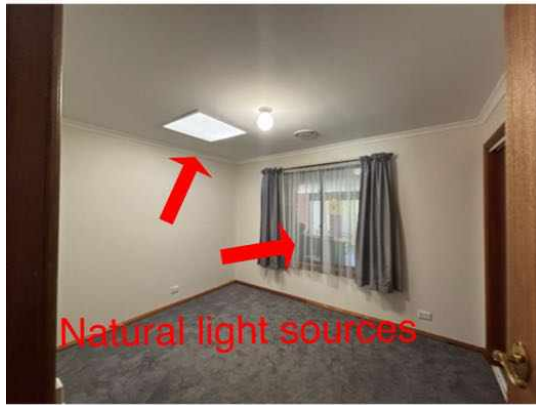
### Defects 3.06

Building:	Main Building
Location:	Internal bedroom
Finding:	FYI internal bedroom
Information:	FYI the internal bedroom has a window that opens to the entertainment area. It has also been fitted with a sky light. This may not meet current building standards, however this is not a new construction report.

If this were a new construction, the building surveyor would have had to assess the plans and approve or not approve. Maybe this was approved.

I have to assume it was approved, and am not considering a defect.

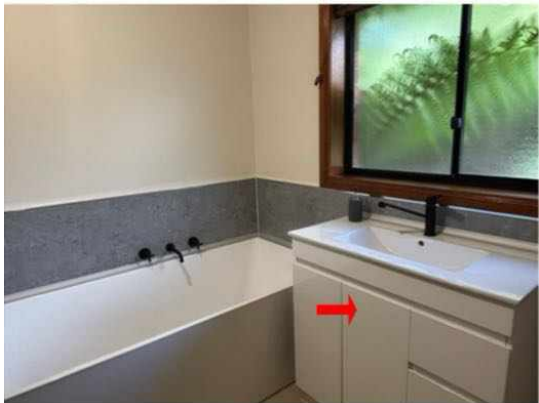
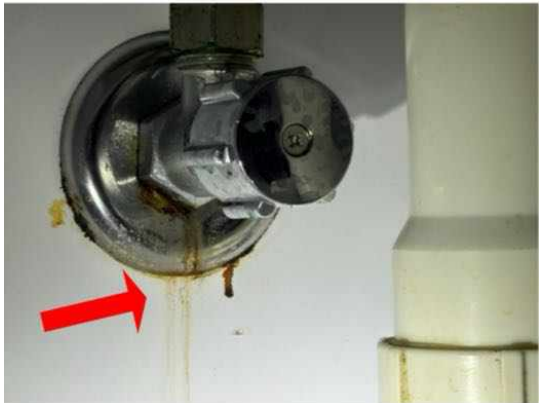
### Defects 3.07

Building:	Main Building
Location:	Bathroom
Finding:	Bathroom vanity cabinet water leak
Information:	In the bathroom vanity cabinet there is corrosion and evidence of water leak from the stop cock. It appeared to be dry at the time.

Internal water leaks can be detrimental to surrounding building elements. Rust, corrosion, decay and water damage are potential outcomes where a water leak is left unattended. In extreme cases, structural damage may develop due to a prolonged water leak.

Recommend client engage a Lic Plumber to inspect and rectify if required when attending for other items.

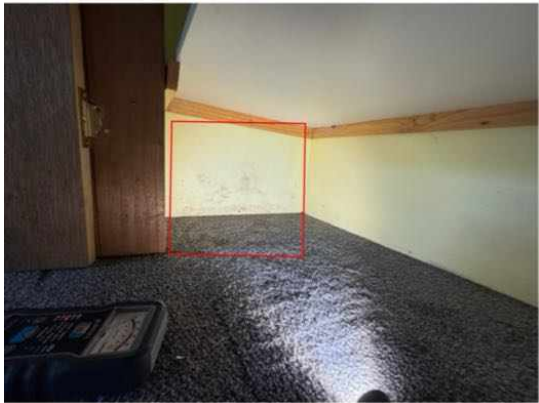
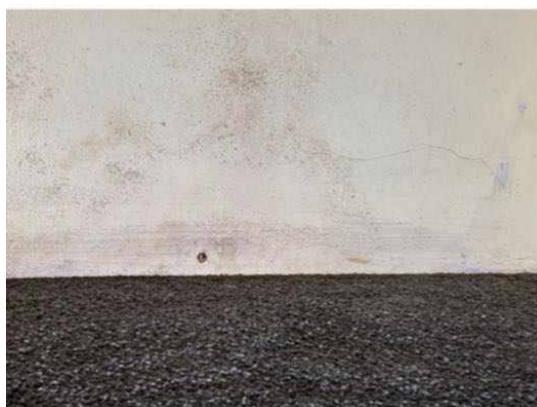
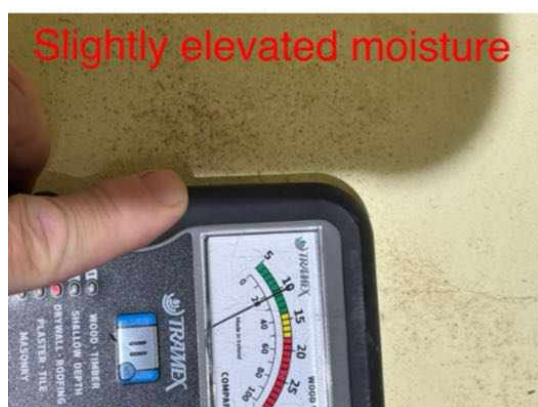
**Defects 3.08**

Building: Main Building  
 Location: Back bedroom to the deck  
 Finding: Mould  
 Information: In the back bedroom to the deck, there is mould in the lower section of the robe. This robe backs onto the ensuite. The mould will need to be treated and then painted, (after the ensuite issues has been rectified).

Mould can cause health related issues.

Recommend client engage a Handy Person to rectify as soon as practicable.

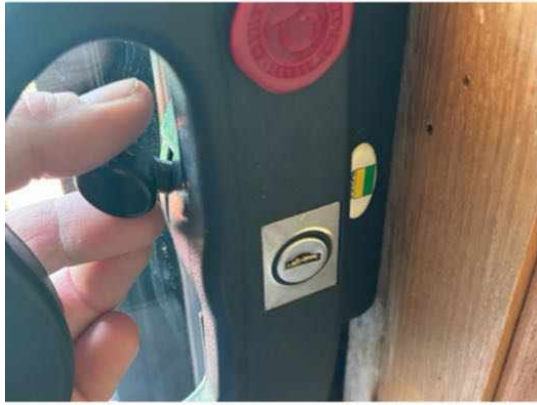
### Defects 3.09

Building:	Main Building
Location:	Back bedroom to the deck
Finding:	Sliding door latch is broken
Information:	The sliding door latch is broken to the back bedroom with the deck. This impedes the function of the door.

Recommend client engage Handy Person to repair as soon as practicable.

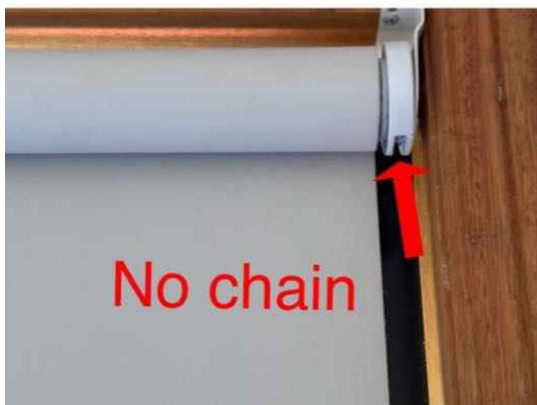
### Defects 3.10

Building: Main Building  
Location: Back bedroom to the deck  
Finding: Blind cord missing  
Information: In the back bedroom to the deck, the blind cord is missing. This impedes the function of the blind.

Recommend that client engage a Handy Person to rectify as soon as possible.

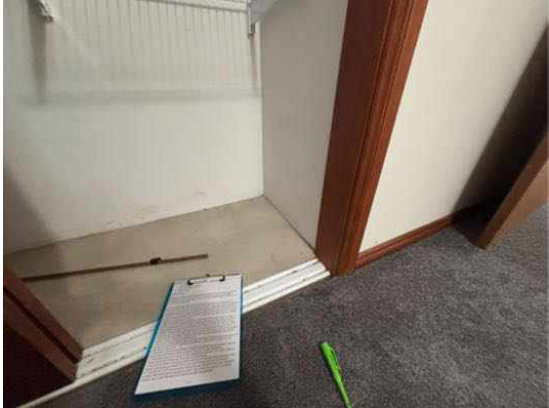
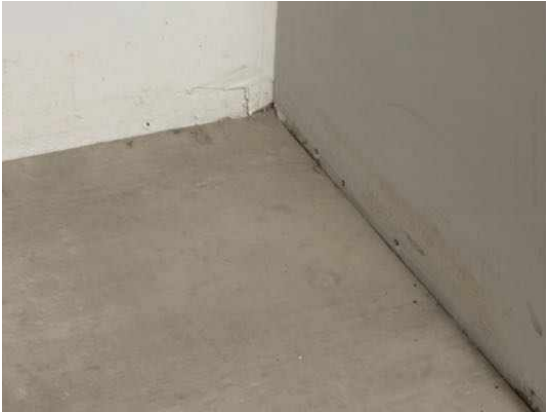
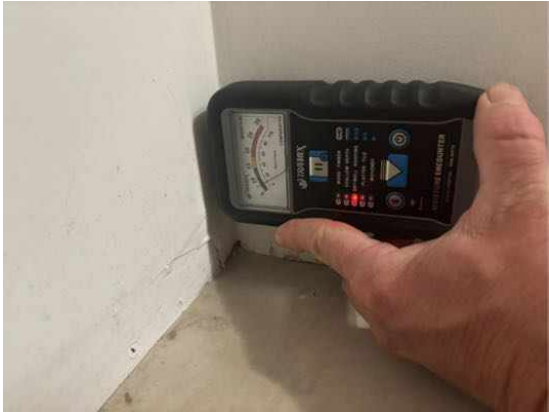
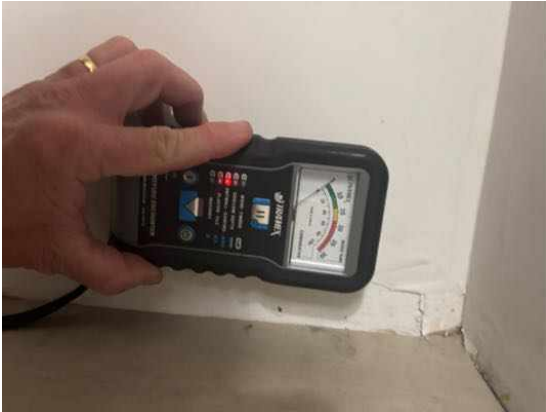
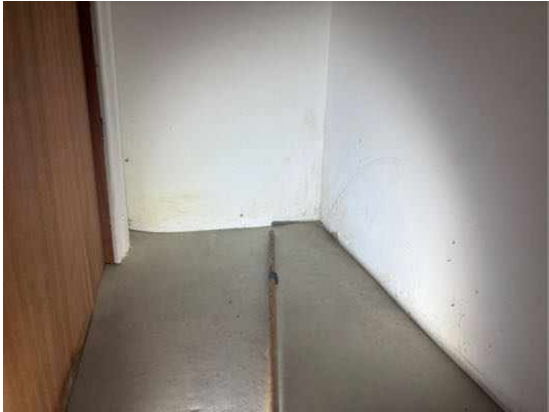
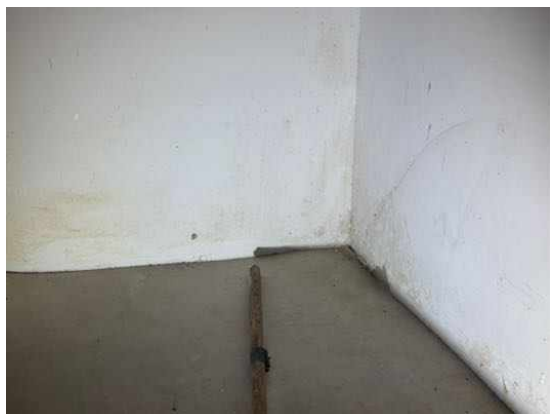
### Defects 3.11

Building: Main Building  
Location: Internal bedroom  
Finding: Internal bedroom - flooring  
Information: In the internal bedroom, the robe doesn't have carpet. However it does have vinyl over cement sheet flooring underlay, on top of chipboard. The flooring underneath this area is stained in the subfloor and there is evidence of previous water damage. There is some discoloration to the plasterboard.

This area backs onto the main bathroom where a leak has been identified. It is recommended that the flooring in the robe be removed, when carrying out other investigations for the shower that backs onto this robe.

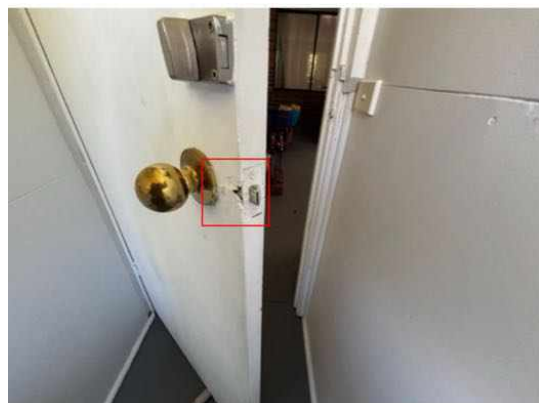
### Defects 3.12

Building:	Main Building
Location:	Entertaining Area
Finding:	Door damaged
Information:	The toilet door near the entertainment area has been damaged.

Recommend client engage a Handy Person to rectify at clients convenience, to prevent any further damage.

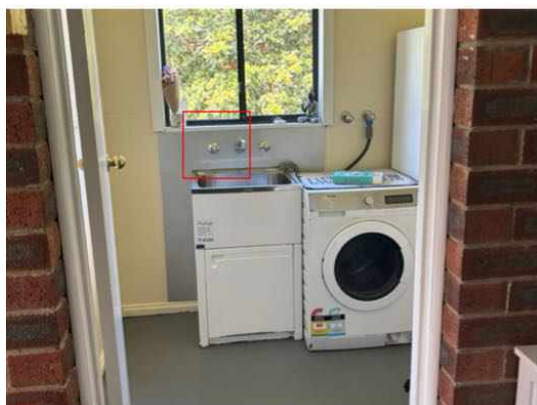
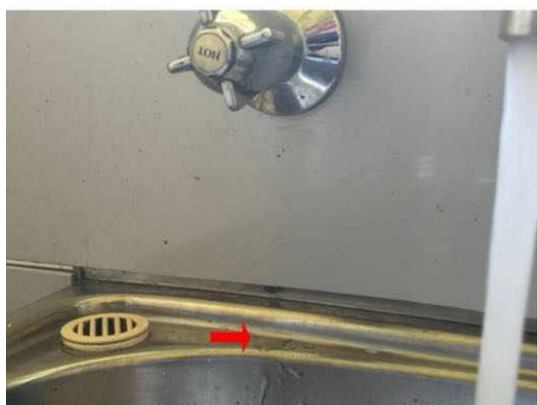
### Defects 3.13

Building:	Main Building
Location:	Laundry
Finding:	Tap dripping
Information:	The hot tap in the laundry is dripping.

Internal water leaks can be detrimental to surrounding building elements. Rust, corrosion, decay and water damage are potential outcomes where a water leak is left unattended. In extreme cases, structural damage may develop due to a prolonged water leak.

Recommend client engage a Lic Plumber to rectify as soon as possible.

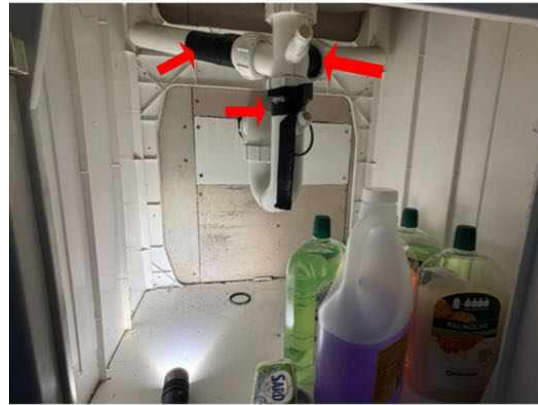
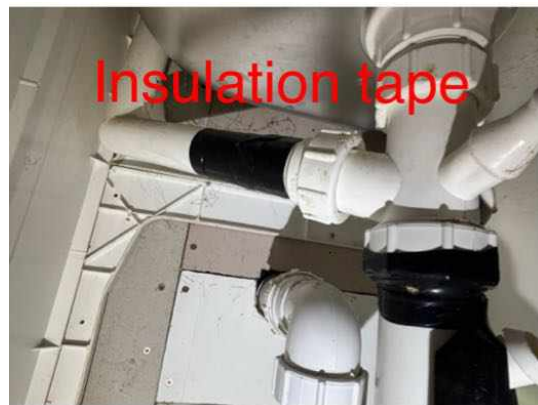
### Defects 3.14

Building:	Main Building
Location:	Laundry
Finding:	Non orthodox plumbing repairs
Information:	Under the laundry sink there are unorthodox plumbing repairs.

Internal water leaks can be detrimental to surrounding building elements. Rust, corrosion, decay and water damage are potential outcomes where a water leak is left unattended. In extreme cases, structural damage/subsidence may develop due to a

Recommend client engage a Lic Plumber to inspect and rectify when attending for other items.

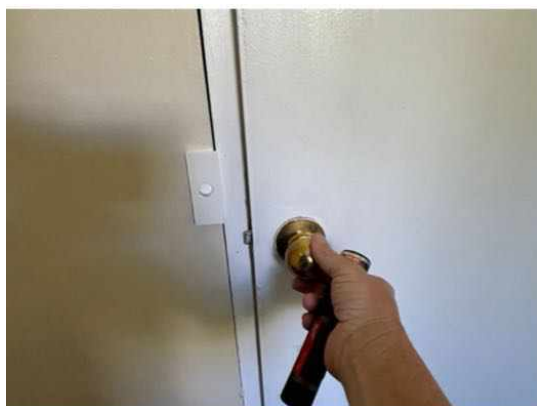
### Defects 3.15

Information: The laundry door is binding on the top of the door, also the hinge is loose or is bent. This defect inhibits the function of the door, and can cause further damage to the door and door frame if not rectified.

Recommend client engage a Handy Person to rectify at clients convenience.

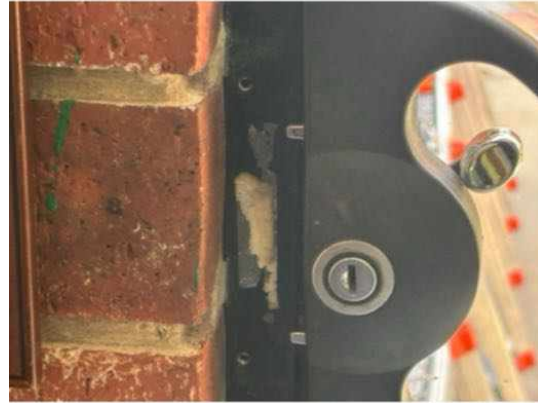
Defects 3.17

Building: Main Building  
 Location: Entertainment Area  
 Finding: Sliding door latch broken  
 Information: The sliding door latch is broken in the entertainment area. This impedes the function of the door.

Recommend client engage handy person to repair at clients convenience.

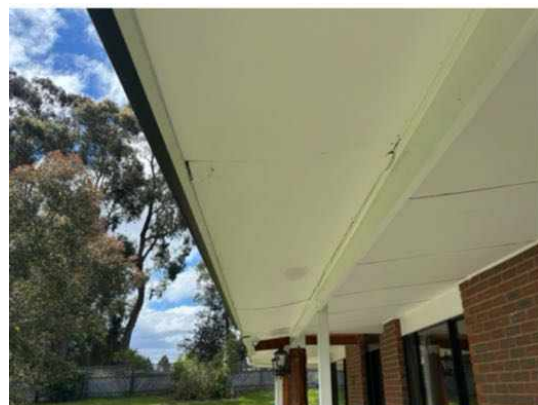
### Defects 3.18

Building: Main Building  
 Location: Front porch  
 Finding: Eaves sheeting sagging  
 Information: In multiple locations the eaves sheets are sagging. Possibly insufficient framing beneath to support the span. The eaves trim prevents vermin entry and paint to eaves protects them from window blown rain.

Recommend client engage a Handy Person the rectify as clients convenience.

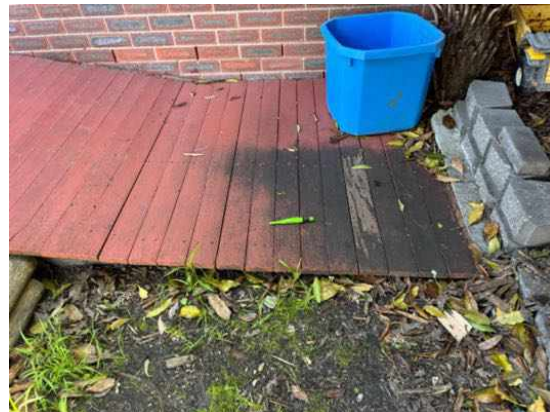
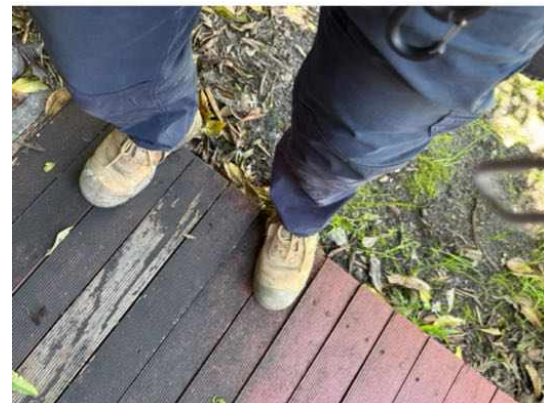
Defects 3.20

Building: Main Building  
 Location: Deck  
 Finding: Wood rot / timber decay  
 Information: The rear ramp appears to be built directly onto the ground and some timbers are rotting. Also some deck boards are bouncing.

Wood rot, also known as Fungal Decay, occurs when timbers and other cellulose building materials are exposed to damp conditions on an ongoing basis. This could be the result of exposure to weathering over a prolonged period of time, or the attraction of excessive moisture from other abutting building materials.

Paint is the only protection the timbers have from water ingress.

Recommend client engage a Carpenter to rectify as soon as possible.

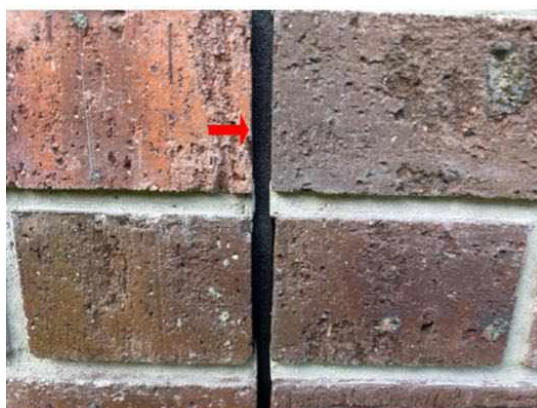
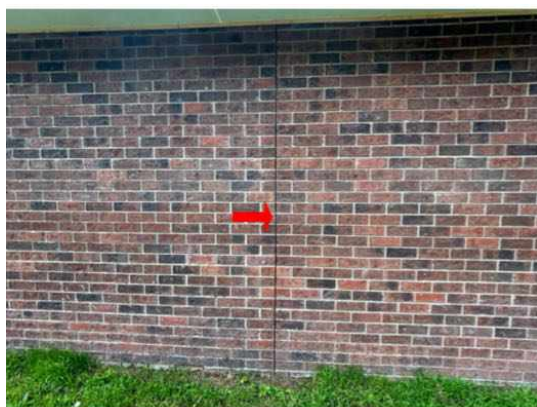
**Defects 3.22**

Control joints fills joints and intersections between bricks in masonry walls and structures, if not rectified gaps will allow water ingress to the surrounding building elements.

Recommend client engage a Handy Person to remedy as soon as practicable.

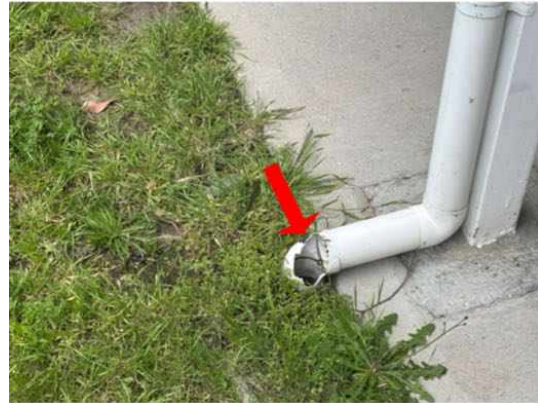
### Defects 3.23

Building: Main Building  
 Location: Front of house  
 Finding: Down pipe broken  
 Information: There is a broken down pipe to the front of the house.

Failure to rectify could lead to deterioration of the surrounding building elements as the water is discharging to the footings of the house. This could eventually cause subsidence.

Recommend client engage a Lic Plumber to rectify as soon as possible.

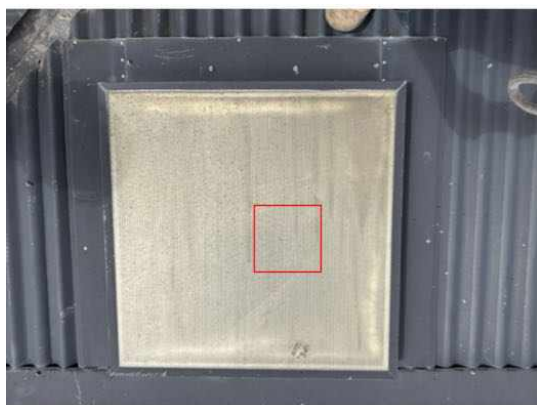
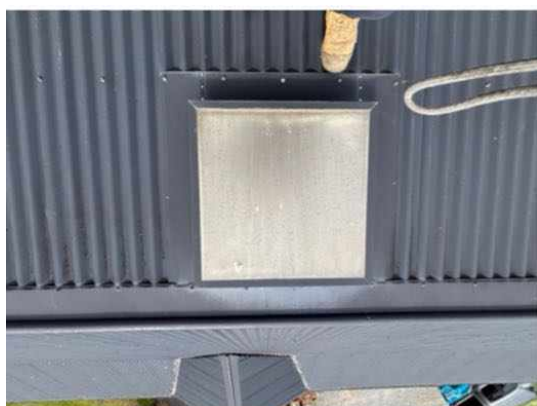
Defects 3.25

Building: Main Building  
 Location: Roof exterior  
 Finding: Skylights deteriorated  
 Information: There is a sky light fitted to the kitchen area and also the internal bedroom. The top of the skylights are made of plastic coreflute material. The top layers of coreflute have started to deteriorate, as they have been damaged by UV which causes holes. This happens to these skylights eventually.

Failure to rectify will allow water into the roof eventually.

Recommend client engage a Handy Person to rectify as soon as practicable.

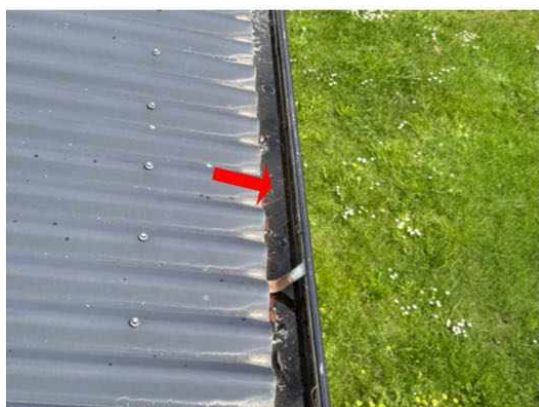
### Defects 3.26

Building: Main Building  
 Location: Roof exterior  
 Finding: Water pooling to gutters  
 Information: The gutters to the front verandah has water pooling. Water pooling can cause corrosion.

Blocked gutters are likely to lead to high levels of moisture in the affected areas. Such moisture can cause rust and decay of the associated building materials. Blockages in gutters should therefore be removed immediately to ensure dry conditions are maintained.

Recommend client engage a lic plumber to rectify as soon as possible.

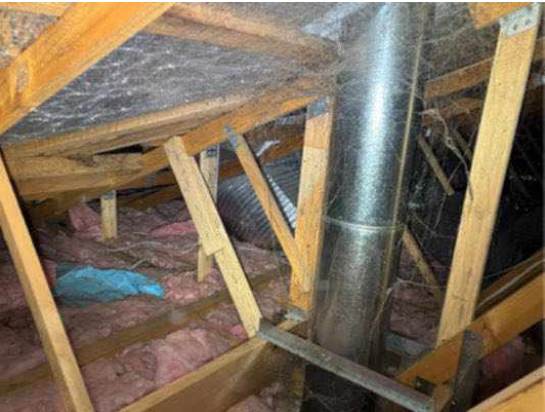
Information: FYI in the living room there is a wood heater fitted. Inspection of the wood heater is outside the scope of this report. Recommend that the client engage a Wood Heater and Flue Specialist to check the condition of the fire box and flue, to ensure safety before the wood heater is used. Faulty wood heaters and flues can cause health and fire risks.

Additionally, there were some cracks to the wood heater hearth tiles (unfortunately the photo didn't come out).

Recommend Client monitor for signs of deflection (slump). If there is any increase recommend Client engage a Lic Builder to investigate and rectify as soon as possible.

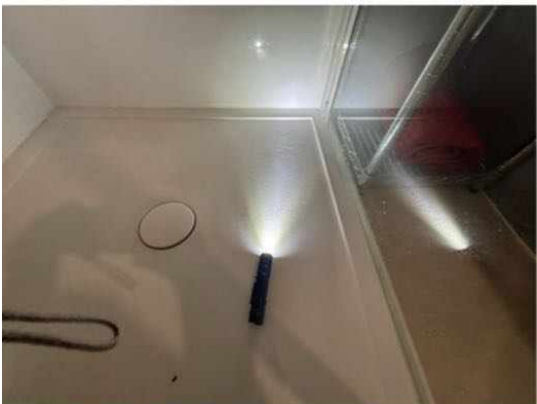
**Noted Item**

Building: Main Building  
Location: Bathroom  
Finding: FYI bathroom shower tray  
Information: FYI the shower tray in the bathroom is pitted and scratched and had a fine coating. It almost appears like crystallization of salts. Possibly the tray has become porous and this may be contributing to water damage in the subfloor. Or maybe residue from a cleaning product.
