Building and Timber Pest Inspection Report

Inspection Date: Fri, 6 Mar 2026

Property Address: 18 Fingal Ave, Glenhaven NSW 2156,
Australia

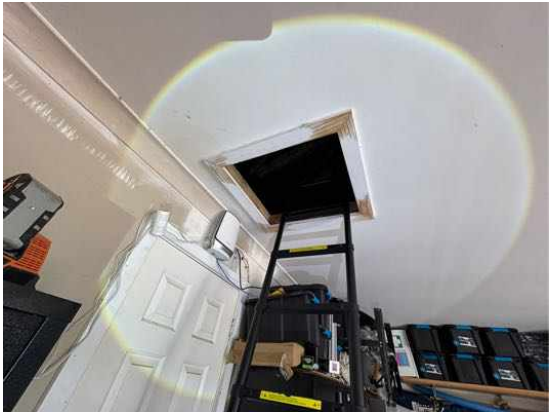
Where sarking is damaged, both insulation and moisture protection of the property are inhibited. This creates a loss of energy and thus negatively impacts the energy efficiency of the property, allowing potential for moisture ingress from condensation or leaking roof tiles.

It is important to repair any holes or damaged sections of sarking to ensure that the building material is fully functional. A registered roofer should be consulted to provide further advice on this defect and to perform rectification works at client discretion.

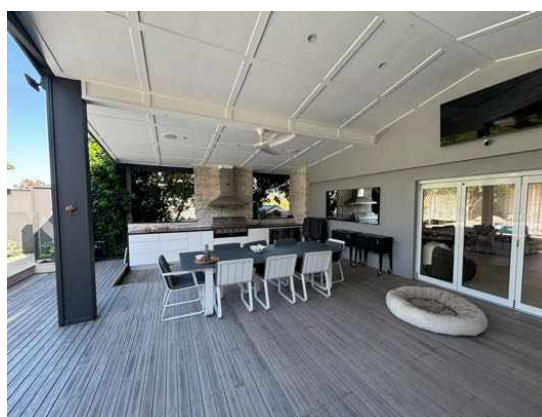
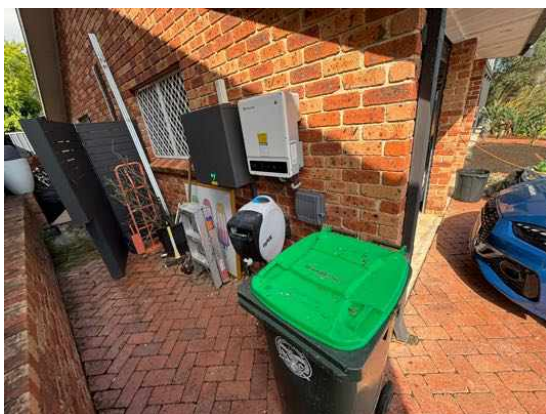
It is essential that these obstructions be cleared to allow for a comprehensive inspection of the external areas. Removing these barriers will enable a more accurate assessment of the property's condition and allow any hidden defects to be identified and addressed promptly. Failure to do so could result in undetected issues worsening over time, potentially leading to more costly repairs in the future.

Therefore, it is strongly recommended that the obstructions be removed and a re-inspection be scheduled once the affected areas are made fully accessible. This will ensure a complete evaluation of the property's exterior and provide the client with a clear understanding of any potential issues that may have been concealed during the initial inspection.

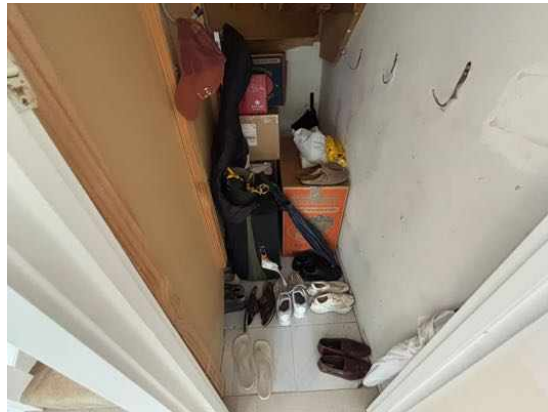
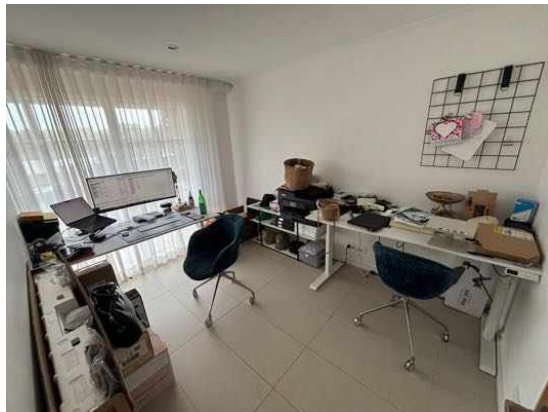
Building:	Main Building
Location:	All Internal Areas
Finding:	Obstructions and Limitations - Internal Areas
Information:	The accompanying photographs provide clear evidence of the obstructions and limitations that restricted a comprehensive inspection of the internal areas of the property at the time of assessment. These obstructions, which may include furniture, personal belongings, stored items, or structural elements such as wall coverings and built-ins, significantly hindered the ability to thoroughly evaluate these areas. It is important to note that such obstructions can potentially conceal a wide array of defects, ranging from hidden structural damage, water leaks, pest infestations, or electrical issues, to deteriorating materials that may not be visible during the initial inspection.

previously concealed issues can be properly identified and rectified. This follow-up inspection will provide a more accurate assessment of the property's internal condition and help the client make informed decisions about any necessary repairs or maintenance.

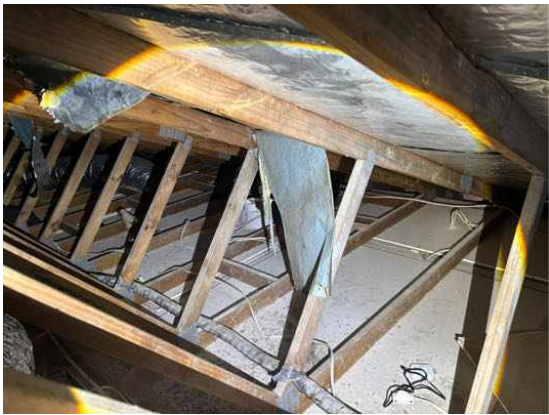
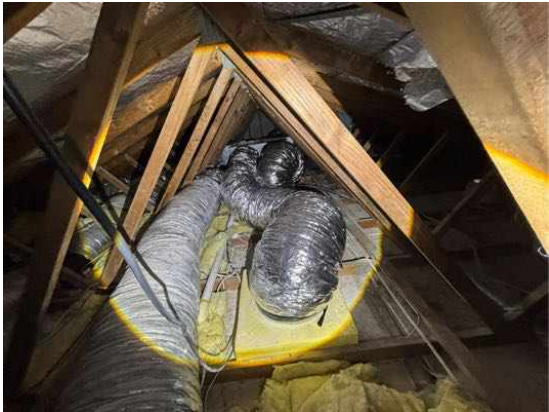
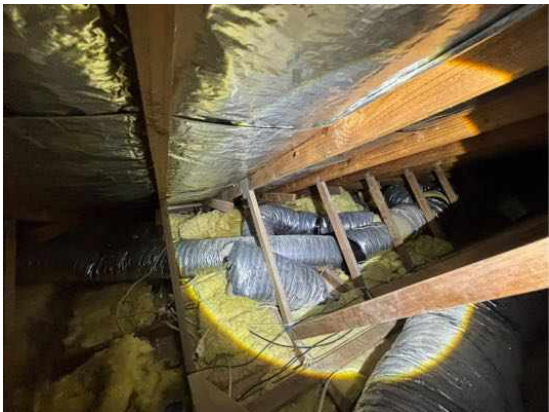
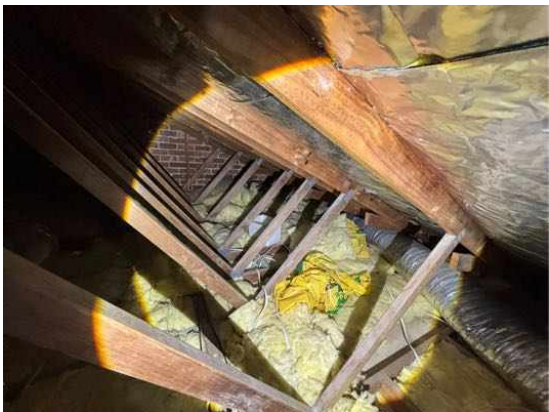
Obstructions of this nature may conceal a variety of potential defects, including damaged framing, compromised insulation, evidence of moisture ingress, pest activity, or electrical hazards. While no major issues were observed in the visible areas, the presence of these limitations means that some defects may remain undetected.

It is recommended that these barriers be removed or repositioned to facilitate full and safe access to the roof space. Once clear, a follow-up inspection should be conducted to allow for a thorough assessment of all concealed areas. This will help ensure that the condition of the roof cavity is accurately evaluated and any hidden issues are appropriately identified and addressed.

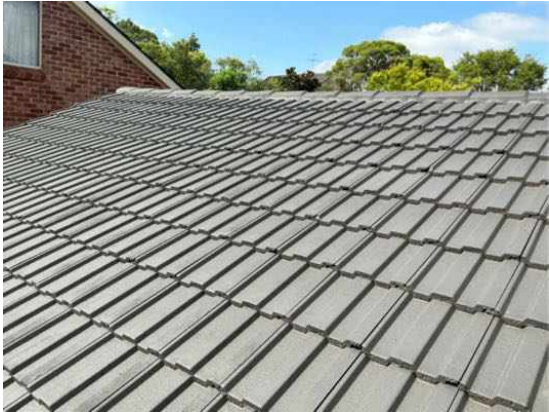
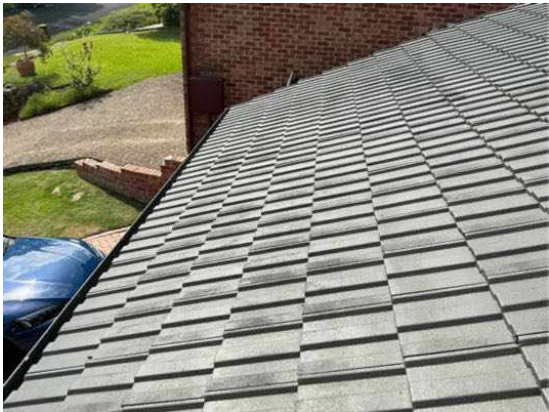
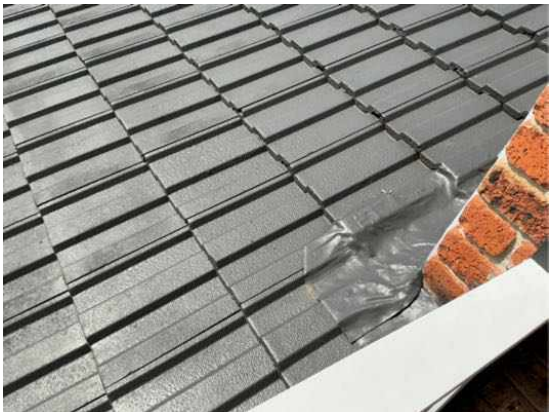
Building: Main Building
Location: Roof Exterior
Finding: Additional Roof Photos

Information: As part of the information provided, please note that the attached roof photos represent the condition of the roof at the time of inspection. These photos are for visual reference only and do not constitute a detailed roofing assessment. Any defects or issues identified with the roof are mentioned separately in the defect statements. It is strongly recommended that the client engage a qualified roofer to conduct a thorough inspection of the roof, ensuring that any potential issues, such as leaks, structural integrity, or wear and tear, are properly identified and addressed.

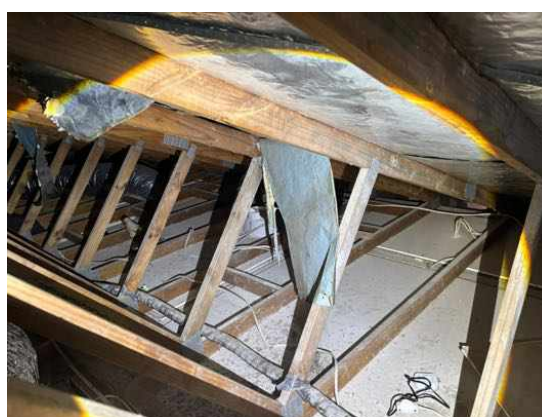
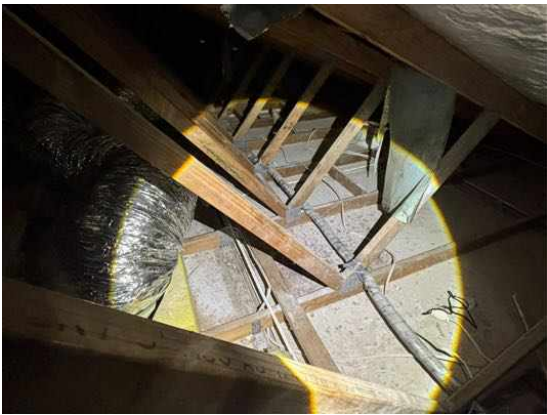
Building:	Main Building
Location:	Upstairs Roof Void
Finding:	Insulation - Not Installed
Information:	It was noted during inspection, that insulation has not been installed. This significantly undermines the thermal efficiency of the property, leading to increased energy consumption for heating and cooling. Properly installed insulation is crucial for maintaining a consistent indoor temperature, reducing energy costs, and enhancing overall comfort. Immediate corrective action is required to install the insulation as per the manufacturer's guidelines, ensuring it provides the intended thermal performance and complies with building standards.

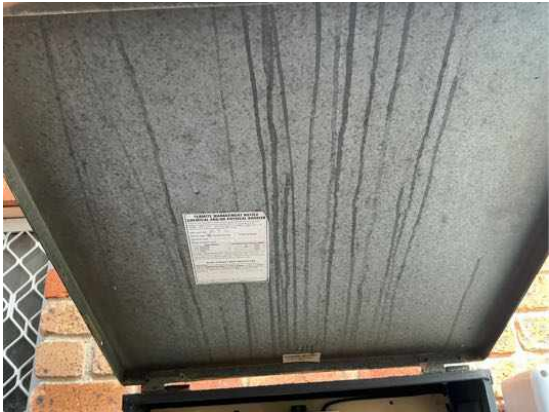
Where a Termite Management System has been identified you should refer to the type of barrier date of installation warranty conditions and any documentation provided by a builder or past owner. Consult the company who installed the barrier to confirm whether the system is still under warranty.

Most chemical termite management systems expire and require replenishment and all physical systems are primarily designed to prevent concealed entry.
