Building Inspection Report

Inspection Date: Tue, 7 Apr 2026

Property Address: 5/528 Pascoe Vale Rd, Pascoe Vale VIC
3044, Australia

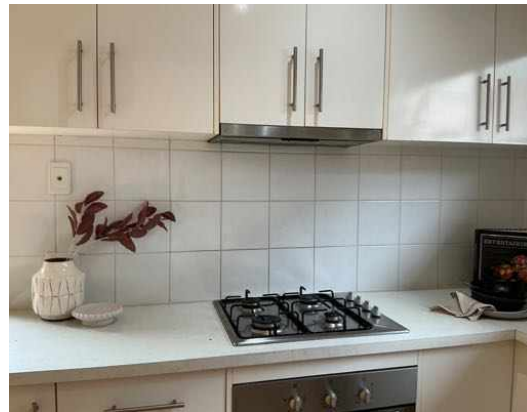
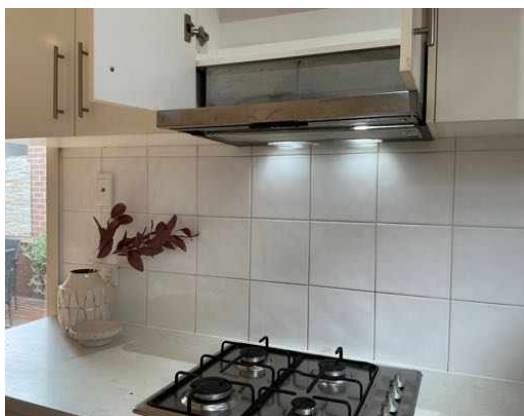
Defects 1.01

Building:	Main Building
Location:	Kitchen
Finding:	Rangehood - Vented into kitchen
Information:	The range hood flue was found to lead directly back into the kitchen, rather than venting to the exterior of the building.

The positioning of this flue is likely to lead to a build-up of grease and grime in the surrounding area, which can pose as a fire hazard and health hazard.

Without re-direction to the exterior of the building, the Rangehood is not considered fully operational and is deemed a minor safety hazard. It is therefore preferable that the flue be re-directed to vent into the external environment. A licensed plumber should be appointed as soon as possible to provide further consultation on the scope of these works and to provide quotations for any necessary works.

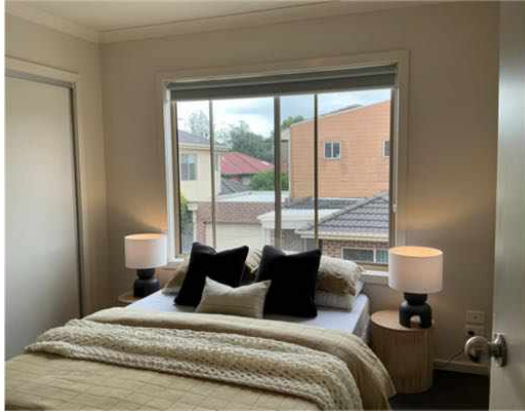
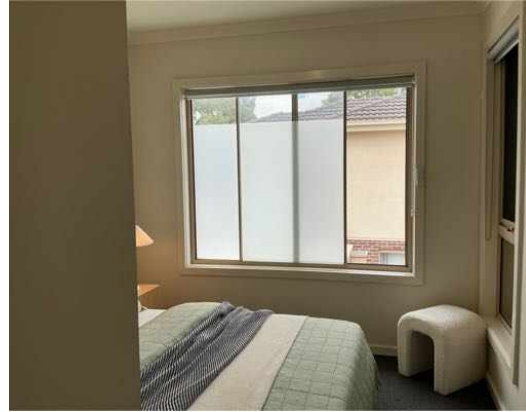
Defects 1.02

Building:	Main Building
Location:	Upstairs windows
Finding:	Windows not restricted opening
Information:	Second story windows in buildings constructed after 2013 must be fitted with devices to restrict the window opening more than 12.5cm to prevent falls. Even if this property was constructed prior to this date it is a safety hazard not to have restricting devices installed.

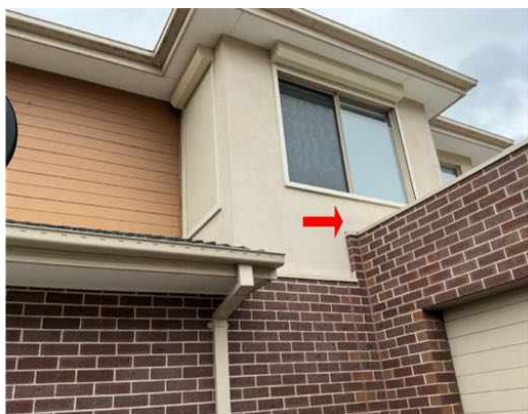
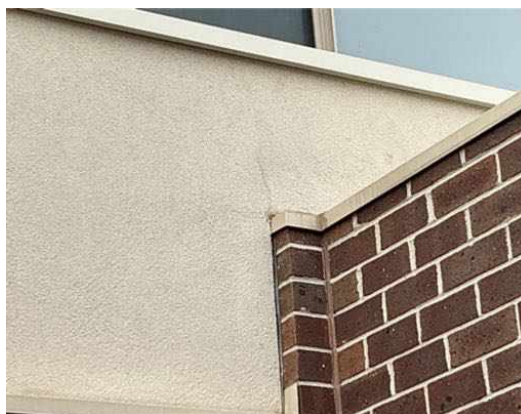
Defects 3.01

Building:	Main Building
Location:	Exterior walls - front
Finding:	Render - Cracking hairline
Information:	Hairline Cracking to the exterior render in this area was identified at the time of inspection.

This type of cracking is often consistent with general age of the property, and may continue to develop if left unmaintained.

At the time of inspection, the cracking was extensive but extremely minor. Frequent monitoring should be carried out to identify any further damage.

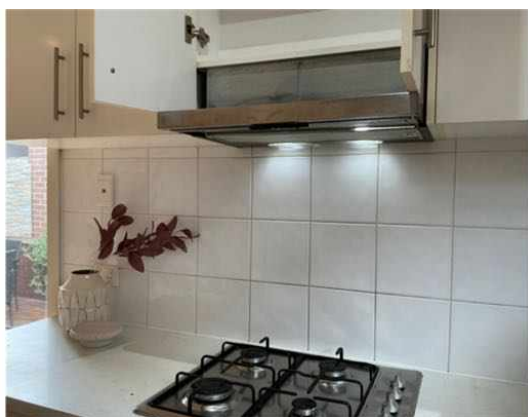
Defects 3.02

Building:	Main Building
Location:	Kitchen
Finding:	Rangehood - Fan not working
Information:	While the range hood appears to be working at a satisfactory level, the fan to the structure was not working at the time of inspection.

Without a functional fan, a build-up of grease and evaporative moisture is likely to accelerate deterioration of the range hood and associated flue. This potential build up may also create a minor fire hazard, particularly if left uncleaned.

A licensed electrician should be appointed to replace the fan on the range hood to restore it to a fully operational state.

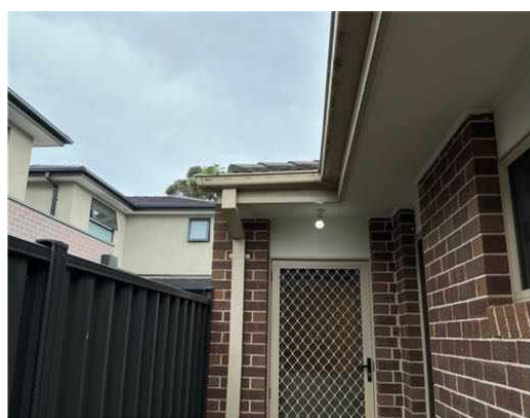
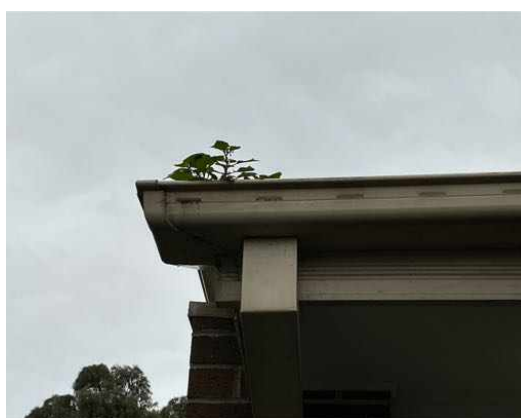
Defects 3.03

Building:	Main Building
Location:	All Areas
Finding:	Gutters - Blocked
Information:	Roof plumbing structures, such as guttering and downpipes, should be free of all debris to prevent blockages. Blockages of the guttering and downpipes will lead to pooling and accumulated water overflows, which is likely to subsequently flood eaves

Blocked gutters are likely to lead to high levels of moisture in the affected areas. Such moisture will not only cause rust and decay of the associated building materials, but can also provide conditions that are conducive to termite and timber pest activity. Blockages in gutters should therefore be removed immediately to ensure dry conditions are maintained.

Consult a Licensed Plumber for further specific advice on remedial works that may be required. In the interim, it is highly advised that blocked gutters be removed by the homeowner or a general handyperson as a matter of urgency.

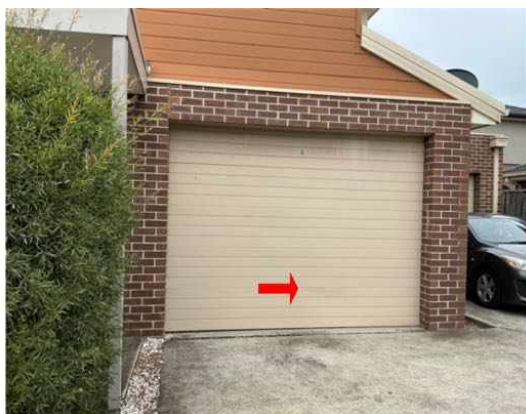
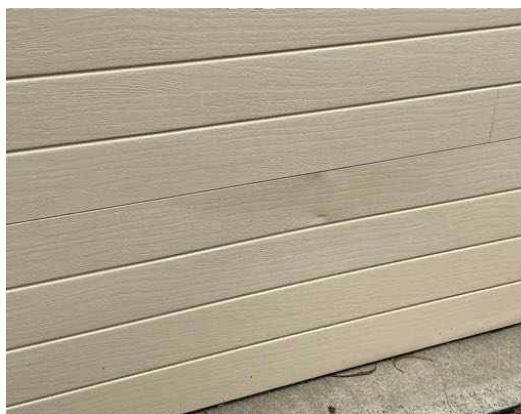
Defects 3.04

Building:	Main Building
Location:	Exterior walls - front
Finding:	Garage door - Superficial markings
Information:	The garage roller door has a number of marks and dents likely to have resulted from impact damage be it accidental or deliberate impact at sometime.

Garage roller doors can fail when the building materials have aged but may be indicative of impact damage (accidental or deliberate). While superficial markings detract from the aesthetics of the building element, the functionality has not been hindered in any way.

Repair and/or replacement of the two garage doors would improve the condition of the garage but certainly not an urgent item

A qualified roller door installer or supplier should be engaged to check out the operation and overall condition of the doors to determine if repair is an option otherwise replacement may need to be considered.

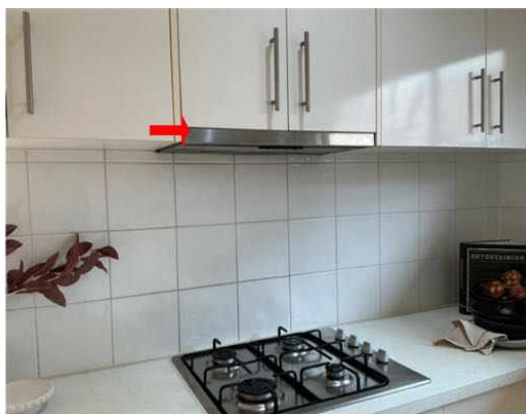
Defects 3.05

Building:	Main Building
Location:	Kitchen Rangehood
Finding:	Sticking or jamming
Information:	Building elements which are sticking or jamming are difficult to operate and don't function as intended. There are a variety of causes for sticking and jamming.

The most usual causes are swelling of timbers due to moisture, bulging or bowing of metal frames, or general material deterioration. Generally, sticking and jamming building elements indicate that their frames are uneven or out of level, generally as result of movement to surrounding walls and floors.

Easement will be required, which usually depends on the building materials used. This may involve some sanding and/or application of a lubricant. It will almost always include ensuring the areas are cleaned and free of any debris that may be detrimental to their operational state.

Appointment of a carpenter or general handyman is recommended to rectify any sticking/jamming building elements.

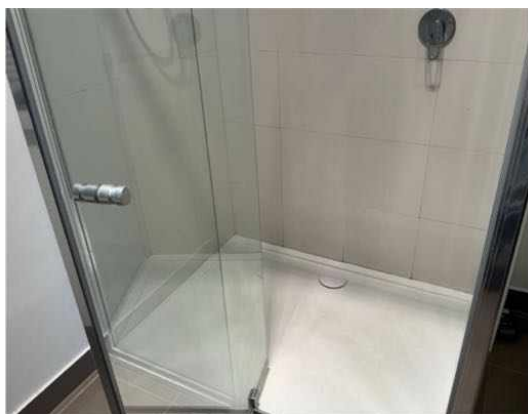
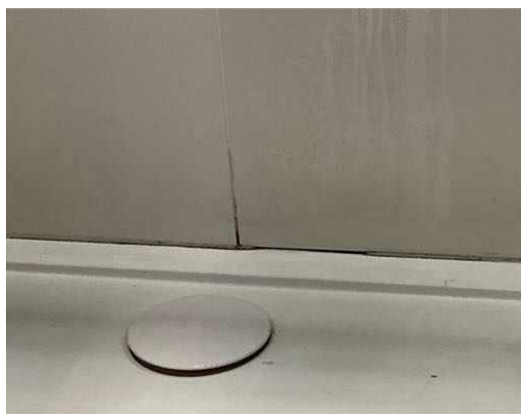
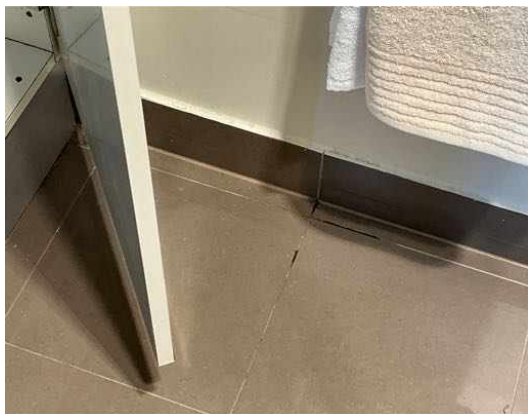
Defects 3.06

Location: Downstairs bathroom
Finding: Sealant and grouting - Missing or damaged
Information: It was noted on inspection that sealant or grout is degraded to the tiled shower alcove and or other areas of the bathroom.

Different materials and floor areas move at different rates, generally causing cracking to grout or sealant at this point. A flexible sealant is required to allow for expected expansion and contraction, while keeping the joint water tight and protective of all associated building materials.

There appears to be excessive mould to the sealant and grout which will likely require scraping out and replacement.

Flexible and mould resistant materials should be applied to affected areas to prevent any subsequent water damage that is likely to occur. Regular maintenance and replacement of damage or missing or damaged sealant and grout is highly recommended to the wet areas, as this is a regular wear and tear defect. Sealant and grouting in areas that come into regular contact with water should be maintained for the long term care of your property.

A sealant specialist or tiling contractor should be appointed to complete these works as soon as possible

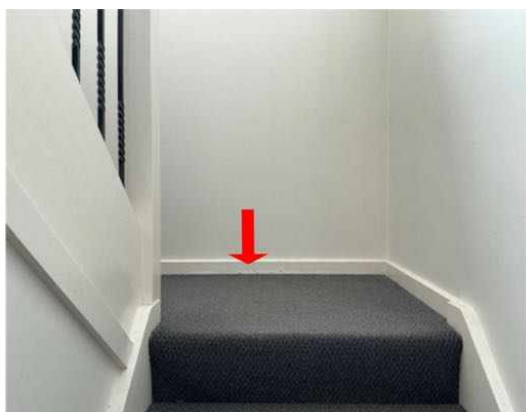
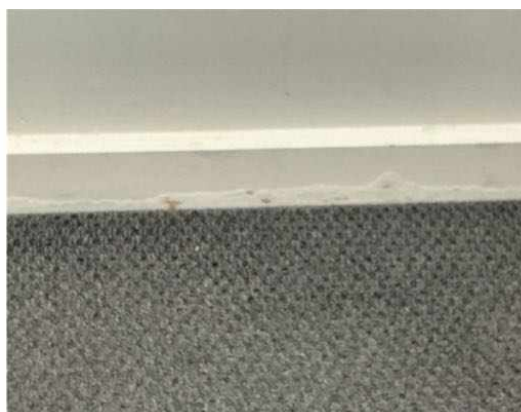
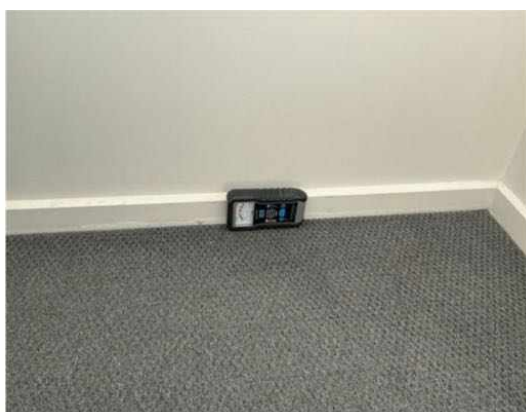
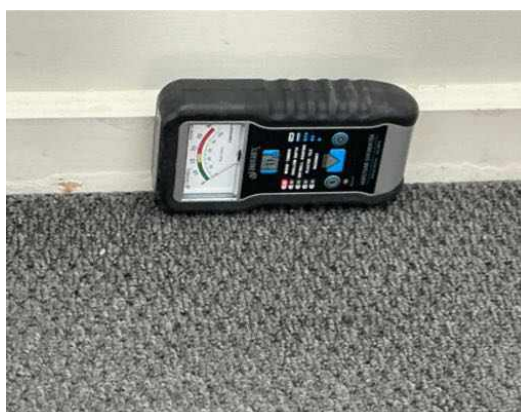
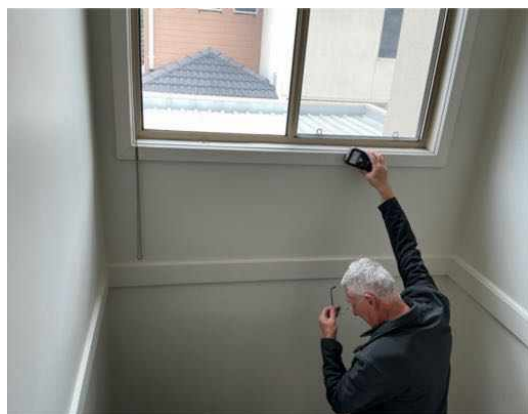
Defects 3.07

Building: Main Building
Location: Stair Landing
Finding: Building element - Swollen
Information: Swollen building elements generally indicate that the building materials have been affected by excessive moisture over a prolonged period of time, and have swollen as a result. The formation and development of mould/fungi or mildew is also a likely consequence of excessive moisture, which may pose major respiratory issues for occupants, particularly the elderly, the very young and those with existing illnesses and could be potential health safety hazards. In these cases an appropriately qualified inspector/tester should also be contacted for advice and/or technical assistance.

The structural integrity of swollen building elements can not be guaranteed, and further damage is likely to develop if left unmanaged. Excessive moisture is likely to lead to the development of secondary damage to any associated building elements, which may necessitate major reparation works if prolonged.

Rectification of the cause of the water leak should be addressed prior to any remedial works to the swollen building elements. A licensed plumber should be appointed immediately to identify the cause of the leak and provide advice on remedial works as necessary, Repair and/or replacement of swollen building elements should be conducted as a matter of urgency by a registered builder or qualified carpenter.

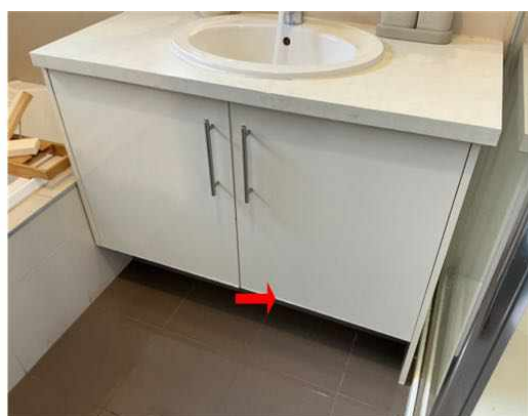
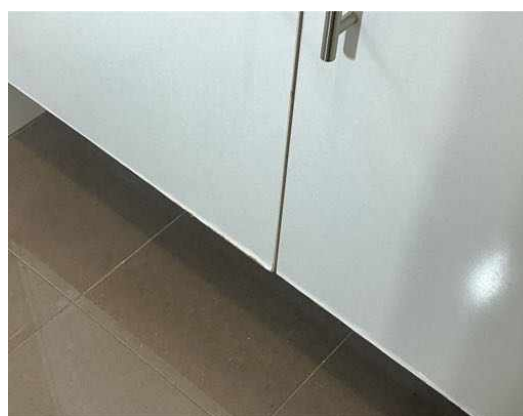
Defects 3.08

Building:	Main Building
Location:	Upstairs bathroom
Finding:	Building element - Swollen
Information:	Swollen building elements generally indicate that the building materials have been affected by excessive moisture over a prolonged period of time, and have swollen as a result. The formation and development of mould/fungi or mildew is also a likely consequence of excessive moisture, which may pose major respiratory issues for occupants, particularly the elderly, the very young and those with existing illnesses and could be potential health safety hazards. In these cases an appropriately qualified inspector/tester should also be contacted for advice and/or technical assistance.

The structural integrity of swollen building elements can not be guaranteed, and further damage is likely to develop if left unmanaged. Excessive moisture is likely to lead to the development of secondary damage to any associated building elements, which may necessitate major reparation works if prolonged.

Rectification of the cause of the water leak should be addressed prior to any remedial works to the swollen building elements. A licensed plumber should be appointed immediately to identify the cause of the leak and provide advice on remedial works as necessary, Repair and/or replacement of swollen building elements should be conducted as a matter of urgency by a registered builder or qualified carpenter.

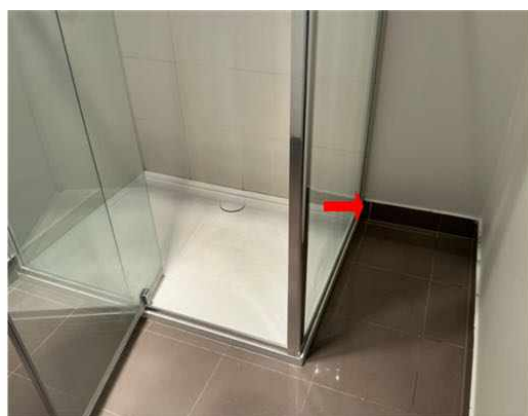
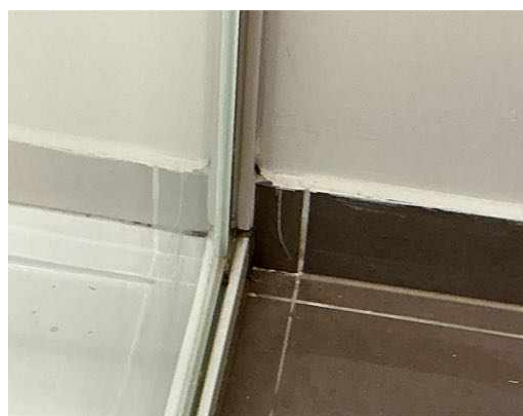
Defects 3.09

Building:	Main Building
Location:	Downstairs bathroom
Finding:	Tiles - Cracked or damaged
Information:	Cracking was evident to the tiling in this area at the time of inspection. While the cracking appears to be minor, this area is frequently exposed to water, allowing potential for water penetration into adjoining sections of walls or flooring.

If left unmanaged, water penetration to these areas may lead to subsequent water damage, which is likely necessitate repair work to affected building elements.

A tiling contractor should be appointed to ensure that no further water damage occurs. The re-application of silicone and grouting throughout remaining tile work is also advised, to further protect the area against water penetration.

Where water penetration has led to water damage, appointment of a relevant tradesperson may be required to repair damaged building elements.

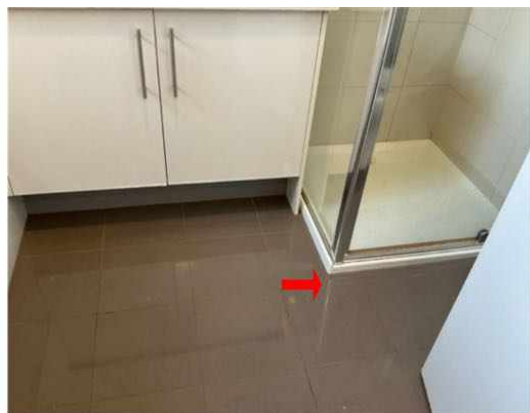
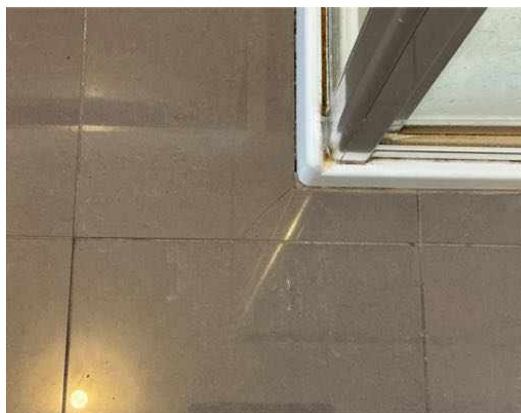
Defects 3.10

Building:	Main Building
Location:	Upstairs bathroom
Finding:	Floor tiles - Cracked and drummy
Information:	Cracking in the floor tiles was evident in this area at the time of inspection. It is suspected that this cracking has occurred as a result of the floor being uneven and lacking a solid or suitable foundation for the tiles to be laid on. Settlement in the floor foundations may also have caused movement and resulted in the cracking of tiles in this area.

Cracked tiles throughout the household detract from the overall appearance of the affected areas, as well as creating potential for water penetration to adjoining building elements. If left unmanaged, water damage may occur as a result of constant water penetration over a prolonged period of time.

While not considered a matter of urgency, replacement of cracked floor tiles is advised as a solution. A tiling contractor or general handyperson may be appointed to perform these works at client discretion. Where cracks become more numerous, consultation with a registered builder specialising in re-stumping may be required.

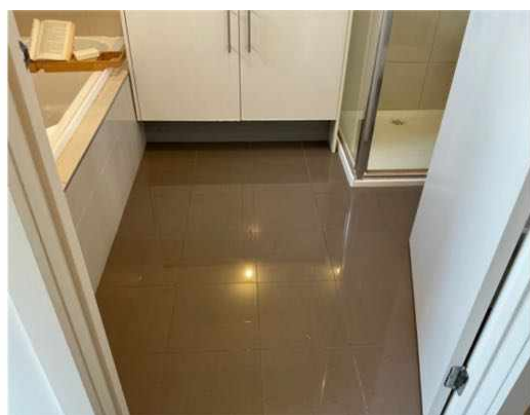
Defects 3.11

Building:	Main Building
Location:	Upstairs bathroom
Finding:	Grout - Missing
Information:	Grout is missing in this area. Grout is used to protect gaps and crevices in building materials to ensure that they are water-tight and prevent water penetration to the associated structures.

Where grout is missing, a tiling contractor should be appointed immediately to apply grout and re-apply any silicone where necessary. Failure to do so is likely to lead to water damage to the surrounding area.

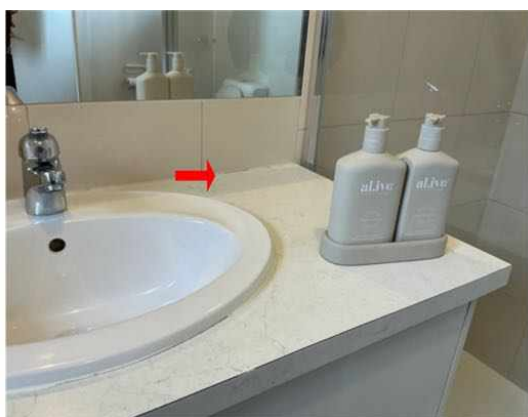
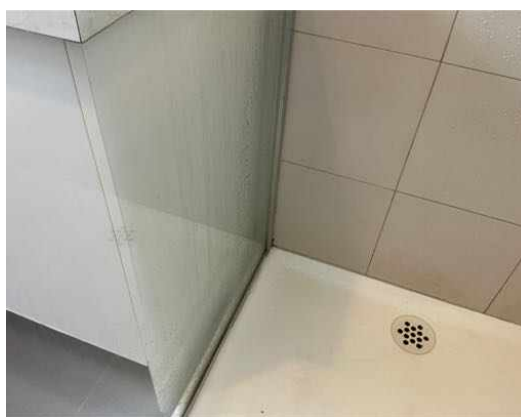
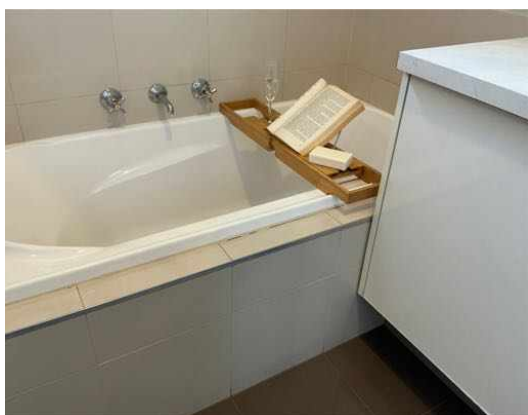
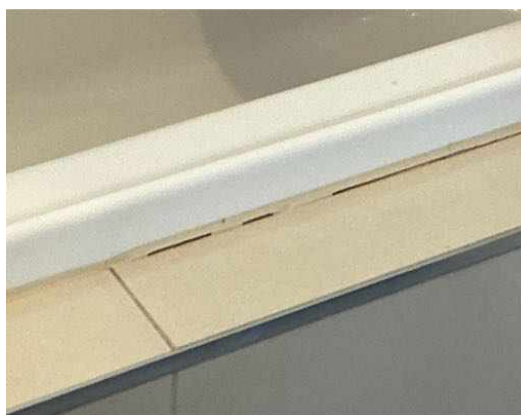
Defects 3.12

Building:	Main Building
Location:	Upstairs bathroom
Finding:	Sealant and grouting - Missing or damaged

Information: It was noted on inspection that sealant or grout is degraded to the tiled shower alcove and or other areas of the bathroom.

Different materials and floor areas move at different rates, generally causing cracking to grout or sealant at this point. A flexible sealant is required to allow for expected expansion and contraction, while keeping the joint water tight and protective of all associated building materials.

There appears to be excessive mould to the sealant and grout which will likely require scraping out and replacement.

Flexible and mould resistant materials should be applied to affected areas to prevent any subsequent water damage that is likely to occur. Regular maintenance and replacement of damage or missing or damaged sealant and grout is highly recommended to the wet areas, as this is a regular wear and tear defect. Sealant and grouting in areas that come into regular contact with water should be maintained for the long term care of your property.

A sealant specialist or tiling contractor should be appointed to complete these works as soon as possible

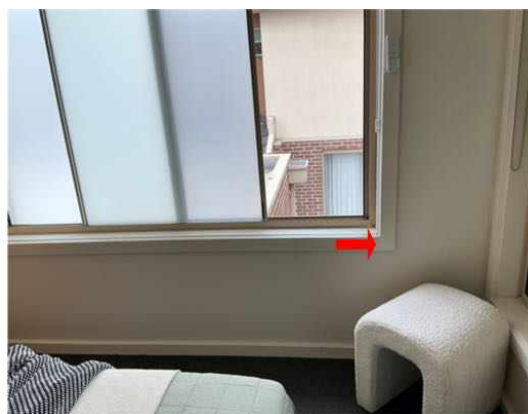
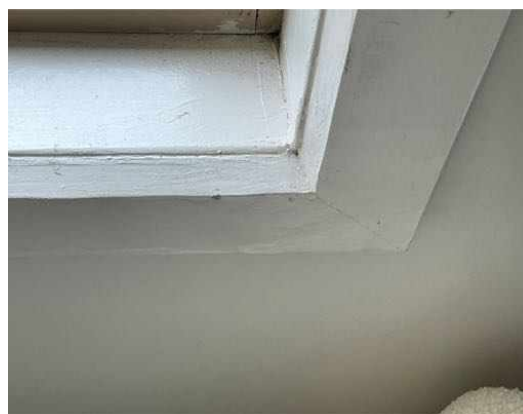
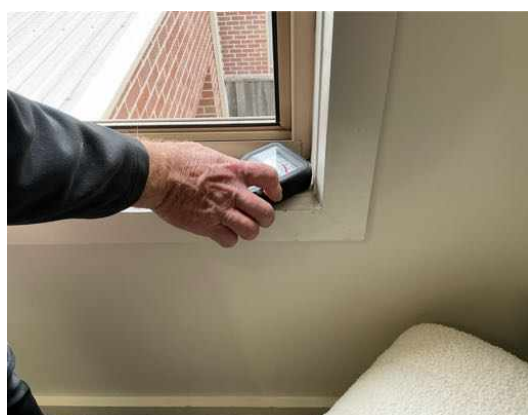
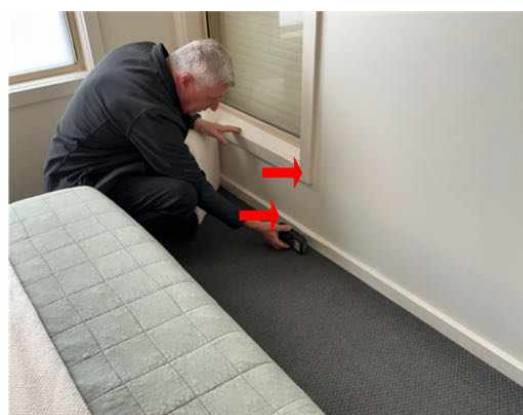
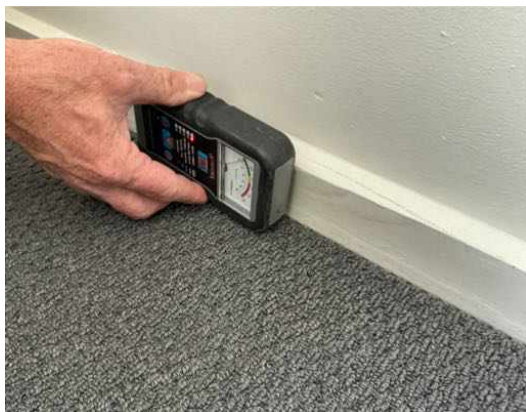
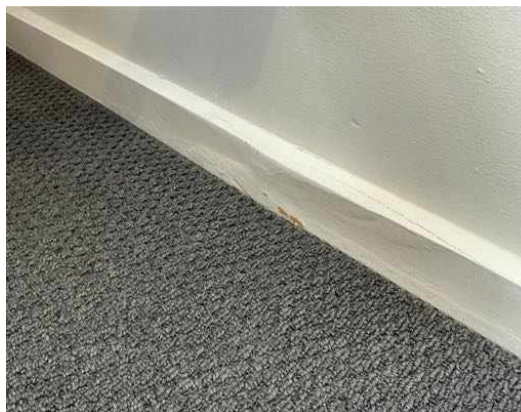
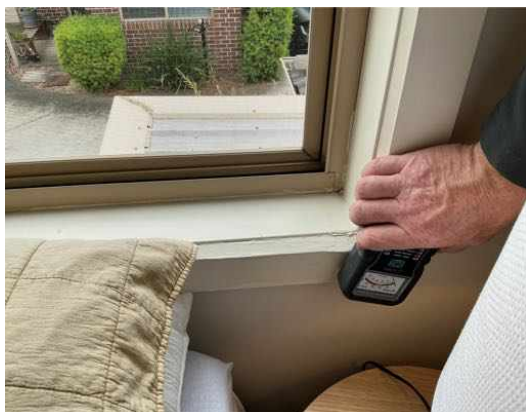
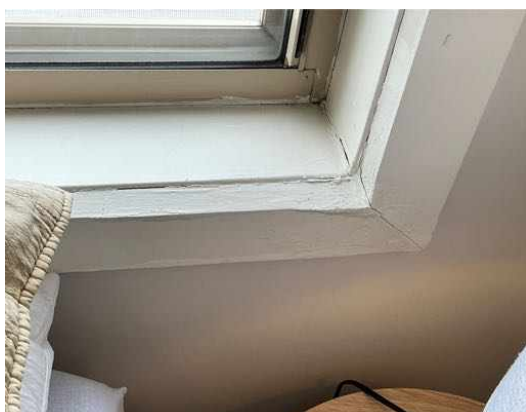
Defects 3.13

Location: Upstairs windows
Finding: Building element - Swollen
Information: Swollen building elements generally indicate that the building materials have been affected by excessive moisture over a prolonged period of time, and have swollen as a result. The formation and development of mould/fungi or mildew is also a likely consequence of excessive moisture, which may pose major respiratory issues for occupants, particularly the elderly, the very young and those with existing illnesses and could be potential health safety hazards. In these cases an appropriately qualified inspector/tester should also be contacted for advice and/or technical assistance.

The structural integrity of swollen building elements can not be guaranteed, and further damage is likely to develop if left unmanaged. Excessive moisture is likely to lead to the development of secondary damage to any associated building elements, which may necessitate major reparation works if prolonged.

Rectification of the cause of the water leak should be addressed prior to any remedial works to the swollen building elements. A licensed plumber should be appointed immediately to identify the cause of the leak and provide advice on remedial works as necessary. Repair and/or replacement of swollen building elements should be conducted as a matter of urgency by a registered builder or qualified carpenter.

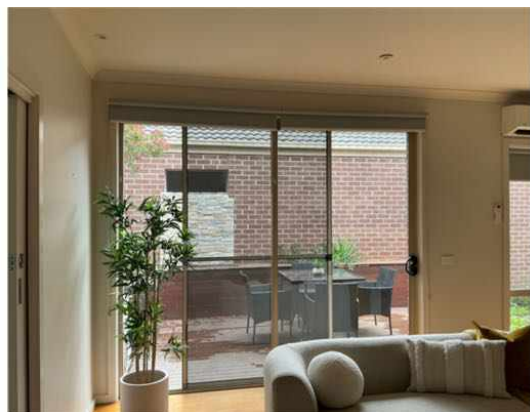
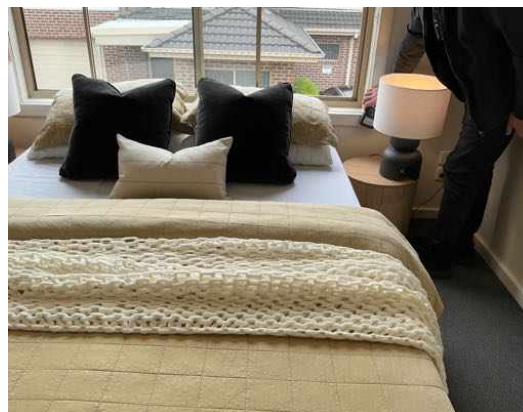
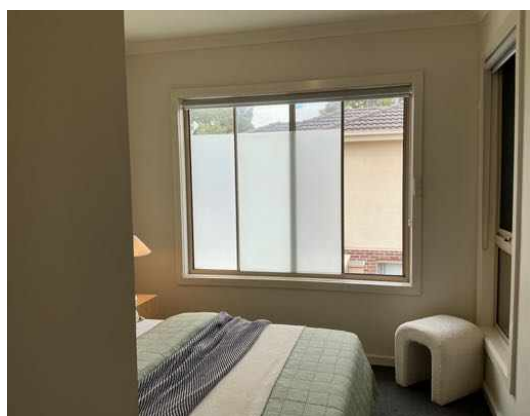
Defects 3.14

Building:	Main Building
Location:	Windows and sliding doors
Finding:	Doors and windows- stiff to slide
Information:	The doors and windows to these areas were difficult to operate at the time of inspection. This is likely due to damaged wheels which help the door to operate in a smooth fashion.

Doors provide ventilation and exits to the adjoining area and should be at a fully operational level to ensure user comfort and safety. Restricted function of the door may also pose as a potential safety hazard if required for emergency egress from the building.

Generally, factors such as general age of the building element and a lack of maintenance are the usual causes for this type of defect.

Replacement of door running hardware may be required, as well as minor repairs and cleaning. A registered builder or general handy person will be required to repair the sliding door.

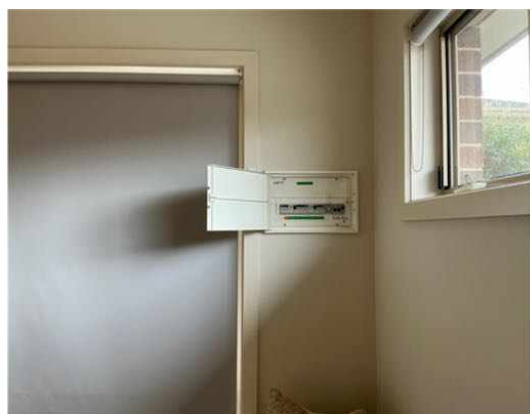
Building:	Main Building
Location:	Electrical Switchboard
Finding:	Termite Management System - no evidence of a chemical installation
Information:	The application of a post-construction chemical termite barrier is highly recommended for all properties, particularly if live termite activity has been found on the site previously. Such barriers are highly effective in preventing termite attack on any timber building elements throughout the property.

A durable notice should be placed in the switchboard unit to indicate current termite barriers. At the time of inspection, it appeared as though no termite management system has been installed, with no evidence to suggest preventative works taking place.

The client may consider gaining further advice from a pest controller as to the costs and procedures involved with this application. It is recommended that obtaining such advice be a short-term priority.

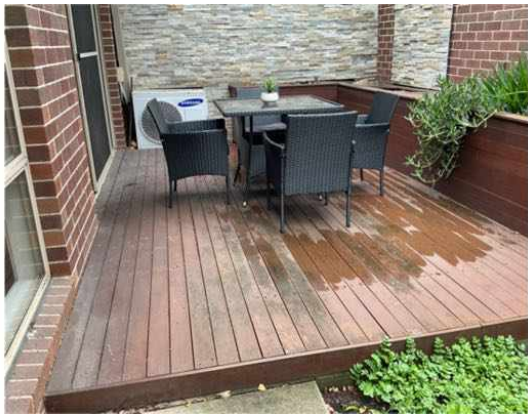
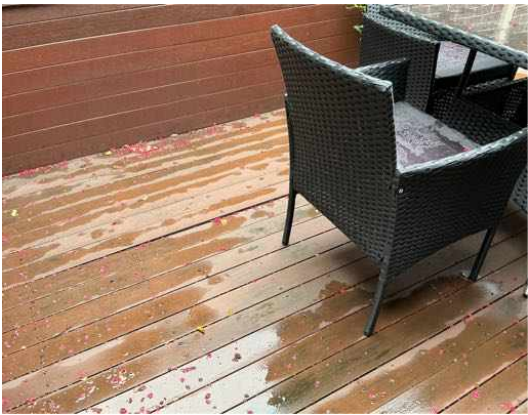
Building:	Main Building
Location:	Deck
Finding:	External Timber Balcony or Deck - Structural Stability
Information:	The load capacity of the external balcony or deck could not be verified during the inspection.

External timber structures are also constantly exposed to weather elements and can deteriorate in an accelerated manner, ongoing assessments are required.

Regular maintenance inspections by competent practitioners is recommended .

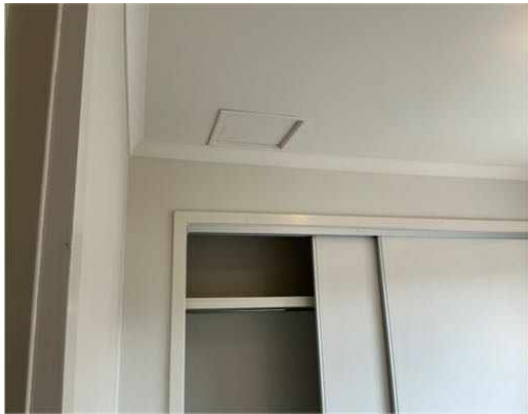
Building: Main Building
Location: Roof Void
Finding: Roof void access limitations
Information: Limited access to the roof void was present due to facts including but not limited to access hatch size or placement, for this reason access to the roof void was minimal.
