Building Inspection Report

Inspection Date: Tue, 24 Feb 2026

Property Address: 23 Munro Ave, Cheltenham VIC 3192,
Australia

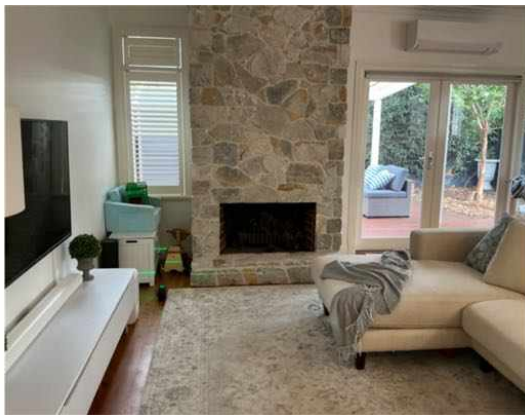
Defects 1.01

Building:	Main Building
Location:	Family Room
Finding:	Fireplace
Information:	It is beyond the scope of this inspection report to comment on fireplaces, we recommend a professional chimney sweep check the safety of this fireplace prior to use.

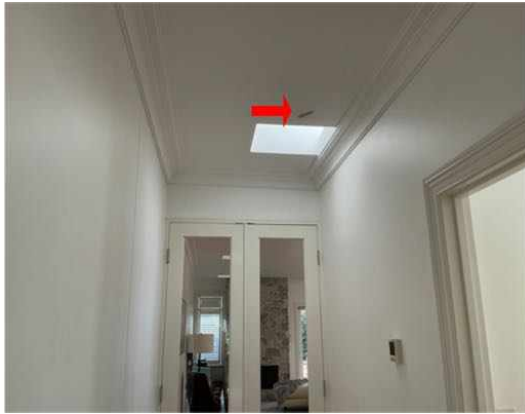
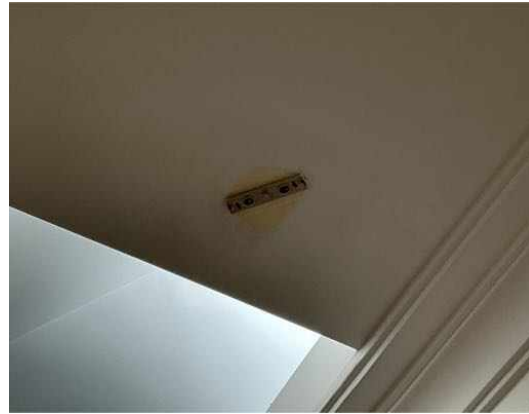
Defects 1.02

Building:	Main Building
Location:	Hallway
Finding:	Smoke Detectors and Alarms
Information:	Reporting on Smoke Detectors or Alarms, including hard wired smoke detection systems and their legislative requirements, is outside the Scope of this Report.

Please note that this defect is highlighted as a caution only. We suspect, based on our experience in the building industry, that the absence of smoke detectors, or their poor condition, should be addressed as a matter of urgency to improve occupant safety.

Further Inspection and/or advisory services is necessary to provide advice on the sufficiency, type and location of smoke detectors, and to test the functionality of all devices. Greater requirements for fire safety and detection exist for commercial buildings.

Always ensure sufficient working and suitable smoke detectors are installed prior to occupying any building. Additionally, it is advised that all smoke detectors be tested by the homeowner on a monthly basis.

Please refer to AS3786 and state based legislation, which may also apply.

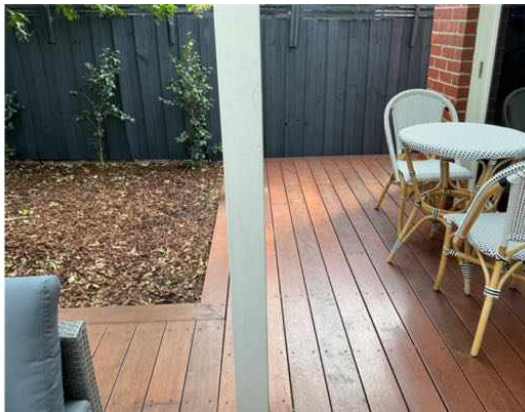
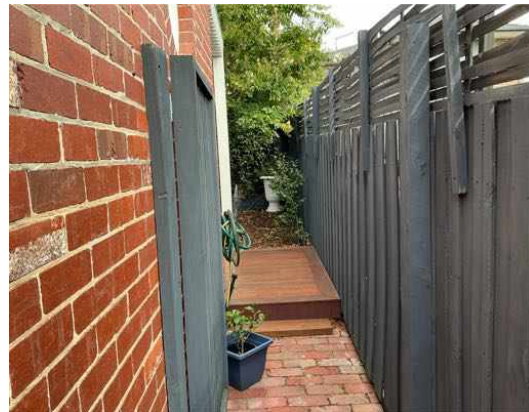
Defects 1.03

Building: Main Building

Location: Rear deck

Finding: Timber deck to fence

Information: A timber deck cannot encroach into the minimum 900mm setback required by the NCC, unless it is provided with some means of fire resistant construction. This ensures there is adequate fire separation between decks and the boundary to prevent the spread of fire to adjoining properties. This is particularly important due to the possibility of adjoining properties having decks that abut the common boundary fence, consequently enhancing the potential for spread of fire between both properties.

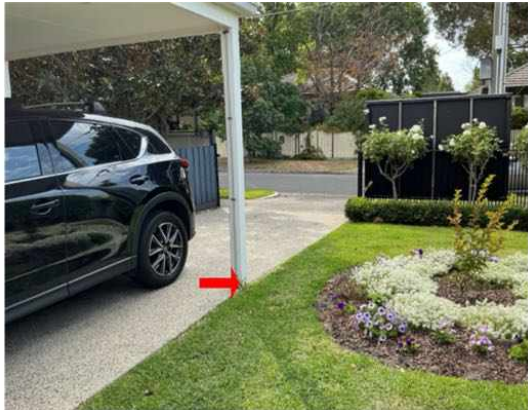
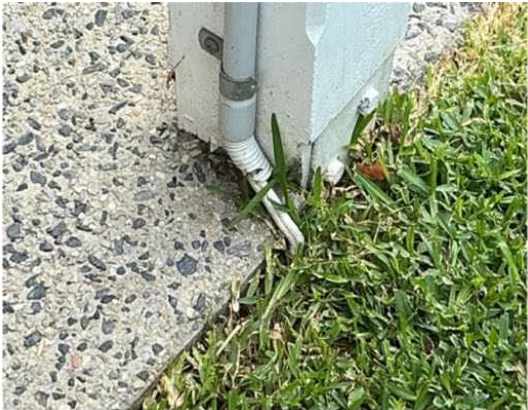
Defects 1.04

Building: Main Building

Location: Carport

Finding: Electrical wires exposed

Information: Exposed electrical wiring was identified. Exposed electrical wiring represents a potential safety hazard including for fire and personal contact. Contact a licensed electrician urgently for further inspection investigation and rectification.

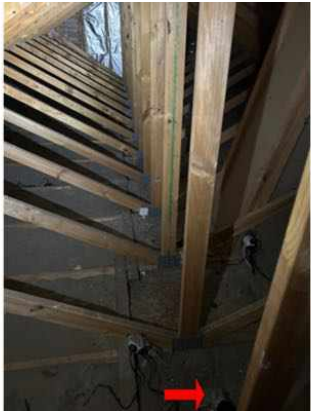
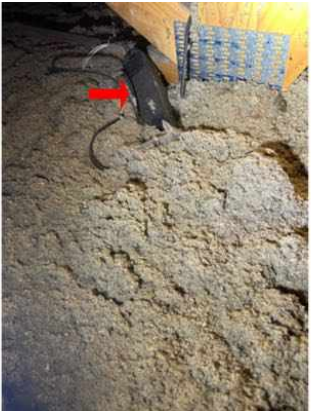
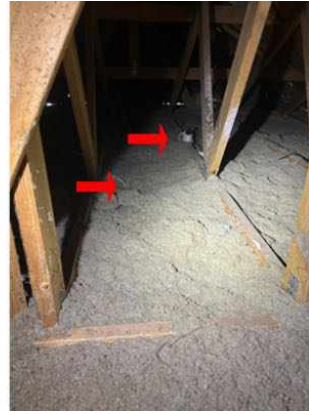
Defects 1.05

Building: Main Building
Location: All Areas
Finding: Insulation - Covering downlights
Information: Sections of insulation in the roof void have been poorly installed or moved from their original position and are covering down light fittings. While the down lights have been fitted with appropriate protective covers, the presence of this insulation creates a potential fire hazard.

Any insulation within the vicinity of down light fixtures should be moved and re-applied to more appropriate sections of the roof void, thus ensuring the area is fire-safe. An insulation contractor should be appointed as soon as possible to perform any necessary works as required.

Unless the lighting manufacturer has approved that insulation can be installed over their lighting fixtures.

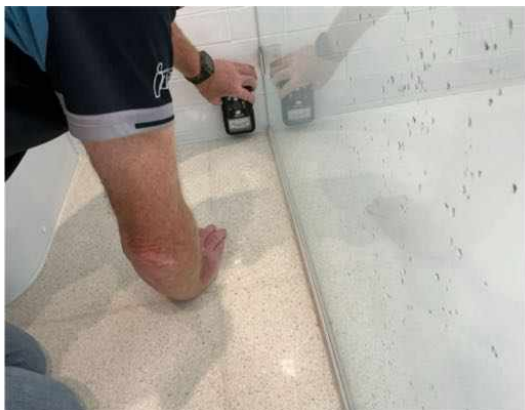
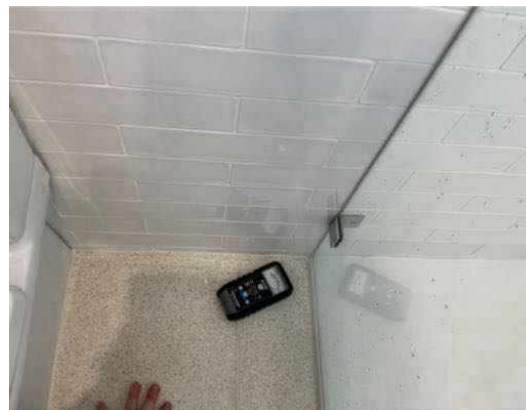
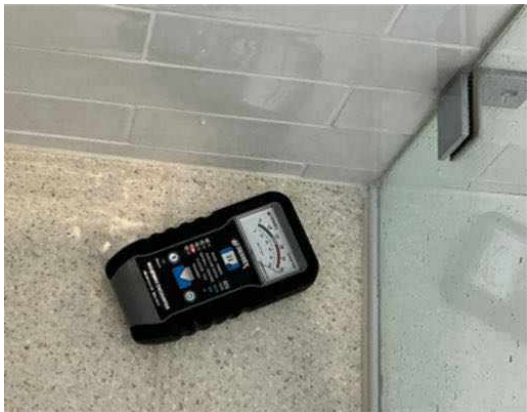
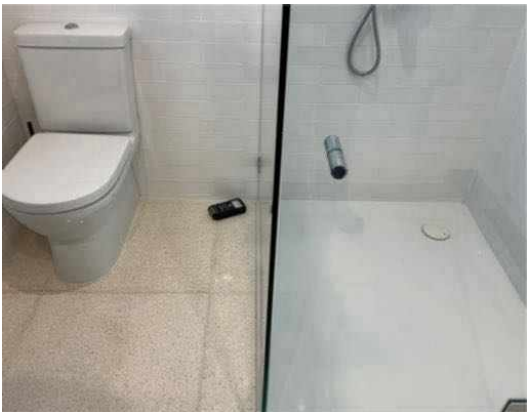
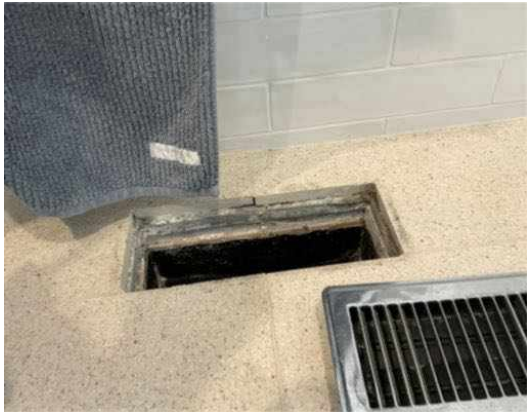
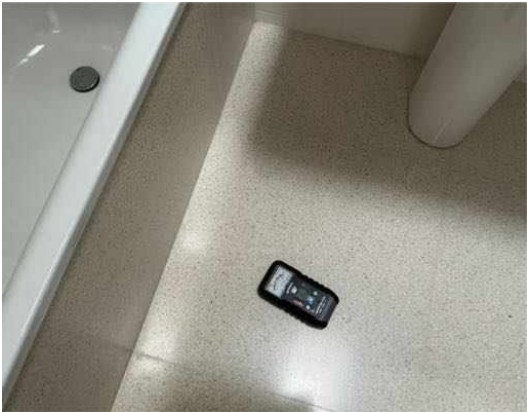
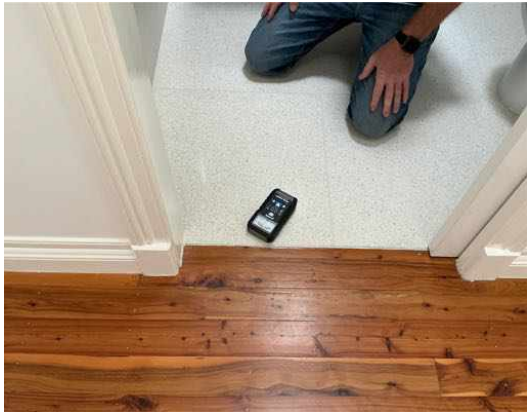
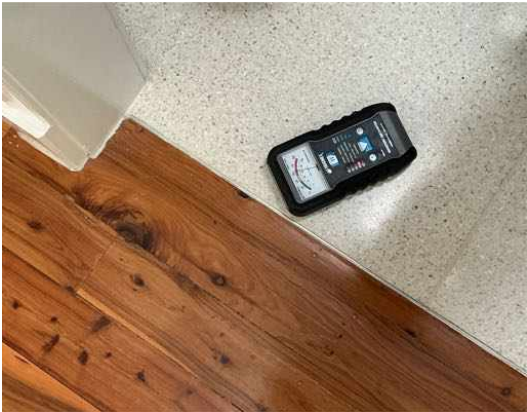
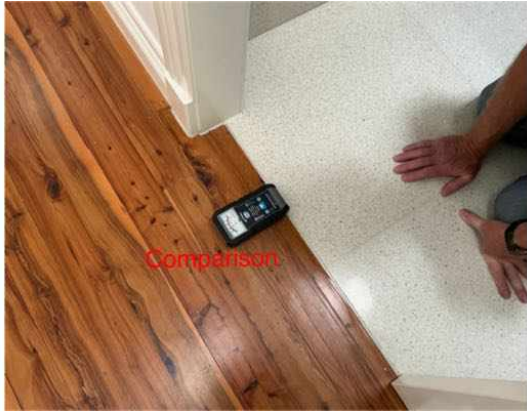
Defects 3.01

Building:	Main Building
Location:	Ensuite
Finding:	Evidence of excessive moisture in the bathroom was present at the time of inspection
Information:	Excessive moisture can attract termites and produce conditions that promote termite attack fungal growth and wood decay and deteriorate the surrounding building elements.

Excessive moisture may caused by poorly sealed shower screens, porous tiles, broken or deteriorated grouting and more.

It is highly recommended that all sealant, grouting, plumbing and drainage fixtures and fittings be maintained regularly in order to prevent excessive moisture being present in the internal property.

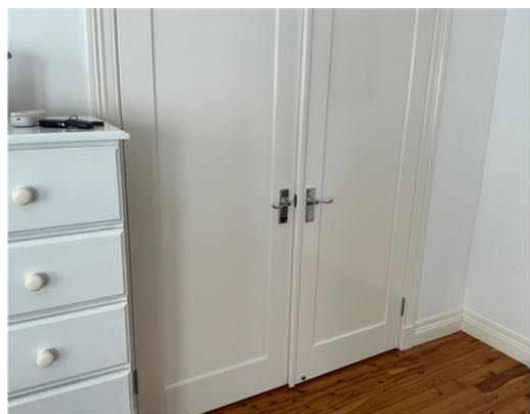
Defects 3.02

Building: Main Building
 Location: Bedroom - Master
 Finding: Door handle - Not latching
 Information: It was noted that the door in this area was not latching during operation at the time of inspection. Whilst detracting from the functionality of this building element, this minor defect may also be a security risk, and may therefore have serious implications if left unattended.

It is suspected that this defect has occurred due to minor issues with the associated hinges. Such damage is identified as general wear and tear, which is expected for building elements of this age.

A qualified carpenter or general handyperson may be appointed to perform rectification works as necessary, at client discretion. If left unattended, further functional impairment is likely to occur.

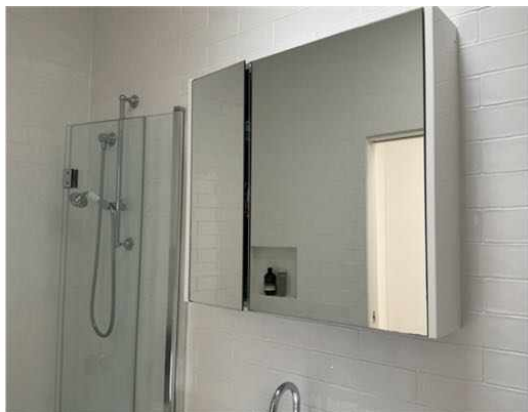
Defects 3.03

Building: Main Building
 Location: Bathroom
 Finding: Cabinetry - Loose hinges
 Information: Several cupboard doors are not level and detract from the operational state of the cabinetry. Upon further inspection, it was noted that the hinges to the cupboard doors have deteriorated over time and, as a result, have come loose from their original fixing. To improve operation of the affected cupboard doors, a general handyman may be appointed to replace the faulty hinges. Such works should be completed at discretion of the client.

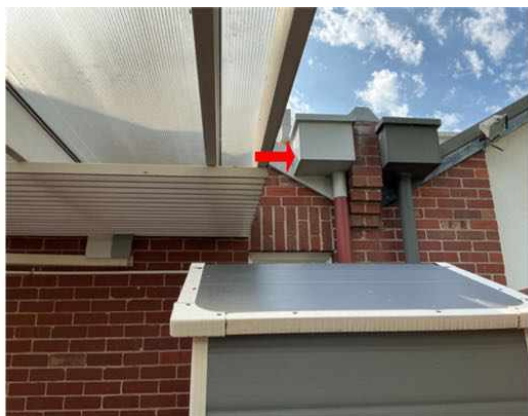
Defects 3.04

Building:	Main Building
Location:	Rear Elevation
Finding:	Rain heads (Not Compliant)
Information:	The Stormwater Rainheads installed on this building were found to be non compliant with current standards.

A company called Dambusters make a suitable product that is considered compliant.

We recommend that a Roof Plumber be contacted as soon as possible to rework or replace to achieve Compliance.

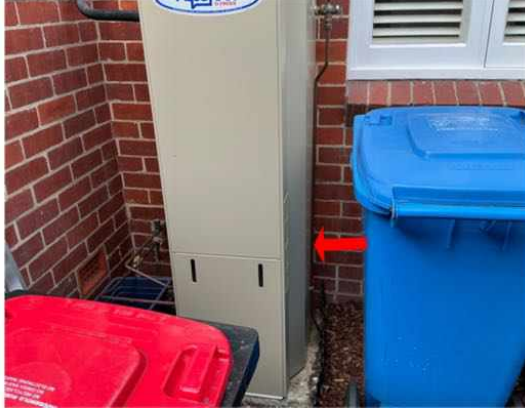
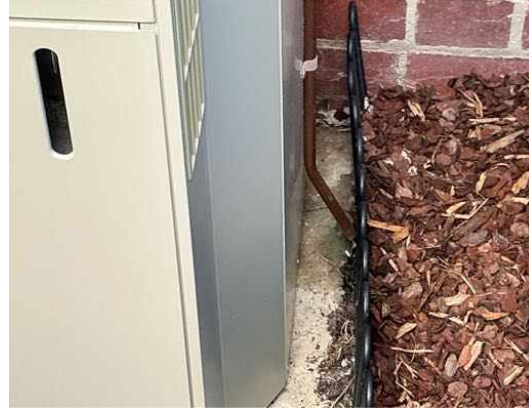
Defects 3.05

Building:	Main Building
Location:	Exterior walls - right side
Finding:	HWS Overflow - Not Connected
Information:	The Hot Water System (HWS) overflow was found to be disconnected from storm water drainage and is creating excessive moisture in the surrounding area.

These damp conditions can lead to secondary defects such as rot, rust or corrosion of associated building elements, the formation of fungal decay, or even the creation of potential slip hazards. When coupled with poor site drainage, pooling of water may

also attract termite activity to this area.

It is highly recommended that a licensed plumber be appointed to connect the HWS overflow in order to prevent such an environment from being created. These minor works should be carried out as soon as possible.

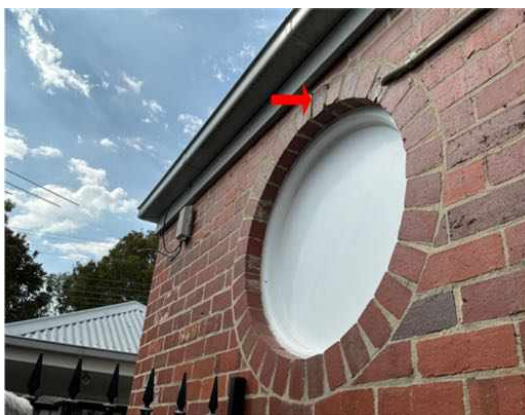
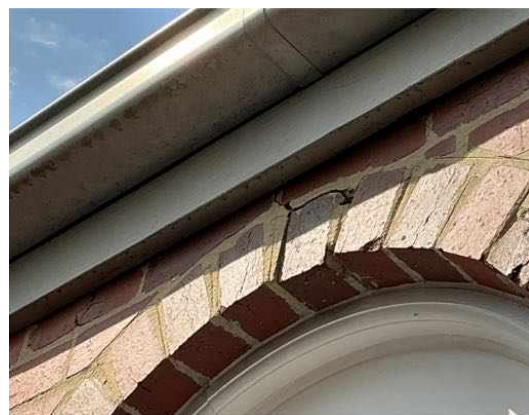
Defects 3.06

Building: Main Building
 Location: Exterior walls - right side
 Finding: Brickwork - Step cracking (minor)
 Information: Step cracking was identified to the brickwork in this area at the time of inspection. Step cracking, which is similar to other forms of cracking, has a variety of possible causes. However, the most common is the subsidence of adjacent footings.

Step cracking is a relatively common defect, and is most likely to occur adjacent to windows, doors and other openings. Mortar failure in the gaps between affected bricks indicates the stresses and tensions affecting the wall.

Where step cracking is extensive or severe, the client is advised to consult a structural engineer. Minor step cracking can be used as a warning sign to address factors causing stress to the wall, which can include the effect of surrounding trees, water leaks, soil erosion, or even the presence of reactive soils in the surrounding area.

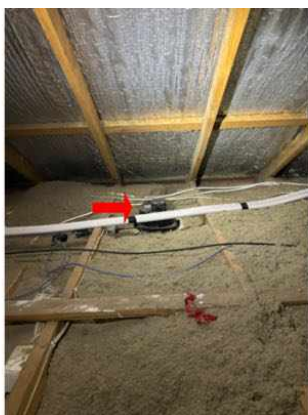
Defects 3.07

Building:	Main Building
Location:	Bathrooms
Finding:	Exhaust fan - sarking on roof
Information:	On inspection of the roof void, it was observed that the exhaust fans to the bathroom and ensuite do not exhaust directly to the outside of the building, which is required by the NCC if sarking has been fitted, as it has in this home.

NCC 3.8.5.1 states:

An exhaust fan or other means of mechanical ventilation may be used to ventilate a sanitary compartment, laundry or bathroom, or where mechanical ventilation is provided in accordance with 3.8.5.3(b), provided contaminated air exhaustsâ€”

(i) directly to outside the building by way of ducts or

(ii) into a roof space thatâ€”

(A) is adequately ventilated by open eaves, and/or roof vents or

(B) is covered by roof tiles WITHOUT SARKING or similar materials which would prevent venting

through gaps between the tiles.

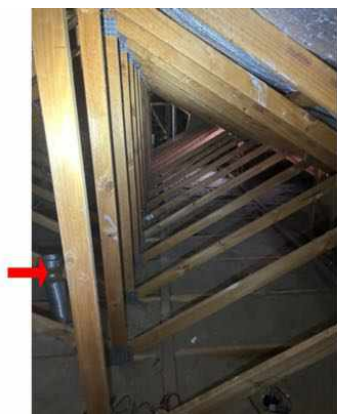
Defects 3.08

Building:	Main Building
Location:	Kitchen
Finding:	Rangehood - Vented into roof space
Information:	The range hood flue was found to lead directly into the roof space, rather than venting to the exterior of the building.

The positioning of this flue is likely to lead to a build-up of grease and grime in the

surrounding area within the ceiling void, which can pose as a fire hazard in the roof void. The presence of insulation surrounding the flue adds to this fire safety risk.

Without re-direction to the exterior of the building, the Rangehood is not considered fully operational and is deemed a minor safety hazard. It is therefore preferable that the flue be re-directed to vent into the external environment. A licensed plumber should be appointed as soon as possible to provide further consultation on the scope of these works and to provide quotations for any necessary works.

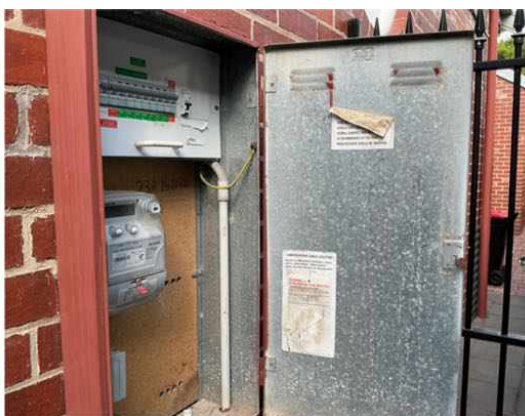
Noted Item

Building: Main Building
 Location: Electrical Switchboard
 Finding: Termite Management System - no evidence of a chemical installation
 Information: The application of a post-construction chemical termite barrier is highly recommended for all properties, particularly if live termite activity has been found on the site previously. Such barriers are highly effective in preventing termite attack on any timber building elements throughout the property.

A durable notice should be placed in the switchboard unit to indicate current termite barriers. At the time of inspection, it appeared as though no termite management system has been installed, with no evidence to suggest preventative works taking place.

The client may consider gaining further advice from a pest controller as to the costs and procedures involved with this application. It is recommended that obtaining such advice be a short-term priority.

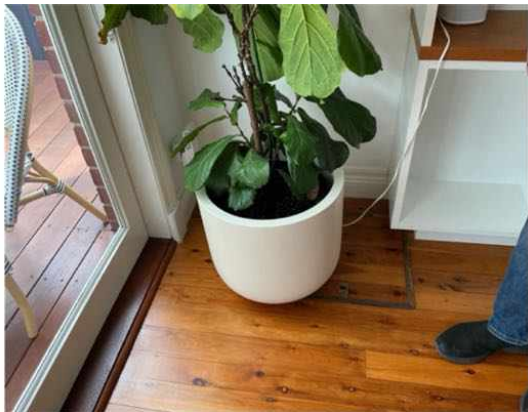
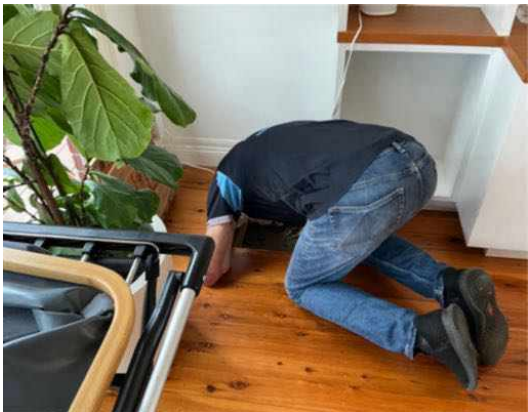
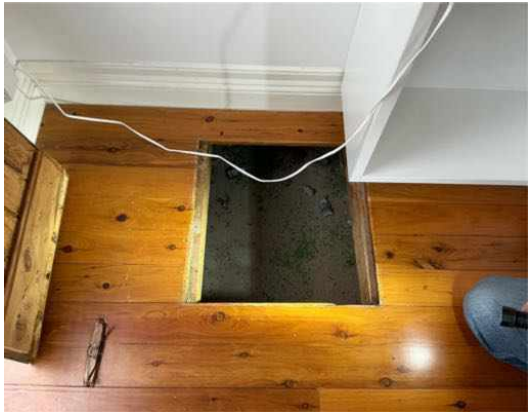
Noted Item

Building: Main Building
Location: Subfloor
Finding: Subfloor access limitations
Information: Limited access to the subfloor was present due to facts including but not limited to access hatch size or placement, limited subfloor space and ductwork, for this reason access to the subfloor was minimal.
