Building Inspection Report

Inspection Date: Tue, 10 Feb 2026

Property Address: U6 341 Princes Hwy, Albion Park Rail NSW
2527, Australia

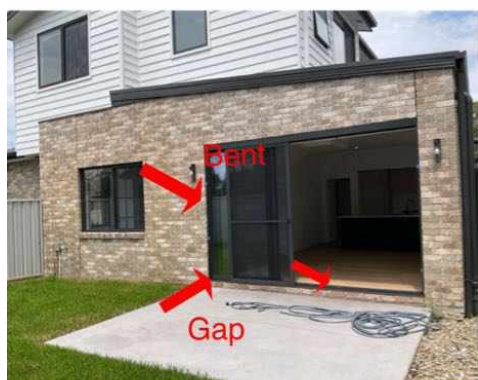
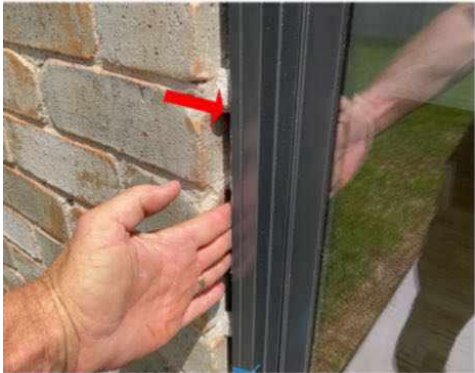
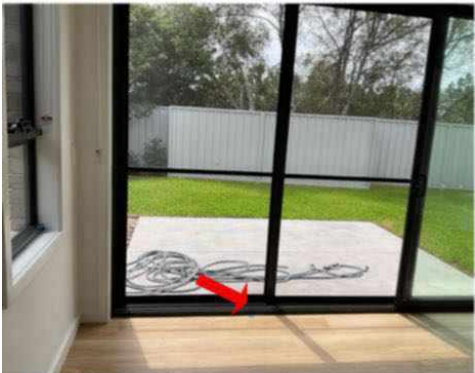
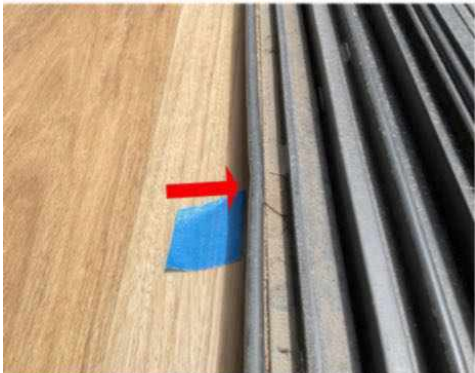
Defects 3.01

Building: Building 1
Location: Lounge Room door
Finding: Sliding door and track damaged
Information: These pictured large rear door is bent 20mm over 2 metres and the internal track is also bent.

This door appears to require replacement prior to purchase with effective sealing to all external perimeter areas due to the damage found.

This should be brought to the attention of the builder.

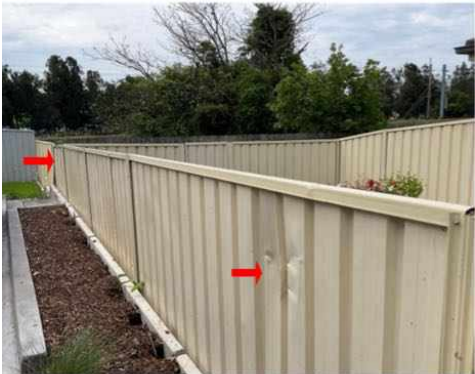
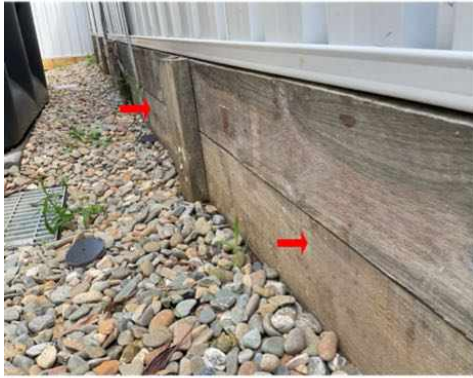
Defects 3.02

Building: Building 1
 Location: Pictured fences and small retaining wall
 Finding: Fences and retaining wall damaged and leaning
 Information: Evidence of damage to the pictured fences and lower rear retaining wall was identified at the time of the inspection. The likely cause of the leaning retaining wall and fence is not enough concrete used in the post footings. If left unmanaged this fence and wall will deteriorate further.

It is suggest a fencing contractor be engaged for rectification. This should be brought to the attention of the builder for rectification.

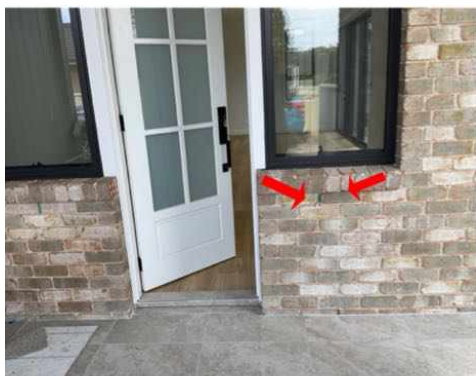
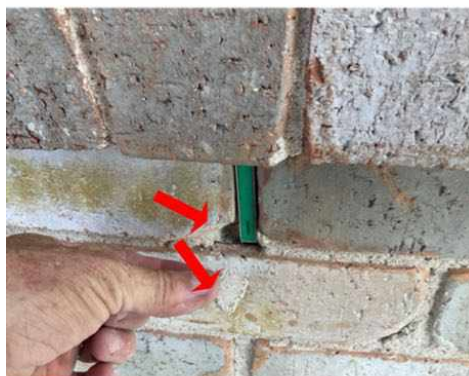
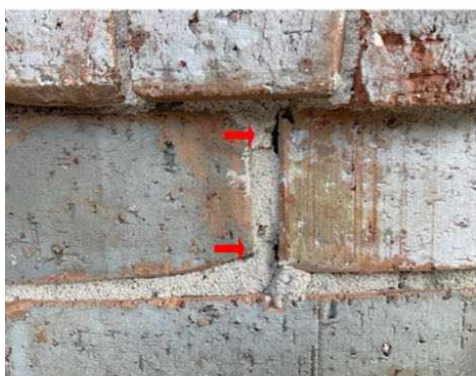
Defects 3.07

Building: Building 1
 Location: Entry
 Finding: Mortar Joints
 Information: Small areas of missing and damaged mortar joints were evident at the time of the inspection.

are defective if they are visible from normal viewing position, which is 1.5 metres

These areas need to be brought to the attention of the builder.

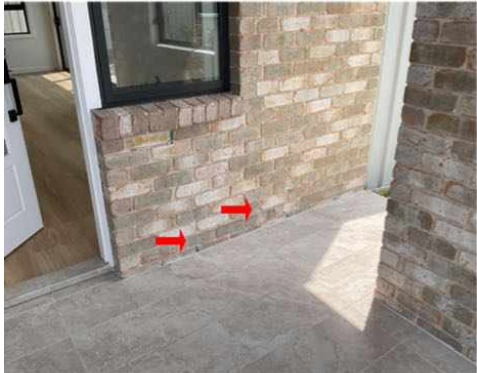
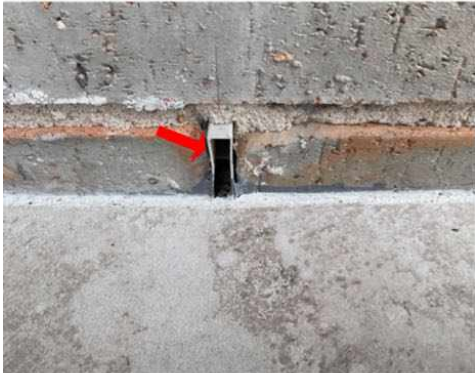
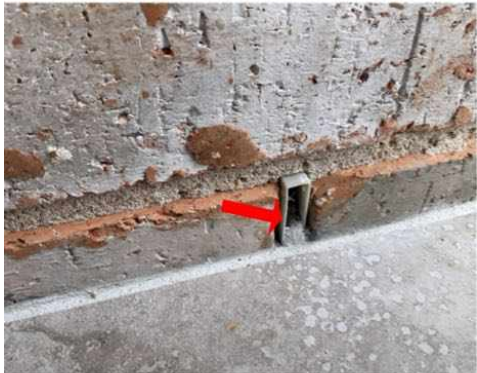
Defects 3.08

Building:	Building 1
Location:	Porch
Finding:	Weep holes - Blocked
Information:	It was noted during the time of inspection that some of the weep holes to the brickwork were blocked. Weep holes are designed to allow water from leaks or seepages in brickwork to be directed to the external environment, prior to entering the wall cavity or associated building materials. Weep holes should therefore be kept clean and free of debris or blockages.

Blocked weep holes are likely to result in the presence of excessive moisture within the brickwork and associated structures, creating potential for water damage and moisture problems.

This should be brought to the attention of the builder.

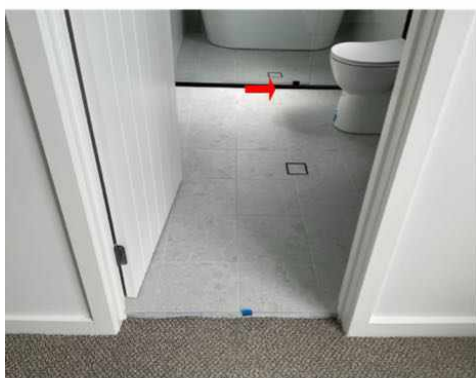
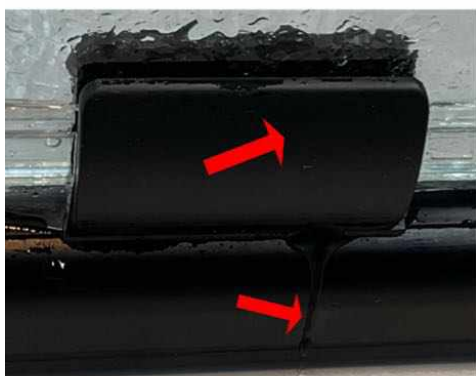
Defects 3.10

Building: Building 1
 Location: Upstairs bathroom
 Finding: Shower screen - Leaking
 Information: Leaking was evident to the ensuite shower screen through the hinge at the time of inspection. Leaking from the shower , where left unattended, is likely to lead to water damage to adjoining flooring and walls. Such damage can lead to water damage and necessitate extensive remedial works being required. Active water leaks may also create an environment that is susceptible to the formation and development of mould.

Appointment of a sealant expert is required by the builder.

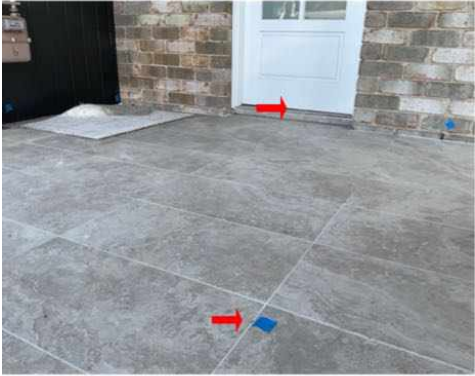
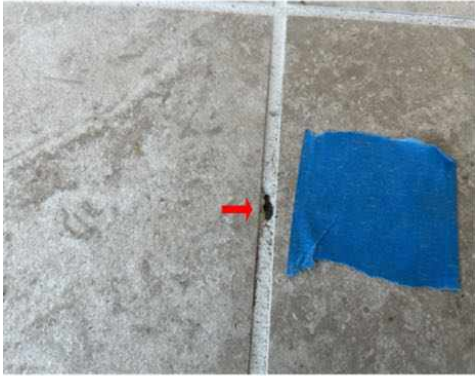
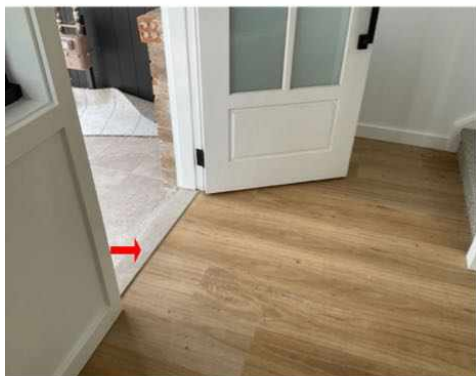
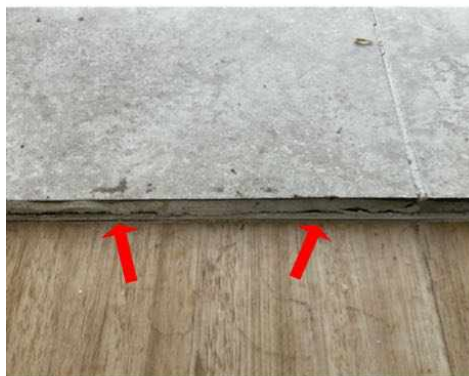
Defects 3.12

Building: Building 1
Location: Entry
Finding: Sealant and grouting - Missing
Information: It was noted on inspection that sealant or grout is missing to the pictured areas of the house entry.

A flexible sealant or grout is required to allow for expected expansion and contraction, while keeping the joint water tight and protective of all associated building materials.

These areas need to be brought to the attention of the builder.

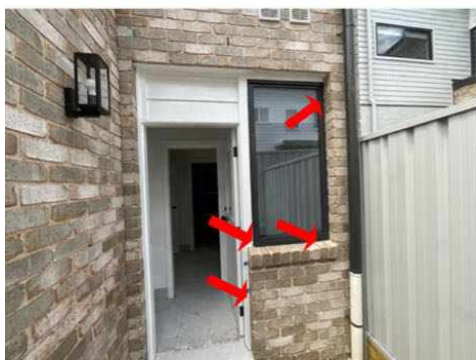
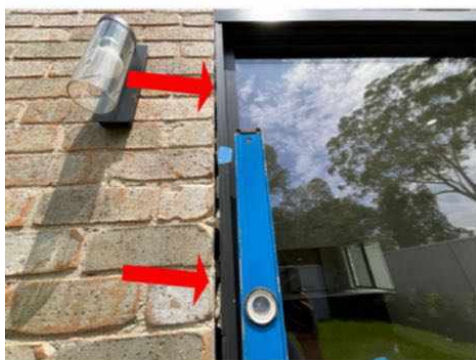
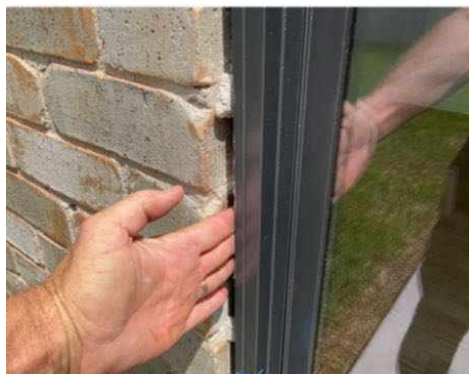
Defects 3.13

Building:	Building 1
Location:	Garage, laundry, window areas, tank pipes
Finding:	Sealant in External areas - The NSW Standards and Tolerances 2017 - 12.7
Information:	It was noted on inspection that sealant is missing or damaged to the entry, garage, front balcony, and other areas on the external walls. The right side of the main entry door and the area between the front driveway and porch are of substandard construction and require rectification works to fill gaps. The left side wall has gaps in architraves and cladding.

Flexible or waterproof sealants to junctions are defective if they are not installed

when required by the BCA and AS 3958.1.

All holes, gaps or cracks should be adequately filled by a suitable sealant or trimmings as soon as possible to prevent any water damage that may occur.

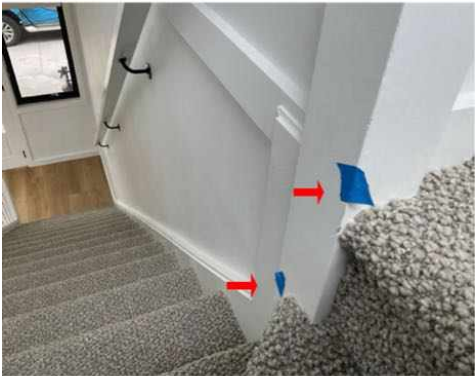
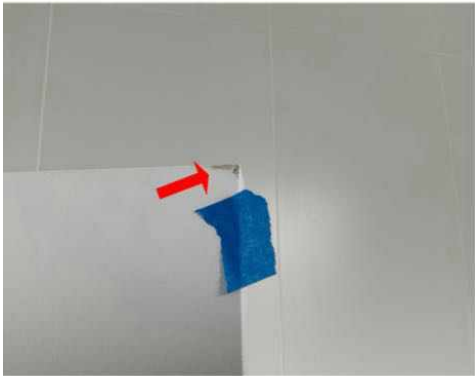
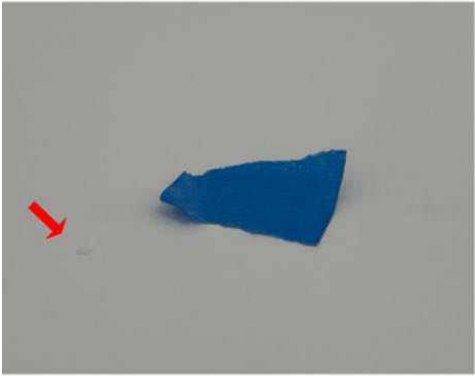
Defects 3.14

Building: Building 1
 Location: Marked up internal areas
 Finding: Paintwork defective - NSW Guide to standards and tolerances part 13.2
 Information: Several areas of substandard paint finishes were identified on the building at the time of the inspection.

Paintwork is defective if the application has blemishes such as paint runs, paint sags, wrinkling, dust, bare or starved painted areas, colour variations, surface cracks, irregular and coarse brush marks, sanding marks, blistering, non-uniformity of gloss level and other irregularities in the surface that are visible from a normal viewing position. Paintwork is defective if the application results in excessive over-painting of

fittings, trims, skirtings, architraves, glazing and other finished edges.

These areas need to be brought to the attention of the builder.

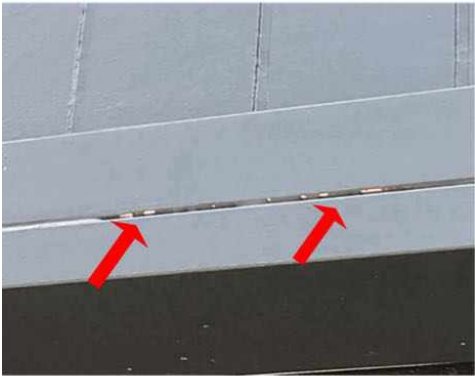
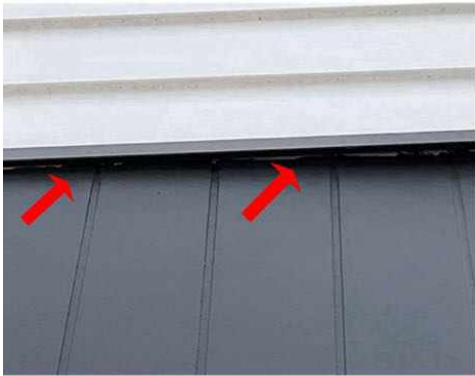
Defects 3.15

Building:	Building 1
Location:	Pictured external areas
Finding:	Paintwork defective - NSW Guide to standards and tolerances part 13.2
Information:	Several areas of substandard external paint finishes were identified on the building at the time of the inspection.

These areas need to be brought to the attention of the builder.

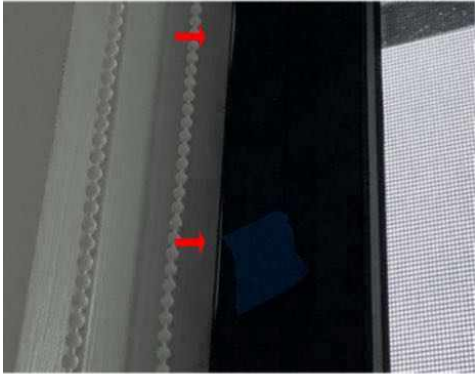
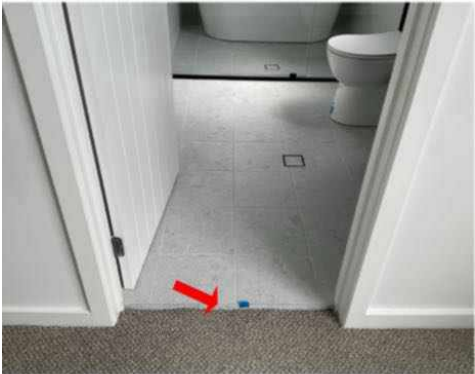
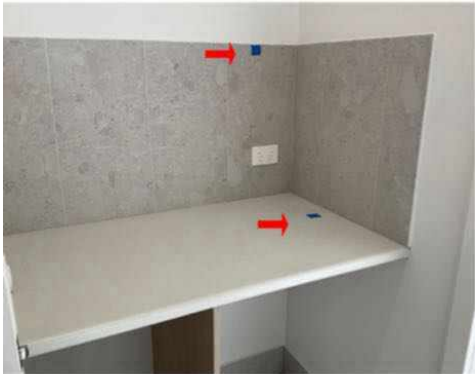
Defects 3.16

Building: Building 1
Location: Many external and internal areas marked by tape at the time of the inspection
Finding: Cleaning of building elements - NSW Standards and Tolerance 2017 - 3.11
Information: It was observed that many building elements including most windows, door hinges, floor wastes and other areas are not cleaned and ready for use.

The NSW Standards and Tolerances 2017 - 3.11 state - Cleaning, mortar smears and stains

“Stains, mortar smears and damage caused by cleaning are defective if they are visible from a normal viewing position.”

These areas need to be cleaned and ready for use.

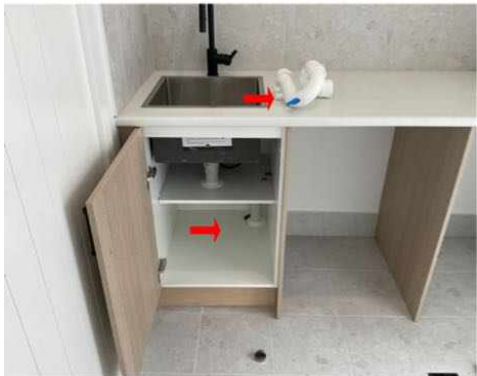
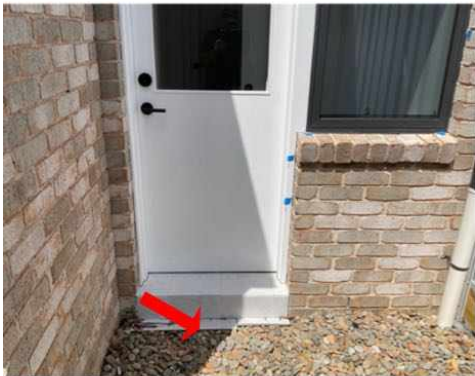
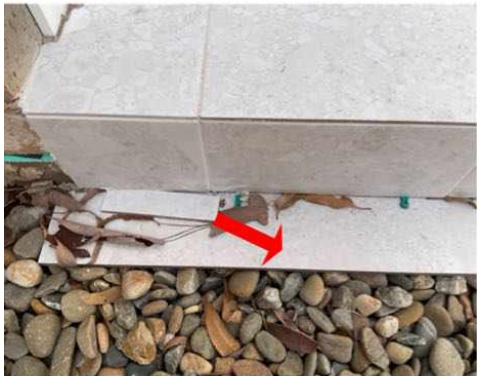
Defects 3.18

Building: Building 1
Location: Garage & rear laundry
Finding: Unfinished construction
Information: The construction in the laundry area appears to be incomplete. The plumbing is not connected and the outdoor tiling is not finished.

The Builder should complete this construction process.

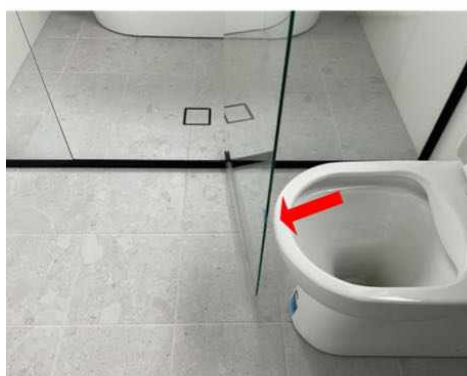
Defects 3.19

Building: Building 1
Location: Internal Areas
Finding: Door stops - Missing
Information: These areas are missing door stops. These areas required to stop the doors from damaging the wall/ toilet. Although some building elements may seem irrelevant or unnecessary, all building elements play a key role in the operation and function of the overall structure and its performance.

Installation of the door stops is advised as soon as possible to prevent any subsequent damage.

This should be brought to the attention of the builder.

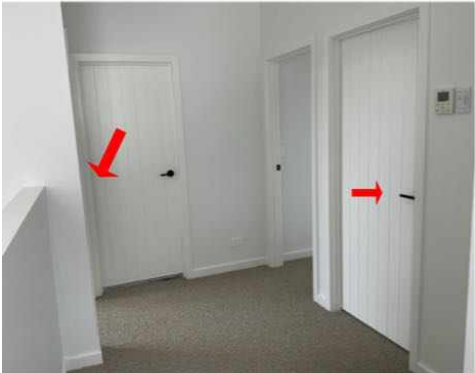
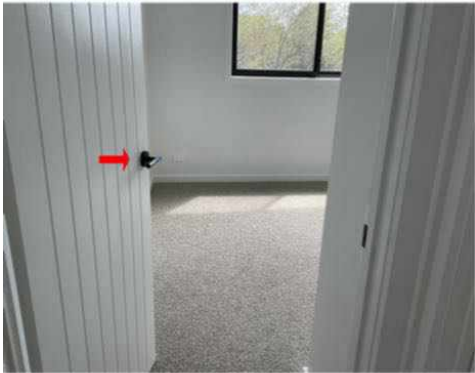
Defects 3.20

Building: Building 1
Location: Upper bedrooms
Finding: Doors not latching - NSW guide to standards and tolerances 9.3
Information: These two bedroom doors were found to be not latching at the time of the inspection.

The NSW guides to standards and tolerances 9.3 states that handles, locks and latches are defective if they do not operate as intended by the manufacturer.

This should be brought to the attention of the builder.

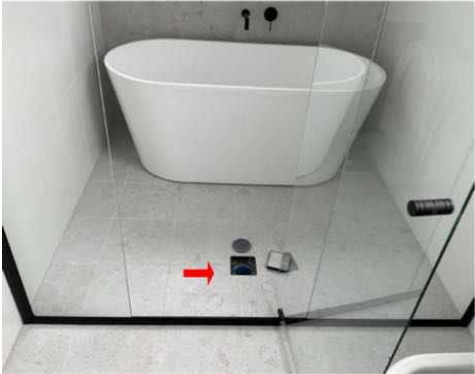
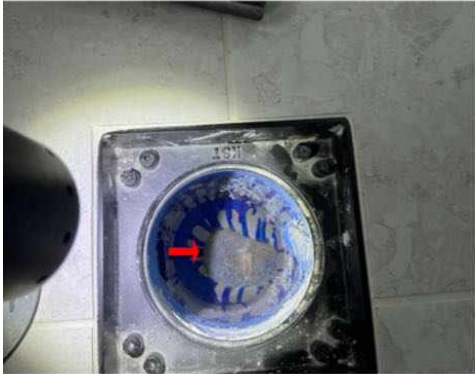
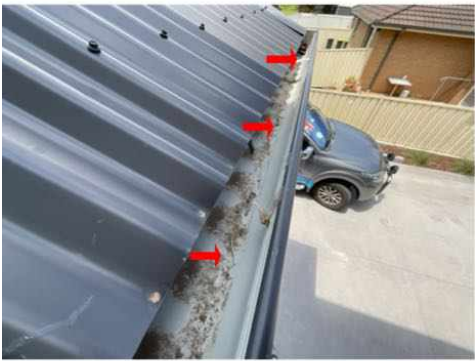
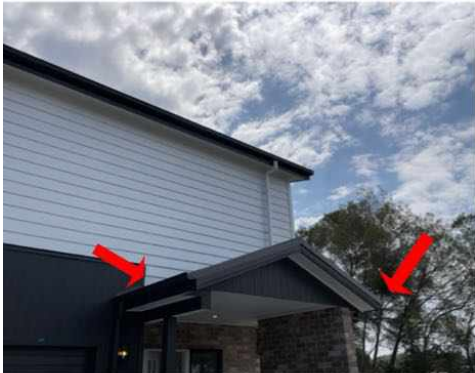
Defects 3.21

Building: Building 1
Location: Bathroom, laundry, front gutters
Finding: Building waste in drains and gutters
Information: Builders waste was found inside floor wastes and gutters at the time of the inspection. Builders waste left in these areas has the potential to interrupt the normal function of these drains and may lead to blockages and flooding of surrounding areas. These areas need to be brought to the attention of the builder.

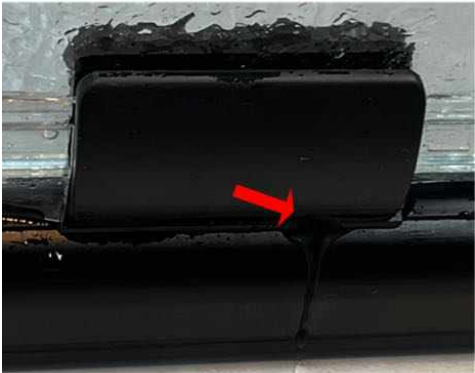
Defects 3.22

Building: Main Building
Location: Internal Areas
Finding: Shower screen - Leaking
Information:

Leaking was evident to the shower screening at the time of inspection. It is suspected that the leaking has occurred as a result missing sealant. Leaking from the shower , where left unattended, is likely to lead to water damage to adjoining flooring and walls. Such damage can lead to water damage and necessitate extensive remedial works being required. Active water leaks may also create an environment that is susceptible to the formation and development of mould.

Appointment of a sealant expert is required to repair or replace this missing sealant. These areas need to be brought to the attention of the builder.

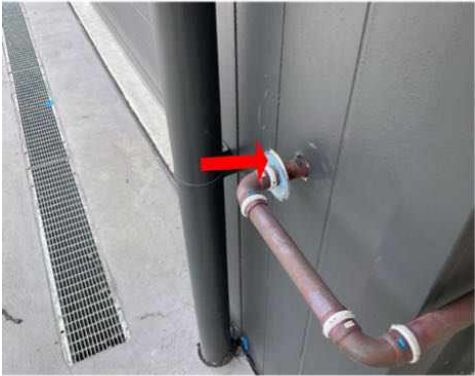
Defects 3.23

Building: Building 1
Location: Toilet (WC) - 2 and porch gas cover
Finding: Door handle loose & may not latch & gas cover loose
Information: The door handle and gas covers in these areas was found to be loose at the time of the inspection. Repair then testing of this door latch is advised to improve the operational state of the associated door. Fixing the gas covers to the wall is also required.

These areas need to be brought to the attention of the builder.

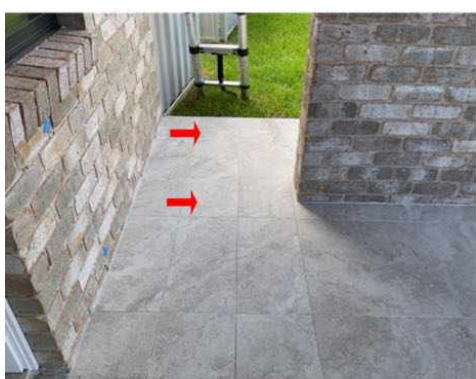
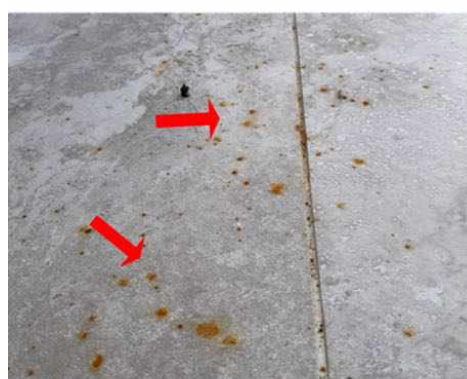
Defects 3.24

Building:	Building 1
Location:	Porch
Finding:	Swarfing stains
Information:	This pictured areas shows evidence of rusting and corrosion, which is a result of swarfing.

Fresh swarf stains are characterised by small red-brown coloured areas with a central dark spot (the remains of the steel particles).

Prevention of swarf staining is the responsibility of the installer. This needs to be removed.

This needs to be brought to the attention of the builder.
