Building and Timber Pest Inspection Report

Inspection Date: Tue, 17 Feb 2026

Property Address: 2/62 Ashburn Grove, Ashburton VIC 3147,
Australia

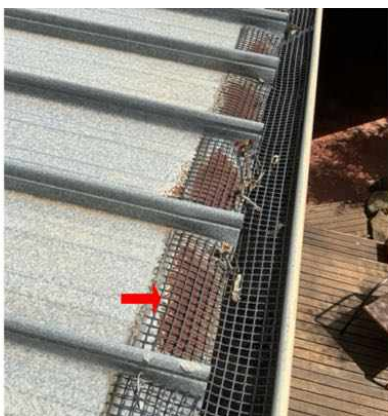
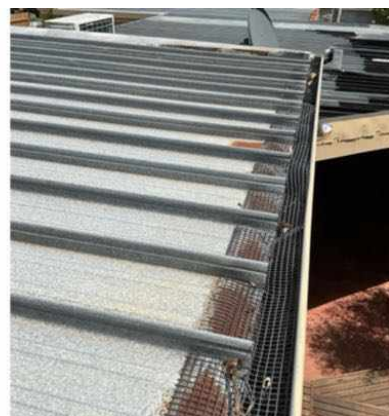
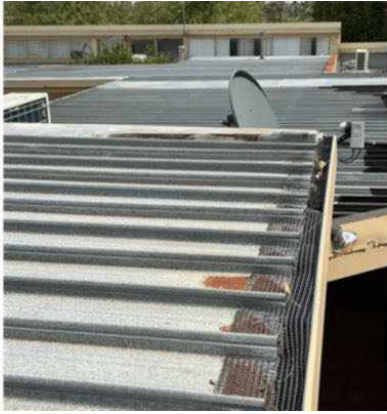
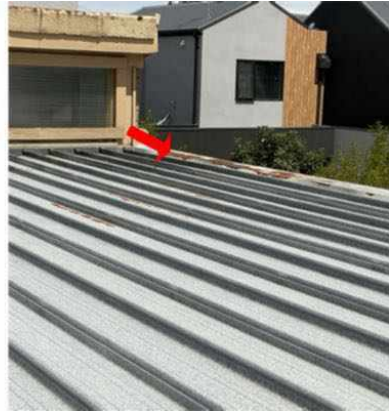
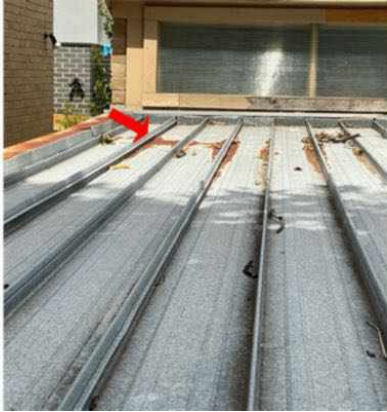
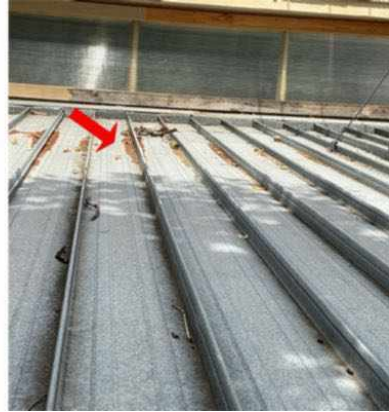
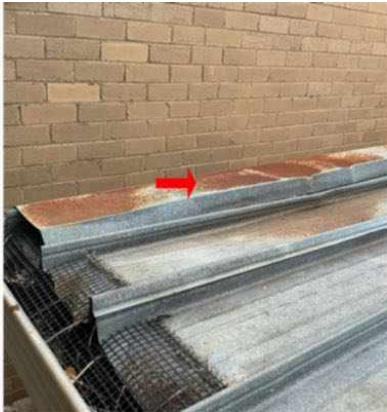
Building: Main Building
Location: Roof Exterior
Finding: Colorbond roof sheeting corrosion
Information: Corrosion was observed on sections of the Colorbond roof sheeting during inspection.

The affected areas appear to be surface rust developing along fixings and sheet edges, likely due to prolonged exposure to moisture, accumulation of debris, or inadequate maintenance of roof coatings. If left untreated, corrosion can progress and lead to perforation of the roof sheets, water ingress, and potential damage to roof framing or ceiling linings below.

A licensed roof plumber should be engaged to assess the extent of corrosion and carry out appropriate rectification, which may include cleaning, rust treatment, and re-coating or replacement of affected sheets as required.

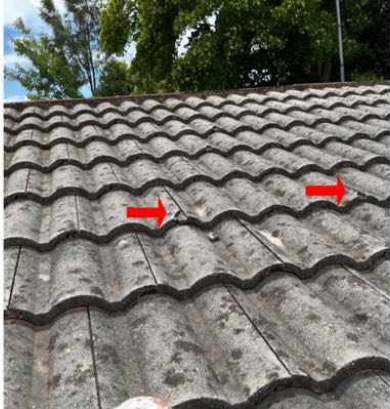
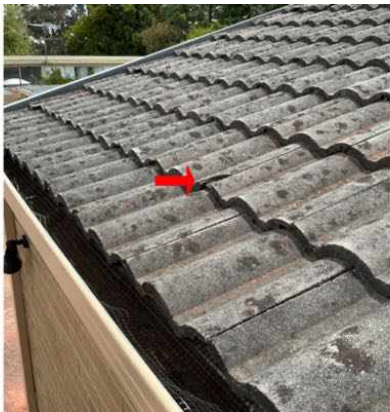
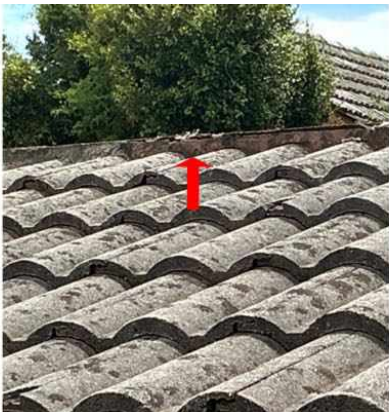
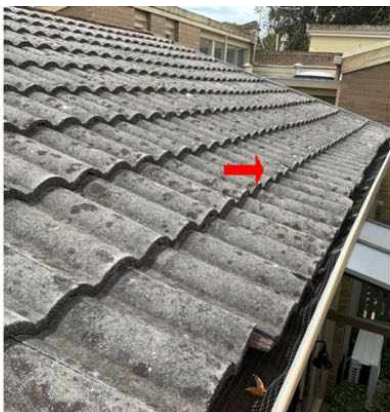
Finding 3.02

Information: Upon inspection of the exterior roofing, the majority of roof tiles were considered to be in a fair condition. While weathering of the tiles is consistent with the age of the property, maintenance works are required.

Isolated areas of mortar have come loose in the valleys and minor cracking is also present. Re-pointing and re-sealing the may be considered as an interim solution by the client to help preserve and extend the life span of the tiles.

Where left unmanaged, deteriorating roof tiles are likely to lead to a number of secondary defects, including minor water leaks and weather exposure to internal roofing structures.

Consultation with a roofing contractor is highly advised to gain advice on cost of remedial works that may be required in the short to medium term. Remedial works are likely to increase the longevity of the exterior roofing structure.

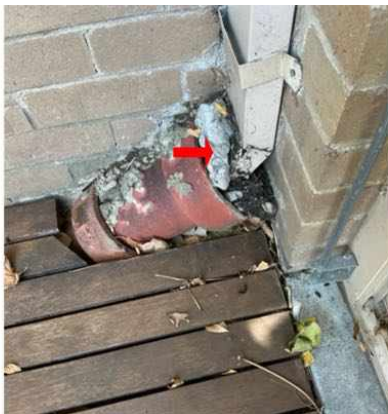
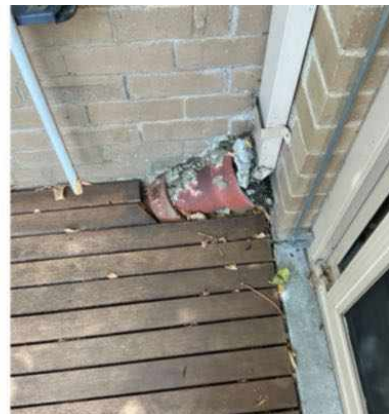
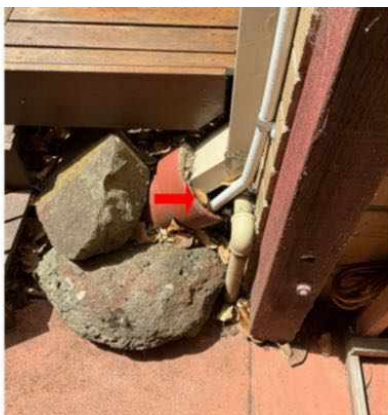
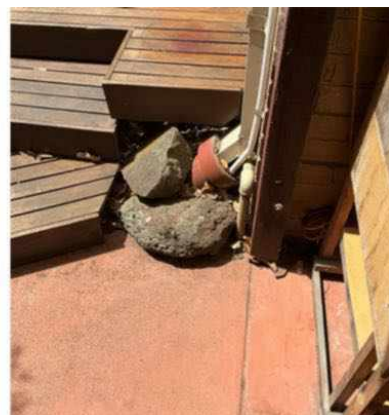
Finding 3.03

Building: Main Building
Location: Yard - Back

Finding: Debris accumulation
 Information: Debris accumulation was observed at the downpipe connection to the terracotta stormwater pipe (leaf litter and sediment present within/around the inlet).

Debris build-up may restrict stormwater flow and increase the likelihood of blockage, overflow and localised ponding at the base of the wall during heavy rainfall, which can contribute to dampness and deterioration of adjacent building elements.

Clear the debris promptly and implement regular inspection/maintenance (particularly after storms and during leaf drop) to ensure the stormwater system remains free-flowing and unobstructed.

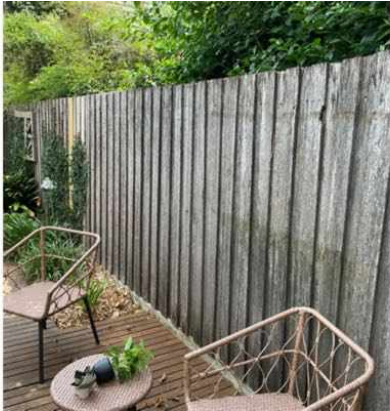
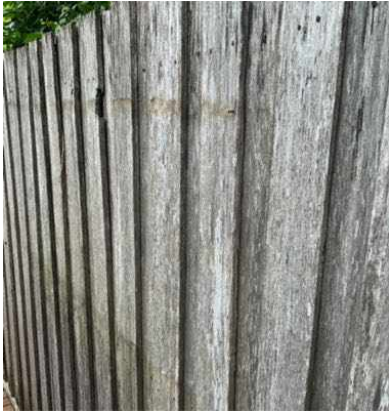
Finding 3.04

Building: Main Building
 Location: Fencing
 Finding: Fencing - Deteriorated
 Information: It was noted at the time of inspection that sections of the fencing throughout the property have deteriorated. Typically fencing deteriorates due to age and or wear, rot and or rust which is generally expected for a structure of this age, due to prolonged exposure to weather conditions. Sometimes inadequate installation or maintenance can be to blame.

If left unattended, it is likely that further damage will occur. It is suspected that repair of several elements of the fencing may be required however replacement may be a consideration of the client also.

A licensed fencing contractor should be appointed to provide further advice and perform rectification works as necessary.

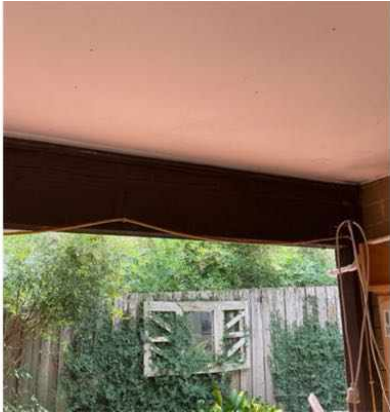
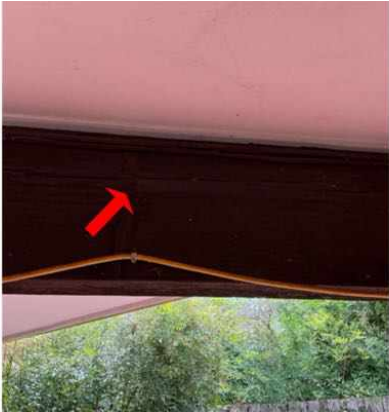
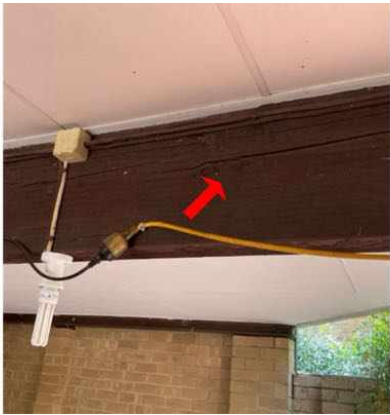
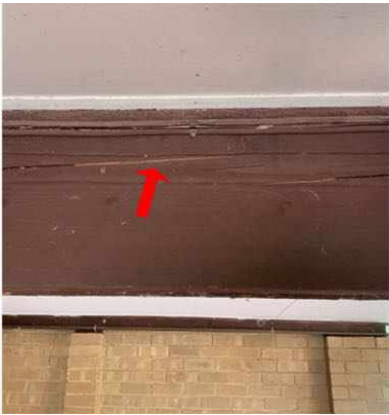
Finding 3.05

- Building: Main Building
- Location: Garage
- Finding: Splitting timber
- Information: Splitting was observed to the garage timber beam, with visible longitudinal cracks along the member.

Timber splitting may be associated with age, shrinkage or long-term loading. If deterioration progresses, the structural capacity of the beam may be reduced and could eventually require repair or replacement.

Continue to monitor the condition of the beam for any increase in cracking, deformation or movement. If the condition worsens, engage a qualified structural engineer to assess the beam and provide recommendations for repair or replacement if required.

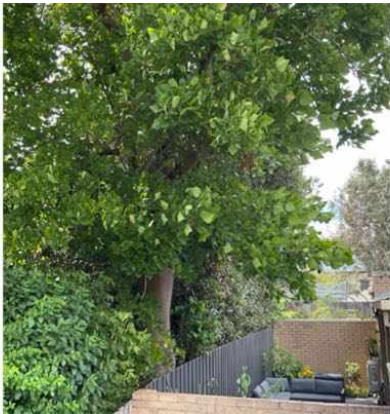
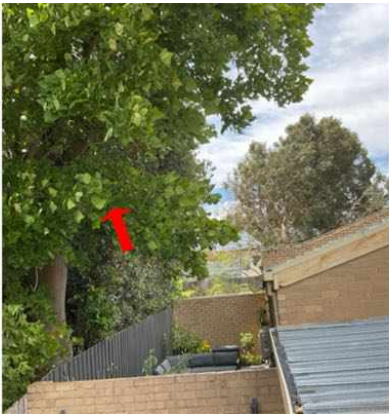
Finding 3.06

Building: Main Building
 Location: Roof Exterior
 Finding: Trees - Overhanging and filling gutters
 Information: Overhanging trees often result in excessive amounts of leaf debris accumulating in gutters.

Gutters are a critical part of the building's management of storm water and rain. It is therefore important that they be kept clear to prevent secondary damage to associated building elements, including exterior and interior walls, ceiling linings and any adjoining building elements. Where gutters are blocked, pooling of rainwater is likely to occur, fast-tracking rust and corrosion of the roof plumbing elements.

It is highly advised that all overhanging tree branches be removed as soon as possible to prevent any further damage. Repair and/or replacement of sections of damaged guttering may also be required where the extent of the damage necessitates.

Such works should be performed by the homeowner; however, appointment of a landscape contractor or an arborist may be required. Consultation with a licensed roof plumber is required where guttering has been damaged.

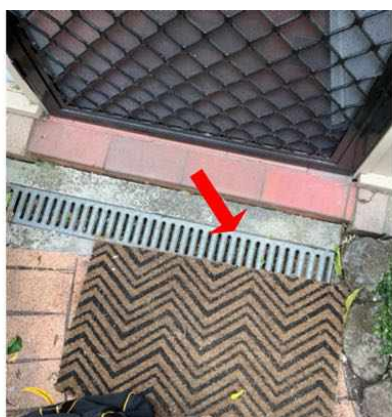
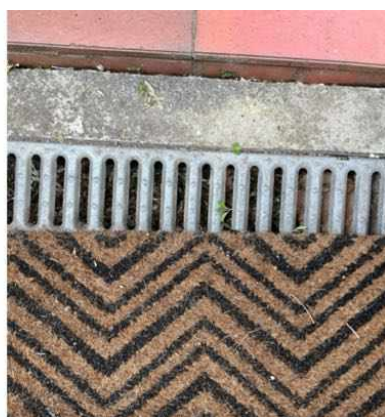
Finding 3.07

Building: Main Building
 Location: Yard - Front
 Finding: Debris in grated drain
 Information: Debris accumulation was observed within/around the grated trench drain at the entry, with the doormat partially covering the grate.

Blocked or restricted drainage may reduce water flow capacity and increase the likelihood of water ponding/overflow at the doorway area, which can contribute to slip hazards and potential moisture ingress to the threshold during heavy rainfall.

Clear debris from the grate and drain channel, and ensure the grate remains unobstructed (including repositioning the doormat). Ongoing maintenance/periodic cleaning is recommended, particularly after storms and leaf drop.

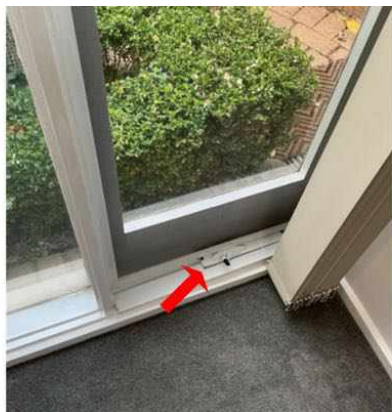
Finding 3.08

Building: Main Building
 Location: Bedroom
 Finding: Window Unable to Operate
 Information: At the time of inspection, the window could not be opened using the designed operating mechanism. The mechanism appears faulty and is not functioning as intended.

Client is advised to engage a qualified window contractor or competent handyman to replace the window mechanism and restore normal operation.

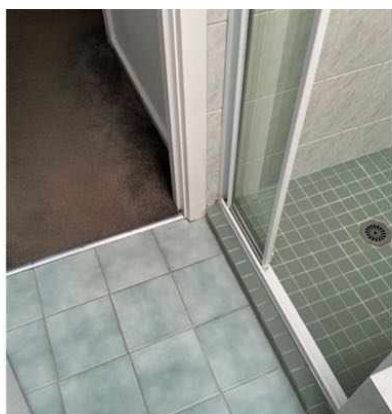
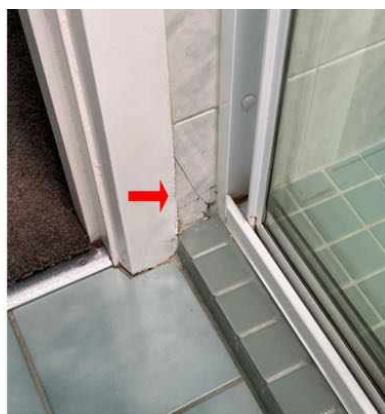
Finding 3.09

Building:	Main Building
Location:	Bathroom
Finding:	Tile Cracking— bathroom
Information:	Cracked tiles were observed at the bathroom/shower entry area.

Cracked tiles and joints may allow moisture to penetrate behind the tiling, which can contribute to deterioration of the substrate and potential waterproofing issues over time.

Engage a qualified tiler/waterproofing contractor to assess the extent of damage and carry out repairs as required (e.g., replace cracked tiles, re-grout and re-seal junctions). Monitor the area for any signs of water leakage or loosening tiles and attend promptly if symptoms worsen.

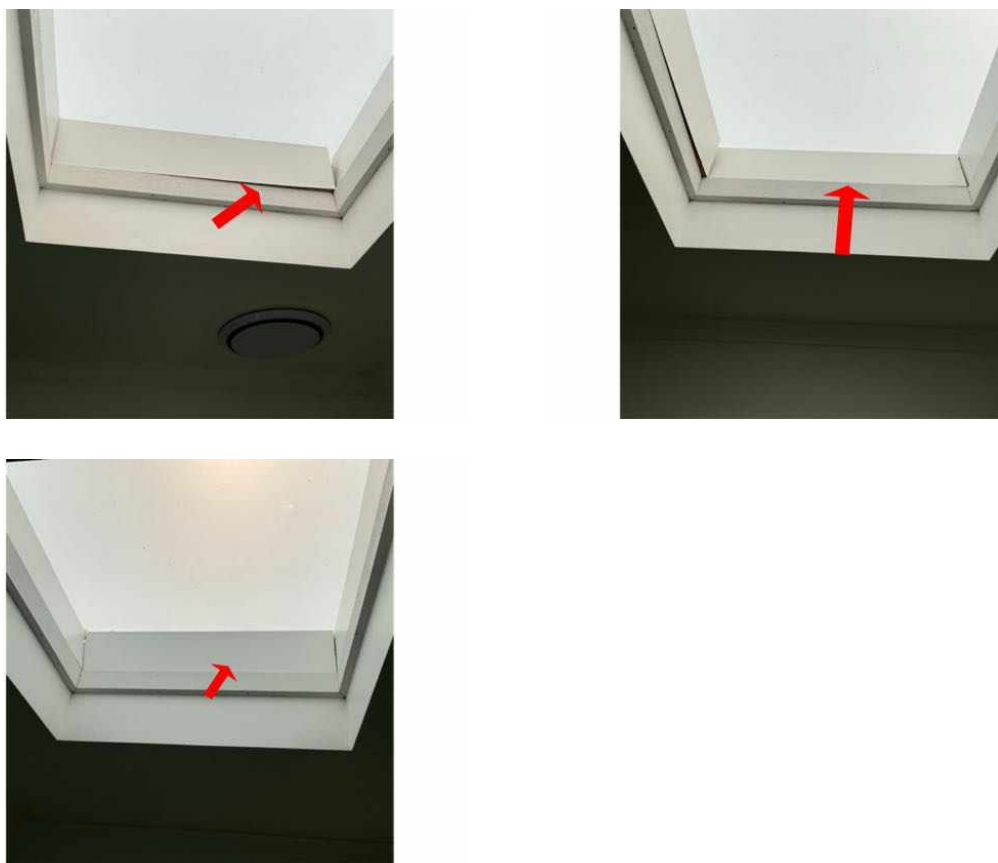
Finding 3.10

Building:	Main Building
Location:	Bathroom
Finding:	Skylight observation
Information:	The skylight internal finish/trim cover appears partially detached with visible gaps at the junctions.

Loose/detached trim can indicate movement or poor fixing and may allow air leakage, dust/insects entry, and conceal early signs of moisture staining if minor water ingress is present around the skylight shaft.

Engage a qualified handyman/carpenter (or skylight installer) to refix the skylight trim and seal junctions as required. Monitor the area after heavy rainfall for any signs of water staining or dampness and arrange further investigation if staining develops.

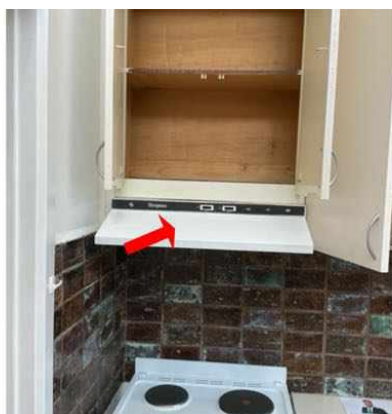
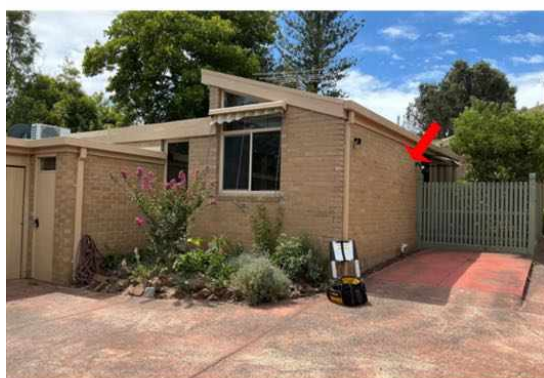
Finding 3.11

Building:	Main Building
Location:	Kitchen
Finding:	Rangehood observation
Information:	The rangehood appears to be operating as a recirculating unit (no visible ducting within the overhead cupboard and no external wall/roof discharge outlet was observed at the time of inspection).

Engage a qualified appliance installer/ducting contractor to confirm the rangehood configuration and performance. If external ducting is required/desired, arrange

installation of compliant ductwork and an appropriate external discharge point (subject to access/feasibility). Clean/replace any charcoal filters regularly if the unit is designed for recirculation.

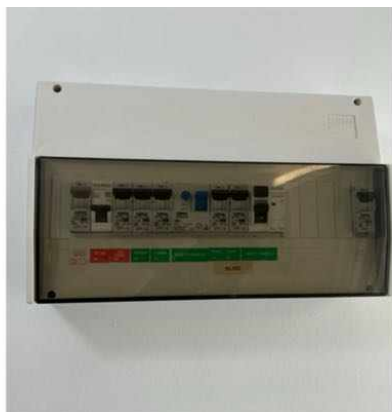
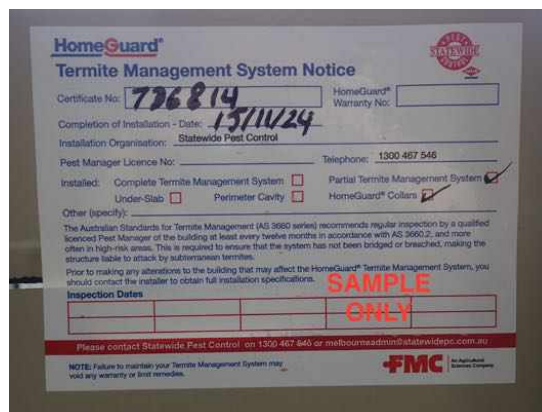
Building:	Main Building
Location:	Electrical switchboard
Finding:	Termite Management System - no evidence of a chemical installation
Information:	The application of a post-construction chemical termite barrier is highly recommended for all properties, particularly if live termite activity has been found on the site previously. Such barriers are highly effective in preventing termite attack on any timber

A durable notice should be placed in the switchboard unit to indicate current termite barriers. At the time of inspection, it appeared as though no termite management system has been installed, with no evidence to suggest preventative works taking place.

The client may consider gaining further advice from a pest controller as to the costs and procedures involved with this application. It is recommended that obtaining such advice be a short-term priority.

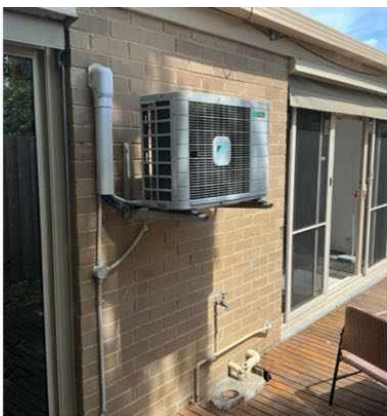
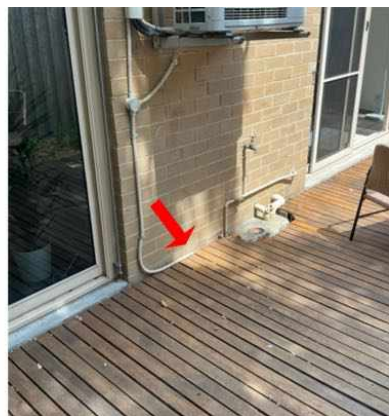
Finding: The air conditioning condensation pipe is not properly connected and discharges directly into the soil adjacent to the building.

Information: This creates a conducive condition for termite activity by providing a constant moisture source near the structure. It may also lead to soil erosion, mould growth, or damage to nearby building materials.

The overflow should be redirected to an appropriate discharge point—such as a stormwater connection or designated drainage area—away from the building foundation, in accordance with plumbing and termite management standards.

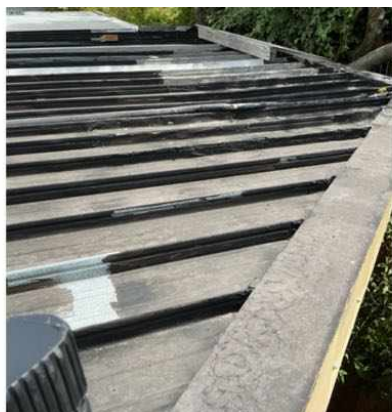
Building:	Main Building
Location:	Roof Exterior
Finding:	Evidence of previous repair on garage roof sheet
Information:	Evidence of previous repairs/patching was observed to the garage roof sheeting (including areas of applied coating/sealant over sheet laps and fixings).

Prior repairs indicate the roof may have experienced leakage or deterioration previously. Patched areas can degrade over time (UV/weather exposure), increasing the risk of future water ingress and ongoing corrosion to the roof sheets and supporting structure.

Engage a qualified roof plumber to assess the condition of the garage roof, verify the effectiveness of the existing repairs, and carry out further rectification as required (e.g., re-sealing, replacing affected sheets, and confirming correct falls/drainage) to minimise the risk of ongoing leaks.

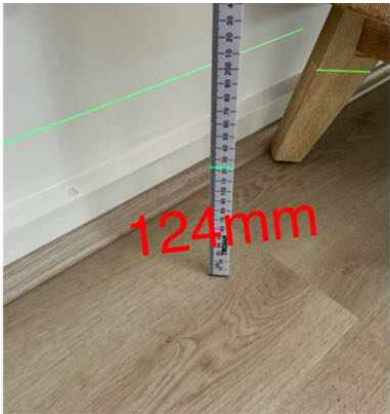
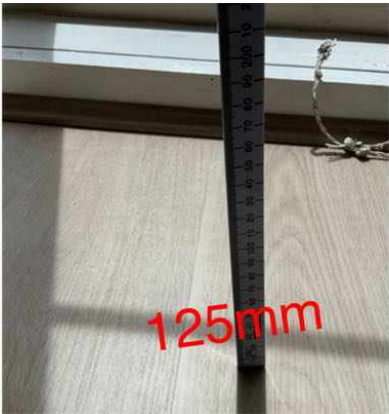
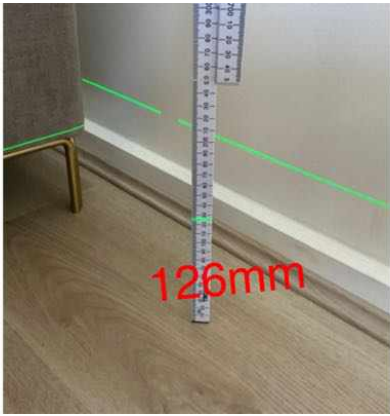
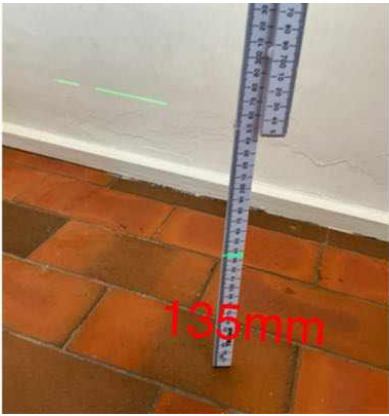
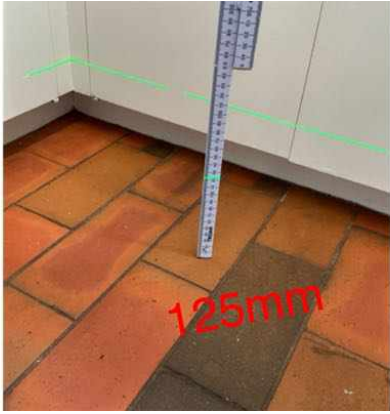
Building:	Main Building
Location:	All Areas
Finding:	floor unevenness - v4
Information:	The standard laser level was positioned 125 mm above the floor, as shown in the photo. The measured floor deviation across the room ranges from the lowest point to the highest point by approximately 10mm

Considering the age of the property and no visible significant cracks were observed at time of inspection. This degree of settlement is generally within an acceptable range for a building of its era. However, for buyers who have higher expectations regarding

floor levelness or sensitivity to uneven floors, it should be noted that restumping or re-leveling can involve a considerable cost. This should be taken into account when planning the overall purchase budget.
