Building and Timber Pest Inspection Report

Inspection Date: Wed, 11 Feb 2026

Property Address: 53 Woodlands Dr, Glenmore Park NSW
2745, Australia

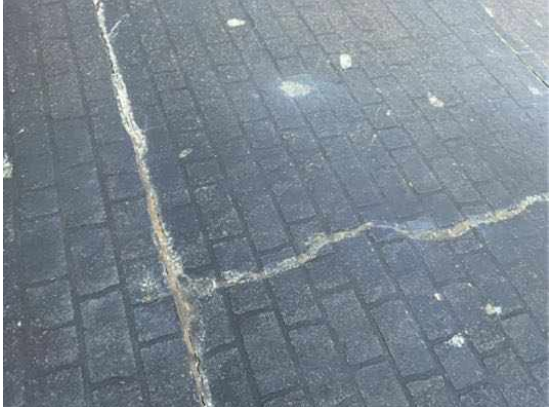
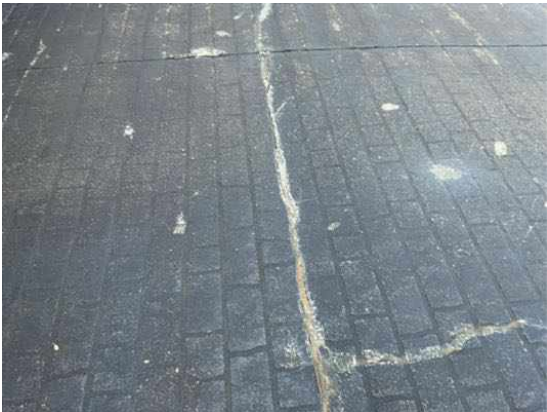
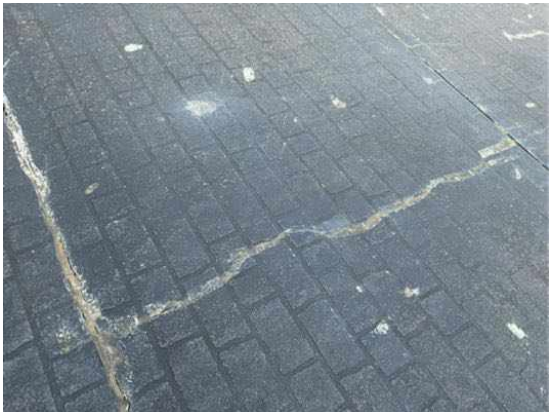
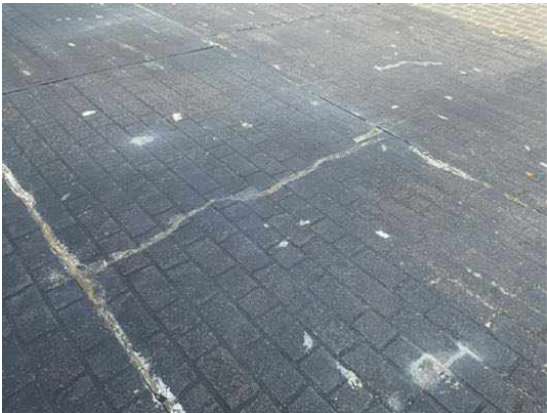
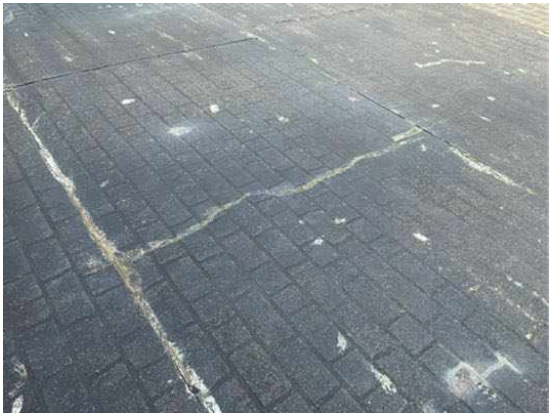
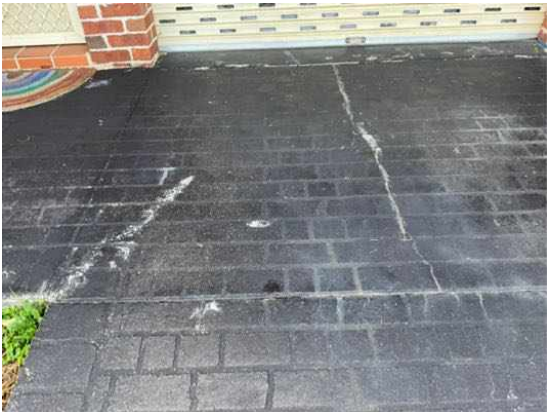
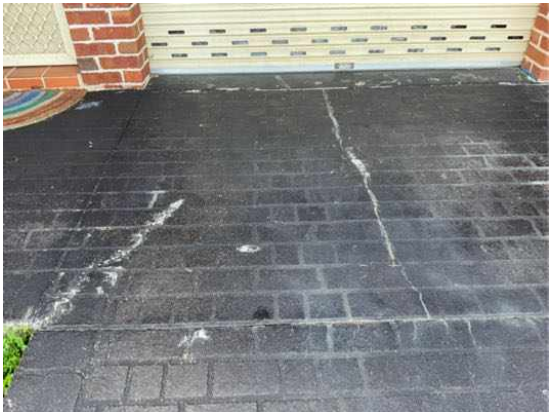
Building: Main Building
Location: All Areas
Finding: Noticeable Cracking in Concrete Slab
Information: Noticeable cracking has been observed in the concrete slab, failing to meet the required construction and quality standards.

- Cracks are visible on the surface and may extend through the depth of the slab.
- Evidence of improper curing or inadequate reinforcement leading to cracking.

- Compromised structural integrity of the slab, potentially leading to failure under load.
- Water ingress through cracks, causing corrosion of reinforcement and further weakening the structure.
- Potential trip hazards and aesthetic issues, reducing the overall value and safety of the property.
- Increased maintenance and repair costs due to ongoing deterioration.

- A structural engineer should be engaged to assess the extent of the cracking and recommend appropriate repair methods.
- A licensed contractor or concrete repair specialist should carry out the recommended repairs under the guidance of the structural engineer.

A detailed inspection should be conducted post-repair to confirm compliance with the required standards and to ensure that the structural integrity of the concrete slab has

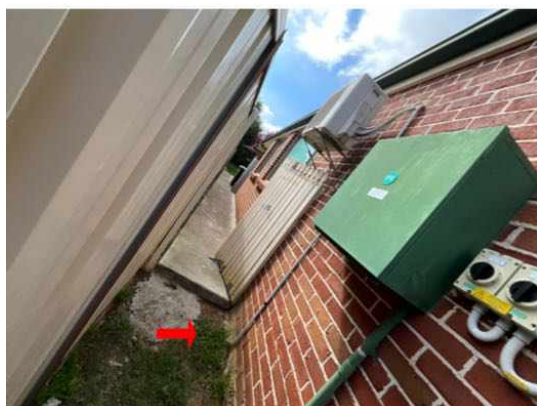
Finding 3.02

| Finding: | Air conditioner - Disconnected overflow |
| Information: | The Air Conditioner (A/C) overflow was found to be disconnected from storm water drainage and is creating excessive moisture in the surrounding area. |

Such leaking creates an environment which is conducive to an array of defects, including water damage to associated building elements and the attraction of termite or timber pest infestation.

It is highly recommended that a licensed plumber be appointed to connect the A/C overflow in order to prevent such an environment from being created. These minor works should be carried out as soon as possible.

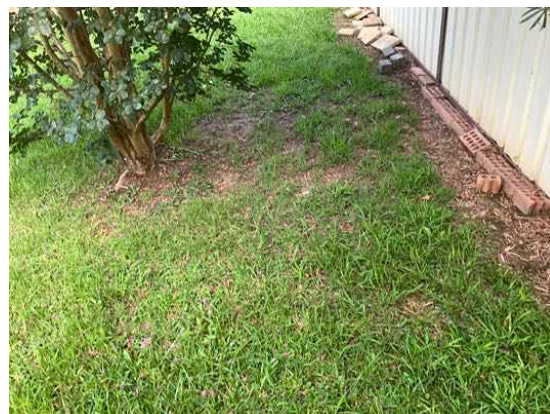
Surface water drainage is defective if it is not in accordance with the requirements of the Building Code of Australia.

Such water pooling also increases the risk of termite activity and the development of fungal decay in the area.

Consult a Licensed Plumber regarding the cost of potential site drainage rectification works.

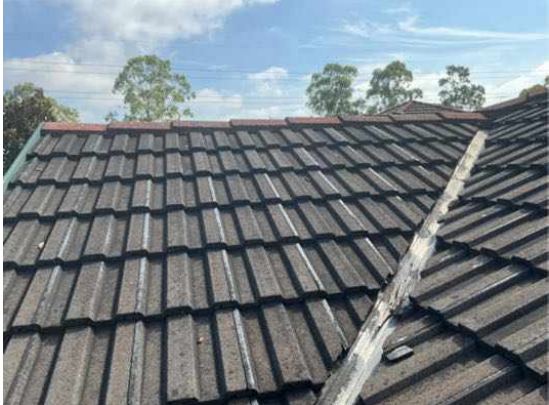
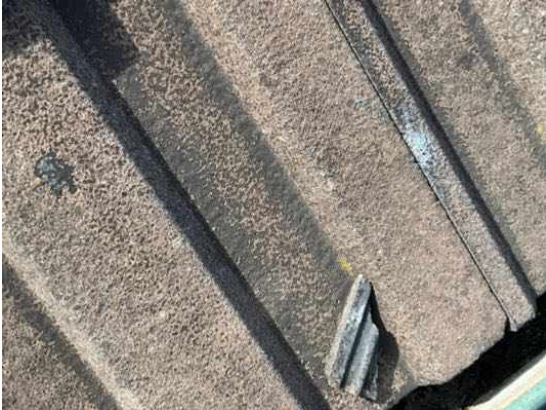
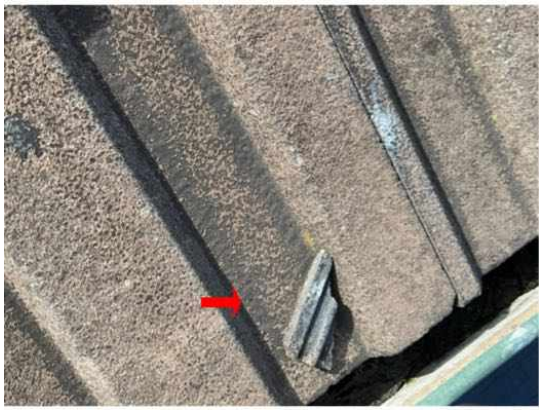
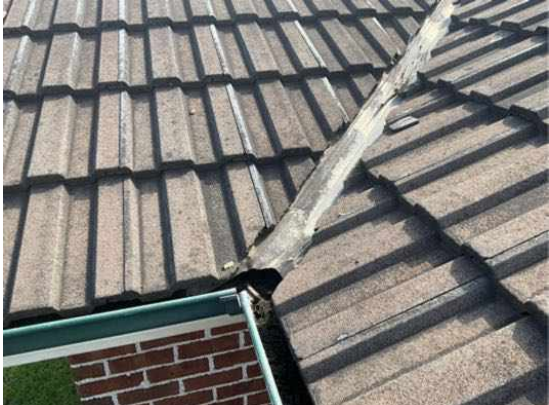
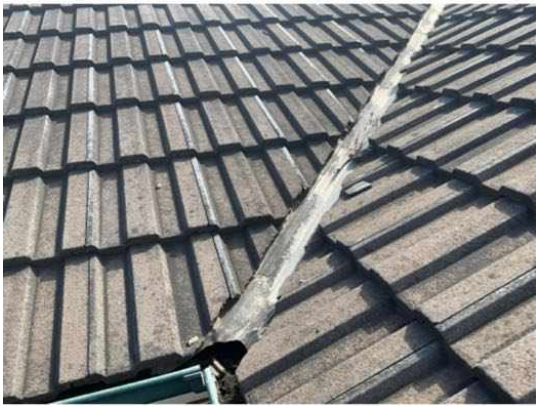
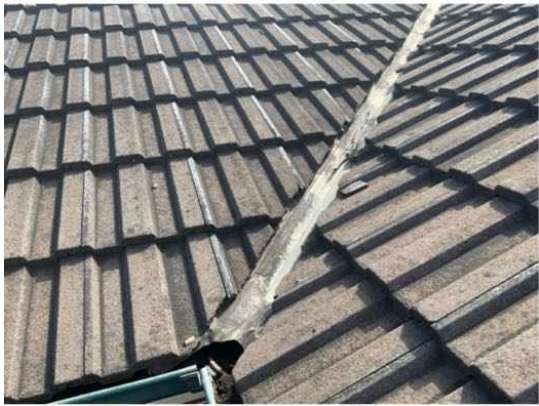
Finding 3.06

| Information: | Upon inspection of the exterior roofing, the majority of roof was not in a fair condition. While weathering of the roof is consistent with the age of the property, maintenance works are required. |

Isolated areas of mortar have come loose in the valleys and minor cracking is also present. Re-pointing and re-sealing may be considered as an interim solution by the client to help preserve and extend the life span of the tiles.

Where left unmanaged, deteriorating roof are likely to lead to a number of secondary defects, including minor water leaks and weather exposure to internal roofing structures.

Consultation with a roofing contractor is highly advised to gain advice on cost of remedial works that may be required in the short to medium term. Remedial works are likely to increase the longevity of the exterior roofing structure.

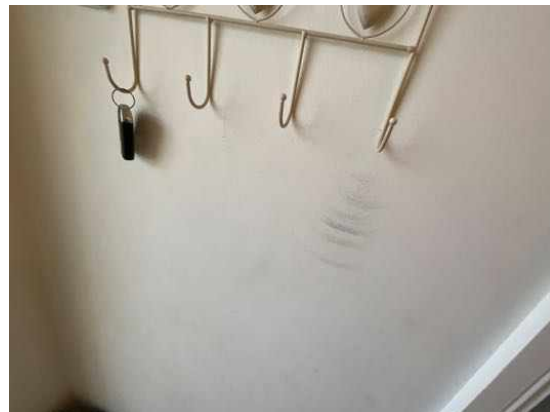
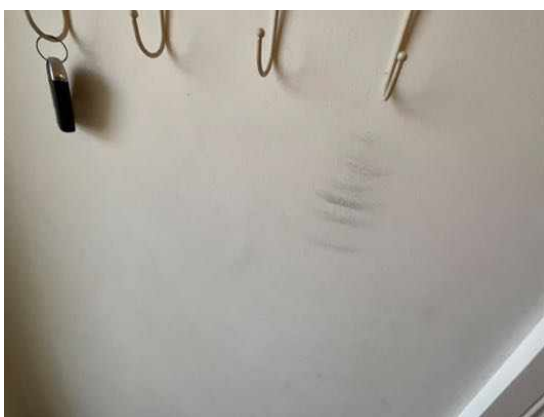
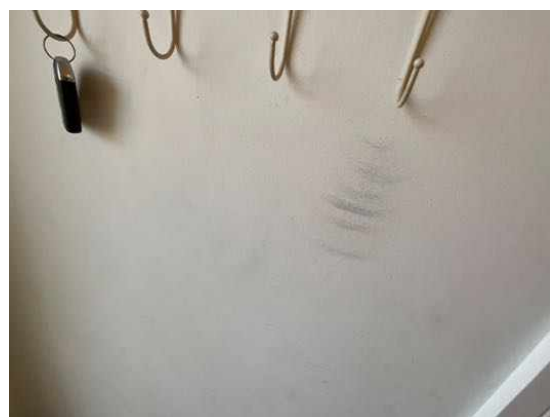
1. Aesthetic Degradation: Scratches mar the appearance of the painted surface, diminishing its visual appeal and potentially lowering property value.
2. Corrosion Vulnerability: Exposed areas of bare metal due to scratched paint are susceptible to corrosion, leading to structural damage and compromised durability.
3. Environmental Hazards: Scratched paint can release hazardous chemicals into the environment, posing risks to both human health and the ecosystem.

A qualified painter should address the issue promptly to repair the scratched paint. Depending on the severity of the scratches, repair options may include sanding, priming, and repainting the affected area to restore the integrity and appearance of the paint surface.

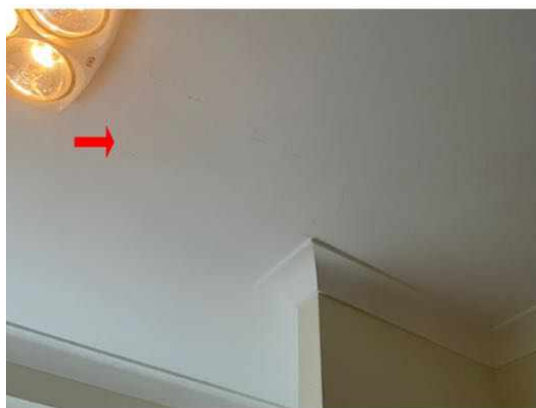
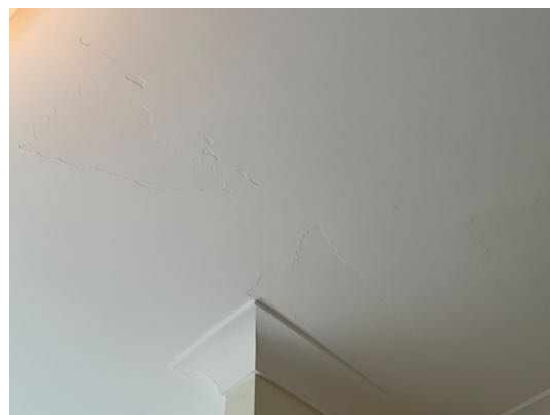
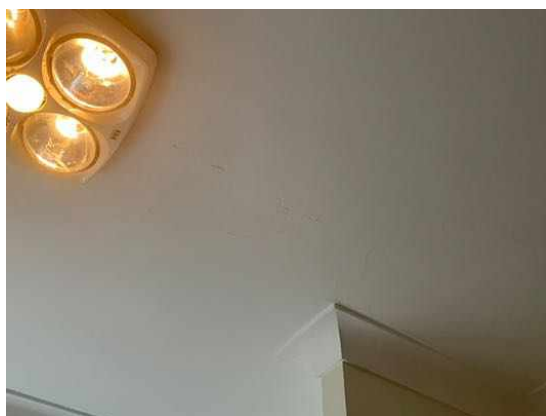
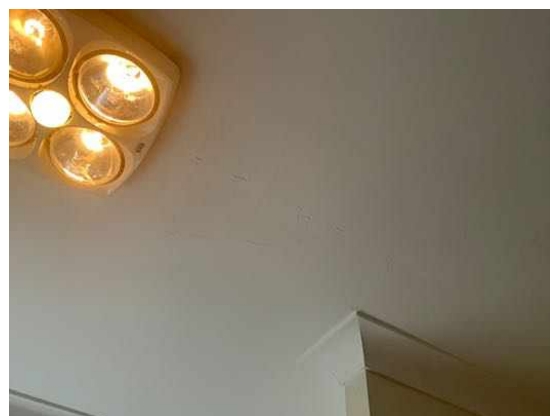
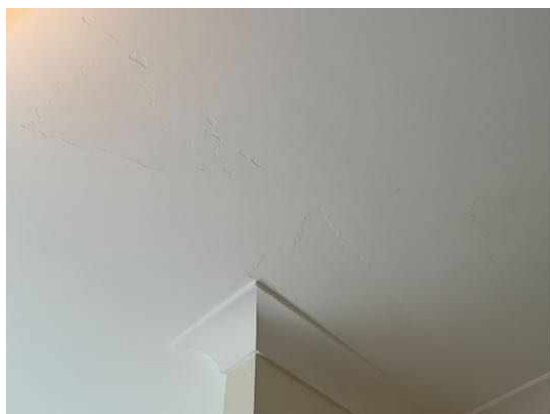
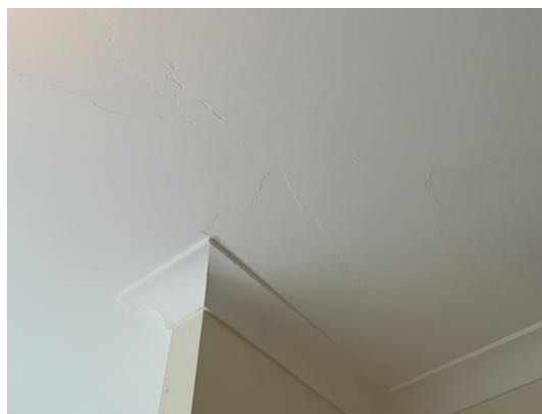
Finding 3.09

Building: Main Building
Location: Bathroom

Finding: Paint surface deteriorated

Information: Sections of the paint in this area was found to have bubble and deteriorated. Paint bubbling is generally an indication of excessive moisture in the area that is currently hidden by the painted surface.

The presence of excessive moisture can have major implications on associated building elements if left unattended. While only seemingly minor at this stage, the damage cannot be determined due to the paint, obstructing any further inspection of the damage.

It is highly advised that the affected paint to be cleaned to allow a further, more invasive inspection by a licensed builder/painter. Failure to act on this defect may necessitate major works in the future.

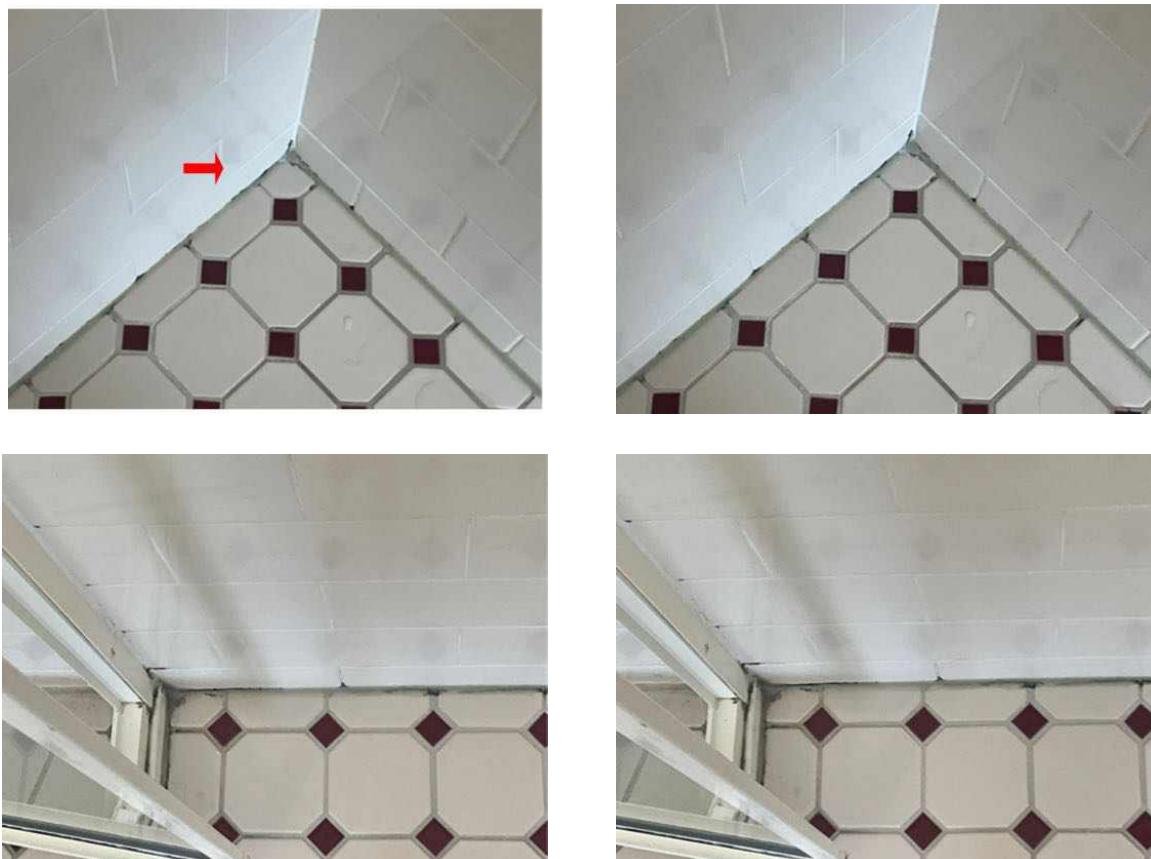
Finding 3.10

| Finding: | Sealant and grouting - Missing or damaged |
| Information: | It was noted on inspection that sealant or grout is degraded to the tiled shower alcove and or other areas of the bathroom. |

Different materials and floor areas move at different rates, generally causing cracking to grout or sealant at this point. A flexible sealant is required to allow for expected expansion and contraction, while keeping the joint water tight and protective of all associated building materials.

There appears to be excessive mould to the sealant and grout which will likely require scraping out and replacement.

Flexible and mould resistant materials should be applied to affected areas to prevent any subsequent water damage that is likely to occur. Regular maintenance and replacement of damage or missing or damaged sealant and grout is highly recommended to the wet areas, as this is a regular wear and tear defect. Sealant and grouting in areas that come into regular contact with water should be maintained for the long term care of your property.

A sealant specialist or tiling contractor should be appointed to complete these works as soon as possible

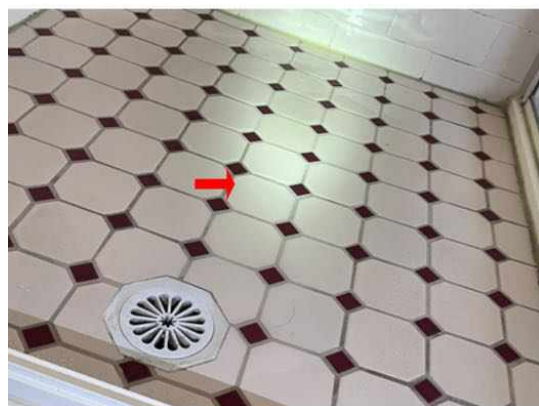
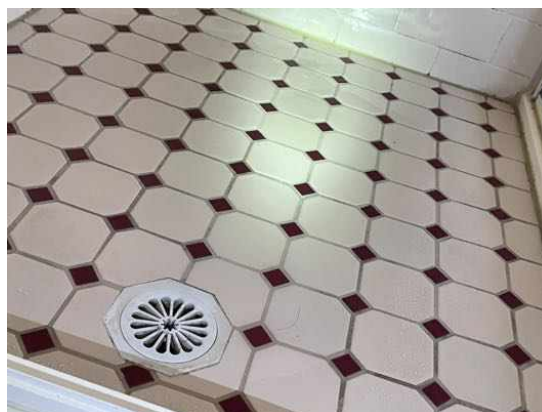
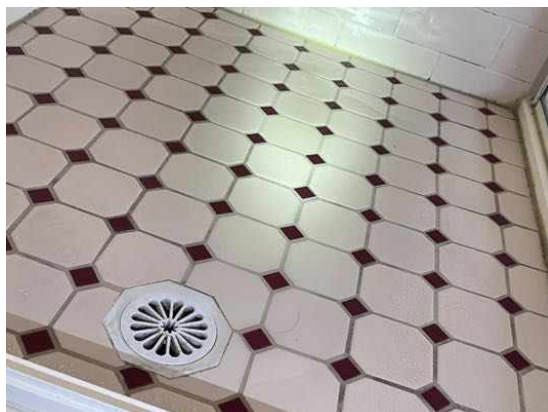
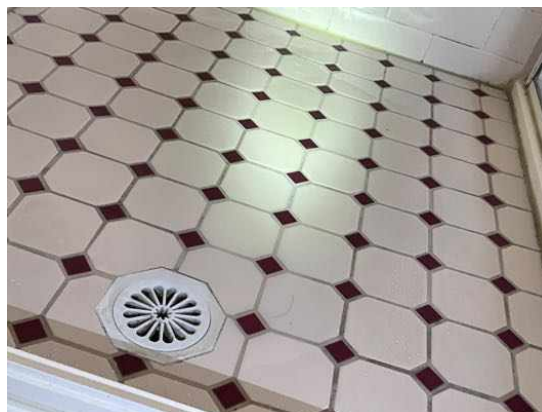
Building: Main Building
 Location: Bathroom
 Finding: Shower base - Water pooling
 Information: Evidence of water pooling around the floor waste in the shower recess was noticed at the time of inspection. It is suspected that this excessive moisture is attributed to insufficient fall in the shower floor tiles.

This pooling is minor overall but is still considered unsatisfactory, as standard tiling practices would not permit this situation to occur. Pooling water around floor wastes can create a slip hazard in extreme cases and create conditions that are conducive to mould growth over time. Where left unmanaged, the degradation of sealant and grouting is also likely to occur, possibly necessitating further repair works.

Remedial works may involve some sections of tiling and flooring repair and replacement. A tiling contractor or bathroom specialist should be appointed to provide further advice on reparation options and to perform works as necessary.

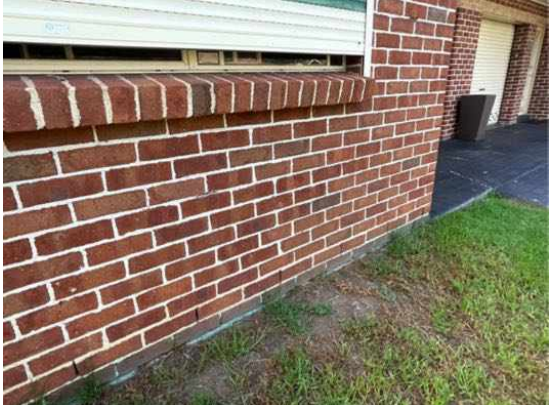
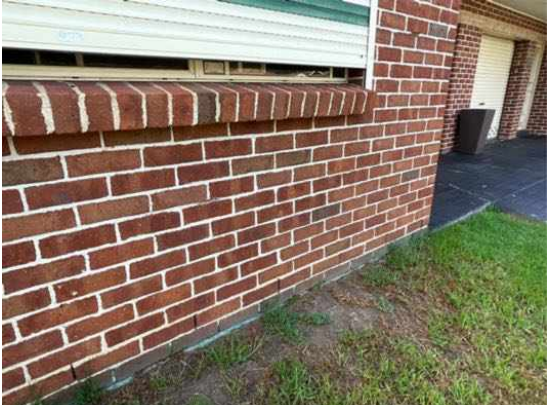
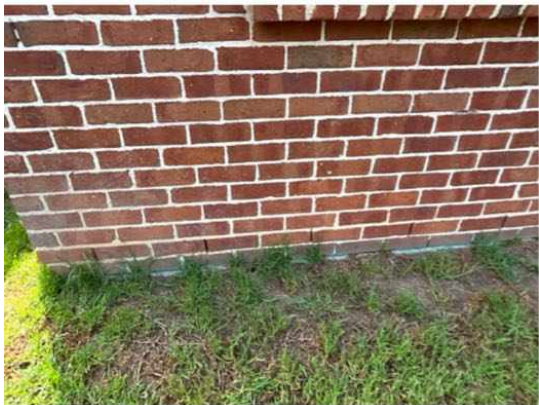
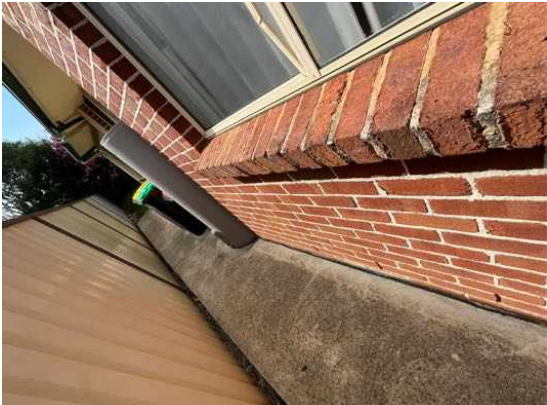
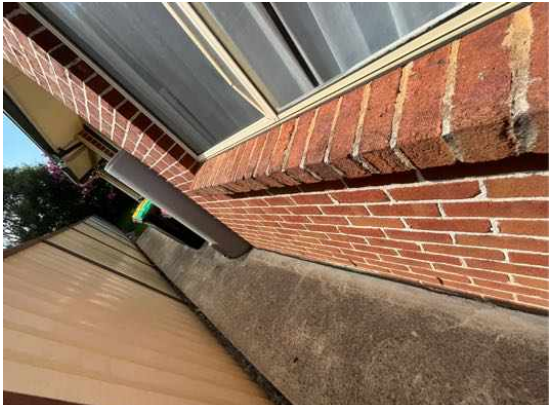
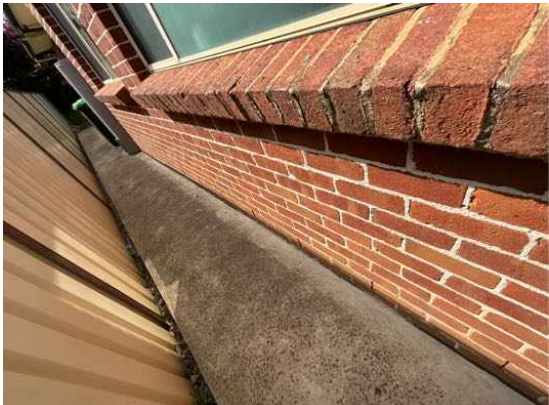
If the slab edge is not properly exposed there is a high risk of termite attack. Sometimes, in order to determine the type of slab, a suitably qualified person such as an architect or builder may be required to consult the construction plans.

Where the slab edge cannot be properly inspected, it is highly recommended that termite or timber pest inspections be carried out every 6-12 months to aid protection of the property against infestation.

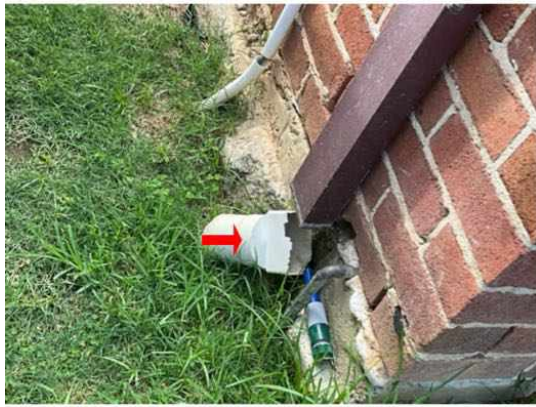
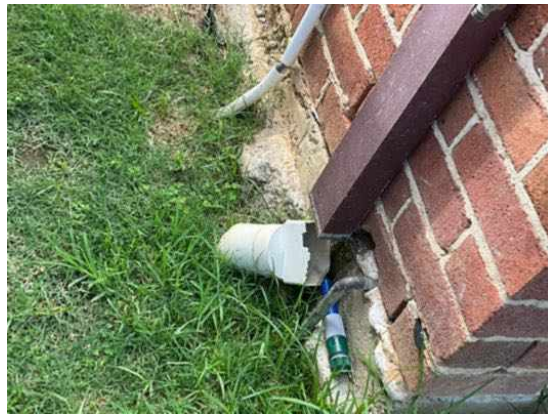
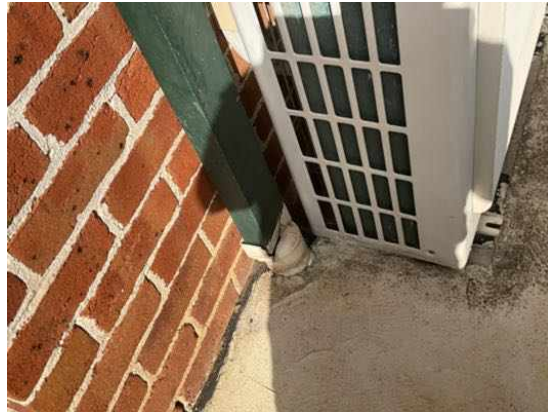
| Finding: | Downpipes not connected- Conducive conditions for timber pest |
| Information: | Unconnected downpipes can indeed pose a risk for attracting termites, as they provide a source of moisture near a building's foundation. Termites are attracted to moisture and wood, so it's important to address this issue to prevent potential infestations. Connecting downpipes to the stormwater system or ensuring proper drainage away from the building can help mitigate this a licensed plumber is the most qualified professional to handle plumbing-related tasks, including connecting downpipes to the stormwater system. They have the necessary expertise and tools to ensure proper installation. |

Please remember that proper installation is essential to ensure effective drainage and prevent future issues, so it's often best to hire a qualified professional, especially for complex or extensive downpipe installations.

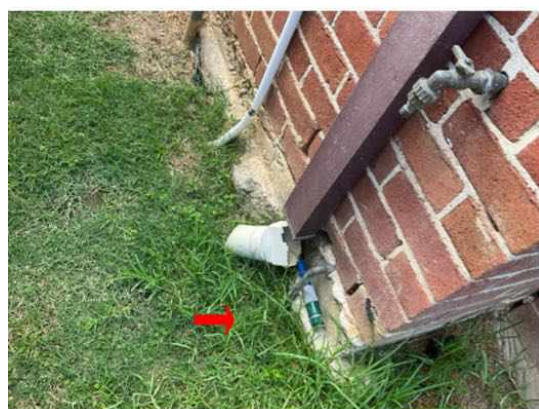
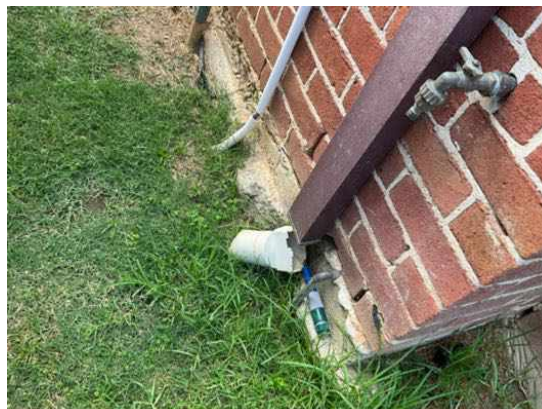
Finding 6.04

Building: Main Building
 Location: All Areas
 Finding: No Drain under tap
 Information: There is no drain installed under the tap, leading to water accumulation and creating conducive conditions for timber pests. This defect needs immediate attention to prevent potential damage and pest infestation.

2. Timber Pest Infestation: The damp environment created by standing water is highly conducive to timber pests, such as termites and wood borers, which thrive in moist conditions and can cause significant damage to wooden structures.

3. Structural Damage: Prolonged exposure to moisture can lead to wood rot and deterioration of structural timber, compromising the integrity of the building.

A licensed plumber or a qualified building contractor can address this defect by:

3. Repair and Prevention: Inspecting and repairing any existing water damage and implementing measures to prevent future water accumulation and pest infestations.

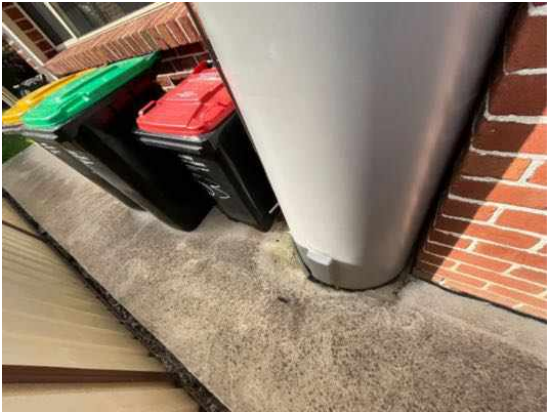
Where bridging has occurred full inspection is prevented and termites may enter a property in a concealed or undetected manner.

Recommended moving obstructions away from the external walls for further and future inspections.

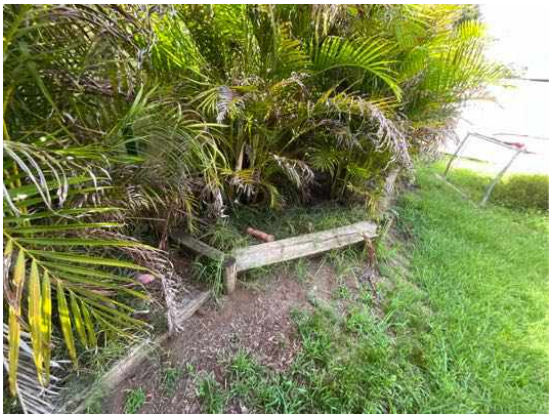
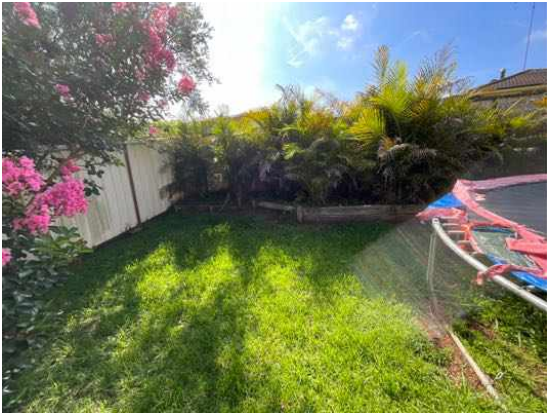
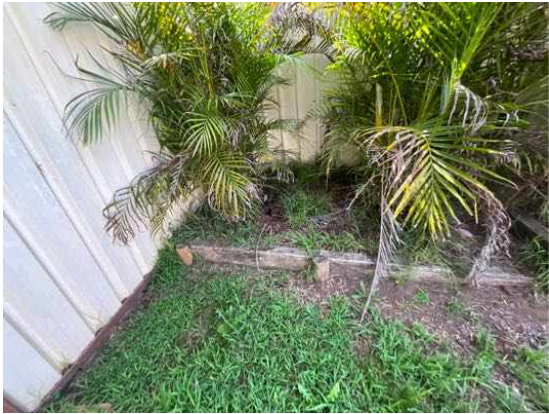
Finding 6.07

Building: Main Building
Location: All Areas
Finding: Dense vegetation around a property can increase the risk of termite infestation
Information: The presence of dense vegetation around a property can increase the risk of termite infestation, as it provides a conducive environment for them. To address this, consider maintaining a clear space between the vegetation and your home. If you suspect a termite issue, it's advisable to consult with a licensed pest control professional for inspection and treatment.

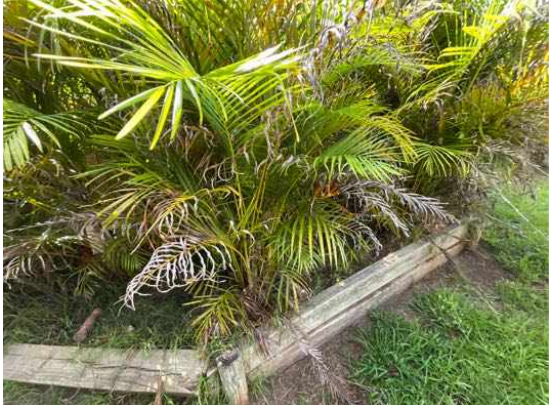
Finding 6.08

Building: Main Building
 Location: All Areas
 Finding: Timber on ground / conducive conditions to termite damage
 Information: Timber on the ground is indeed conducive to termite damage. Termites are known to thrive in moist environments, and wood in contact with soil or moisture is more susceptible to infestation.

To prevent this, it's important to keep timber elevated and away from direct ground contact. Regular inspections and proper termite control measures are also essential to protect your wooden structures from termite damage.

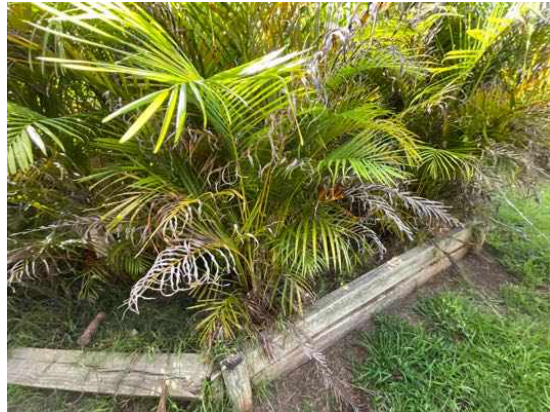
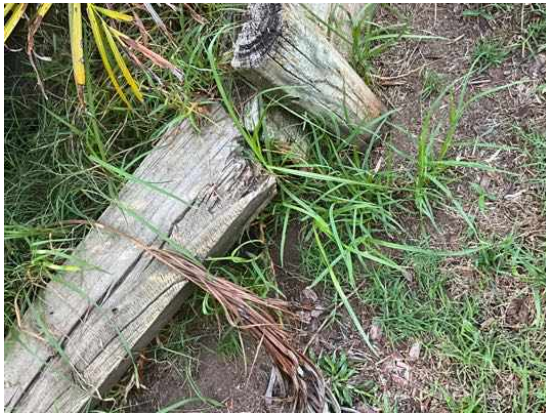
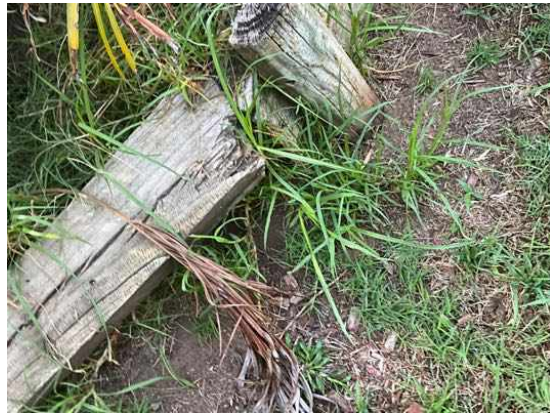
| Finding: | Wood rot |

Early intervention and regular maintenance, particularly of exterior timbers, will prolong the useful life of these building elements. Prior to any works being performed, the cause of the moisture that has created the visible wood rot should be identified and addressed in a suitable manner. Replacement of affected timbers may then be a necessary step in protecting surrounding building elements from such deterioration.

A qualified plumber may be appointed to assess the cause of excessive moisture and to provide advice on any remedial works as required. A qualified carpenter or registered builder may also be required to replace affected building materials.

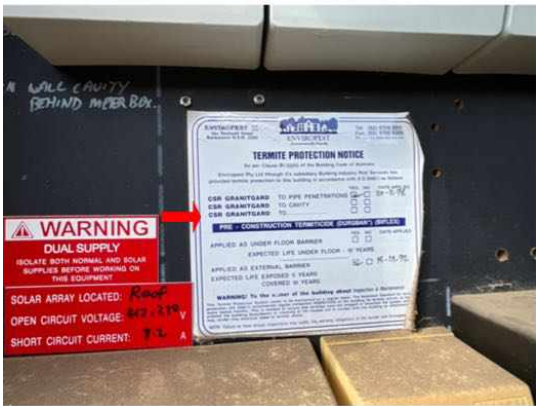
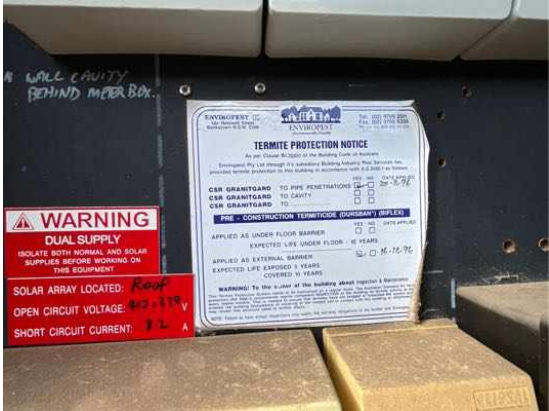
A durable notice placed in the switchboard unit to indicate termite barriers at the time of inspection.

Client must seek further information from the vendor or real estate agent if the conditions of termite management systems were maintained as per the label or seek advise from licensed pest controller.
