Building and Timber Pest Inspection Report

Inspection Date: Wed, 1 Apr 2026

Property Address: 3 Swain Cr Dapto NSW 2530, Australia

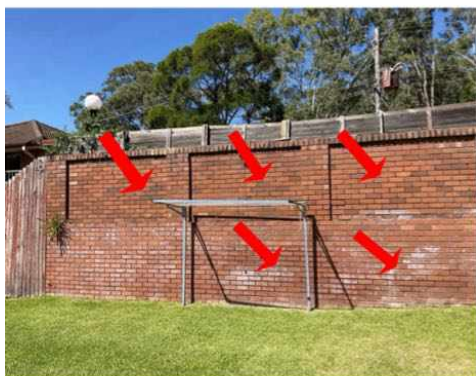
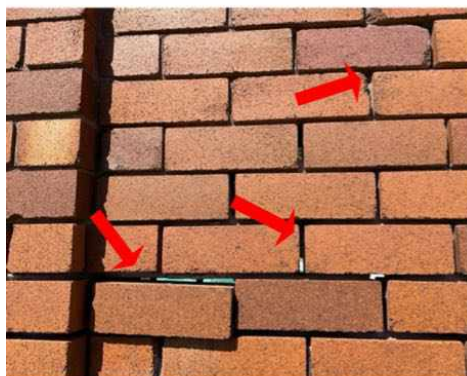
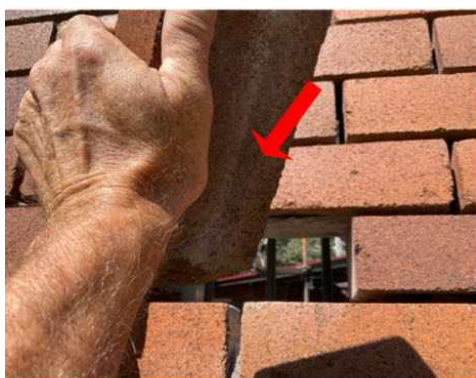
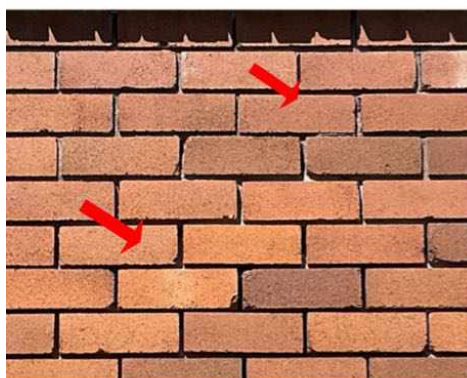
Building: Building 1
 Location: Pictured left rear fence areas
 Finding: Brickwork mortar missing
 Information: Large areas of mortar was found to be missing in the left rear wall at the time of the inspection. Mortar, or 'bedding', is the material which fills joins and intersections between bricks. Mortar that is missing is allowing these bricks to become loose, fall and potentially injure nearby persons as well as severely destabilize this large rear wall.

Missing mortar should be attended to by bricklayer immediately. The cost of fences/dividing walls is often shared between neighbours.

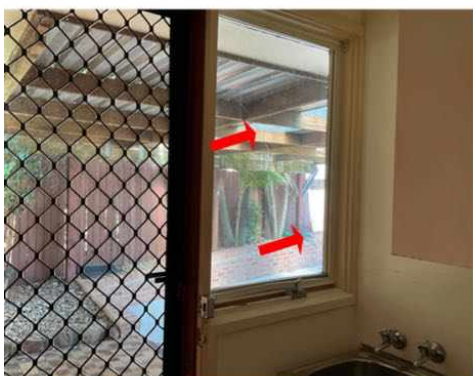
Building:	Building 1
Location:	Laundry
Finding:	Window - Cracked
Information:	Cracks were identified in the window in this area. Cracking in windows is generally the result of impact damage, and is likely to develop further when left unmanaged.

The likelihood of this windowpane further cracking and shattering is increased exponentially, providing a safety hazard in the area. The cracked window also impairs the weather tightness of the building, creating potential for minor water leaks.

A qualified glazier is required to repair the window as soon as possible. Depending on the extent of the cracking, replacement of the window may be required. Please be advised that any persons coming into contact with the cracked window should do so with due caution to avoid any personal injury that may ensue.

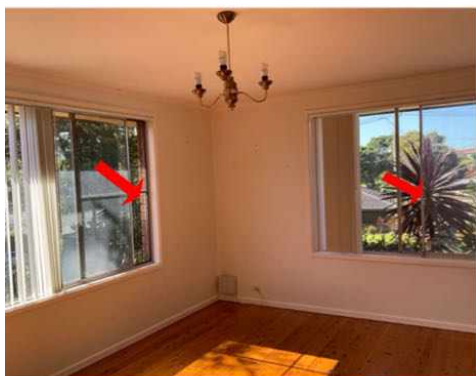
Finding 1.04

Building:	Building 1
Location:	Many windows
Finding:	Window opening restrictors missing.
Information:	The Building Code of Australia rules require all openable windows (where the internal floor is more than 2m above the ground outside) in residential rooms to be fitted with a suitable screen or restrictor. Windows located 1.7m above the floor level do not require protection.

Window restrictors are required where people who are vulnerable to the risk of falling have access to windows. This means all windows above ground level which do not have another fall prevention safety measure in place, such as a balcony or balustrade should have a restrictor.

These need to be added urgently for the safety of all persons.

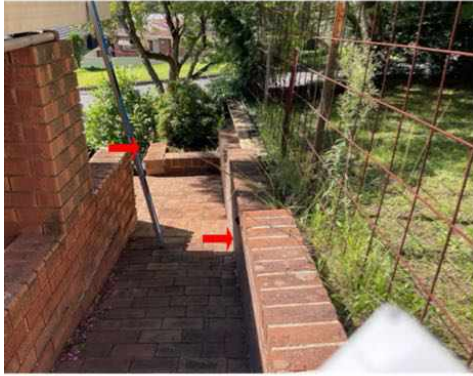
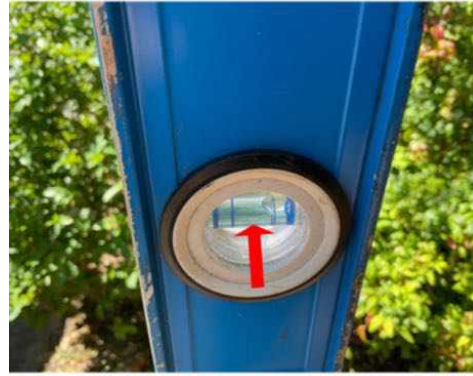
Building:	Building 1
Location:	Exterior walls
Finding:	Front left retaining walls on a minor lean
Information:	The front left retaining walls were found to be defective at the time of inspection. Generally, defective retaining walls are caused by poor original design or material use. However, deteriorated retaining walls may also be a result of substandard construction, poor site drainage or unmanaged stormwater flows.

If left unmanaged, the retaining wall may become a safety hazard if it continues to destabilise. Where retaining walls further rot and decay, an environment is created that is conducive to termite and pest infestation.

A landscaper or retaining wall installer may be appointed to repair or replace the wall, at the discretion of the client. These front left walls are listed as a minor defect due to the small size of these walls.

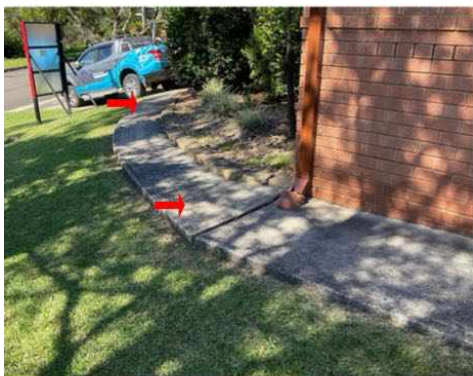
Finding 3.02

Building:	Building 1
Location:	Front path
Finding:	Subsidence - monitor annually
Information:	It appears that this front paved area has been affected by movement, often referred to as sinking or subsidence. General subsidence is usually initiated by changes in soil moisture content. The most critical factor is identifying the specific causes, and identifying if this is a recurring or ongoing problem, or one that has been resolved by previous works in the past.

At this point it is recommended to contain storm water flows, ensure pavements flow away from buildings to lessen any excessive wetting and drying effects.

A landscaping contractor can repair this area when convenient.

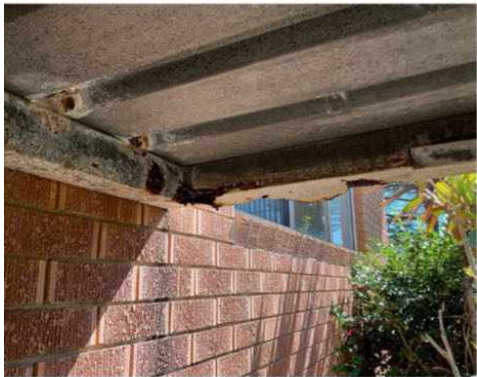
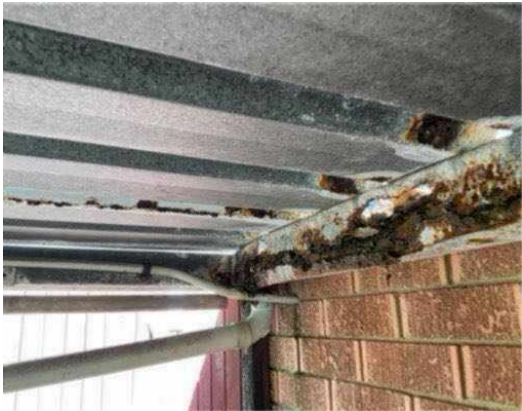
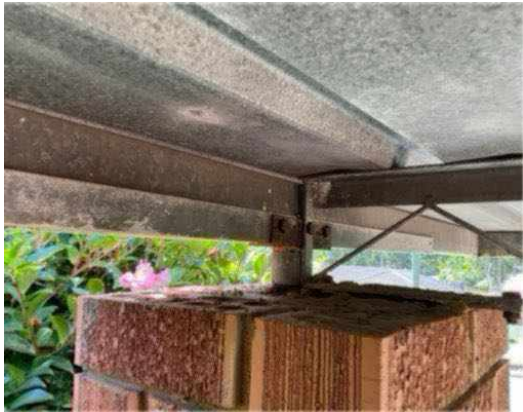
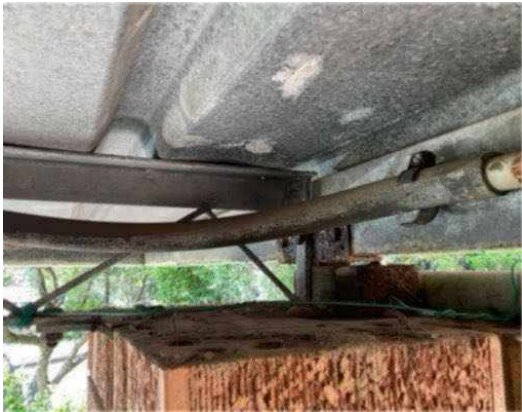
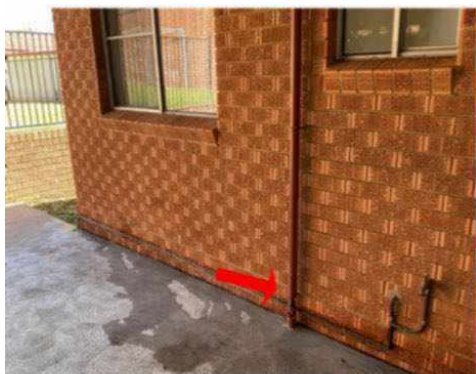
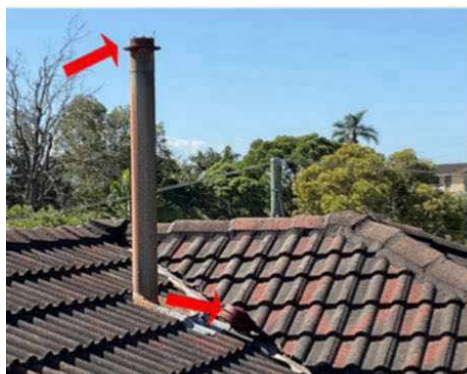
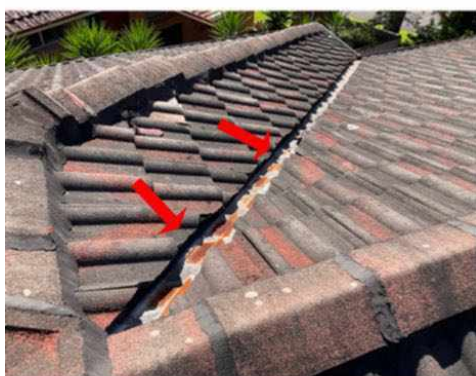
Finding 3.03

Building: Building 1
Location: Pictured areas
Finding: Building element - Rusted or corroded
Information: This building element shows evidence of rusting and corrosion, which is likely to have developed as a result of excessive exposure to moisture and or inadequate coatings.

As surface rust provides no protection to the underlying iron, the deteriorating condition is likely to worsen if not addressed in the short-term future.

Where possible, the use of galvanized (treated) metals or aluminium coated metals aid in rust prevention, as does regular general maintenance. Rust formation can be controlled with coatings, such as paint, that isolate the iron from the environment.

Rusting and corrosion should be managed by ideally removing or limiting the affected surface from exposure to moisture. A registered builder may be appointed to replace any building elements that have been severely affected by rust or water damage.

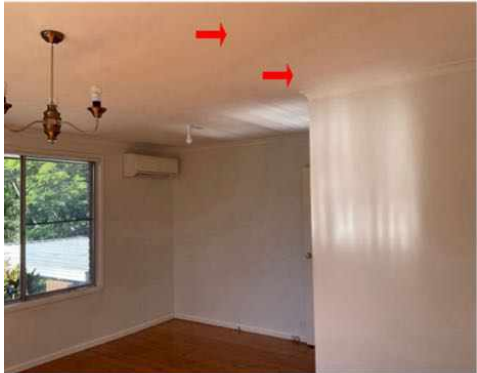
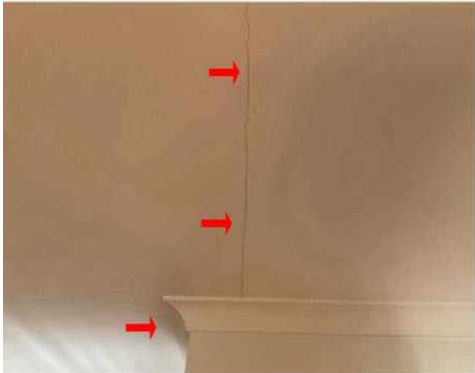
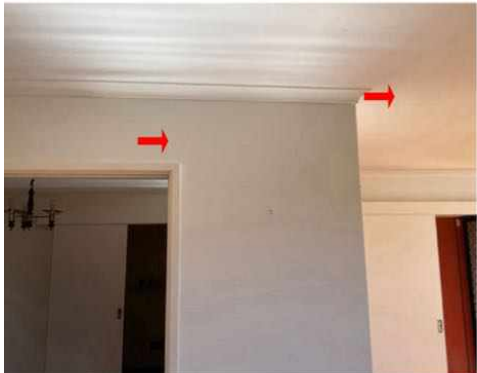
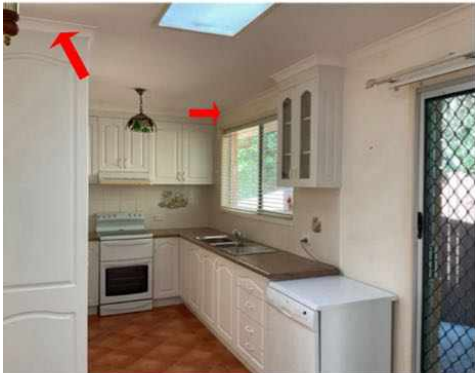
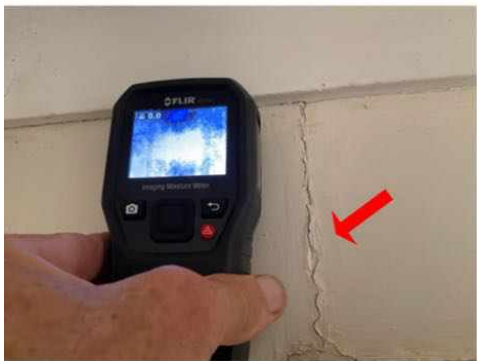
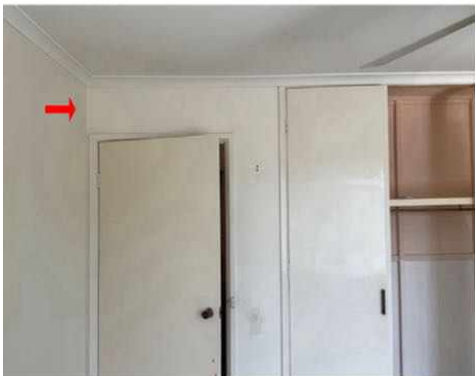
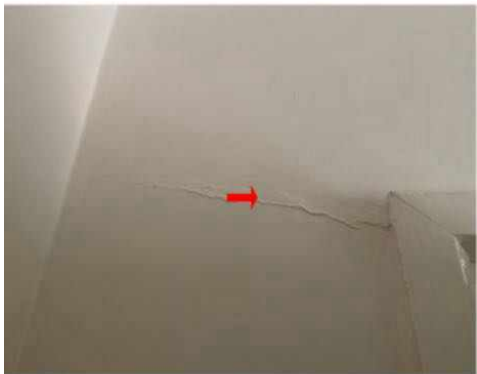
Finding 3.04

Building:	Building 1
Location:	Many small areas
Finding:	Cracking - Damage Category 1 - Fine (up to 1mm)
Information:	Although fine cracks are quite noticeable, they are often only considered to be an appearance defect, and usually do not indicate any structural damage. Generally, the cause of a fine crack is indicative of a separation between building materials and finishes (e.g. paint, plaster, etc.) along joints.

Cracking of this nature can generally be repaired with minor sanding, filling and/or repainting. Such works should be performed by a qualified painter or a general handyman.

Monitoring of all cracking should be conducted frequently. Always contact a building inspector should cracks widen, lengthen, or become more numerous.

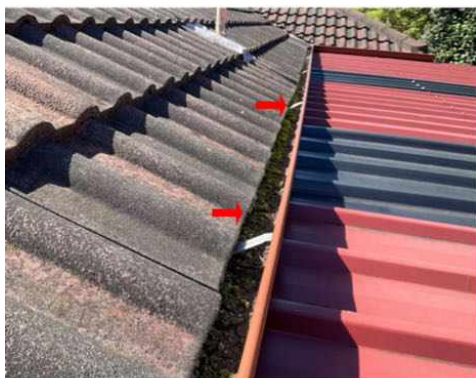
Finding 3.05

Building: Building 1
 Location: Roof exterior
 Finding: Gutters - Full and blocked
 Information: The guttering on around the roof was found to be blocked at the time of the inspection. Roof plumbing structures, such as guttering and downpipes, should be free of all debris to prevent blockages. Blockages of the guttering and downpipes will lead to pooling and accumulated water overflows, which is likely to subsequently flood eaves and exterior walls.

Blocked gutters are likely to lead to high levels of moisture in the affected areas which can cause rust and decay of the gutters and downpipes and wood rot to adjoining timber areas. Blockages in gutters should therefore be removed immediately to ensure dry conditions are maintained.

It is highly advised that gutters be cleaned by the homeowner or a general handyman as a matter of urgency.

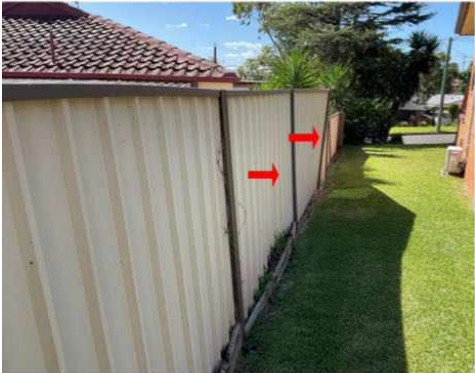
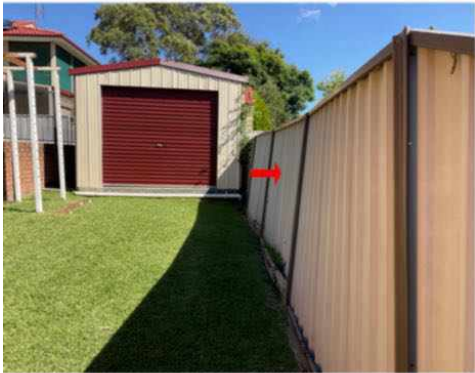
Finding 3.06

Building: Building 1
 Location: Left fence
 Finding: Fences damaged - leaning
 Information: Evidence of damage to the pictured fence, was identified at the time of the inspection. The likely cause of this fence leaning is not enough concrete used in the post footings.

If left unmanaged this fence may deteriorate further. It is suggest a fencing contractor be engaged for rectification when convenient.

The cost of repairing fences is often shared between neighbours.

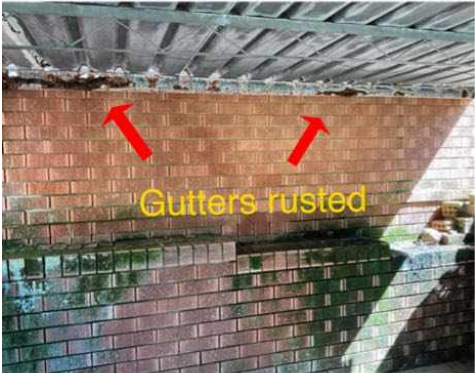
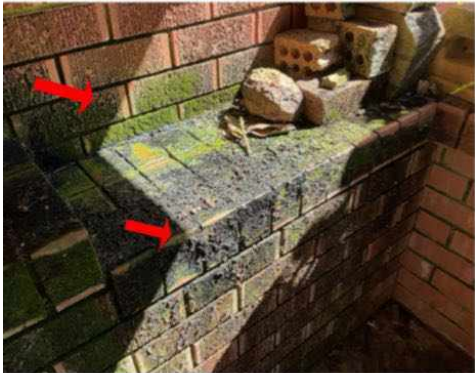
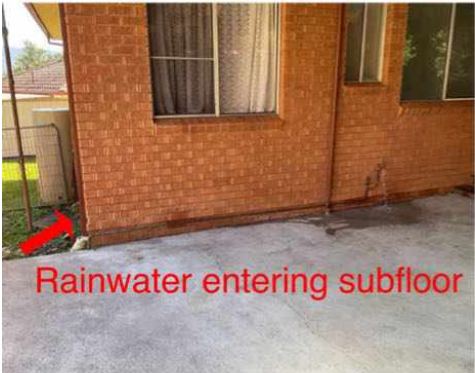
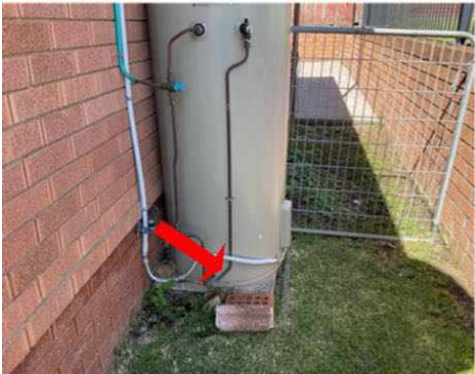
Building:	Building 1
Location:	Walls
Finding:	Site drainage - Inadequate
Information:	The site drainage in these areas was found to be inadequate at the time of inspection, creating potential for subsequent water damage to associated building elements.

The carport gutters have rusted requiring replacement. This is causing wood rot to the left gate and damaged mortar in the rear carport/ front house wall.

Rainwater from the rear house runs under the house causing further defects. The garage downpipes are not connected.

The air conditioner and hot water system overflows run against the house walls.

It is important that water does not lie against the base of walls; surrounding paths and ground levels should be sloped to drain water away from walls. Downpipes should not discharge stormwater onto lower walls or plinths. Stormwater should be carried away by large, regularly cleaned drains. Ground levels may need to be lowered to expose a buried DPC.

Where site drainage is inadequate, installation of an Agricultural (Aggie) Drain may be required. A qualified plumber should be appointed to further inspect the property and perform any remedial works as necessary. Secondary defects are likely to occur if left unmanaged.

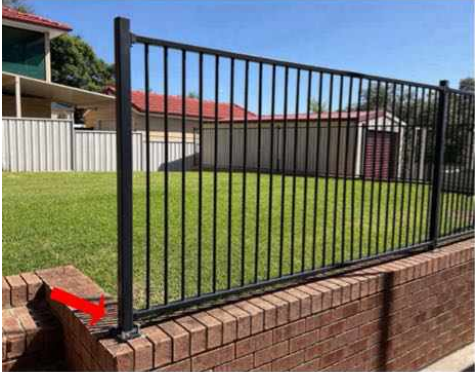
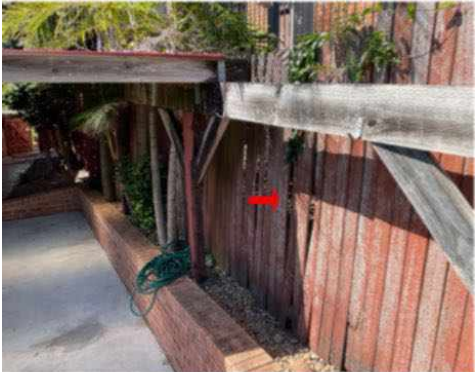
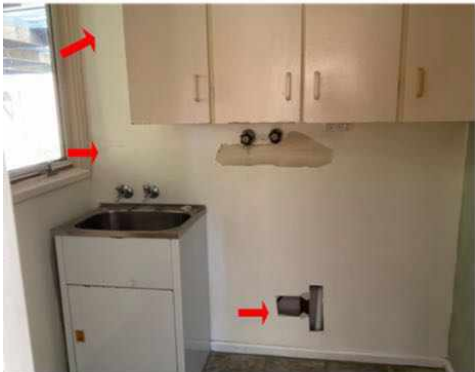
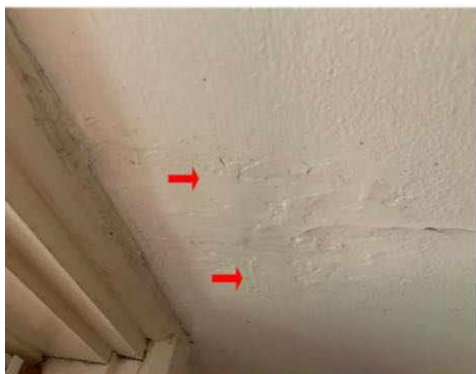
Finding 3.09

Building: Building 1
 Location: Pictured areas
 Finding: Building elements loose or damaged
 Information: Evidence of minor missing or damaged areas was identified at the time of the inspection. These include -

1. Some sections of the rear black fence is loose requiring a carpenter to add additional fixings. Other fences have minor damage.
2. The laundry and front doors are delaminating and will need replacenment in future years.

4. The internal laundry wall and some floor areas need repair due to fibro and timber damage.

A carpenter would be the trade responsible for rectification of these areas when convenient.

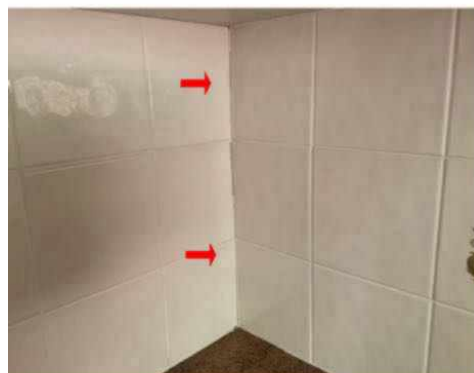
Building:	Building 1
Location:	Kitchen and bathroom
Finding:	Sealant and grouting - Missing or damaged
Information:	It was noted on inspection that sealant or grout is degraded to these pictured wet areas.

Different materials and floor areas move at different rates, generally causing cracking to grout or sealant at this point. A flexible sealant is required to allow for expected expansion and contraction, while keeping the joint water tight and protective of all associated building materials.

Flexible and mould resistant materials should be applied to affected areas to prevent any subsequent water damage that is likely to occur. Regular maintenance and replacement of damage or missing or damaged sealant and grout is highly recommended to the wet areas, as this is a regular wear and tear defect. Sealant and grouting in areas that come into regular contact with water should be maintained for the long term care of your property.

A sealant specialist or tiling contractor should be appointed to complete these works as soon as possible

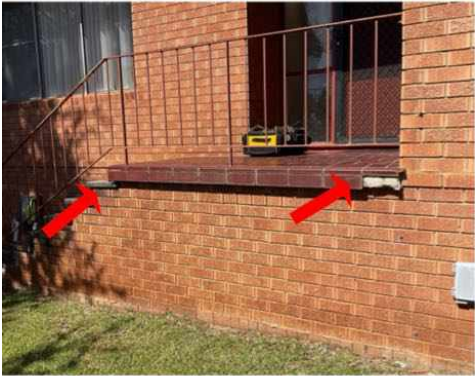
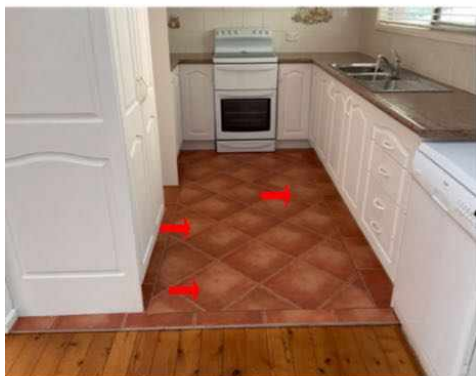
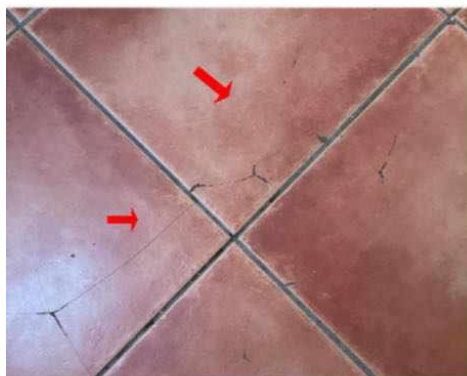
Finding 3.13

Building: Building 1
Location: Front porch and kitchen
Finding: Tiles cracked or missing
Information:

Cracked and missing tiles were evident in these pictured areas at the time of inspection. It is suspected that this cracking has occurred as a result of minor settlement or impact damage. Cracked tiles throughout the household detract from the overall appearance of the affected areas. In wet areas of kitchens and bathrooms, it can lead to water damage of adjoining walls and floors.

Replacement of cracked tiles is recommended as soon as possible. A tiling contractor may be appointed to perform these works. Where cracks become more numerous, contact a licensed building inspector for further investigation.

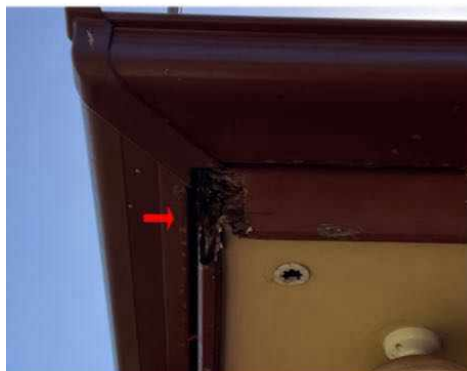
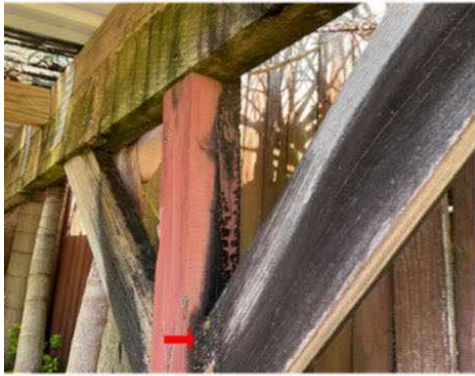
Finding 3.14

Building:	Building 1
Location:	Pictured small areas
Finding:	Wood rot
Information:	The building shows evidence of wood rot. Wood rot, also known as Fungal Decay, occurs when timbers and other cellulose building materials are exposed to damp conditions on an ongoing basis. This could be the result of exposure to weathering over a prolonged period of time, or the attraction of excessive moisture from other abutting building materials.

Early intervention and regular maintenance, particularly of exterior timbers, will prolong the useful life of these building elements. Prior to any works being performed, the cause of the moisture that has created the visible wood rot should be identified and addressed in a suitable manner. Replacement of affected timbers may then be a necessary step in protecting surrounding building elements from such deterioration.

A qualified carpenter or registered builder may also be required to replace affected building materials.

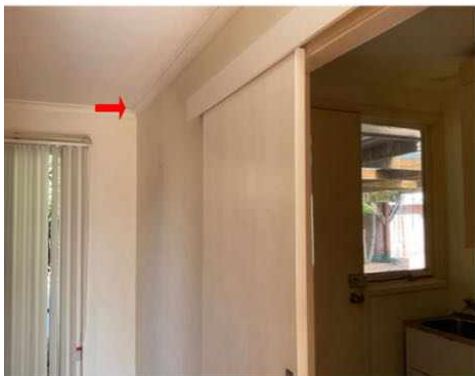
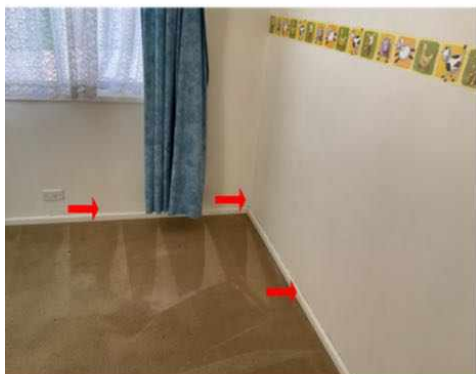
Finding 3.15

Information: Where evidence of mould growth was noted, there may be environmental, biological or health issues associated with the report. A specialist inspection by a suitably qualified environmental health inspector is warranted, where mould is extensive or where any queries regarding air quality spores or other related issues apply.

Generally, the client is advised to ensure that the general environment is free of moisture and humidity to aid in the prevention of mould formation and development. Any mould found during the inspection should be cleaned immediately by a cleaning contractor or the homeowner as applicable. Additional brick vents, mechanical ventilation and removal of all subfloor debris will all assist in keeping this subfloor mould free.

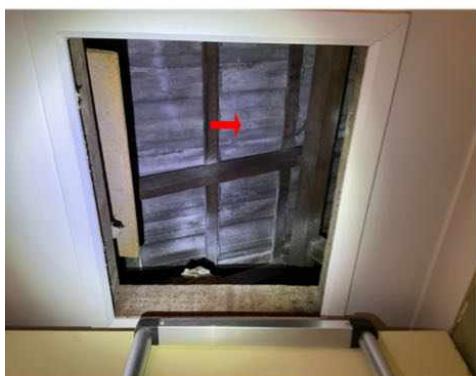
Finding 3.16

Building:	Building 1
Location:	Roof Void
Finding:	Sarking - Missing
Information:	Sarking is missing under the roof sheeting. Sarking acts as an insulator that helps with noise reduction and protects against water penetration. Sarking plays a key role in the operation and function of the overall roofing structure and its performance.

Although not a requirement at the time of construction, replacement of any missing building element is advisable (although this can be quite expensive to do after the time of construction). Where sarking is missing, regular inspections of the roof tiles for cracking and potential moisture penetration is required.

Sarking may be retrospectively fitted by a registered builder at the discretion of the client.

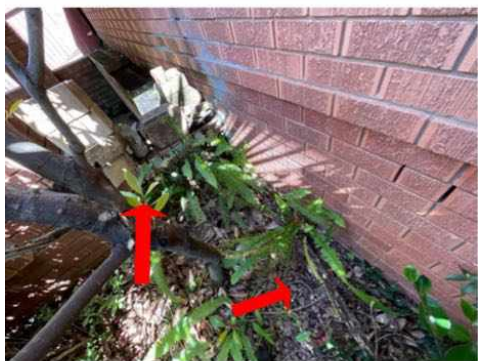
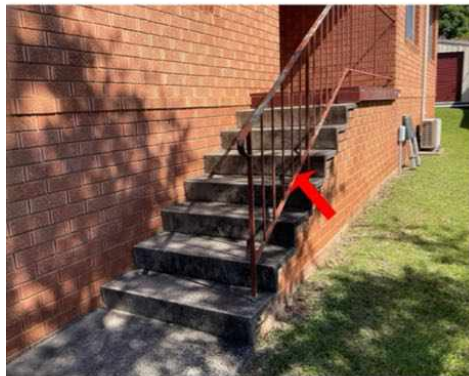
Building:	Building 1
Location:	Yard - front
Finding:	Bridging - Vegetation and decking
Information:	Where vegetation and decking obstructs inspection of building elements, also known as bridging as it provides a bridging point for the access of termites, full inspection can not be achieved. Consequently moisture or dampness may be present and the areas becomes conducive to termite activity. Plants and decks against or very close to buildings provide cover, shade and can provide an environment that is attractive to termite infestation.

The removal of any such stored building or plant materials that may be conducive to termite activity should be carried out as soon as possible and arrange re inspection to minimize the risk of termite attack.

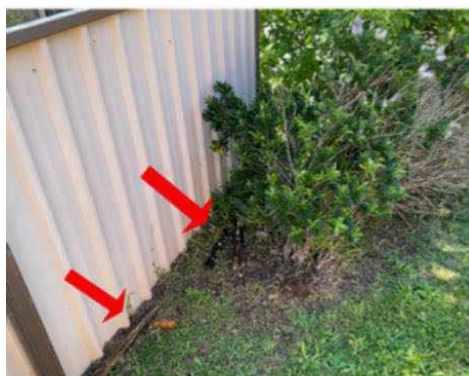
Finding 6.03

Building: Building 1
 Location: Yard & subfloor areas
 Finding: Timber in contact with the ground
 Information: Any timbers in direct ground contact provide opportunity for concealed termite entry and are likely to be subject to premature rot and decay as the soil retains moisture or damp conditions against the timbers.

Removal of all waste timber that is in direct contact with ground is highly advised. This timber is promoting mould and wood rot and is very attractive to termites.

Frequent pest inspections are advised to readily identify any termite activity in these areas.

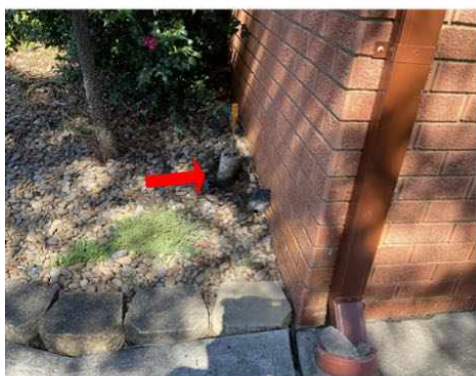
Finding 6.05

Building:	Building 1
Location:	Front wall
Finding:	Tree stumps - left in ground
Information:	Tree stumps left in ground provide opportunity for termite attack as they are likely to be subject to rot and decay providing an attractive food source. Treatment and/or Removal of the stump is highly recommended. A pest controller and tree removalist should be engaged to perform such works.

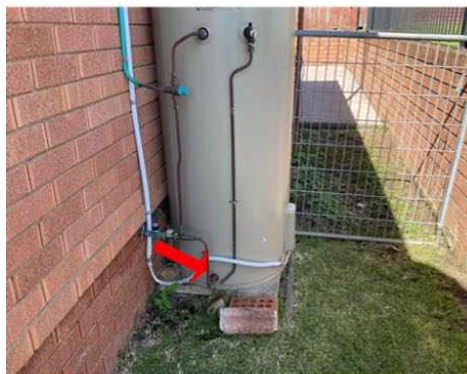
These damp conditions can lead to secondary defects such as rot, rust or corrosion of associated building elements, the formation of fungal decay, or even the creation of potential slip hazards. When coupled with poor site drainage, pooling of water may also attract termite activity to this area. It is highly recommended that a qualified plumber be appointed to install adequate drainage to these areas. These works will ensure that the area remains dry and free of any secondary defects.

Consultation with a qualified plumber is advised immediately to identify the cause of the damp and perform remedial works as required.

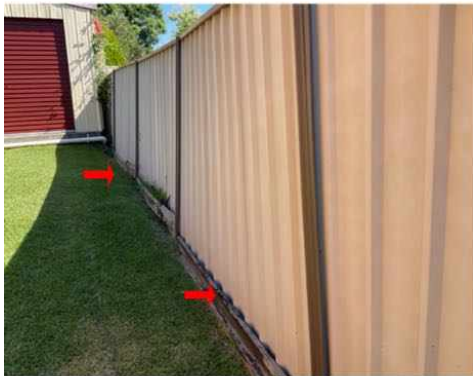
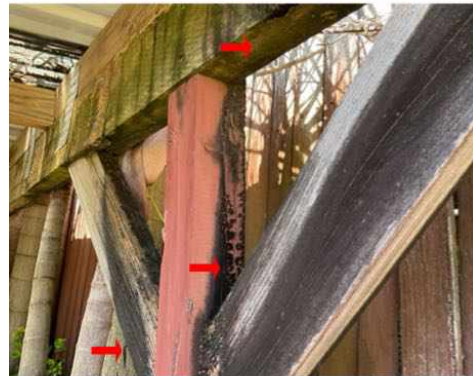
Note - See ALL wood rot photos, all these show fungal decay.
