Building and Timber Pest Inspection Report

Inspection Date: Mon, 16 Mar 2026

Property Address: b8/35 Toongabbie Rd, Toongabbie NSW
2146, Australia

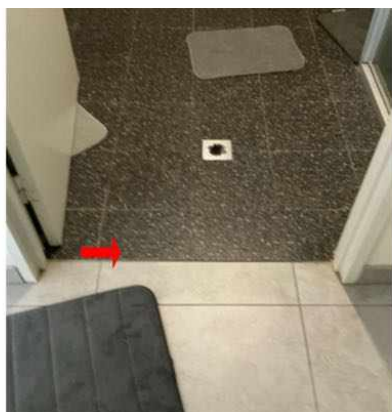
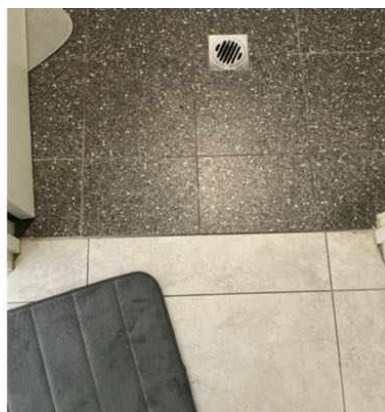
Finding 3.01

Building: Main Building
 Location: All External Areas
 Finding: Bathroom & external floor threshold
 Information: The bathroom floor is at the same level as the adjoining flooring. This configuration is typical in modern apartments and is permitted where compliant waterproofing and floor falls are provided. No evidence of moisture damage was observed at the time of inspection; however, waterproofing performance cannot be confirmed without invasive inspection.

Care should be taken to avoid excessive water migration beyond the bathroom during use.

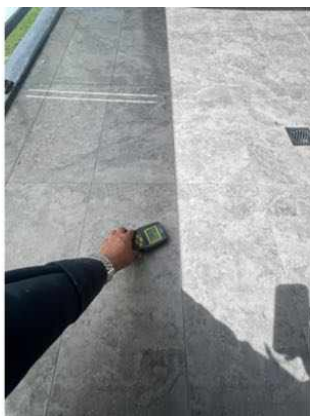
Finding 3.03

Building:	Main Building
Location:	Balcony
Finding:	Elevated Moisture Detected – No Visual Deterioration Observed
Information:	Moisture readings taken indicated elevated levels above typical thresholds. However, at the time of inspection, no visible signs of water damage, staining or mould growth were identified. While this may be due to recent exposure or concealed moisture, further monitoring is recommended. If concerns persist, a licensed builder or water ingress specialist should be engaged to assess concealed areas and verify the source, especially given the expectations of durability and weatherproofing.

Depending on the strata plan, this area may form part of the common property, in which case remedial responsibility may rest with the owners corporation (strata). Purchasers should seek clarification from the strata manager and legal adviser prior to purchase.

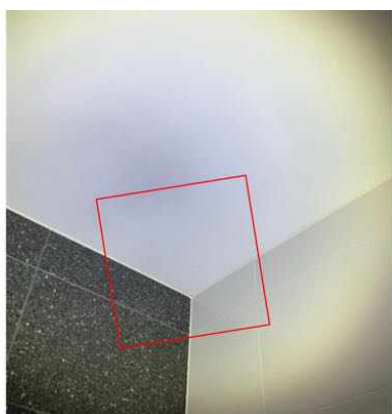
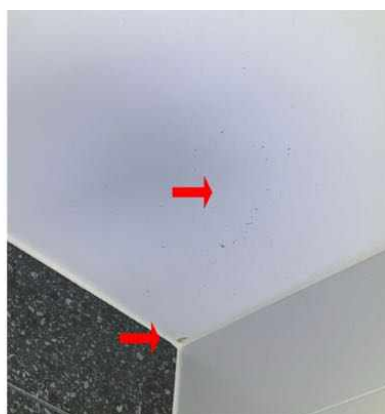
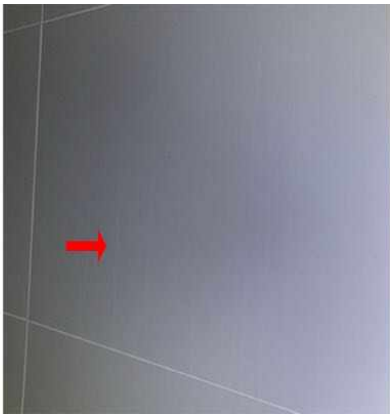
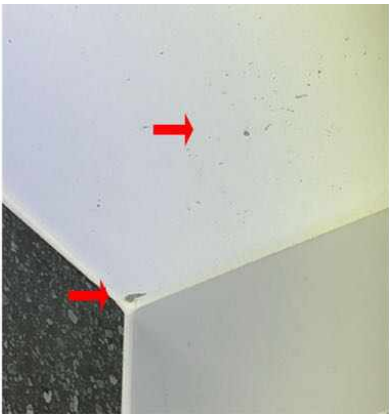
Finding 3.04

Finding: Water Staining - Humidity or Ventilation

Information: The ceiling surface shows peeling paint and water staining on the walls faint commonly consistent with humidity-related staining, often found in bathroom or wet areas with insufficient ventilation. While there is no visible sagging or major water damage, the pattern suggests prolonged moisture exposure, possibly due to steam accumulation or minor condensation issues. According to AS 4349.1-2007 (Appendix C), this would be classified as a minor defect unless further deterioration or active leaks are found. Recommend improving mechanical or natural ventilation, cleaning the surface with mould treatment, and monitoring for recurrence.

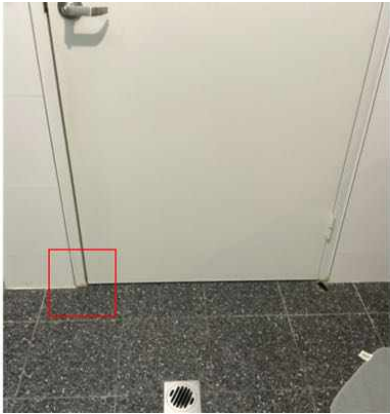
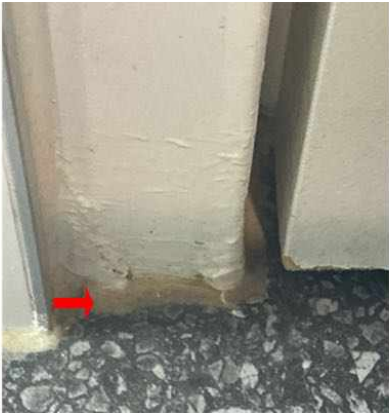
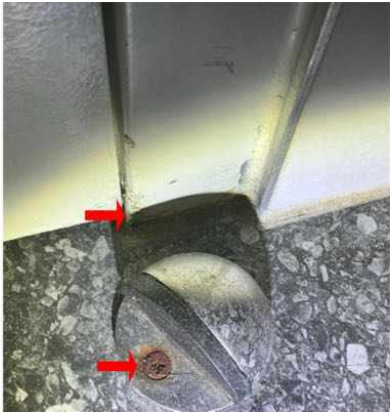
Finding 3.05

Building: Main Building
Location: All Internal Areas
Finding: Wet-Area Door Jambs – Moisture Staining
Information: moisture staining and minor deterioration were observed at the base of the wet-area door jamb and architraves. This is commonly due to water splashing or moisture tracking from the bathroom floor into adjacent joinery or inadequate waterproof transition at the bathroom threshold.

Further inspection by a licensed waterproofing contractor is recommended to verify exact cause and remedial measures.

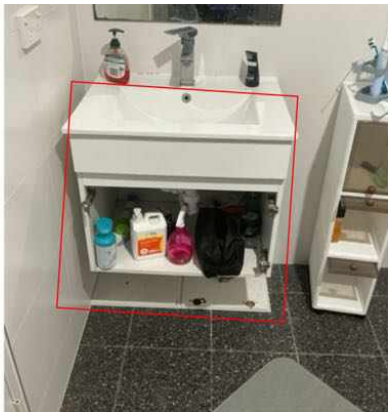
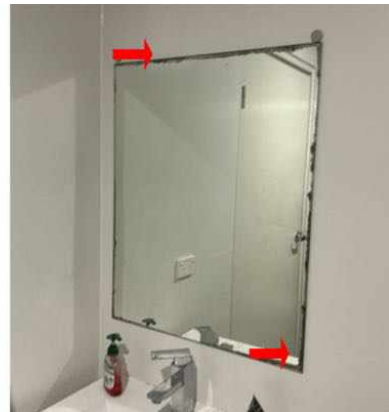
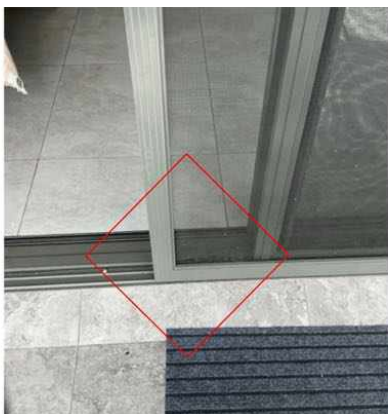
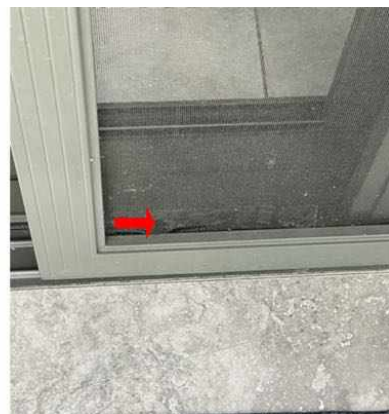
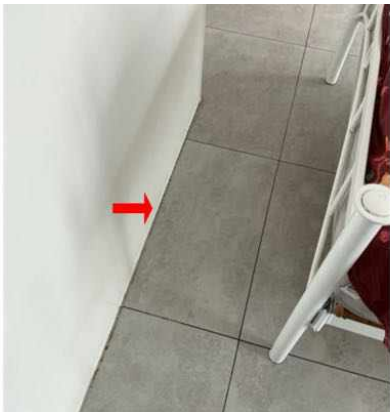
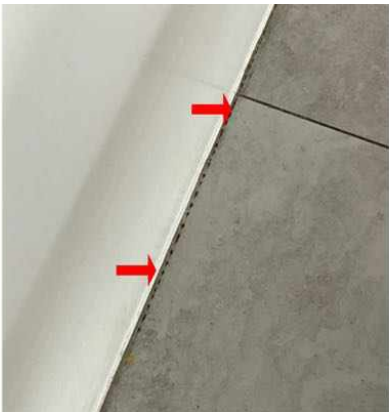
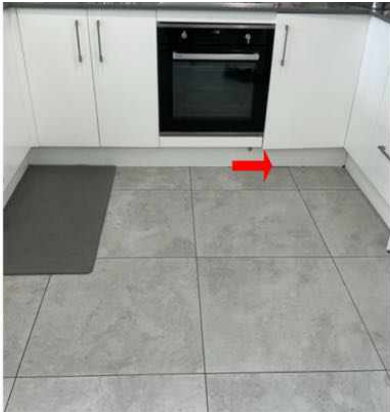
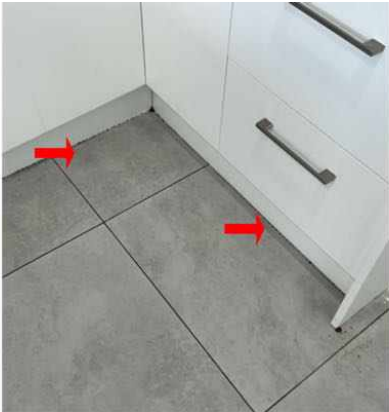
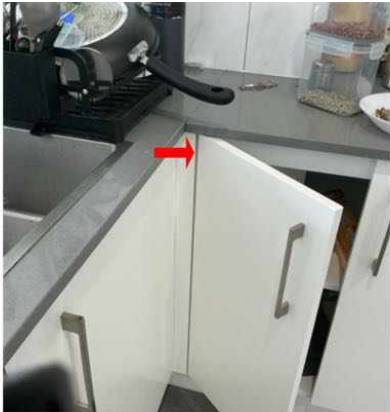
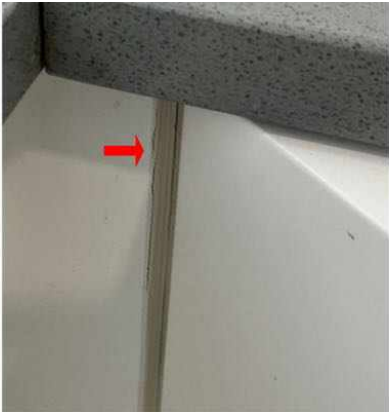
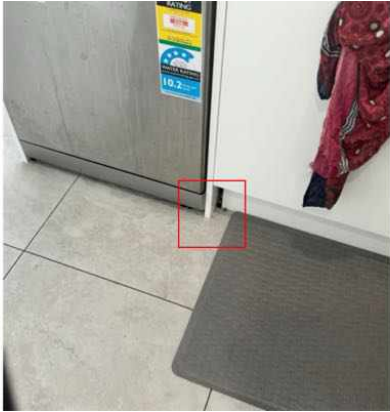
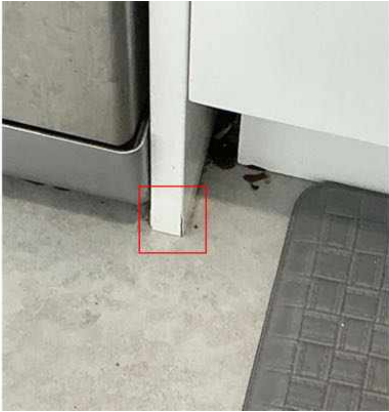
Finding 3.06

Building:	Main Building
Location:	All Internal Areas
Finding:	Building element - Damaged - Vanity broken bathroom , mirror desilvering , fly screen damage balcony , residue on floor near kitchen , minor damage kitchen cupboard ,
Information:	Breakage occurs generally when the building materials have either aged and decayed, or as a result of damage (accidental or deliberate).

Repair and/or replacement of broken elements is advised to ensure that additional secondary defects do not arise as a consequence. Such works are necessary, as all building elements play a key role in the operation and function of the overall structure and its performance.

A relevant tradesperson should be appointed to repair or replace the affected building element prior to any subsequent damage being caused.

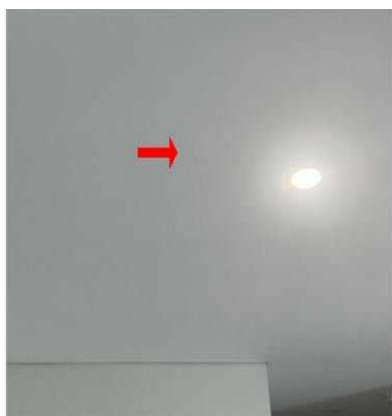
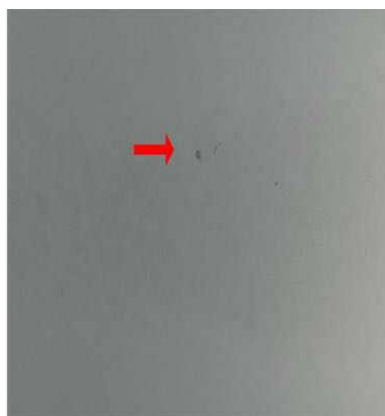
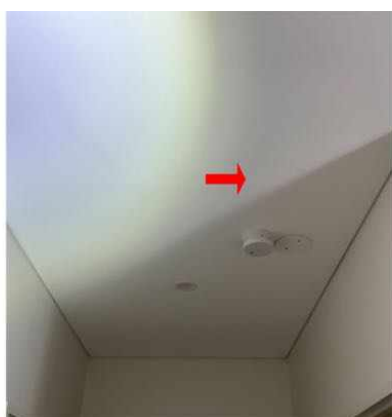
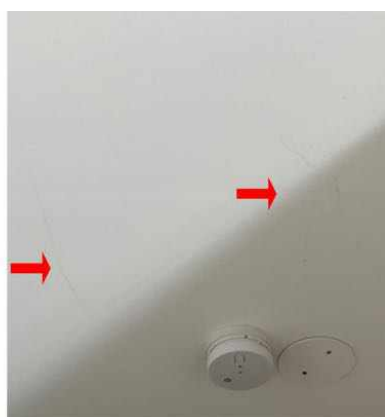
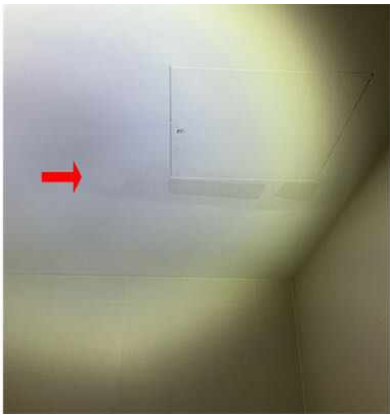
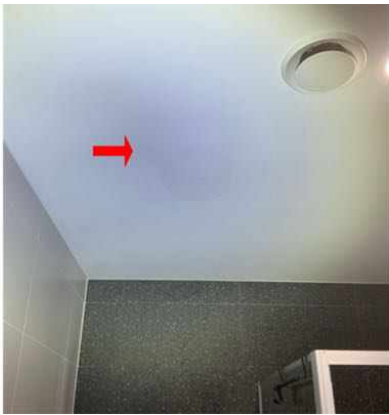
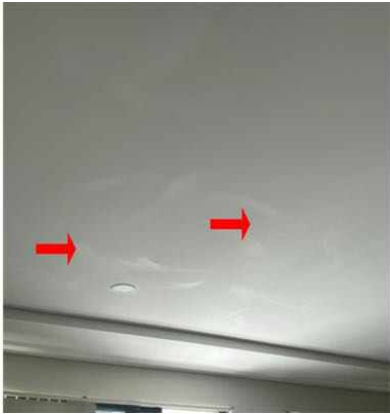
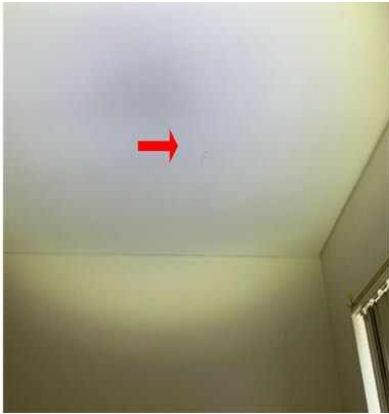
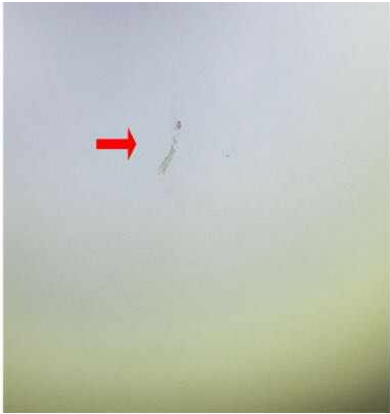
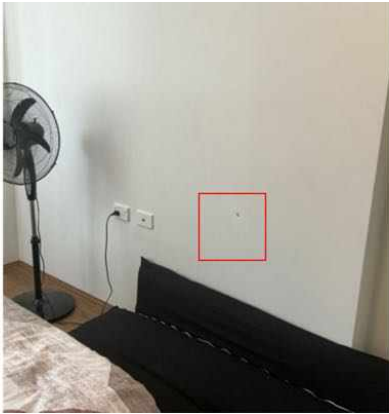
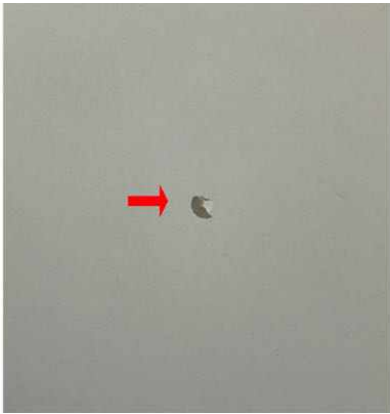
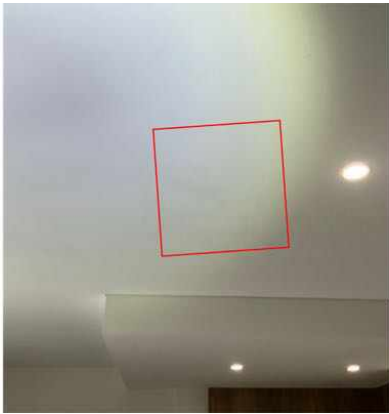
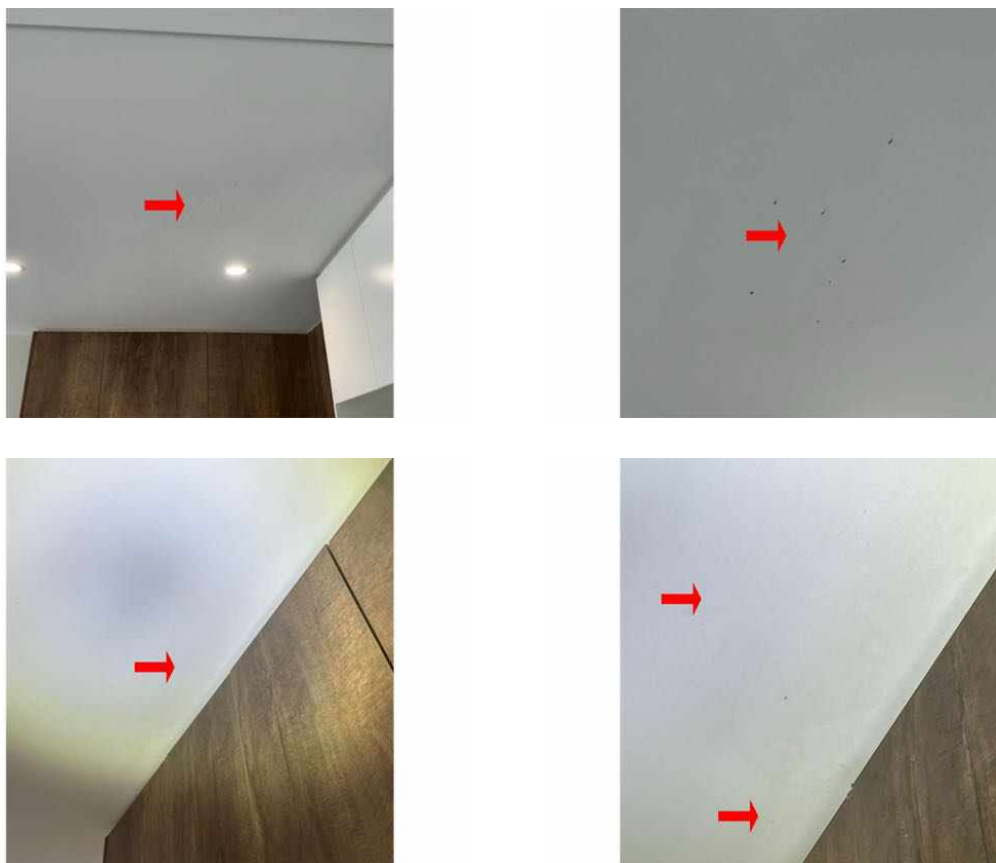
Finding 3.07

Building:	Main Building
Location:	All Internal Areas
Finding:	Paint finish and hairline cracking
Information:	The paint finish in this area was identified as being incomplete at the time of inspection including some hairline minor cracking.

Whilst incomplete or missing paint finish is generally an appearance defect, it can also lead to the development of secondary building defects over time. Incomplete areas of paint finish expose the area to moisture, potentially accelerating the deterioration of underlying building materials.

Incomplete paint finishes should be sanded back, filled, leveled and painted, as applicable. Where inadequate or missing paint protection has led to the deterioration of the associated building element, repair and/or replacement of this building element may be required.

A painting contractor should be appointed as soon as possible to perform necessary works to aid the appearance of the affected area and to ensure the area is protected against further deterioration. Alternatively, the homeowner following manufacturer instructions may perform these works.

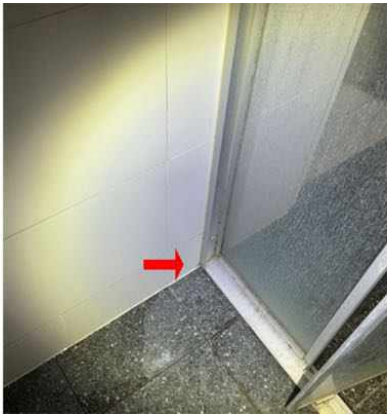
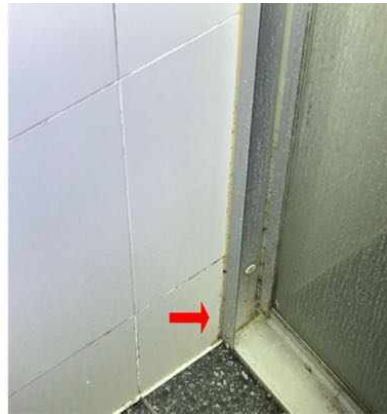
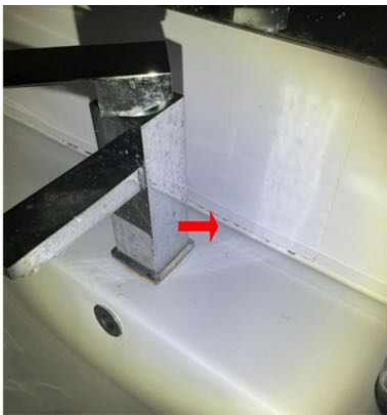
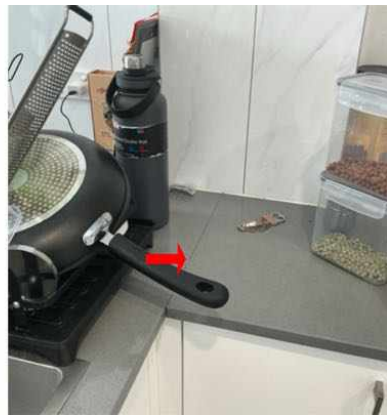
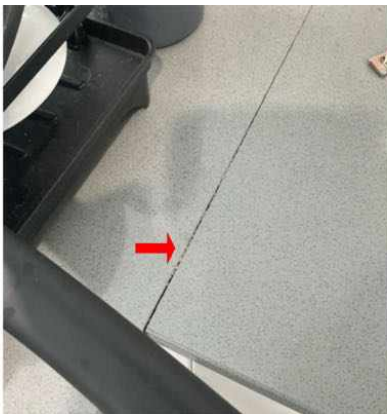
Finding 3.08

Building:	Main Building
Location:	All Internal Areas
Finding:	Sealant and grouting - Missing or degraded
Information:	It was noted on inspection that sealant or grout is degraded. There is also evidence of poor workmanship and excessive use of sealant. Silicone should never be used as a first line of defence against waterproofing. Further inspection by a licensed waterproofing contractor is highly recommended.

Different materials and floor areas move at different rates, generally causing cracking to grout or sealant at this point. A flexible sealant is required to allow for expected expansion and contraction, while keeping the joint water tight and protective of all associated building materials.

There appears to be excessive mould to the sealant and grout which will likely require scraping out and replacement.

Flexible and mould resistant materials should be applied to affected areas to prevent any subsequent water damage that is likely to occur. Regular maintenance and replacement of damage or missing or damaged sealant and grout is highly recommended to the wet areas, as this is a regular wear and tear defect. Sealant and grouting in areas that come into regular contact with water should be maintained for the long term care of your property.

A sealant specialist or tiling contractor should be appointed to complete these works as soon as possible
