Building and Timber Pest Inspection Report

Inspection Date: Wed, 14 Jan 2026

Property Address: 38 Trinity Dr, Evanston Park SA 5116,
Australia

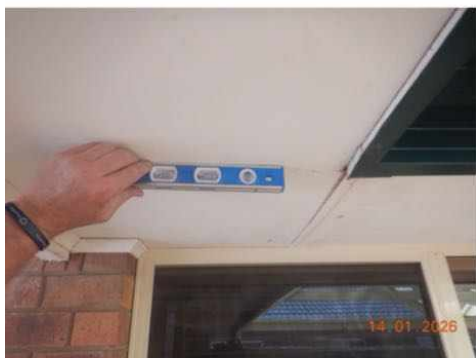
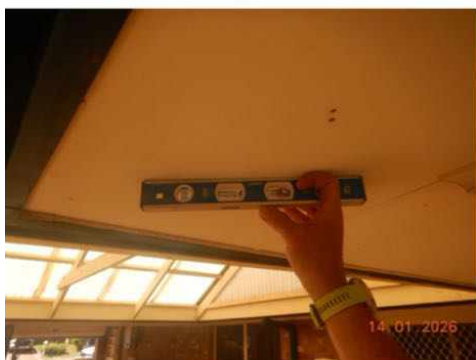
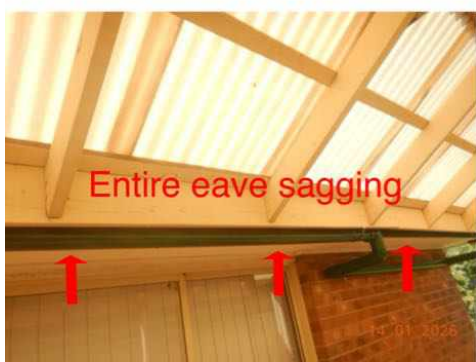
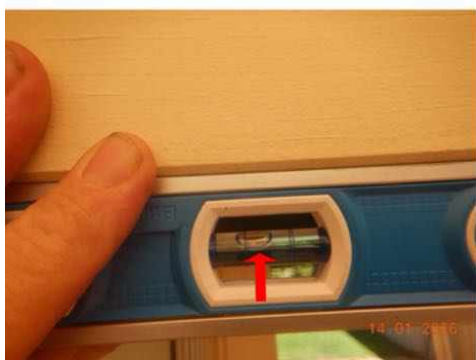
Finding 2.01

Building: Building 1
Location: Pergola
Finding: Pergola inadequate connection to house.
Information: This rear pergola structure appeared to have inadequate connection to the roof structure which intern has led to sagging of several elements.

Sagging is evident to the eaves, fascia and pergola and as such the structural integrity of the roof cannot be guaranteed. If not address the pergola may deteriorate further creating additional stress to the house and as such, immediate repair works are recommended.

Sagging to these areas can also increase the risk of leaking during rain events.

A licensed builder should be appointed to make repairs to the structure at the clients soonest convenience.

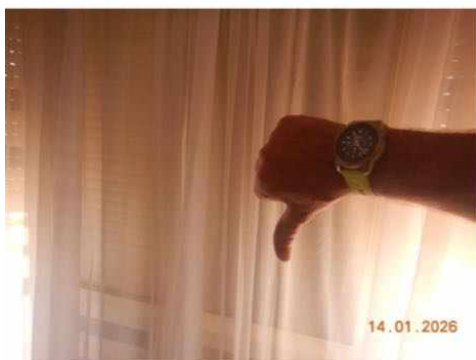
Finding 3.01

- master bedroom electric roller shutter not operating.
- kitchen rangehood not operating.
- Electrical isolation switch for oven broken switch mechanism.

This condition may indicate faulty components, lack of connection, incomplete installation or a lack of familiarity of the equipment. Further investigation and rectification by a suitably licensed tradespeople is recommended.

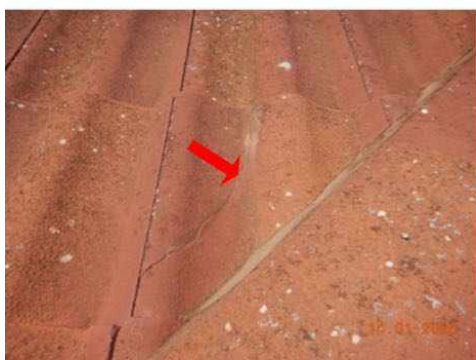
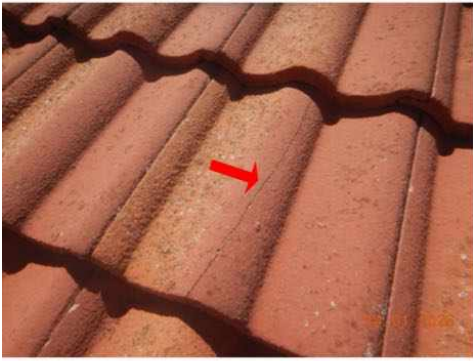
Finding 3.02

Building:	Building 1
Location:	Roof Exterior
Finding:	Roof tiles - Broken
Information:	Upon inspection of the exterior roof covering, 3 broken roofing tiles were identified.

Broken and friable roof tiles are generally the result of ageing and weathering of what is essentially a porous material.

If left to further deteriorate, broken and brittle roof tiles are likely to lead to water penetration via the roof into the ceiling space, causing secondary damage to ceiling linings, insulation and roof structures.

Broken roof tiles are also likely to detract from the effectiveness of the roof drainage system, creating potential for secondary damage to the exterior roof covering and roof plumbing.

Replacement of broken tiles is required and should be performed by a roofing contractor as required.

Repair cracked roof tiles.

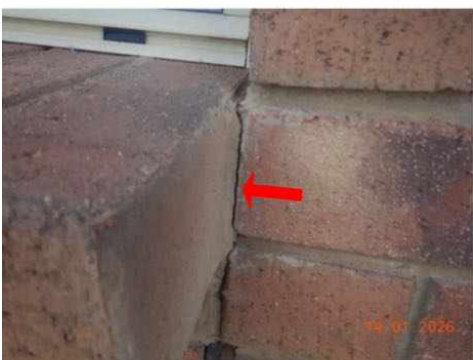
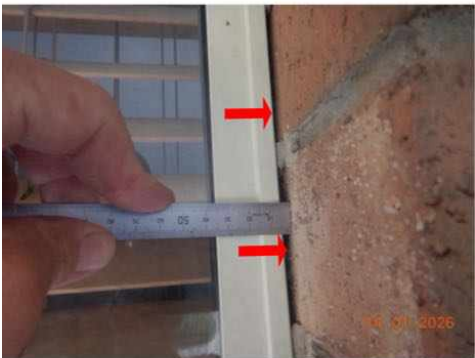
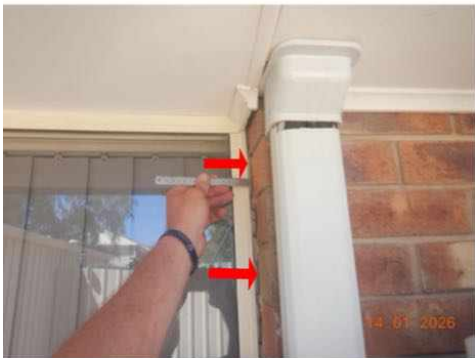
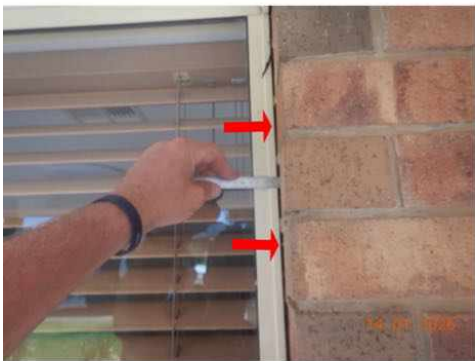
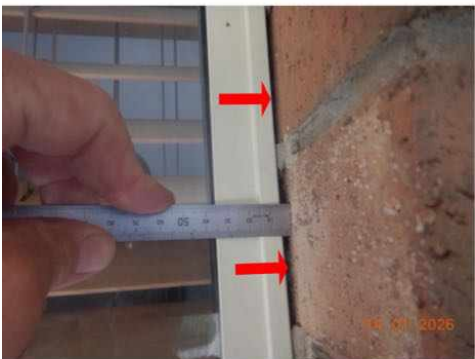
Finding 3.03

Building:	Building 1
Location:	Exterior walls - rear
Finding:	Brickwork - Cracking and or gaps noticeable
Information:	There were several cracks and or gaps around windows/ articulation joints evident to external brickwork at the time of inspection.

Noticeable cracks are a common occurrence in external brickwork and are a likely result of age expected building movement, general expansion, and/or contraction of building materials in different weather conditions.

As buildings move doors and windows can become difficult to operate with seasonal changes. Often after when a building settles it will hit solid ground and remain stable as long as as stormwater and perimeter of pavement are kept in good condition.

It is advised to closely monitor any movement and contact a Jim's Building Inspections should cracks widen, lengthen, or become more numerous.

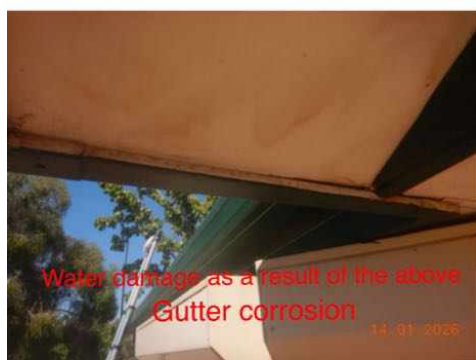
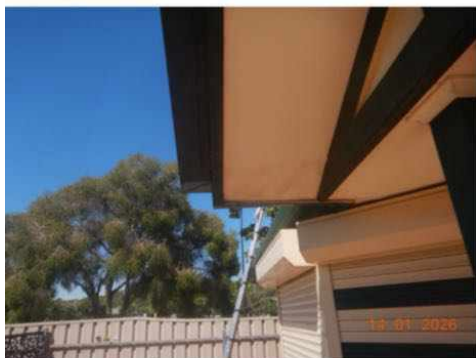
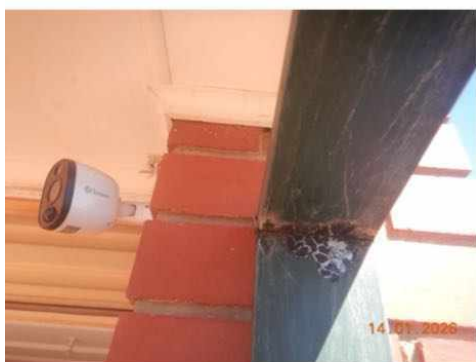
Building: Building 1
Location: Roof Exterior
Finding: Roof plumbing - Rusted or corroded
Information: The roof plumbing had small areas of rust and corrosion at the time of inspection subsequently causing significant water damage in the underlying eaves in some areas. It is suspected that this has been caused by blockages, resulting in pooling or standing water, that have prematurely rusted elements of the roof plumbing.

Rusted roof plumbing will generally develop holes and leaks that can affect other building elements with poor drainage of storm water.

Poorly drained roof areas will also lead to damp conditions surrounding the base perimeter of the building which, if left unmanaged, can lead to a range of secondary building defects.

Repair and/or replacement of rusted roof plumbing is highly required in order to reinstate the roof drainage system to a fully operational level.

A licensed plumber or specialist roof restoration company should be appointed to undertake these works. It is advised that such works be completed as soon as possible to prevent any further damage and deterioration.

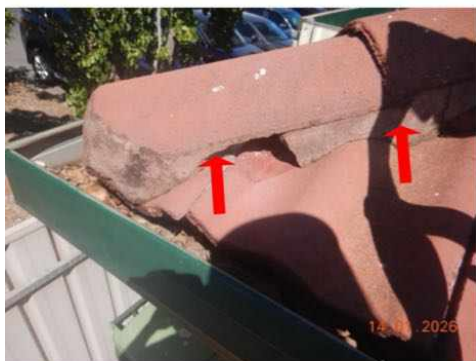
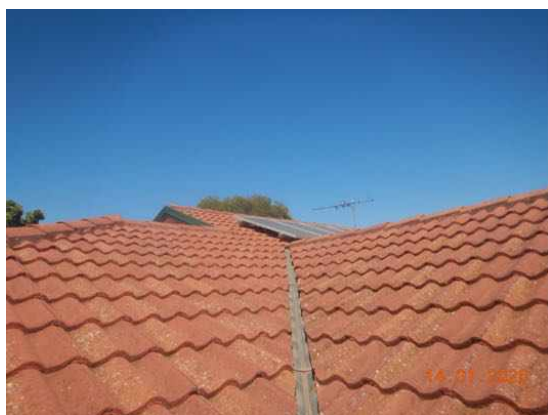
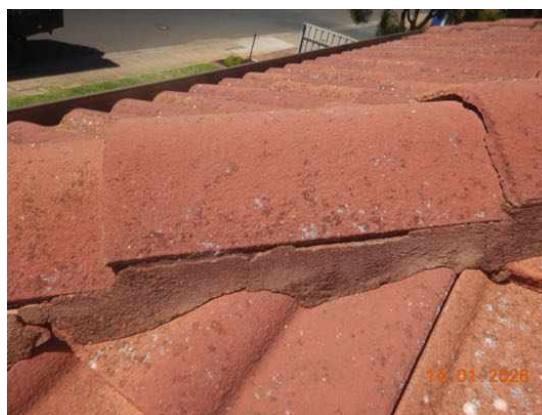
Finding 3.06

Building:	Building 1
Location:	Roof Exterior
Finding:	Mortar - Deterioration
Information:	The ridge capping mortar to the hips of the roof were found to have extensive deterioration at the time of inspection.

Mortar, or 'bedding', is the material which fills joins and intersections between tiles and other building elements on the exterior roof covering, such as gable ends, hip capping and valleys. Upon inspection of the exterior roof, it was noted that sections of the mortar show varying levels of deterioration.

Mortar generally deteriorates as a result of frequent exposure to weather conditions over a prolonged period of time. Mortar that is deteriorating may allow water ingress into the roof void, putting associated building elements and roofing structures at risk of water damage.

Deteriorated mortar also detracts from the functionality of roof tiles and other roofing elements, potentially decreasing weather tightness and roof drainage.

Mortar deterioration can be attended to by a handyperson where areas of deterioration are localised and easily accessible. Otherwise, consultation with a roofing contractor is advised where greater works are required.

Minor repairs to roof mortar

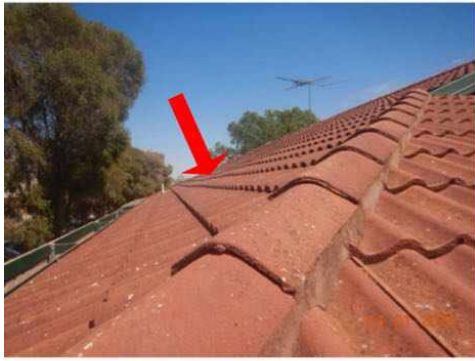
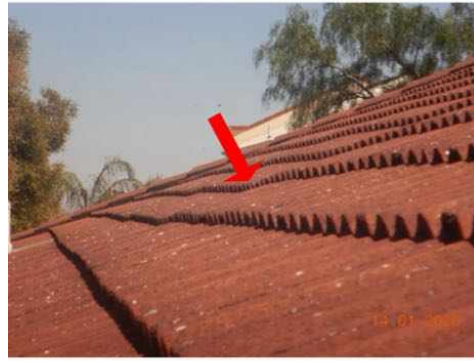
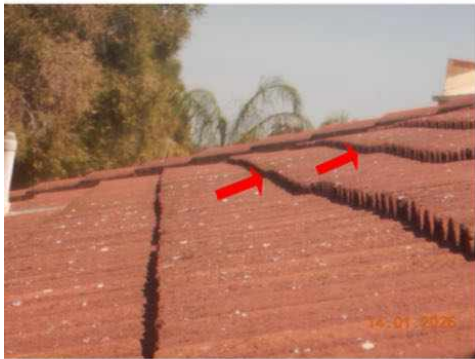
Finding 3.07

Building:	Building 1
Location:	Roof Exterior
Finding:	Sagging roof - Expected for age
Information:	The roofing structure was found to be sagging at the left side of the roof at the time of inspection. Minor roof sag is likely due to age-related deflection of roof framing from long-term loading, fatigued members, and gradual settlement or creep of structural timbers over time.

Sagging roof structures are likely to create strain on associated building elements, creating potential for secondary damage including the deterioration of roof coverings and may lead to further sagging in the future.

As sagging is minimal at this stage and has likely been evident for a long period of time closely monitoring the area is recommended and should further movement become apparent then a Structural engineer should be appointed to provide remedial advice which then could then be carried out by a licensed builder.

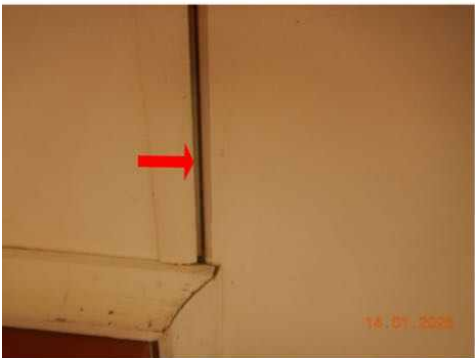
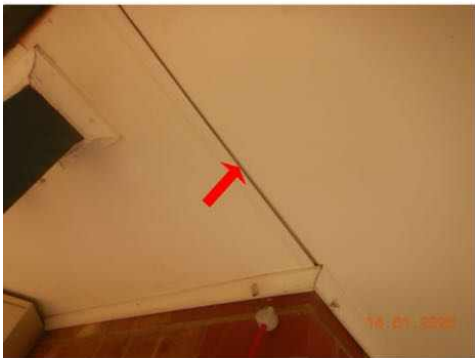
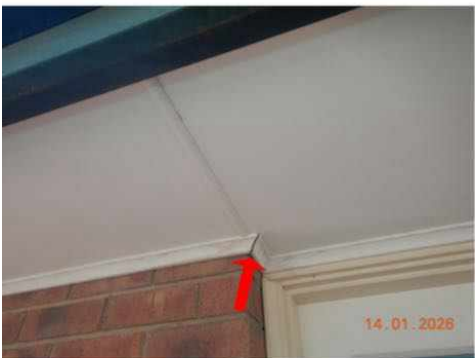
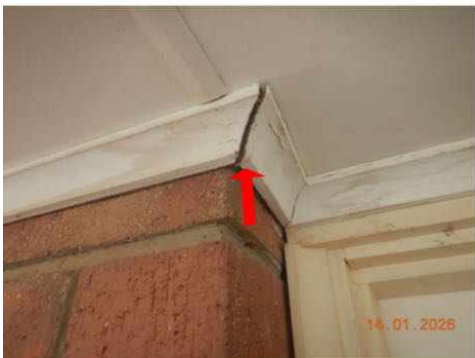
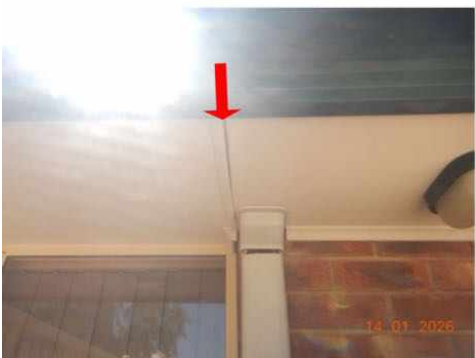
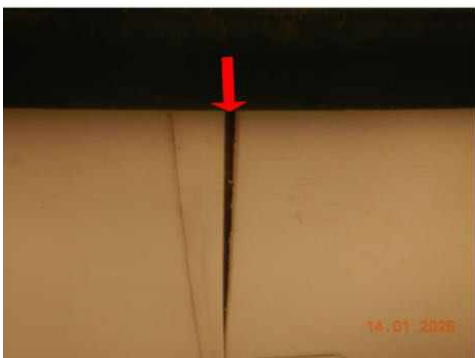
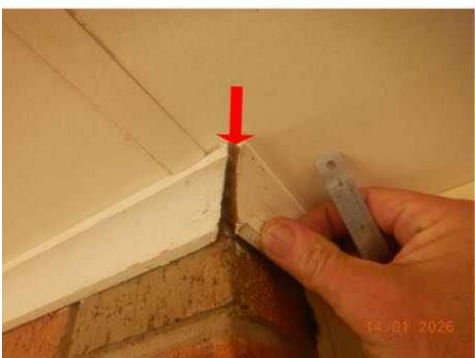
Finding 3.08

Building:	Building 1
Location:	Eaves
Finding:	Eaves Gaps Timber Frame
Information:	Several minor gaps and movement was identified to the eaves around the dwelling at the time of inspection.

The damage may have been sustained as a result of a number of possible causes, including minor settlement of the property or general expansion and contraction of building materials.

Movement has been documented in photographs and monitoring the areas is recommended. A licensed carpenter or a general handy-person could be appointed to make repairs at the discretion of the client.

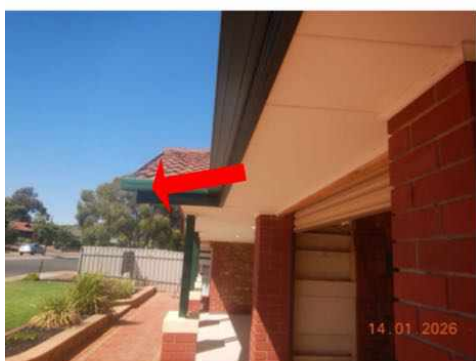
Finding 3.09

Building: Building 1
 Location: Gutter above porch
 Finding: Gutters - Water pooling - fall issue
 Information: Inadequate fall to the guttering was identified to the gutter above the garage at the time of inspection. This is generally due to inadequate fall placed in the guttering when built.

Adjustments to the guttering should be carried out to ensure the pooling water does not create accelerated corrosion to the guttering.

These works could be carried out by a handyman or a licensed roof plumber at your soonest convenience.

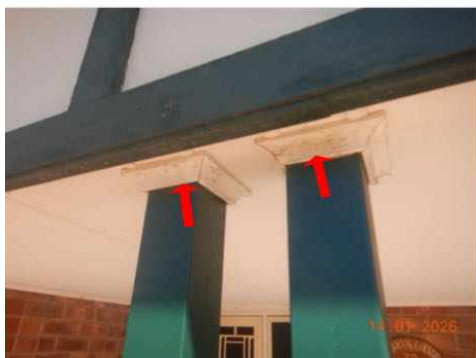
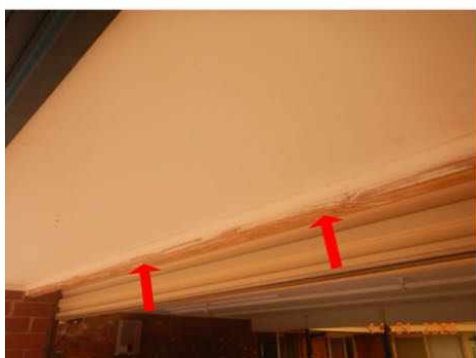
Building:	Building 1
Location:	Front Elevation
Finding:	External painting deteriorated
Information:	Some of the external paintwork including but not limited to the eaves and garage beams have been neglected and require attention to prepare and re-paint.

Whilst incomplete or missing paint finish is generally an appearance defect, it can also lead to the development of secondary building defects over time. Incomplete areas of paint finish expose the area to moisture, potentially accelerating the deterioration of underlying building materials.

Degraded paint finishes should be sanded back, filled, leveled and painted, as applicable. Where inadequate or missing paint protection has led to the deterioration of the associated building element, repair and/or replacement of this building element may be required.

A painting contractor should be appointed as soon as possible to perform necessary works to aid the appearance of the affected area and to ensure the area is protected against further deterioration. Alternatively, the homeowner following manufacturer instructions may perform these works.

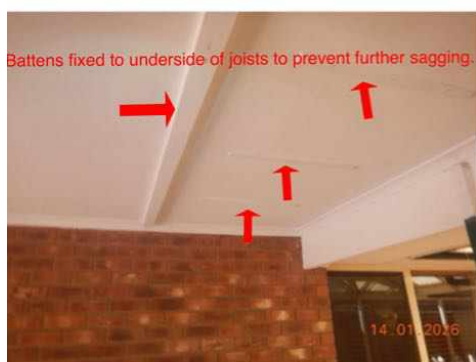
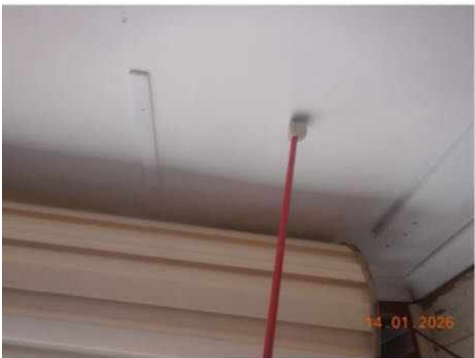
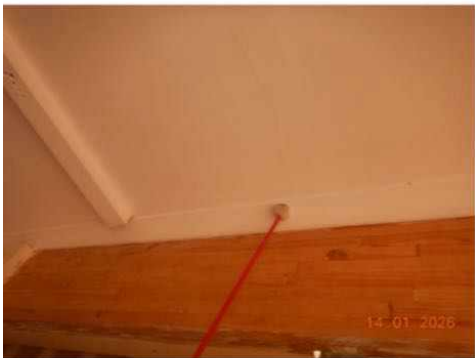
Finding 3.12

Building: Building 1
Location: Garage
Finding: Ceiling sagging - garage
Information: Extensive sag was evident to the garage ceiling at the time of inspection. Works have obviously been carried out to by way of installation of battens underneath the ceiling linings to prevent further sagging.

Sagging to the fixed ceiling structure generally indicates that the building materials have swollen, due to contact with water, or that fixings (e.g. nails or glue) have become loose and require reattachment.

This is a very common defect in carports due to their lack of insulation and or their susceptibility to moisture. Condensation builds up in the roof and rests on the plasterboard softening it somewhat which makes it more likely to sag and release from its fixing points.

Replacement of the ceiling by licensed builders, plasterers and painters may be an option if the appearance of the area is an issue.

Insulating the area is also highly recommended if replacement of the ceiling is carried out.

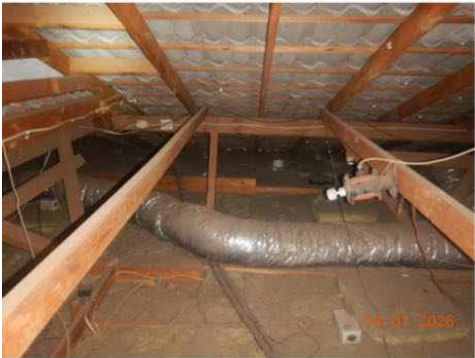
Finding 3.13

Finding: Roof structure - Collar ties loose

Information: Upon inspection of the roofing structure, it was noted that several collar ties has become dislodged from their original fixings and require bolting in position. Another colour tie appears to have been removed by the air-conditioner installation.

Damage to roofing members can create secondary defects, ranging from sagging of the roof to degradation of ceiling linings.

A licensed carpenter should be appointed to install bolts to collar ties to ensure no further movement in the future.

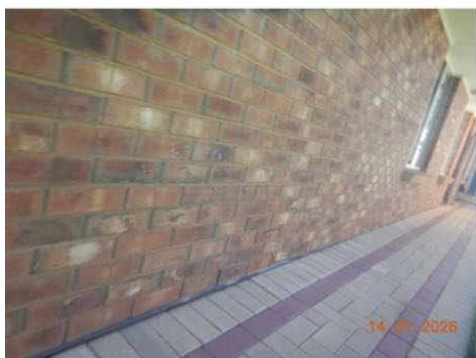
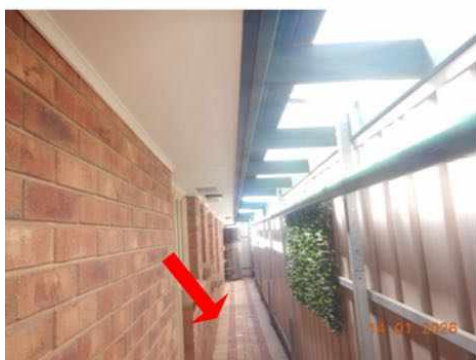
If the slab edge is not properly exposed there is a high risk of concealed termite attack which your inspector will likely not be able to see. Sometimes, in order to determine the type of slab, a suitably qualified person such as an architect or builder may be required to consult construction plans.

Where the slab edge cannot be properly inspected, it is highly recommended that termite or timber pest inspections be carried out every 6-12 months to aid protection of the property against infestation and termite treatment advice is followed closely.

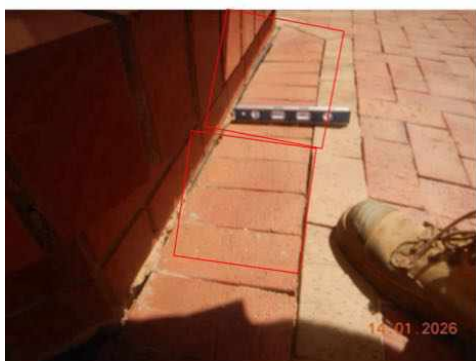
Building: Building 1
 Location: Footpath front
 Finding: Perimeter Paving - Insufficient Fall
 Information: Small areas of the front paving were found to have an inadequate slope away from the adjoining building structure, creating potential for water pooling in this area.

This standard ensures that excessive moisture does not pool around the base of building structures, which creates potential for water and structural damage, as well as

making the area susceptible to termite and timber pest activity.

Where paving or ground levels do not have adequate fall, a licensed paving contractor should be appointed to install or remove and re-level pavement.
