Building and Timber Pest Inspection Report

Inspection Date: Fri, 6 Feb 2026

Property Address: 8 Spinebill Place, Cranebrook NSW 2749

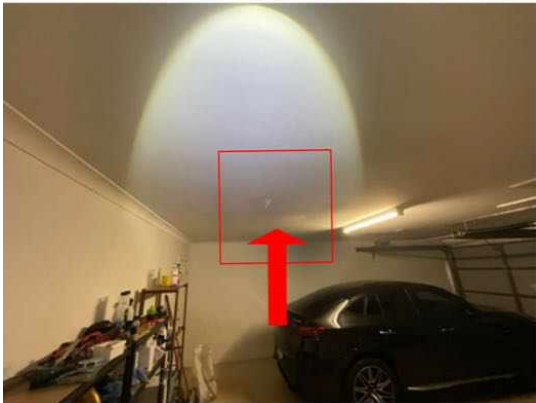
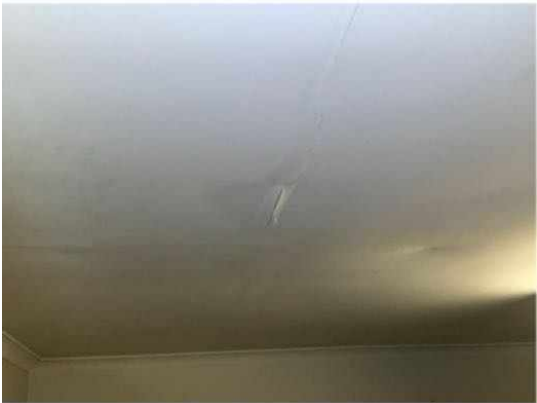
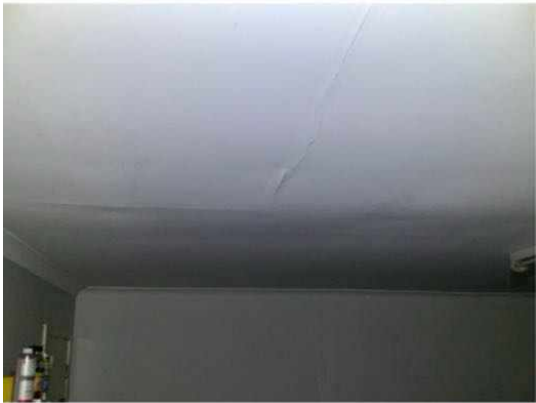
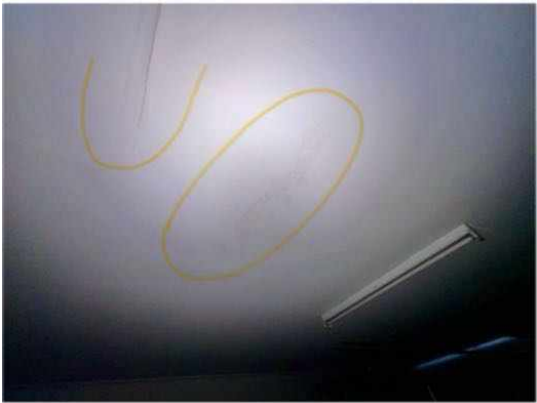
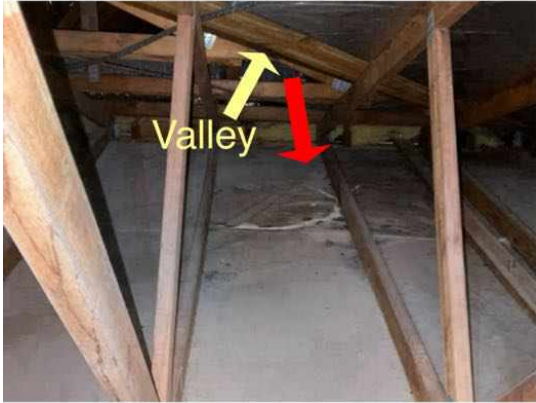
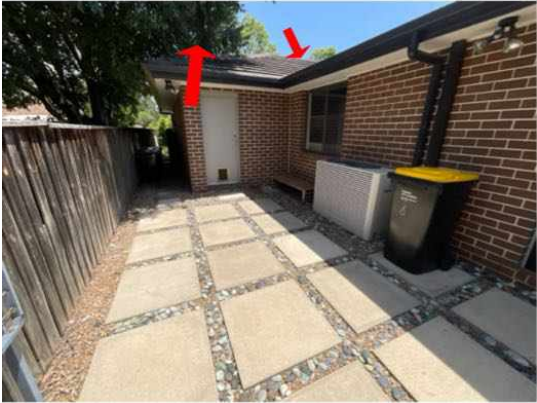
Building:	Main Building
Location:	Garage
Finding:	Ceiling - Water damaged
Information:	Observation

Water damage to the internal ceiling lining was evident at the time of inspection, indicated by visible staining and deterioration to the affected area. Within the roof void above this location, mould growth was observed, consistent with prolonged or recurrent moisture exposure. Timber roof trusses in this area exhibited water staining; however, no visible signs of structural deterioration, rot, or loss of section were noted at the time of inspection. A roof valley is located directly above the affected ceiling area and tree branches were observed overhanging the roof in this location, which increases the likelihood of leaf debris accumulation. This condition is likely to have contributed to blocked or restricted roof valleys, resulting in overflow during periods of heavy rainfall.

If left unrectified, ongoing moisture ingress may lead to further deterioration of internal finishes, expansion of mould growth, and potential adverse health impacts for occupants. Continued water exposure also increases the risk of progressive damage to roof framing timbers over time, which may not be readily visible during a standard inspection. Blocked roof valleys and overhanging vegetation significantly increase the risk of recurring leaks during future rainfall events.

The primary requirement is to promptly identify and rectify the source of the roof leak. A suitably qualified roofing contractor or licensed roof tiler should be engaged as soon as practicable to inspect the roof valley, clear any debris, address overhanging vegetation, and carry out any necessary repairs to reinstate the roof drainage system to a fully serviceable condition. Once the leak has been effectively repaired, further assessment by appropriate trades is recommended. Rectification works may include mould treatment within the roof void and repair or replacement of damaged ceiling lining, followed by patching and repainting as required, depending on the extent of deterioration. Ongoing monitoring during and after future rainfall events is advised to

confirm the effectiveness of repairs and to ensure no further moisture ingress occurs.

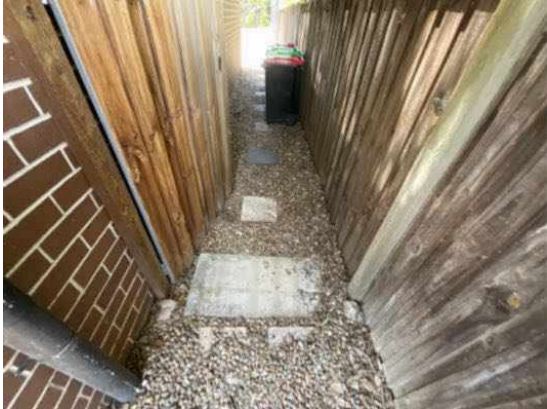
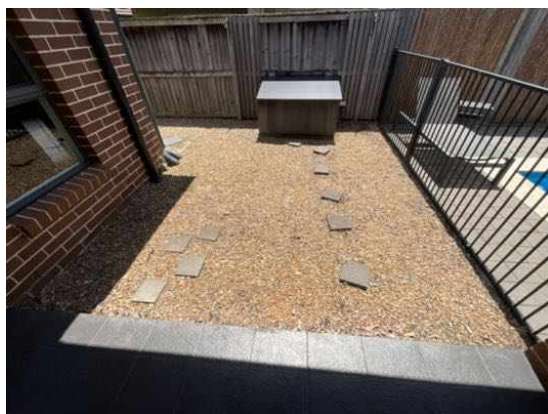
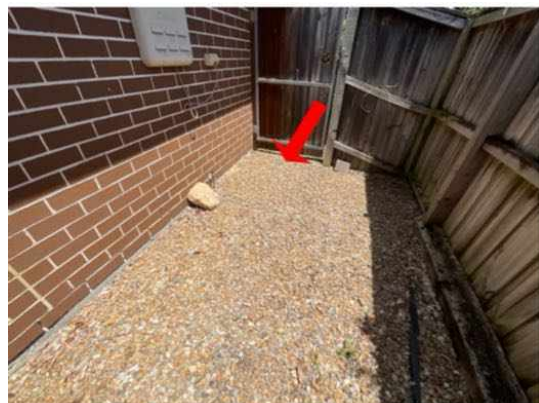
Finding 3.01

Site drainage in the inspected areas appears to be below average, with no surface drains observed in critical areas at the time of inspection. Ground surfaces and paved areas adjacent to the building do not appear to be adequately graded to facilitate effective surface water runoff. Some drainage points were observed, however, don't appear to be adequate with some covers to surface drains missing.

- Water should not be allowed to accumulate against the base of external walls or around the perimeter of the dwelling.
- Prolonged moisture exposure can contribute to:
 - Dampness and structural deterioration
 - Movement of footings or erosion of subsoils
 - Conditions that are conducive to timber pest activity, including termites, which are attracted to moist environments
- Best practice site drainage includes:
 - Paved surfaces falling away from the building by at least 25mm over the first metre
 - Bare ground sloping away by at least 50mm over the first metre

Failure to meet these minimum drainage falls increases the risk of water ingress, foundation issues, and secondary building defects.

- Evaluate the current site grading and surface runoff conditions
- Install or upgrade surface water drainage (e.g. strip drains, spoon drains, grated channels) as required
- Improve grading around the building to ensure water flows away from the structure

Addressing these issues proactively will assist in protecting the structural integrity of the building, while also reducing environmental conditions favourable to termite activity.

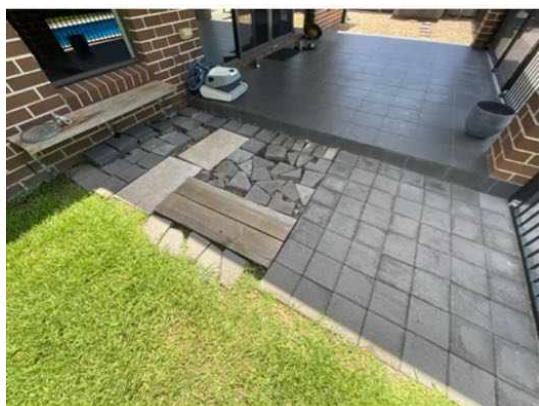
Finding 3.02

Building:	Yard
Location:	Exterior - right/rear side
Finding:	Paving - Uneven.
Information:	Sections of the external paved area were observed to be uneven and irregular, with noticeable height variations between adjoining pavers. This condition appears consistent with either rough or substandard installation practices, possible soil movement, or settlement of the underlying base material over time.

Uneven paving poses a significant trip and fall hazard, particularly in areas of regular pedestrian use such as paths, patios, or entryways. The risk of personal injury increases if individuals are unaware of the uneven surface or during periods of low visibility or wet conditions. From a safety perspective, this issue requires timely attention to ensure compliance with general building and accessibility standards.

In addition to safety concerns, uneven paved areas can also negatively affect surface drainage. Poorly graded or uneven sections may allow water to pond or flow back toward the building's foundation, contributing to moisture accumulation, potential dampness issues, and premature surface deterioration. Over time, these conditions can lead to further instability of the paving and may necessitate more extensive repair works.

It is recommended that the affected sections be re-laid or re-paved to achieve an even

and stable finish. Works should include assessment and correction of the underlying substrate to prevent recurrence of movement or settlement. Ensuring appropriate compaction, grading, and drainage will improve both the functionality and longevity of the surface.

A qualified concreter or paving specialist should be consulted to inspect the area, determine the extent of remediation required, and carry out the necessary works in accordance with relevant building and safety standards. Prompt rectification will help eliminate potential safety hazards and preserve the overall condition and presentation of the property.

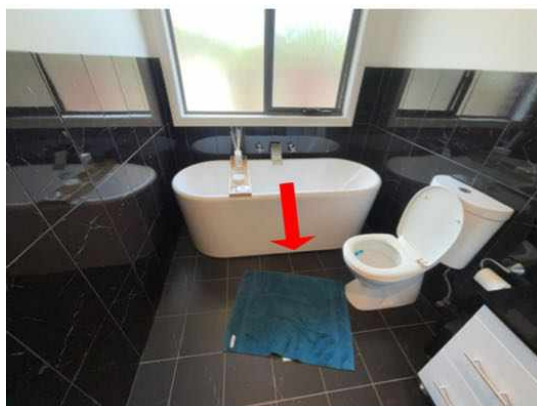
Finding 3.03

Building:	Main Building
Location:	Bathroom
Finding:	Bathtub - Not secured.
Information:	Defect – Freestanding Bathtub Not Secured

The freestanding bathtub was found to be unsecured to the floor at the time of inspection. The tub is capable of movement when pressure is applied, indicating that it has not been mechanically or adhesively fixed. Freestanding baths require stabilisation and proper sealing to ensure safe and compliant use. Without adequate fixing, plumbing connections may also be placed under strain.

An unsecured bathtub presents several functional and safety risks. Movement during use can cause shifting or tipping, creating a hazard for occupants. Ongoing movement may stress or partially dislodge the waste outlet or other plumbing connections, increasing the likelihood of concealed water leakage. Water escaping beneath the tub can lead to moisture accumulation, mould development, and deterioration of flooring or subfloor materials. Over time, this can escalate into significant repair costs and potential microbial health risks.

Engage a licensed plumber to secure the bathtub in accordance with manufacturer guidelines and relevant plumbing standards. Acceptable methods typically include mechanical fixing or the application of a flexible, mould-resistant adhesive sealant to stabilise the unit and ensure a watertight junction with the flooring. The plumber should also confirm that all waste and overflow connections are sound and compliant. Proper fixing and sealing will improve safety, protect plumbing integrity, and reduce the risk of moisture-related damage.

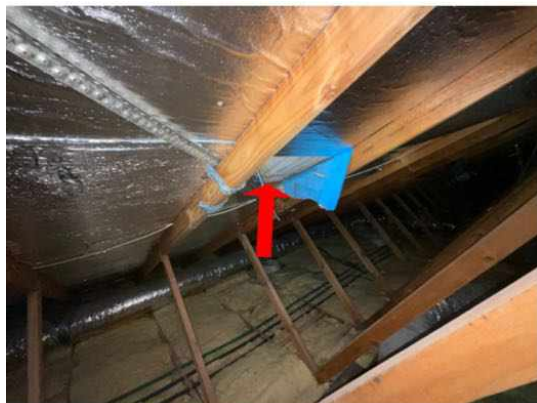
Finding 3.04

Building: Main Building
 Location: Roof Void
 Finding: Sarking was found to be damaged in this area.
 Information: Damaged Roof Sarking

Defect Classification: Minor Defect / Maintenance Item

Where sarking is damaged, its ability to insulate and prevent moisture ingress is compromised. This may reduce the property's energy efficiency and increase the risk of moisture penetration, particularly from condensation or leaking roof tiles.

Any holes or damaged sections of sarking should be repaired or replaced to restore full functionality. These works should be completed by a roofing contractor or other suitably qualified tradesperson.

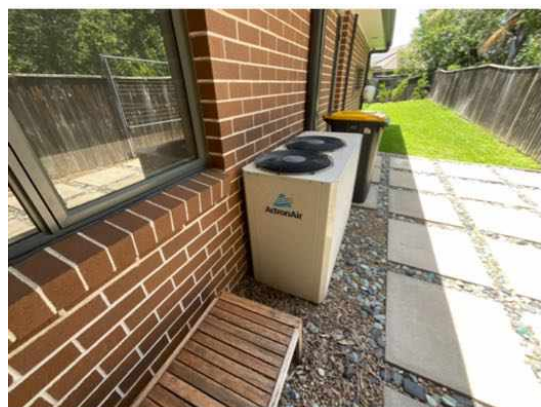
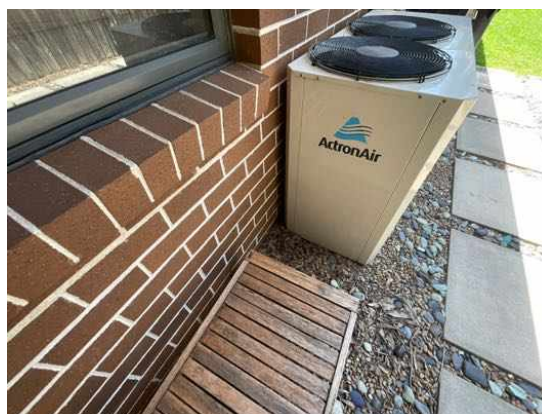
Building:	Main Building
Location:	Exterior walls
Finding:	Plumbing and/or yard drainage - Conducive conditions..
Information:	Observation: Drainage Issues Around Property

Areas of the property—both around the perimeter and within the external yard—were noted to have drainage problems, resulting in water pooling, ponding, or stagnation. These conditions are considered highly conducive to timber pest activity.

An air conditioning unit is positioned in close proximity to the external wall, obstructing visual access to the wall surface and/or weep holes in this location.

- Obstructions such as this limit the ability to detect evidence of termite activity or conditions conducive to infestation.
- Termites may enter a structure in a concealed or undetectable manner, particularly where weep holes are blocked or not visible, allowing them to bridge physical barriers unnoticed.

It is important that appropriate drainage improvements be undertaken to prevent moisture build-up around the building. This may include plumbing repairs, grading adjustments, or installation of drainage systems.

- It is recommended that the A/C unit or associated obstruction be moved to allow a clear inspection of the wall and weep holes.
- A re-inspection should be carried out once access is available.
- It is also recommended that external walls remain clear of obstructions for ongoing periodical termite inspections, in accordance with best practice.

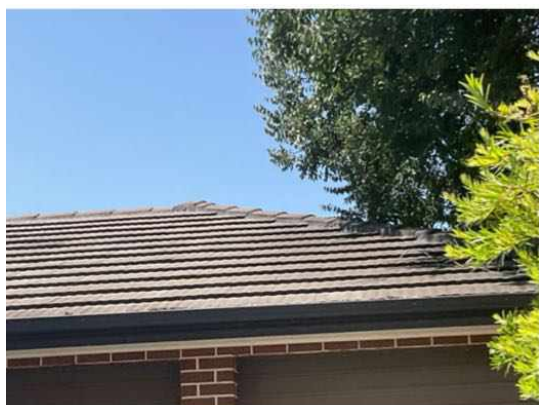
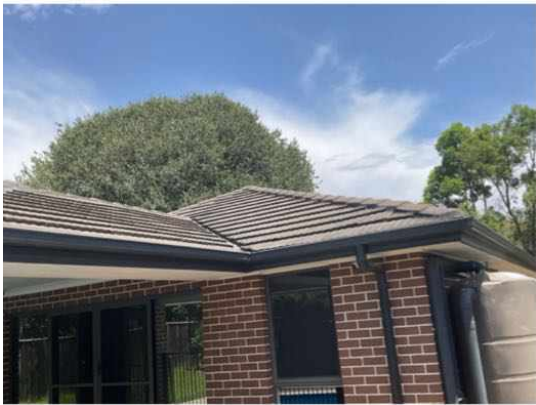
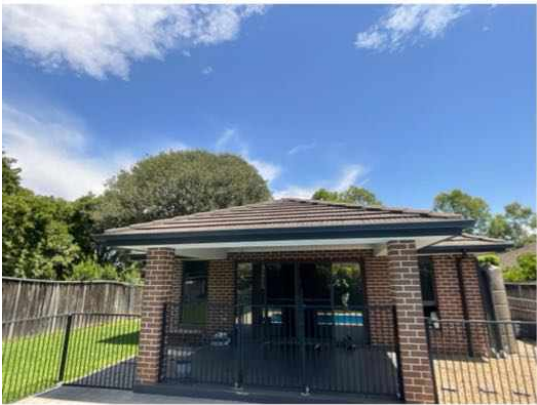
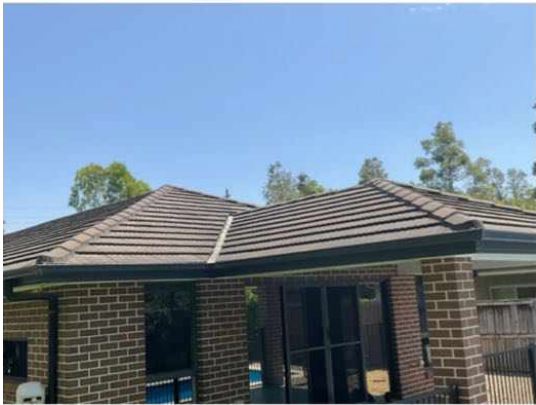
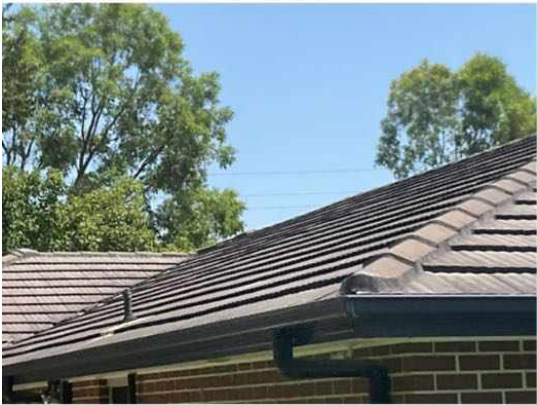
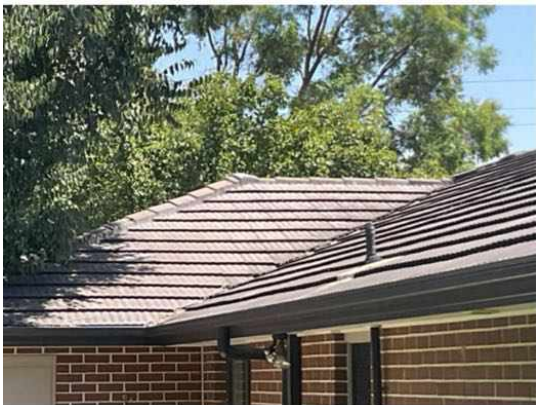
Building: Main Building
 Location: Roof Exterior
 Finding: Roof Tiles – External Inspection.
 Information: Condition Overview:

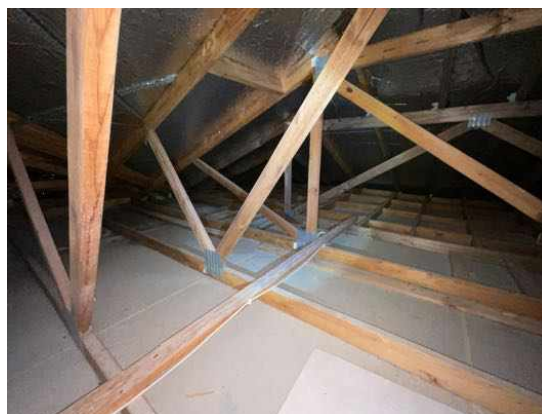
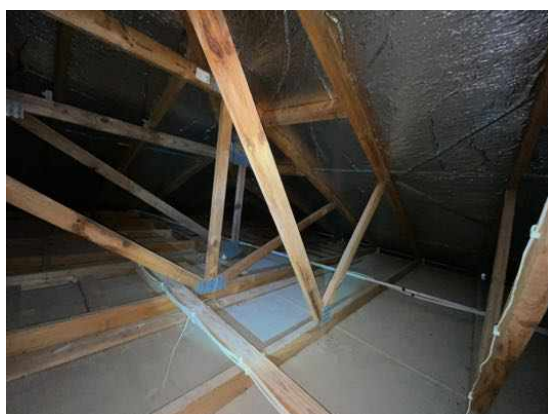
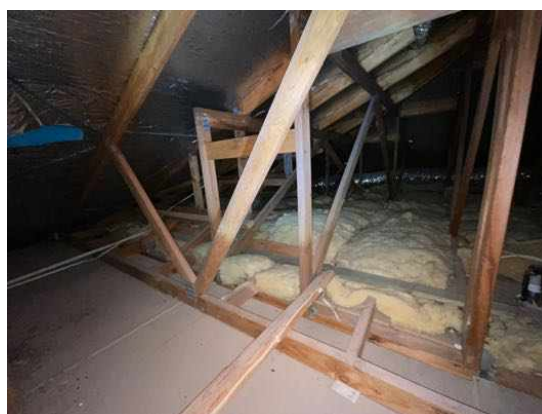
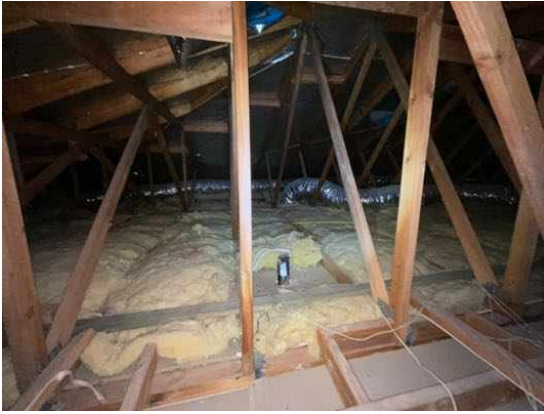
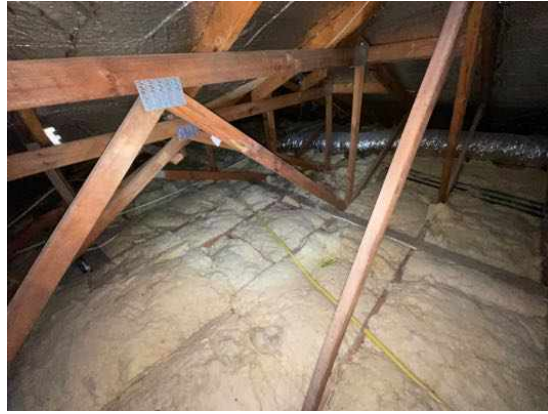
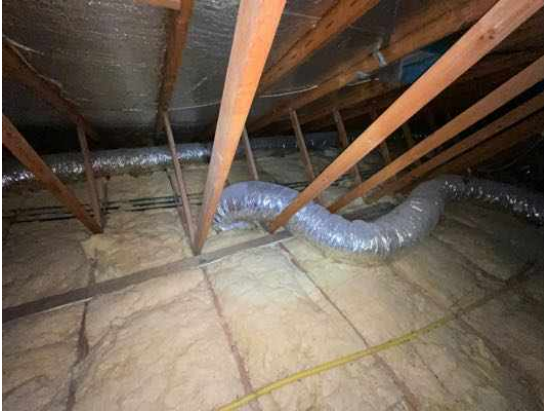
Building: Main Building
Location: Roof Void
Finding: Roof Void – Limited Accessibility..
Information: Observation:

Installation of an additional manhole is recommended to facilitate a re-inspection and enable a more thorough assessment of the roof void in the future. This will help ensure that all structural elements and concealed areas are properly evaluated.

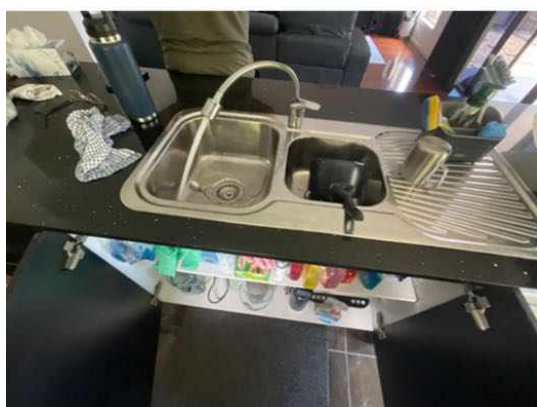
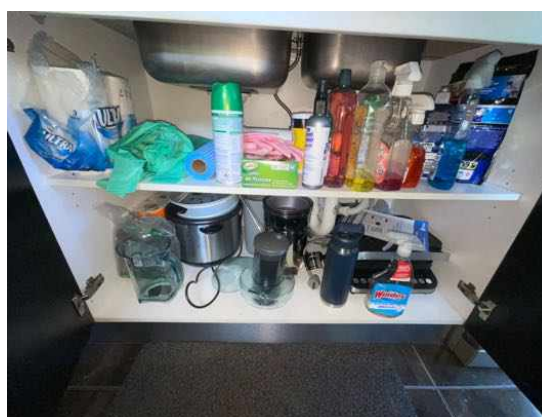
Building: Main Building
 Location: Kitchen
 Finding: Kitchen Sink – Overall Condition & Recommendations.
 Information: Observations:

- Further monitoring and testing are recommended once the tap(s) are in constant use, to identify any drainage issues or signs of slow leaks not evident during the limited inspection.
- It is recommended that the stored items beneath the sink be removed to allow for a full re-inspection of the plumbing and cabinetry, ensuring no concealed defects are present.

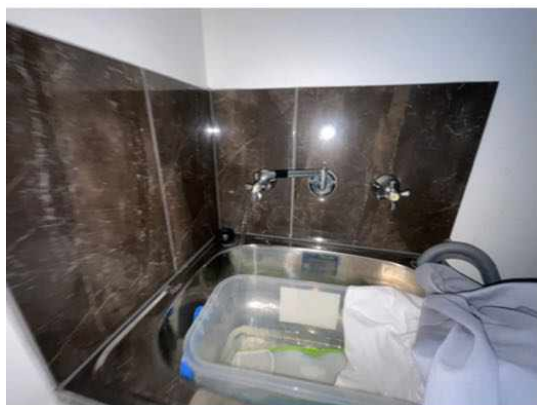
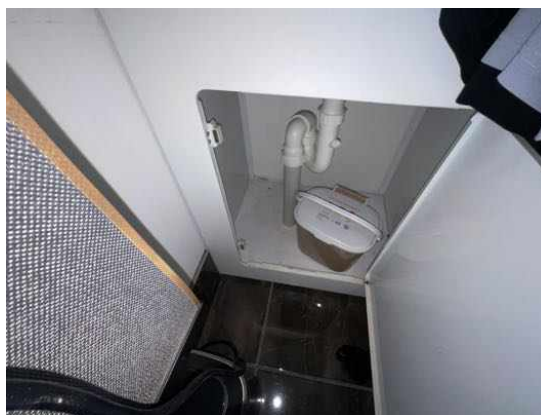
Building: Main Building
 Location: Laundry
 Finding: Laundry - Taps/Plumbing/Drainage.
 Information: Observation: Laundry Tub – Taps, Plumbing, and Cabinetry

- Further monitoring or testing is recommended once the taps are placed into regular use, to ensure no leaks develop over time and that the drainage system continues to perform adequately.
- Sealant and grouting in wet areas should be maintained as part of the long-term

care and upkeep of the property.
