Building and Timber Pest Inspection Report

Inspection Date: Wed, 25 Mar 2026

Property Address: 33 Bruce St, West Wodonga VIC 3690,
Australia

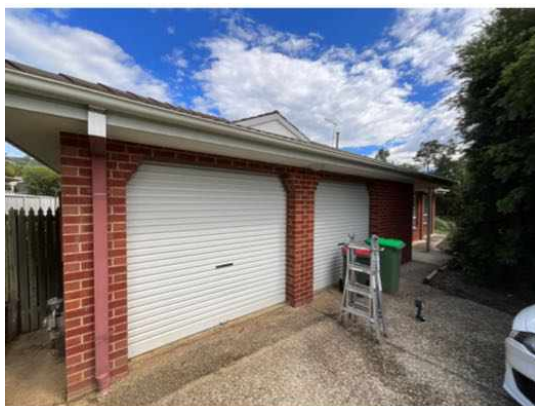
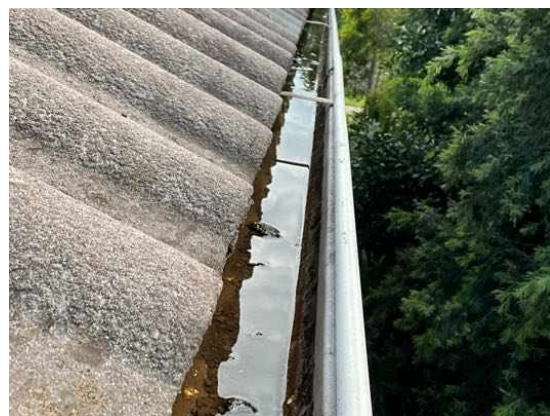
Finding 3.01

Building:	Building 1
Location:	Eaves > Front
Finding:	Gutters - Water pooling
Information:	Water was found to be pooling in sections of the roof guttering. This is generally a secondary defect caused by blocked or partially blocked gutters. Such blockages and subsequent water pooling are likely to lead to rust and water damage to associated structures if left unattended.

Any areas of guttering that shows evidence of water pooling should be checked for partial or full blockages and any secondary damage that may have occurred as a result. Depending on the extent of the damage, building elements may require repair and/or replacement to ensure adequate roof drainage and function of exterior plumbing system.

A roofing plumber should be appointed as soon as possible to rectify this issue. It is highly advised that all gutters be maintained on a frequent basis to ensure the condition of roof plumbing.

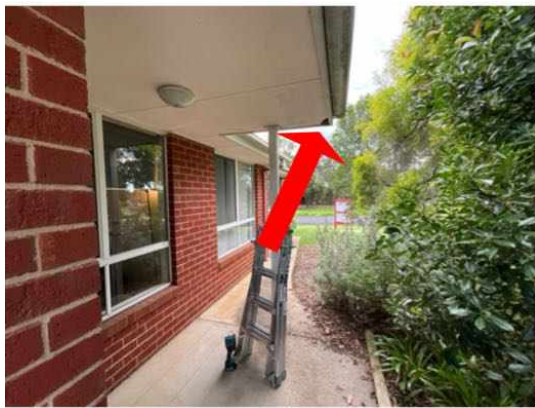
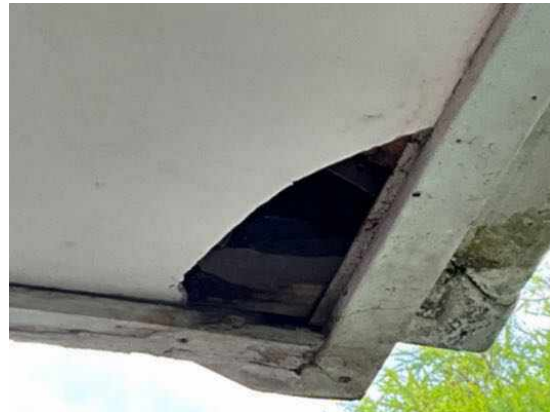
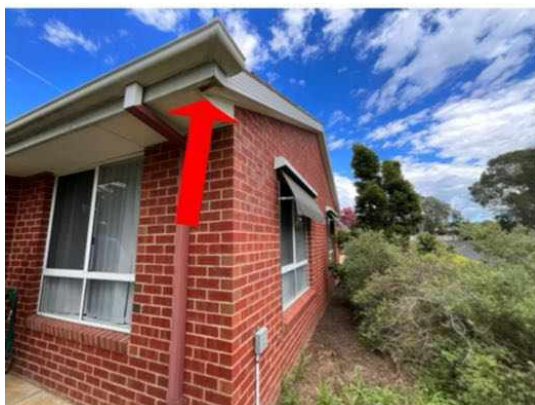
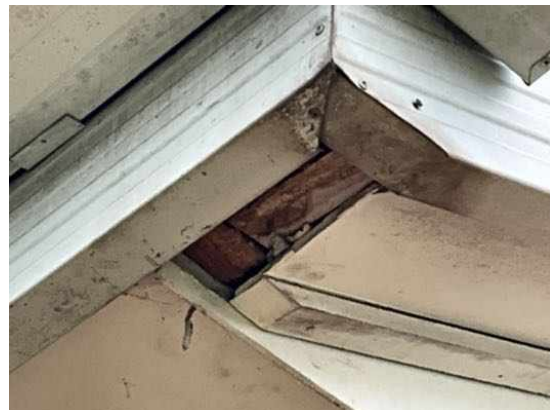
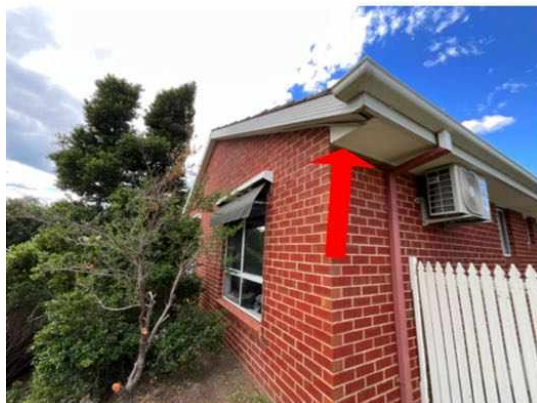
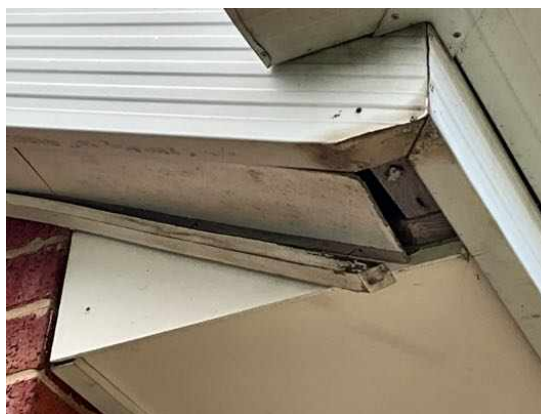
Finding 3.02

Finding: Eaves - Damaged

Information: The eaves at the entry of the property were found to be in a visibly poor condition. The damage may have been sustained as a result of a number of possible causes, including poor roof drainage, leaking roof plumbing or minor impact damage.

The damage to the eave sheeting in this area detracts from the appearance of the structure, as well as potentially compromising the structural integrity of the roofing area.

Where eaves show moderate to severe damage, remedial works may be required. Where water damage is suspected as being the underlying cause, appointment of a licensed plumber is advised as a matter of urgency to identify the source of the water leak.

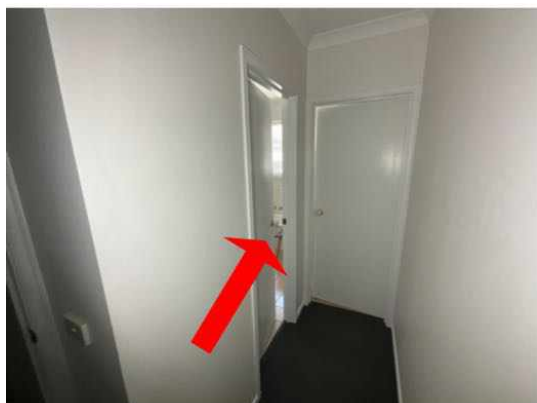
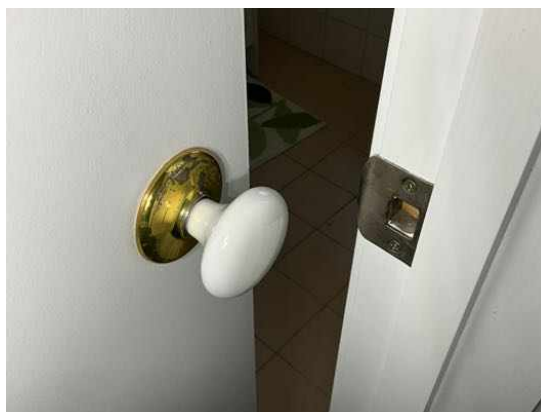
Finding 3.03

Building: Building 1
 Location: Bathroom
 Finding: Door - Striker plate misaligned
 Information: The striker plate to this door appears to have become misaligned and has consequently resulted in the door's operation being compromised.

This is a common defect and is expected in a property of this age, whether being due to substandard installation or general deterioration of the door hardware.

Readjustment of the striker plate is recommended at client discretion. Works such as these can be completed by a general handyman or qualified carpenter.

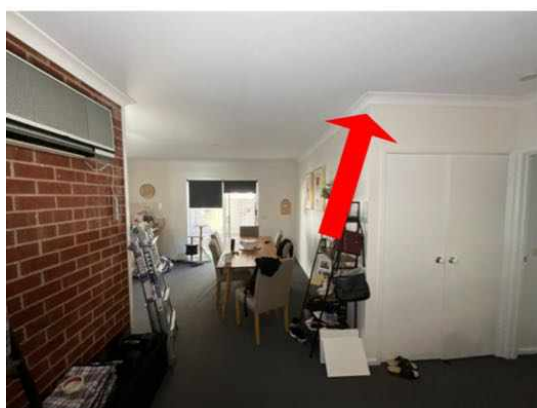
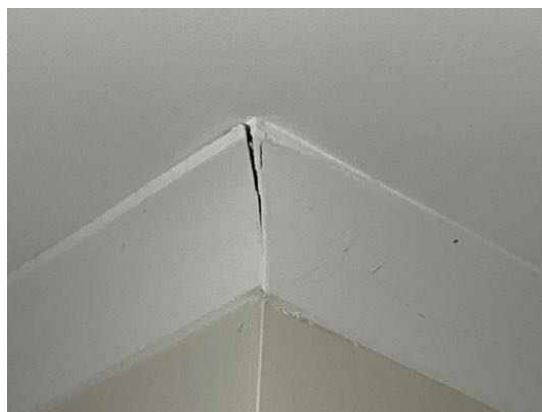
Finding 3.04

Building: Building 1
 Location: Living Room
 Finding: Cracking - Damage Category 2 - Noticeable (up to 5mm)
 Information: Noticeable cracks are a common occurrence as a result of many primary defects. Such causes may include age, general wear and tear, expected building movement, general expansion/contraction of building materials in different weather conditions, and/or minor failings in the installation or application of building materials.

Noticeable cracks may result in minor sticking or jamming of associated doors and windows, which require easement. However, noticeable cracks are easily filled and repaired. A plasterer can be consulted to install an expansion joint at this point to allow for this movement during different weather conditions.

Monitoring of all cracking should be conducted frequently. Always contact a building inspector should cracks widen, lengthen, or become more numerous. Additionally, your building inspector should also be contacted if associated building elements such as doors and windows become more difficult to operate over time.

Relevant tradespeople, such as carpenters, painters and plasterers, should be appointed to perform remedial works, as deemed necessary.

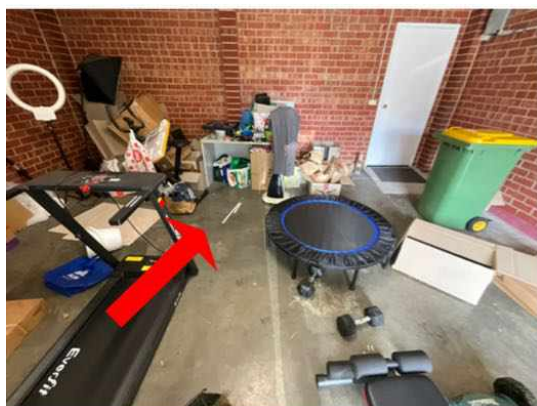
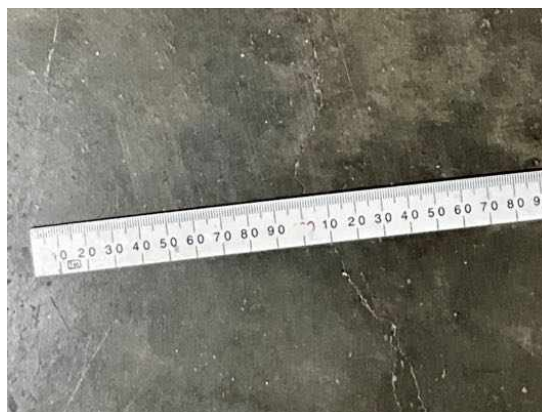
Finding 3.05

Building:	Building 1
Location:	Garage
Finding:	Crack in concrete slab - Category 1
Information:	A crack coded as Category 1 was identified in the slab. A Category 1 crack is described as a fine but noticeable crack, with the slab at an otherwise reasonable level.

To be considered Category 1, the approximate width of the crack is less than 1.0mm, or a less than 10mm change in offset when a 3m straight edge is placed over the defect.

Category 1 cracks should be monitored for a period of 12 months. At the end of the monitoring period, identified cracks that are rated greater than Category 2 are considered defects, and require rectification.

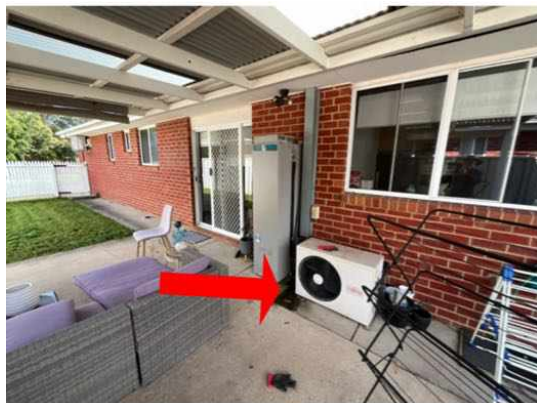
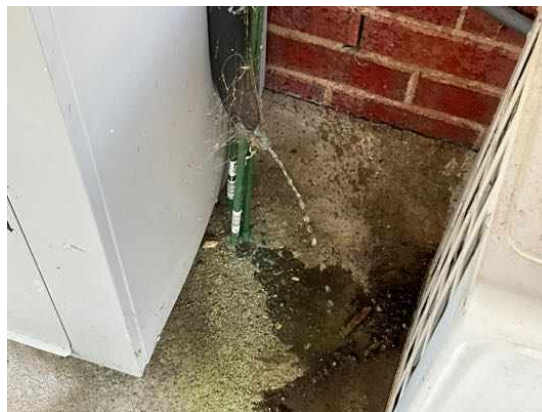
Finding 6.02

Building:	Building 1
Location:	Alfresco
Finding:	HWS Overflow - Not Connected
Information:	The Hot Water System (HWS) overflow was found to be disconnected from storm water drainage and is creating excessive moisture in the surrounding area.

These damp conditions can lead to secondary defects such as rot, rust or corrosion of associated building elements, the formation of fungal decay, or even the creation of potential slip hazards. When coupled with poor site drainage, pooling of water may also attract termite activity to this area.

It is highly recommended that a licensed plumber be appointed to connect the HWS overflow in order to prevent such an environment from being created. These minor works should be carried out as soon as possible.

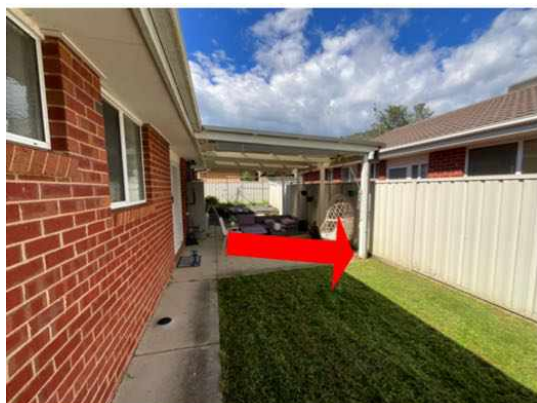
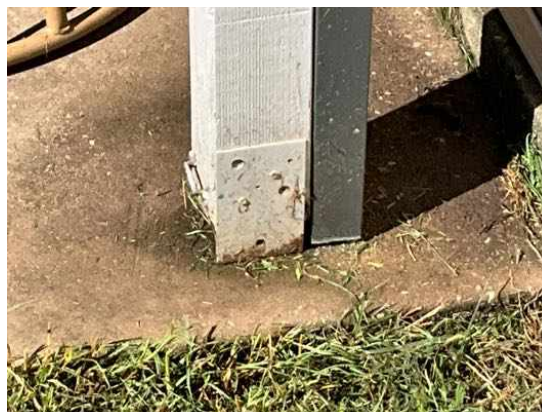
Finding 6.03

Building: Building 1
 Location: Alfresco
 Finding: Stormwater drain - Not connected
 Information: The roof plumbing is not adequately connected to stormwater drainage on the site. This disconnection negatively impacts the functional capacity of the roof plumbing.

Where roof plumbing doesn't drain adequately, the area at the base perimeter can become excessively damp, potentially creating an environment that is susceptible to rust and corrosion of surrounding building elements, as well as attracting termites and other pests.

It is highly recommended that a plumber be appointed to further inspect the area and to install adequate drainage equipment where necessary.

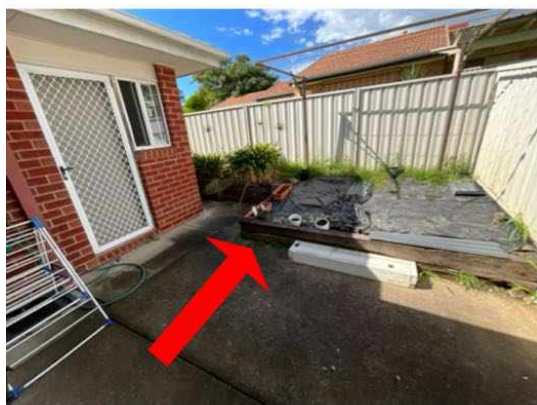
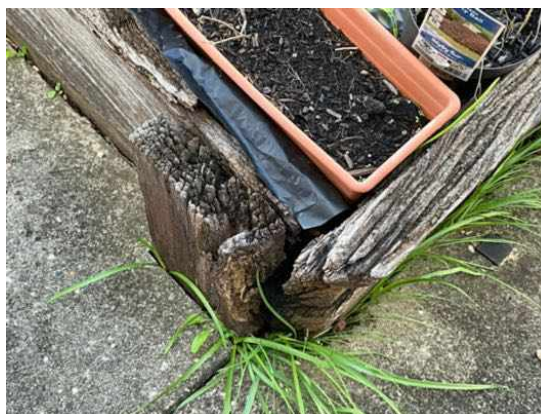
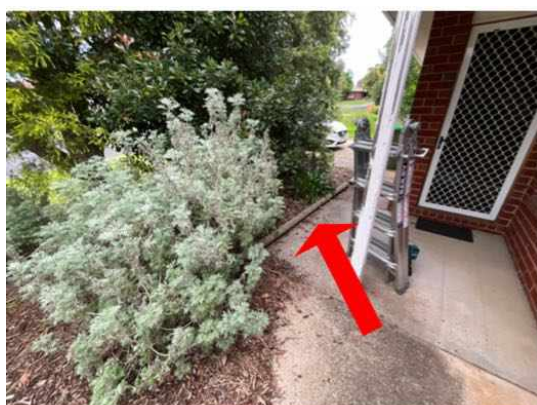
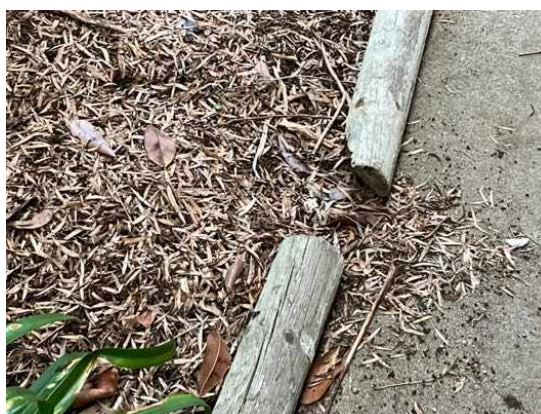
Finding 6.04

Building: Building 1
 Location: Yard - Back, front
 Finding: Untreated or non-durable timbers in a hazardous environment
 Information: To reduce the risk of timber pest attack it is essential that timber used in a hazardous environment (e.g. in direct contact with the ground or frequently exposed to damp

conditions) is of sufficient durability and/or is adequately preservative treated.

Untreated timbers in direct contact with the ground are likely to develop severe wood rot and/or fungal decay if left unattended creating attraction for subterranean termites to infest the timbers from surrounding areas.

If untreated or non-durable timbers are found to be in a hazardous environment it is highly advised that replacement of these building elements be performed as soon as possible to aid the protection of the property against termite / timber pest attack.

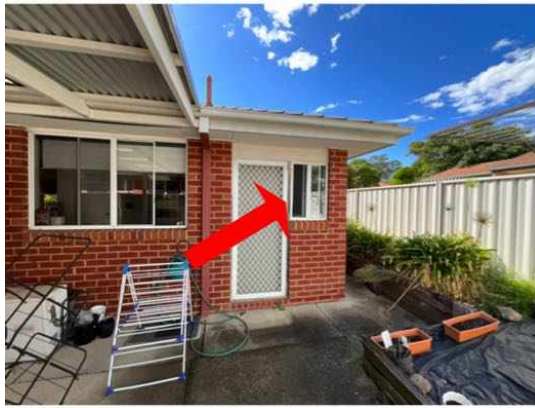
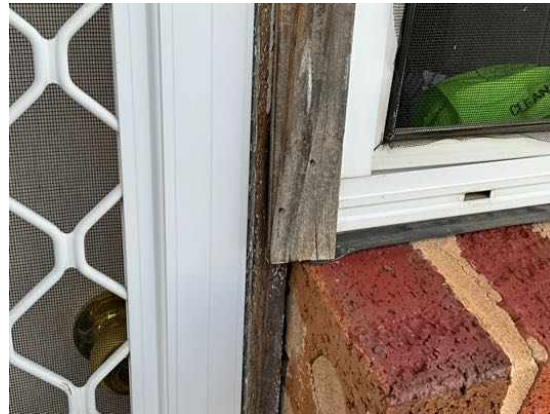
Finding 6.05

Building:	Building 1
Location:	Laundry
Finding:	Timber - exposed to weather
Information:	External timbers that are frequently exposed to harsh weather conditions require adequate protection in order to maintain their condition. Where timbers have not been painted or treated adequately, general deterioration is likely to occur at an accelerated rate.

If left unattended, replacement of these timbers is likely to be necessary in the short-term future. Adequate treatment of these timbers is required as soon as possible by a painting contractor or general handyman.

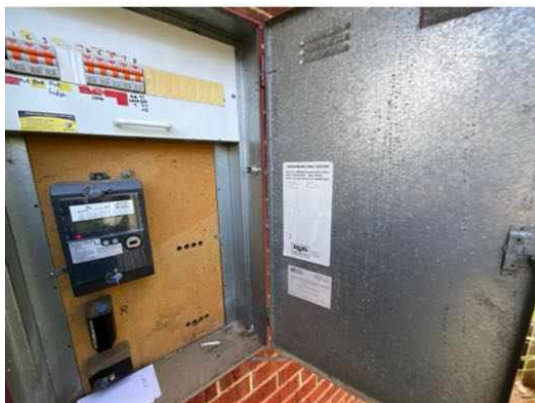
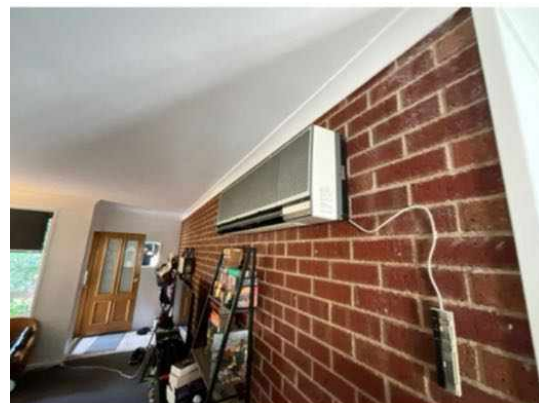
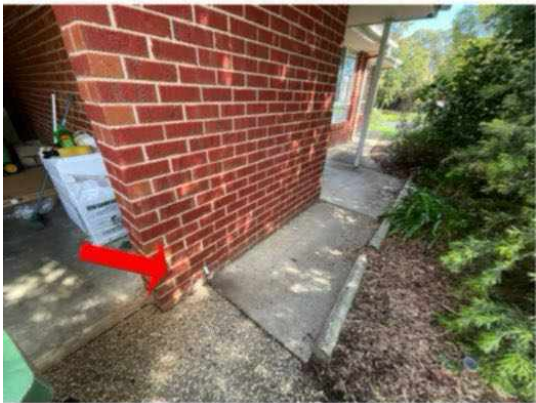
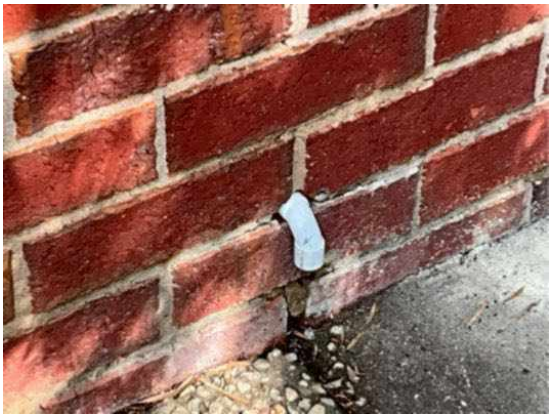
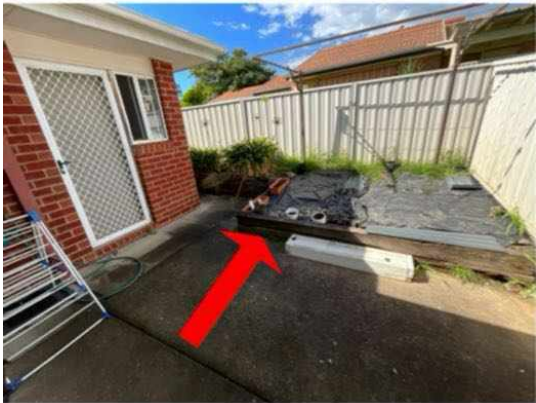
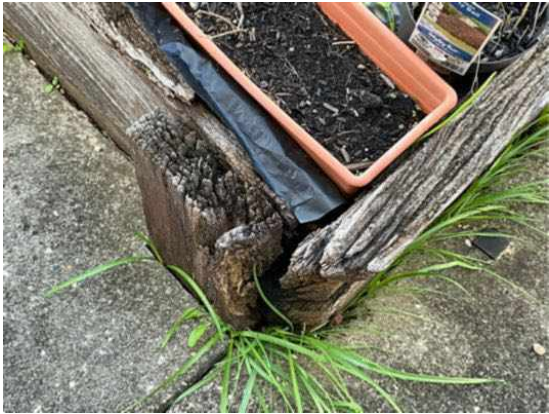
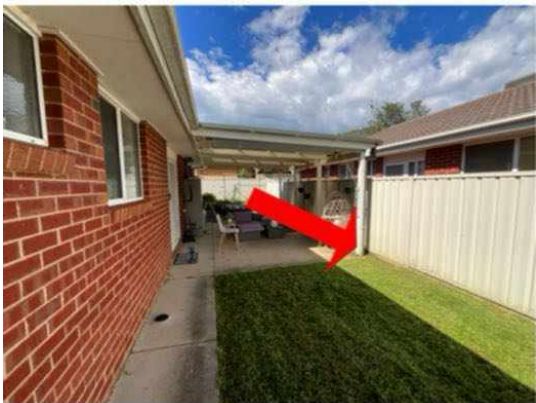
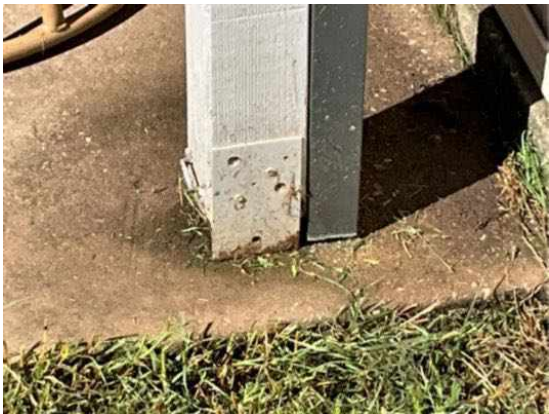
Finding 6.06

Building:	Building 1
Location:	All External Areas
Finding:	Termite Management System - no evidence of a chemical installation
Information:	The application of a post-construction chemical termite barrier is highly recommended for all properties, particularly if live termite activity has been found on the site previously. Such barriers are highly effective in preventing termite attack on any timber building elements throughout the property.

A durable notice should be placed in the switchboard unit to indicate current termite barriers. At the time of inspection, it appeared as though no termite management system has been installed, with no evidence to suggest preventative works taking place.

The client may consider gaining further advice from a pest controller as to the costs and procedures involved with this application. It is recommended that obtaining such advice be a short-term priority.

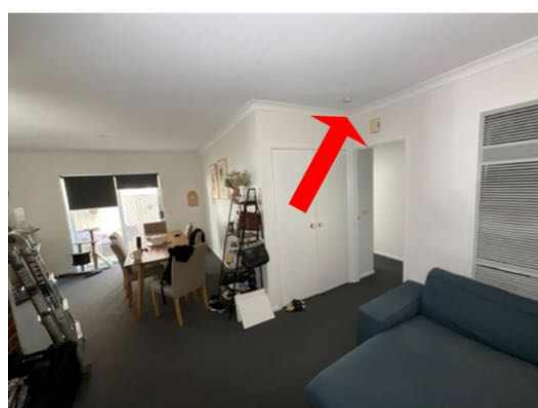
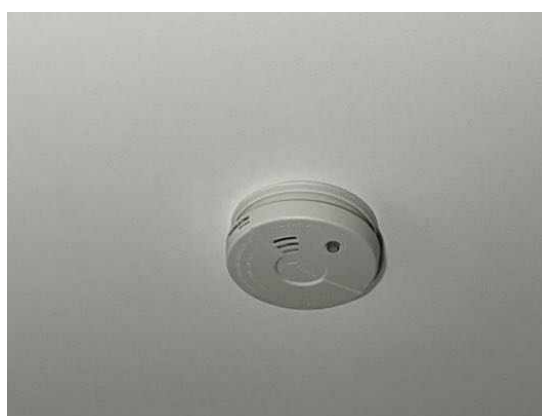
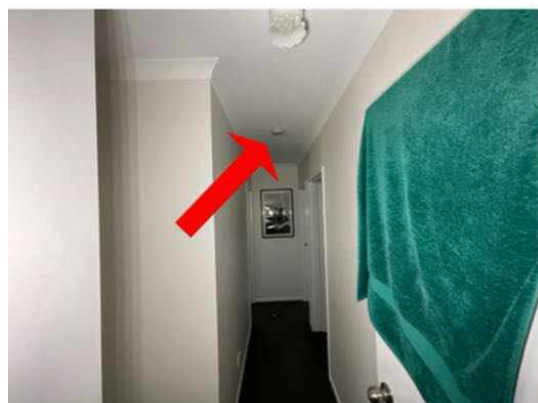
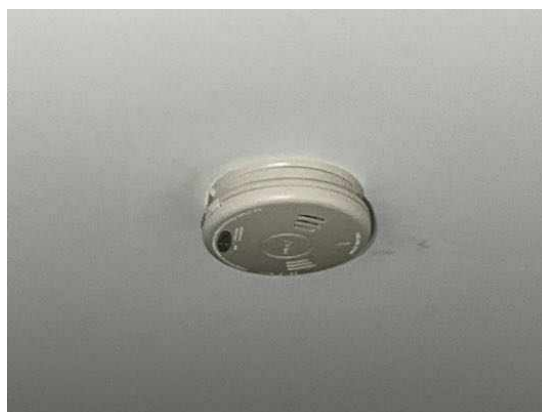
Building: Building 1
 Location: All Internal Areas
 Finding: Smoke detectors- Working
 Information: The smoke detectors were found to be functional at the time of inspection.

Monitoring should be ongoing to ensure the safety of the occupants.

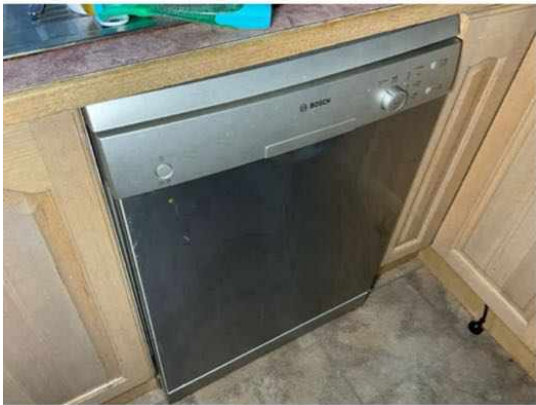
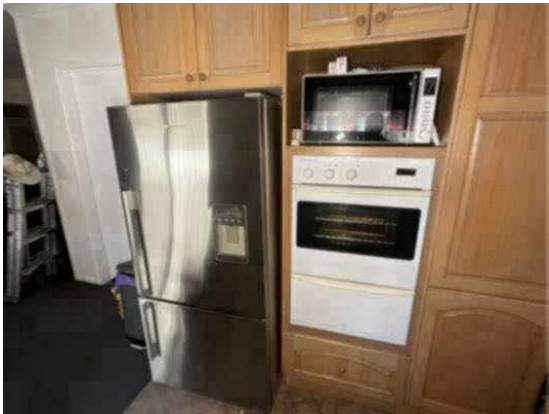
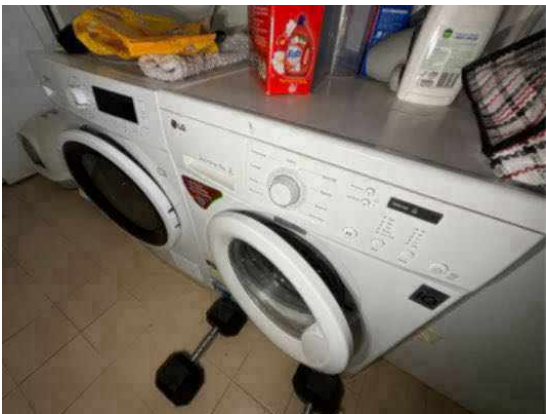
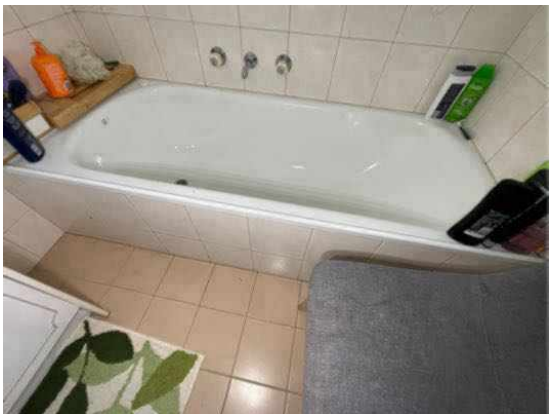
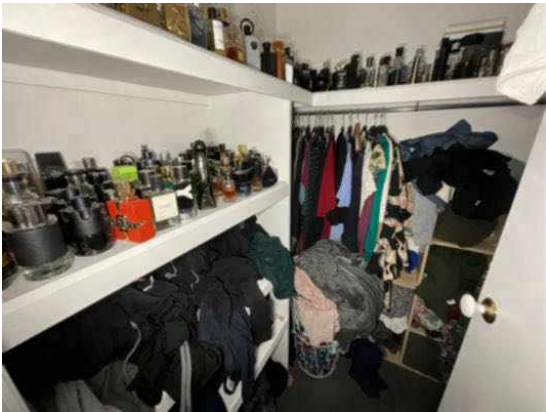
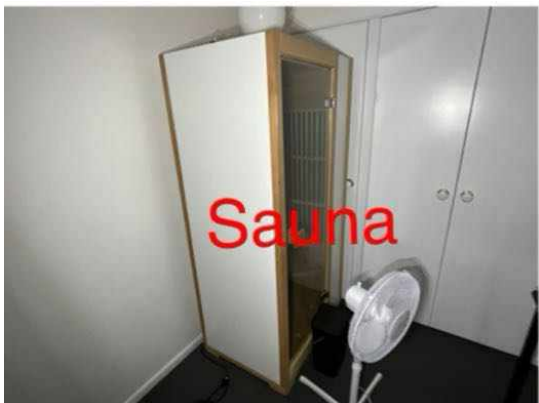
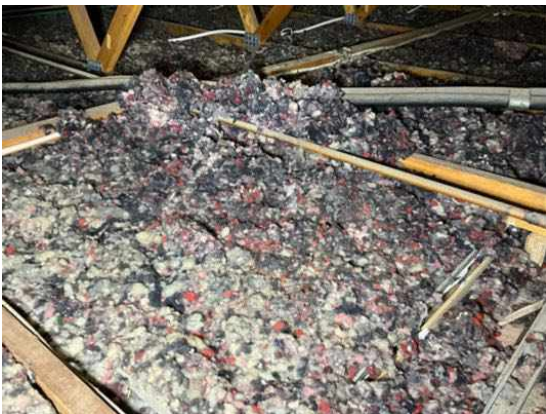
Building: Building 1
 Location: All Areas
 Finding: Additional Photos - Obstructions and Limitations
 Information: These photographs are an indication of the obstructions and limitations which impeded full inspection of the property at the time of inspection. These obstructions can hide an array of defects and should be removed to allow full inspection to be carried out. A re-inspection is recommended once the areas are made accessible.
