Building and Timber Pest Inspection Report

Inspection Date: Fri, 27 Feb 2026

Property Address: 2 Ondieki Ct, Blacktown NSW 2148,
Australia

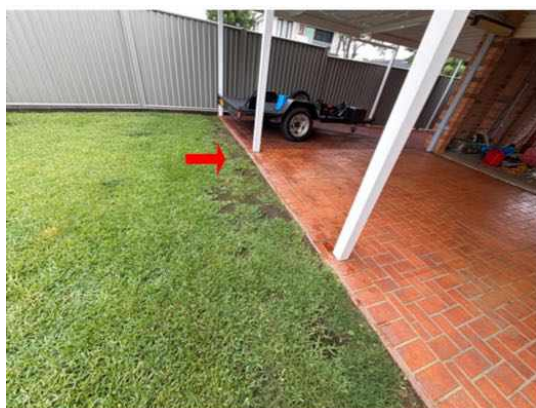
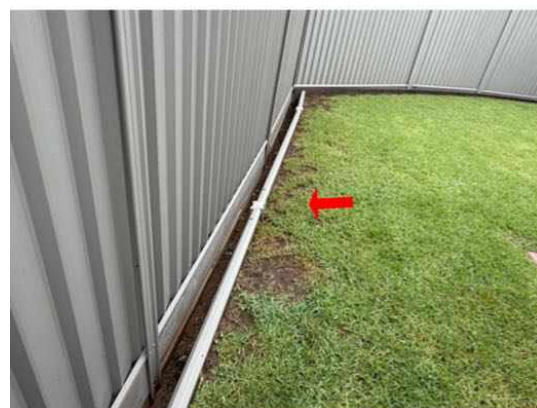
Building: Main Building
 Location: Backyard
 Finding: Site drainage— Inadequate
 Information: The site drainage in this area was found to be inadequate at the time of inspection, creating potential for subsequent water damage to associated building elements. This is additionally conducive to termite activity.

It is important that water does not lie against the base of walls; surrounding paths and ground levels should be sloped to drain water away from walls. Downpipes should not discharge stormwater onto lower walls or plinths. Stormwater should be carried away by large, regularly cleaned drains. Ground levels may need to be lowered to expose a buried DPC.

Where site drainage is inadequate, installation of an Agricultural (Aggie) Drain may be required. A licensed plumber should be appointed to further inspect the property and perform any remedial works as necessary. Water damage and secondary defects are likely to occur if left unmanaged.

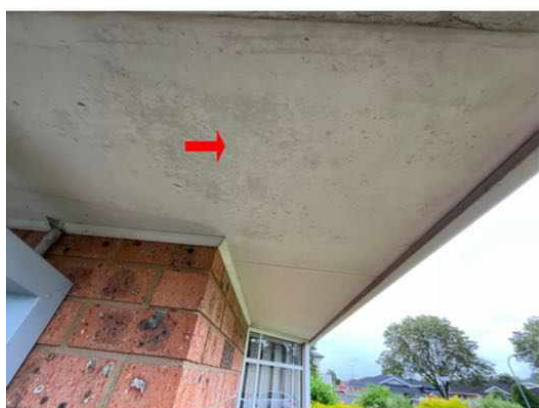
Finding 3.02

| Information: | Where evidence of mould growth was noted, there may be environmental, biological or health issues associated with the report. A possible cause could be excess moisture due to overflow of stormwater from the gutters as a result of gutters being blocked. |

Generally, the client is advised to ensure that the general environment is free of moisture and humidity to aid in the prevention of mould formation and development. Any mould found during the inspection should be cleaned immediately by a cleaning contractor or the homeowner as applicable.

The client is advised to ensure the gutters are always maintained and free of debris.

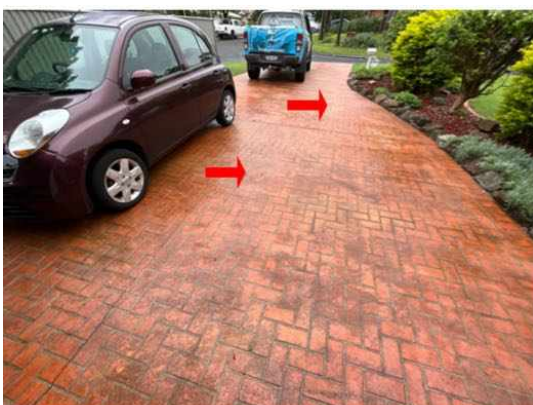
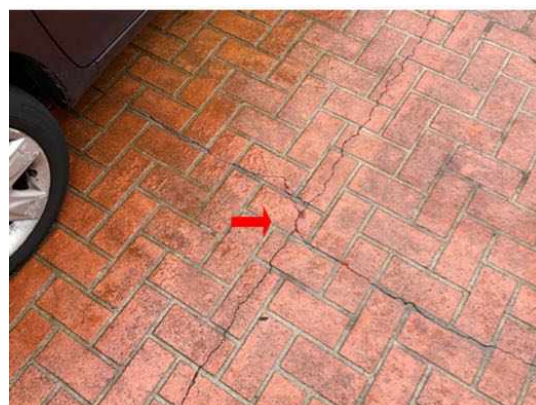
| Finding: | Cracking - External Concrete Paving Damage Category 0 - Hairline (less than 1mm) |
| Information: | Hairline cracks were identified in external concrete paving. Hairline cracks are very minor in nature and generally are only ever an appearance defect. To be classified as a Category 0 or hairline crack, the crack width would be less than 0.3mm. While such cracking may be noticeable in some cases, it is common and does not indicate any structural damage. |

Generally the cause of a hairline crack in existing concrete paving such as driveways and pathways is indicative of the expansion and contraction of the concrete. Such causes are generally due to environmental factors, such as moisture levels, weather conditions, root systems of nearby trees or the soil types on which they are laid.

Hairline cracks may also be due to poor original installation of the concrete. Factors such as poor compaction of the sub surface and/or inadequate reinforcing of the slab may create cracking and other secondary defects.

Monitoring of all cracking should be conducted frequently. Always contact a building inspector should cracks widen, lengthen, or become more numerous.

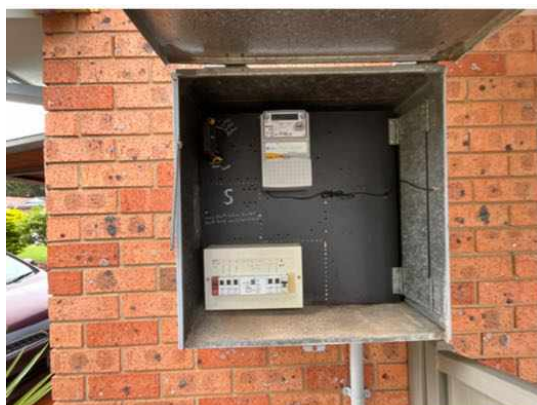
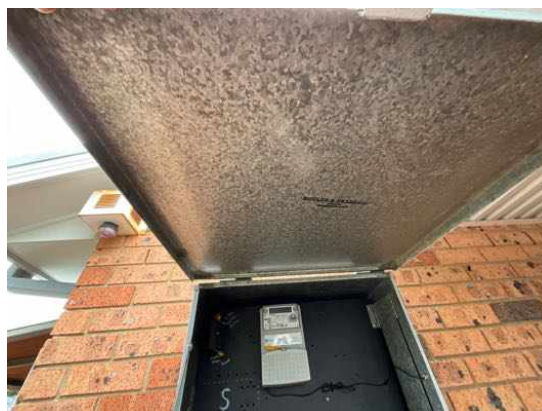
| Information: | The application of a post-construction chemical termite barrier is highly recommended for all properties, particularly if live termite activity has been found on the site previously. Such barriers are highly effective in preventing termite attack on any timber building elements throughout the property. |

A durable notice should be placed in the switchboard unit to indicate current termite barriers. At the time of inspection, it appeared as though no termite management system has been installed, with no evidence to suggest preventative works taking place.

The client may consider gaining further advice from a pest controller as to the costs and procedures involved with this application. It is recommended that obtaining such advice be a short-term priority.

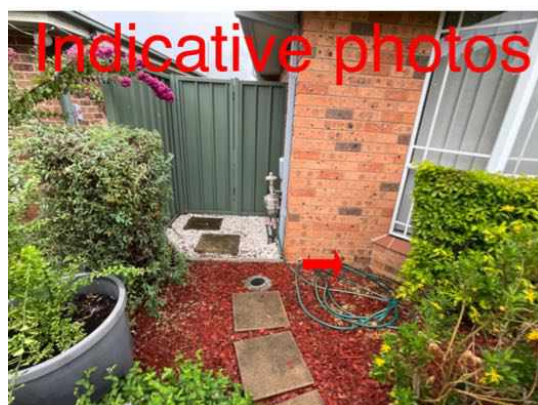
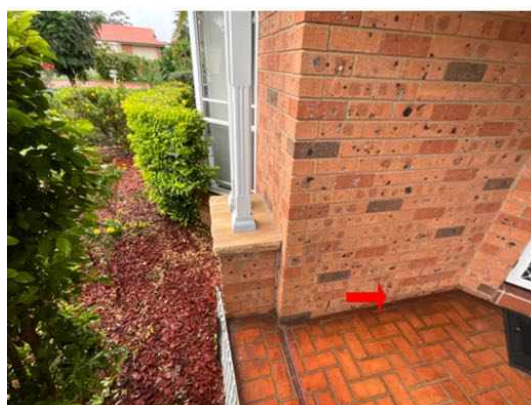
Finding 6.03

| Information: | Slab Edge Exposure: Where external concrete slab edges are not exposed there is a high risk of concealed termite entry. In some buildings built since July 1995 the edge of the slab forms part of the termite shield system. In these buildings an inspection zone of at least 75mm should be maintained to permit detection of termite entry. The concrete edge should not be concealed by render, tiles, cladding, flashings, adjoining structures, paving, soil, turf or landscaping etc. Where this is the case you should arrange to have the slab edge exposed for inspection. Concealed termite entry may already be taking place but could not be detected at the time of the inspection. This may have resulted in concealed timber damage. Does the slab edge inspection zone fully comply? |

Not able to comment. A very high proportion of termite attacks are over the edge of both Infill and other concrete slabs types. Covering the edge of a concrete slab makes concealed termite entry easy. Infill slab type construction has an even higher risk of concealed termite ingress as the slab edge is concealed due to the construction design and cannot be exposed. The type of slab may only be determined by assessment of the construction plans by a qualified person e.g. Builder, Architect. Construction Plans may be obtainable by your local Council or Builder. Termite activity and or damage may be present in concealed timbers of the building. We strongly recommend frequent regular inspections in accordance with AS 3660.2. Where the slab edge is not fully exposed or the slab is an infill slab or the slab type cannot be determined then we strongly recommend inspections every 3 to 6 months in accordance with AS 3660.2 or AS 4349.3.

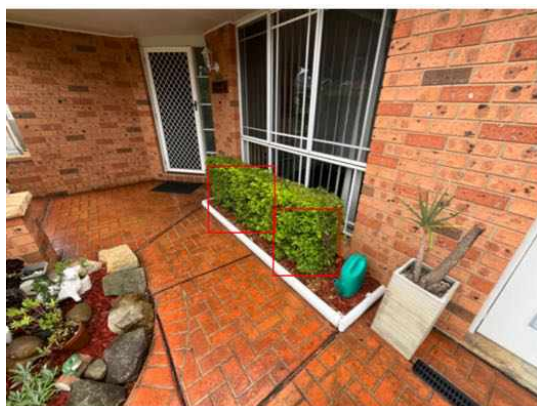
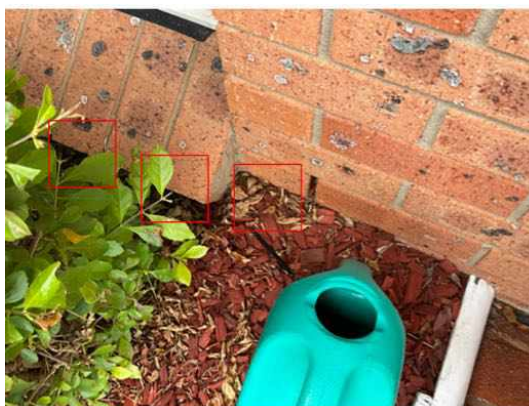
Finding 6.04

Damp proof course (DPC) is a barrier of impervious material built into a wall or pier to prevent moisture from moving to any part of the building. Where external ground levels are built up over this barrier ingress is provided for moisture from the exterior grounds into the base brickwork or other building material and allowed to rise.

Such conditions attract termites into these damp areas which is likely to lead to infestation if left untreated.

While retrospective fitting of DPC is considered to be impractical works are required in order to prevent the extraction of moisture from the external environment into exterior brickwork or wall materials. Landscaping or re-paving of external grounds may be considered by the client. Regular annual inspections are strongly advised.

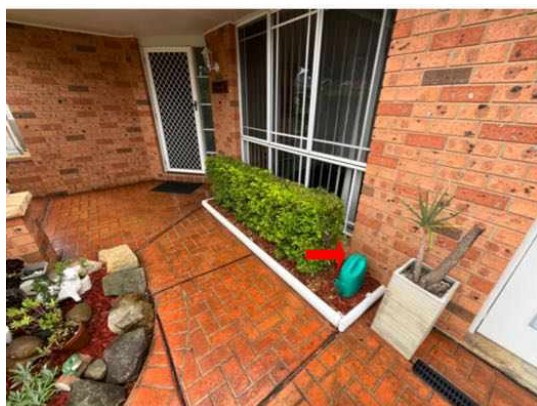
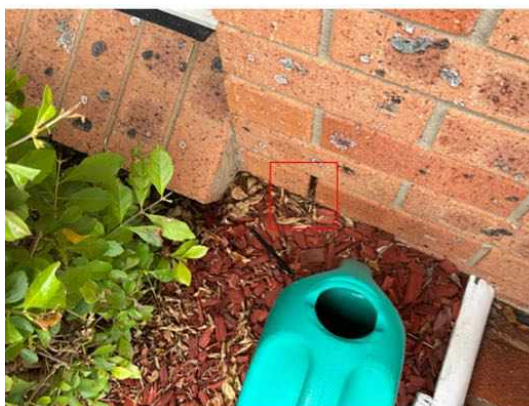
Finding 6.06

Weep holes in the exterior brickwork of the property are designed to allow condensation that may build up between the brickwork and subsequent timber framework to drain from within the wall hence preventing any deterioration of the timber building elements.

Additionally build-up of moisture is likely to occur if weep holes are covered further attracting termite activity to these areas.

It is highly recommended that weep holes are left exposed in all areas throughout the external property. Therefore if any termite activity leading into weep holes becomes easily detectable during frequent pest inspections.

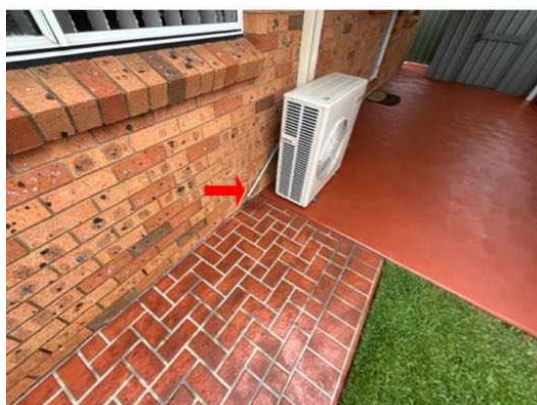
Finding 6.07

Building: Main Building
 Location: Yard - Side
 Finding: Overflow - Not plumbed for drainage
 Information: The overflow is not plumbed or connected to suitable drainage, which can result in the surrounding area becoming excessively damp.

These damp conditions can lead to secondary defects such as rot, rust or corrosion of associated building elements, the formation of fungal decay, or even the creation of potential slip hazards. When coupled with poor site drainage, pooling of water may also attract termite activity to this area.

It is highly recommended that a licensed plumber be appointed to install adequate drainage to the overflow. These works will ensure that the area remains dry and free of any secondary defects.

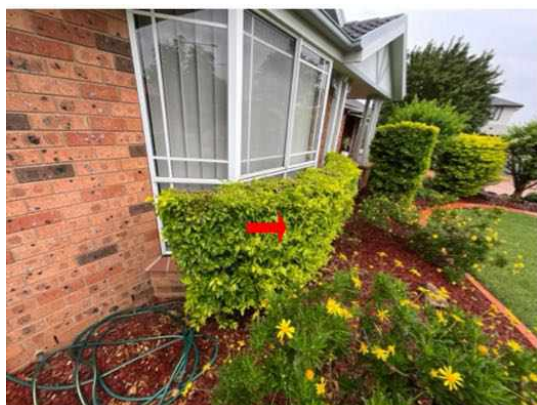
| Finding: | Vegetation - Abutting property |
| Information: | Vegetation against external wall may have an invasive root system. If there are weak points in the brick work or concrete slab, it is possible for the roots to gain entry into these areas. Once the roots have gained entry, it is possible for termites to gain concealed entry via these roots. It is recommended to remove the vegetation and root system where possible. |

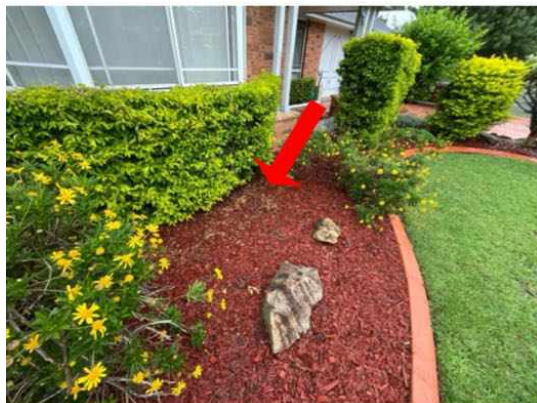
Finding 6.10

| Finding: | Garden Beds |
| Information: | Garden beds were found to be evident in the garden area. These garden beds can include untreated timber, and with a combination of moisture from watering hosing can make conditions conducive to termite activity and termite ingress. |

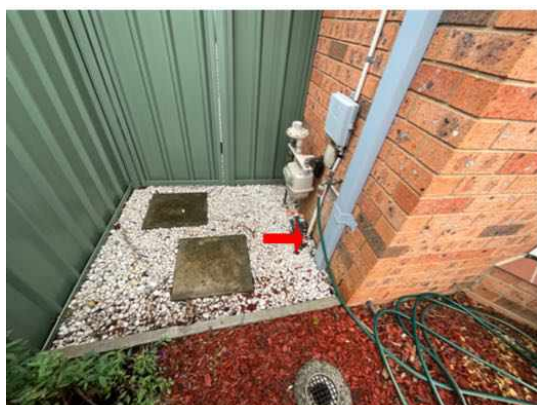
Finding 6.11

Building: Main Building
 Location: External tap
 Finding: Tap - No drain
 Information: The external tap in this area was noted to have no drain at the time of inspection.

This keeps the surrounding surfaces damp while using the tap, which becomes conducive to termite activity.

A licensed plumber must be appointed to ensure an appropriate drain is installed.

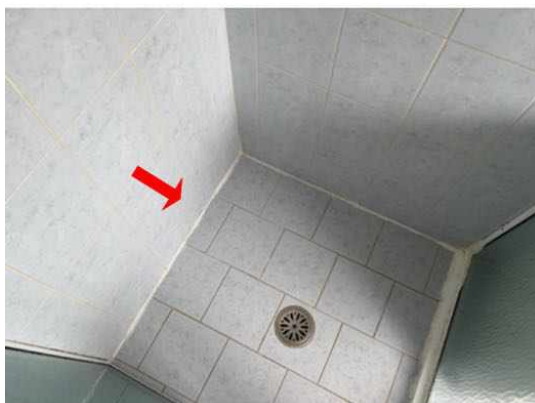
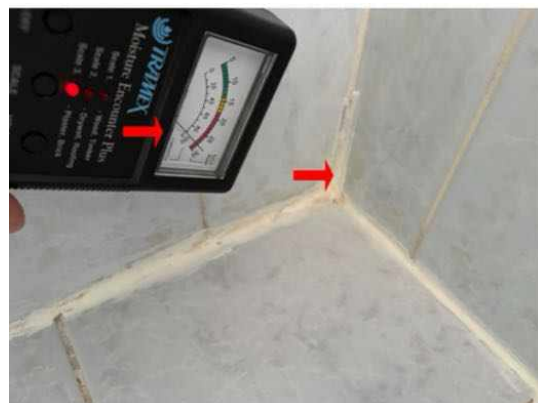
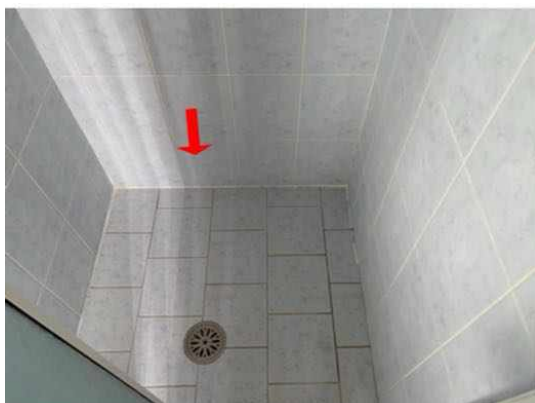
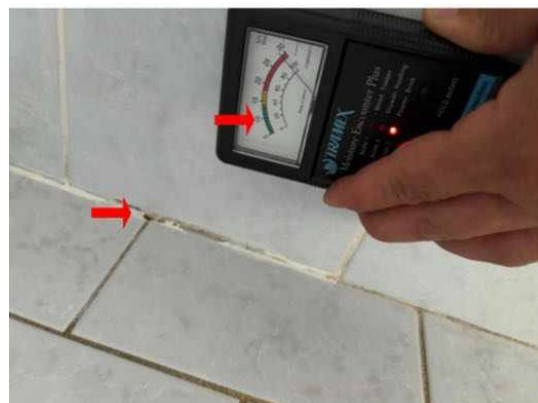
Finding 6.12

Building: Main Building
 Location: Bathroom, ensuite
 Finding: Shower damp - Sealant and grout
 Information: Damp is evident to the lower 400mm of wall to the shower alcove. This defect is quite common, and is suspected to have been caused by moisture permeating or leaching through the grouting and sealant in this area, which shows evidence of deterioration. Leaking pipes within the wall is also a possible cause however this seems unlikely in this instance as there is no moisture build up around the taps or transferring to the other side of the wall. There appears to be no sealant around the tap spindles which

Damp (or structural damp) refers to the presence of unwanted moisture in the structure of a building, either as the result of intrusion from outside, or condensation from within the structure. In the shower area, internal water leaks, degraded materials or other sources of excessive moisture are generally the cause of damp.

Unmanaged damp in the shower recess is likely to facilitate the formation and development of mould and fungi growth, decaying associated building materials and compromising their structural integrity of associated elements. It is important to address damp conditions, as the World Health Organisation notes that excess moisture leads - on almost all indoor materials - to growth of microbes such as moulds, fungi and bacteria, which subsequently emit spores and other matter into the indoor air. Exposure to these contaminants is associated with a wide range of respiratory and other health-related problems. Damp conditions also create a conducive environment for termite infestation.

Consultation with a bathroom sealant specialist is advised immediately to identify the cause of damp and to perform remedial works as required.

Always ensure that sealant and grout is in good condition to prevent any moisture issues occurring in the future.
