# Building and Timber Pest Inspection Report

Inspection Date: Wed, 14 Jan 2026

Property Address: 10 Briarwood Avenue, Glenmore Park NSW  
2745

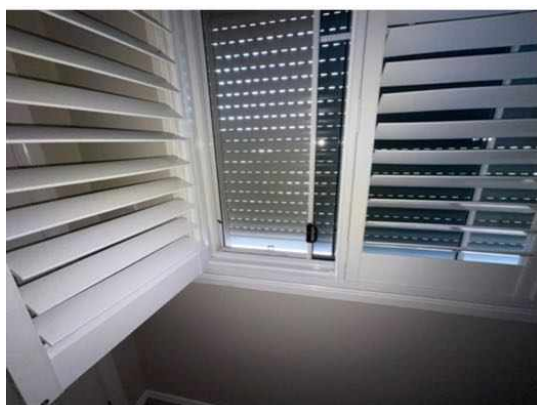
Building:	Main Building
Location:	All Areas > Upstairs
Finding:	Caution: Missing Window Restriction Devices.
Information:	Please note that this is highlighted as a caution only.

It has been noted that window restriction devices are either missing or not installed on the affected windows.

#### Recommendation

It is strongly recommended that window restrictors be installed to mitigate this safety hazard. A qualified window specialist should be appointed to fit the appropriate safety devices as soon as possible to comply with safety standards and ensure the protection of occupants.

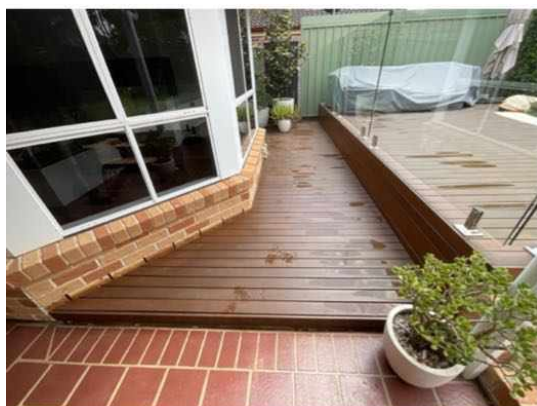
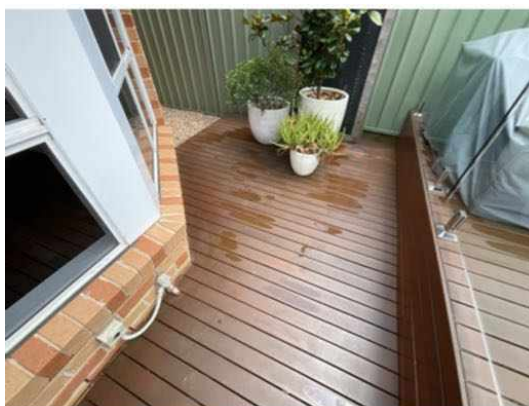
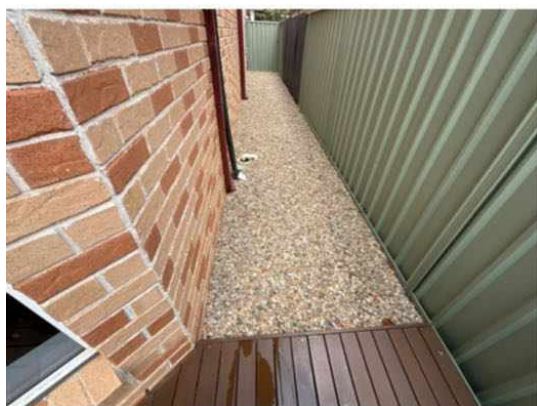
Building:	Yard
Location:	Yard - Left Side & Rear
Finding:	Site/Yard Drainage – Further investigation recommended.
Information:	Observation: Potential Drainage Issue Beneath Deck

The ground level directly beneath the deck, which is attached to the house perimeter, appears to be lower than the surrounding yard. This creates a natural depression where stormwater may pool if adequate sub-deck drainage is not provided. Given the reduced visibility and lack of access beneath the deck, the assessment relies partly on information supplied by the vendor. The concealed nature of this area prevents full confirmation of existing drainage conditions. Additionally no surface drainage was noted on the left side of the house.

A low-lying sub-deck area without effective drainage can trap moisture, leading to persistent dampness, soft or unstable soil, and potential water ingress to adjacent building elements. Prolonged pooling can also contribute to timber deterioration, attract pests, and create ideal conditions for mould or fungal growth. If unchecked, long-term moisture build-up may impact the durability of the deck structure or nearby foundations.

### Recommendation

Monitor the area during periods of rain to determine whether water is collecting beneath the deck. If ponding is observed, consult a licensed drainage plumber to assess the site and install appropriate measures such as sub-surface drainage, spoon drains, or regrading to redirect stormwater away from the deck perimeter. Ensuring consistent drainage will reduce moisture-related risks and support long-term structural performance.

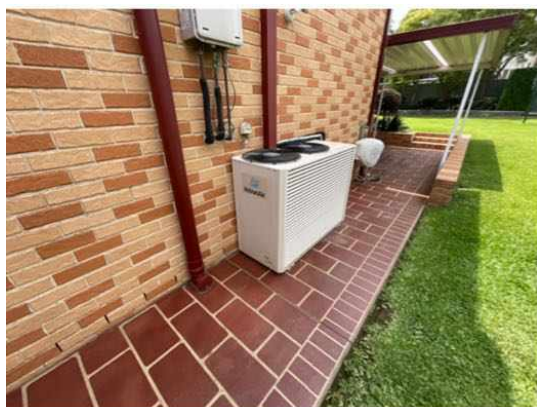
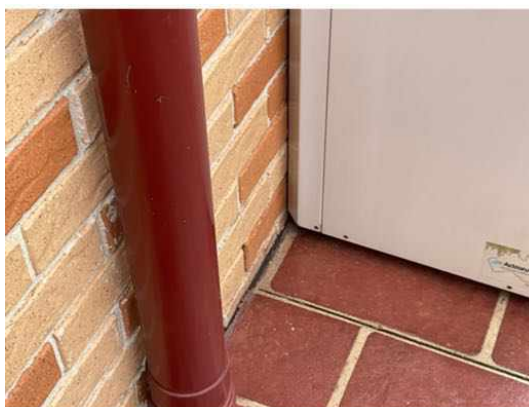
Defect Type: Restricted Access / Concealed Entry Risk

An air conditioning unit is positioned in close proximity to the external wall, obstructing visual access to the wall surface and/or weep holes in this location.

- Obstructions such as this limit the ability to detect evidence of termite activity or conditions conducive to infestation.
- Termites may enter a structure in a concealed or undetectable manner, particularly where weep holes are blocked or not visible, allowing them to bridge physical barriers unnoticed.

Recommendation:

- It is recommended that the A/C unit or associated obstruction be moved to allow a clear inspection of the wall and weep holes.
- A re-inspection should be carried out once access is available.
- It is also recommended that external walls remain clear of obstructions for ongoing periodical termite inspections, in accordance with best practice.

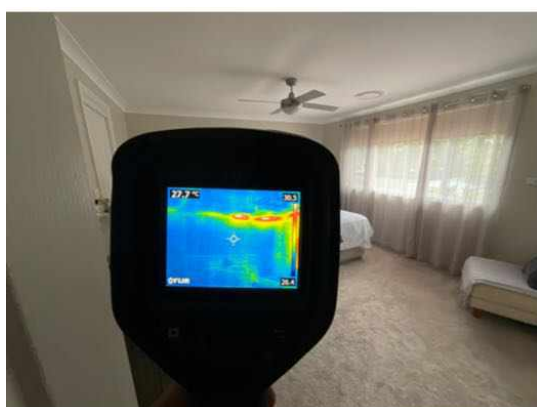
Termites release heat in the form of carbon dioxide and build mud tubes with high moisture content, which can create irregular heat patterns on surfaces such as walls, ceilings, and floors.

At the time of the inspection, no abnormalities indicating live termite activity were observed. However, it's important to note that various factors—such as obstructions, ambient temperature, and wall material/thickness—can impact the accuracy of thermal readings. In cases where surfaces are visually restricted or obstructed, a comprehensive thermal scan may not always be feasible.

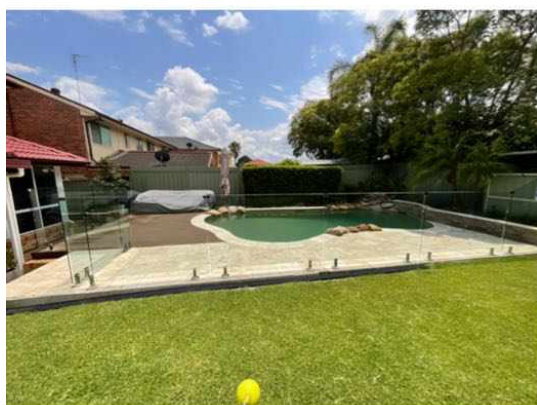
Building:	Yard
Location:	Pool Area
Finding:	Swimming Pool – Excluded from Standard Building Inspection.

Recommendation:

- The structural condition and interior finish of the pool
- Fencing and safety barriers (including compliance with local council and legislative requirements)
- The operation and condition of pool equipment, including pumps, filters, and heating systems
- The condition of pool surrounds, paving, and drainage systems

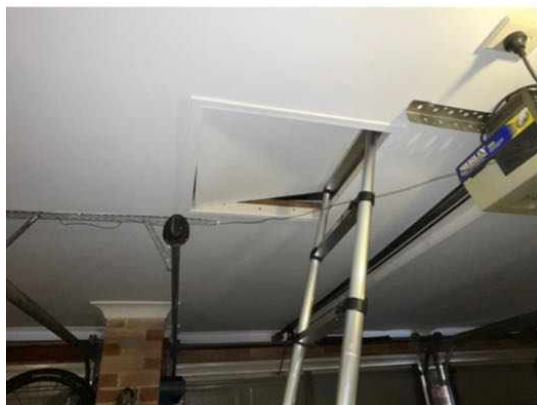
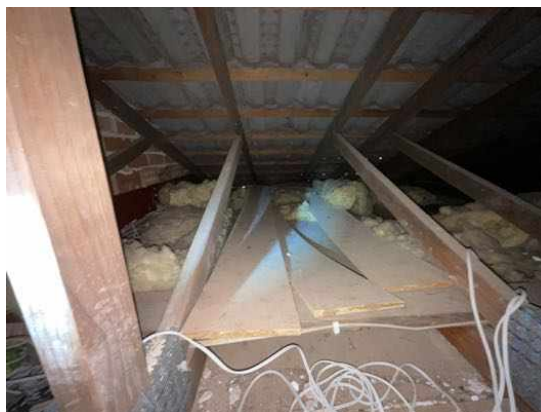
Building: Main Building  
Location: Roof Void  
Finding: Roof Void – Limited Accessibility..  
Information: Observation:

Recommendation:

Installation of an additional manhole is recommended to facilitate a re-inspection and enable a more thorough assessment of the roof void in the future. This will help ensure that all structural elements and concealed areas are properly evaluated.

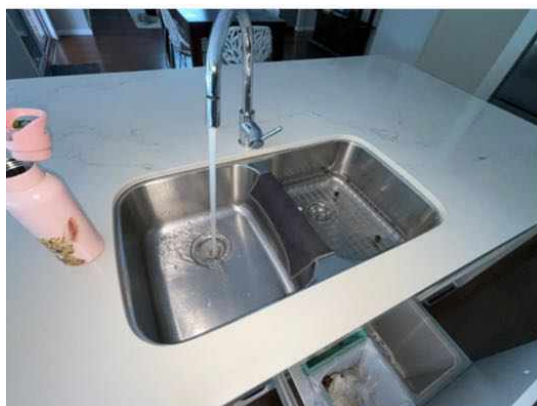
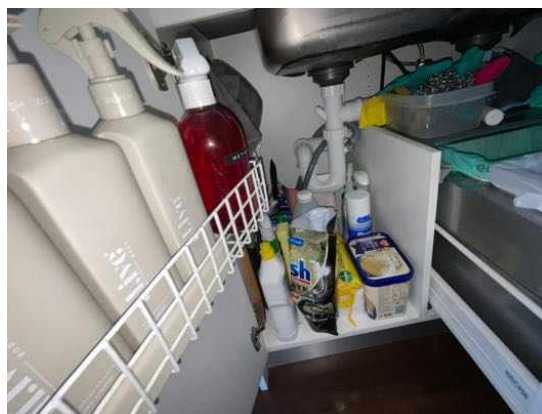
Building: Main Building  
 Location: Kitchen  
 Finding: Kitchen Sink – Overall Condition & Recommendations.  
 Information: Observations:

Recommendations:

- Further monitoring and testing are recommended once the tap(s) are in constant use, to identify any drainage issues or signs of slow leaks not evident during the limited inspection.
- It is recommended that the stored items beneath the sink be removed to allow for a full re-inspection of the plumbing and cabinetry, ensuring no concealed defects are present.

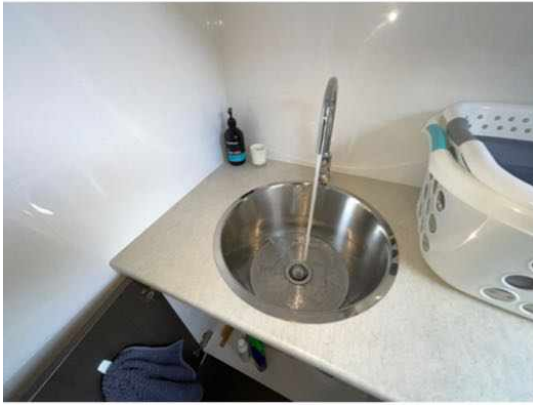
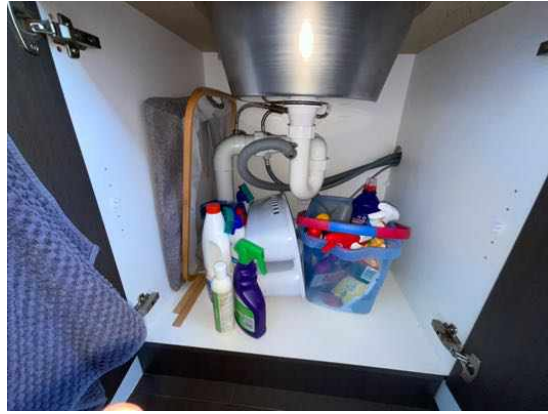
Building: Main Building  
 Location: Laundry  
 Finding: Laundry - Taps/Plumbing/Drainage.  
 Information: Observation: Laundry Tub – Taps, Plumbing, and Cabinetry

### Recommendations:

- Further monitoring or testing is recommended once the taps are placed into regular use, to ensure no leaks develop over time and that the drainage system continues to perform adequately.
- Flexible and mould-resistant sealant should be applied to junctions between the basin and the wall to prevent water ingress that may lead to damage.
- Sealant and grouting in wet areas should be maintained as part of the long-term care and upkeep of the property.

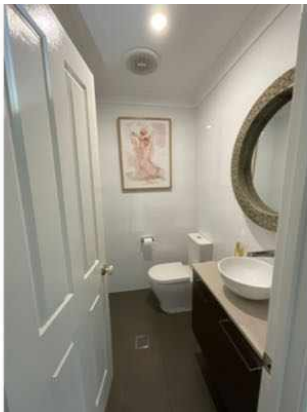
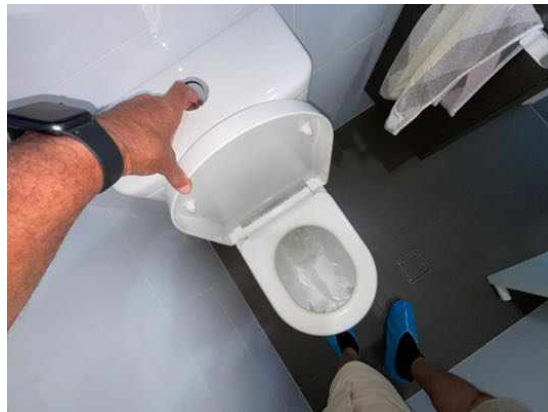
Building: Main Building  
 Location: Toilet (WC)  
 Finding: Overall Condition: Toilet.  
 Information: TOILET ASSESSMENT

Toilet:

- No leaks were observed during the flushing process.
- The toilet operated normally with no signs of malfunction or abnormal water flow.
- The toilet pan was securely fixed to the floor at the time of inspection.
- The exhaust fan appeared to be operational, which is a requirement as there is no other source of external ventilation such as a window.

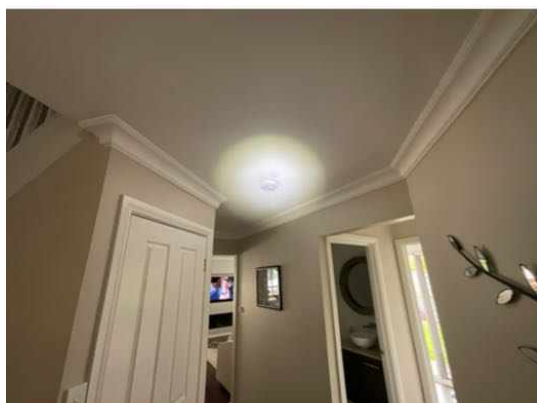
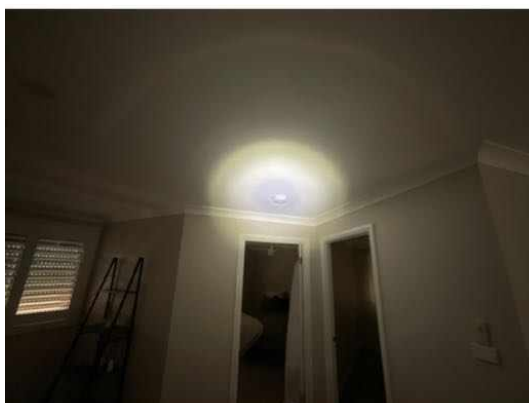
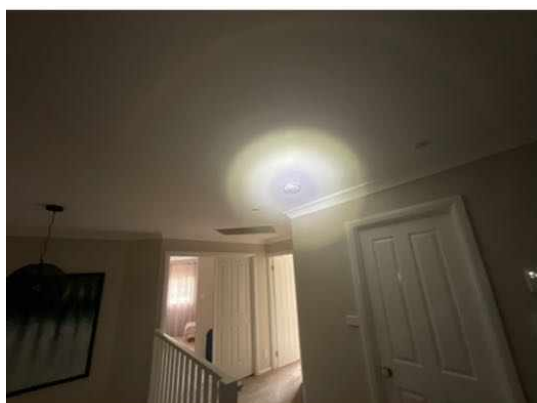
Building: Main Building  
Location: All Areas  
Finding: Smoke Detectors / Alarms.

- All smoke detectors be tested monthly by the homeowner.
- All systems comply with the requirements of AS 3786 and any applicable state-based legislation.
