Building and Timber Pest Inspection Report

Inspection Date: Thu, 22 Jan 2026

Property Address: 48-52 Darley St, Newtown NSW 2042,
Australia

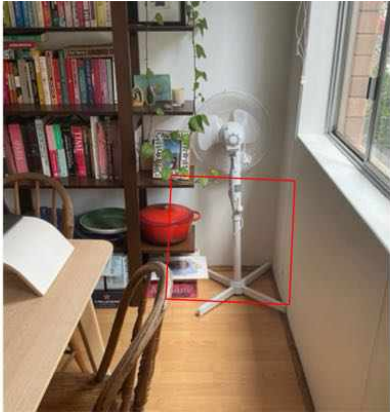
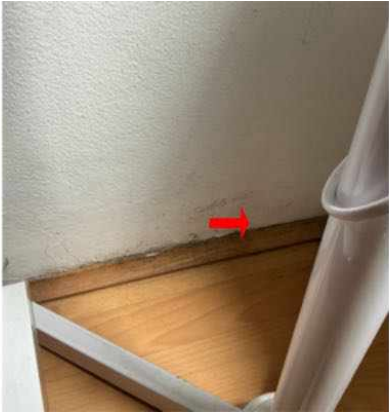
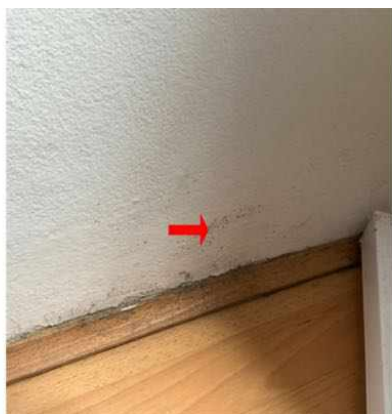
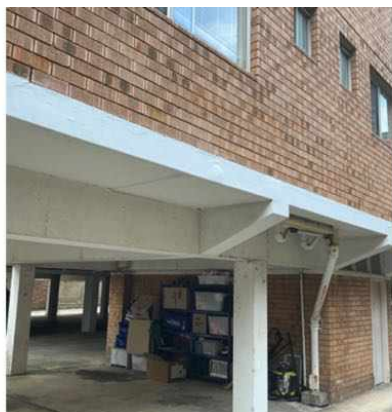
Finding 3.02

Building: Main Building
Location: Dining Room
Finding: Elevated Moisture & Minor Deterioration
Information: Minor deterioration was observed with visible minor deterioration and elevated moisture, the elevated moisture level indicates a risk of ongoing deterioration if the source of moisture ingress is not rectified. Further investigation by a strata appointed remedial builder or licensed plumber is highly recommended to further access and rectify if required.

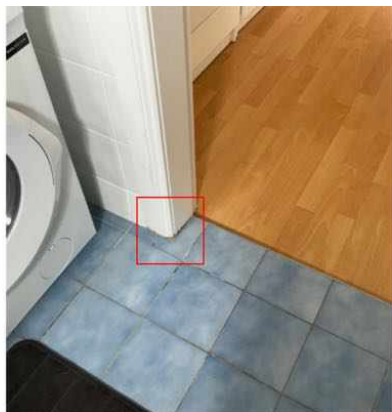
Finding 3.03

Building:	Main Building
Location:	All Internal Areas - Bathroom
Finding:	Wet-Area Door Jambs – Moisture Staining / Decay
Information:	Minor moisture staining and early signs of deterioration were observed at the base of the wet-area door jamb and architraves. This is commonly due to water splashing or moisture tracking from the bathroom floor into adjacent joinery. At the time of inspection, the condition appears superficial and non-structural, consistent with general wear typical of wet-area use.

It is recommended that the door junctions be resealed with a suitable moisture-resistant sealant and that ventilation and drainage within the bathroom be maintained to reduce further dampness. Where timber swelling or decay has progressed, localised repair or replacement using moisture-resistant materials (H3-treated or equivalent) should be undertaken.

For information only — further inspection by a licensed carpenter or waterproofing contractor is recommended to confirm the extent of deterioration and verify whether remedial sealing or minor replacement works are warranted.

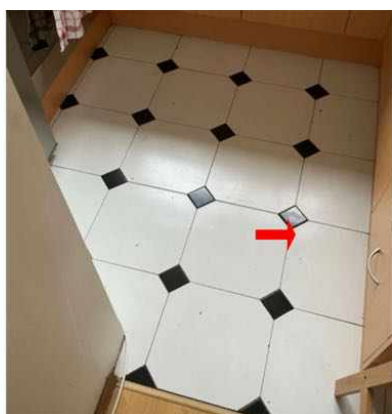
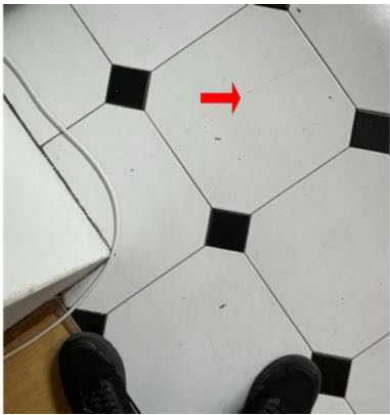
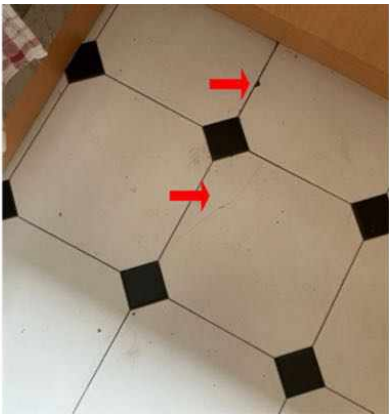
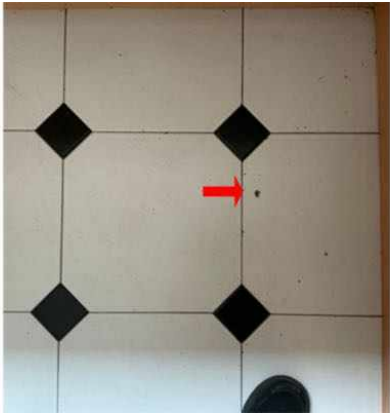
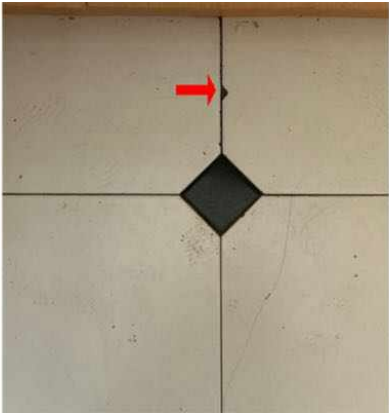
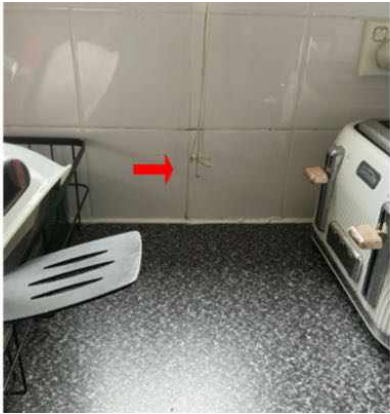
Finding 3.04

Building:	Main Building
Location:	All Internal Areas - Kitchen, bathroom
Finding:	Tiles - Cracked or damaged
Information:	Cracking was evident to the tiling in this area at the time of inspection. While the cracking appears to be minor, this area is frequently exposed to water, allowing potential for water penetration into adjoining sections of walls or flooring.

If left unmanaged, water penetration to these areas may lead to subsequent water damage, which is likely necessitate repair work to affected building elements.

A tiling contractor should be appointed to ensure that no further water damage occurs. The re-application of silicone and grouting throughout remaining tile work is also advised, to further protect the area against water penetration.

Where water penetration has led to water damage, appointment of a relevant tradesperson may be required to repair damaged building elements.

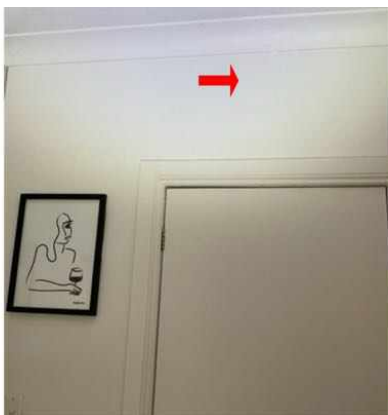
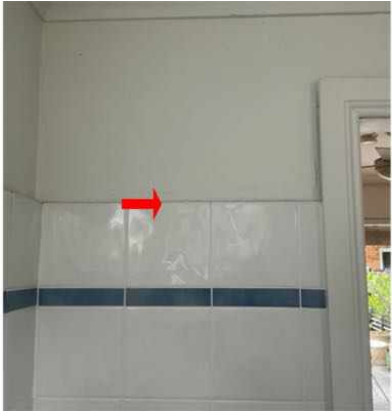
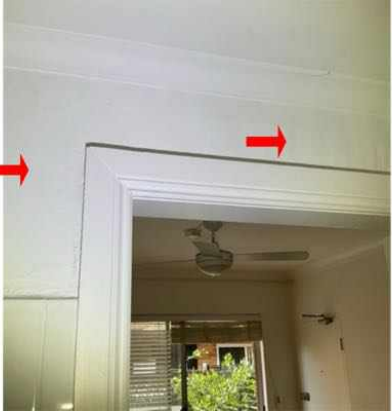
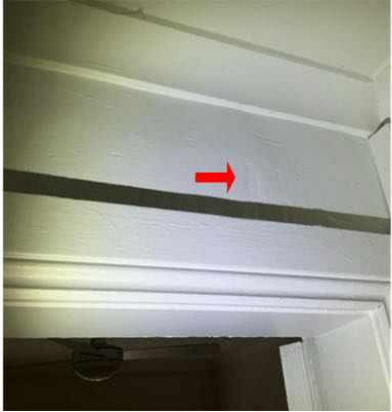
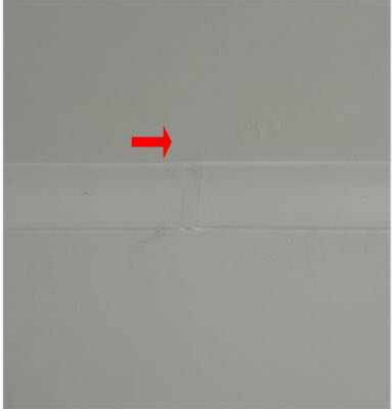
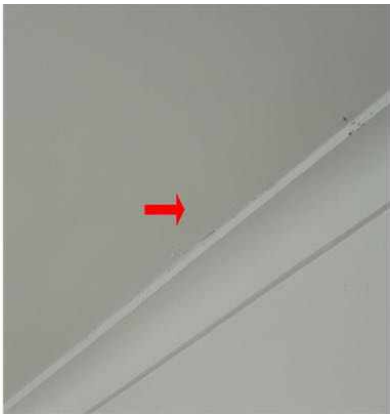
Finding 3.05

Building:	Main Building
Location:	All Internal Areas
Finding:	Paint finish and hairline cracking
Information:	The paint finish in this area was identified as being incomplete at the time of inspection including some hairline minor cracking.

Whilst incomplete or missing paint finish is generally an appearance defect, it can also lead to the development of secondary building defects over time. Incomplete areas of paint finish expose the area to moisture, potentially accelerating the deterioration of underlying building materials.

Incomplete paint finishes should be sanded back, filled, leveled and painted, as applicable. Where inadequate or missing paint protection has led to the deterioration of the associated building element, repair and/or replacement of this building element may be required.

A painting contractor should be appointed as soon as possible to perform necessary works to aid the appearance of the affected area and to ensure the area is protected against further deterioration. Alternatively, the homeowner following manufacturer instructions may perform these works.

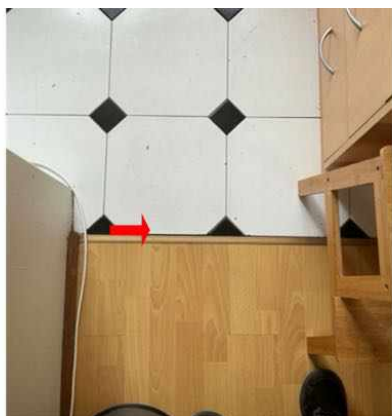
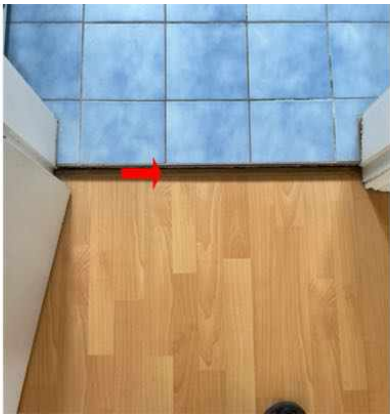
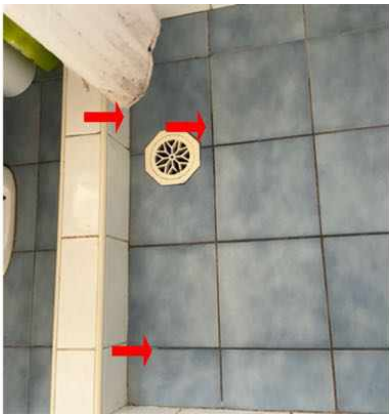
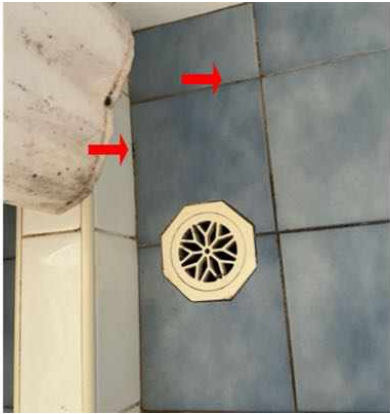
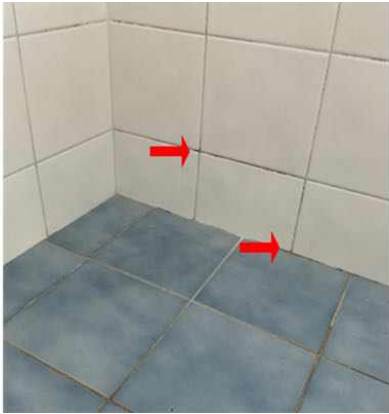
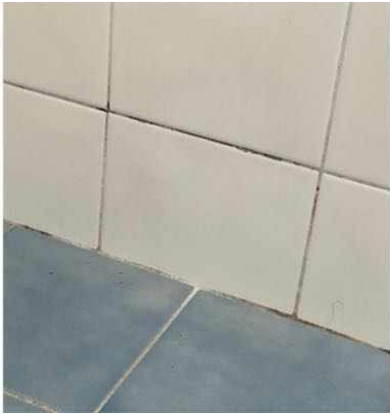
Finding 3.06

Building: Main Building
Location: All Internal Areas
Finding: Sealant and grouting - Missing or degraded
Information: It was noted on inspection that sealant or grout is degraded. There is also evidence of poor workmanship and excessive use of sealant. Silicone should never be used as a first line of defence against waterproofing. Further inspection by a licensed waterproofing contractor is highly recommended.

Different materials and floor areas move at different rates, generally causing cracking to grout or sealant at this point. A flexible sealant is required to allow for expected expansion and contraction, while keeping the joint water tight and protective of all associated building materials.

There appears to be excessive mould to the sealant and grout which will likely require scraping out and replacement.

Flexible and mould resistant materials should be applied to affected areas to prevent any subsequent water damage that is likely to occur. Regular maintenance and replacement of damage or missing or damaged sealant and grout is highly recommended to the wet areas, as this is a regular wear and tear defect. Sealant and grouting in areas that come into regular contact with water should be maintained for the long term care of your property.

A sealant specialist or tiling contractor should be appointed to complete these works as soon as possible.

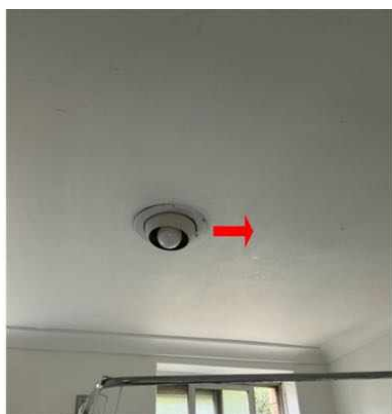
Finding 3.07

Building:	Main Building
Location:	Bathroom
Finding:	Water Staining - Humidity or Ventilation
Information:	The ceiling surface shows peeling paint and water staining on the walls faint commonly consistent with humidity-related staining, often found in bathroom or wet areas with insufficient ventilation. While there is no visible sagging or major water damage, the pattern suggests prolonged moisture exposure, possibly due to steam accumulation or minor condensation issues. According to AS 4349.1–2007 (Appendix C), this would be classified as a minor defect unless further deterioration or active leaks are found. Recommend improving mechanical or natural ventilation, cleaning the surface with mould treatment, and monitoring for recurrence.

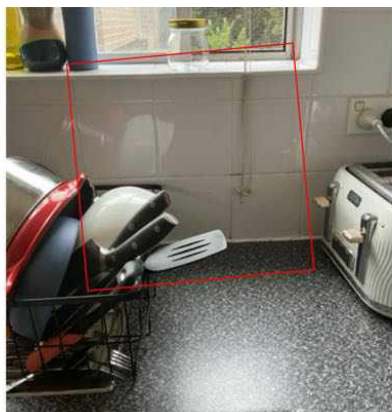
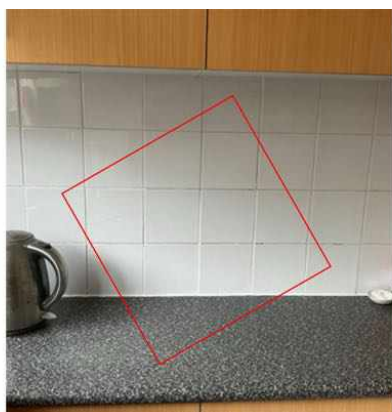
Finding 3.08

Building:	Main Building
Location:	All Internal Areas - Kitchen
Finding:	Tiles - Drummy
Information:	Drummy tiled areas were identified at the time of inspection. The term 'drummy' refers to tiles that have become detached from their fixing, despite otherwise being in relatively good condition. Such defects are generally caused by physical or moisture damage to the area. Drummy tiled areas may also be a direct result of poor workmanship during the construction process.

Tiled areas may swell and shrink with changes in air humidity if the area has sustained moisture damage. Any exposure to moisture is capable of causing tiled areas to become drummy and/or cracked over a prolonged period of time. Drummy tiled areas generally require removal and replacement of affected tiles, with adequate sealant and grouting.

Specialist trades are available for these types of services. A registered builder may be required to undertake works if damage is extensive or if secondary building defects have resulted. Otherwise, it is advised that a tiling contractor be appointed to perform works as necessary. Immediate action is recommended to ensure that no further damage is sustained in the affected area.

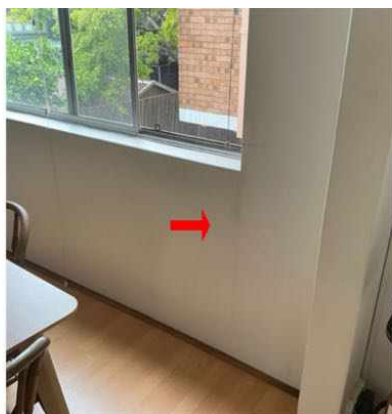
Finding 3.09

Finding: Water staining

Information: Water staining was evident in this area at the time of inspection. Water staining indicates that surfaces have been exposed to excessive moisture over time. The minerals and other elements in the water lead to staining, which may graduate to corrosion and deterioration if left unmanaged.

While mostly an appearance defect, water staining can be indicative of more serious defects, which may be currently concealed by other building elements.

Where water staining is active, a licensed plumber must be consulted to identify the cause of the staining and to provide advice on any reparation works that may be required. Replacement of any broken or damaged structures is advised.

Conversely, where water staining is old and inactive, affected building materials may be repaired or replaced at client discretion. A qualified carpenter or registered builder may be appointed to perform these works.

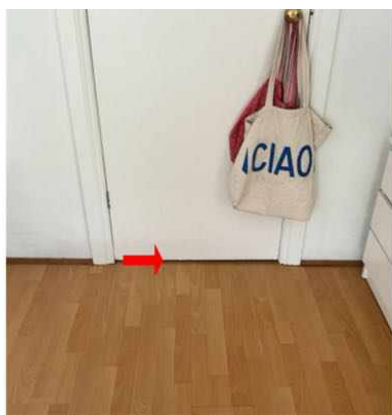
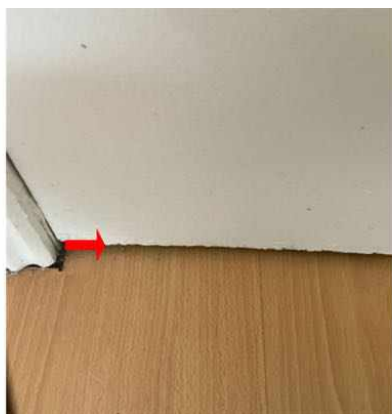
Finding 3.10

Building:	Main Building
Location:	All Internal Areas - Bathroom
Finding:	Delamination of timbers
Information:	Delamination is one means by which composite materials (e.g. layered timber composites) may fail over time. In laminated materials, repeated cyclic stresses may lead to the formation of mini-structures of separate layers, with significant loss of mechanical toughness. Water penetration or the presence of excessive moisture also generally contributes to delamination.

Where building materials have become delaminated, they lose their structural strength, and are likely to have a variety of appearance and serviceability defects as a result.

Delamination of timbers may be repaired where the area affected is minor and/or easily accessible, by gluing and screwing layers back together. However, this is an interim repair, and where delamination has occurred, the client should plan for the replacement of affected timbers sooner than would otherwise be expected.

All timber structures affected by delamination should be replaced as soon as possible to avoid any further damage. Repair and replacement estimates should be sought from a registered builder or qualified carpenter.

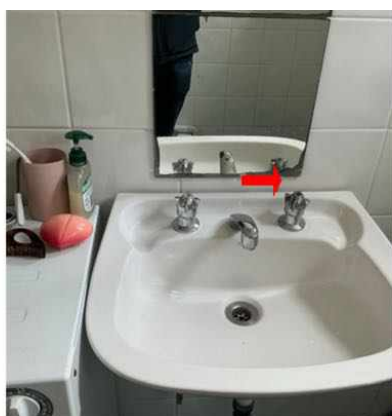
Finding 3.11

Building:	Main Building
Location:	All Internal Areas
Finding:	Mirror Desilvering at Bathroom Vanity
Information:	Desilvering is evident along the bottom edge of the bathroom mirror above the vanity unit. This defect is located in the main bathroom and presents as brown-black deterioration of the reflective backing of the mirror. The desilvering is likely caused by prolonged exposure to moisture or water splashes from the basin below. This issue is considered a minor defect under AS 4349.1, affecting aesthetic appearance rather than function, and may worsen over time if left unaddressed. A licensed bathroom contractor or glazier should replace the mirror, and adequate sealing or ventilation should be ensured to prevent recurrence.

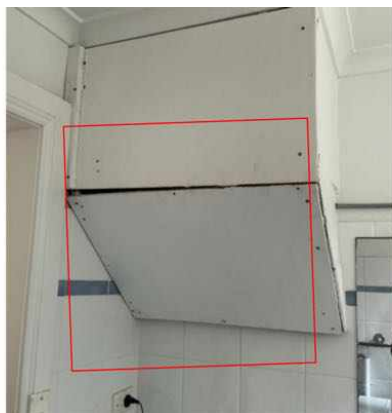
Finding 3.12

Building:	Main Building
Location:	Bathroom
Finding:	Installation - substandard or incomplete - Poor Finish and alignment
Information:	The installation of this building element appears to have been completed to a substandard level of workmanship or is incomplete. Generally substandard repairs or installation are related to poor workmanship, the use of inappropriate materials, or a failure to complete installation to a suitable standard.

Where installation is substandard and/or incomplete, the client should contact the responsible trade to undertake rectification. Unfinished and substandard building works are likely to degrade more quickly and may create potential for secondary defects to associated building elements.

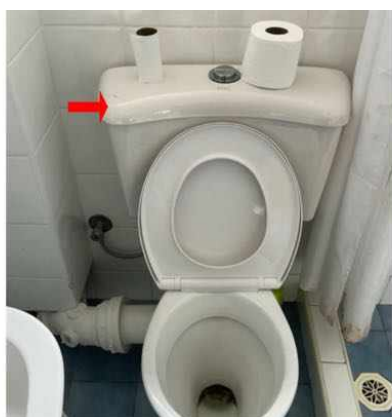
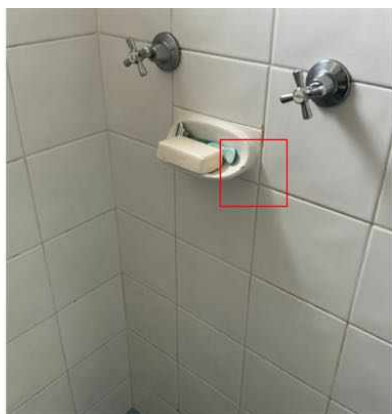
Finding 3.13

Building:	Main Building
Location:	Bathroom
Finding:	Building element - Damaged - Cistern cracked , soap holder chipped
Information:	Breakage occurs generally when the building materials have either aged and decayed, or as a result of damage (accidental or deliberate).

Repair and/or replacement of broken elements is advised to ensure that additional secondary defects do not arise as a consequence. Such works are necessary, as all building elements play a key role in the operation and function of the overall structure and its performance.

A relevant tradesperson should be appointed to repair or replace the affected building element prior to any subsequent damage being caused.

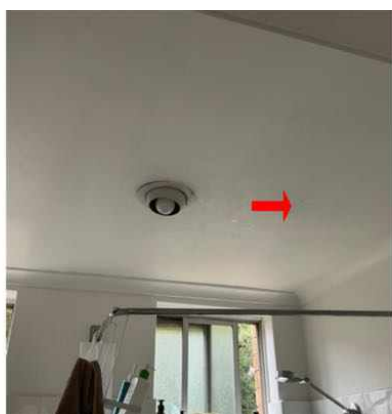
Finding 3.14

Building: Main Building
 Location: Bathroom,
 Finding: Ceiling nails - Popping
 Information: Numerous popped nails were identified in the internal ceiling at the time of inspection. Nails and screws hold simply by the friction between them and the surface they are applied to. Over time, the nails and screws can back out, which is often a result of general ageing and deterioration of the building structure.

If left unmanaged, the ceiling sheets may become loose and unstable, increasing the rate of deterioration of the internal ceiling and creating potential for the development of secondary defects.

Re-fastening of popped nails will help to maintain the stability of the internal ceiling and associated building elements. Such minor works will also help to improve the appearance of the affected area and secure the ceiling sheets, so as to prevent the onset of ceiling sagging. These works should be performed by a qualified carpenter or plasterer at client discretion.

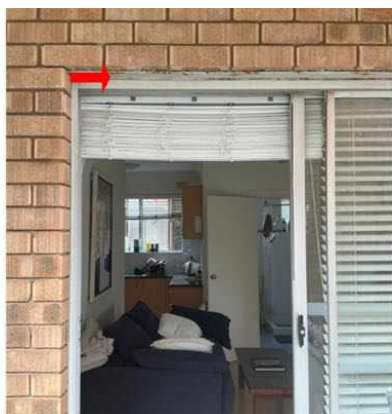
Finding 3.15

Finding: Building element - Rusted or corroded
 Information: This building element shows evidence of rusting and corrosion, which is likely to have developed as a result of excessive exposure to moisture and or inadequate coatings.

As surface rust provides no protection to the underlying iron, the deteriorating condition is likely to worsen if not addressed in the short-term future.

Where possible, the use of galvanized (treated) metals or aluminium coated metals aid in rust prevention, as does regular general maintenance. Rust formation can be controlled with coatings, such as paint, that isolate the iron from the environment.

Rusting and corrosion should be managed by ideally removing or limiting the affected surface from exposure to moisture. A registered builder may be appointed to replace any building elements that have been severely affected by rust or water damage.

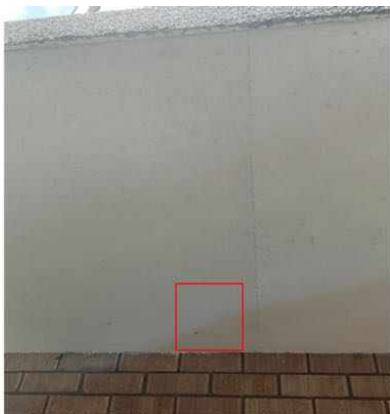
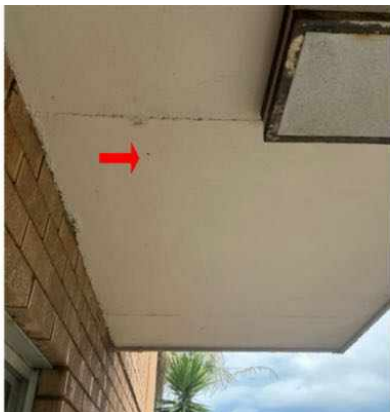
Finding 3.16

Building: Main Building
 Location: Balcony
 Finding: Rust Staining
 Information: The marks appear consistent with historic screw penetrations and/or minor rust staining through paint. No symptoms of concrete spalling was observed. Recommend the Owners Corporation engage a painter or remedial contractor to seal any exposed steel and apply an appropriate external-grade coating during routine maintenance. If moisture staining worsens or cracking develops, further investigation by a remedial engineer is advisable.

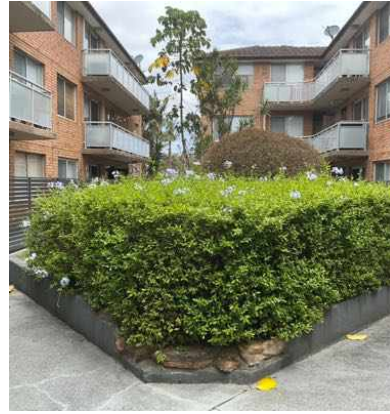
Finding 6.01

Building: Main Building
Location: All External Areas
Finding: Trees within 50m
Information: Trees within 50m of the property can be conducive to termite activity. It is recommended an invasive inspection of all trees with 50m to the property be carried out by a qualified pest control expert.
