Building and Timber Pest Inspection Report

Inspection Date: Fri, 6 Feb 2026

Property Address: 54 Brigantine Dr, Shell Cove NSW 2529,
Australia

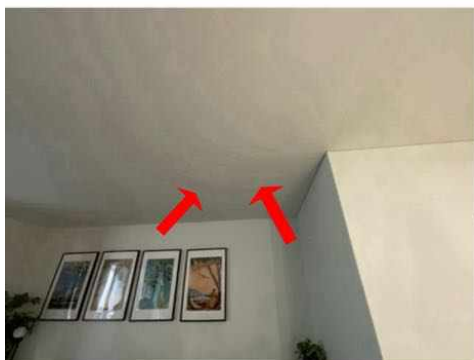
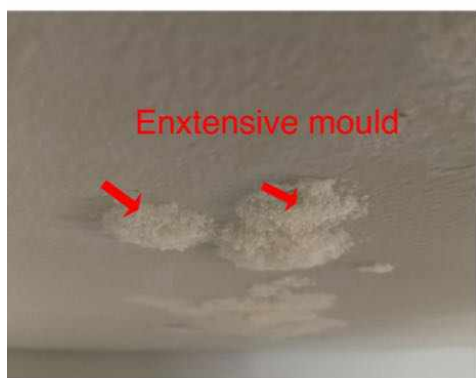
Finding 2.01

Building:	Building 1
Location:	Lounge Room - Sw corner under upstairs shower / toilet
Finding:	Evidence of excessive moisture and mould was present at the time of inspection
Information:	Excessive moisture was found in the downstairs loungeroom. A reading of 52.2 shows an active water leak. This can attract termites and produce conditions that promote termite attack, fungal growth and wood decay. Excessive moisture appears to be caused by a damaged waterproofing membrane in the above bathroom. It is highly recommended to get a licensed plumber or sealant specialist to pressure test the above bathroom to start to locate the leak, and get quotes for repair before purchase. Repairs could be very costly.

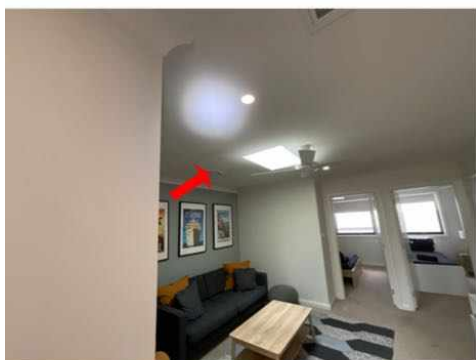
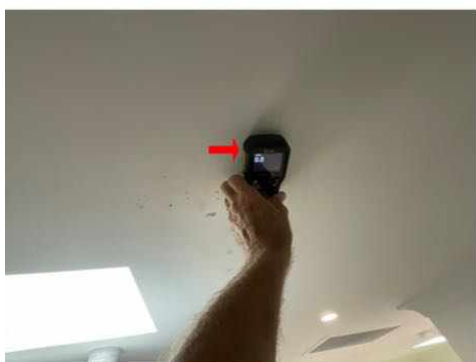
Finding 3.01

Building:	Building 1
Location:	Lounge Room 2 upstairs
Finding:	Ceiling - Water stained and mouldy.
Information:	<p>Water staining to ceiling linings in this skylight area was evident at the time of inspection. Water staining indicates that surfaces have been exposed to excessive moisture over time. The minerals and other elements in the water lead to staining, which may graduate to corrosion and deterioration if left unmanaged.</p> <p>While mostly an appearance defect, water staining can be indicative of more serious defects, which may be currently concealed by interior ceilings.</p> <p>Where water staining is active, a licensed roof plumber must be consulted to identify the cause of the staining and to provide advice on any reparation works that may be required. Replacement of any damaged structures is advised.</p> <p>Conversely, where water staining is old and inactive, affected building materials may be repaired or replaced at client discretion.</p> <p>Five moisture readings resulted in no moisture readings found in this area at the time of the inspection.</p>

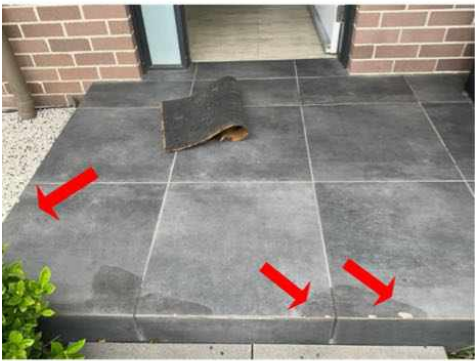
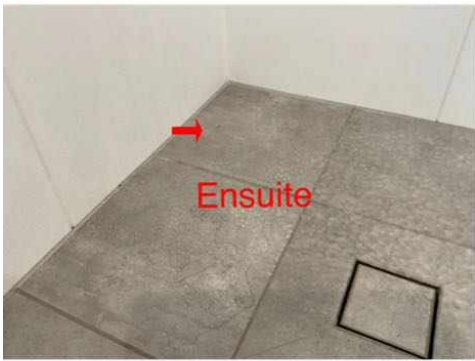
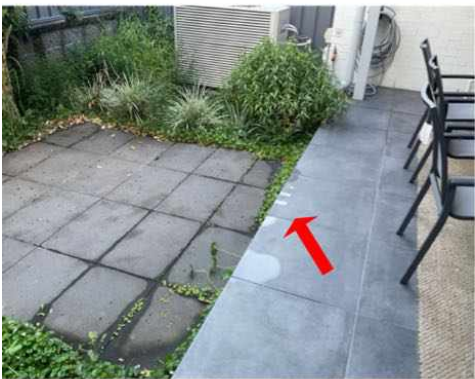
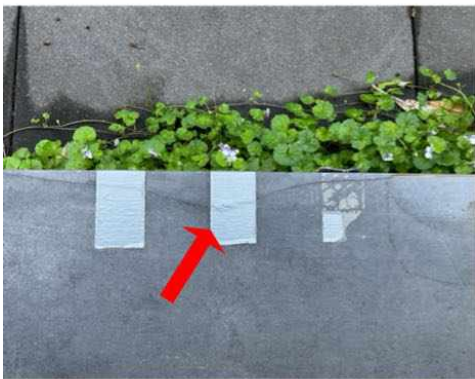
Finding 3.02

Building:	Building 1
Location:	Front & rear verandahs & ensuite
Finding:	Tiles cracked or chipped
Information:	Cracked tiles were evident in these pictured areas at the time of inspection. It is suspected that this cracking has occurred as a result of minor settlement or impact damage.

Cracked tiles throughout the household detract from the overall appearance of the affected areas. In wet areas of kitchens and bathrooms, it can lead to water damage of adjoining walls and floors.

Replacement of cracked tiles is recommended as soon as possible. A tiling contractor may be appointed to perform these works. Where cracks become more numerous, contact a licensed building inspector for further investigation.

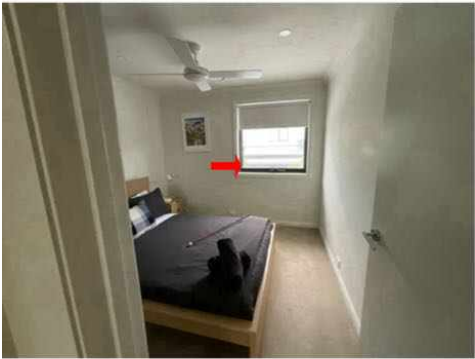
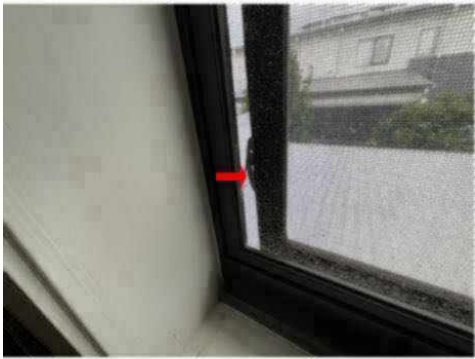
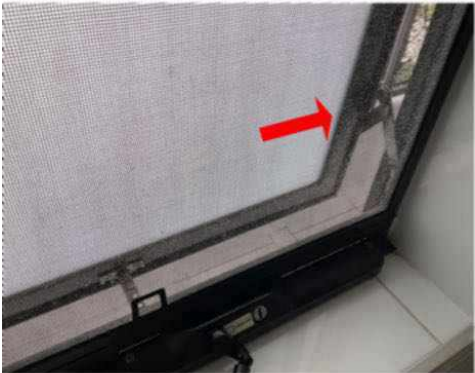
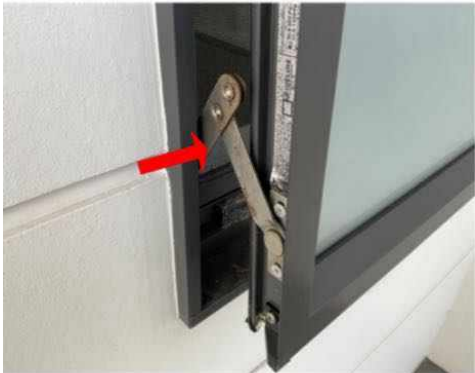
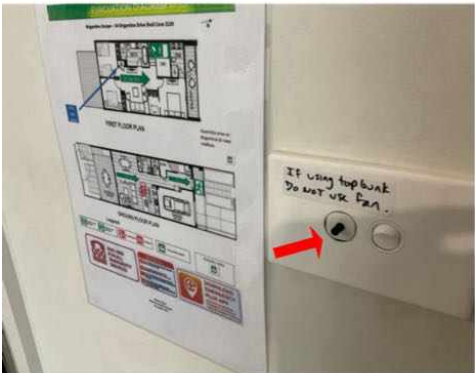
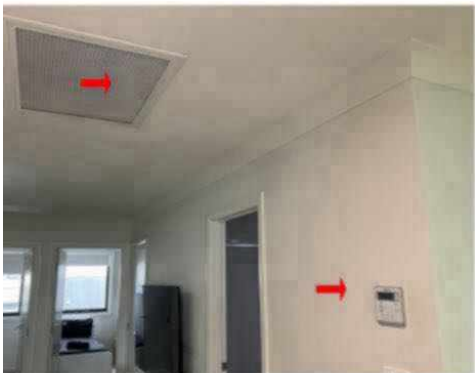
Building:	Building 1
Location:	Pictured areas
Finding:	Building elements - Damaged
Information:	Evidence of minor missing or damaged areas was identified at the time of the inspection. These include -

1. The left rear bedroom and ensuite windows will not close as the hinges are bent. This may allow rainwater in rain and wind events.
2. The right rear bedroom fan is missing the switch dial.

- 3. The AC is slightly noisy on high setting.
- 4. All drains need clearing to prevent blockages.
- 5. The rear AC pipes have minor cover damage.

A carpenter and plumber would be the trades responsible for rectification of these areas when convenient.

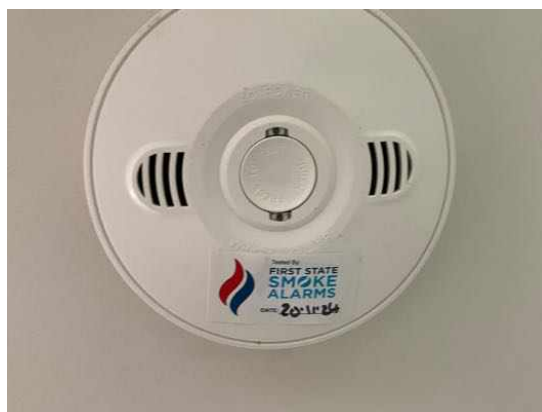
Finding 3.06

Always ensure sufficient working and suitable smoke detectors are installed prior to occupying any building. Additionally, it is advised that all smoke detectors be tested by the homeowner on a monthly basis as this test button on this device did not work.

Further Inspection and/or advisory services is necessary to provide advice on the sufficiency, type and location of smoke detectors, and to test the functionality of all devices. Greater requirements for fire safety and detection exist for commercial buildings.

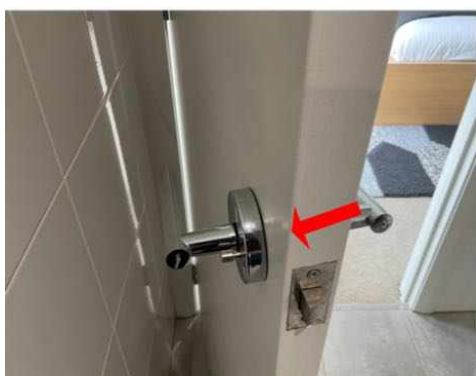
Finding 3.07

Building:	Building 1
Location:	Ensuite - Master
Finding:	Door - loose handle
Information:	The door handle in this area was found to be loose at the time of the inspection. Repair of the broken door handle is advised to improve the operational state of the associated door.

A qualified carpenter or general handyman should be appointed to repair the door handle at the client's discretion.

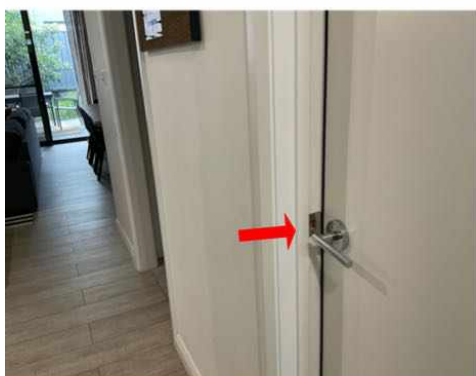
Finding 3.08

Building:	Building 1
Location:	Toilet (WC)
Finding:	Door handle - Not latching
Information:	It was noted that the door in this area was not latching during operation at the time of inspection. Whilst detracting from the functionality of this building element, this minor

defect may also be a security risk, and may therefore have serious implications if left unattended.

It is suspected that this defect has occurred due to minor issues with the associated hinges. Such damage is identified as general wear and tear, which is expected for building elements of this age.

A qualified carpenter or general handyperson may be appointed to perform rectification works as necessary, at client discretion. If left unattended, further functional impairment is likely to occur.

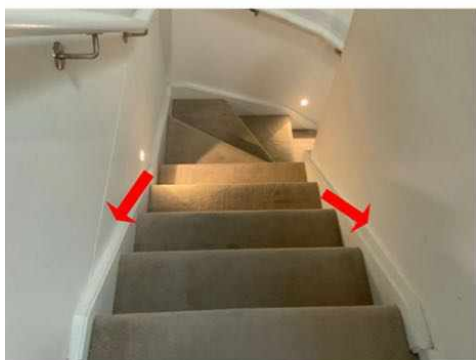
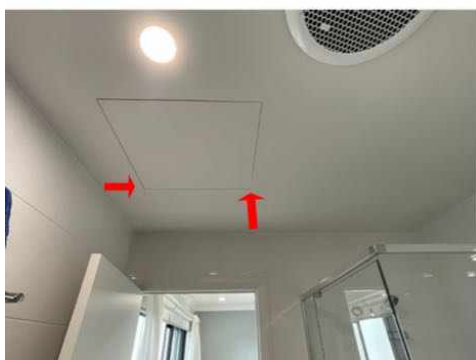
Finding 3.09

Building:	Building 1
Location:	Pictured areas
Finding:	Cracking - Damage Category 1 - Fine (up to 1mm)
Information:	Although fine cracks are quite noticeable, they are often only considered to be an appearance defect, and usually do not indicate any structural damage. Generally, the cause of a fine crack is indicative of a separation between building materials and finishes (e.g. paint, plaster, etc.) along joins.

Cracking of this nature can generally be repaired with minor sanding, filling and/or repainting. Such works should be performed by a qualified painter or a general handyman.

Monitoring of all cracking should be conducted frequently. Always contact a building inspector should cracks widen, lengthen, or become more numerous.

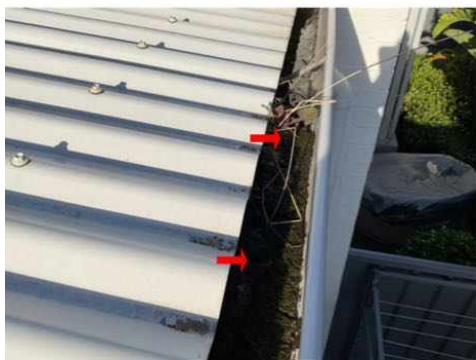
Building:	Building 1
Location:	Roof exterior
Finding:	Gutters - Full and blocked at rear
Information:	The guttering on around the roof was found to be blocked at the time of the inspection. Roof plumbing structures, such as guttering and downpipes, should be free of all debris to prevent blockages. Blockages of the guttering and downpipes will lead to pooling and accumulated water overflows, which is likely to subsequently flood eaves and exterior walls.

Blocked gutters are likely to lead to high levels of moisture in the affected areas which can cause rust and decay of the gutters and downpipes and wood rot to adjoining

timber areas. Blockages in gutters should therefore be removed immediately to ensure dry conditions are maintained.

It is highly advised that gutters be cleaned by the homeowner or a general handy person as a matter of urgency.

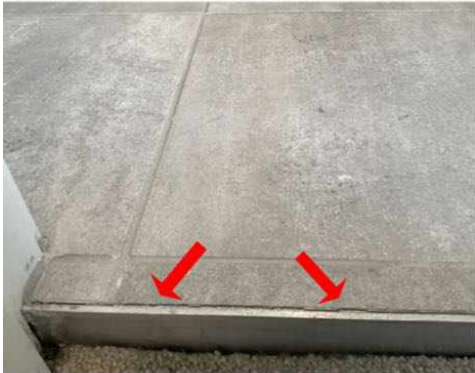
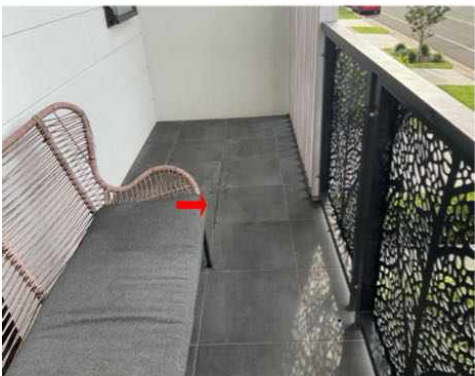
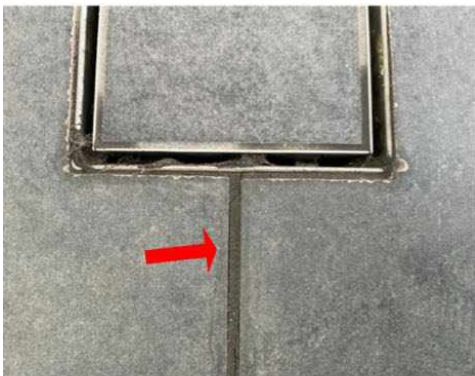
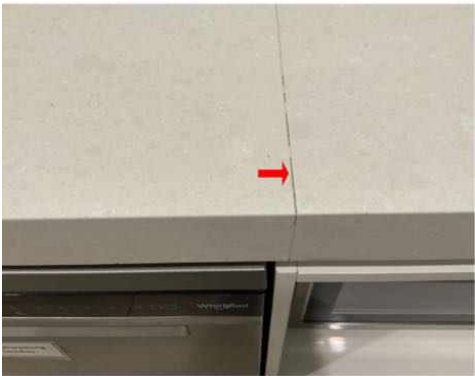
Finding 3.12

Building:	Building 1
Location:	Kitchen & bathroom
Finding:	Sealant and grouting - Missing or damaged
Information:	It was noted on inspection that sealant or grout is degraded to these pictured areas.

Different materials and floor areas move at different rates, generally causing cracking to grout or sealant at this point. A flexible sealant is required to allow for expected expansion and contraction, while keeping the joint water tight and protective of all associated building materials.

Flexible and mould resistant materials should be applied to affected areas to prevent any subsequent water damage that is likely to occur. Regular maintenance and replacement of damage or missing or damaged sealant and grout is highly recommended to the wet areas, as this is a regular wear and tear defect. Sealant and grouting in areas that come into regular contact with water should be maintained for the long term care of your property.

A sealant specialist or tiling contractor should be appointed to complete these works as soon as possible

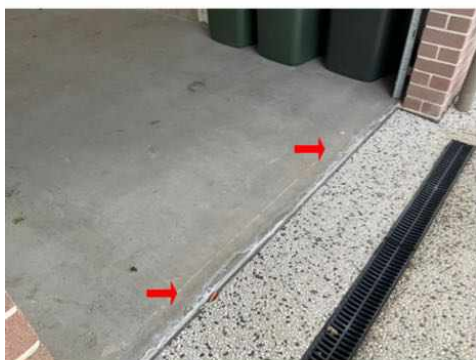
Finding 3.13

Building:	Building 1
Location:	Garage entry
Finding:	Efflorescence
Information:	Efflorescence appears to be affecting the concrete in this area. Efflorescence typically occurs when excess salts within the concrete or cement mortar is leached to the surface due to water transfer.

It is typically seen as white salt deposits on the surfaces of concrete. While detracting from the overall appearance of the affected area, efflorescence is not likely to develop into secondary damage if left unmanaged.

Generally, soluble salt deposits can be removed by dry brushing with a stiff-bristled brush. Repeated dry brushing is an ideal treatment for eliminating this forming of efflorescence. A cleaning contractor or general handyperson may be appointed to perform these works at the discretion of the client.

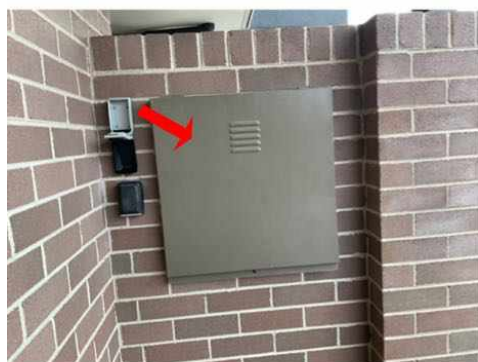
Building:	Building 1
Location:	Meter Box
Finding:	Termite Management System - no evidence of a chemical installation
Information:	The application of a post-construction chemical termite barrier is highly recommended for all properties. Such barriers are highly effective in preventing termite attack on any

A durable notice should be placed in the switchboard unit to indicate current termite barriers. At the time of inspection, the durable notice was evident and it appeared as though no chemical termite management system has been installed, with no evidence to suggest preventative works taking place since the property was built.

The client may consider gaining further advice from a pest controller as to the costs and procedures involved with a 'chemical' application. It is recommended that obtaining such advice be a short-term priority.

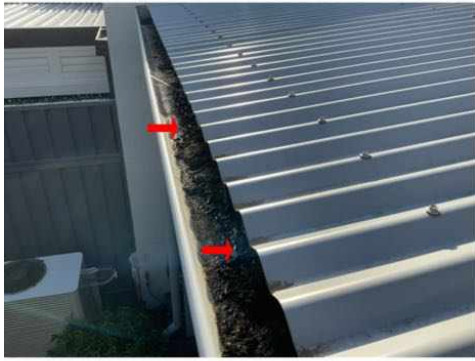
Finding 6.02

Building:	Building 1
Location:	Roof exterior
Finding:	Gutters - Full and blocked
Information:	The guttering on around the roof was found to be blocked at the time of the inspection. Roof plumbing structures, such as guttering and downpipes, should be free of all debris to prevent blockages. Blockages of the guttering and downpipes will lead to pooling and accumulated water overflows, which is likely to subsequently flood eaves and exterior walls.

Blocked gutters are likely to lead to high levels of moisture in the affected areas. Such moisture will not only cause rust and decay of the associated building materials, but can also provide conditions that are conducive to termite and timber pest activity. Blockages in gutters should therefore be removed immediately to ensure dry conditions are maintained.

It is highly advised that gutters be cleaned by the homeowner or a general handyperson as a matter of urgency.

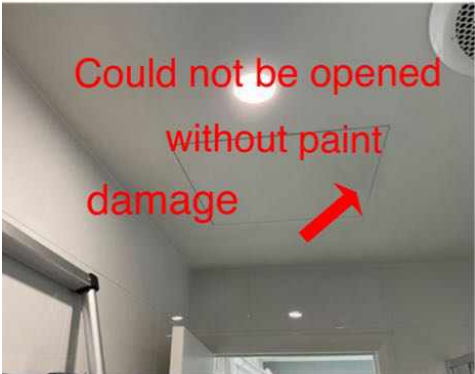
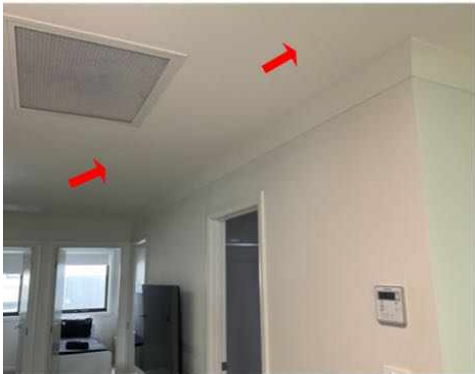
Paint damage was likely as this manhole was not functioning normally.
