Building and Timber Pest Inspection Report

Inspection Date: Mon, 12 Jan 2026

Property Address: 2 Melomys Street, Melonba NSW 2765

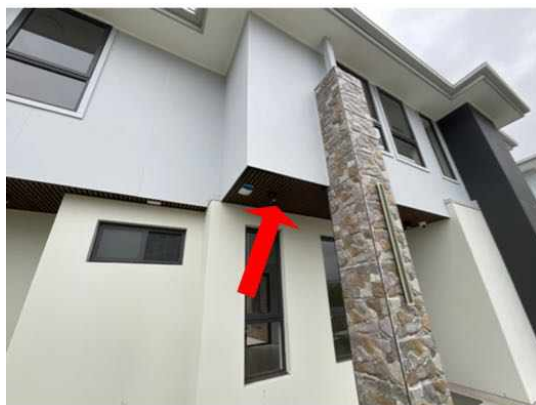
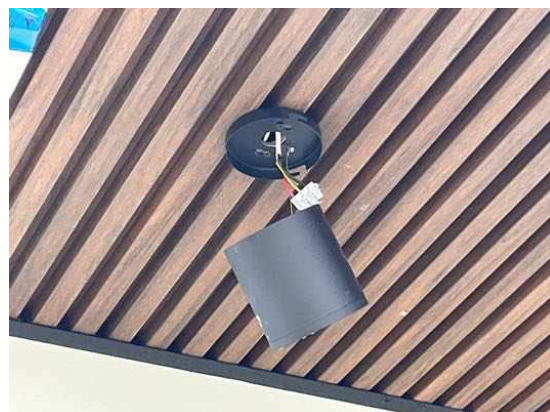
Building:	Main Building
Location:	Garage
Finding:	Light fitting - Damaged.
Information:	Observation

The light fitting in this area was found to be damaged at the time of inspection. The associated electrical wiring was exposed.

Damage to light fittings can occur due to age-related deterioration or as a result of impact (accidental or otherwise). Exposed and unmanaged electrical wiring presents a safety hazard, increasing the risk of electric shock, short-circuiting, or fire. There is also a risk of inadvertent contact by occupants or persons accessing the area.

Repair and/or replacement of the damaged light fitting is advised as a matter of urgency. A licensed electrician should be appointed immediately to repair or replace the fitting and ensure all electrical wiring is safely enclosed and compliant with applicable standards.

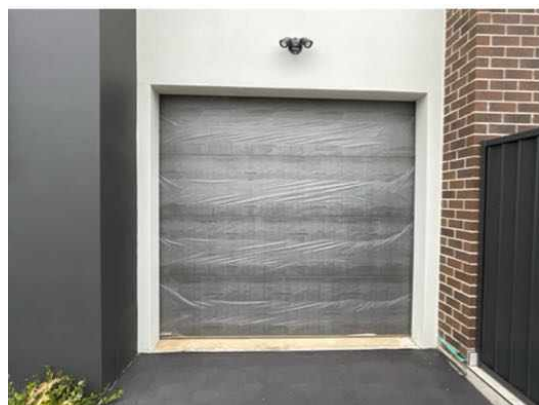
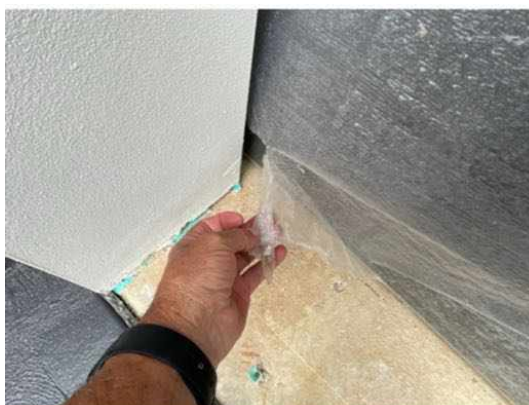
It was observed that some building elements were not fully cleaned prior to handover.

Ensure all building elements are cleaned and presented in a ready-for-use condition. Protective film should be removed to prevent residue or staining from prolonged exposure.

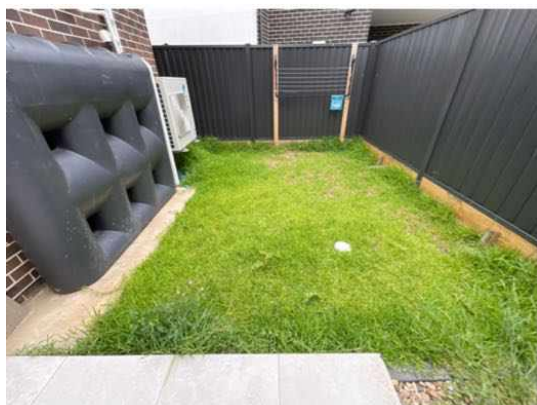
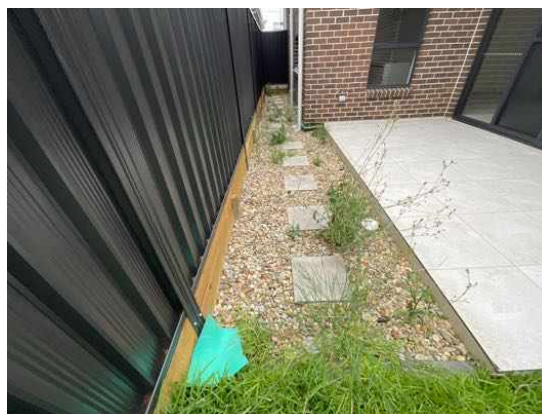
Finding 3.02

Building: Yard
 Location: Yard - Back
 Finding: Site/Yard Drainage – Below Average.
 Information: Defect – Below Average Site Drainage

Site drainage in the inspected areas appears to be below average, with no surface drains observed at the time of inspection. Ground surfaces and paved areas adjacent to the building do not appear to be adequately graded to facilitate effective surface water runoff.

- Water should not be allowed to accumulate against the base of external walls or around the perimeter of the dwelling.
- Prolonged moisture exposure can contribute to:
 - Dampness and structural deterioration
 - Movement of footings or erosion of subsoils
- Conditions that are conducive to timber pest activity, including termites, which are attracted to moist environments
- Best practice site drainage includes:
 - Paved surfaces falling away from the building by at least 25mm over the first metre
 - Bare ground sloping away by at least 50mm over the first metre

Failure to meet these minimum drainage falls increases the risk of water ingress, foundation issues, and secondary building defects.

- A licensed plumber and/or landscaping contractor should be engaged to:
 - Evaluate the current site grading and surface runoff conditions
 - Install or upgrade surface water drainage (e.g. strip drains, spoon drains, grated channels) as required
 - Improve grading around the building to ensure water flows away from the structure

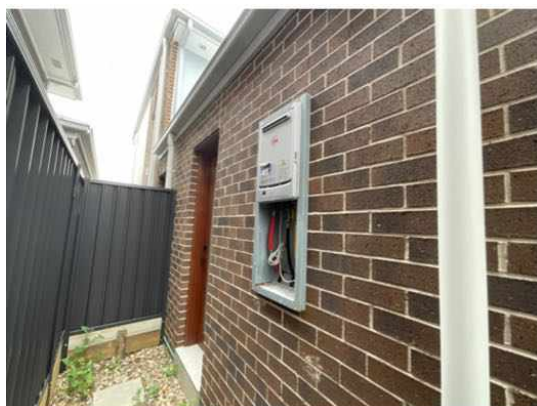
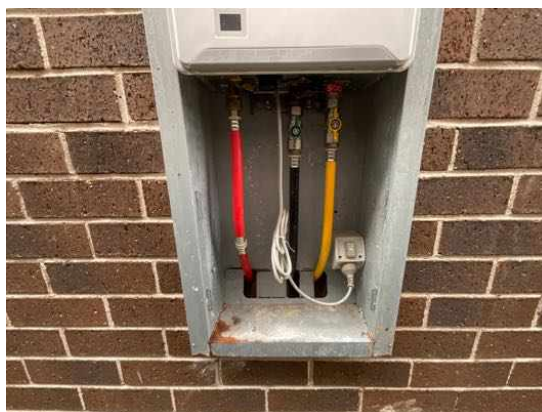
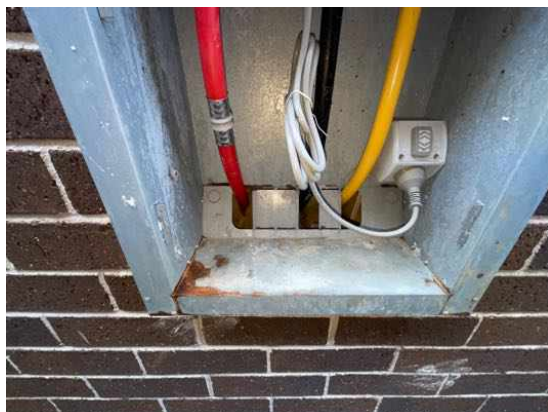
Finding 3.03

Building:	Main Building
Location:	Exterior walls - rear
Finding:	HWS - Cover Missing
Information:	Observation

The external cover to the gas instantaneous hot water system was missing at the time of inspection.

The absence of the cover may allow moisture to enter the wall cavity, which can lead to deterioration of internal building elements, corrosion of components, and potential damage over time.

The missing cover should be reinstated as required to provide adequate protection against moisture ingress. Installation should be carried out in accordance with the manufacturer's requirements and applicable standards.

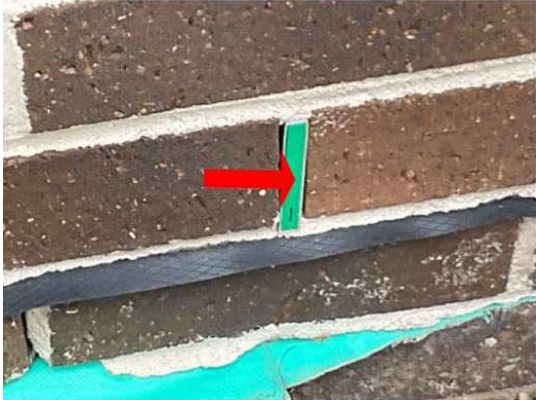
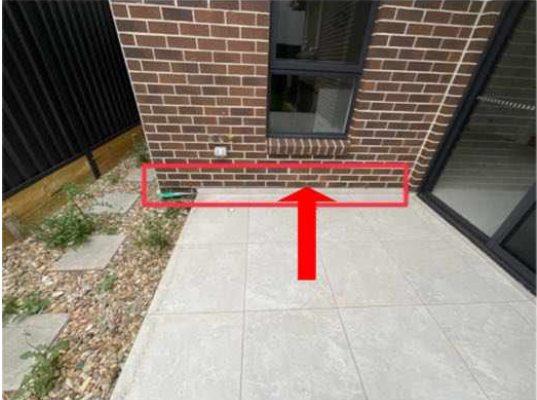
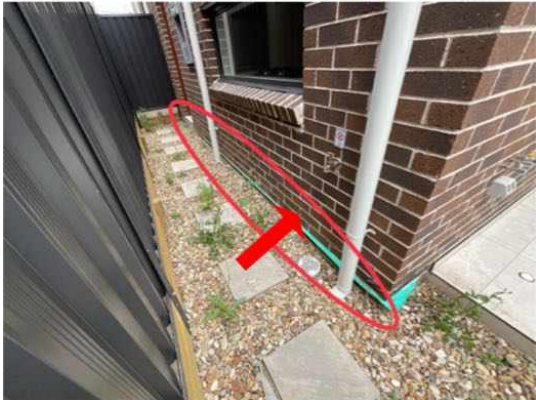
Finding 3.04

Building:	Main Building
Location:	All Areas
Finding:	Weep hole covers need to be removed.
Information:	Observation

Blocked weep holes prevent moisture from draining from the wall cavity. This may allow water from leaks or seepage through the brickwork to accumulate within the cavity, increasing the risk of moisture ingress, deterioration of wall components, and potential damage to internal linings, particularly around windows and door openings.

All temporary green plastic protective covers should be removed and the weep holes cleared to ensure they are open and functional. This is a basic maintenance and completion item that should be attended to by the builder to comply with good building practice and relevant standards.

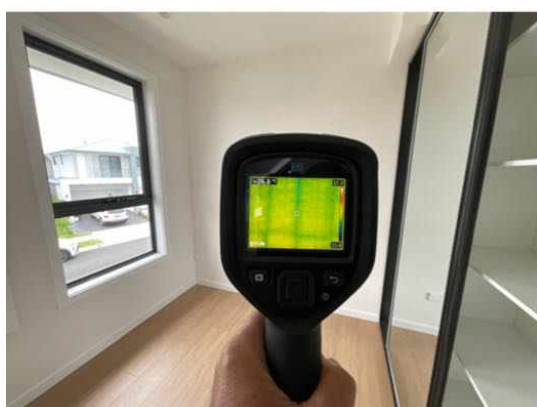
Termites release heat in the form of carbon dioxide and build mud tubes with high moisture content, which can create irregular heat patterns on surfaces such as walls, ceilings, and floors.

At the time of the inspection, no abnormalities indicating live termite activity were observed. However, it's important to note that various factors—such as obstructions, ambient temperature, and wall material/thickness—can impact the accuracy of thermal readings. In cases where surfaces are visually restricted or obstructed, a comprehensive thermal scan may not always be feasible.

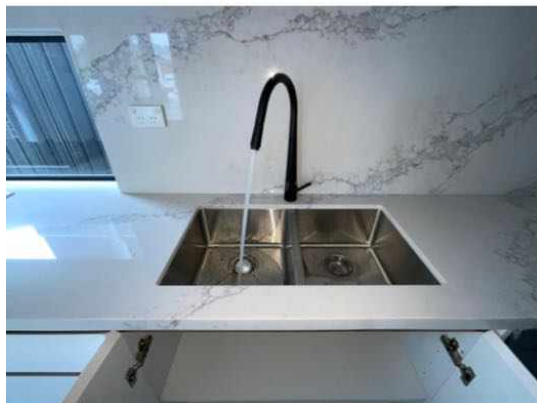
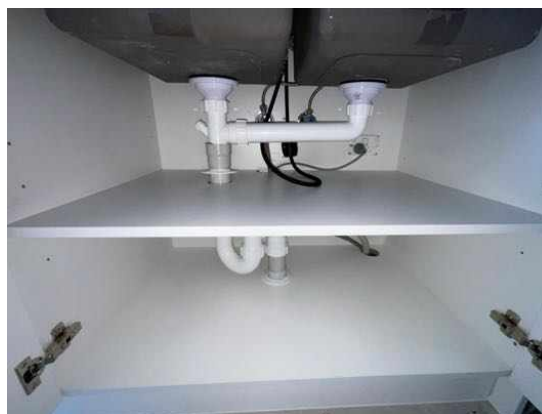
Building: Main Building
 Location: Laundry
 Finding: Laundry - Taps/Plumbing/Drainage.
 Information: Observation: Laundry Tub – Taps, Plumbing, and Cabinetry

- Further monitoring or testing is recommended once the taps are placed into regular use, to ensure no leaks develop over time and that the drainage system continues to perform adequately.
- Sealant and grouting in wet areas should be maintained as part of the long-term care and upkeep of the property.

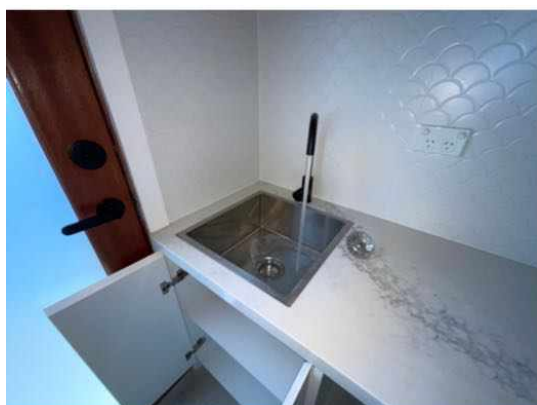
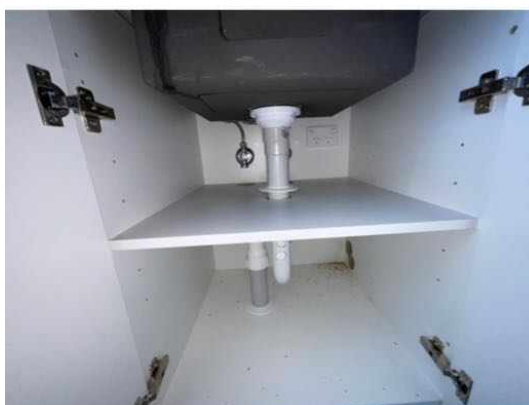
Building: Main Building
Location: Powder Room
Finding: Wet Areas - Bathroom(s) - Overall Condition & Recommendations.
Information: Overall Condition & Recommendations

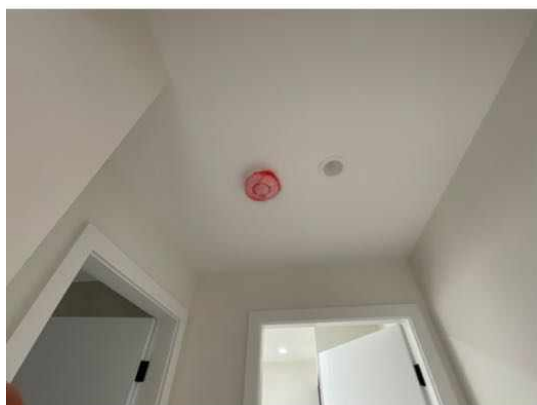
Building: Main Building
Location: All Areas
Finding: Smoke Detectors / Alarms.

- All smoke detectors be tested monthly by the homeowner.
- All systems comply with the requirements of AS 3786 and any applicable state-based legislation.
