Building and Timber Pest Inspection Report

Inspection Date: Wed, 18 Mar 2026

Property Address: 5/183-185 John St, Lidcombe NSW 2141,
Australia

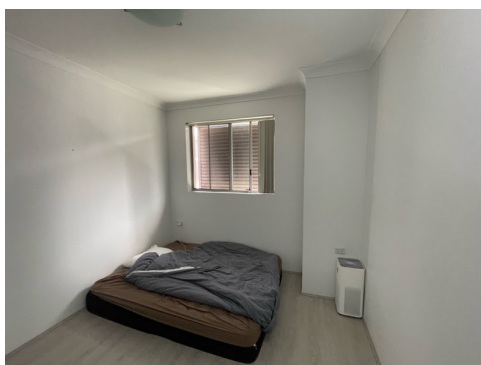
Finding: Window - Opening Restrictor / Barrier Missing

Information: During the inspection, a window was observed without an opening stopper/restrictor and with the required safety barrier protection missing. Where windows are located above lower ground levels or otherwise accessible, the absence of these safety measures may create an increased risk of falls, particularly for children.

Window opening control devices and barriers are important safety features intended to limit excessive opening and reduce the likelihood of accidental falls. Their absence indicates the window may not provide an adequate level of occupant protection in its current condition.

A qualified builder or suitably licensed contractor should be engaged to assess the affected window and install an appropriate window opening restrictor and/or compliant barrier system as required. This issue should be treated as a safety concern and addressed without delay.

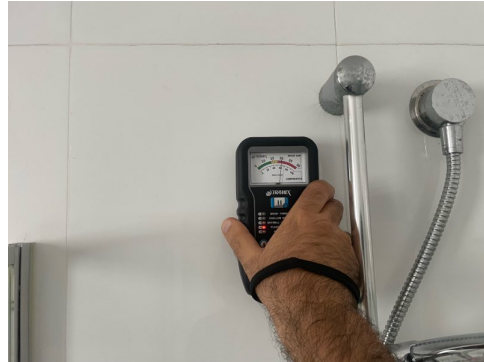
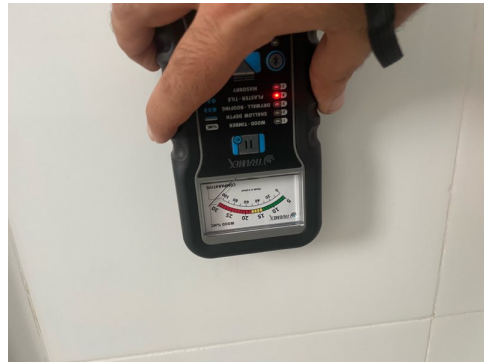
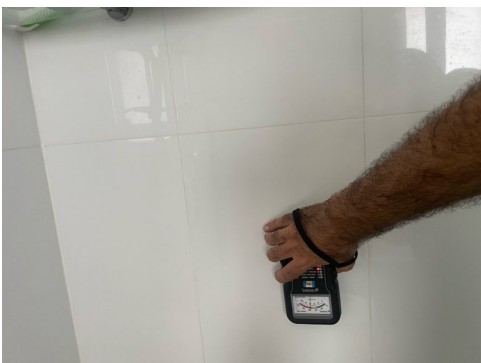
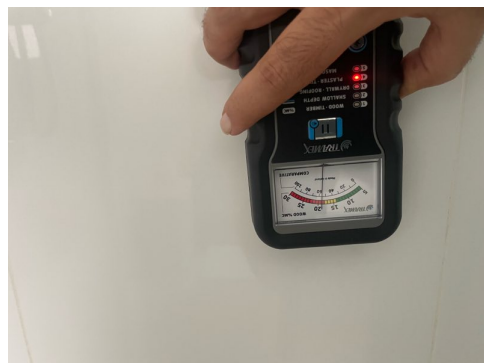
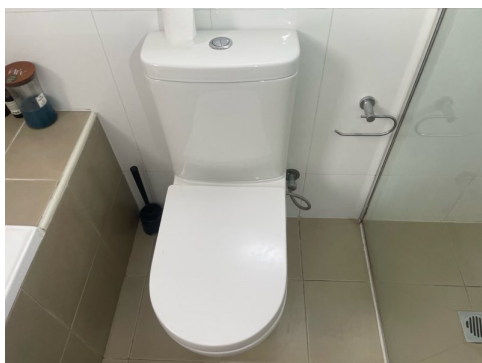
Finding 2.01

Finding: Shower Alcove Severe Wall Damp - Elevated Moisture

Information: During the inspection, elevated moisture levels were detected throughout the full height of the shower alcove wall and extending into the adjacent wall area. The moisture readings reached up to the ceiling level, indicating that the dampness was not confined to the lower section. No elevated moisture was recorded around the tap fixtures or on the opposite wall, suggesting that the leakage is not related to plumbing fittings within the wall cavity. The silicone sealant appears to have been recently repaired, and both the sealant and grout were observed to be in acceptable visual condition at the time of assessment.

The widespread damp condition suggests that moisture has penetrated behind the wall tiling and migrated into the substrate. This may have occurred through previous failures in grout joints, sealant edges, or the waterproof membrane beneath the tiles. Even when surface finishes appear intact, small gaps or voids can allow moisture to be absorbed into the wall structure over time. The persistence of moisture after recent sealing indicates that the underlying waterproofing may have been compromised before cosmetic repairs were undertaken.

Uncontrolled dampness within a shower recess can have serious consequences if not addressed in a timely manner. Moisture trapped behind the tiling system promotes mould and fungal growth, deterioration of plasterboard or cement sheeting, and eventual decay of adjacent framing or structural members. Over time, these conditions can weaken the building fabric, reduce the lifespan of finishes, and contribute to unhealthy indoor environments due to microbial contamination.

It is recommended as a short-term priority that a licensed plumber or bathroom waterproofing specialist conduct further investigation to confirm the source and extent of moisture ingress. Depending on findings, the affected area may require removal of tiles and reinstatement of the waterproof membrane to ensure long-term integrity. The wall should be allowed to fully dry before any rectification is carried out, and moisture monitoring should continue until readings stabilise within a normal range.

Regular maintenance of grout and sealant joints is essential to prevent recurrence of similar issues. Shower alcoves are high-moisture environments and require ongoing attention to ensure that joints, corners, and transitions remain watertight. Periodic inspection, prompt resealing, and maintaining adequate ventilation will assist in preventing future dampness and preserving the performance of the waterproofing system.

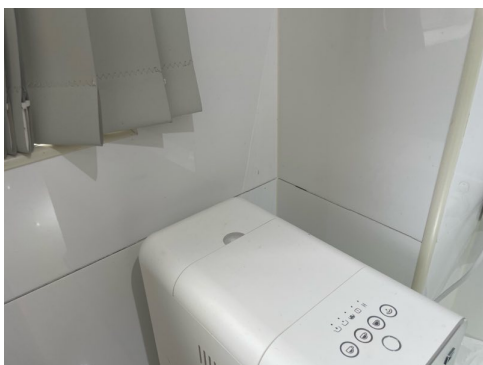
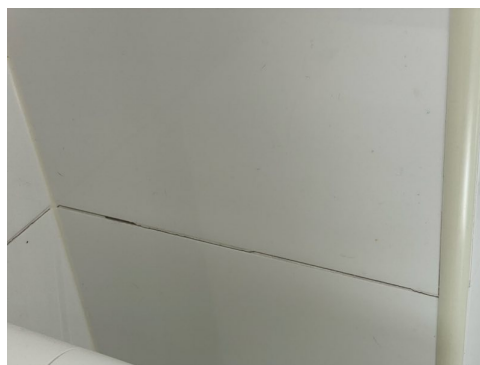
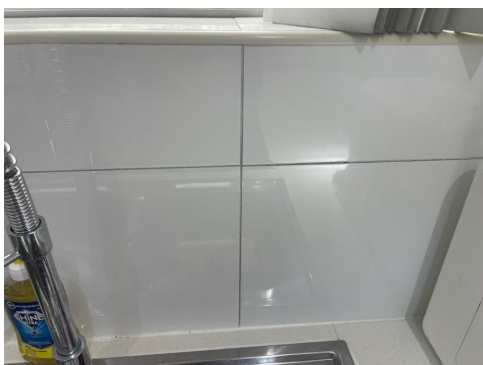
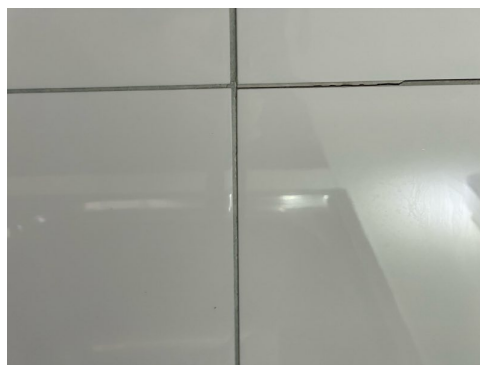
Finding 3.01

Information: Drummy tiled areas were identified at the time of inspection. The term 'drummy' refers to tiles that have become detached from their fixing, despite otherwise being in relatively good condition. Such defects are generally caused by physical or moisture damage to the area. Drummy tiled areas may also be a direct result of poor workmanship during the construction process.

Tiled areas may swell and shrink with changes in air humidity if the area has sustained moisture damage. Any exposure to moisture is capable of causing tiled areas to become drummy and/or cracked over a prolonged period of time. Drummy tiled areas generally require removal and replacement of affected tiles, with adequate sealant and grouting.

Specialist trades are available for these types of services. A registered builder may be required to undertake works if damage is extensive or if secondary building defects have resulted. Otherwise, it is advised that a tiling contractor be appointed to perform works as necessary. Immediate action is recommended to ensure that no further damage is sustained in the affected area.

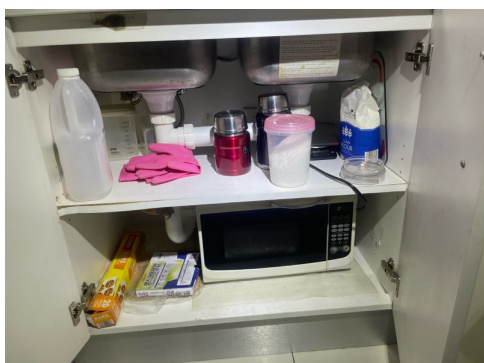
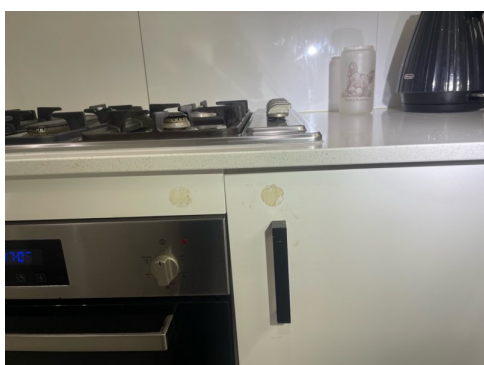
Finding 3.02

Finding: Kitchen Cabinetry (Vanity/Joinery) – Damaged (Wear & Tear)

The kitchen cabinetry (vanity/joinery) was observed to be in a damaged condition at the time of inspection, including visible scratches to cabinet doors/panels, water staining and general wear and tear. This condition detracts from the overall presentation and may reduce the practical serviceability of the storage areas.

The observed deterioration may be consistent with long-term use, impact damage, and moisture exposure from routine kitchen activities (spills, cleaning, steam, or minor leaks). Where laminated or painted finishes are scratched, worn, or water stained, the protective coating can be compromised, increasing the likelihood of moisture absorption into board products, swelling, delamination, and progressive deterioration—particularly around sink cabinetry and kickboards.

It is recommended that the client arrange further assessment and repair or replacement of the affected cabinetry components as required to restore function and reduce the risk of ongoing deterioration. If staining is present near the sink, dishwasher, fridge water line, or plumbing penetrations, it is also recommended that these areas be checked to confirm there is no active leak contributing to the damage.

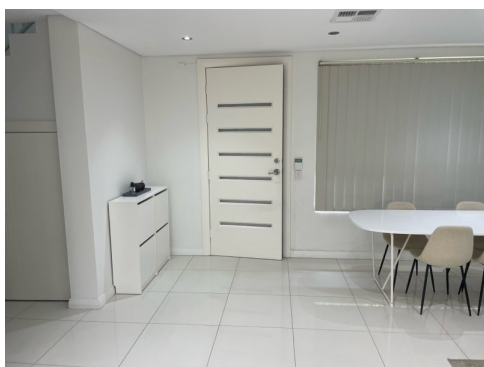
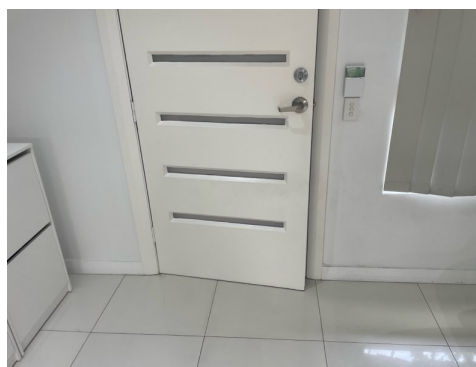
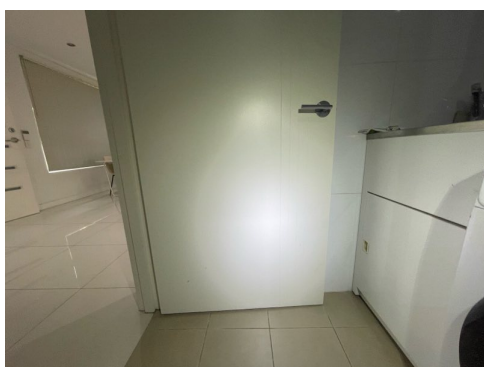
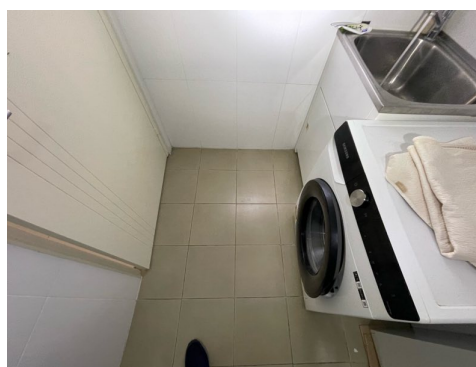
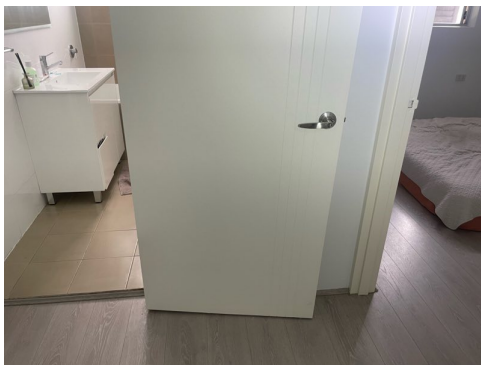
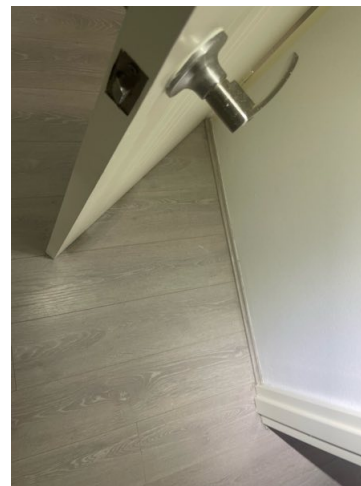
Finding 3.03

Finding: Door - Missing Stopper

Information: During inspection, it was noted that one internal door does not have a door stopper installed. Without a stopper, the door handle is at risk of striking the adjoining wall or architrave, which may lead to surface damage over time.

This is a minor but important fitting that protects both the door and surrounding finishes.

It is recommended that a suitable door stopper be installed to this door to prevent impact damage and ensure proper functionality.

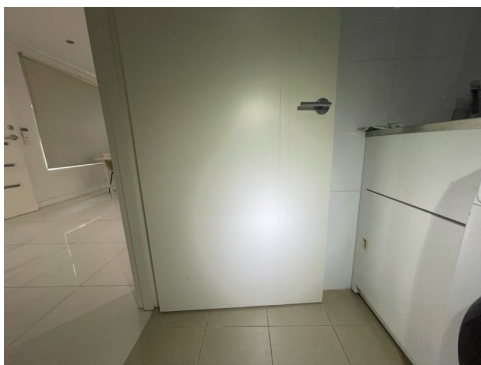
Finding 3.04

Building: Main Building
Location: Bathroom Ground Level
Finding: Tiles - Cracked or damaged

Information: Cracking was evident to the tiling in this area at the time of inspection. While the cracking appears to be minor, this area is frequently exposed to water, allowing potential for water penetration into adjoining sections of walls or flooring.

If left unmanaged, water penetration to these areas may lead to subsequent water damage, which is likely necessitate repair work to affected building elements.

A tiling contractor should be appointed to ensure that no further water damage occurs. The re-application of silicone and grouting throughout remaining tile work is also advised, to further protect the area against water penetration.

Where water penetration has led to water damage, appointment of a relevant tradesperson may be required to repair damaged building elements.

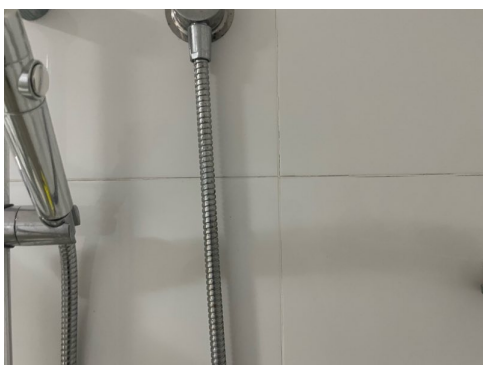
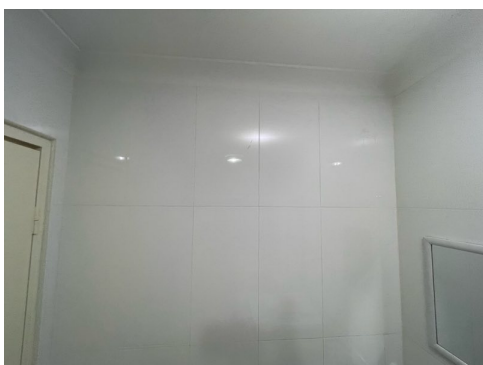
Finding 3.05

Building: Main Building
Location: Bathroom Ground Level
Finding: Sealant and grouting - Missing or damaged

It was noted on inspection that sealant or grout is degraded to the tiled shower alcove and or other areas of the bathroom.

Different materials and floor areas move at different rates, generally causing cracking to grout or sealant at this point. A flexible sealant is required to allow for expected expansion and contraction, while keeping the joint water tight and protective of all associated building materials.

There appears to be excessive mould to the sealant and grout which will likely require scraping out and replacement.

Flexible and mould resistant materials should be applied to affected areas to prevent any subsequent water damage that is likely to occur. Regular maintenance and replacement of damage or missing or damaged sealant and grout is highly recommended to the wet areas, as this is a regular wear and tear defect. Sealant and grouting in areas that come into regular contact with water should be maintained for the long term care of your property.

A sealant specialist or tiling contractor should be appointed to complete these works as soon as possible

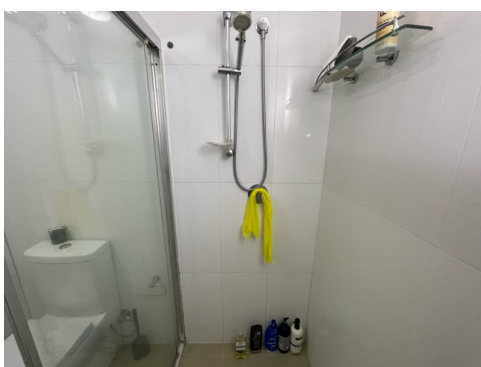
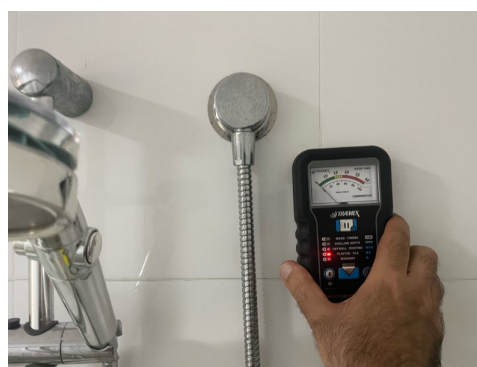
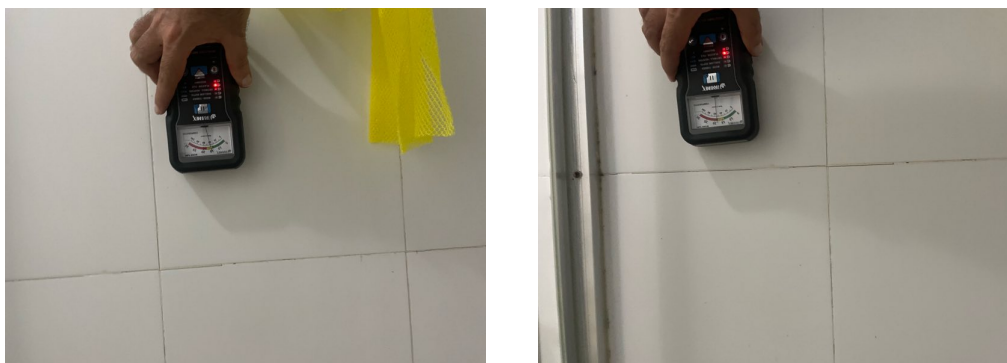
Finding 3.06

Finding: Shower Alcove Wall Damp - Elevated Moisture

Information: During inspection, damp was detected to the lower wall area of the shower alcove, extending up to approximately 1 metre. There were no elevated moisture readings identified around the taps, nor were there readings transferring through to the opposite side of the wall. The sealant appears to have been repaired recently, and both the sealant and grout are currently in acceptable condition.

This type of defect is quite common and is suspected to have been caused by moisture permeating or leaching through the grouting and/or gaps in the sealant prior to the recent repairs. Even when surface finishes appear intact, moisture can penetrate behind tiling and into the substrate over time.

Unmanaged damp in a shower recess is likely to facilitate mould and fungi growth, decay of associated building materials, and compromise of structural integrity. Excessive indoor moisture is also linked to the growth of microbes that can emit spores and cause health-related issues, particularly respiratory problems.

It is recommended that the affected wall area be rectified in the close future by a licensed plumber or bathroom waterproofing specialist to ensure the moisture issue is properly resolved. Monitoring should continue until rectification is carried out.

Ongoing maintenance of grout and sealant is essential to prevent future recurrence of damp conditions in the shower alcove.

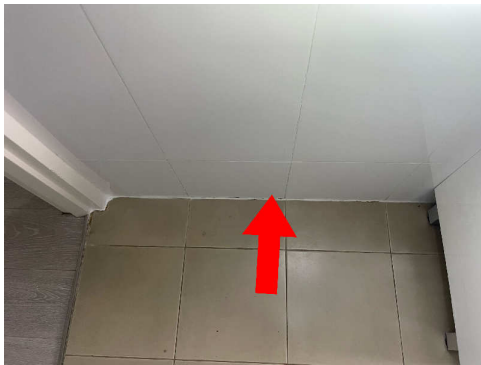
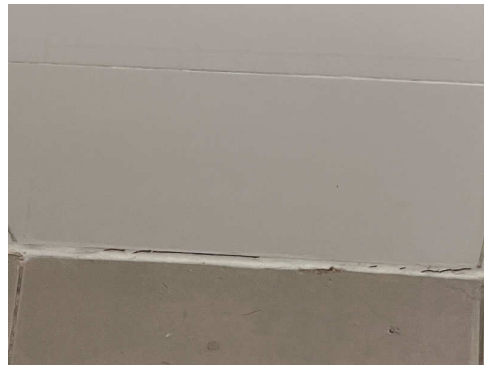
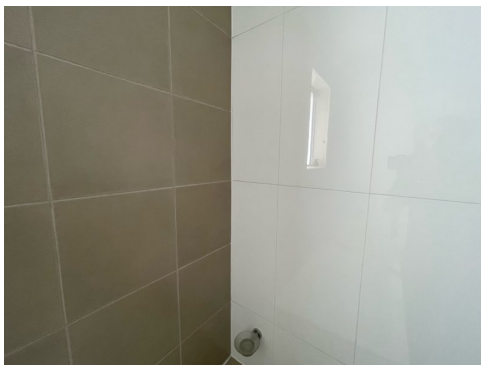
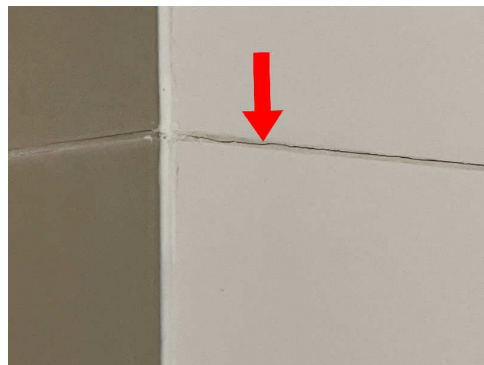
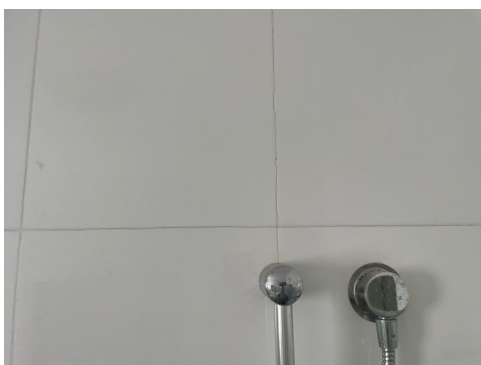
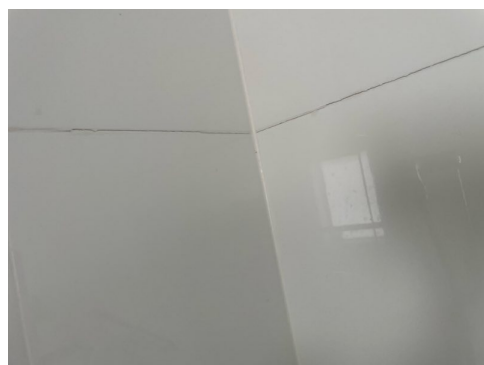
Finding 3.07

Finding: Tiles - Missing Sealants and/or Grouts

Information: During the inspection, sections of the existing tiled surfaces were observed with missing, cracked, or deteriorated grout and/or sealant. These gaps were visible along tile joints and at junctions where tiles meet adjoining walls, skirtings, or fixtures.

The deterioration has likely occurred over time due to general wear, building movement, or ongoing moisture exposure. Missing or damaged grout and sealant allow water to penetrate behind tiles, which can lead to staining, mould growth, or damage to the substrate and surrounding finishes.

It is recommended that the affected areas be re-grouted and re-sealed by a qualified tiler or trade as a short-term priority to maintain a watertight finish and prevent further deterioration.

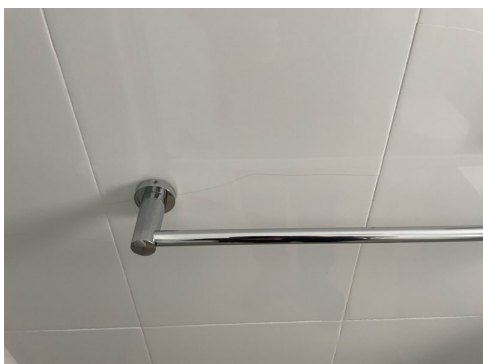
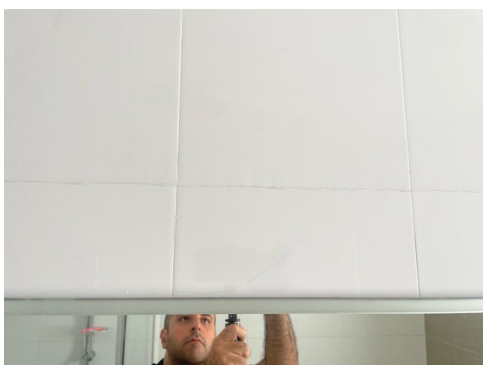
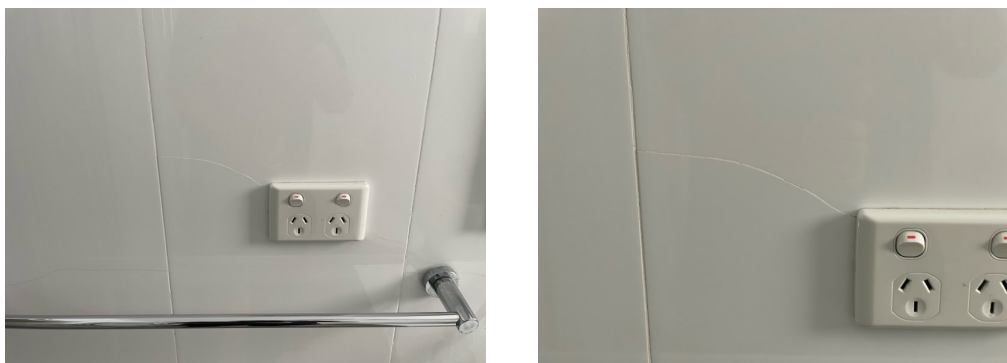
Finding 3.08

Finding: Tiles - Cracked or damaged

Information: Cracking was evident to the tiling in this area at the time of inspection. While the cracking appears to be minor, this area is frequently exposed to water, allowing potential for water penetration into adjoining sections of walls or flooring.

If left unmanaged, water penetration to these areas may lead to subsequent water damage, which is likely necessitate repair work to affected building elements.

A tiling contractor should be appointed to ensure that no further water damage occurs. The re-application of silicone and grouting throughout remaining tile work is also advised, to further protect the area against water penetration.

Where water penetration has led to water damage, appointment of a relevant tradesperson may be required to repair damaged building elements.

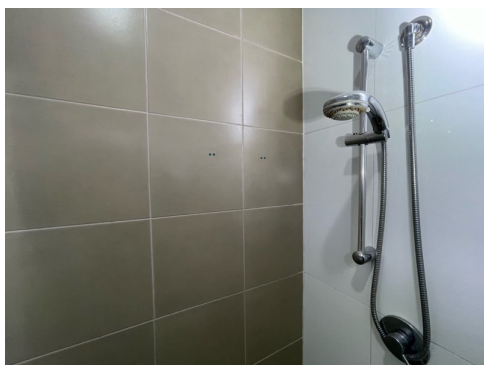
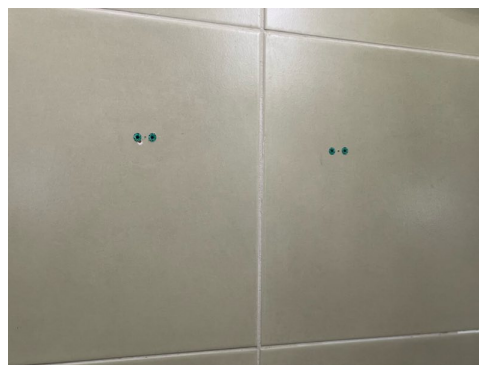
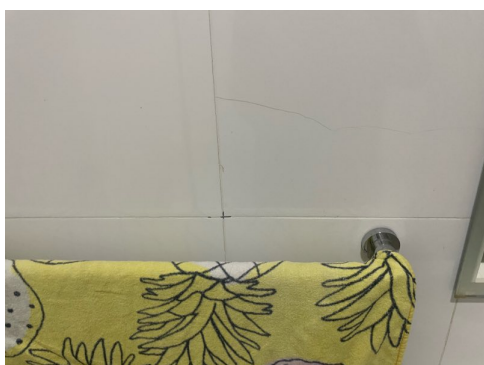
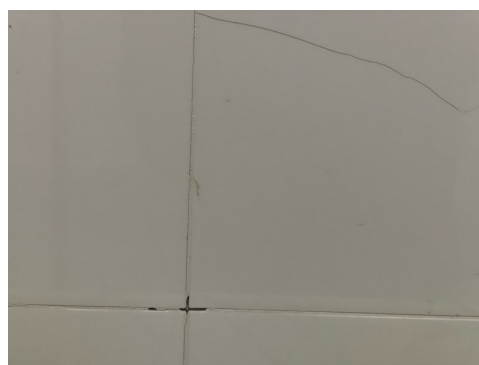
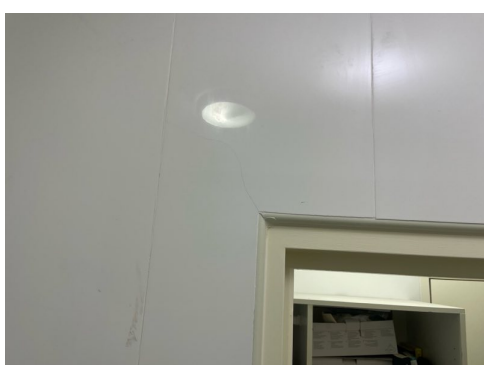
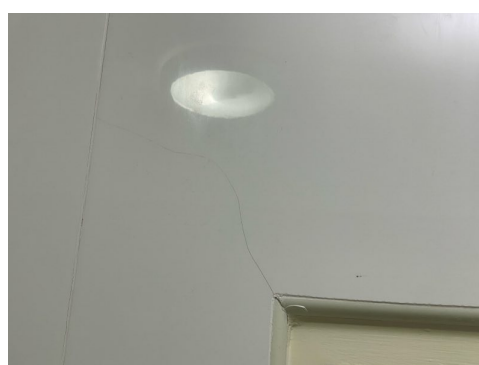
Finding 3.09

Finding: Tiles - Cracked or damaged

Information: Cracking was evident to the tiling in this area at the time of inspection. While the cracking appears to be minor, this area is frequently exposed to water, allowing potential for water penetration into adjoining sections of walls or flooring.

If left unmanaged, water penetration to these areas may lead to subsequent water damage, which is likely necessitate repair work to affected building elements.

A tiling contractor should be appointed to ensure that no further water damage occurs. The re-application of silicone and grouting throughout remaining tile work is also advised, to further protect the area against water penetration.

Where water penetration has led to water damage, appointment of a relevant tradesperson may be required to repair damaged building elements.

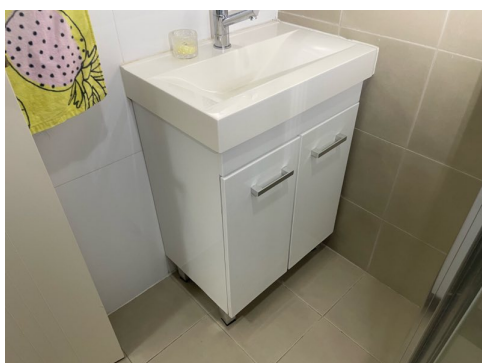
Finding 3.10

Finding: Bathroom Vanity – Damaged (Scratches, Water Staining, Wear & Tear)

Information: The bathroom vanity was observed to be in a damaged condition at the time of inspection, including visible scratches to the vanity surfaces, water staining, general wear and tear. This condition affects both presentation and serviceability of the fixture.

The observed staining and deterioration may be consistent with ongoing moisture exposure (splashing, minor leakage, or poor drying/ventilation) combined with normal use over time. Where laminated or painted finishes are scratched, worn, or water stained, the protective coating can be compromised, which may allow moisture absorption and lead to swelling, delamination, and progressive deterioration of the cabinet materials.

It is recommended that the client arrange further assessment and repair or replacement of the affected vanity components as required to restore function and reduce the risk of further deterioration. If water staining is active or worsening, it is also recommended that the plumbing and surrounding junctions (basin waste, taps, silicone seals, and adjacent wall/floor interfaces) be checked to confirm there is no ongoing leak contributing to the damage.

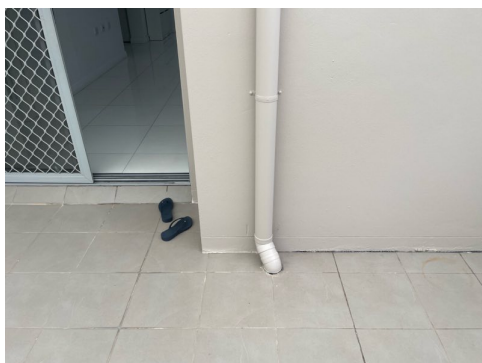
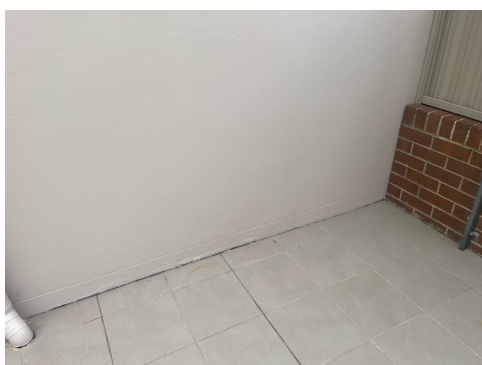
Finding 6.02

Building:	Main Building
Location:	Yard
Finding:	Weep holes - Blocked
Information:	<p>It was noted during the time of inspection that some of the weep holes to the brickwork were blocked. Weep holes are designed to allow water from leaks or seepages in brickwork to be directed to the external environment, prior to entering the wall cavity or associated building materials. Weep holes should therefore be kept clean and free of debris or blockages.</p> <p>Blocked weep holes are likely to result in the presence of excessive moisture within the brickwork and associated structures, creating potential for water damage and moisture problems.</p> <p>Depending on the nature of the blockage, the homeowner may be able to undertake remedial works to remove blockages. Alternatively, appointment of a registered builder may be required to remove blockages. Preventative works are necessary in ensuring the structural integrity of the affected brickwork and should be performed as soon as possible.</p>

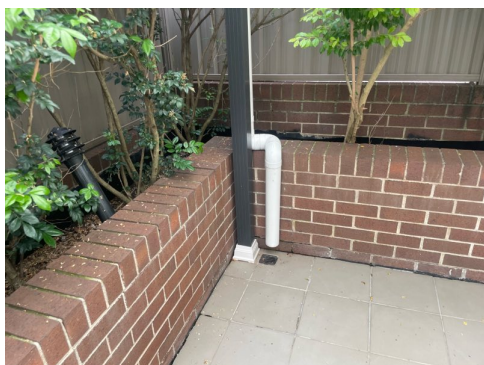
Finding 6.03

Where roof plumbing doesn't drain adequately, the area at the base perimeter can become excessively damp, potentially creating an environment that is susceptible to rust and corrosion of surrounding building elements, as well as attracting termites and other pests.

It is highly recommended that a plumber be appointed to further inspect the area and to install adequate drainage equipment where necessary.

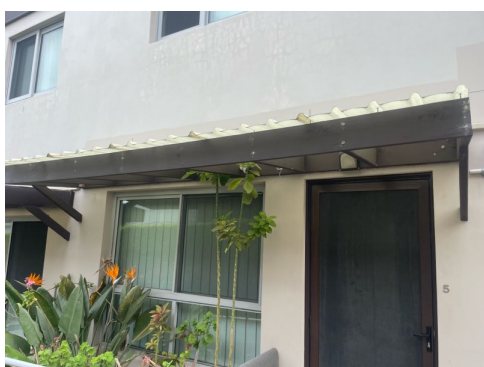
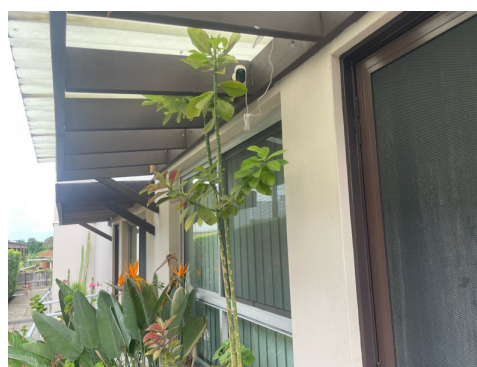
Finding 6.04

Finding: Large trees/stumps within 30m of house

Information: There are a number of large trees/stumps within 30m of the house which may contain natural termite activity. It is important to monitor these areas to ensure no natural activity is allowed to progress into the main house. Regular inspections are recommended. Consider test drilling any large trees. A pest controller can be contacted to carry out such testing at the owners discretion.

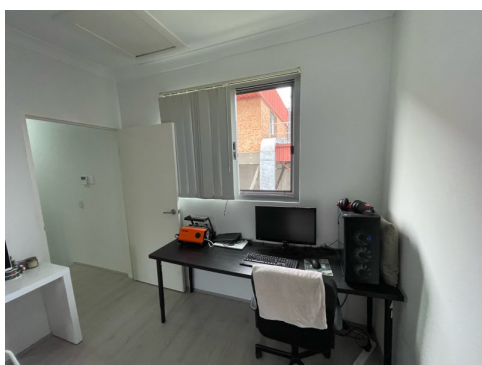
This condition represents an inspection limitation under the scope of a visual building inspection in accordance with AS 4349, as safe access could not be achieved. The limited size and poor location of the manhole increase the difficulty of entry and may prevent proper assessment of concealed roof framing, sarking, insulation, ventilation, and any signs of defects, damage, or water ingress within the roof space.

A suitably qualified contractor should be engaged to provide compliant and safe access to the roof void if internal inspection is required. Until such access is made available, no comment can be offered on the condition of the concealed roof space areas that were inaccessible at the time of inspection.
