Building and Timber Pest Inspection Report

Inspection Date: Wed, 11 Mar 2026

Property Address: 41B Wanda St, Merrylands West NSW 2160,
Australia

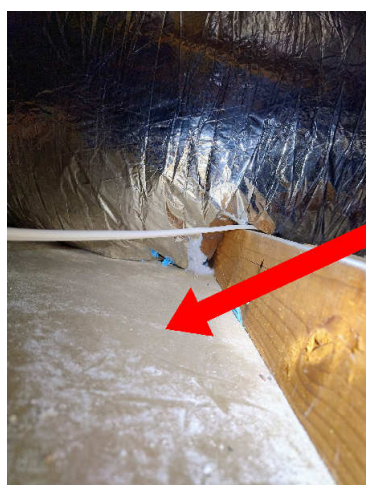
Information: Sections of insulation in the roof void have been poorly installed or moved from their original position and are covering down light fittings at the time of inspection. While the down lights have been fitted with appropriate protective covers, the presence of this insulation creates a potential fire hazard.

Any insulation within the vicinity of down light fixtures should be moved and re-applied to more appropriate sections of the roof void, thus ensuring the area is fire-safe. An insulation contractor should be appointed as soon as possible to perform any necessary works as required.

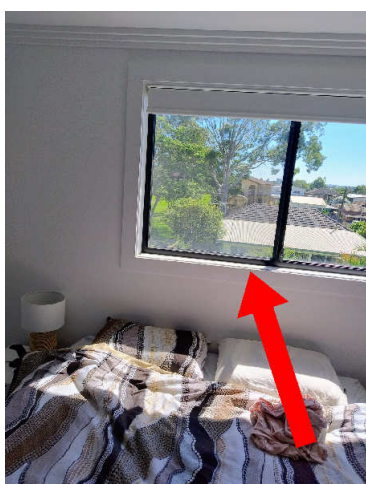
Finding 1.02

Finding: Window Opening is more than 125mm - Safety hazards

Information: All window in L1 Bedrooms were observed to have opening clearance of more than 125 mm (which is safety hazard)at the time of the inspection. It pose as a safety risk.

A general handy person or qualified carpenter should be appointed to perform or fix these to improve the safe operational state of the window by limiting the opening gap of less than 125mm and improve the safety of the internal area on urgent priority.

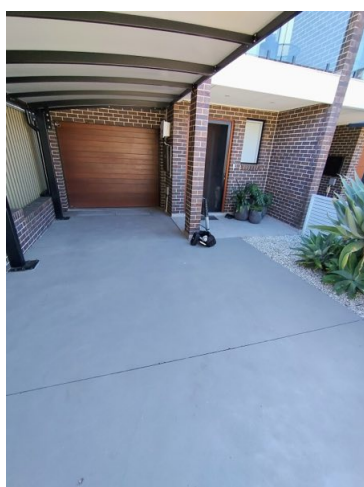
Finding: Site drainage - Inadequate

Information: The site drainage in all external area was found to be inadequate at the time of inspection, creating potential for subsequent water damage to associated building elements.

It is important that water does not lie against the base of walls; surrounding paths and ground levels should be sloped to drain water away from walls. Downpipes should not discharge stormwater onto lower walls or plinths. Stormwater should be carried away by large, regularly cleaned drains. Ground levels may need to be lowered to expose a buried DPC.

Where site drainage is inadequate, installation of an Agricultural (Aggie) Drain may be required. A qualified plumber should be appointed to further inspect the property and perform any remedial works as necessary. Water damage and secondary defects are likely to occur if left unmanaged.

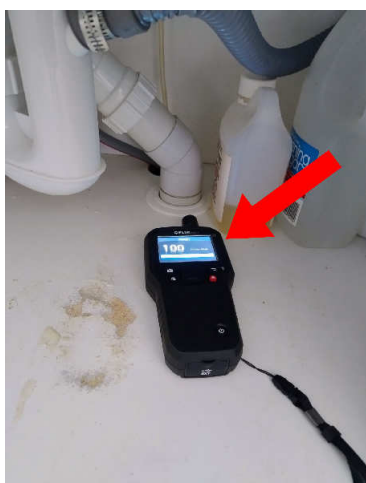
Finding 3.02

Finding: Evidence of Excessive moisture and Mould - identified

Information: Evidence of excessive moisture recorded by moisture meter and mould impressions were observed in the cabinet of kitchen (Below Wash basin).

Excessive moisture can attract termites and produce conditions that promote fungal growth and wood decay.

Excessive moisture is generally caused by deteriorated, inadequate or missing roof drainage, leaking plumbing pipes or fixtures, poorly plumbed HWS overflows or condenser units and poor site drainage.

If mould growth has been found there may be environmental biological or health issues involved. In these cases an appropriately qualified inspector should also be contacted.

Prior to any remedial works being performed a qualified plumber should be appointed to further inspect the property and to identify the cause of the excessive moisture. Works to remove affected building elements may then be necessary and should be performed by an appropriate tradesperson.

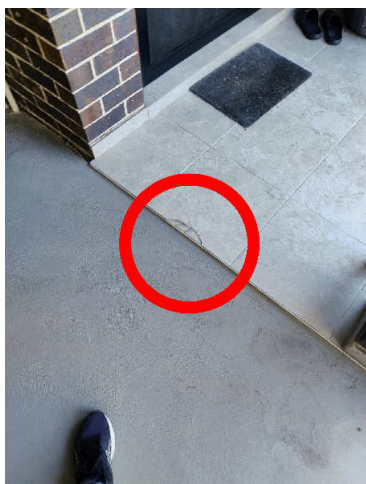
Finding 3.03

Building: Main Building
 Location: Front Elevation
 Finding: Floor tile - Cracked and damaged

Cracking and damage in the floor tiles was evident in this area at the time of inspection in front area. It is suspected that this cracking has occurred as a result of the floor being uneven and lacking a solid or suitable foundation for the tiles to be laid on or due to sudden impact. Settlement in the floor foundations may also have caused movement and resulted in the cracking of tiles in this area.

Cracked tiles throughout the household detract from the overall appearance of the affected areas, as well as creating potential for water penetration to adjoining building elements. If left unmanaged, water damage may occur as a result of constant water penetration over a prolonged period of time.

While not considered a matter of urgency, replacement of cracked floor tiles is advised as a solution. A tiling contractor or general handyperson may be appointed to perform these works at client discretion. Where cracks become more numerous, consultation with a registered builder specialising in re-stumping may be required.

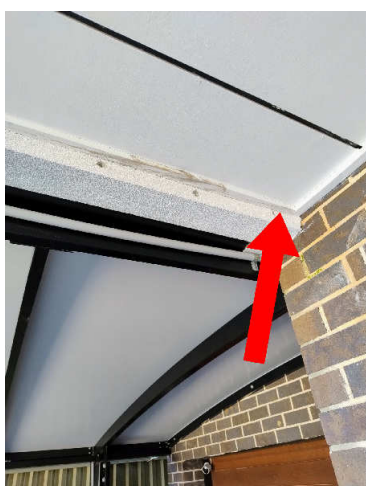
Finding 3.04

Building:	Main Building
Location:	Front Elevation
Finding:	Cracking - Damage Category 2 - Noticeable (up to 5mm)

Cracks were observed in the ceiling of front elevation area at the time of inspection. Noticeable cracks are a common occurrence as a result of many primary defects. Such causes may include age, general wear and tear, expected building movement, general expansion/contraction of building materials in different weather conditions, and/or minor failings in the installation or application of building materials.

Noticeable cracks may result in minor sticking or jamming of associated doors and windows, which require easement. However, noticeable cracks are easily filled and repaired. A plasterer can be consulted to install an expansion joint at this point to allow for this movement during different weather conditions.

Monitoring of all cracking should be conducted frequently. Always contact a building inspector should cracks widen, lengthen, or become more numerous. Additionally, your building inspector should also be contacted if associated building elements such as doors and windows become more difficult to operate over time.

Relevant tradespeople, such as carpenters, painters and plasterers, should be appointed to perform remedial works, as deemed necessary.

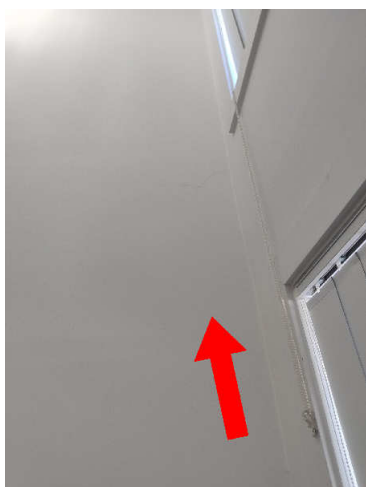
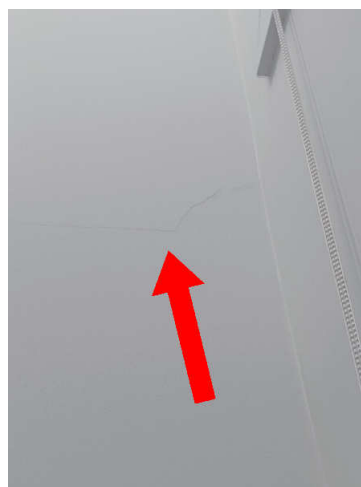
Finding 3.05

Building:	Main Building
Location:	Near Stairs + Dining room
Finding:	Cracking in Gyprock - Damage Category 2 -

The crack in gyprock wall area near staircase at the entrance, Above window and sliding door framing in Living area were observed at the time of inspection. Noticeable cracks are a common occurrence as a result of many primary defects. Such causes may include age, general wear and tear, expected building movement, general expansion/contraction of building materials in different weather conditions, and/or minor failings in the installation or application of building materials.

Noticeable cracks may result in minor sticking or jamming of associated doors and windows, which require easement. However, noticeable cracks are easily filled and repaired. A plasterer can be consulted to install an expansion joint at this point to allow for this movement during different weather conditions.

Monitoring of all cracking should be conducted frequently. Always contact a building inspector should cracks widen, lengthen, or become more numerous. Additionally, your building inspector should also be contacted if associated building elements such as doors and windows become more difficult to operate over time.

Relevant tradespeople, such as carpenters, painters and plasterers, should be appointed to perform remedial works, as deemed necessary.

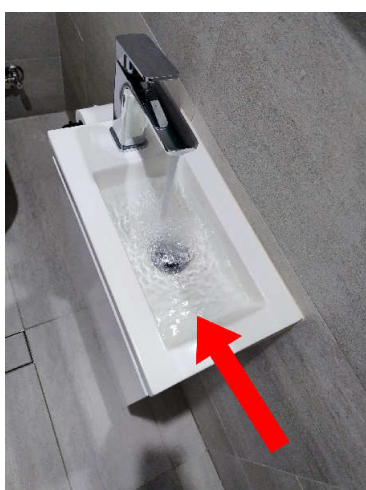
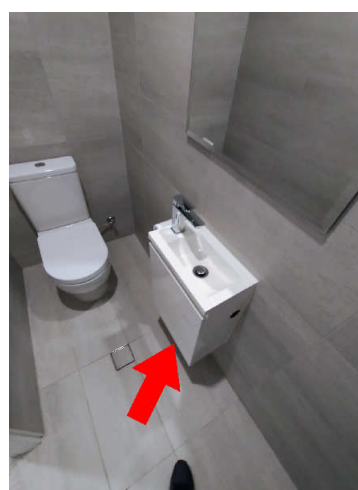
Finding 3.06

The basin drain appeared to be blocked or draining the water at slower rate at the time of inspection in WC area at Ground floor. Blockages prevent building elements from operating as intended. If left unmanaged, a lack of general maintenance may lead to the development of more significant defects, such as water damage to surrounding building materials.

It is advised that the blockage be removed prior to any further inspection or remedial works. Additionally, check for any secondary or concealed damage and then attempt to address the cause of the blockage to prevent any water damage to associated structures.

A licensed plumber should be appointed as soon as possible to perform any remedial works where required. Please be advised that a cabinet maker or qualified carpenter may be required if water damage is evident.

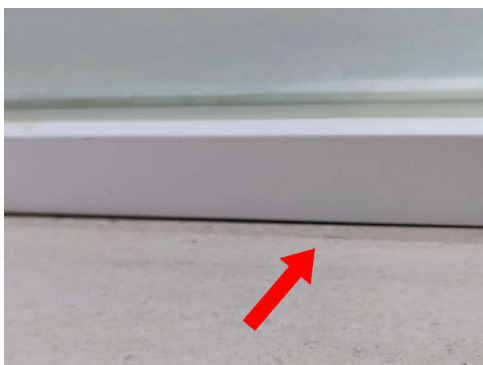
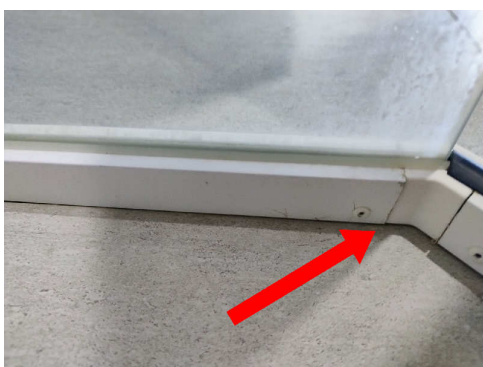
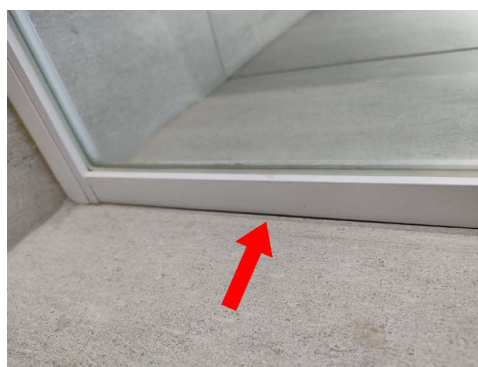
**Finding 3.07**

Building:	Main Building
Location:	Bathroom GF
Finding:	Sealant and grouting - Missing or damaged

It was noted on inspection that sealant or grout is degraded to the tiled shower alcove and or other areas of the bathroom at ground floor

Different materials and floor areas move at different rates, generally causing cracking to grout or sealant at this point. A flexible sealant is required to allow for expected expansion and contraction, while keeping the joint water tight and protective of all associated building materials.

There appears to be excessive mould to the sealant and grout which will likely require scraping out and replacement.

Flexible and mould resistant materials should be applied to affected areas to prevent any subsequent water damage that is likely to occur. Regular maintenance and replacement of damage or missing or damaged sealant and grout is highly recommended to the wet areas, as this is a regular wear and tear defect. Sealant and grouting in areas that come into regular contact with water should be maintained for the long term care of your property.

A sealant specialist or tiling contractor should be appointed to complete these works as soon as possible

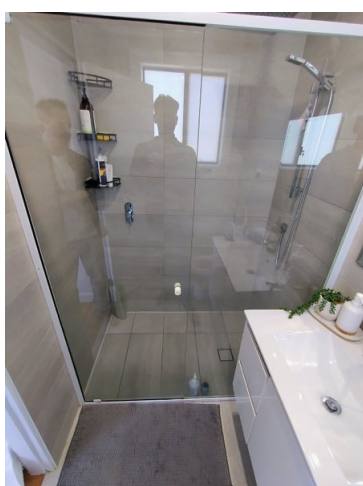
Finding 3.08

Finding: Sealant and Grouting - Damaged or Detriorated

Information: It was noted on inspection that sealant or grout is degraded to the tiled shower alcove and or other areas of ensuit.

Different materials and floor areas move at different rates, generally causing cracking to grout or sealant at this point. A flexible sealant is required to allow for expected expansion and contraction, while keeping the joint water tight and protective of all associated building materials.

There mould to the sealant and grout which will likely require scraping out and replacement.

This can lead to water ingress into the shower base and creates conducive condition to termite activity. If left unmanaged can cause further deterioration to building elements.

Flexible and mould resistant materials should be applied to affected areas to prevent any subsequent water damage that is likely to occur. Regular maintenance and replacement of damage or missing or damaged sealant and grout is highly recommended to the wet areas, as this is a regular wear and tear defect. Sealant and grouting in areas that come into regular contact with water should be maintained for the long term care of your property.

Qualified trade person or plumber must be appointed for rectification on priority.

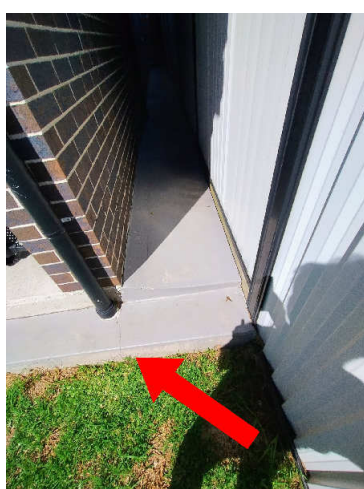
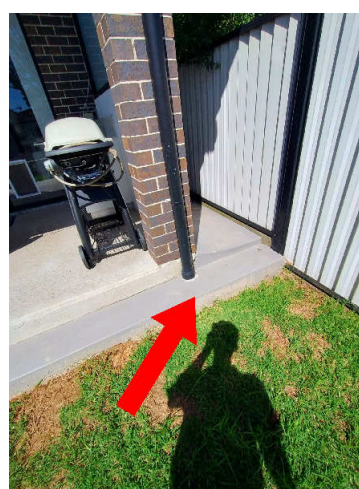
Finding 3.09

Finding: Crack in concrete slab - Category 1

Information: A crack coded as Category 1 was identified in the rear elevation slab. A Category 1 crack is described as a fine but noticeable crack, with the slab at an otherwise reasonable level.

To be considered Category 1, the approximate width of the crack is less than 1.0mm, or a less than 10mm change in offset when a 3m straight edge is placed over the defect.

Category 1 cracks should be monitored for a period of 12 months. At the end of the monitoring period, identified cracks that are rated greater than Category 2 are considered defects, and require rectification.

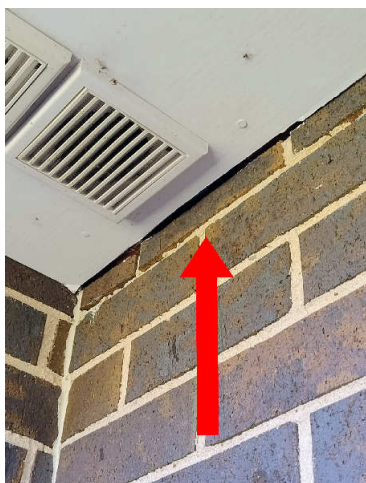
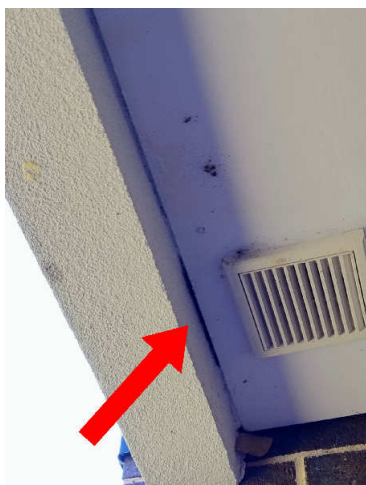
Finding 3.10

Any gaps to the exterior walls of the building that are larger than 3mm are deemed a defect and require filling, beading or replacement of brickwork to close or cover the gaps. Such gaps create potential for pest ingress, excessive moisture and structural issues, and should therefore be minimised prior to the development of secondary defects.

Such works should be carried out by the builder on site to prevent secondary defects and to comply with Australian Standards.

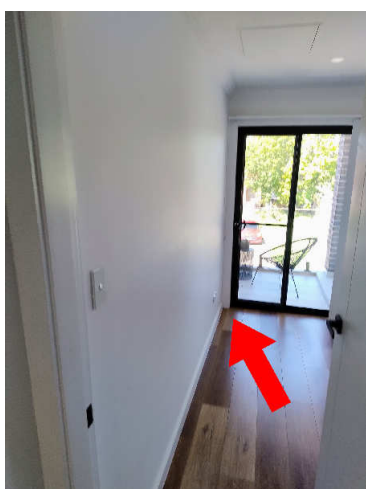
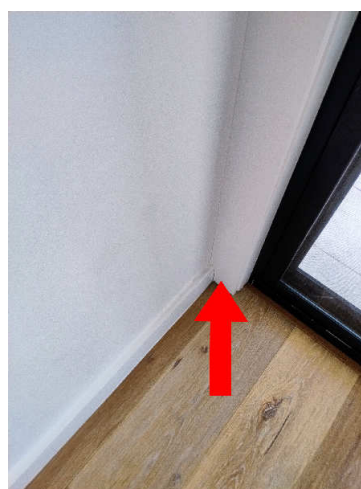
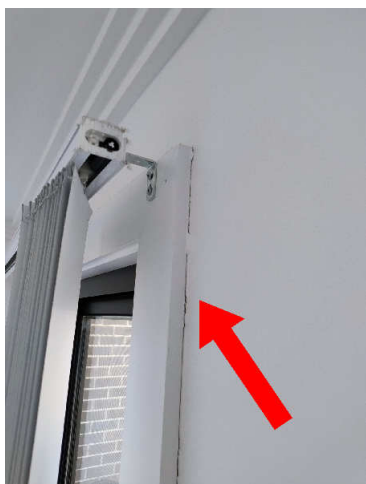
Finding 3.11

Building: Main Building
Location: Front Bedroom
Finding: Cracking - Damage Category 1 - Fine (up to 1mm)

Minor crack was observed in the Front bedroom on L1 at the time of inspection. Although fine cracks are quite noticeable, they are often only considered to be an appearance defect, and usually do not indicate any structural damage. Generally, the cause of a fine crack is indicative of a separation between building materials and finishes (e.g. paint, plaster, etc.) along joins.

Cracking of this nature can generally be repaired with minor sanding, filling and/or repainting. Such works should be performed by a qualified painter or a general handyman.

Monitoring of all cracking should be conducted frequently. Always contact a building inspector should cracks widen, lengthen, or become more numerous.

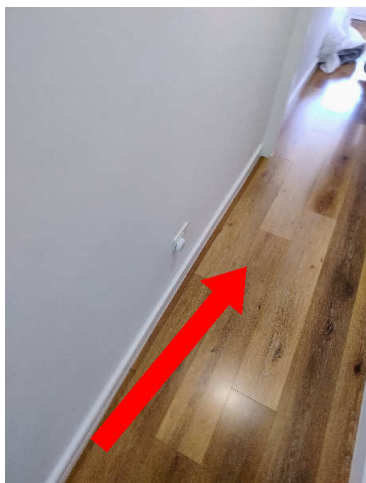
**Finding 3.12**

Bouncy floors generally indicate that the floorboards or the subfloor structures are coming loose from the joists that they are installed on. Bouncy flooring may also be the result of gaps between flooring and stumps or joist structures, which require packing.

The client is advised to seek quotations for required repairs from a Registered Builder specialising in re-stumping. The potential resolution may range from packing gaps in subfloor structures through to replacement of subfloors stumps and refixing of flooring.

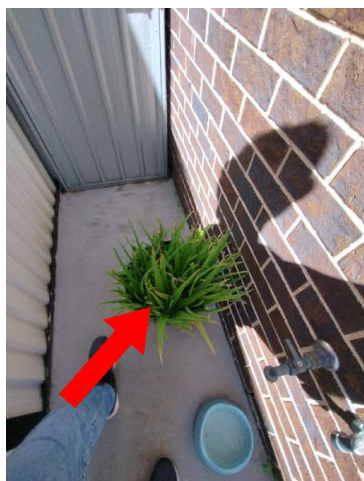
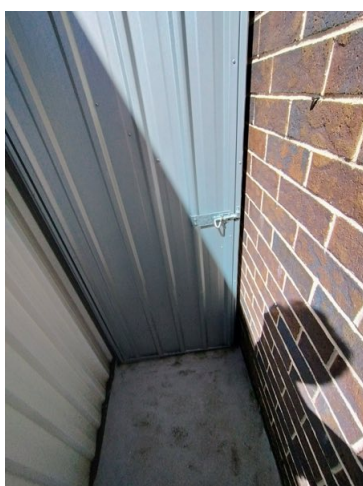
Finding 6.02

If the slab edge is not properly exposed there is a high risk of termite attack. Sometimes, in order to determine the type of slab, a suitably qualified person such as an architect or builder may be required to consult the construction plans.

Where the slab edge cannot be properly inspected, it is highly recommended that termite or timber pest inspections be carried out every 6-12 months to aid protection of the property against infestation.

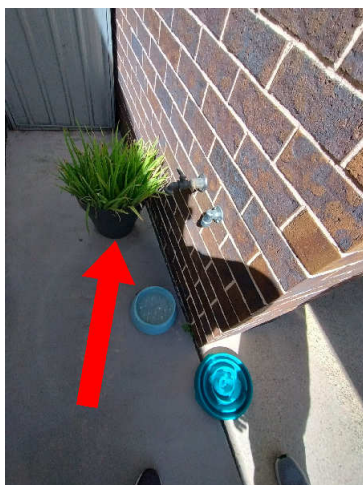
Finding 6.03

Information: The storing of timbers and other stored material around the external property increases the risk of termite activity being present at the time of inspection. As they are likely to come into contact with weather conditions or excessive moisture wood rot is likely to develop on timbers that are not treated.

It is highly recommended that any stored timbers be immediately removed from areas in which they may attract any termite / timber pest attack. Minimisation of risk / prevention of termite attack is far more adequate than dealing with the presence of termite activity.

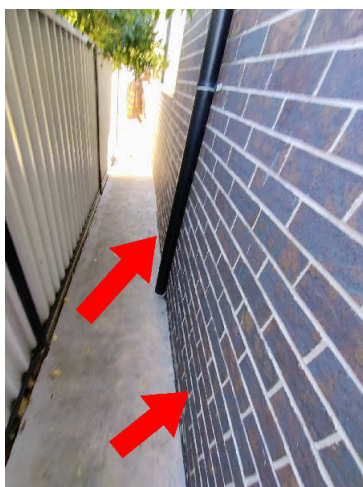
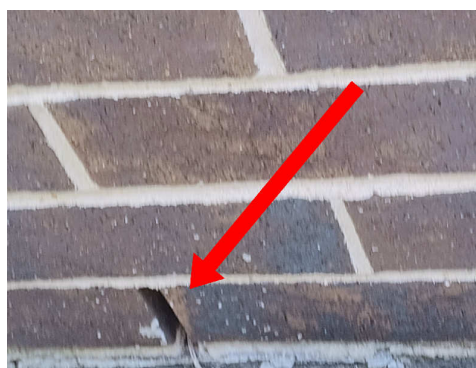
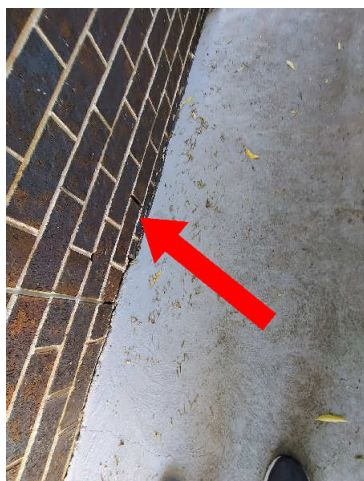
Finding 6.04

Building: Main Building
Location: All External Areas
Finding: Bridging or breaching of termite barriers - weep holes

Additionally build-up of moisture is likely to occur if weep holes are covered further attracting termite activity to these areas.

It is highly recommended that weep holes are left exposed in all areas throughout the external property. Therefore if any termite activity leading into weep holes becomes easily detectable during frequent pest inspections.

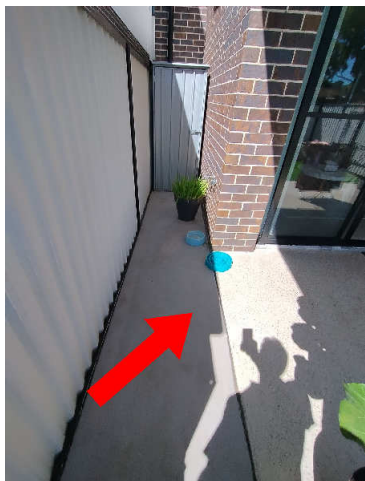
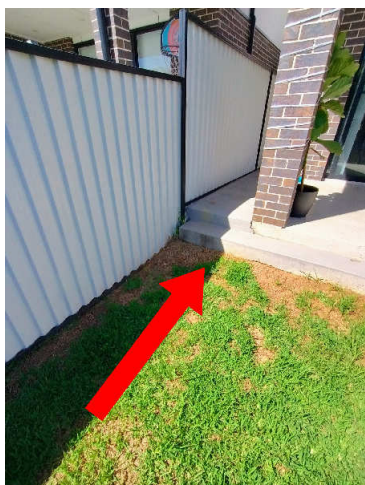
Finding 6.05

Finding: Site drainage - Inadequate

It is important that water does not lie against the base of walls; surrounding paths and ground levels should be sloped to drain water away from walls. Downpipes should not discharge stormwater onto lower walls or plinths. Stormwater should be carried away by large, regularly cleaned drains. Ground levels may need to be lowered to expose a buried DPC.

Where site drainage is inadequate, installation of an Agricultural (Aggie) Drain may be required. A qualified plumber should be appointed to further inspect the property and perform any remedial works as necessary. Water damage and secondary defects are likely to occur if left unmanaged.

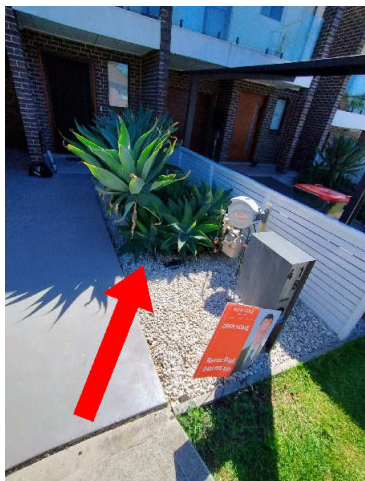
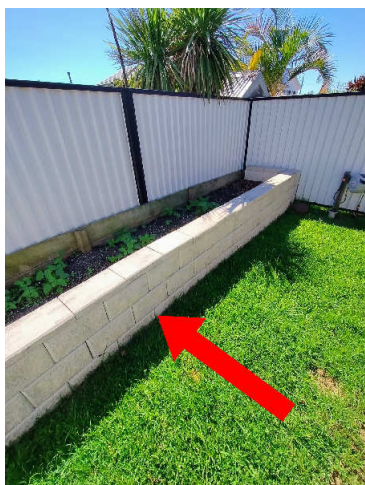
Finding 6.06

Finding: Garden Beds - Conditions Conducive to Termites

Information: Garden beds were found to be evident in the front area. These garden beds can include untreated timber, and with a combination of moisture from watering hosing can make conditions conducive to termite activity and termite ingress.

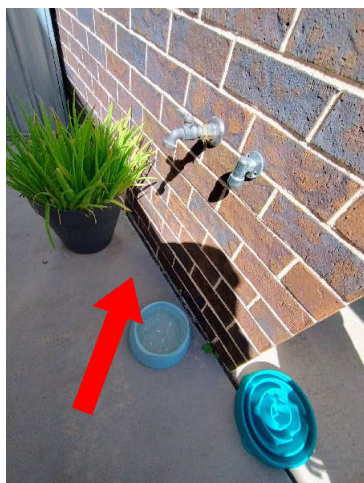
Finding 6.07

This keeps the surrounding surfaces damp while using the tap, which becomes conducive to termite activity.

A licensed plumber must be appointed to ensure an appropriate drain is installed.

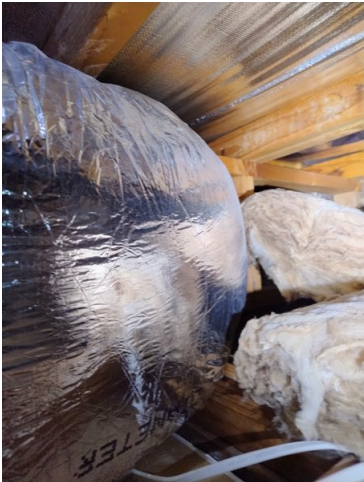
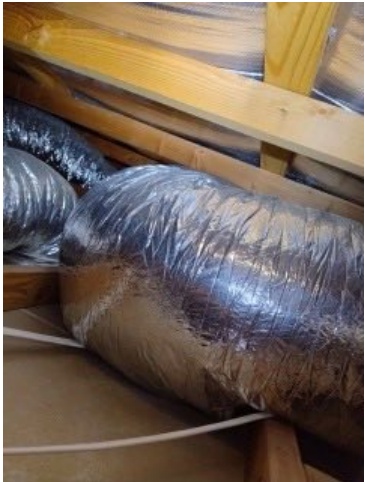
Information: Very Limited access to the roof void was present due to facts including but not limited to access hatch size or placement and obstructions at the entry of roof space, The low pitch of the roof near the roof void entrance was not allowing to enter into the roof space. for this reason access to the roof void was minimal.
