# Building and Timber Pest Inspection Report

Inspection Date: Fri, 6 Feb 2026

Property Address: 609/16B Evans Ave, Eastlakes NSW 2018,  
Australia

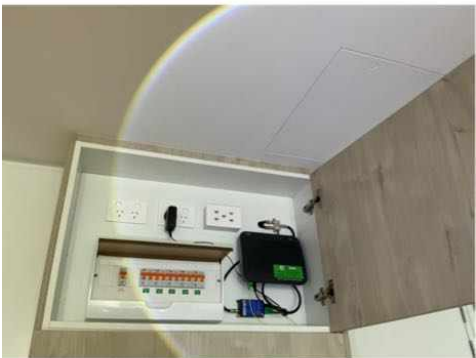
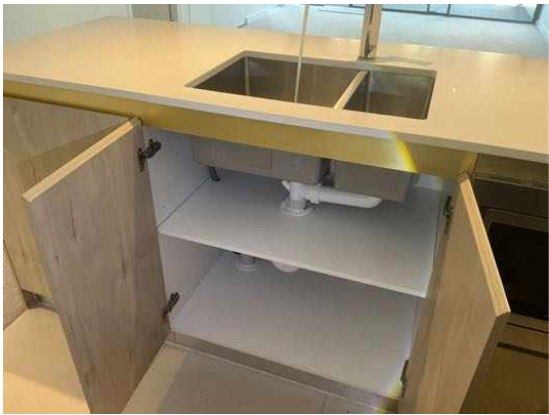
### Finding 6.01

Building:	Main Building
Location:	Switch board & under kitchen sink
Finding:	Termite Management System - no evidence of a chemical installation
Information:	The application of a post-construction chemical termite barrier is highly recommended for all properties, particularly if live termite activity has been found on the site previously. Such barriers are highly effective in preventing termite attack on any timber building elements throughout the property.

A durable notice should be placed in the switchboard unit and also under the kitchen sink to indicate current termite barriers. At the time of inspection, it appeared as though no termite management system has been installed, with no evidence to suggest preventative works taking place.

The client may consider gaining further advice from a pest controller as to the costs and procedures involved with this application. It is recommended that obtaining such advice be a short-term priority.

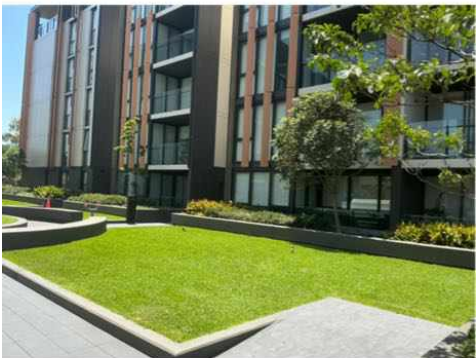
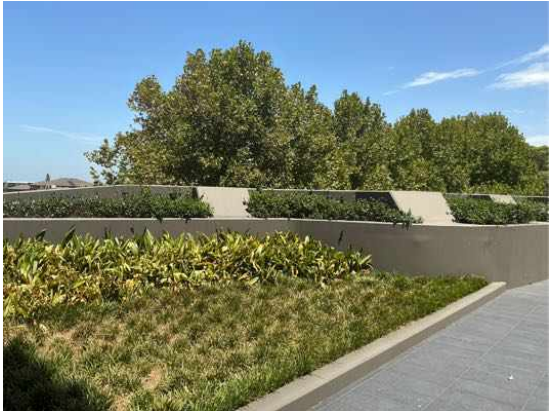
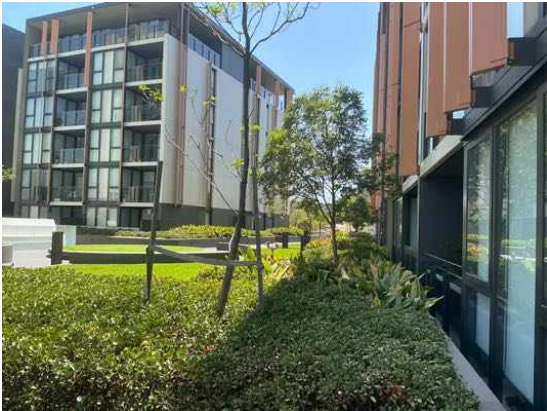
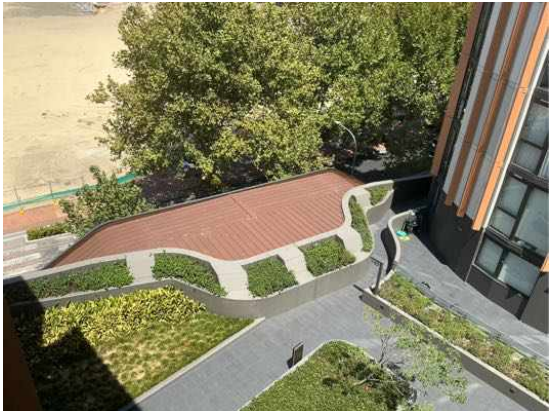
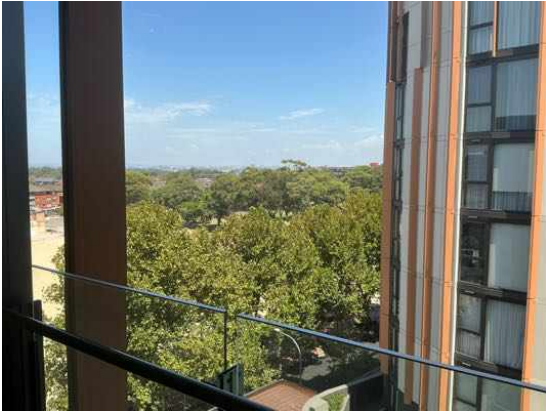
**Finding 6.02**

Building: Main Building  
Location: All Areas  
Finding: Trees to be inspected within the property.  
Information: Trees can be conducive to termite activity and nesting. Trees over 100mm on the property, should be drilled and tested for termite activity.

Regular inspections every 6-12 months- or advised by the termite management system installer.

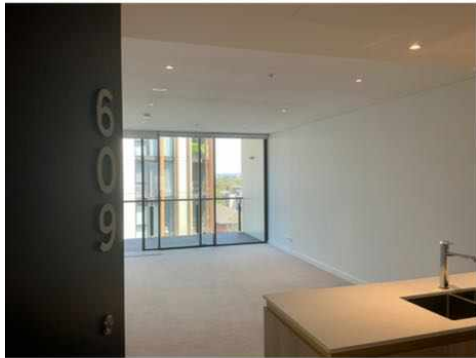
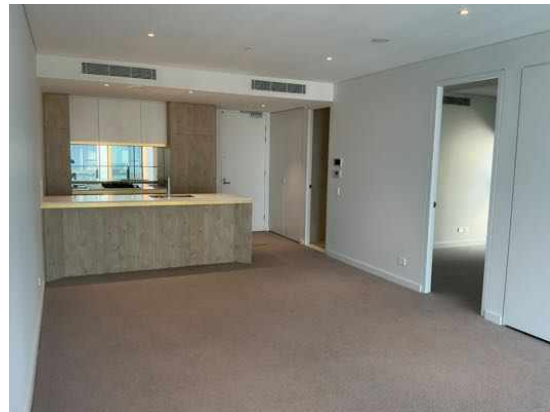
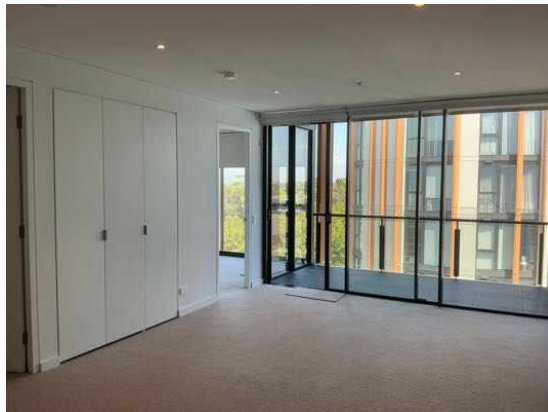
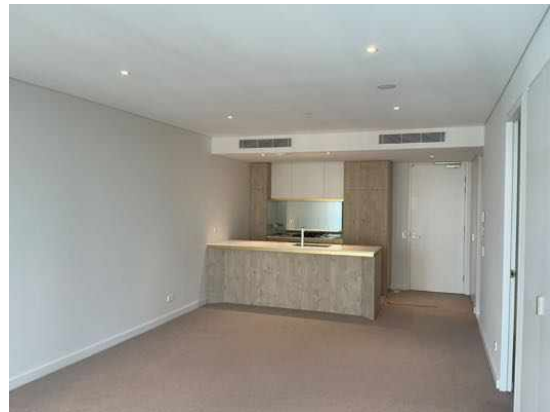
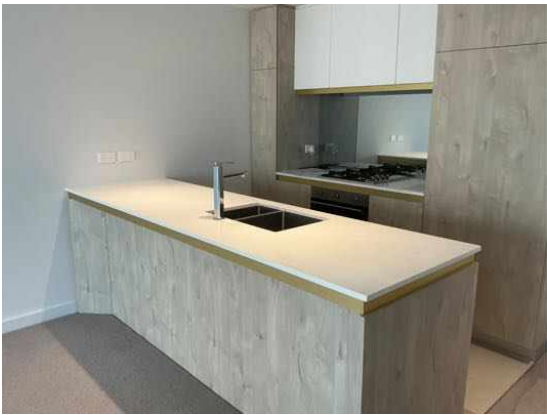
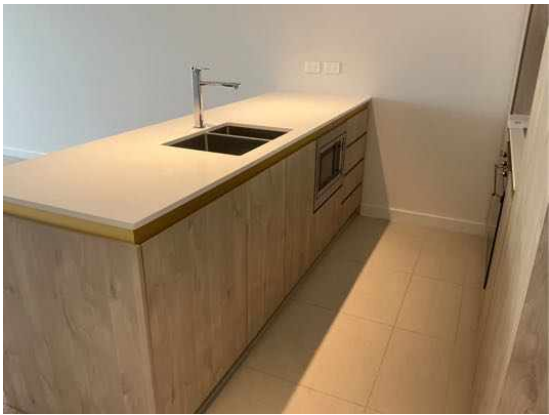
#### Noted Item

Building: Main Building  
Location: All Areas- internal  
Finding: Additional Photos - Obstructions and Limitations  
Information: These photographs are an indication of the obstructions and limitations which impeded full inspection of the property at the time of inspection. These obstructions can hide an array of defects and should be removed to allow full inspection to be carried out. A re-inspection is recommended once the areas are made accessible.
