Building and Timber Pest Inspection Report VR

Inspection Date: Mon, 9 Mar 2026

Property Address: Mystic Park, 281 Mylneford Rd, Mylneford
NSW 2460, Australia

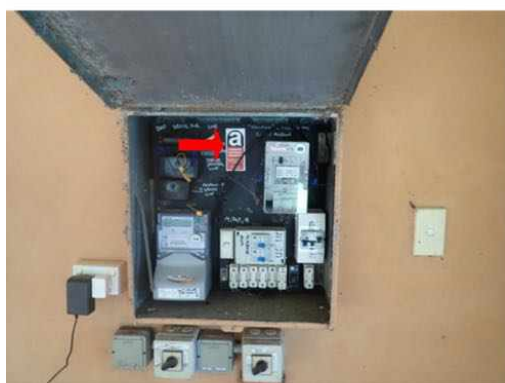
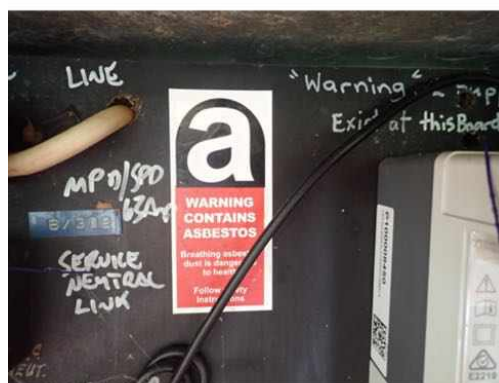
Finding 1.01

Building:	Main Building
Location:	Electrical meter box
Finding:	Asbestos Warning Sticker Located
Information:	An asbestos warning sticker has been identified in the meter box. This indicates that asbestos-containing materials may be present within the building. It is recommended that care be taken when carrying out any works that may disturb building materials, and that a licensed asbestos professional be engaged if disturbance, repair, or removal is required.

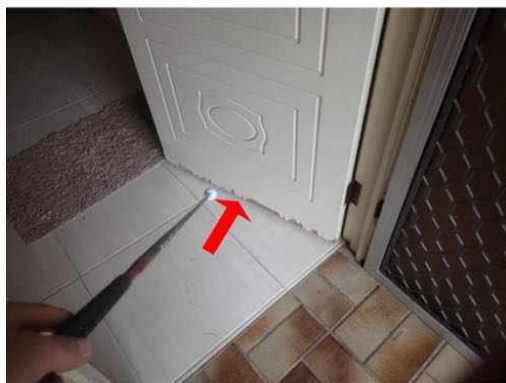
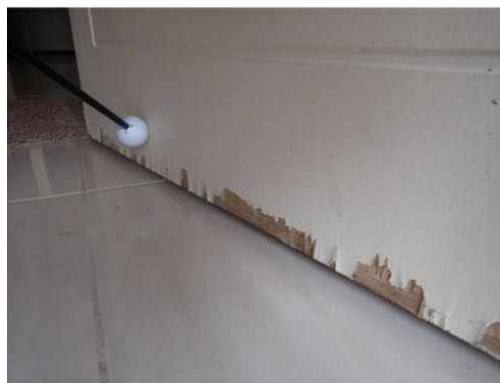
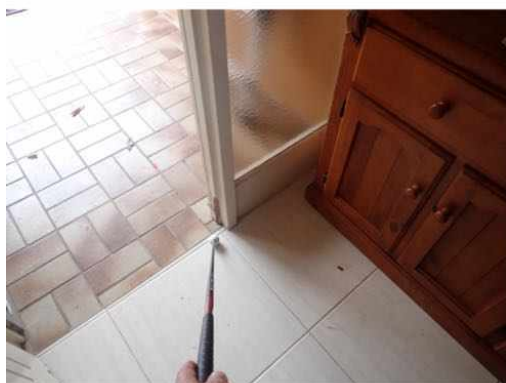
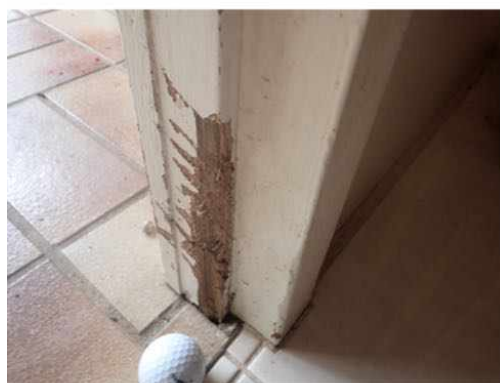
Finding 3.01

Building:	Main Building
Location:	Front entry door
Finding:	Damage To Front Entry Door And Door Jamb At Base
Information:	Damage has been identified to the bottom of the front entry door and door jamb. This is typically associated with moisture exposure, wear and tear, or impact damage. If left unaddressed, the condition may worsen and lead to further deterioration of the timber components. It is recommended that a carpenter or suitably experienced handyman repair or replace the affected areas and apply appropriate protective finishes. Repairs can be carried out at the owner's discretion.

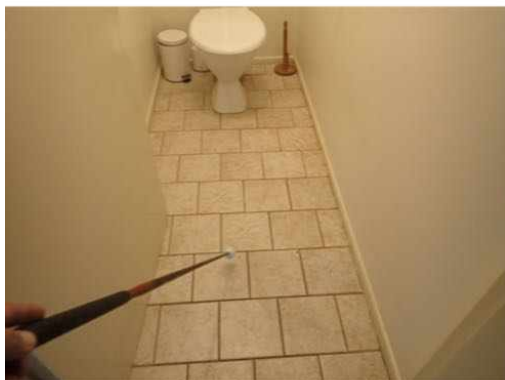
Finding 3.02

Building:	Main Building
Location:	Toilet (WC)
Finding:	Drummy Floor Tiles To Toilet
Information:	Drummy floor tiles have been identified to the toilet area. This is typically associated with poor installation, inadequate adhesion, substrate movement, or age-related deterioration. Loose tiles may worsen over time if left unaddressed. It is recommended that a tiler or suitably experienced handyman remove and replace the affected tiles and assess the condition of the substrate as required. Repairs can be carried out at the owner's discretion.

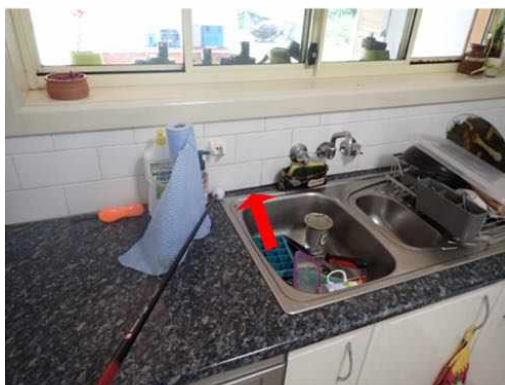
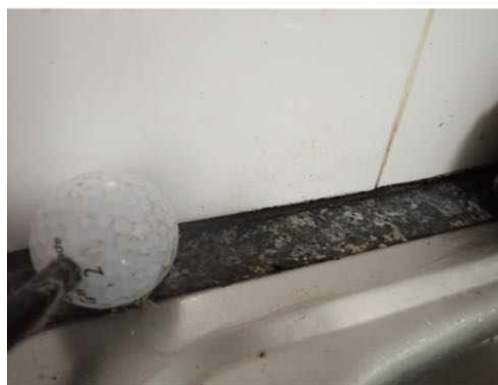
Finding 3.03

Building:	Main Building
Location:	Kitchen
Finding:	Deteriorated Silicone To Kitchen Splashback And Benchtop Junction
Information:	Deteriorated silicone has been identified to the junction between the tiled splashback and benchtop in the kitchen. This is typically associated with age-related wear and breakdown of sealants over time. Defective silicone may allow moisture ingress behind the splashback, potentially leading to deterioration of surrounding materials if left unaddressed. It is recommended that a tiler or suitably experienced handyman remove and replace the affected silicone to ensure a watertight seal. Repairs can be carried out at the owner's discretion.

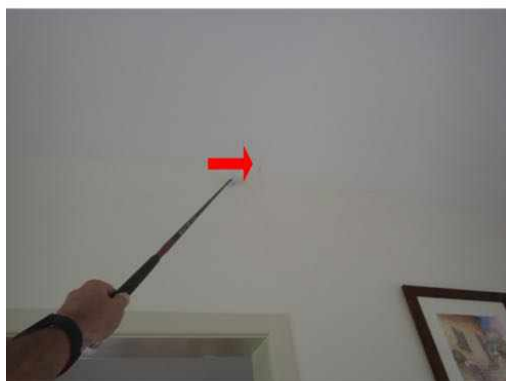
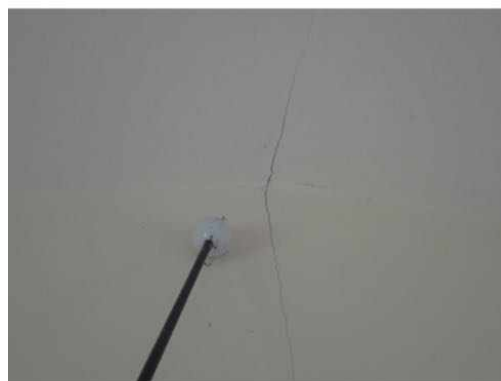
Finding 3.04

Building:	Main Building
Location:	Living room
Finding:	Minor Cracking To Internal Cladding In Living Room
Information:	Minor cracking has been identified to the internal wall cladding within the living room. This is typically associated with normal settlement, minor movement, or age-related deterioration and is considered a common defect. If cracks increase in size over time, further assessment may be required. It is recommended that a plasterer or suitably experienced handyman repair and make good the affected areas as required. Repairs

can be carried out at the owner's discretion.

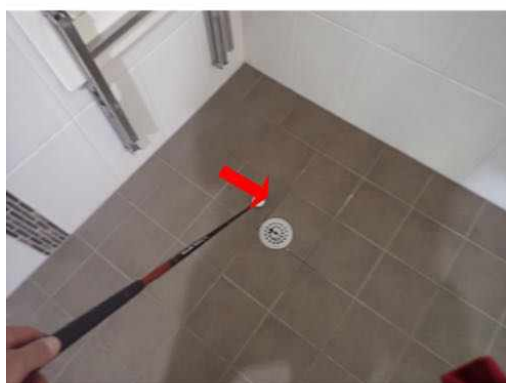
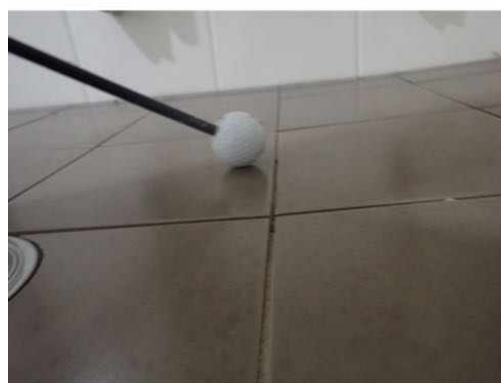
Finding 3.05

Building:	Main Building
Location:	Ensuite
Finding:	Deteriorated Grout To Ensuite Shower
Information:	Deteriorated grout has been identified to the ensuite shower. This is typically associated with age-related wear, moisture exposure, and breakdown of materials over time. Defective grout may allow water ingress into surrounding building materials, potentially leading to further deterioration if left unaddressed. It is recommended that a tiler or suitably experienced handyman remove and replace the affected grout to maintain a watertight seal. Repairs can be carried out at the owner's discretion.

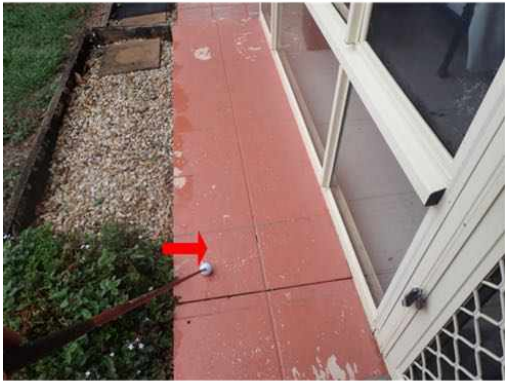
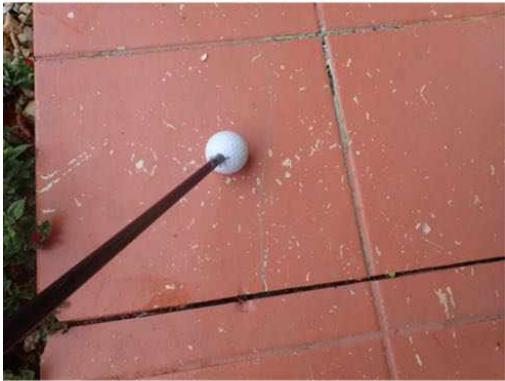
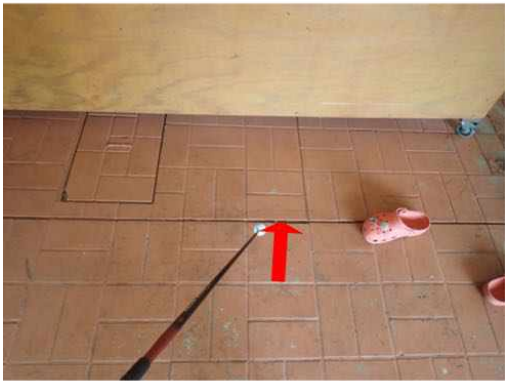
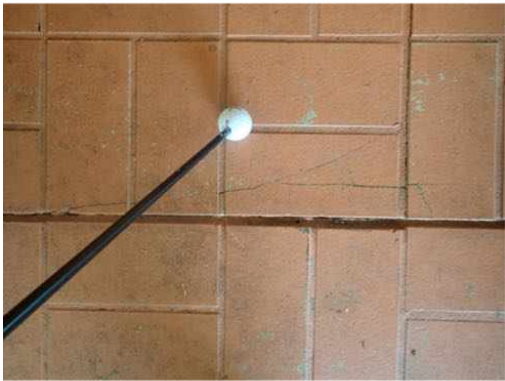
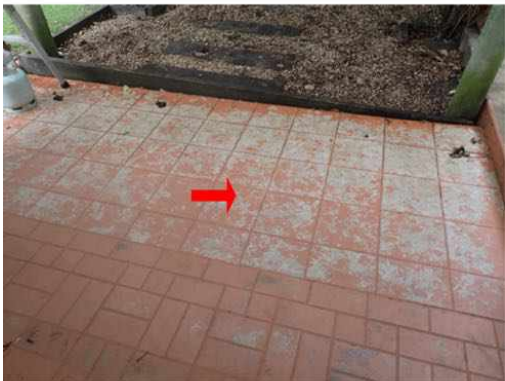
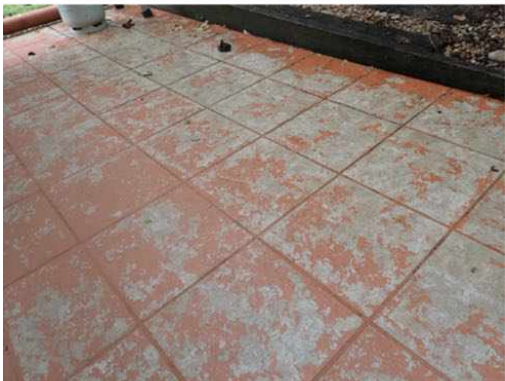
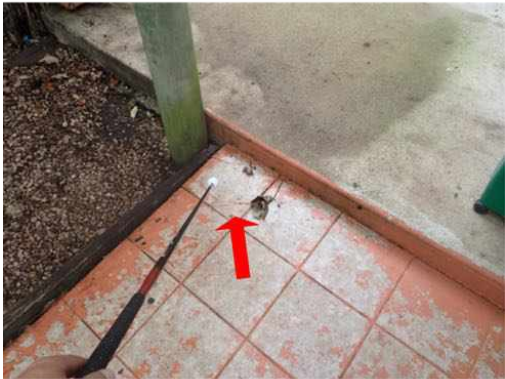
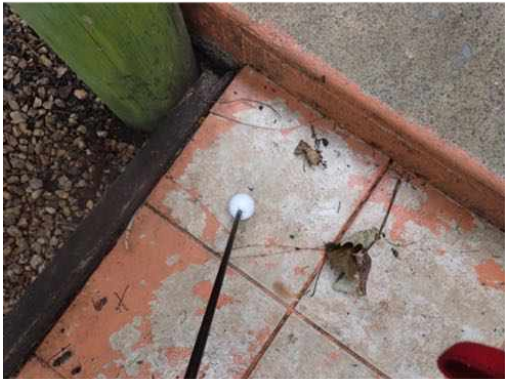
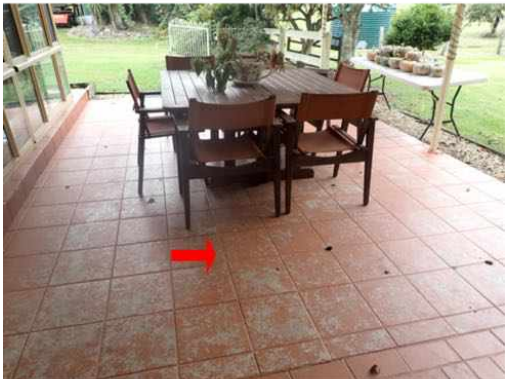
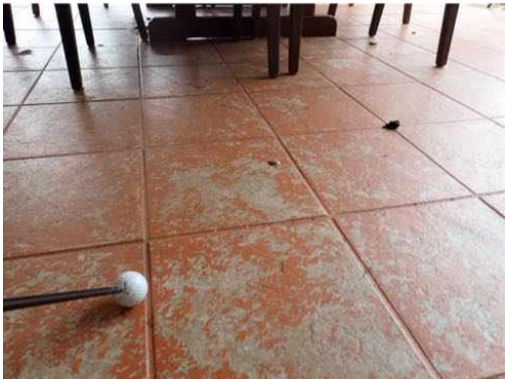
Finding 3.06

Building:	Main Building
Location:	Side alfresco area
Finding:	Cracked And Damaged Tiles And Faded Paint To Side Alfresco Area Floor
Information:	Cracked and damaged tiles along with faded paint have been identified to the side alfresco area floor. This is typically associated with age-related deterioration, weather exposure, substrate movement, or previous surface coatings breaking down over time. The condition may continue to deteriorate if left unaddressed. It is recommended

that a tiler or suitably experienced handyman remove and replace the affected tiles, assess the condition of the substrate, and reapply appropriate floor coatings as required. Repairs can be carried out at the owner's discretion.

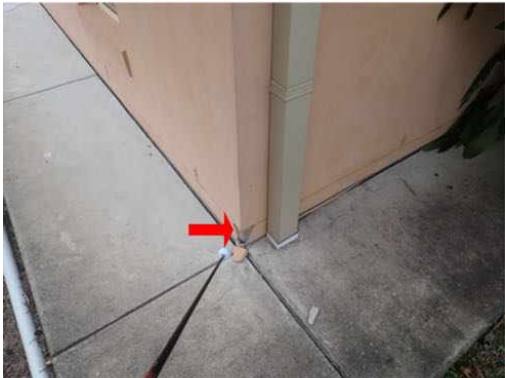
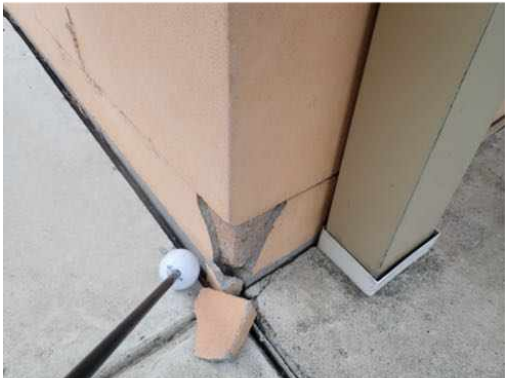
Finding 3.07

Building: Main Building
Location: Corner of building
Finding: Damaged Render To Corner Of Building
Information: Damage has been identified to the render at the corner of the building. This is typically associated with impact damage, minor movement, or age-related deterioration. If left unaddressed, the damage may worsen and allow moisture ingress into the underlying structure. It is recommended that a renderer or suitably experienced handyman repair and make good the affected area to restore the protective finish. Repairs can be carried out at the owner's discretion.

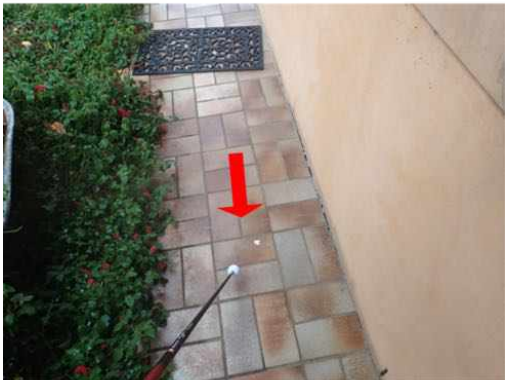
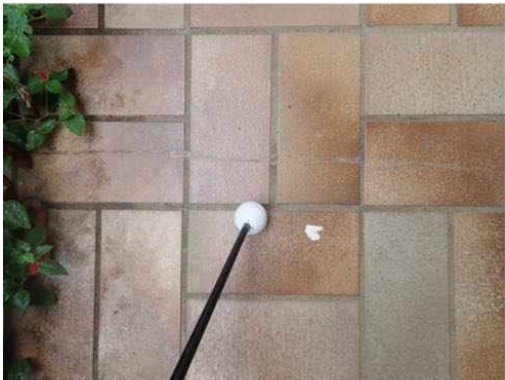
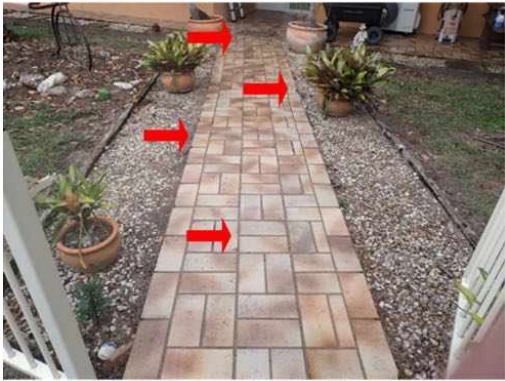
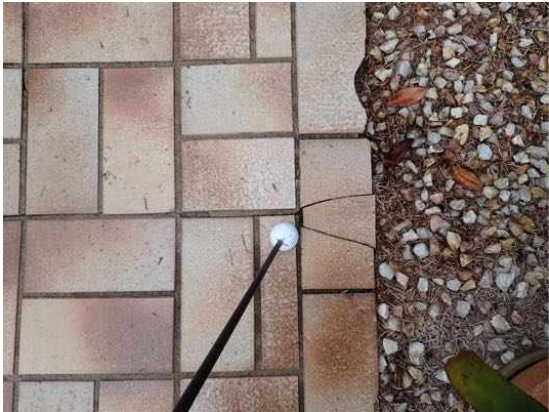
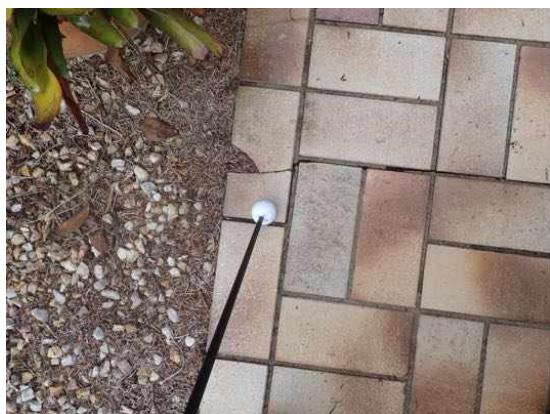
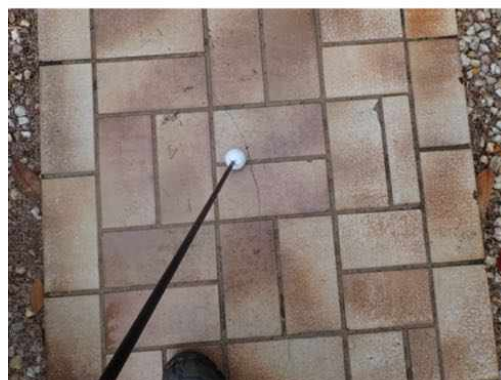
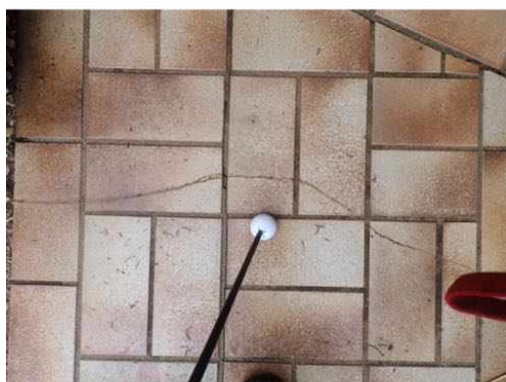
Finding 3.08

Building: Main Building
Location: Tiled path
Finding: Cracked And Damaged Tiles To External Pathways
Information: Cracked and damaged tiles have been identified to the path leading up to the front door and extending around the side of the building. This is likely associated with impact-related damage, substrate movement, or age-related deterioration. The condition may worsen over time if left unaddressed. It is recommended that a tiler or suitably experienced handyman remove and replace the affected tiles and assess the condition of the substrate as required. Repairs can be carried out at the owner's discretion.

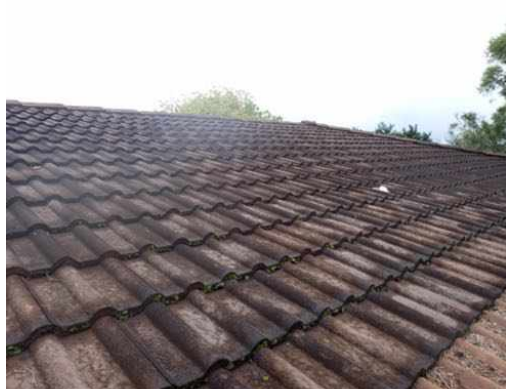
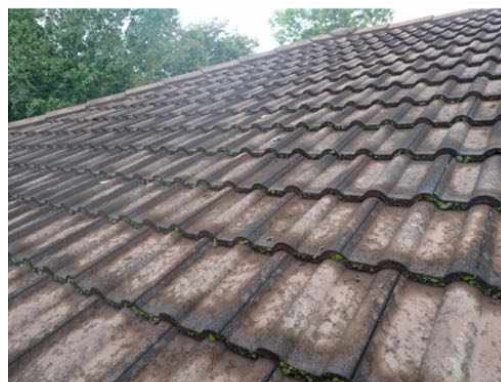
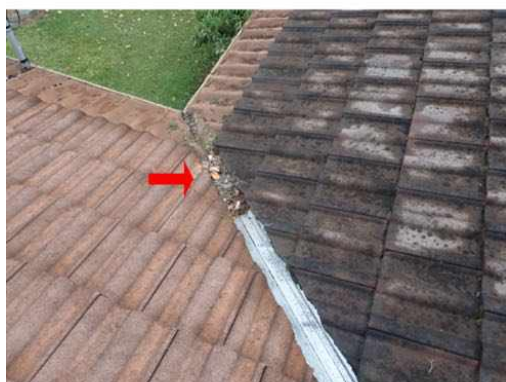
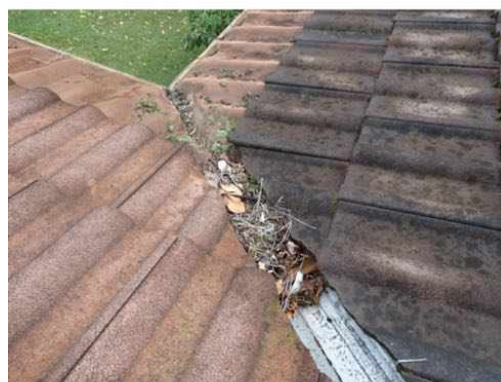
Finding 3.09

Building:	Main Building
Location:	Roof
Finding:	Roof Tiles In Fair Condition With Fading And Moss Growth
Information:	Roof tiles were observed to be in fair condition overall, however fading of the tiles and moss growth to the tiles have been identified. Gutters and roof valleys also require cleaning due to debris and organic buildup. This is typically associated with age-related deterioration and environmental exposure. If left unaddressed, moss growth and blocked drainage components may lead to moisture retention and reduced roof performance. It is recommended that a licensed roofer or suitably experienced handyman clean the roof, gutters, and valleys, and carry out maintenance as required. Repairs and maintenance can be carried out at the owner's discretion.

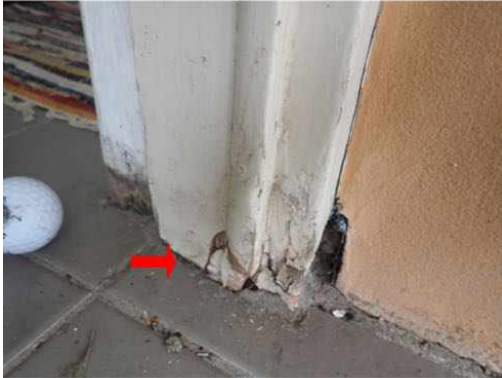
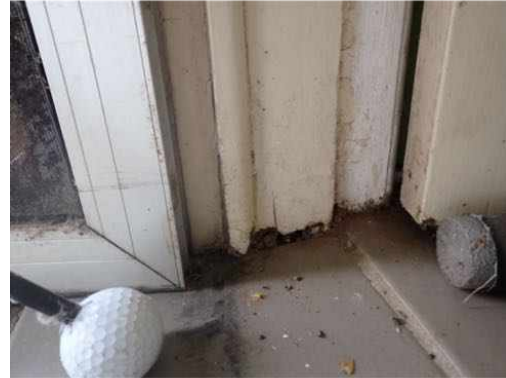
Finding 7.01

Building: Main Building
Location: Laundry
Finding: Wood Rot To Laundry External Door Jamb At Base
Information: Wood rot has been identified to the bottom of the laundry external door jamb. This is typically associated with prolonged moisture exposure and breakdown of protective coatings. Timber in this condition may continue to deteriorate over time and is

conducive to termite attack if left unaddressed. It is recommended that a carpenter or suitably experienced handyman repair or replace the affected timber and apply appropriate protective finishes to prevent recurrence. Repairs can be carried out at the owner's discretion.

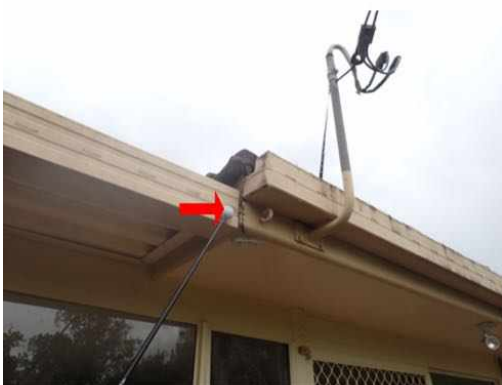
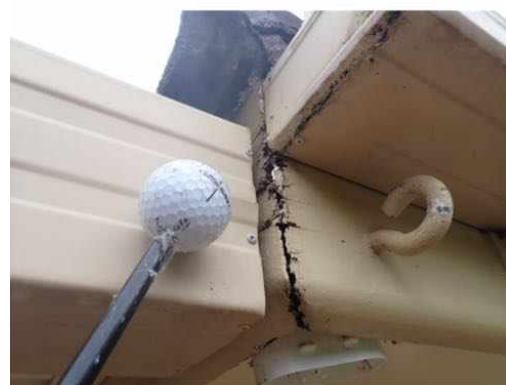
Finding 7.02

Building:	Main Building
Location:	Fascia boards
Finding:	Wood Rot To Fascia Board Corners
Information:	Wood rot has been identified to the corners of the fascia boards. This is typically associated with prolonged moisture exposure and breakdown of protective coatings. Timber in this condition may continue to deteriorate over time and is conducive to termite attack if left unaddressed. It is recommended that a carpenter or suitably experienced handyman repair or replace the affected timber and apply appropriate protective finishes to prevent recurrence. Repairs can be carried out at the owner's discretion.

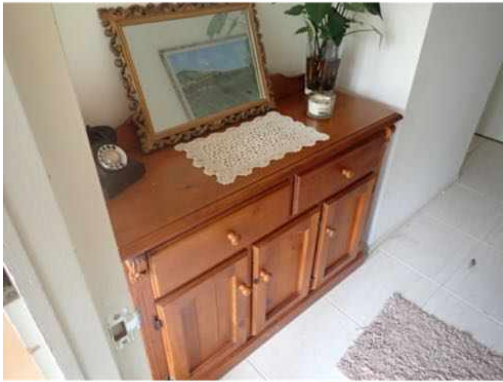
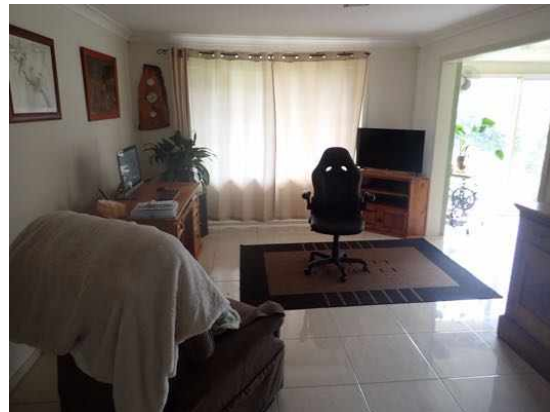
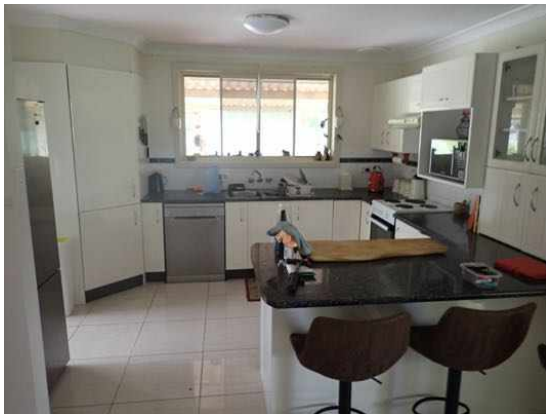
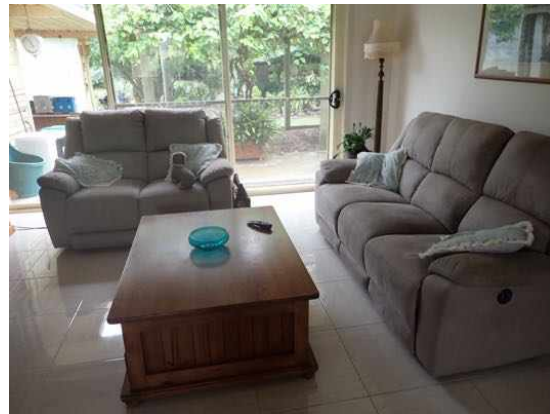
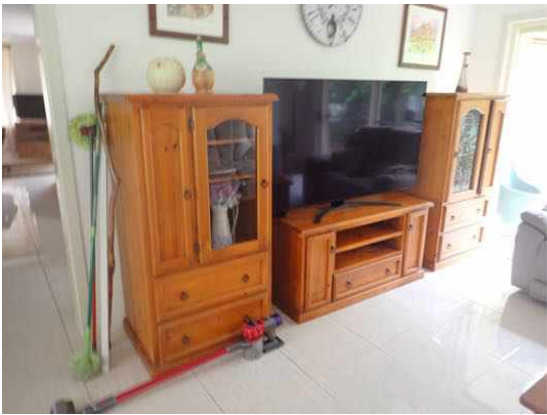
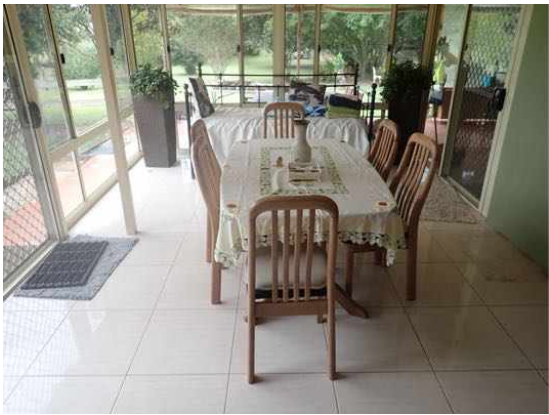
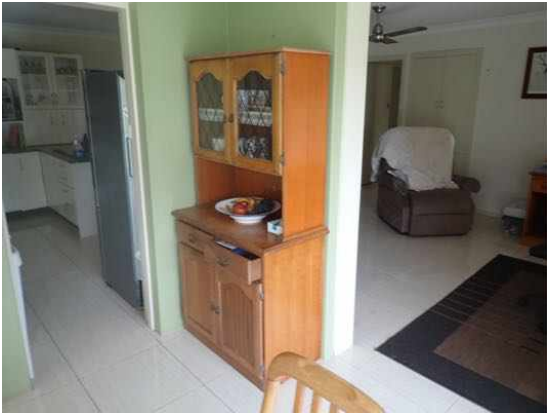
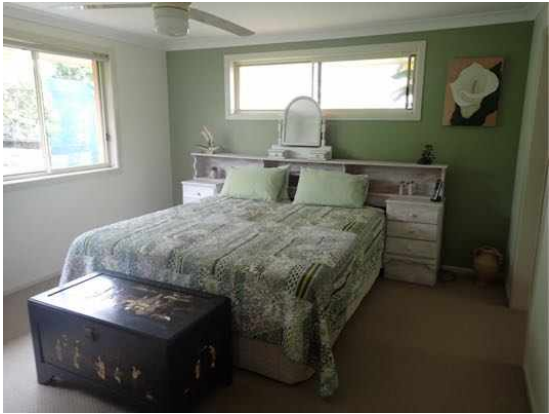
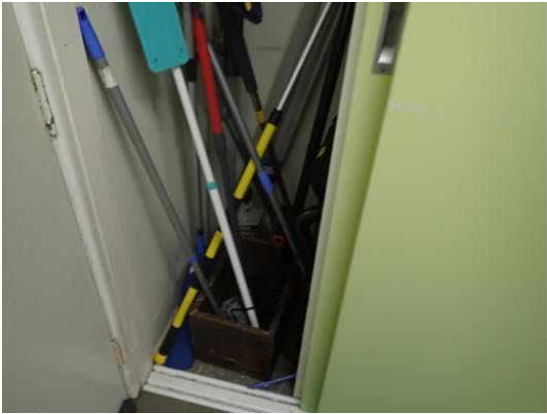
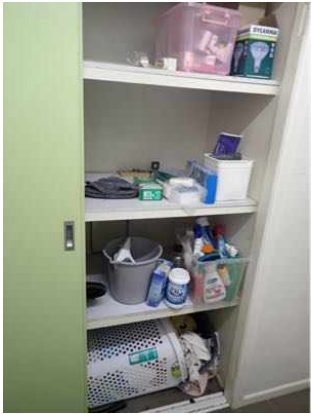
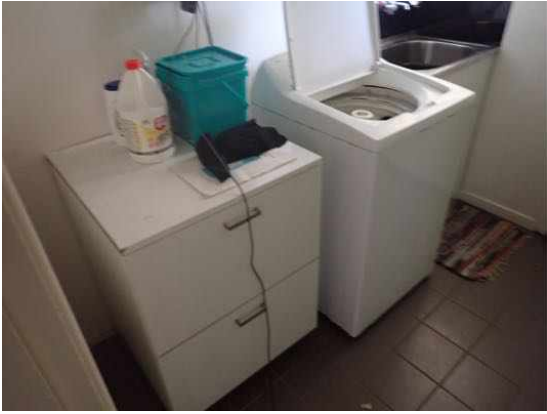
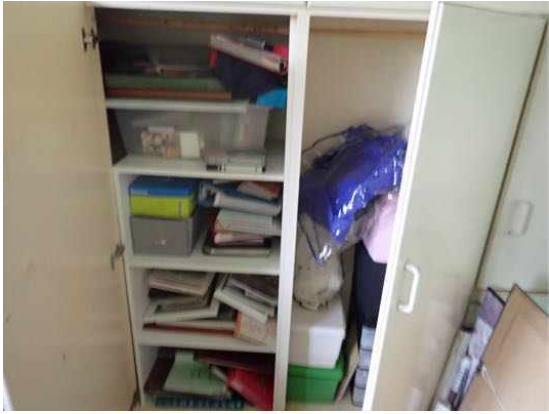
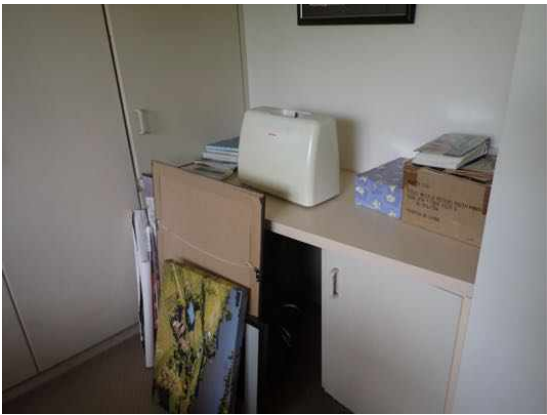
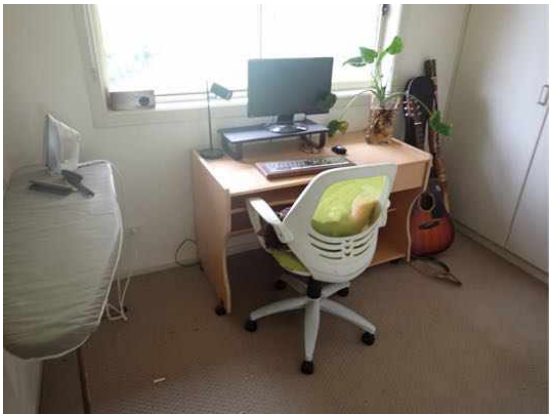
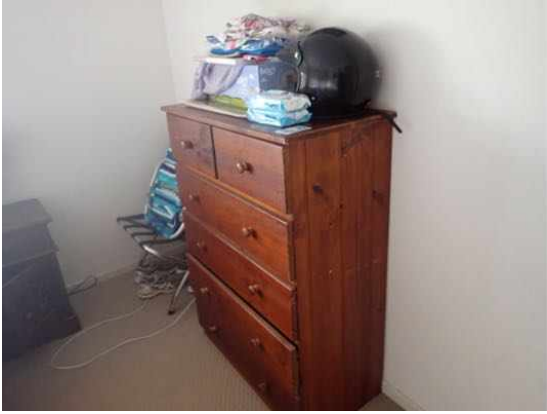
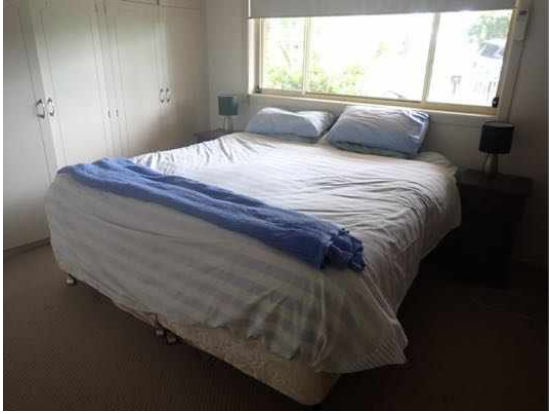
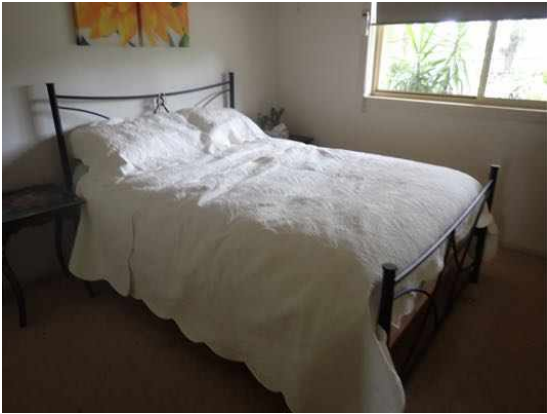
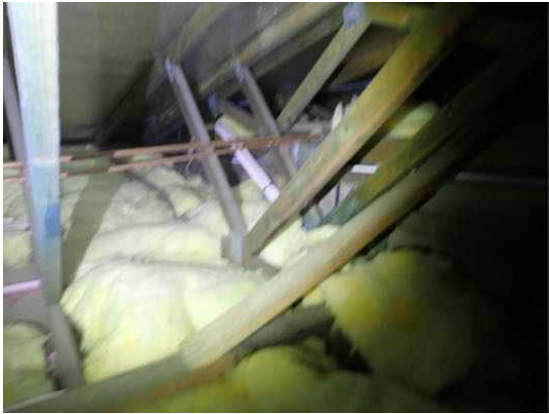
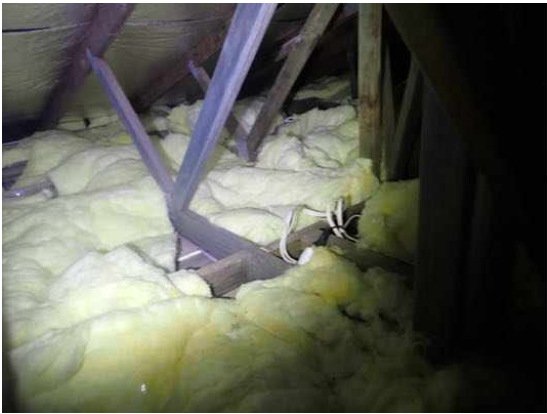
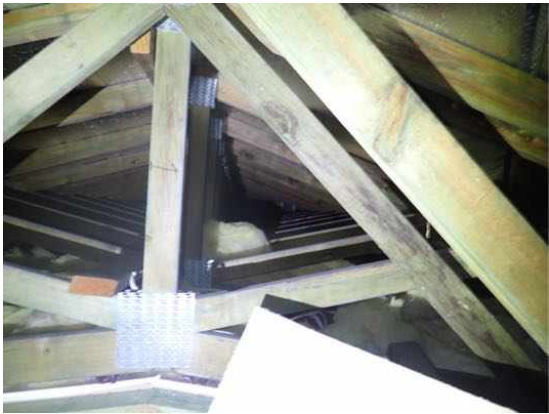
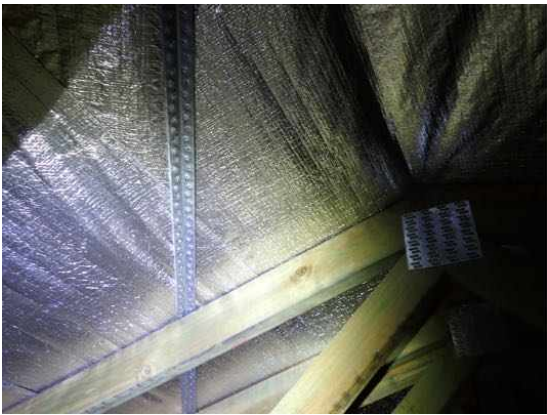
Noted Item

Building: Main Building
Location: All Areas
Finding: Additional Photos - Obstructions and Limitations
Information: These photographs are an indication of the obstructions and limitations which impeded full inspection of the area at the time of inspection. These obstructions can hide an array of defects and should be removed to allow full inspection to be carried out. A re-inspection is recommended once the areas are made accessible.
