## Building Inspection Report

Inspection Date: Mon, 23 Mar 2026

Property Address: 17 Copper Dr, Catherine Field NSW 2557,  
Australia

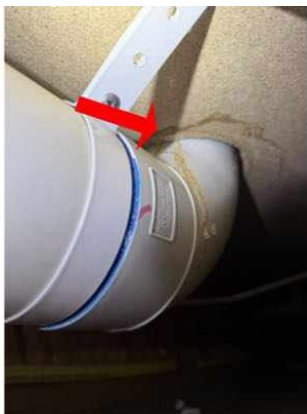
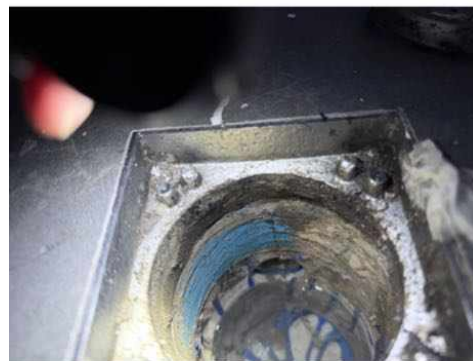
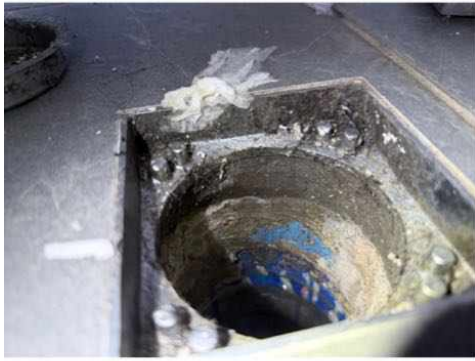
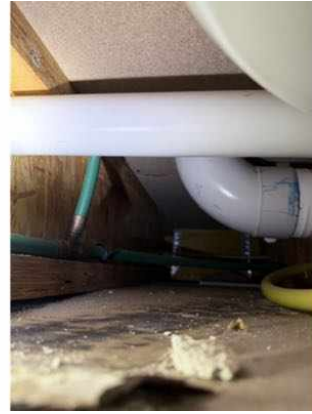
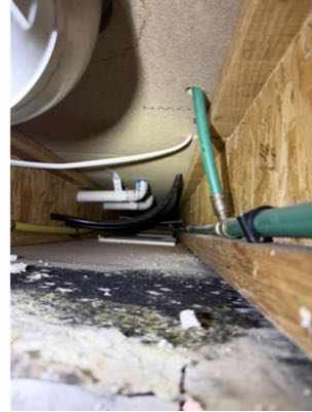
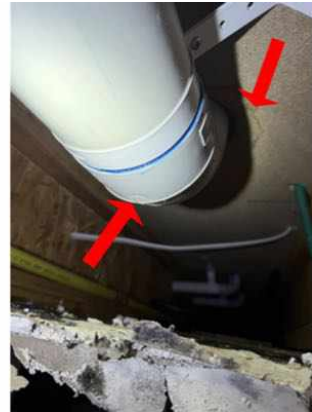
#### Defects 2.01

Building: Main Building  
Location: Bathroom  
Finding: Bathroom Water Leak  
Information: It was found that the bathroom had a water leak to the floor waste.

Water mark is observed to the top of the pipe and around the floor waste.

No water leak was found to the wall and wall junction of the bathroom.

- Waterproofing defects is identified to the floor waste of the bathroom, repair to the waterproofing is recommended.

Remove tile

Repair waterproofing at junction with puddle flange

Reinstate tile

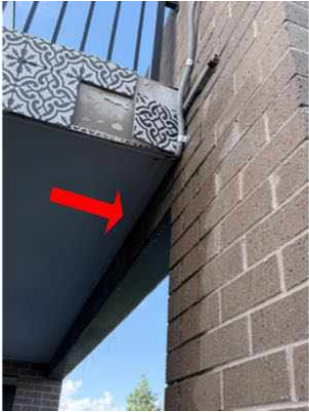
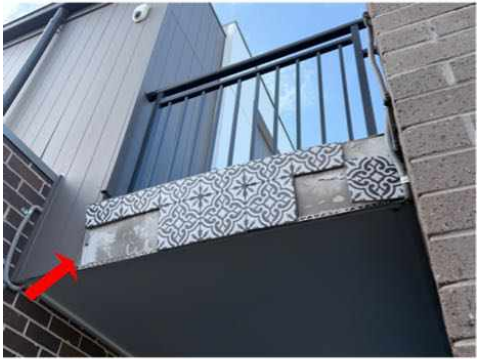
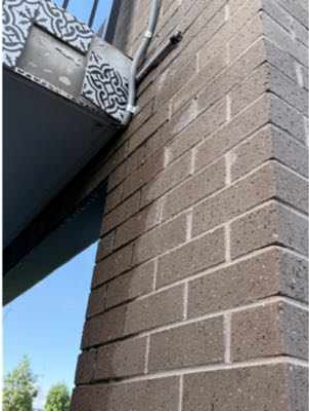
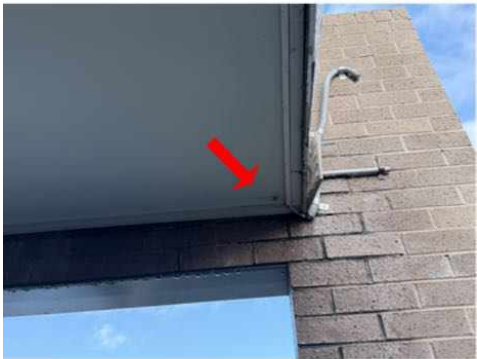
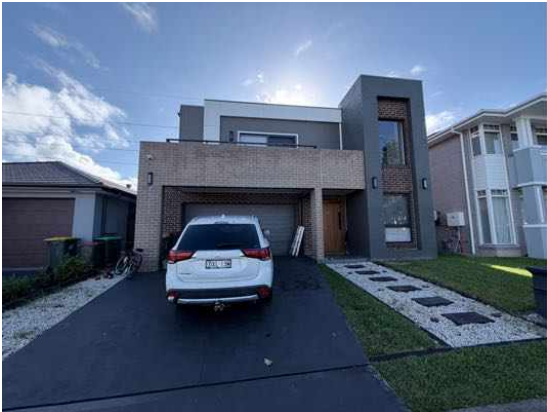
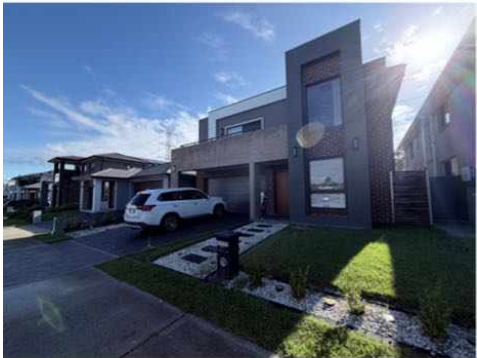
## Defects 2.02

Building: Main Building  
Location: Balcony  
Finding: Balcony Water Leak  
Information: During the inspection, it was found that the balcony is leaking.

It is noted that the builder did not complete the work to the balcony.

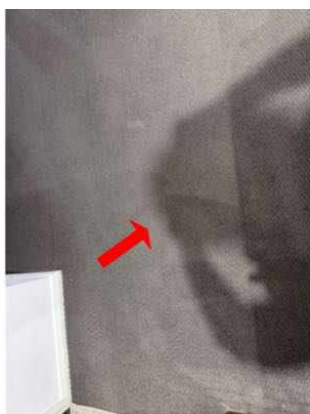
### Defects 3.01

Building: Main Building  
Location: Bedroom - Master  
Finding: Floor Board Squeaking  
Information: The floor board is found to be squeaking to the master bedroom,

Lift up carpet,

Install more fixings to remove squeak.

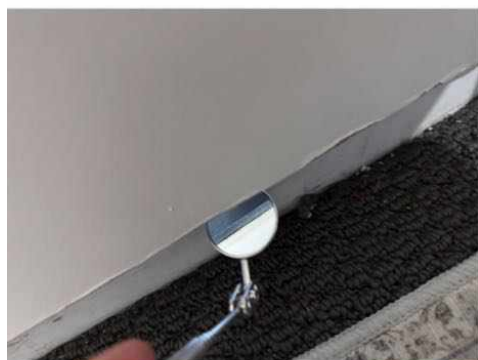
### Defects 3.02

Building: Main Building  
Location: Ensuite - Master  
Finding: Base of Door - Cut and Unpainted  
Information: The base of the ensuite sliding door has been over cut and the base has not been painted.
