Building and Timber Pest Inspection Report

Inspection Date: Fri, 27 Mar 2026

Property Address: 2/1-3 Thomas St, Hornsby NSW 2077,
Australia

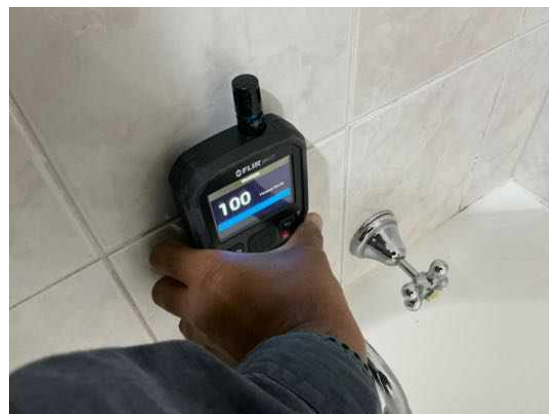
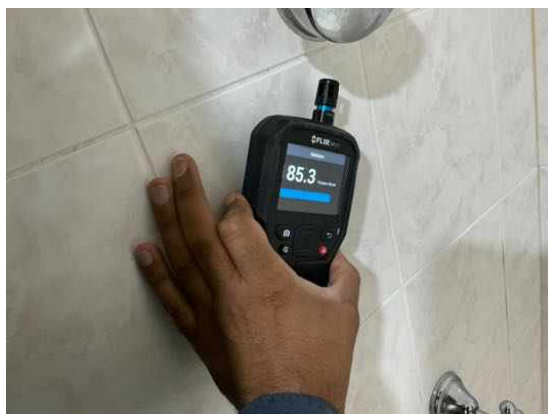
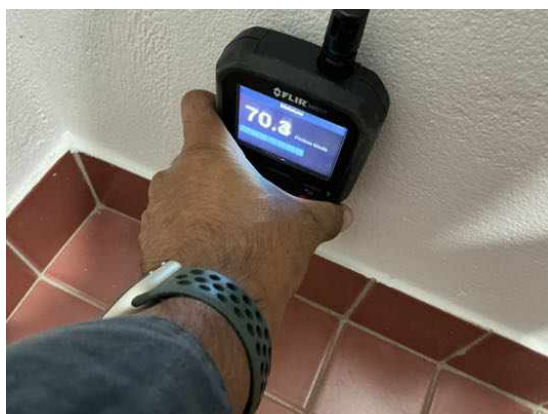
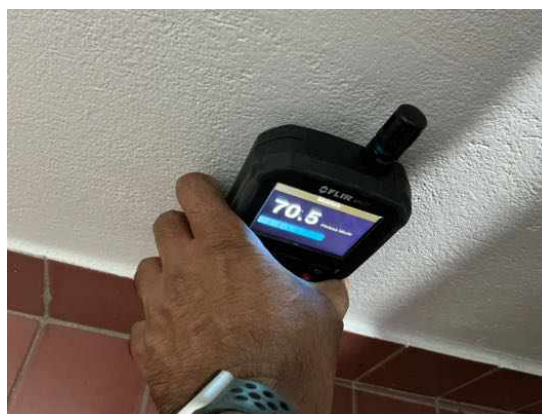
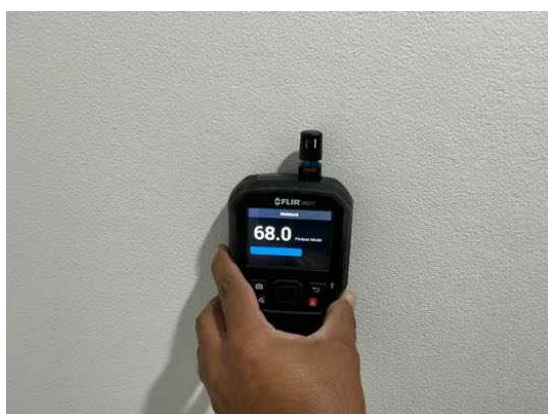
Building:	Main Building
Location:	Toilet (WC)
Finding:	Shower Damp - Adjacent Bathroom (Monitoring)
Information:	At the time of inspection, elevated moisture levels were detected on the wall adjacent to the shower area. While no visible water damage or deterioration was noted, the presence of moisture suggests possible seepage or condensation associated with regular shower use.

At this stage, no immediate action is required. However, the area should be monitored over the next 12 months for any signs of deterioration such as staining, bubbling paint, or mould growth. It should be noted that moisture ingress of this nature does not generally resolve without intervention, and at some point remedial works are likely to be required. Should conditions worsen, the client is advised to engage services of a licensed plumber or waterproofing specialist to rectify the issue of moisture before this minor defect turns into major defect.

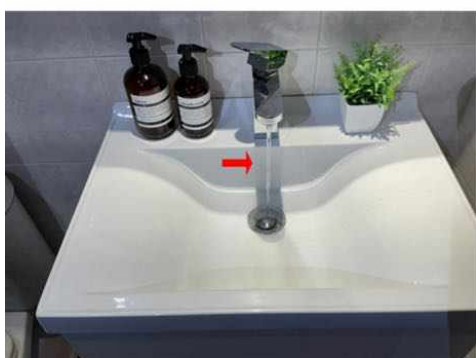
Information: At the time of inspection, low water pressure was observed from these plumbing fixture(s). This condition may be caused by several factors including partially closed isolation valves, blocked or clogged aerators, sediment build-up within the pipework, or issues with the local water supply pressure. In some cases, old or corroded pipework can also restrict water flow.

While the issue may be minor and easily rectified, it is recommended that the client engage a licensed plumber or strata at their discretion.

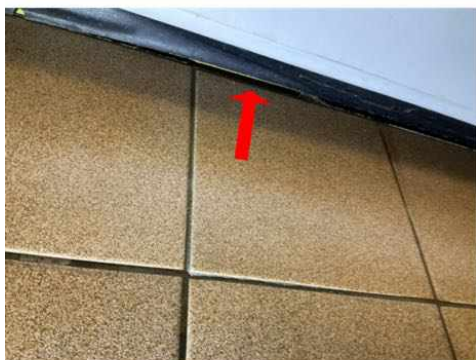
Finding 3.04

Finding: Areas - Not Sealed

Information: At the time of inspection, certain areas were found to be unsealed, which may allow moisture ingress, pest entry, or air leaks. Gaps and unsealed sections can contribute to deterioration over time and reduce the overall integrity of the structure. It is recommended to seal the affected areas to prevent potential damage and ensure better protection against environmental factors.

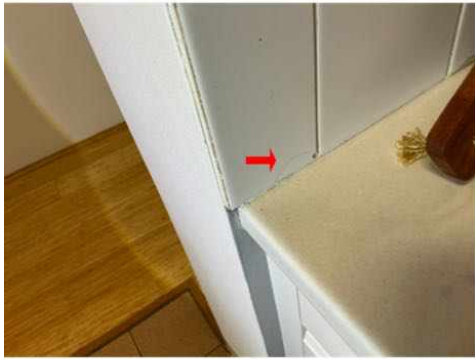
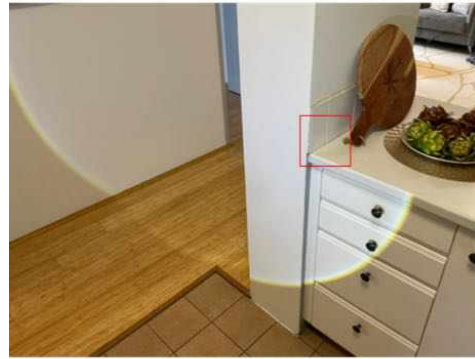
Finding 3.05

Finding: Tiles - Cracked and/or Damaged

Information: At the time of inspection, cracking in the tiles was evident in this area. It is suspected that this cracking has occurred as a result of minor settlement or material shrinkage.

While the cracking appears to be minor, this area may be exposed to water, allowing potential for water penetration into adjoining sections of walls or flooring. In wet areas particularly, cracked or compromised tiles can allow moisture to bypass the surface finish and place additional stress on the underlying waterproofing membrane. Over time, this may contribute to deterioration of the waterproofing system and shorten its effective service life.

While not considered a matter of urgency, replacement of cracked tiles is recommended at the client's discretion, particularly in wet areas to preserve the integrity and longevity of the waterproofing system. A licensed tiling contractor may be appointed to perform these works.

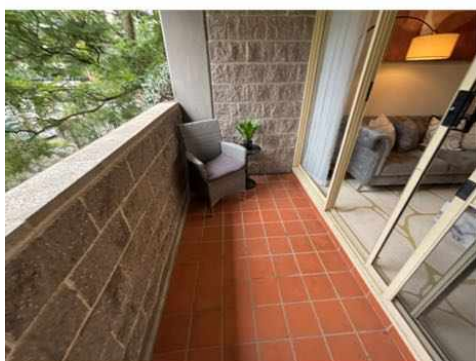
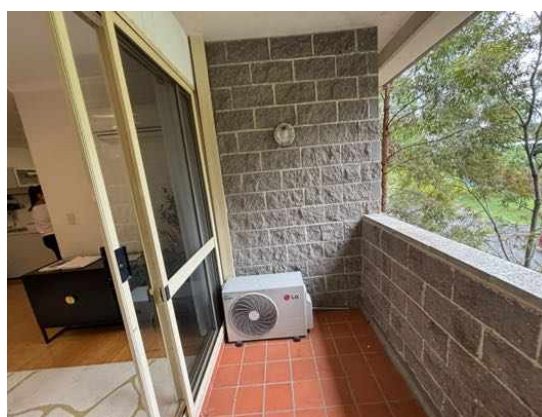
Building: Main Building
 Location: All External Areas
 Finding: Obstructions and Limitations - External Areas
 Information: The attached photographs provide a visual representation of the obstructions and limitations that impeded a full inspection of the external areas of the property at the time of assessment. These obstructions, which may include vegetation, stored items, debris, or other physical barriers, can obscure potential defects and prevent a thorough evaluation of the property's condition. Obstructions of this nature can conceal a wide range of issues, such as structural damage, water ingress, pest infestations, or deteriorating building materials, which may not be visible during the initial inspection.

It is essential that these obstructions be cleared to allow for a comprehensive inspection of the external areas. Removing these barriers will enable a more accurate assessment of the property's condition and allow any hidden defects to be identified and addressed promptly. Failure to do so could result in undetected issues worsening over time, potentially leading to more costly repairs in the future.

Therefore, it is strongly recommended that the obstructions be removed and a re-inspection be scheduled once the affected areas are made fully accessible. This will ensure a complete evaluation of the property's exterior and provide the client with a clear understanding of any potential issues that may have been concealed during the initial inspection.

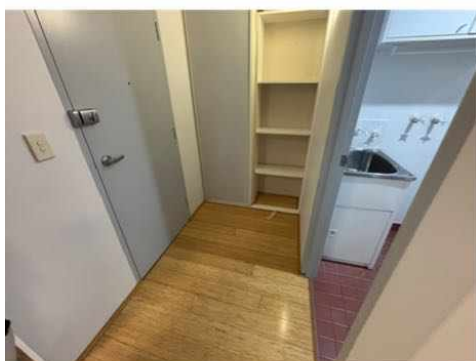
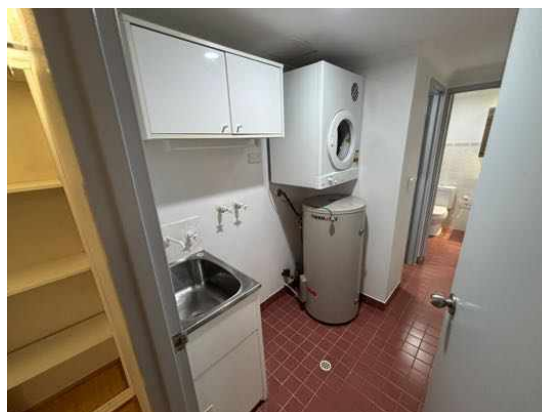
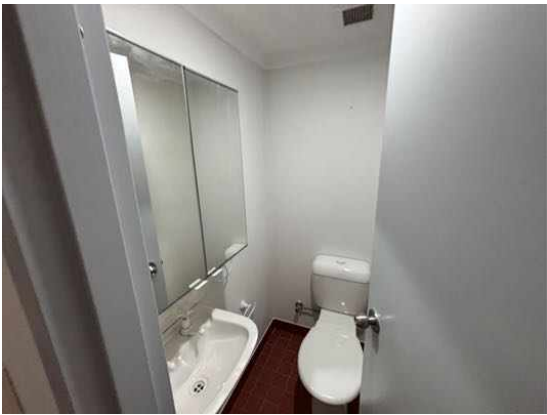
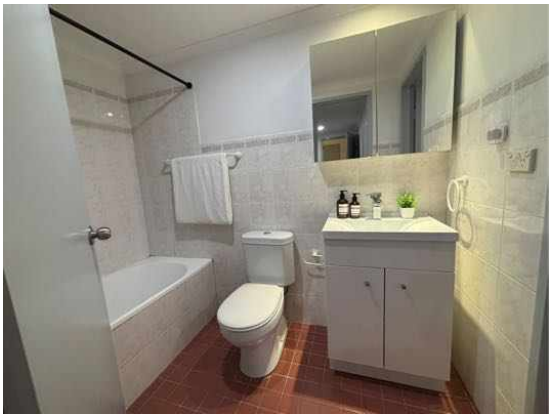
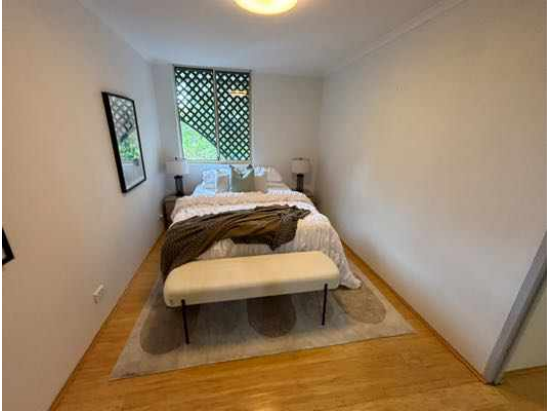
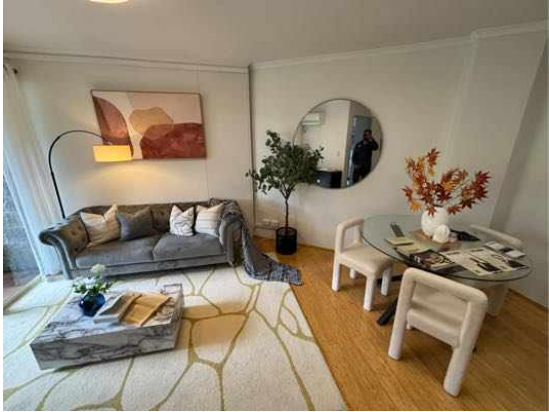
Information: The accompanying photographs provide clear evidence of the obstructions and limitations that restricted a comprehensive inspection of the internal areas of the property at the time of assessment. These obstructions, which may include furniture, personal belongings, stored items, or structural elements such as wall coverings and built-ins, significantly hindered the ability to thoroughly evaluate these areas. It is important to note that such obstructions can potentially conceal a wide array of defects, ranging from hidden structural damage, water leaks, pest infestations, or electrical issues, to deteriorating materials that may not be visible during the initial inspection.

The presence of these impediments means that critical areas of the property were not accessible, and therefore, any underlying defects that may affect the integrity and safety of the property could remain undetected. These hidden defects, if left unaddressed, could worsen over time and may result in costly repairs or pose potential safety hazards to the occupants.

It is highly recommended that all obstructions be cleared to facilitate a complete and thorough inspection of the internal areas. Once the obstructions have been removed and full access is available, a re-inspection should be carried out to ensure that any previously concealed issues can be properly identified and rectified. This follow-up inspection will provide a more accurate assessment of the property's internal condition and help the client make informed decisions about any necessary repairs or maintenance.

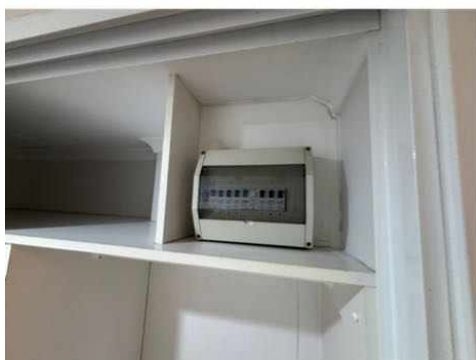
Building: Main Building
Location: Bedroom - Master
Finding: Electrical Meter Box
Information: Electrical meter box is located in master bedroom closet.
