Building and Timber Pest Inspection Report

Inspection Date: Sat, 7 Feb 2026

Property Address: 13/818 Victoria Rd, Ryde NSW 2112,
Australia

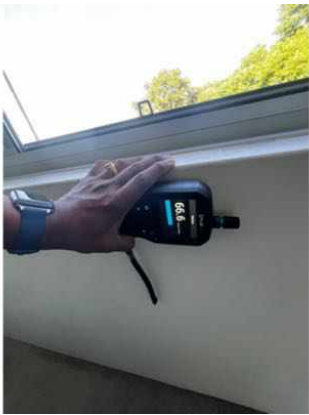
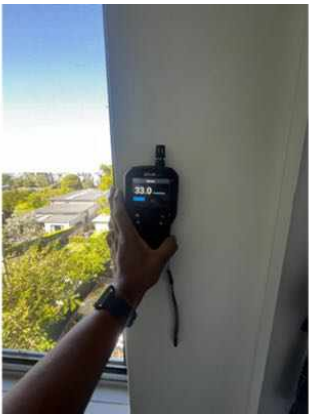
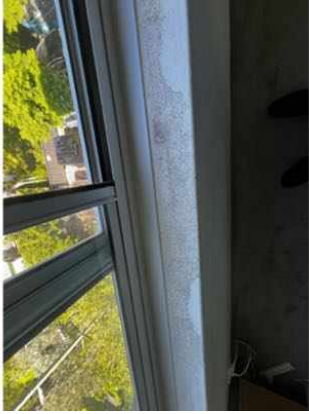
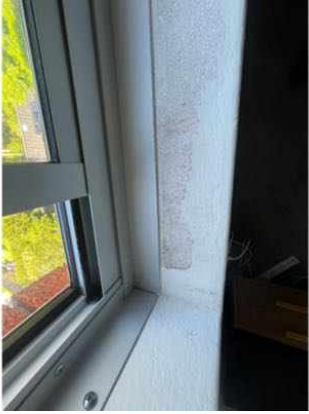
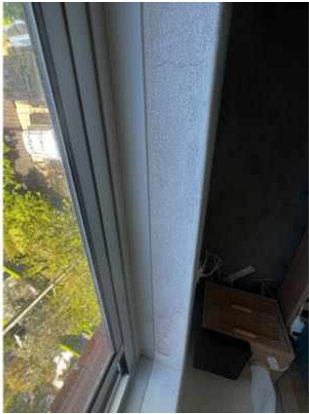
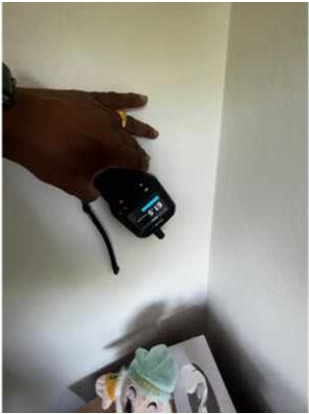
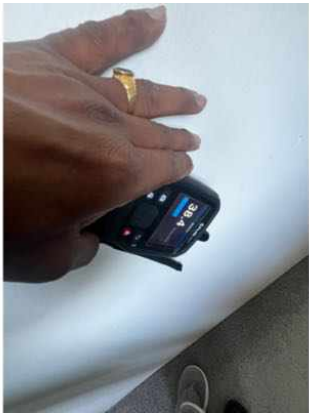
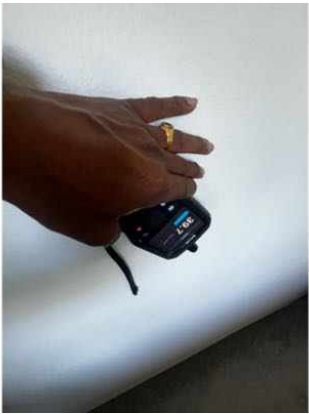
Finding 3.02

Building:	Main Building
Location:	Bathroom wall/ Window surround
Finding:	High Moisture Readings - Evidence of high moisture was present during Inspection.
Information:	All areas of dwellings are checked with particular attention paid to wet areas which were closely assessed to check for moisture levels of moisture and temperature anomalies.

High readings for moisture were found in the walls adjacent the showers in the bathroom and the laundry plumbing area at the time of inspection.

Excessive moisture is generally caused by deteriorated, inadequate or missing roof drainage, leaking plumbing pipes or fixtures, poorly plumbed HWS overflows or condenser units and poor site drainage.

It is highly recommended that all plumbing and drainage fixtures and fittings be maintained regularly in order to prevent excessive moisture being present in the external / internal property.

It is highly advised to consult a Licensed Plumber to inspect and remedy the situation.

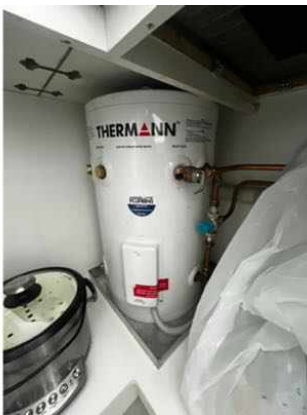
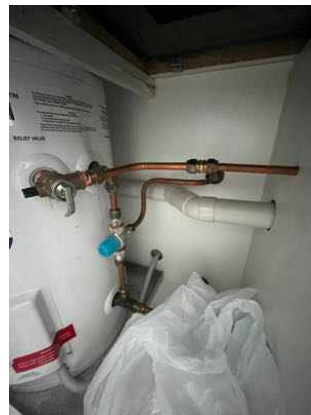
Finding 3.03

Information: The Hot Water Unit could not be inspected as there was no power at the property.

Water pressure appears to be normal, however, this is not an opinion of a licensed plumber. No water hammer was noted when taps are turned off fast.

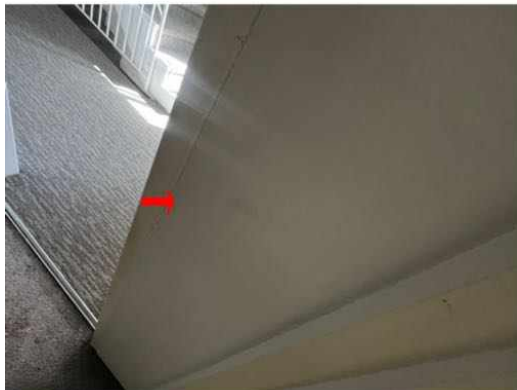
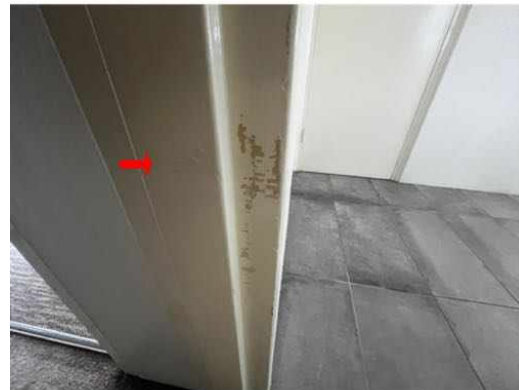
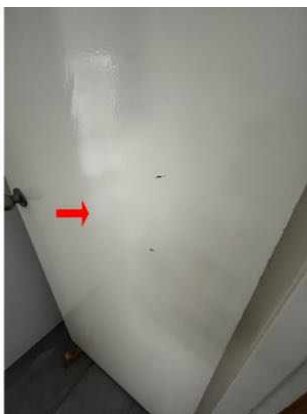
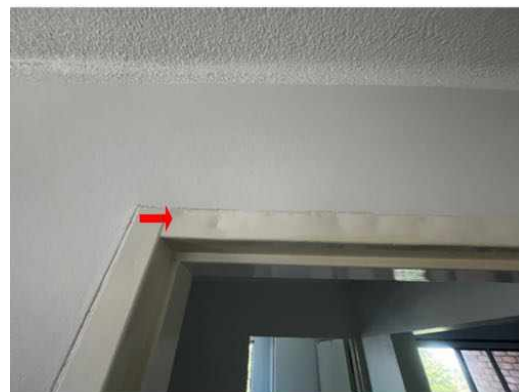
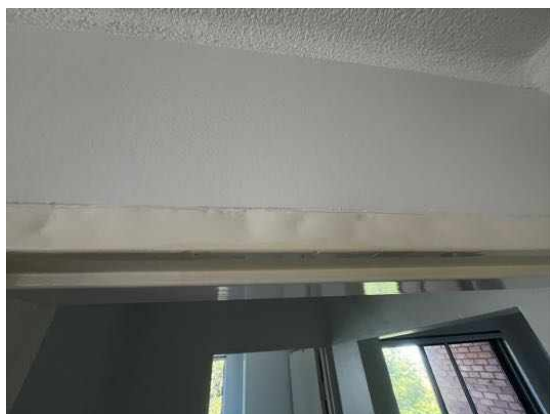
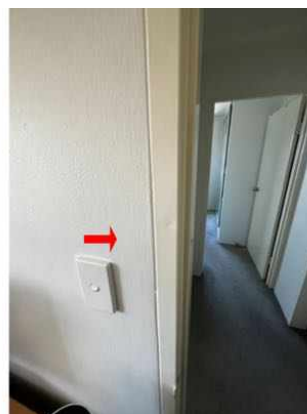
Finding 3.04

Building: Main Building
Location: Bedroom
Finding: Paint finish - Incomplete
Information: The paint finish in some areas were identified as being incomplete/ substandard/ cracks at the time of inspection. I have attached a cluster of photos taken where the defect was visible. There may be hidden defects/ smugges/blemish in the wall and ceiling areas as they were being covered by a number stored items and furniture present at the time of inspection.

Whilst incomplete or missing paint finish is generally an appearance defect, it can also lead to the development of secondary building defects over time. Incomplete areas of paint finish expose the area to moisture, potentially accelerating the deterioration of underlying building materials.

Incomplete paint finishes should be sanded back, filled, leveled and painted, as applicable. Where inadequate or missing paint protection has led to the deterioration of the associated building element, repair and/or replacement of this building element may be required.

A painting contractor should be appointed as soon as possible to perform necessary works to aid the appearance.

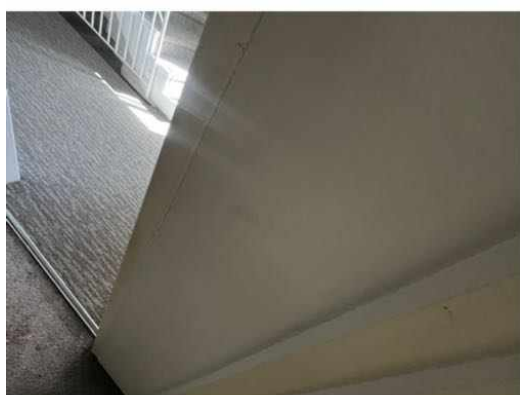
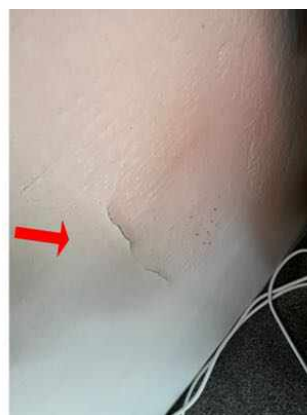
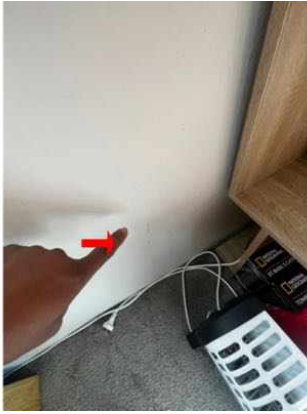
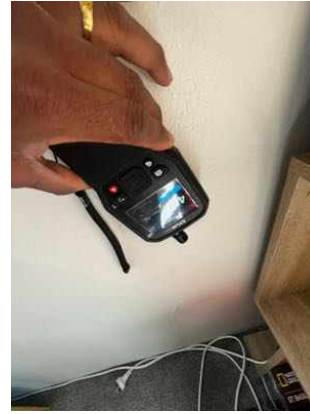
Finding 3.05

Building:	Main Building
Location:	Bedroom
Finding:	Render Cracking - Damage in Interior Render - Noticeable
Information:	Noticeable cracks are a result of many primary defects. Such causes may include age, general wear and tear, expected building movement, general expansion/contraction of building materials in different weather conditions, and/or minor failings in the installation or application of building materials.

The most important cause for the crack of render could be the moisture being trapped between the render and the wall. It could be also be due to poor application and also the sub standard matériels being used.

Extreme heat and cold weather could have also impacted the settlement of applied render. It can also be the cause of Base coat being expanded more than the Top coat being applied.

Relevant tradespeople, Licensed Renderer , Licensed Builder should be consulted before arriving at a decision to take action as they can further do an invasive inspection and remedy the situation.

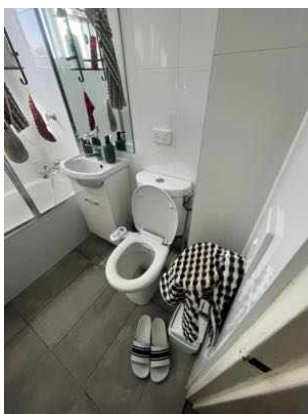
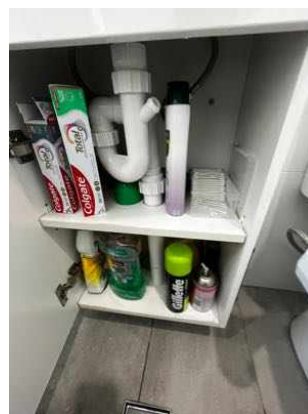
Finding 6.01

Building:	Main Building
Location:	All Areas
Finding:	Additional Photos - Obstructions and Limitations
Information:	These photographs are an indication of the obstructions and limitations which impeded full inspection of the property at the time of inspection. These obstructions can hide an array of defects and should be removed to allow full inspection to be carried out. A re-inspection is recommended once the areas are made accessible.

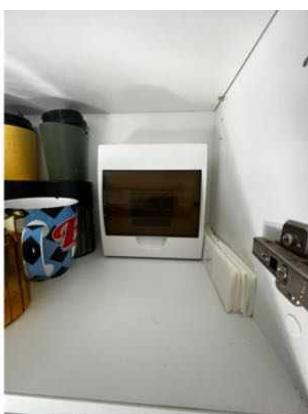
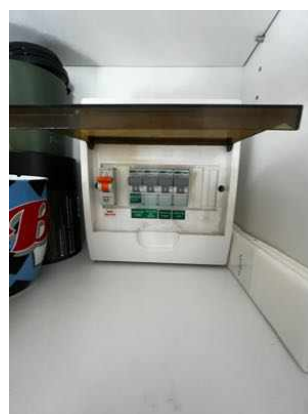
Finding 6.02

Building:	Main Building
Location:	Electrical Switchboard
Finding:	Termite Management System - no evidence of a chemical installation no Durable Notice
Information:	The application of a post-construction chemical termite barrier is highly recommended for all properties, particularly if live termite activity has been found on the site previously. Such barriers are highly effective in preventing termite attack on any timber building elements throughout the property.

A durable notice should be placed in the switchboard unit to indicate current termite barriers. At the time of inspection, it appeared as though no termite management system has been installed, with no evidence to suggest preventative works taking place.

The client may consider gaining further advice from a pest controller as to the costs and procedures involved with this application. It is recommended that obtaining such advice be a short-term priority.

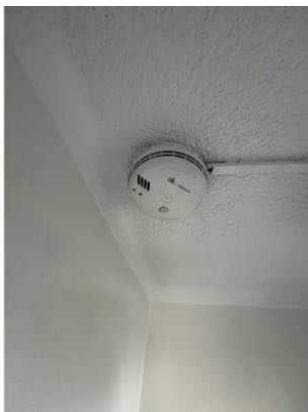
Building:	Main Building
Location:	All Internal Areas
Finding:	Smoke Detector and Alarms
Information:	Reporting on Smoke Detectors or Alarms, including hard wired smoke detection systems and their legislative requirements, is outside the Scope of this Report.

Additionally, it is advised that all smoke detectors be tested by the homeowner on a monthly basis.

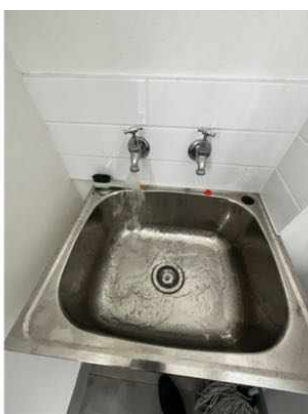
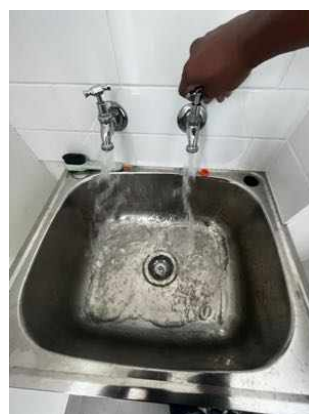
Building: Main Building
 Location: Kitchen/ Bathroom
 Finding: Cabinetry Plumbing - Kitchen/ Bathroom
 Information: All cupboards where sinks and basins with drainage plumbing were inspected and no evidence of leaks were present at the time of inspection.

If damp or wet conditions do occur there are many consequences including the development of fungal decay and/or wood rot, swelling or water damage to building materials.

For your information only no remedial works are required at the time of inspection.
