Building and Timber Pest Inspection Report

Inspection Date: Mon, 2 Mar 2026

Property Address: 9/15 Boundary St, Darlinghurst NSW 2010, Australia

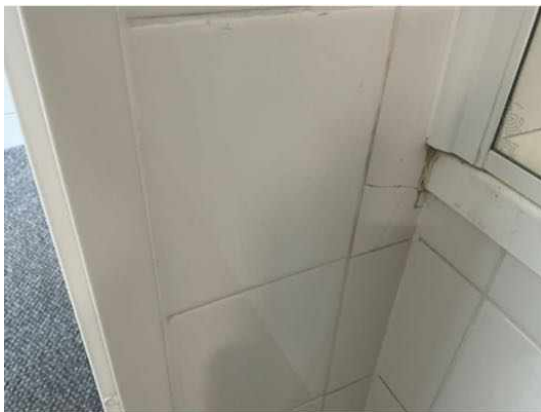
Finding 3.01

Building: Main Building
 Location: Ensuite - Master
 Finding: Cracked tiles
 Information: Cracking of the identified tiles was evident in this area at the time of inspection. It is suspected that this cracking has occurred as a result of minor settlement or impact damage to the area.

Cracked tiles throughout the household detract from the overall appearance of the affected areas however it is unlikely to create or lead to any secondary defects.

While not considered a matter of urgency, replacement of cracked tiles is recommended. A tiling contractor may be appointed to perform these works.

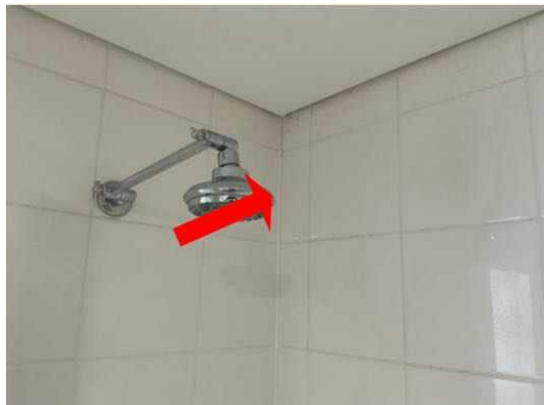
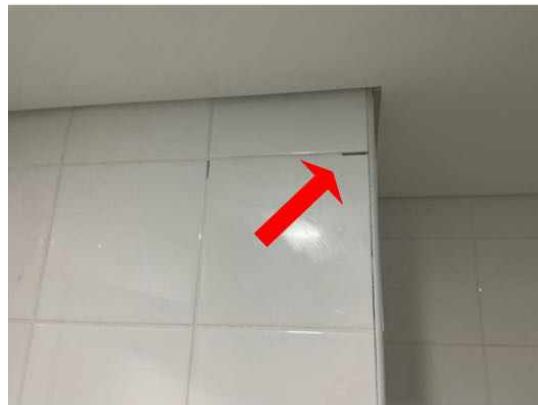
Finding 3.02

Building: Main Building
 Location: Ensuite - Master
 Finding: Grout - Missing
 Information: Grout is missing in these areas. Grout is used to protect gaps and crevices in building materials to ensure that they are water-tight and prevent water penetration to the

associated structures.

Where grout is missing, a tiling contractor should be appointed immediately to apply grout and re-apply any silicone where necessary. Failure to do so is likely to lead to water damage to the surrounding area.

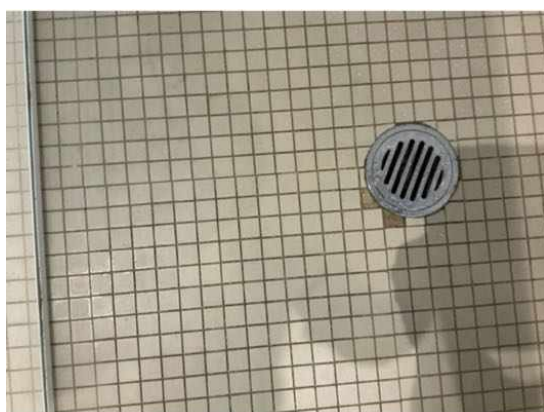
Finding 3.03

Building:	Main Building
Location:	Bathroom 2
Finding:	Tiles - Missing
Information:	Tiles were found to be missing in this tiled area. It appears as though broken tiles have been detached and not replaced, or have come loose from their original fixing through general deterioration.

Where tiles are missing may eventually lead to exposure of the waterproof membrane below the tiles, which may deteriorate.

Any tiles that are missing should be replaced by a tiling contractor or general handyman. If left unmanaged over a prolonged period of time, water damage may occur.

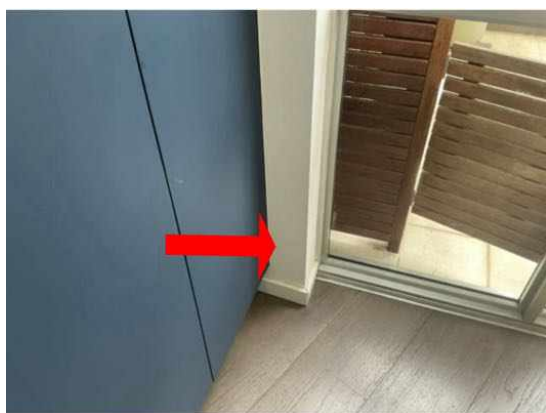
Finding 3.04

Building: Main Building
 Location: Kitchen
 Finding: Damp - Moisture penetration walls
 Information: Damp readings were taken in this area at the time of inspection. Damp penetration is a common form of dampness that can occur through walls, roofs or openings.

Common causes include faulty or missing flashing or bridging of cavities. Moisture penetration can also occur when water tracks over cavities or by tracking across wall ties.

No evidence of damage was currently identified. The cause of the damp can be further inspected by a builder or damp specialist to determine the cause of the damp and advise if repairs are required.

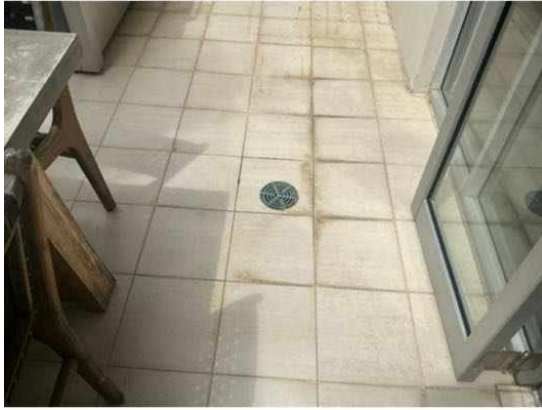
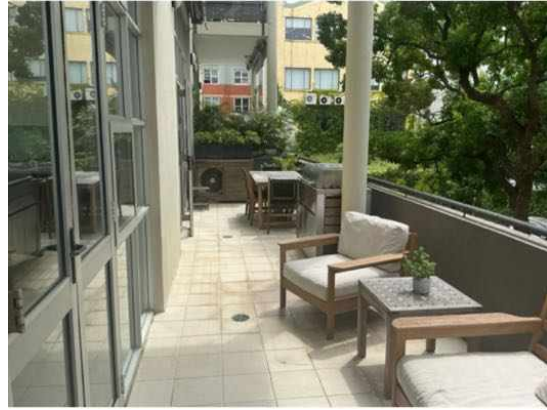
Finding 3.05

Building: Main Building
 Location: Balcony
 Finding: Balcony Overflow Not Installed
 Information: No overflow was identified to the balcony drainage system. The balcony appears to pre-date the period when balcony overflows became commonly installed as part of standard construction practices. While not an immediate defect in itself for older structures, the absence of an overflow increases reliance on the primary drain functioning correctly at all times.

If the balcony drain becomes blocked or obstructed, water may accumulate on the balcony surface and potentially overflow into internal areas, causing water damage. Continued monitoring of the drain to ensure it remains clear and free-flowing is highly advised.

An overflow can be retrofitted at the client's discretion to provide additional protection against water build-up on the balcony. A licensed plumber or builder can be appointed to discuss options and carry out installation if desired.

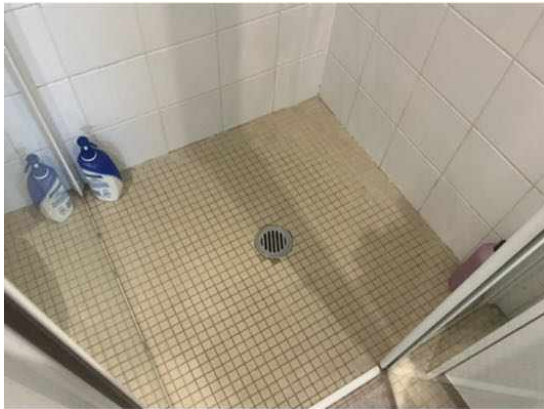
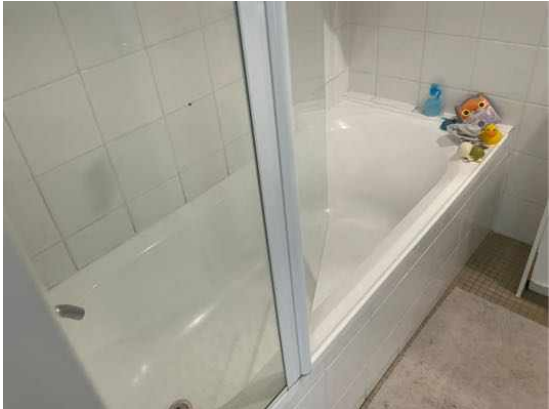
Noted Item

Building:	Main Building
Location:	Bathrooms
Finding:	Water Proofing Membrane - No damp detected
Information:	During the inspection, a moisture meter was used to evaluate the dampness levels in the bathrooms and other wet areas. The readings showed no evidence of moisture or damp, indicating that these areas are functioning properly and do not exhibit any signs of leakage. This result provides reassurance regarding the integrity of the plumbing and waterproofing in these important spaces.
