Building and Timber Pest Inspection Report

Inspection Date: Tue, 17 Mar 2026

Property Address: 21 Spedding Rd, Hornsby Heights NSW
2077, Australia

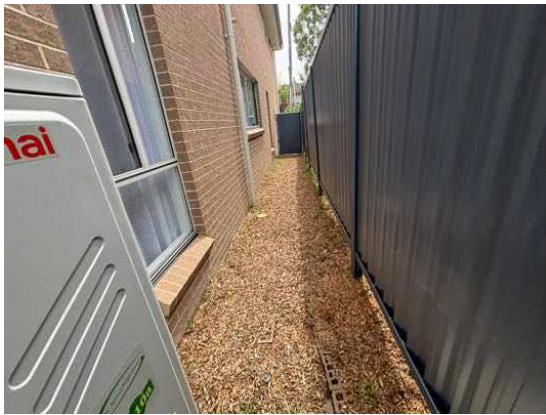
Building: Main Building
Location: All External Areas
Finding: Obstructions and Limitations - External Areas
Information: The attached photographs provide a visual representation of the obstructions and limitations that impeded a full inspection of the external areas of the property at the time of assessment. These obstructions, which may include vegetation, stored items, debris, or other physical barriers, can obscure potential defects and prevent a thorough evaluation of the property's condition. Obstructions of this nature can conceal a wide range of issues, such as structural damage, water ingress, pest infestations, or deteriorating building materials, which may not be visible during the initial inspection.

It is essential that these obstructions be cleared to allow for a comprehensive inspection of the external areas. Removing these barriers will enable a more accurate assessment of the property's condition and allow any hidden defects to be identified and addressed promptly. Failure to do so could result in undetected issues worsening over time, potentially leading to more costly repairs in the future.

Therefore, it is strongly recommended that the obstructions be removed and a re-inspection be scheduled once the affected areas are made fully accessible. This will ensure a complete evaluation of the property's exterior and provide the client with a clear understanding of any potential issues that may have been concealed during the initial inspection.

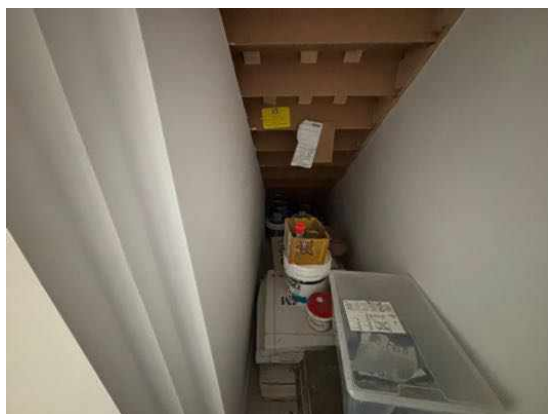
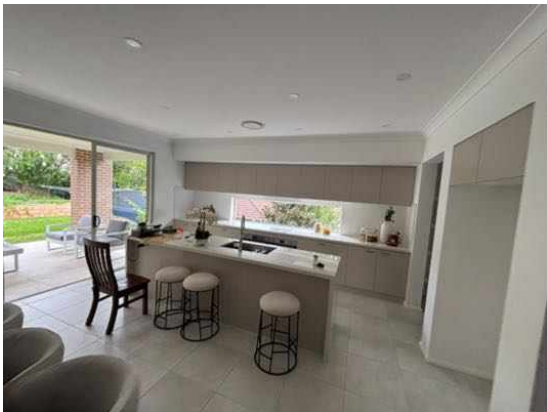
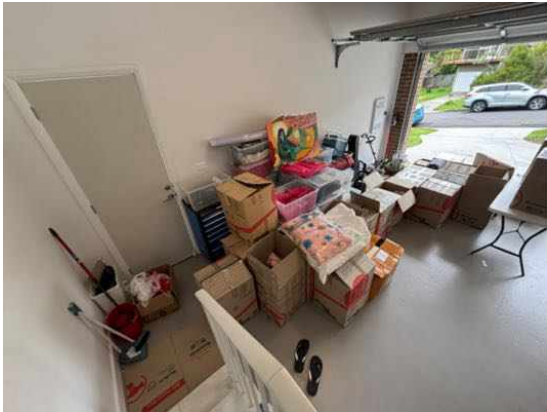
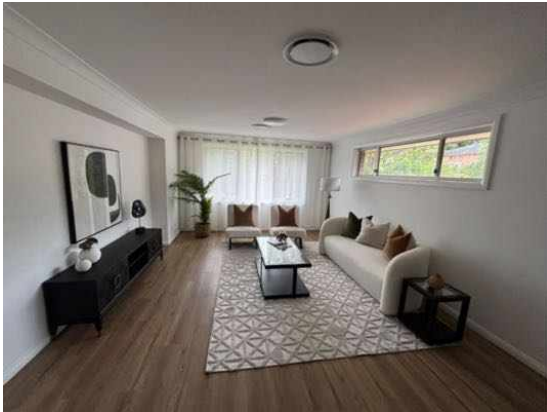
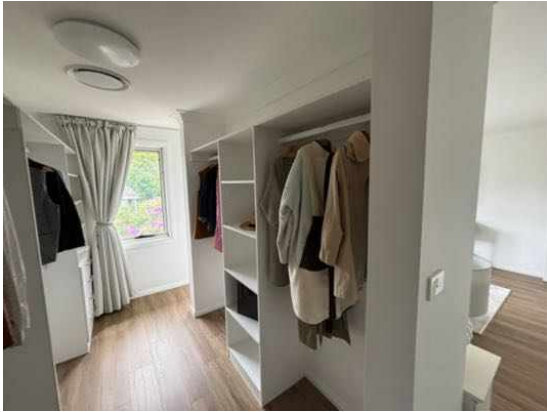
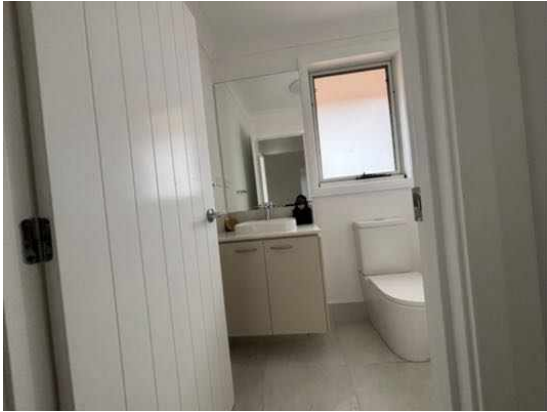
Building:	Main Building
Location:	All Internal Areas
Finding:	Obstructions and Limitations - Internal Areas
Information:	The accompanying photographs provide clear evidence of the obstructions and limitations that restricted a comprehensive inspection of the internal areas of the property at the time of assessment. These obstructions, which may include furniture, personal belongings, stored items, or structural elements such as wall coverings and built-ins, significantly hindered the ability to thoroughly evaluate these areas. It is important to note that such obstructions can potentially conceal a wide array of defects, ranging from hidden structural damage, water leaks, pest infestations, or

electrical issues, to deteriorating materials that may not be visible during the initial inspection.

The presence of these impediments means that critical areas of the property were not accessible, and therefore, any underlying defects that may affect the integrity and safety of the property could remain undetected. These hidden defects, if left unaddressed, could worsen over time and may result in costly repairs or pose potential safety hazards to the occupants.

It is highly recommended that all obstructions be cleared to facilitate a complete and thorough inspection of the internal areas. Once the obstructions have been removed and full access is available, a re-inspection should be carried out to ensure that any previously concealed issues can be properly identified and rectified. This follow-up inspection will provide a more accurate assessment of the property's internal condition and help the client make informed decisions about any necessary repairs or maintenance.

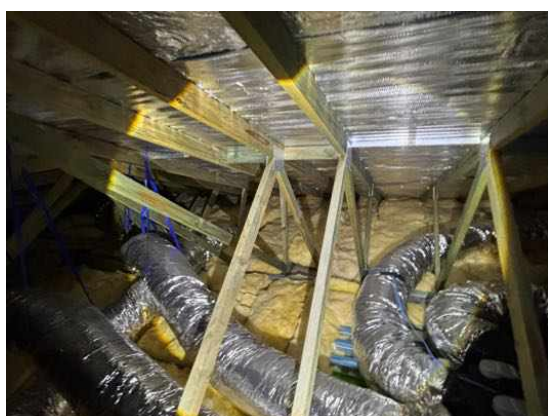
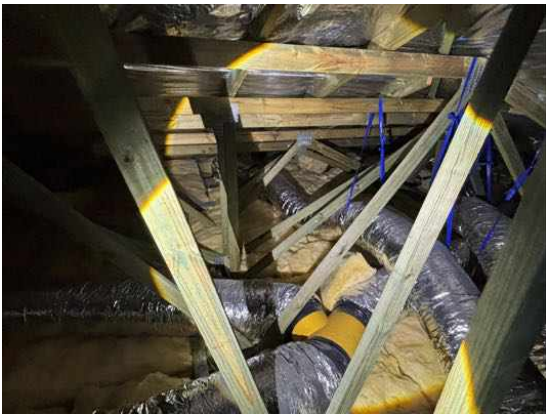
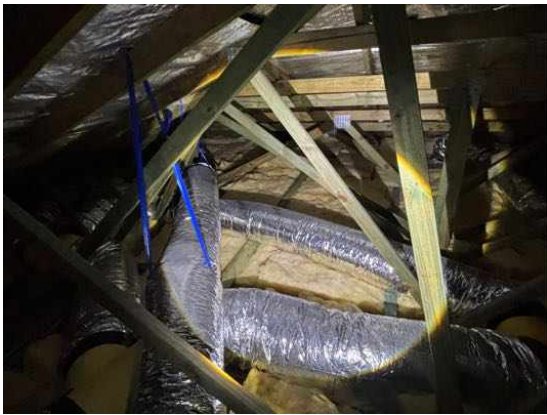
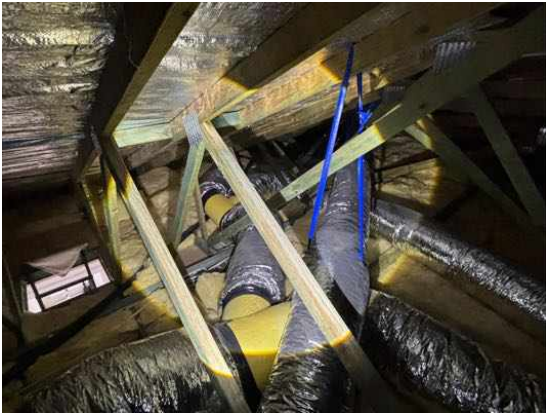
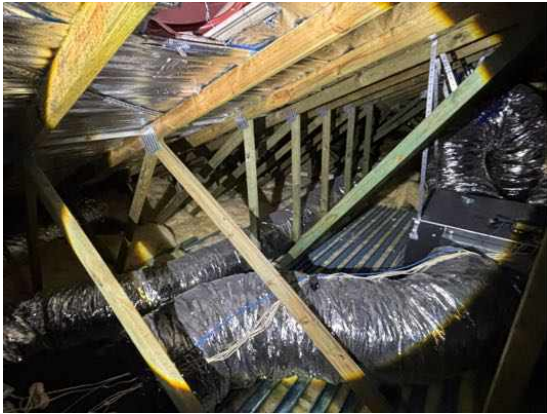
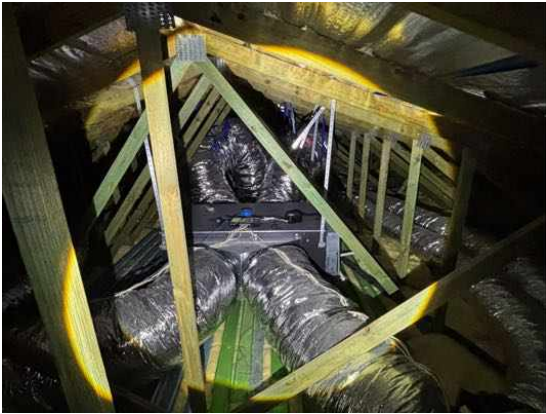
Building: Main Building
Location: Roof Void
Finding: Obstructions, Limitations, and General Roof Space Condition
Information: The photographs provided document both the general condition and the obstructions and limitations that were present in the roof cavity of the main building at the time of inspection. These obstructions—such as insulation materials, stored items, structural elements, or electrical wiring—restricted safe and adequate access to key areas within the roof space. As a result, a comprehensive inspection of all components could not be completed.

Obstructions of this nature may conceal a variety of potential defects, including damaged framing, compromised insulation, evidence of moisture ingress, pest activity, or electrical hazards. While no major issues were observed in the visible areas, the presence of these limitations means that some defects may remain undetected.

It is recommended that these barriers be removed or repositioned to facilitate full and safe access to the roof space. Once clear, a follow-up inspection should be conducted to allow for a thorough assessment of all concealed areas. This will help ensure that the condition of the roof cavity is accurately evaluated and any hidden issues are appropriately identified and addressed.

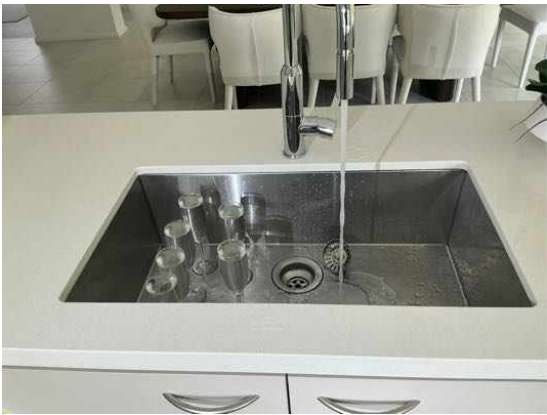
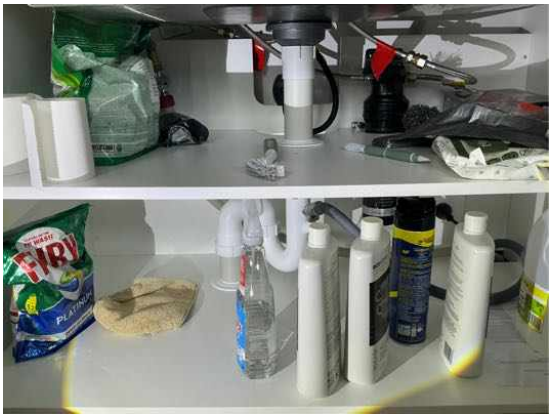
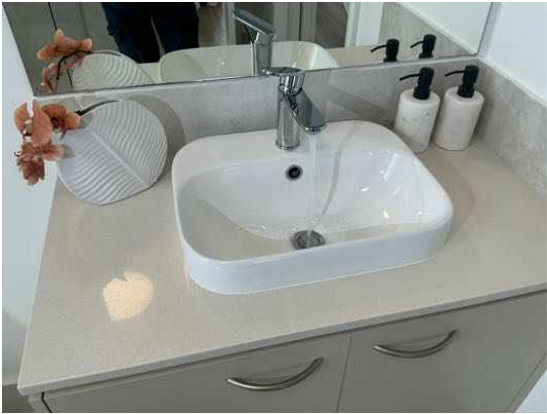
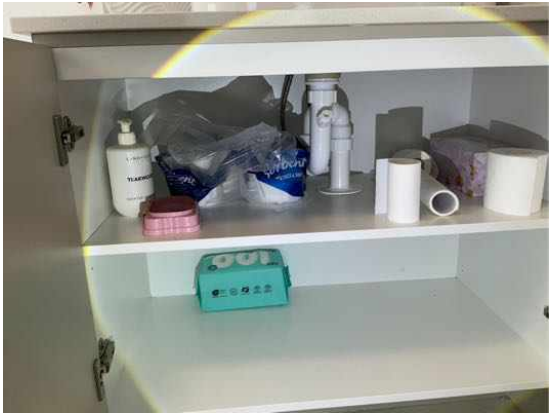
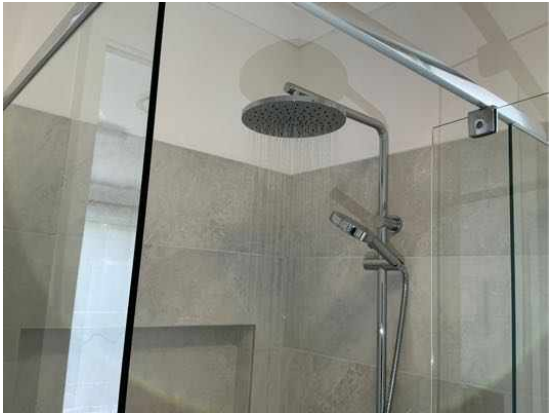
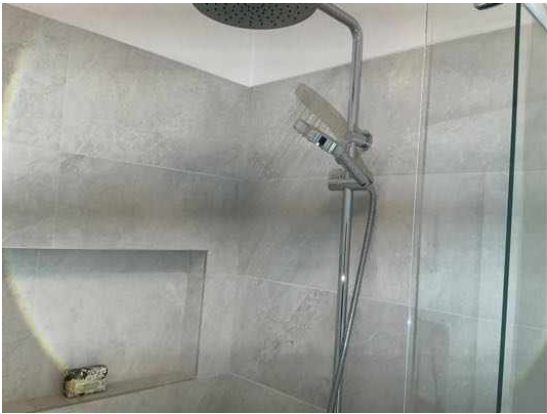
Building:	Main Building
Location:	All Areas
Finding:	FYI - Taps, Drainage & Toilets Tested and Cabinetry Obstructions
Information:	During the inspection, all accessible taps, drainage systems, and toilets were tested for water flow and drainage efficiency, and checked for any visible signs of leakage. At the time of the inspection, no issues were noted in these areas. Unless highlighted in a separate defect statement, no immediate remedial work appears necessary. Supporting images may be found in the additional photos section for reference.

It is important to note that while a visual inspection of cupboards and cabinetry beneath sinks and vanities was undertaken, stored personal items and fixtures presented obstructions that limited full visibility of the internal areas. As per standard inspection practices, inspectors are not permitted to move or disturb personal belongings during the inspection process. Therefore, only visible and accessible sections were inspected, and concealed water damage or plumbing defects may not have been detected.

Given this, a re-inspection is recommended after all obstructions have been cleared to allow for a comprehensive assessment of these areas. Regular maintenance and monitoring of plumbing and drainage systems is also advised to ensure ongoing functionality and early detection of potential issues.

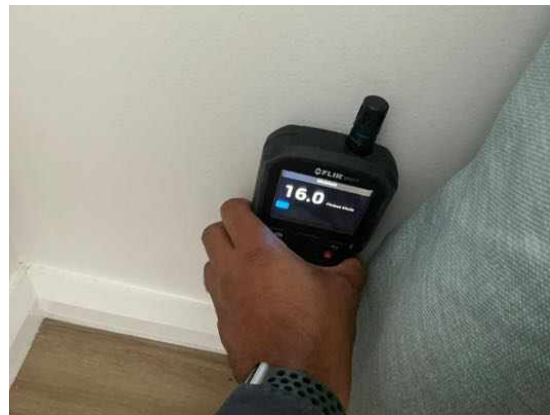
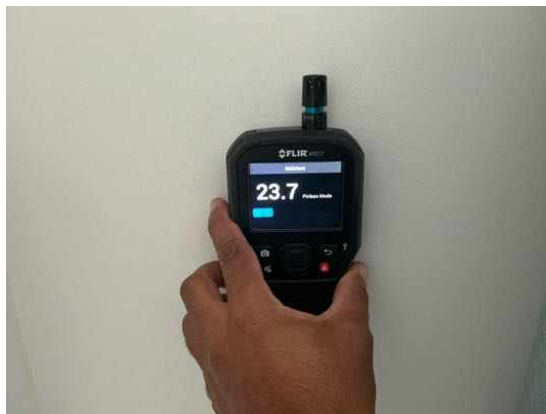
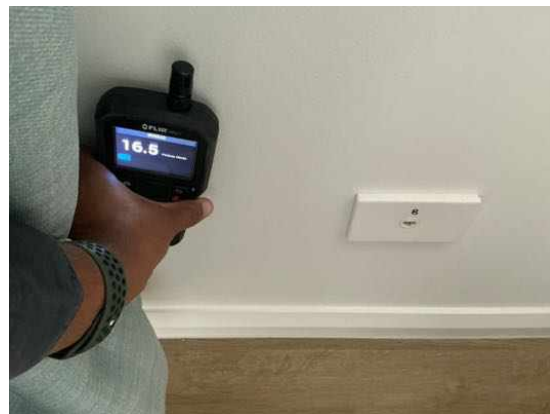
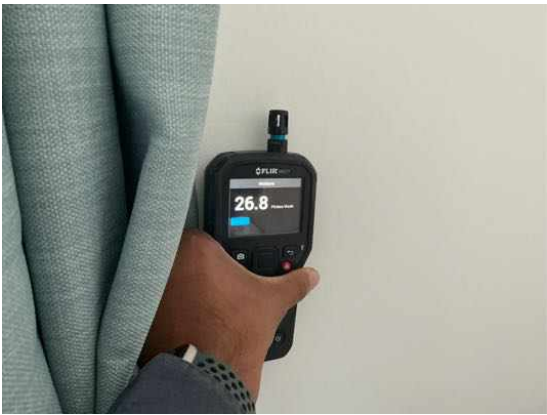
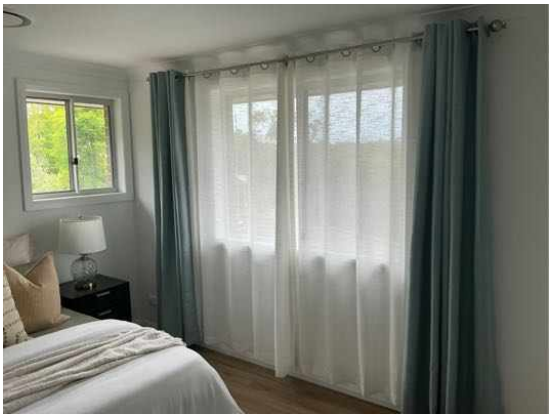
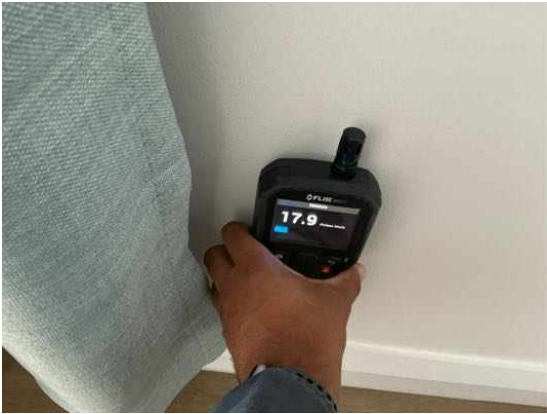
Building: Main Building
Location: All Areas
Finding: Additional Photos - Moisture Meter Readings
Information: Additional moisture meter reading photos have been provided for the property to offer further clarity on areas tested during the inspection. These photos are intended to give a visual reference for the specific locations where moisture levels were measured. These readings were taken at the time of the inspection to assess any potential moisture-related issues within the property. Any defects related to moisture that were identified during the inspection have been separately mentioned in the defect statements within the report.

It is important for the client to understand that moisture levels can fluctuate over time due to various factors, including changes in weather, humidity, and environmental conditions. While the readings reflect the property's moisture levels during the inspection, they may not represent future conditions, and increased moisture could lead to issues such as dampness, mould growth, or deterioration of building materials if left unmonitored.

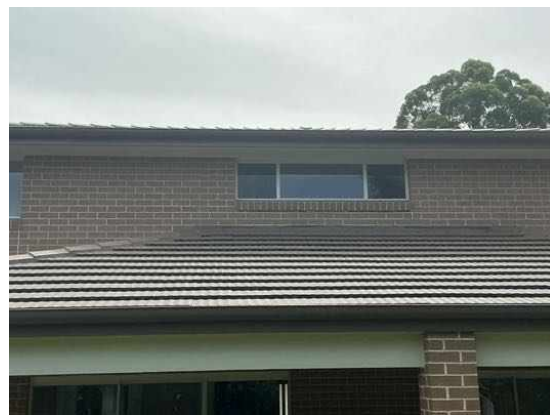
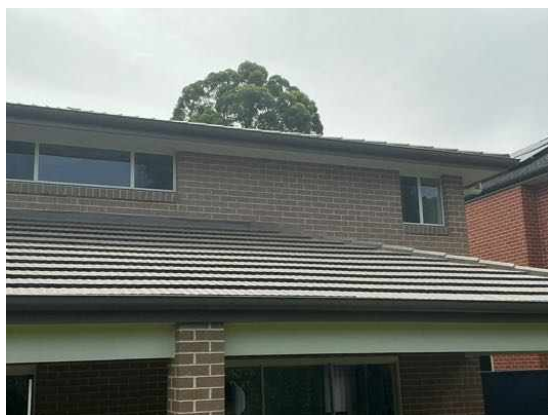
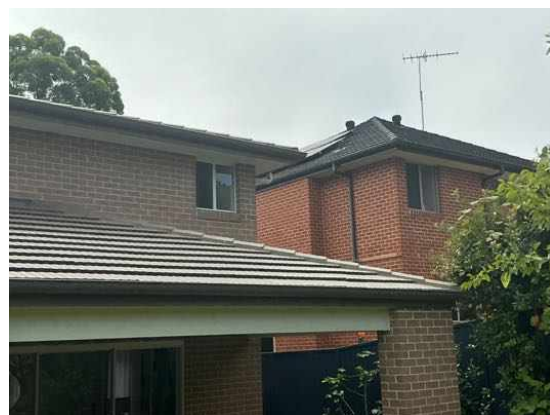
Building: Main Building
 Location: Roof Exterior
 Finding: Additional Roof Photos
 Information: As part of the information provided, please note that the attached roof photos represent the condition of the roof at the time of inspection. These photos are for visual reference only and do not constitute a detailed roofing assessment. Any defects or issues identified with the roof are mentioned separately in the defect statements. It is strongly recommended that the client engage a qualified roofer to conduct a thorough inspection of the roof, ensuring that any potential issues, such as leaks, structural integrity, or wear and tear, are properly identified and addressed.

Additionally, the condition of the roof may change over time due to weather, natural wear, or other unforeseen factors. Regular maintenance and inspections by a licensed professional are advised to ensure the roof remains in good condition and to avoid costly repairs in the future. The information provided in these photos should be considered a snapshot of the roof's condition during the time of inspection and not a guarantee of its future performance.

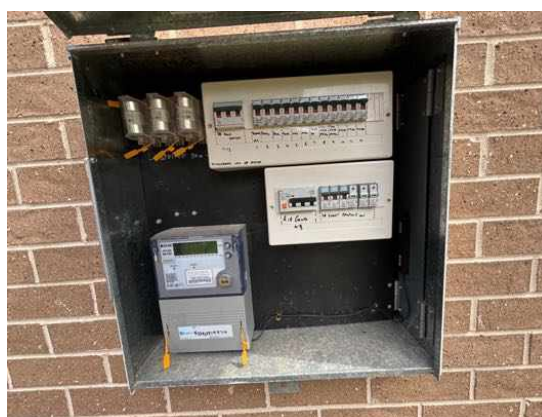
Building: Main Building
 Location: Meter Box
 Finding: Termite Management Recommendation – No Evidence of Chemical Installation

In accordance with standard requirements, a durable notice should be located within the electrical switchboard to detail any termite protection systems applied, including chemical treatments. No such notice was observed during the inspection.

It is recommended that the client engage a licensed pest controller to assess the suitability of installing a chemical barrier, and to provide advice on associated costs and procedures. This should be considered a short-term priority, particularly if the property has any history of termite activity or is located in a high-risk area.
