Building and Timber Pest Inspection Report

Inspection Date: Thu, 19 Feb 2026

Property Address: 36 Smith St, North Bendigo VIC 3550,
Australia

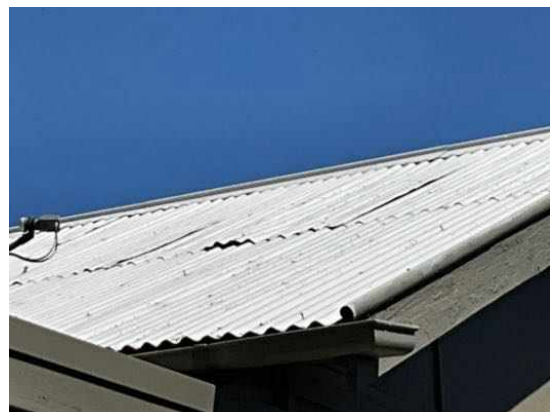
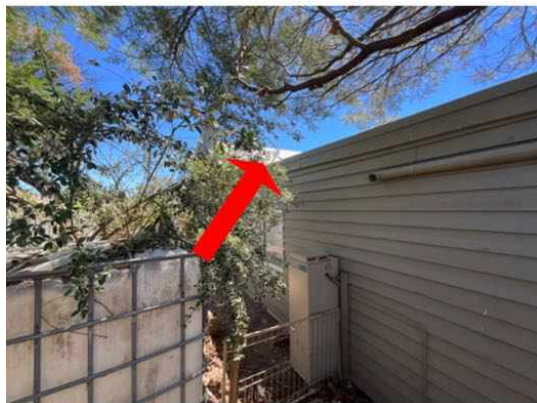
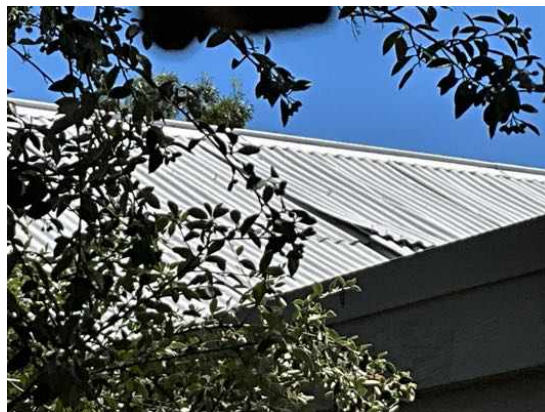
Finding 3.01

Building: Building 1
Location: Roof Exterior
Finding: Roof sheets - Loose
Information: Upon inspection of the exterior roof covering, it was noted that numerous roof sheets have become loose from their original fixings. It is suspected that this defect has developed as a result of a lack of adequate maintenance, but may also have been caused by inappropriate fixings being used in the construction process.

Loose roof sheeting detracts from the weather tightness of the roof covering, making the internal roofing structure susceptible to water penetration and subsequent damage. If left unaddressed, it is likely that secondary damage to associated building elements will develop, potentially necessitating remedial works to these structures.

A roofing restoration contractor should be appointed to advise on rectification options and on the cost of repair. It is advised that remedial works be performed as soon as possible to prevent any further damage.

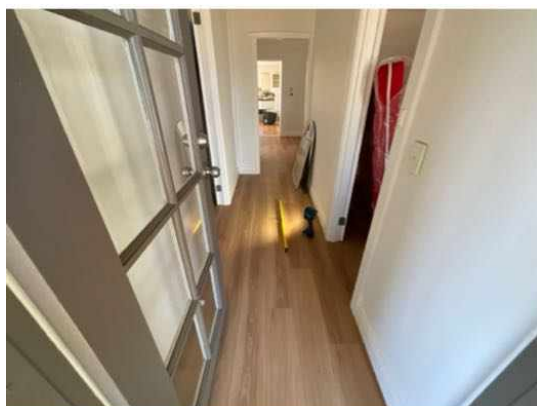
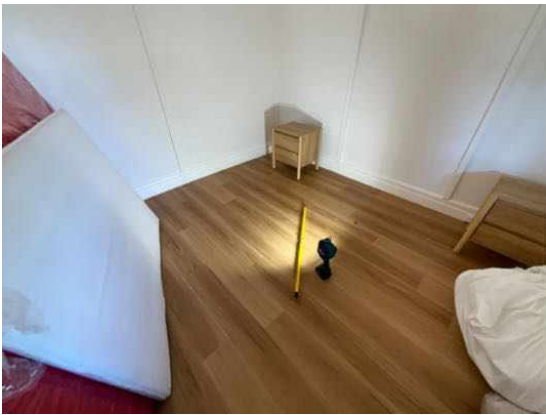
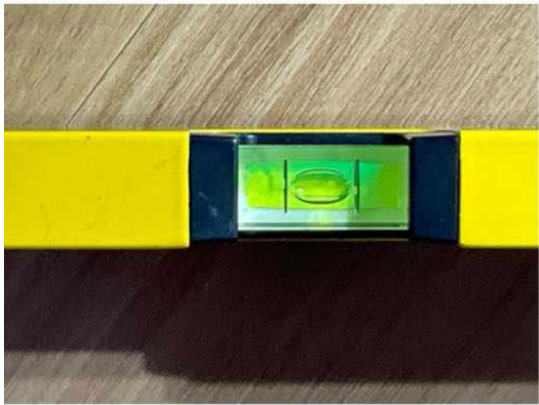
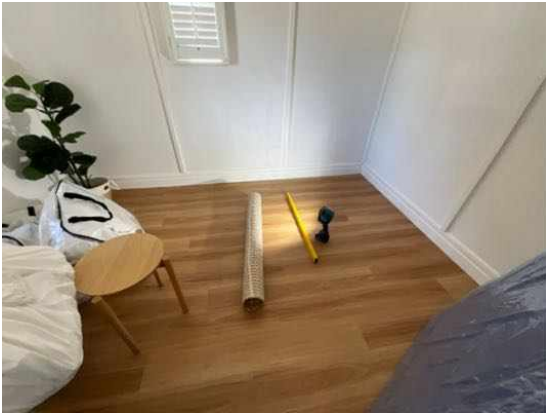
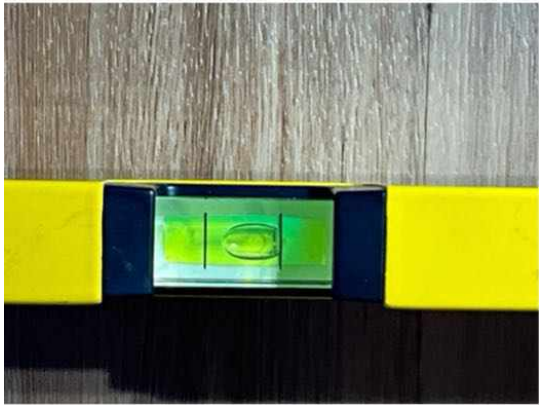
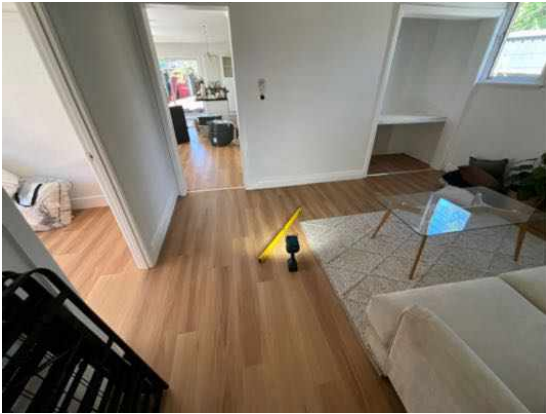
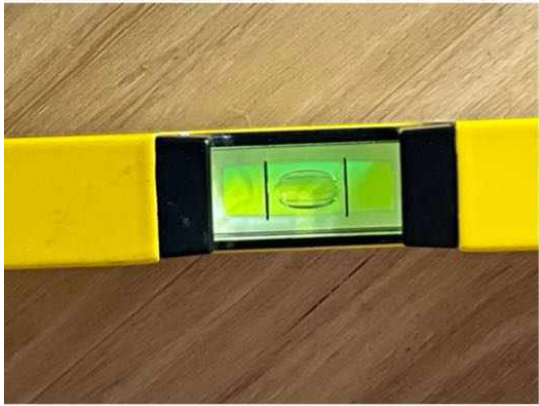
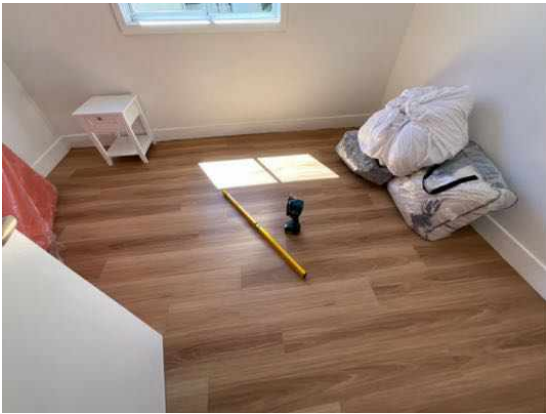
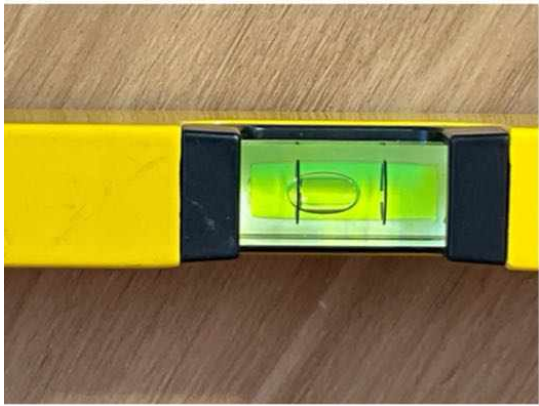
Finding 3.02

Building:	Building 1
Location:	All Internal Areas
Finding:	Flooring - Uneven
Information:	The internal flooring in this area is out of level and uneven. Uneven flooring is likely to indicate minor defects such as expected movement of the foundations of the property, but may also indicate subsidence of the associated subfloor stumps.

It is advised that the flooring be closely monitored to identify any further movement. Where flooring remains relatively unchanged for an extended period of time (i.e. several months), it is likely that this defect has been caused by expected movement of the foundations of the property.

However, where flooring is uneven further, potentially invasive inspection of the subfloor structures and stumps in this area is required. In this case, works to repair are likely to be required, and would be carried out by a registered builder specialising in re-stumping.

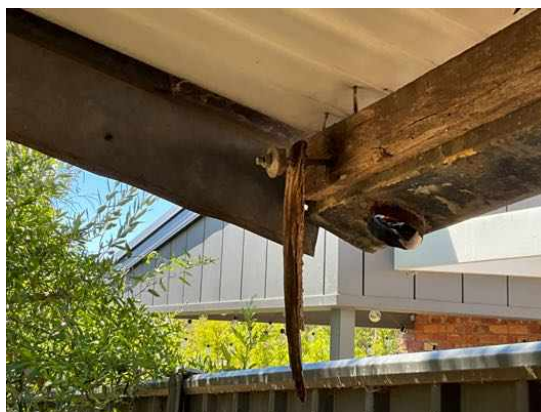
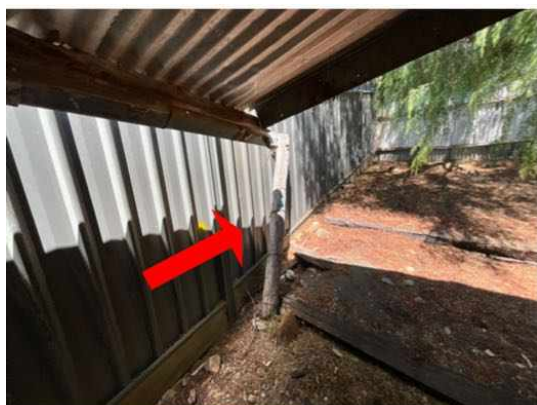
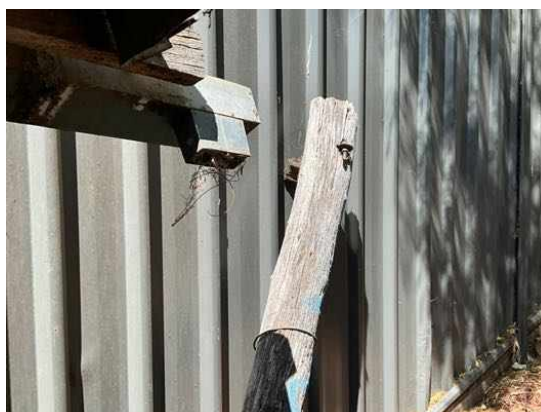
Finding 3.03

Building: Building 1
 Location: Shed
 Finding: structure - Unstable
 Information: Movement was evident in the structure, indicating that it may not be structurally sound or compliant with current building regulations. While some degree of movement is expected of structures of this design, it is suspected that strong winds or forceful impact may cause the stability of the shed to further decline.

Additional bracing of the structure is required immediately to ensure its safety and structural integrity. If left unmanaged, the carport structure is likely to deteriorate further, potentially creating an environment which is unsafe.

A registered builder with the assistance of trades, e.g. qualified carpenter, should be appointed to perform remedial works as a matter of urgency.

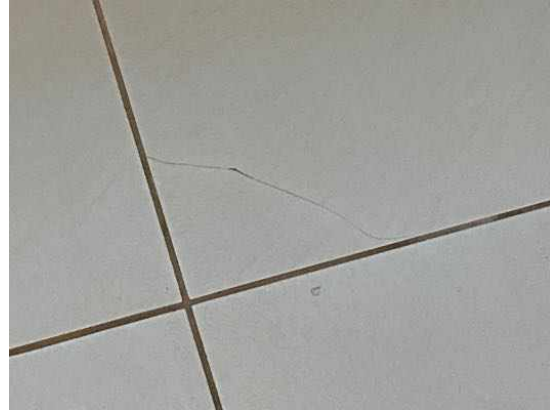
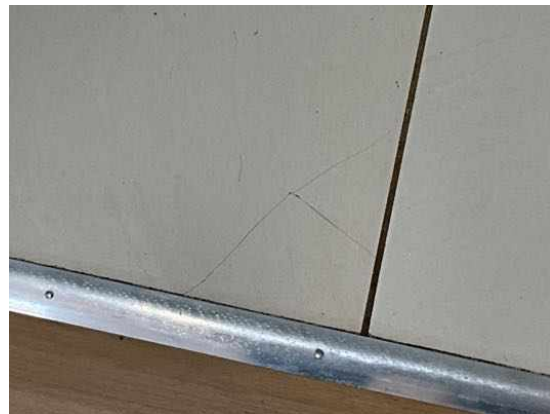
Finding 3.04

Building: Building 1
 Location: Bathroom
 Finding: Cracked floor tiles
 Information: Cracking in the floor tiles was evident in this area at the time of inspection. It is suspected that this cracking has occurred as a result of minor settlement or impact damage.

Cracked tiles throughout the household detract from the overall appearance of the affected areas however it is unlikely to create or lead to any secondary defects.

While not considered a matter of urgency, replacement of cracked floor tiles is recommended at the clients discretion. A tiling contractor may be appointed to perform these works. Where cracks become more numerous, contact a licensed building inspector for further investigation.

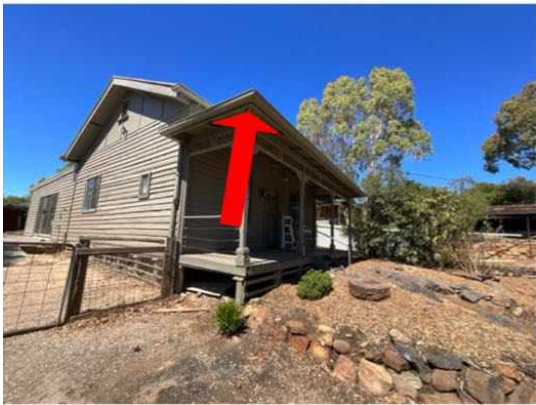
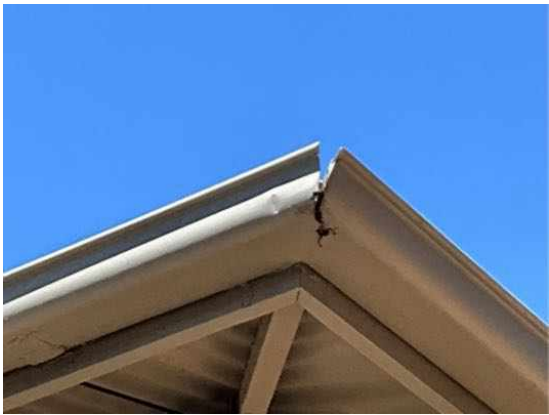
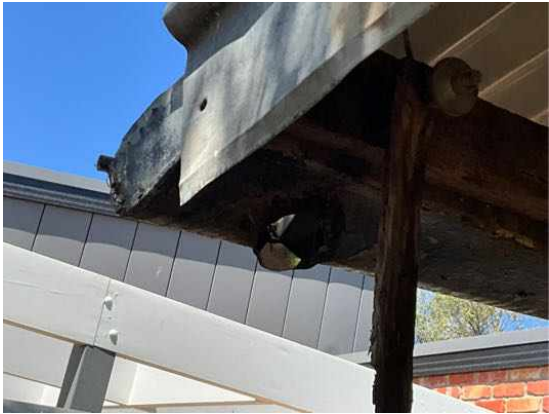
Finding 3.05

Building:	Building 1
Location:	Eaves, shed
Finding:	Gutters- Deteriorated
Information:	The guttering and some downpipes have deteriorated.

Although not a major problem now, they will deteriorate further if left for an extended period.

A Licensed Plumber should be engaged as soon as possible to advise on any repairs or maintenance that may be required.

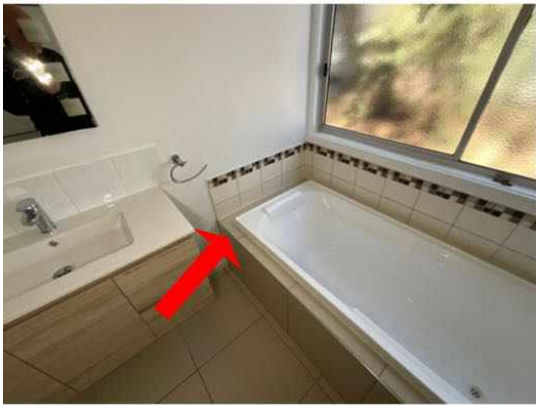
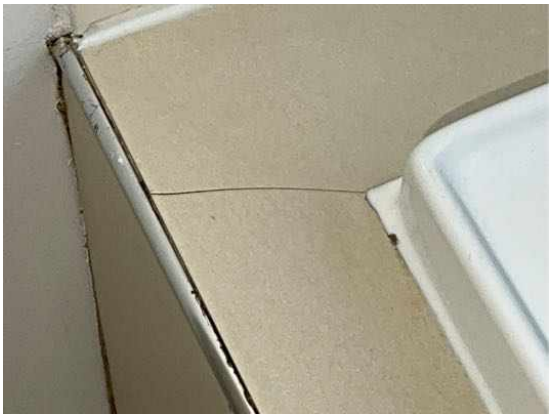
Finding 3.06

Building: Building 1
Location: Bathroom
Finding: Wall Tiles- Cracked
Information: Cracked tiles within the household detract from the overall appearance of the affected areas, as well as creating potential for water penetration to adjoining building elements. If left unmanaged, water damage may occur as a result of constant water penetration over a prolonged period of time.

While not considered a matter of urgency, replacement of tiles is advised as a solution. A Tiling Contractor may be appointed to perform these works at client discretion.

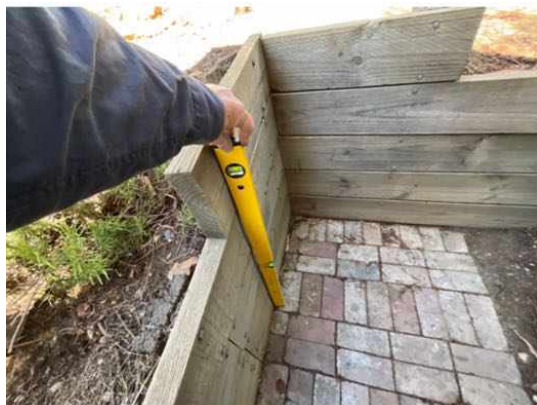
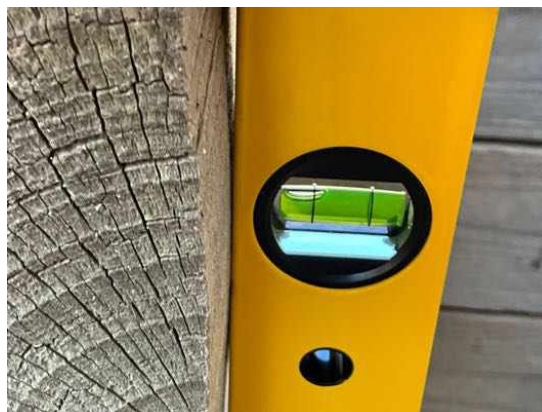
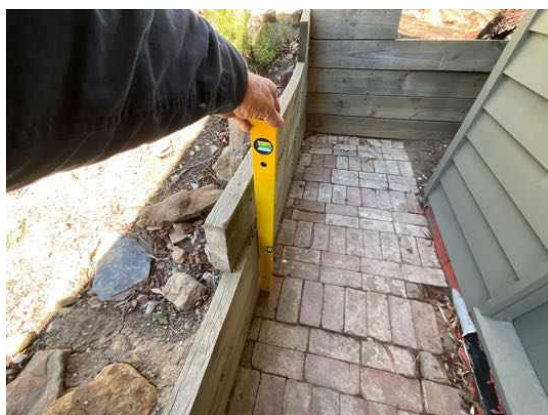
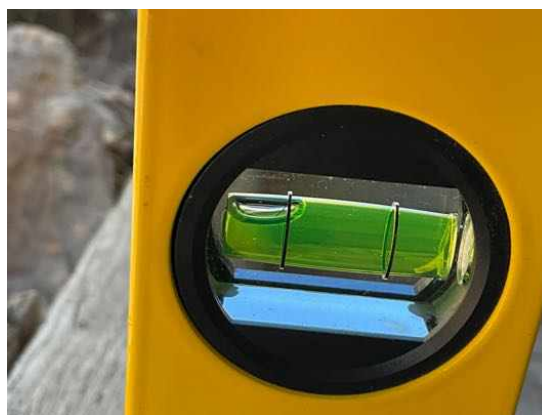
Finding 3.08

Building:	Building 1
Location:	Yard - Back
Finding:	Retaining wall - Defective
Information:	The retaining wall in this area was found to be defective at the time of inspection. Generally, defective retaining walls are caused by poor original design or material use. However, deteriorated retaining walls may also be a result of substandard construction, poor site drainage or unmanaged stormwater flows.

If left unmanaged, the retaining wall may become a safety hazard if it continues to destabilise. Where retaining walls further rot and decay, an environment is created that is conducive to termite and pest infestation.

Significant repair and replacement should be expected. Where retaining walls are considered structural walls, a structural engineer / surveyor should be consulted regarding required remedial works. Otherwise, a landscaper or retaining wall installer may be appointed to repair or replace the wall, at the discretion of the client.

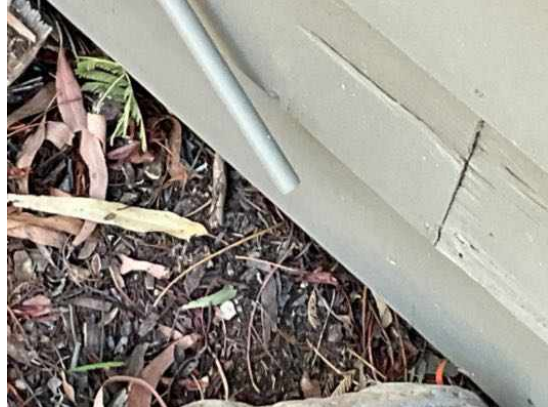
Building: Building 1
 Location: Yard - Side
 Finding: HWS Overflow - Not Connected
 Information: The Hot Water System (HWS) overflow was found to be disconnected from storm water drainage and is creating excessive moisture in the surrounding area.

These damp conditions can lead to secondary defects such as rot, rust or corrosion of associated building elements, the formation of fungal decay, or even the creation of potential slip hazards. When coupled with poor site drainage, pooling of water may

also attract termite activity to this area.

It is highly recommended that a licensed plumber be appointed to connect the HWS overflow in order to prevent such an environment from being created. These minor works should be carried out as soon as possible.

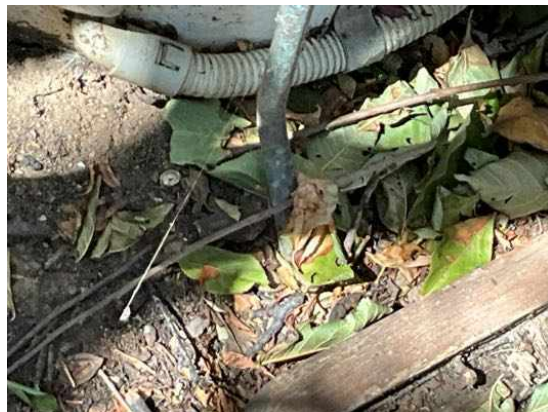
Finding 6.02

Building:	Building 1
Location:	Bungalow
Finding:	HWS Overflow - Not Connected
Information:	The Hot Water System (HWS) overflow was found to be disconnected from storm water drainage and is creating excessive moisture in the surrounding area.

These damp conditions can lead to secondary defects such as rot, rust or corrosion of associated building elements, the formation of fungal decay, or even the creation of potential slip hazards. When coupled with poor site drainage, pooling of water may also attract termite activity to this area.

It is highly recommended that a licensed plumber be appointed to connect the HWS overflow in order to prevent such an environment from being created. These minor works should be carried out as soon as possible.

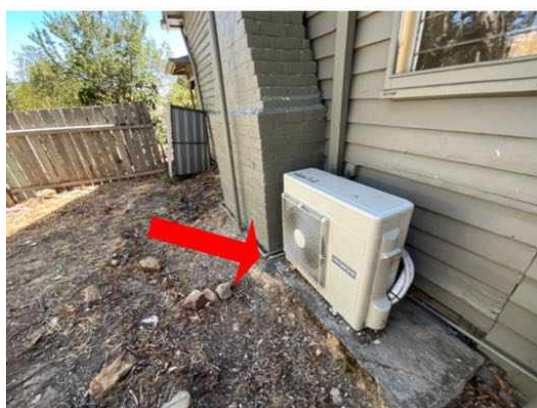
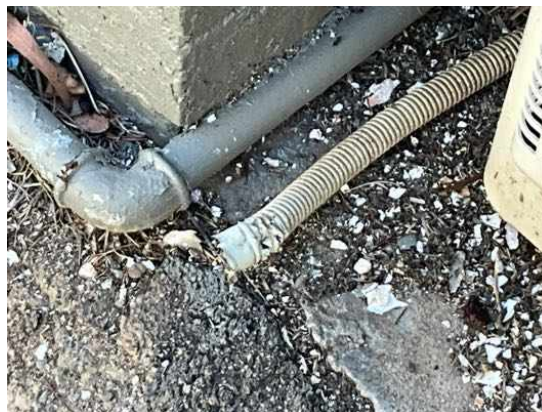
Finding 6.03

Building:	Building 1
Location:	Yard - Side
Finding:	Air conditioner - Disconnected overflow
Information:	The Air Conditioner (A/C) overflow was found to be disconnected from storm water drainage and is creating excessive moisture in the surrounding area.

Such leaking creates an environment which is conducive to an array of defects, including water damage to associated building elements and the attraction of termite or timber pest infestation.

It is highly recommended that a licensed plumber be appointed to connect the A/C overflow in order to prevent such an environment from being created. These minor works should be carried out as soon as possible.

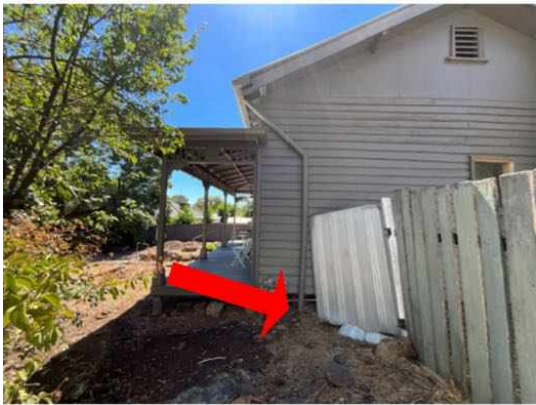
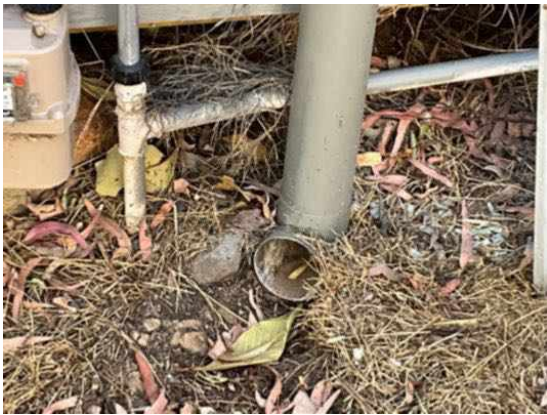
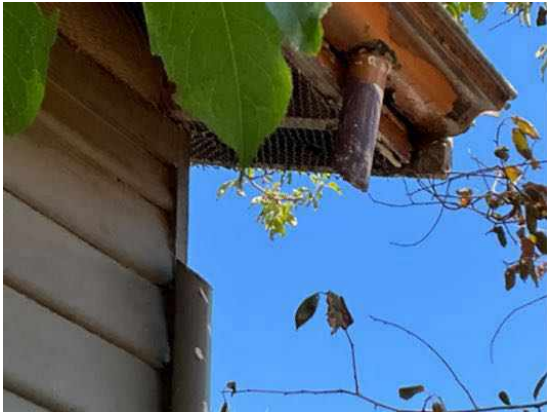
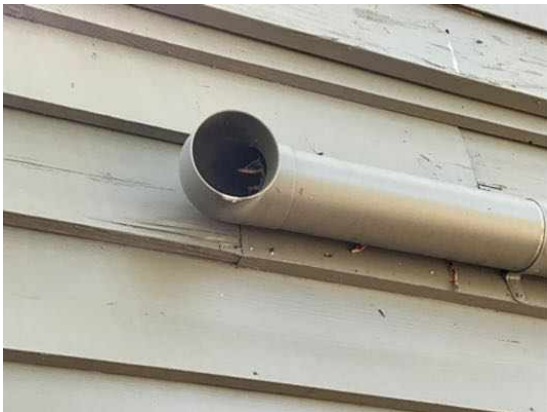
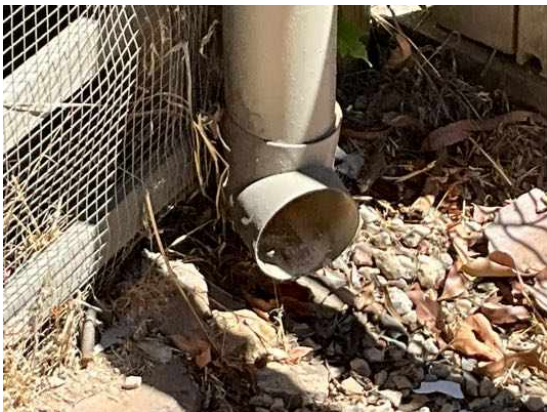
Finding 6.04

Building:	Building 1
Location:	Yard - Front, side, bungalow
Finding:	Stormwater drain - Not connected
Information:	The roof plumbing is not adequately connected to stormwater drainage on the site. This disconnection negatively impacts the functional capacity of the roof plumbing.

Where roof plumbing doesn't drain adequately, the area at the base perimeter can become excessively damp, potentially creating an environment that is susceptible to rust and corrosion of surrounding building elements, as well as attracting termites and other pests.

It is highly recommended that a plumber be appointed to further inspect the area and to install adequate drainage equipment where necessary.

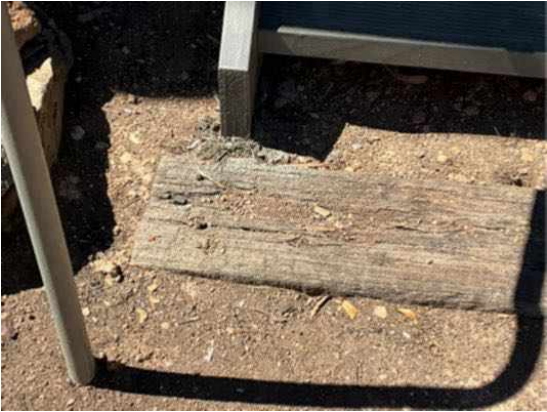
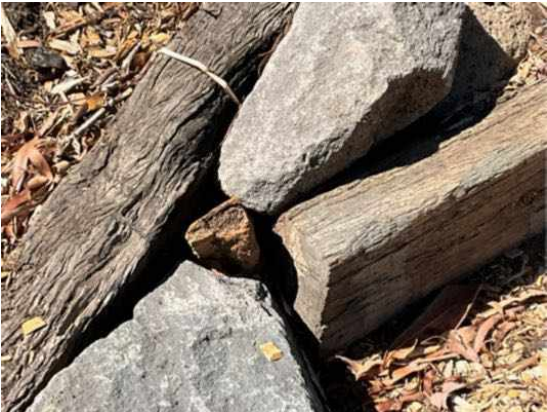
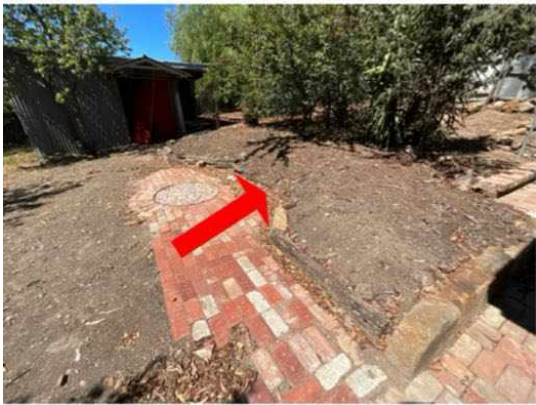
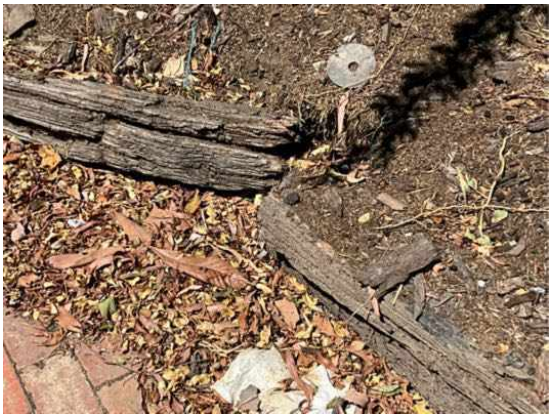
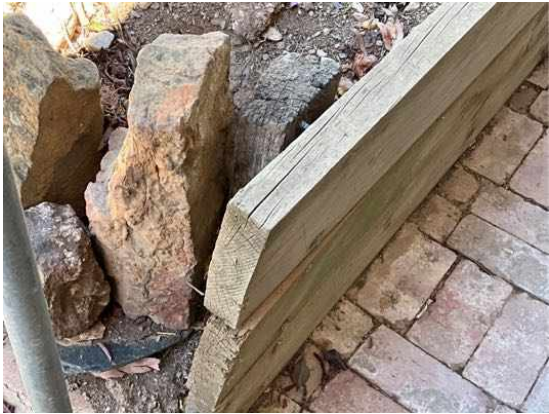
Finding 6.05

Building: Building 1
Location: Yard - Front, back
Finding: Untreated or non-durable timbers in a hazardous environment
Information: To reduce the risk of timber pest attack it is essential that timber used in a hazardous environment (e.g. in direct contact with the ground or frequently exposed to damp conditions) is of sufficient durability and/or is adequately preservative treated.

Untreated timbers in direct contact with the ground are likely to develop severe wood rot and/or fungal decay if left unattended creating attraction for subterranean termites to infest the timbers from surrounding areas.

If untreated or non-durable timbers are found to be in a hazardous environment it is highly advised that replacement of these building elements be performed as soon as possible to aid the protection of the property against termite / timber pest attack.

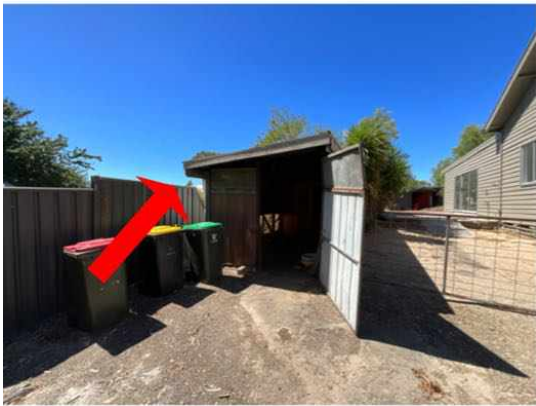
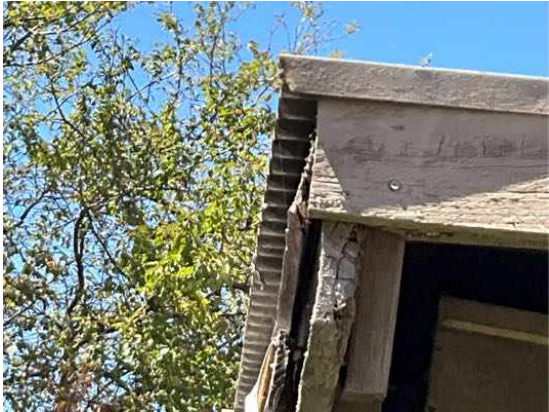
Finding 6.06

Building: Building 1
 Location: Shed
 Finding: Guttering Missing
 Information: The Guttering in this area was missing at the time of inspection. Guttering, Downpipes and Stormwater drainage are vital to protect the integrity of the structure and to prevent an environment conducive to Timber Pest attack.

A Plumber should be contacted as soon as possible to replace and connect to drainage the missing Guttering.

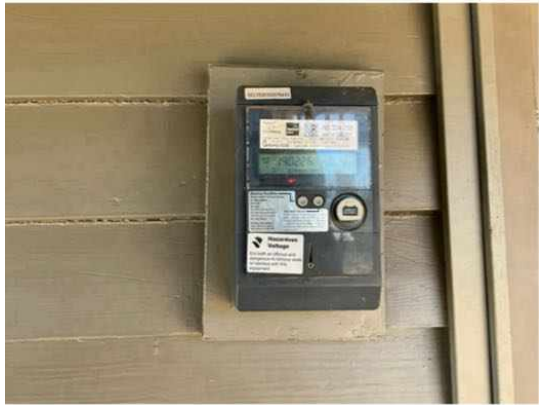
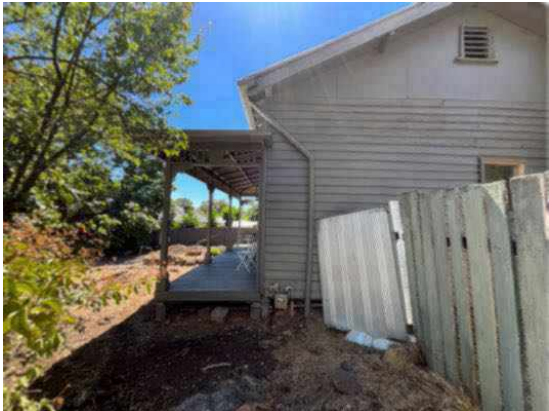
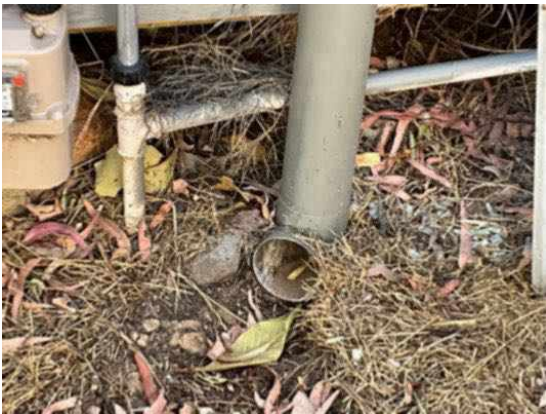
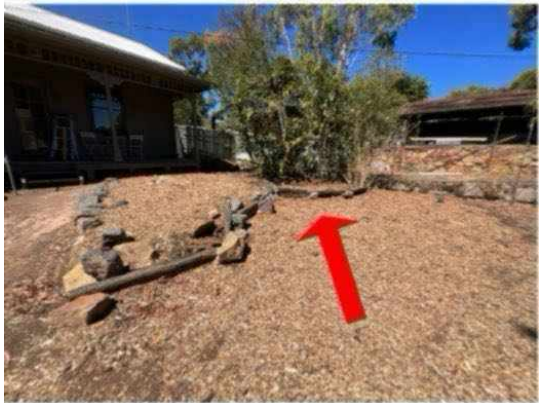
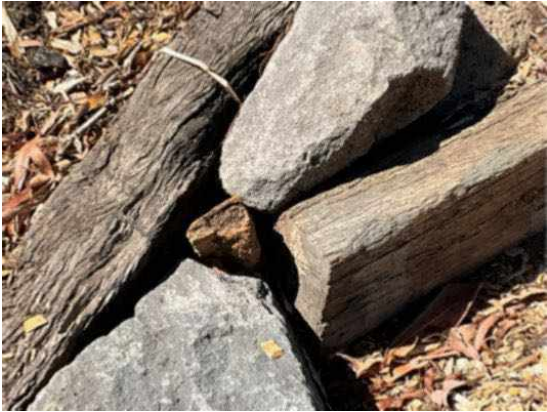
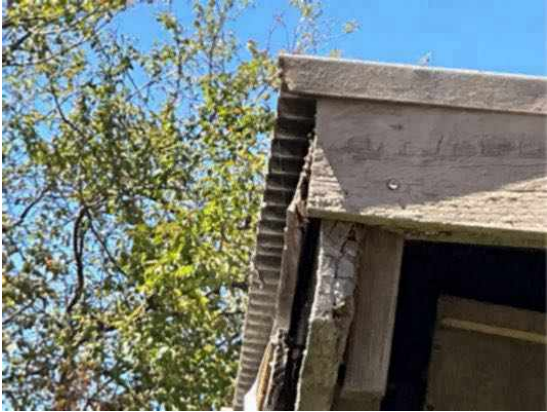
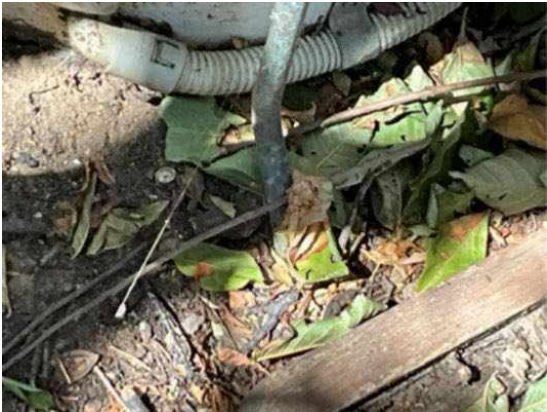
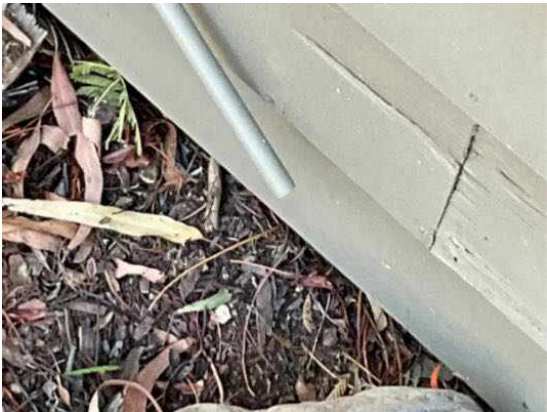
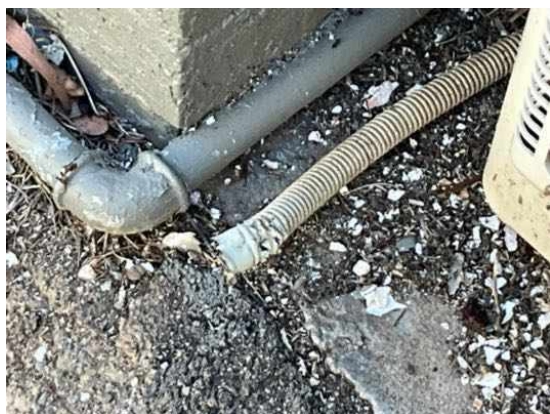
Finding 6.07

Building: Building 1
Location: All External Areas
Finding: Termite Management System - no evidence of a chemical installation
Information: The application of a post-construction chemical termite barrier is highly recommended for all properties, particularly if live termite activity has been found on the site previously. Such barriers are highly effective in preventing termite attack on any timber building elements throughout the property.

A durable notice should be placed in the switchboard unit to indicate current termite barriers. At the time of inspection, it appeared as though no termite management system has been installed, with no evidence to suggest preventative works taking place.

The client may consider gaining further advice from a pest controller as to the costs and procedures involved with this application. It is recommended that obtaining such advice be a short-term priority.

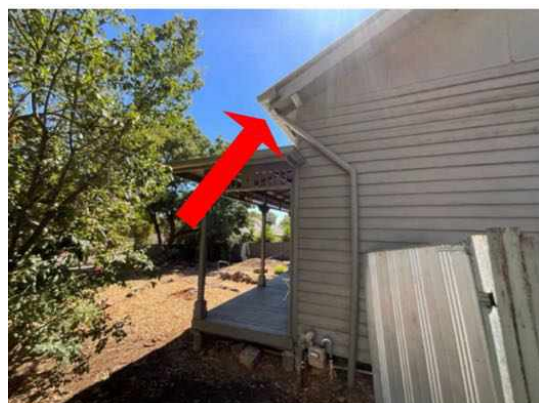
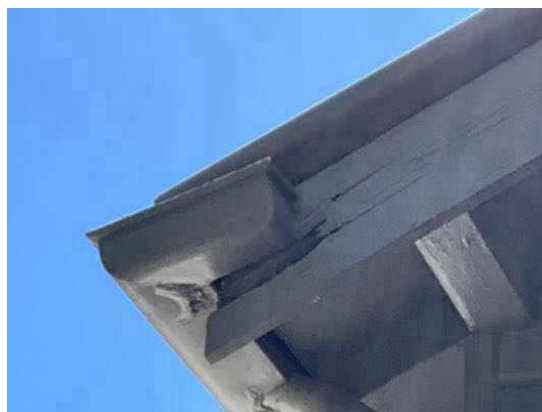
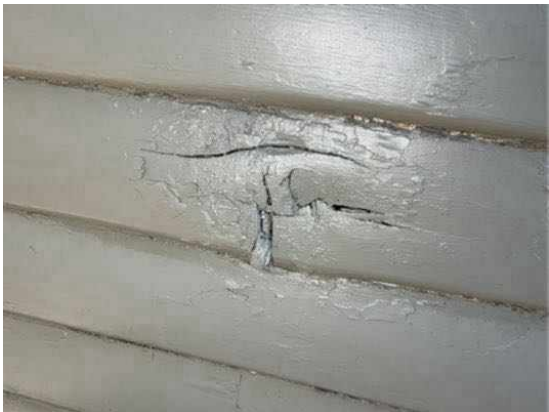
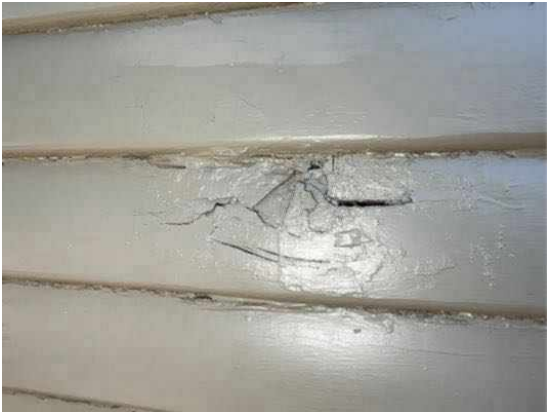
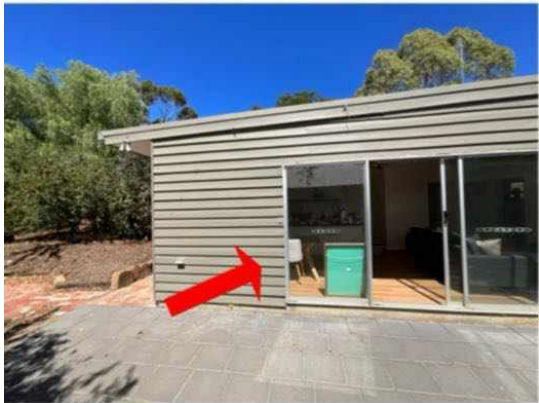
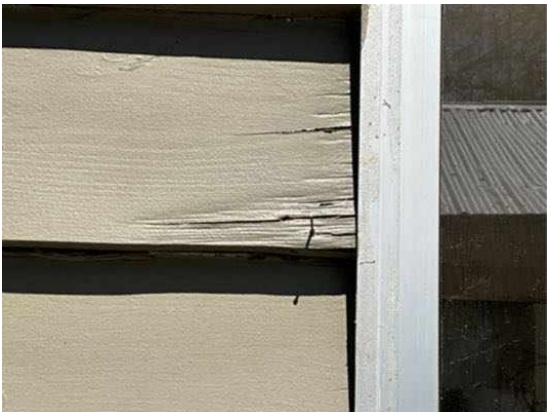
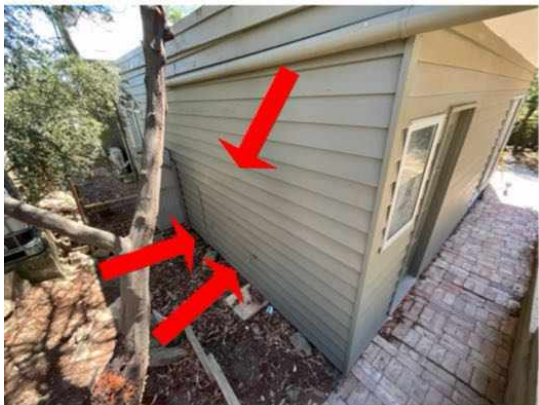
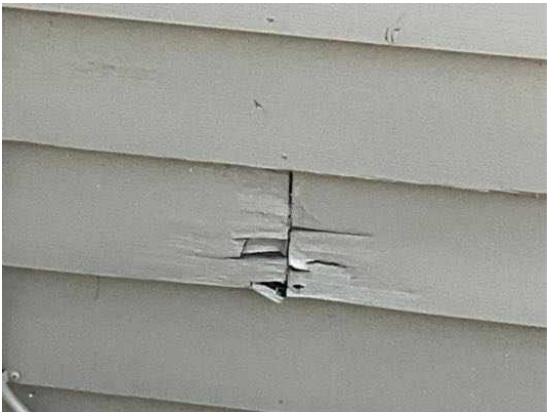
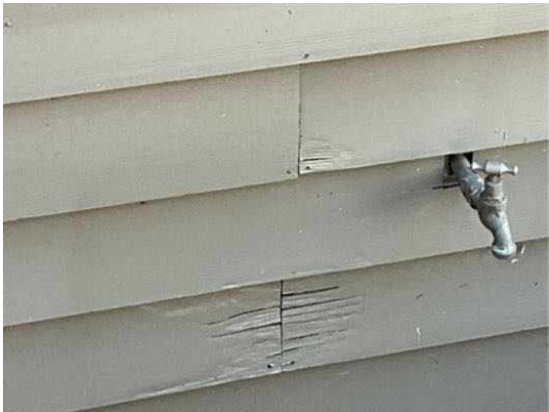
Finding 7.01

Building:	Building 1
Location:	Eaves, bungalow, wall- side,
Finding:	Fungal decay - present (localised)
Information:	Fungal decay also known as wood decay or wood rot generally refers to the deterioration of timber elements when in contact with excessive levels of moisture for a prolonged period of time.

The development of fungal decay is accelerated by temperatures in the range of 5degreeC to 40degreeC as well as the presence of oxygen. Generally fungal decay develops on timber elements that are in use in an external environment which are exposed to rain penetration.

In this case although the affected timber element is in a decaying state the extent of any visible damage appears to be localised to a specific area and is yet to spread to other parts of the building element or affect adjoining structures. The fungal decay is therefore likely to be of a relatively superficial nature with minimal impact on the structural integrity or tensile strength of the timber element.

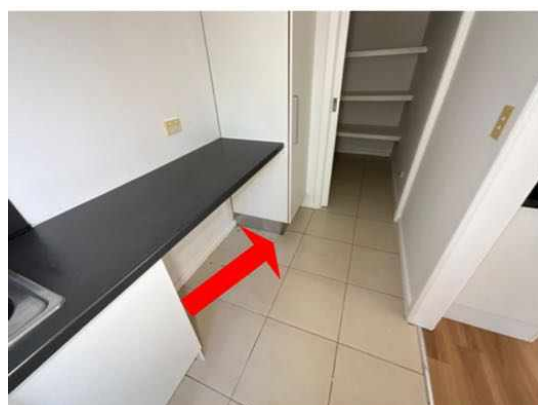
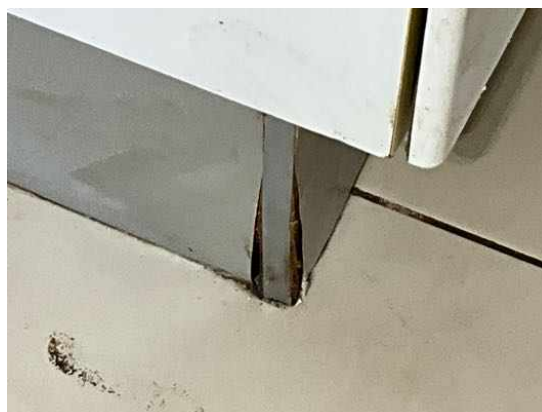
Building: Building 1
 Location: Laundry
 Finding: Cabinets- moisture affected.
 Information: The structure of the Cabinets in this area was found to be deteriorating due to the effects of excessive moisture. Replacement of any damaged board materials is recommended. Parts of the Cabinetry not badly damaged or swollen may be re-sealed or painted.

The source of the moisture must be identified and rectified before repairs and replacement is carried out. The services of a Cabinet maker or General Handy Person should be sought at the discretion of the owner.

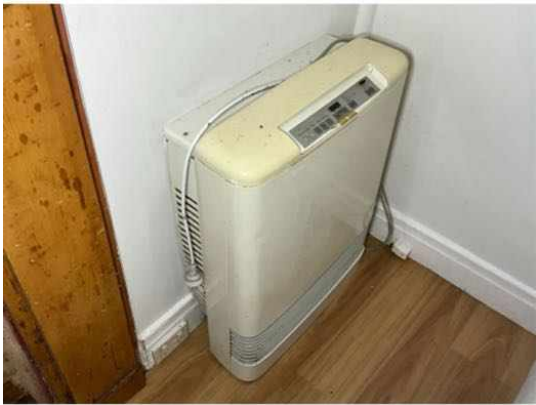
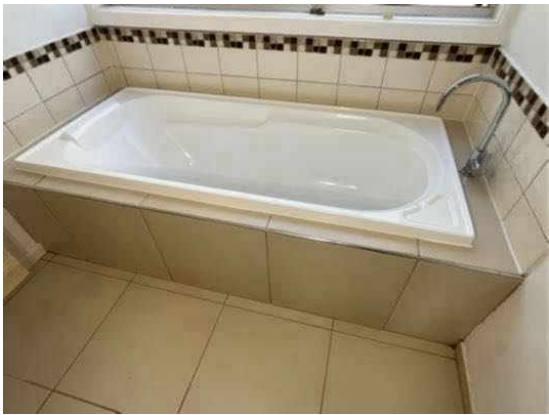
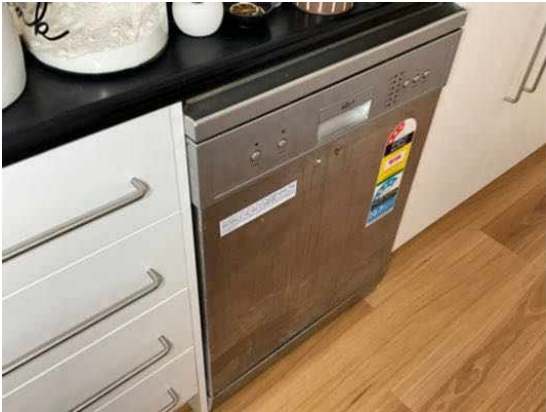
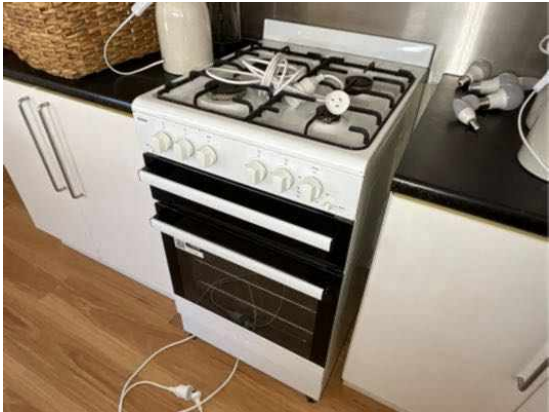
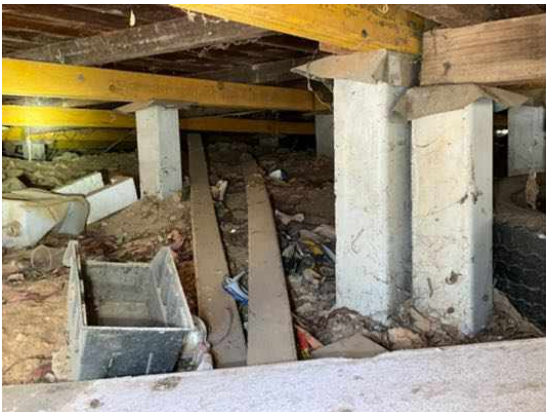
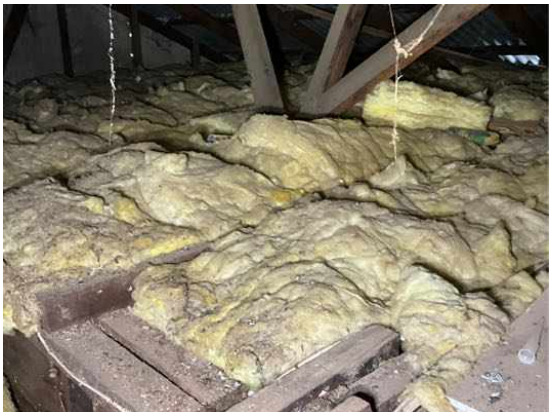
Building: Building 1
 Location: All Areas
 Finding: Additional Photos - Obstructions and Limitations
 Information: These photographs are an indication of the obstructions and limitations which impeded full inspection of the property at the time of inspection. These obstructions can hide an array of defects and should be removed to allow full inspection to be carried out. A re-inspection is recommended once the areas are made accessible.
