Building and Timber Pest Inspection Report

Inspection Date: Tue, 17 Feb 2026

Property Address: 96 Donald St, Hurstville NSW 2220,
Australia

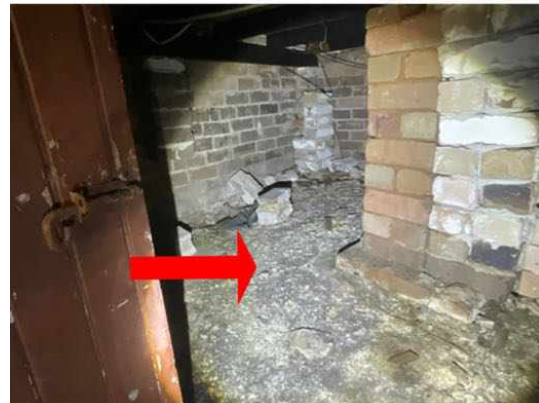
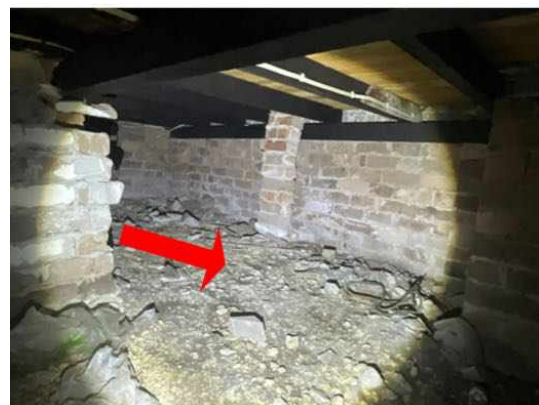
Finding 1.01

Building:	Main Building
Location:	Subfloor > Centre
Finding:	Subfloor Ventilation - Inadequate (mouldy subfloor soil to some areas)
Information:	Adequate subfloor ventilation aids in preventing excessive moisture wood rot and termite activity by ensuring a dry subfloor environment. Where ventilation is substandard it is usually caused by factors such as failure to install adequate vents during construction subsequent building works or earth and vegetation covering over vents low subfloor clearance and items or debris in the subfloor restricting airflow. Subfloor ventilation can be improved in most cases by addressing the causes such as exposing subfloor vents installing additional new vents installing mechanical (forced airflow) ventilation and removing debris from the subfloor. A registered builder should be appointed as soon as possible to perform these works as necessary.

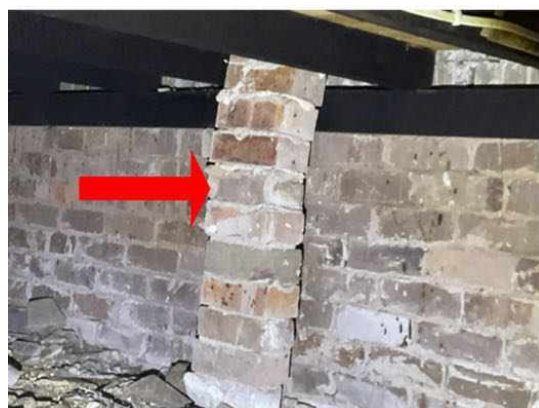
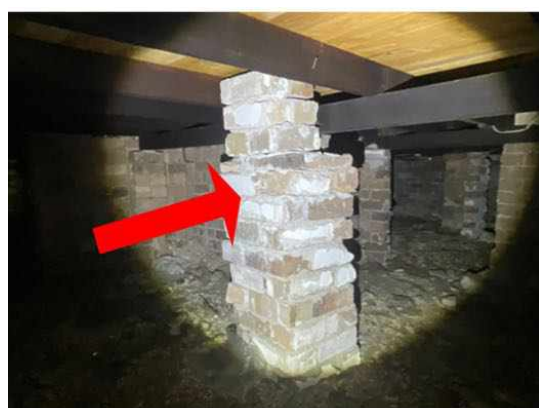
Finding 2.01

Building:	Main Building
Location:	Subfloor
Finding:	Subfloor structures (brick piers) - unstable
Information:	Damages were evident in the structure in the subfloor of the property indicating that it may not be structurally sound or compliant with current building regulations. While some damages are expected of structures of this design, it is suspected that land slippage, footing damaged or forceful impact may cause the stability of the walls to further decline. Additional bracing and supporting of the is required immediately to ensure its safety and structural integrity.

If left unmanaged, the structure is likely to deteriorate further, potentially creating an environment which is unsafe.

An structure engineer and a registered builder with the assistance of trades, e.g. qualified carpenter, should be appointed to perform remedial works as a matter of urgency.

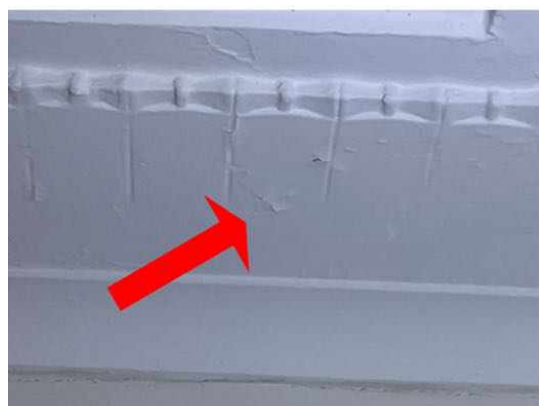
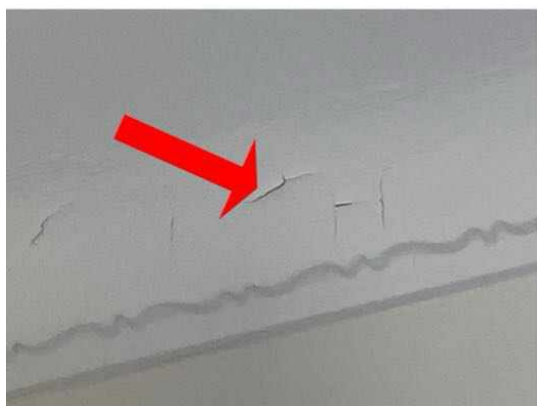
Finding 2.02

Building:	Main Building
Location:	Bedroom
Finding:	Moisture Damage and Possible Mould – Ceiling
Information:	Visible discolouration and patchy staining were observed on the ceiling, indicative of possible mould or mildew growth. This is likely caused by poor ventilation, inadequate exhaust fan performance, or excessive humidity from regular use of the bathroom.

Prolonged moisture exposure can lead to fungal decay, damage to plasterboard, or create conditions conducive to timber pest activity above the ceiling line.

It is recommended that:

- A licensed plumber or building professional assess for hidden water leaks.
- Exhaust fan performance and airflow be reviewed and upgraded if necessary.
- The affected area be cleaned, treated, and repainted with mould-resistant paint.
- The roof void or ceiling cavity above be inspected for hidden moisture or damage if accessible.

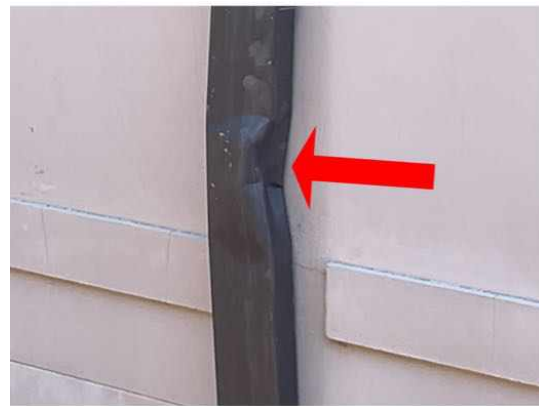
Building: Main Building
 Location: All External Areas
 Finding: Downpipe - Damaged
 Information: The Downpipe in this area was found to be damaged at the time of inspection. Damage occurs generally may be indicative of impact damage to the building element (accidental or deliberate).

Left unmanaged, the fitting is unlikely to cause further damage to surrounding building elements.

Repair and/or replacement of the damaged fitting is advised. A Licensed Plumber should be appointed to repair/replace the light fitting at the client's discretion.

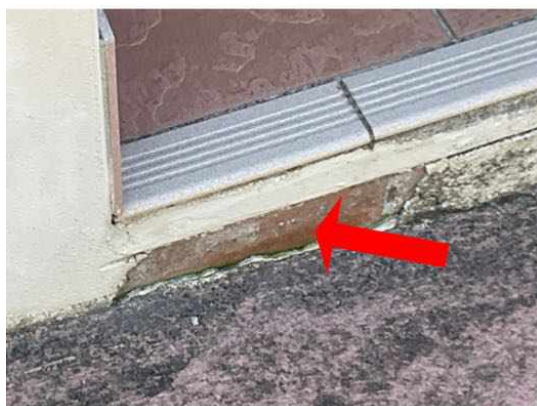
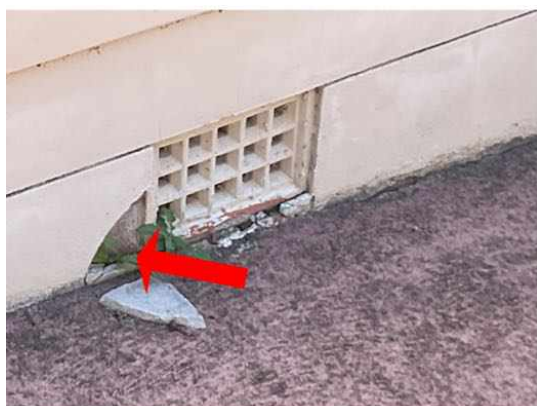
Finding 3.04

Building: Main Building
 Location: All External Areas
 Finding: Render - Drummy
 Information: Drummy rendered areas were identified at the time of inspection. The term 'drummy' refers to render that has become detached from its fixing, despite it still being solid. Such defects are generally caused by physical or moisture damage to the area. Drummy render may also be a direct result of poor workmanship during the construction process.

Render may swell and shrink with changes in air humidity if the area has sustained moisture damage. Any exposure to moisture is capable of causing rendered areas to become drummy and/or cracked over a prolonged period of time. Drummy render generally requires chipping off and re-rendering or painting.

Specialist trades are available for these types of services. A registered builder may be required to undertake works if damage is extensive, or if secondary building defects have resulted. Immediate action is recommended to ensure that no further damage is sustained in the affected area.

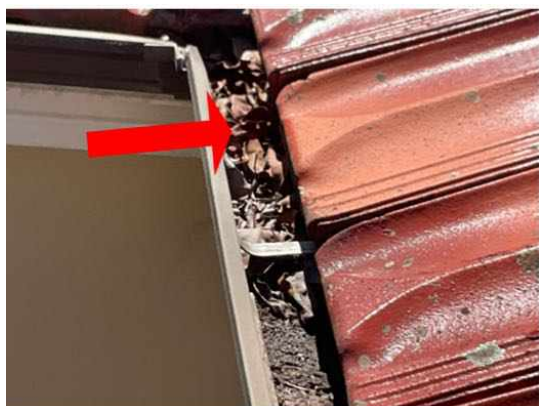
Blocked gutters are likely to lead to high levels of moisture in the affected areas. Such moisture will not only cause rust and decay of the associated building materials, but can also provide conditions that are conducive to termite and timber pest activity. Blockages in gutters should therefore be removed immediately to ensure dry conditions are maintained.

Consult a Licensed Plumber for further specific advice on remedial works that may be required. In the interim, it is highly advised that blocked gutters be removed by the homeowner or a general handyperson as a matter of urgency.

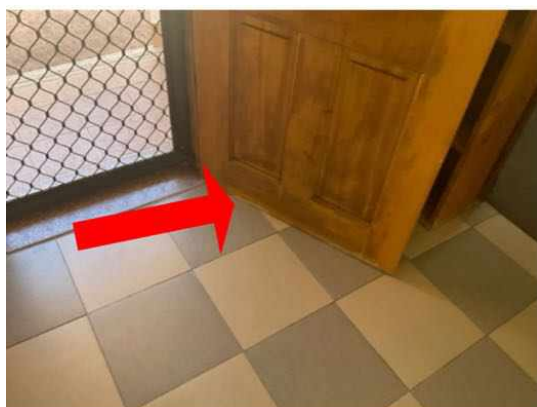
Information: Binding and/or jamming of this door is evident during standard operation. This defect inhibits the functionality of the affected door as well as creating potential for secondary defects to associated building elements, such as damage to the floor covering.

A door that binds to flooring or to the associated door frame may have several causes, ranging from minor defects, such as poor installation of the door or deteriorated hinges, through to major structural issues, such as damage to subfloor structures.

Where door binding/jamming appears to indicate major structural issues, a registered builder specialising in re-stumping should be appointed to provide an estimate on the cost of rectification.

For minor causes, a qualified carpenter or general handyperson should be appointed to perform minor rectification works at client discretion.

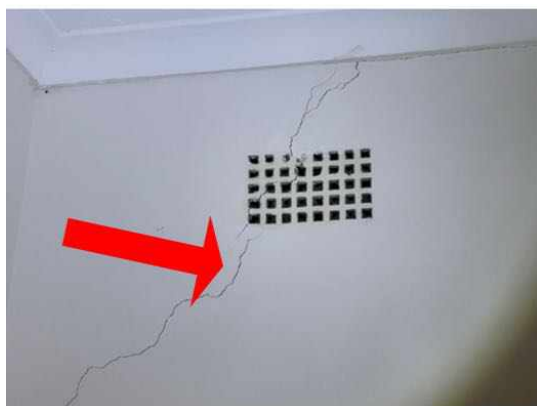
Finding 3.09

Finding: Cracks to internal render - Category 1

Information: It has been observed that cracking to internal rendered surfaces has occurred. The degree of damage falls within Category 1, described as fine cracks that do not need repair and which are less than 1.0mm in width limit.

Damage of this category is not considered a defect for rectification. Always contact your building inspector should cracks widen, lengthen, or become more numerous.

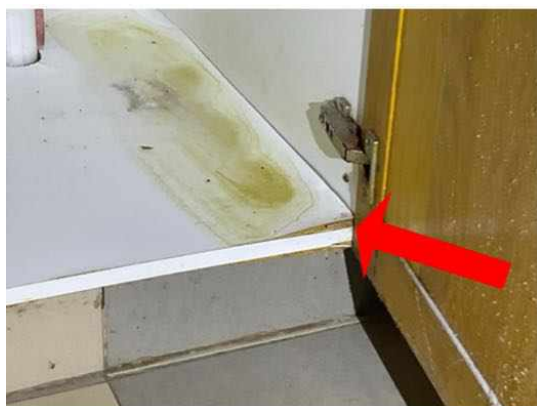
Building:	Main Building
Location:	Kitchen
Finding:	Delamination of timbers
Information:	Delamination is one means by which composite materials (e.g. layered timber composites) may fail over time. In laminated materials, repeated cyclic stresses may lead to the formation of mini-structures of separate layers, with significant loss of mechanical toughness. Water penetration or the presence of excessive moisture also generally contributes to delamination.

Where building materials have become delaminated, they lose their structural strength, and are likely to have a variety of appearance and serviceability defects as a result.

Delamination of timbers may be repaired where the area affected is minor and/or easily accessible, by gluing and screwing layers back together. However, this is an interim repair, and where delamination has occurred, the client should plan for the replacement of affected timbers sooner than would otherwise be expected.

All timber structures affected by delamination should be replaced as soon as possible to avoid any further damage. Repair and replacement estimates should be sought from a registered builder or qualified carpenter.

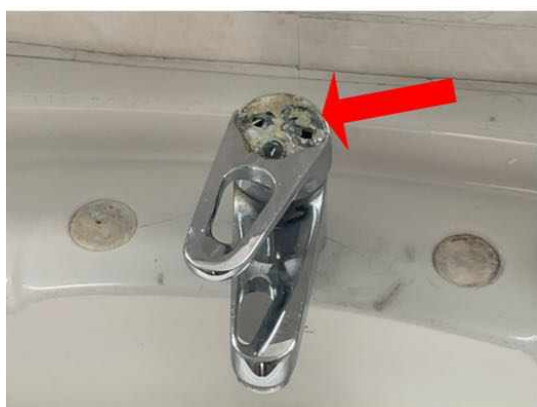
Finding 3.12

Building:	Main Building
Location:	Bathroom
Finding:	Tapwares - Deterioration (old)
Information:	The tapwares shows evidence of general deterioration. This deterioration likely to have developed the leaking in the fitting, providing excess moisture to affected areas. Such damage is expected of a building element of this age and with this level of exposure to excessive moisture. While the fitting is still fully operational, any leaks should be identified and rectified by a licensed plumber as soon as possible. Prevention of further deterioration will delay the need for replacement of the fitting in the near future.

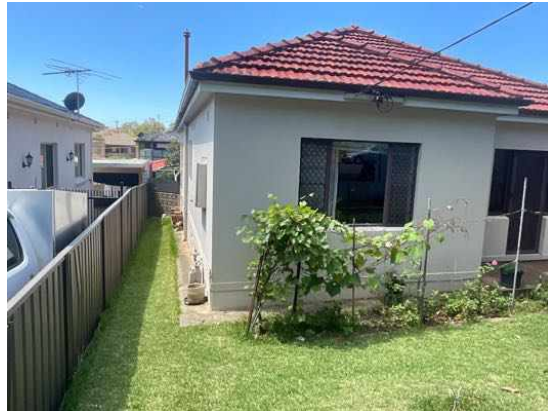
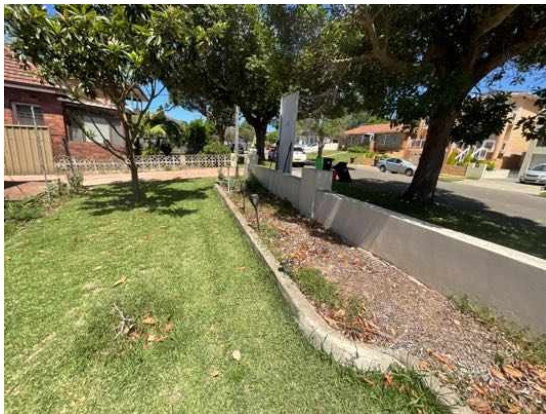
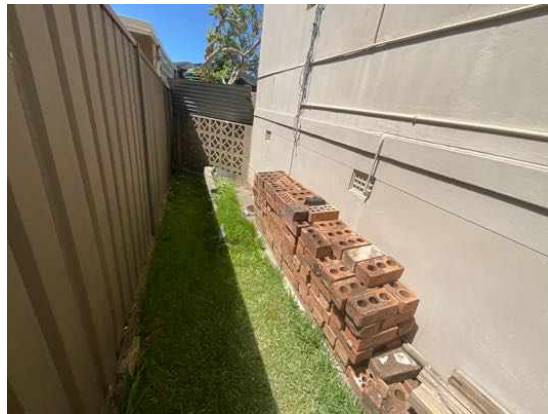
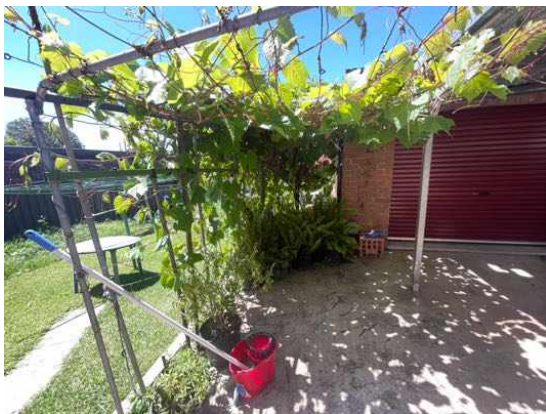
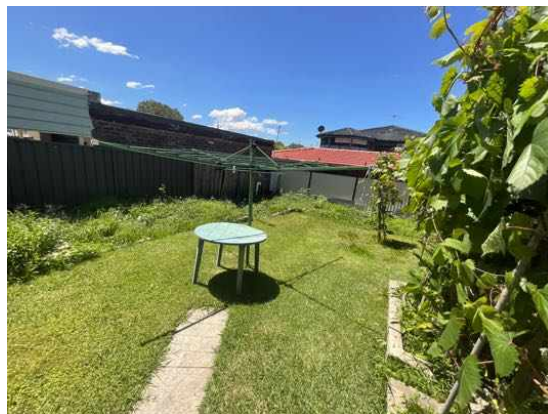
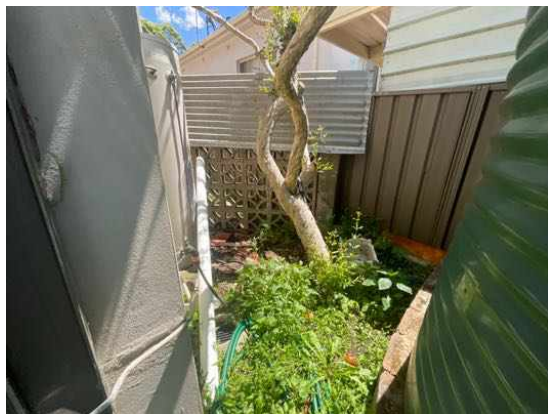
Finding 6.01

Building:	Main Building
Location:	All Areas
Finding:	Garden Beds - Conditions Conducive to Termites
Information:	Garden beds were found to be evident in the garden area. These garden beds can include untreated timber, and with a combination of moisture from watering hosing can make conditions conducive to termite activity and termite ingress.

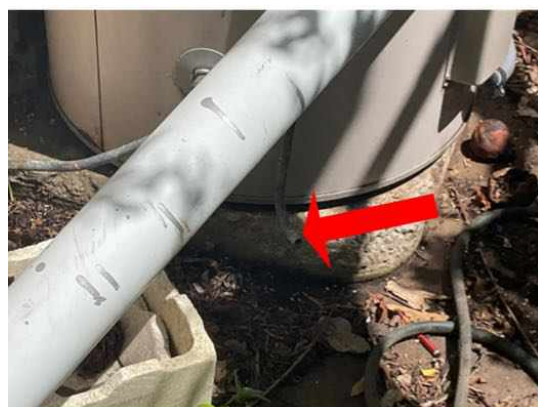
Finding 6.02

Building:	Main Building
Location:	All Areas
Finding:	HWS Overflow - Not Connected
Information:	The Hot Water System (HWS) overflow was found to be disconnected from storm water drainage and is creating excessive moisture in the surrounding area.

These damp conditions can lead to secondary defects such as rot, rust or corrosion of associated building elements, the formation of fungal decay, or even the creation of potential slip hazards. When coupled with poor site drainage, pooling of water may also attract termite activity to this area.

It is highly recommended that a licensed plumber be appointed to connect the HWS overflow in order to prevent such an environment from being created. These minor works should be carried out as soon as possible.

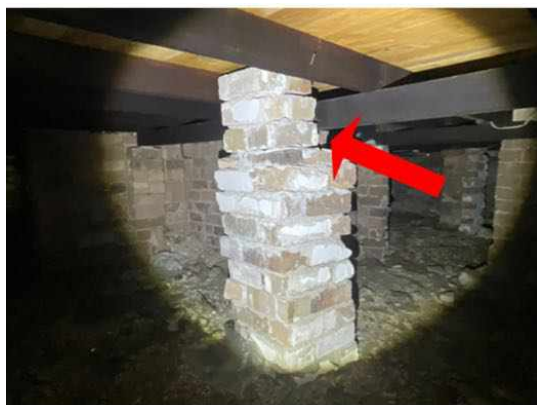
Finding 6.03

Building:	Main Building
Location:	Subfloor
Finding:	Ant caps - Not installed
Information:	Ant caps have not been installed to the subfloor structure at the time of inspection.

Installed during the construction process, ant caps are designed to easily identify termite or pest ingress from stumps to the adjoining bearers.

Where ant caps have not been installed, frequent monitoring of these areas should be carried out in order to identify any signs of termite or timber pest workings.

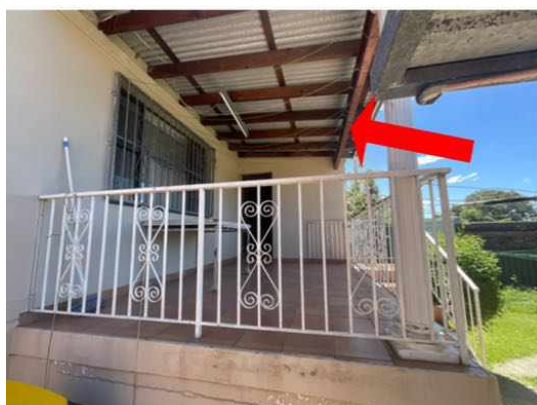
Finding 6.04

Building:	Main Building
Location:	All Areas
Finding:	Timber - exposed to weather
Information:	External timbers that are frequently exposed to harsh weather conditions require adequate protection in order to maintain their condition. Where timbers have not been painted or treated adequately, general deterioration is likely to occur at an accelerated rate.

If left unattended, replacement of these timbers is likely to be necessary in the short-term future. Adequate treatment of these timbers is required as soon as possible by a painting contractor or general handyman.

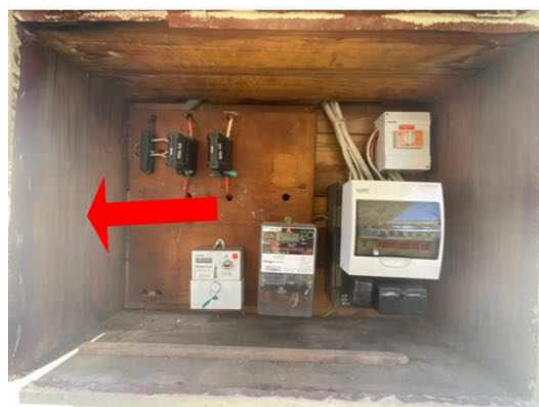
A durable notice should be placed in the switchboard unit to indicate current termite barriers. At the time of inspection, it appeared as though no termite management system has been installed, with no evidence to suggest preventative works taking place.

The client may consider gaining further advice from a pest controller as to the costs and procedures involved with this application. It is recommended that obtaining such advice be a short-term priority.
