Building Inspection Report

Inspection Date: Fri, 9 Jan 2026

Property Address: 41 Hamilton St, Redland Bay QLD 4165,
Australia

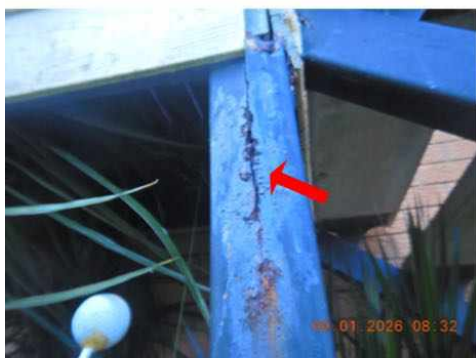
Defects 1.01

Building:	Main Building
Location:	External Stair Landing > Rear
Finding:	Building element - Rusted or corroded
Information:	The rear stairs landing metal support posts shows evidence of advanced rusting and corrosion, which is likely to have developed as a result of excessive exposure to moisture and or inadequate coatings.

As surface rust provides no protection to the underlying iron, the deteriorating condition is likely to worsen if not addressed in the short-term future.

Full replacement will be required as soon as possible.

Where possible, the use of galvanized (treated) metals or aluminium coated metals aid in rust prevention, as does regular general maintenance. Rust formation can be controlled with coatings, such as paint, that isolate the iron from the environment.

Rusting and corrosion should be managed by ideally removing or limiting the affected surface from exposure to moisture. A registered builder may be appointed to replace any building elements that have been severely affected by rust or water damage.

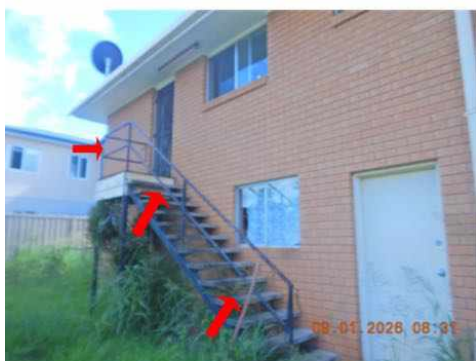
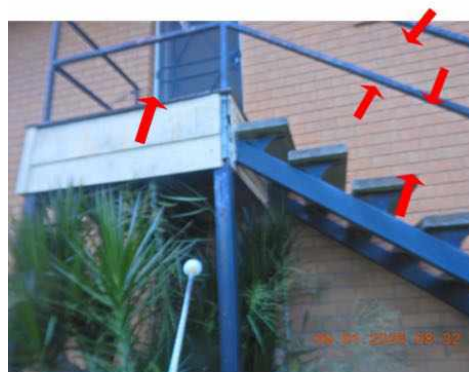
Defects 1.02

Building:	Main Building
Location:	External Stair Landing > All Areas
Finding:	Hand Rail non Compliant
Information:	The rear stairs and landing were found to have metal handrails installed that don't meet current height regulations or requirements of 1000 mm, and gaps in the handrails bigger than 110 mm.

The hand rails installed are 900 mm high and gaps of approximately 400 mm and don't comply to the CURRENT BUILDING code requirements.

Due to the age of the building this code most likely did not apply at the time of this buildings construction.

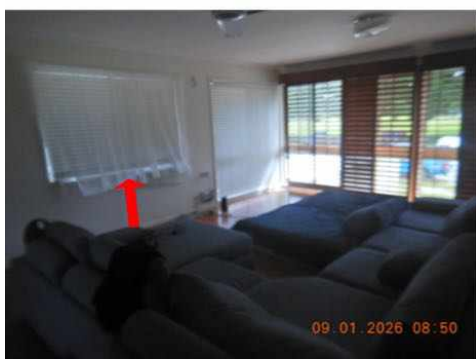
Defects 1.04

It was noted that a large amount of the upper level window with a sill height of less than 1500 mm of the floor, and a fall potential of over 2 meters do not have window restricting devices fitted . As per (A-S 2047) all upper windows must not be able to be opened beyond 125 mm , unless a security screen is fitted over the opening . This is a safety hazard issue that has to be brought to your attention.

Due to the age of this building, this code requirement would not have applied, but the client may consider the installation of security screenings to meet current safety standards.

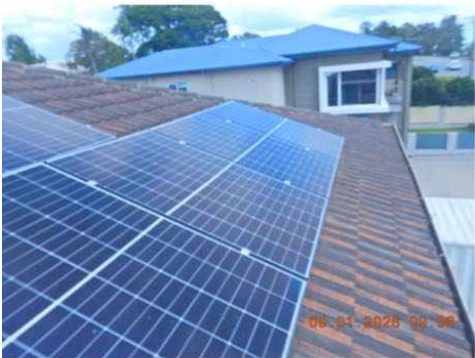
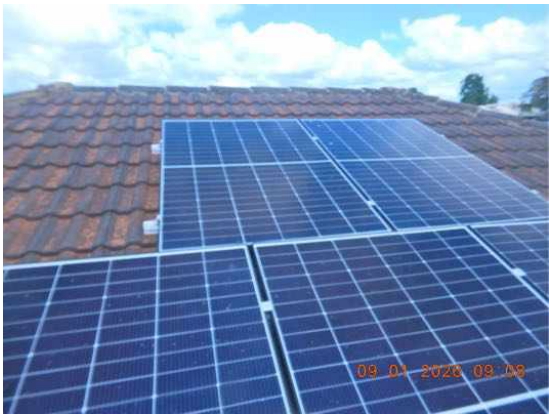
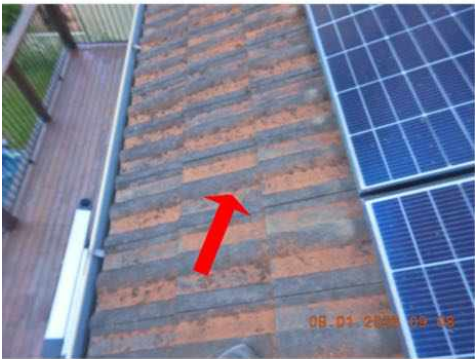
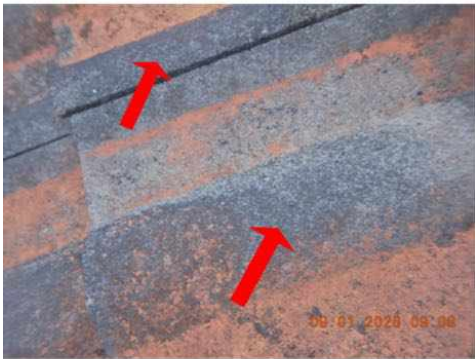
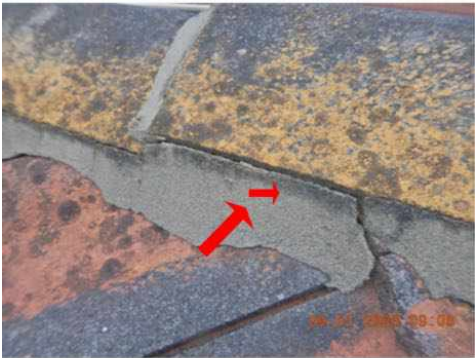
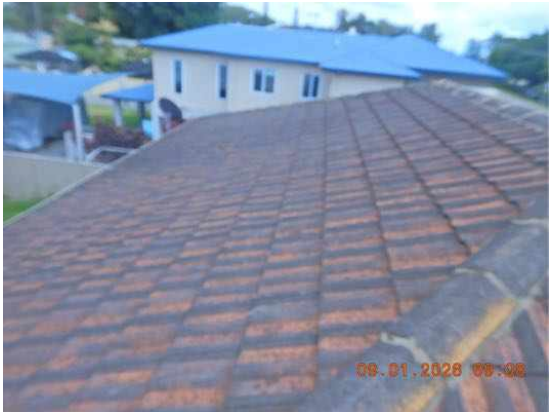
Defects 2.01

Building:	Main Building
Location:	Roof Exterior > All Areas
Finding:	Roof tiles - Weathered
Information:	Upon inspection of the exterior upper level roofing, the majority of roof tiles were considered to be in a fair condition. While weathering of the tiles is consistent with the age of the property, maintenance works are always required.

Isolated areas of mortar may come loose in the valleys and minor cracking is also present. Re-pointing and re-sealing the roof tiles may be considered as an interim solution by the client to help preserve and extend the life span of the tiles.

The roof tile glaze surfaces have significantly deteriorated, and the concrete material of the tiles is exposed.

Where left unmanaged, deteriorating roof tiles are likely to lead to a number of secondary defects, including minor water leaks and weather exposure to internal roofing structures.

Consultation with a roofing contractor is highly advised to gain advice on cost of remedial works that may be required in the short to medium term. Remedial works are likely to increase the longevity of the exterior roofing structure.

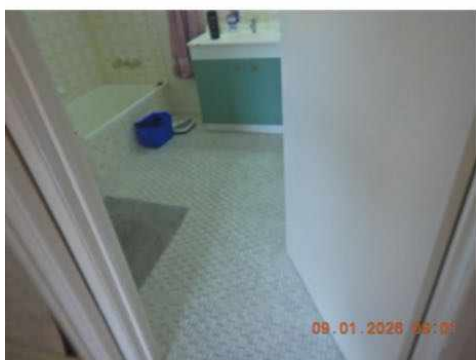
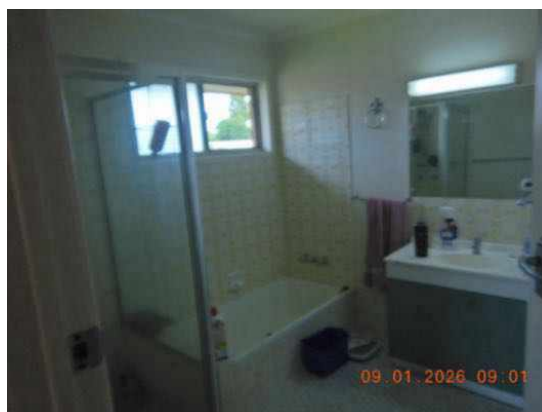
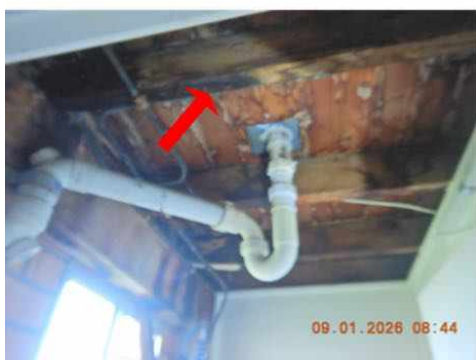
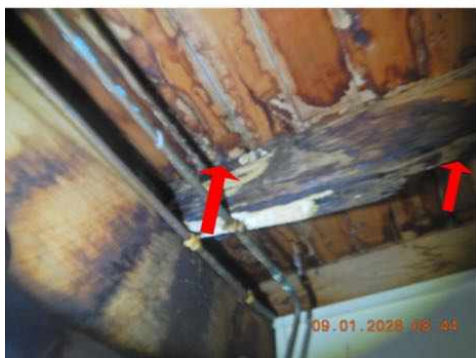
Defects 2.02

Building: Main Building
 Location: Bathroom > Front Left
 Finding: Pipework - Leaking into subfloor
 Information: Dampness to localised sections of the upstairs bathroom shower subfloor area was identified. It is suspected that this dampness has occurred due to leaking pipes in this area.

Dampness in this area has lead to wood rot and general deterioration of structures within the subfloor space. Excessive moisture also creates an environment which is conducive to termite and pest infestation.

Minor moisture deterioration was also noted to areas of the vanity unit.

A licensed plumber should be appointed immediately to repair any pipes that may be leaking. This will ensure a dry subfloor space as well as improving the water efficiency of the property.

Repairs to the damaged subfloor timbers will be required as soon as possible.

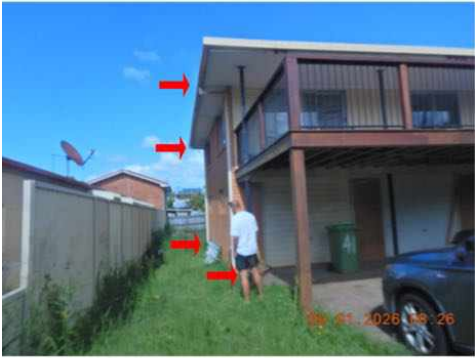
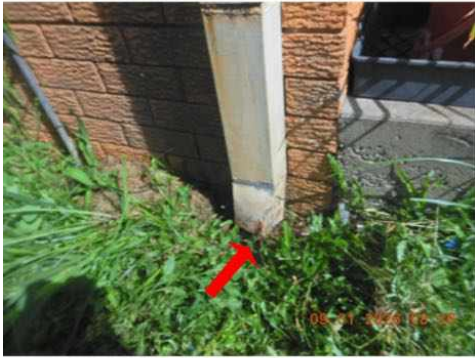
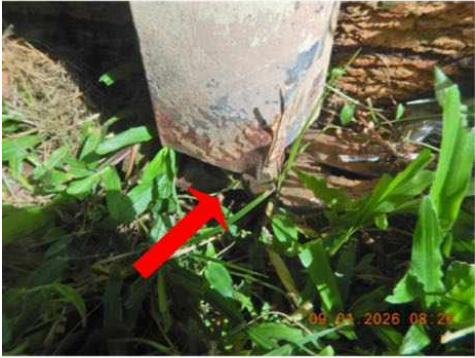
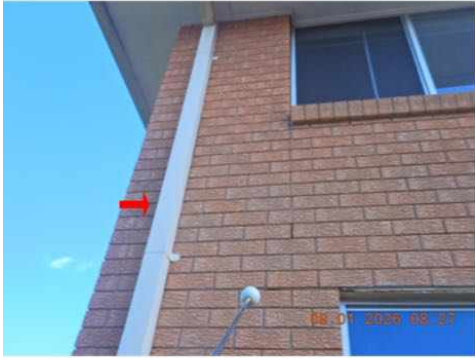
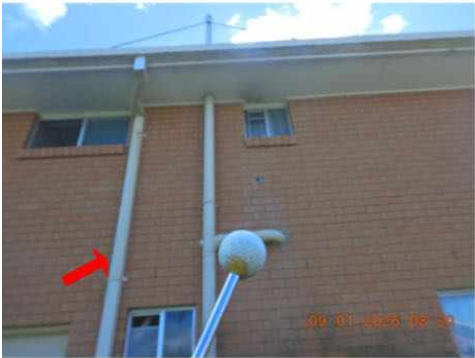
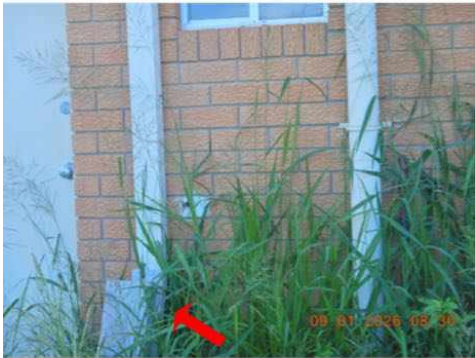
Defects 3.01

Building:	Main Building
Location:	Exterior walls > All Areas
Finding:	Down pipe not connected
Information:	The metal roof water down pipes throughout this property are not connected to the storm water line to the street or legal point of discharge, or are have been removed . At present the down pipes are depositing water to the ground, this may over a period of time contribute to possible subsidence and structural foundation issues and may

contribute to the development of mould and mildew,as well as being conducive to termite activity.

The services of a licensed plumbing contractor could be engaged to connect the storm water system to the street or install a rubble pit in the rear yard area.

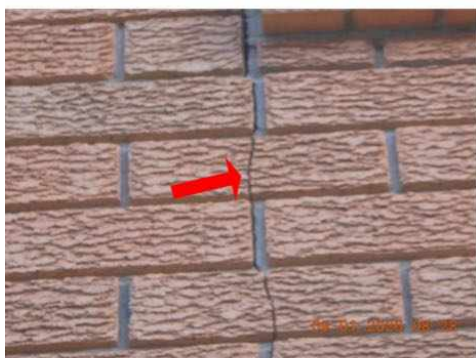
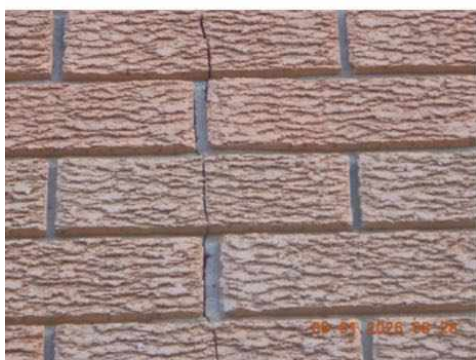
Defects 3.02

Building:	Main Building
Location:	Exterior walls - left side > Rear Left
Finding:	Brickwork - Step cracking
Information:	Minor Step cracking was identified to the rear upper level bedroom-2 window brickwork in this area at the time of inspection. Step cracking, which is similar to other forms of cracking, has a variety of possible causes. However, the most common is the subsidence of adjacent footings.

Step cracking is a relatively common defect, and is most likely to occur adjacent to windows, doors and other openings. Mortar failure in the gaps between affected bricks indicates the stresses and tensions affecting the wall.

Where step cracking is extensive or severe, the client is advised to consult a structural engineer. Minor step cracking can be used as a warning sign to address factors causing stress to the wall, which can include the effect of surrounding trees, water leaks, soil erosion, or even the presence of reactive soils in the surrounding area.

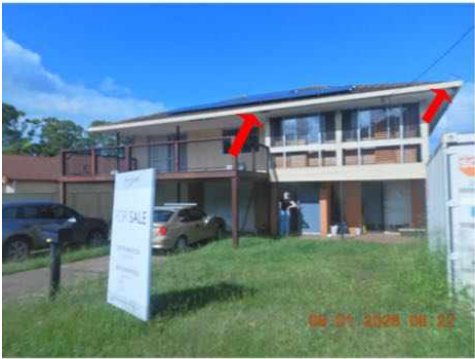
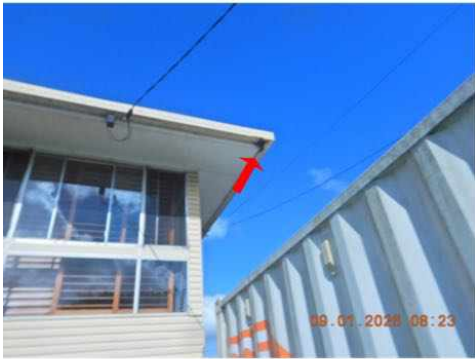
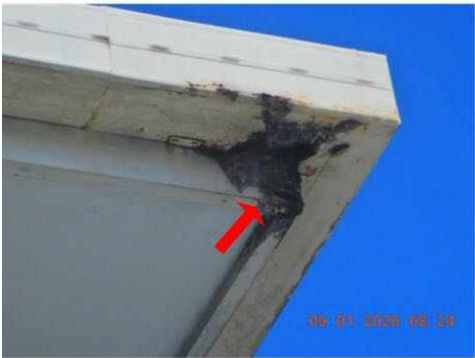
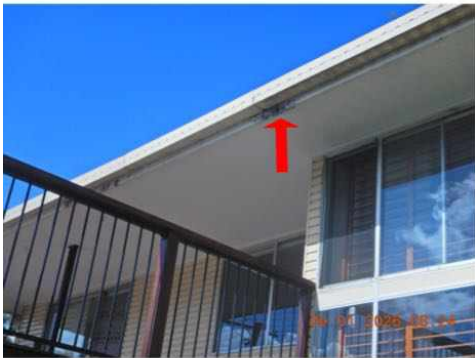
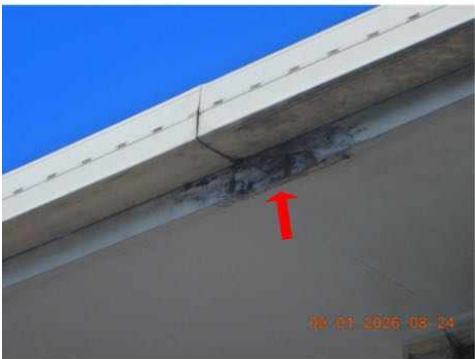
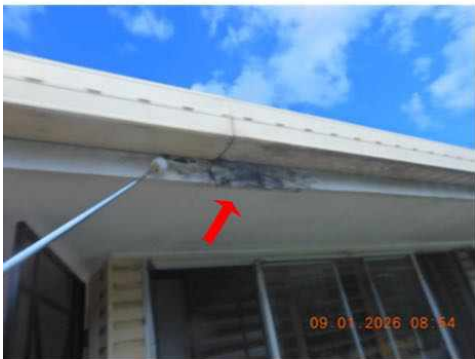
Defects 3.03

Building:	Main Building
Location:	Roof Exterior > All Areas
Finding:	Fascias - Wood rot
Information:	Wood rot was found to be affecting areas of fascias and barges throughout this building area, evidenced by the presence of mould on the surface in some areas. Wood rot, also known as Fungal Decay, occurs when timbers and other cellulose building materials are exposed to damp conditions on an ongoing basis.

It is likely that this wood rot has developed as a result of faults in the roof plumbing, creating excessive moisture in this areas. Frequent exposure to rain and other weather conditions also make fascias and barges susceptible to accelerated deterioration.

Early intervention and regular maintenance will prolong the useful life of these building elements. Prior to any works being performed, the cause of the moisture that has created the visible wood rot should be identified and addressed in a suitable manner.

It is advised that a roof plumber be appointed to inspect all roof plumbing and subsequently identify the cause of the wood rot. Replacement of affected fascias and barges may then be a necessary step in protecting surrounding building elements from such deterioration.

A qualified plumber may be appointed to assess the cause of excessive moisture and

to provide advice on any remedial works as required. A qualified carpenter or registered builder may also be required to replace affected building materials.

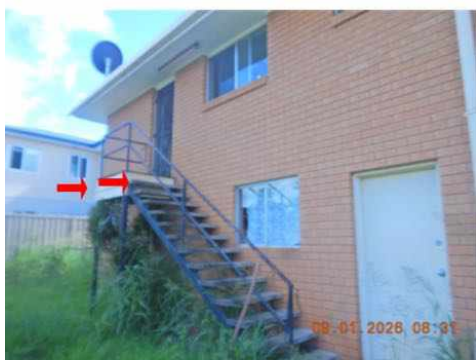
Defects 3.04

Building:	Main Building
Location:	Exterior walls - front/Rear > All Areas
Finding:	Wood rot
Information:	The external wall cladding and timber stops shows evidence of wood rot through isolated areas of this building . Wood rot, also known as Fungal Decay, occurs when timbers and other cellulose building materials are exposed to damp conditions on an ongoing basis. This could be the result of exposure to weathering over a prolonged period of time, or the attraction of excessive moisture from other abutting building materials. Contributing factors also include poor air ventilation in the area.

Wood rot is often associated with general damp problems and is evidenced by a 'musty' smell or mould and mildew occurring on surfaces. If left unmanaged, damp conditions can lead to further health problems and the decay of timbers will continue.

Early intervention and regular maintenance, particularly of exterior timbers, will prolong the useful life of these building elements. Prior to any works being performed, the cause of the moisture that has created the visible wood rot should be identified and addressed in a suitable manner. Replacement of affected timbers may then be a necessary step in protecting surrounding building elements from such deterioration.

A qualified plumber may be appointed to assess the cause of excessive moisture and to provide advice on any remedial works as required. A qualified carpenter or registered builder may also be required to replace affected building materials.

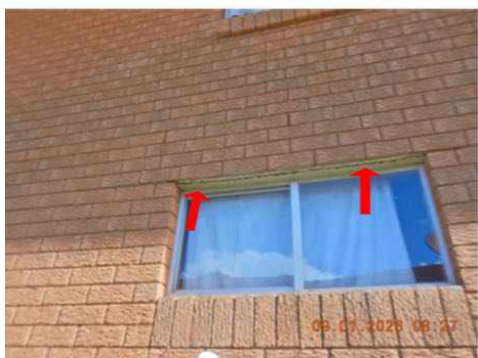
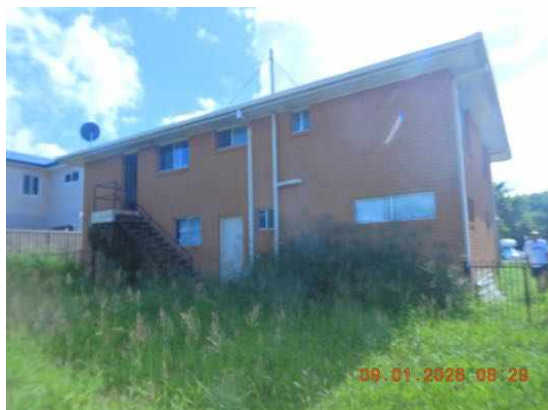
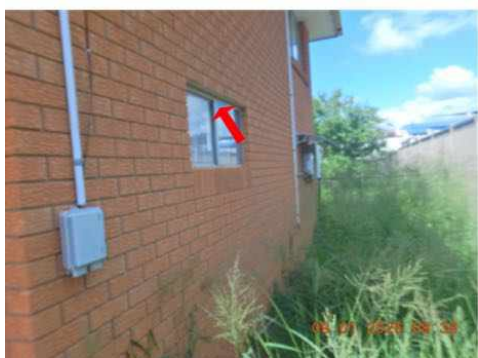
Defects 3.05

Building:	Main Building
Location:	Exterior walls > All Areas
Finding:	Building element - Rusted or corroded
Information:	The lower level window brick lintel angles shows evidence of rusting and corrosion throughout , which is likely to have developed as a result of excessive exposure to salt air moisture and or inadequate coatings.

As surface rust provides no protection to the underlying iron, the deteriorating condition is likely to worsen if not addressed in the short-term future.

Where possible, the use of galvanized (treated) metals or aluminium coated metals aid in rust prevention, as does regular general maintenance. Rust formation can be controlled with coatings, such as paint, that isolate the iron from the environment.

Rusting and corrosion should be managed by ideally removing or limiting the affected surface from exposure to moisture. A registered builder may be appointed to replace any building elements that have been severely affected by rust or water damage.

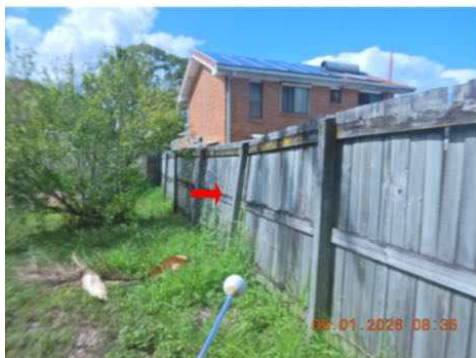
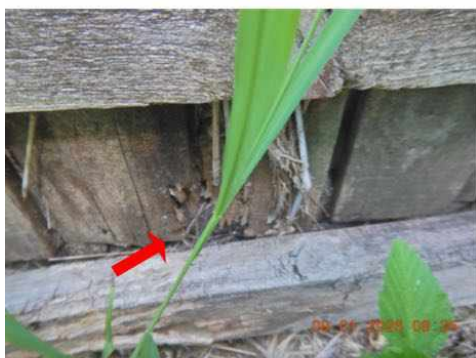
Defects 3.06

Building: Main Building
 Location: Yard - Back > All Areas
 Finding: Fencing - Deteriorated
 Information: It was noted at the time of inspection that sections of the rear timber fencing throughout the property have deteriorated, and minor termite damage was identified. Typically fencing deteriorates due to age and or wear, rot and or rust which is generally expected for a structure of this age, due to prolonged exposure to weather conditions. Sometimes inadequate installation or maintenance can be to blame.

If left unattended, it is likely that further damage will occur. It is suspected that repair of several elements of the fencing may be required however replacement may be a

consideration of the client also.

A licensed fencing contractor should be appointed to provide further advice and perform rectification works as necessary.

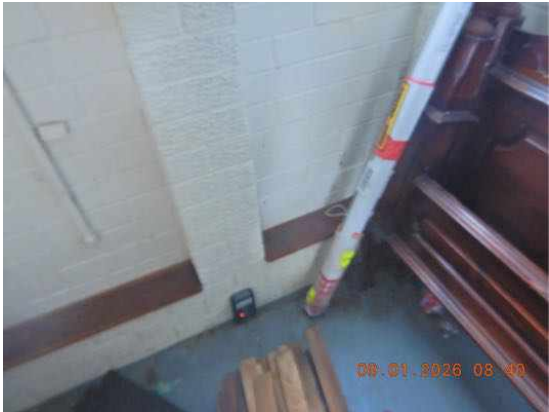
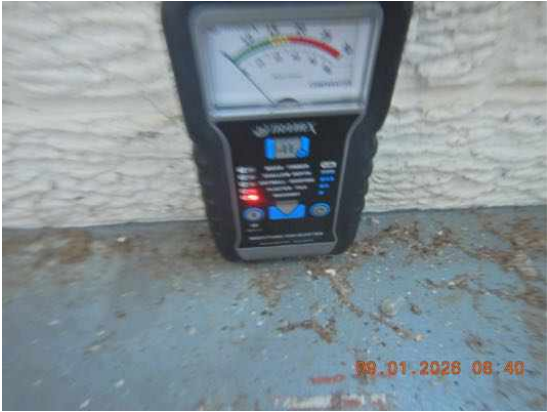
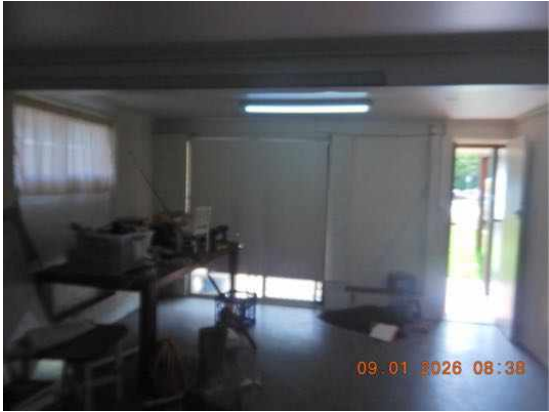
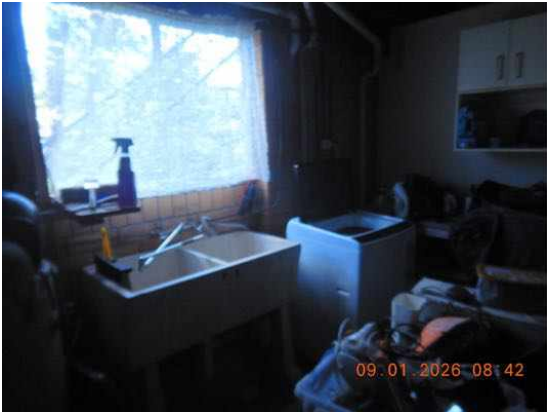
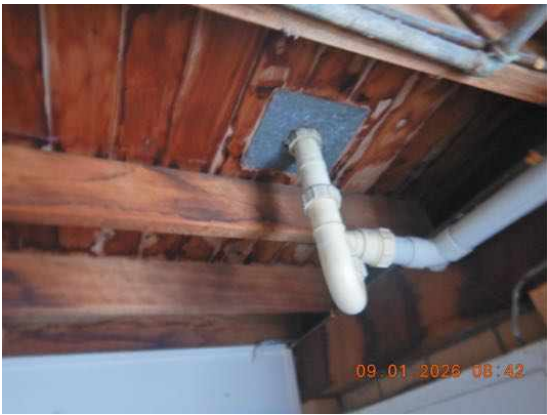
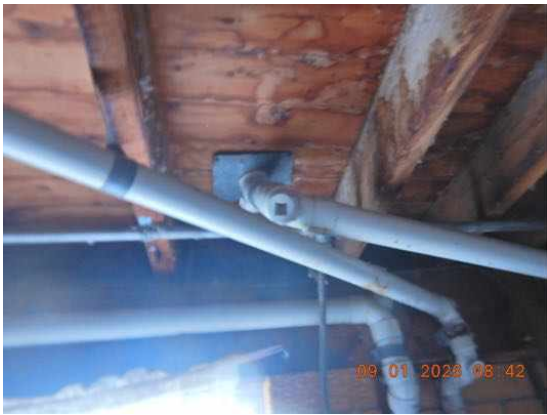
Defects 3.07

Building:	Main Building
Location:	Toilet (WC) > All Areas
Finding:	Subfloor structure - Wood rot
Information:	The upstairs bathroom shower subfloor structures are showing signs of deterioration and wood rot (fungal decay) of the timbers, and is visible from sth subfloor toilet broom . It is suspected that this defect has developed as a result of damp conditions in the upstairs bathroom shower subfloor.

Damp conditions cause the timbers to fail, resulting in the subfloor structures failing to bear the load (or weight) of the building as originally intended. Without repairs and maintenance, including potential replacement of affected elements, it is likely that serious structural faults will result, as well as an array of minor defects.

The presence of wood rot to the subfloor structure is also conducive to termite infestation.

Where wood rot is present to any structural timber, rectification or replacement of the

affected timber building element is required as soon as possible . The adequate timeframe for such works are dependent on the severity of the rot. Where rot has developed to become widespread, replacement of sections of the subfloor structure may be required. Consultation with a structural engineer or registered builder specialising in re-stumping is highly advised as soon as possible.

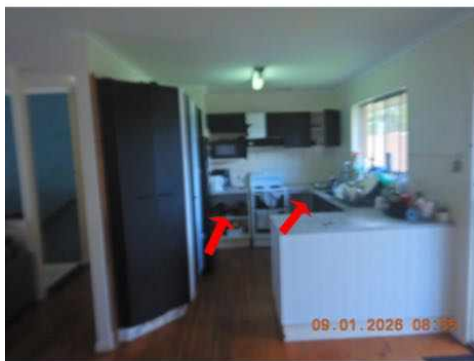
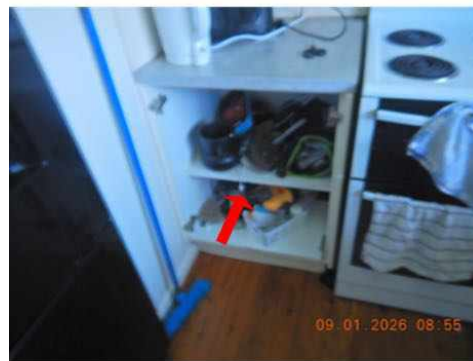
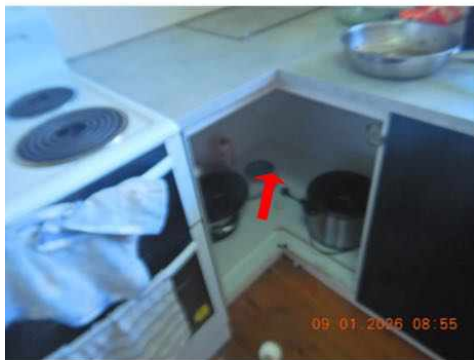
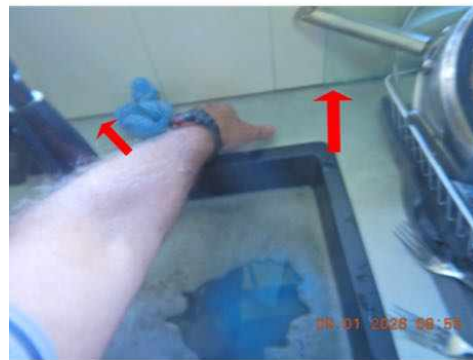
Defects 3.08

Building: Main Building
Location: Kitchen > All Areas
Finding: Kitchen joinery deteriorated
Information: There were some areas of the kitchen joinery that are showing signs of deterioration or damage occurring.

This may be a result of age and wear or possibly due to moisture penetration and deterioration.

Doors were found to be missing in the under bench areas, and silicon not installed at the sink tiled areas.

These areas should be monitored for further deterioration occurring and repair or replacement work will be required.

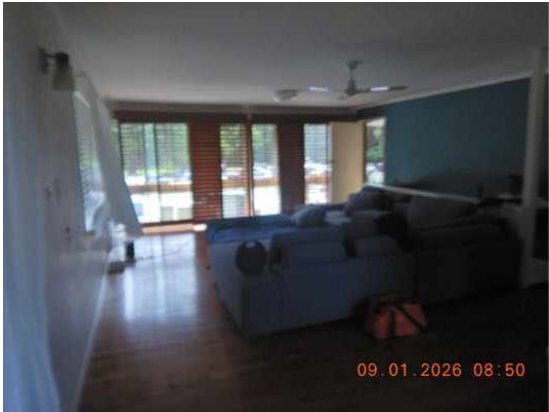
Defects 3.09

Building: Main Building
 Location: Living Room/ Dining > Centre
 Finding: Cracks to internal rendered surfaces - Category 1
 Information: It has been observed that cracking to the upstairs living/dining room internal ceiling rendered surfaces has occurred in this area. The degree of damage falls within Category 1, described as fine cracks that do not need repair and which are less than 1.0mm in width limit.

Damage of this category is not considered a defect for rectification. Always contact your building inspector should cracks widen, lengthen, or become more numerous.

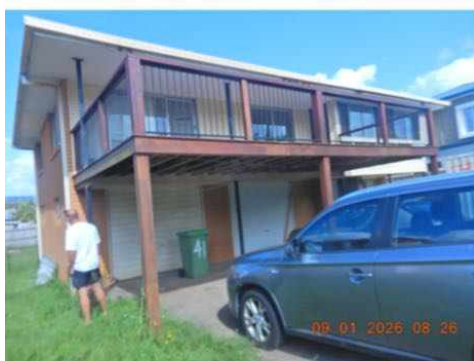
External timber structures are also constantly exposed to weather elements and can deteriorate in an accelerated manner, ongoing assessments are required.

It is highly recommended that a Structural Engineer further assess the external timber balcony or deck to inform the client of its load capacity. Regular maintenance inspections by competent practitioners is needed.
