# Building and Timber Pest Inspection Report

Inspection Date: Wed, 25 Mar 2026

Property Address: 10 Lucas St, Reservoir VIC 3073, Australia

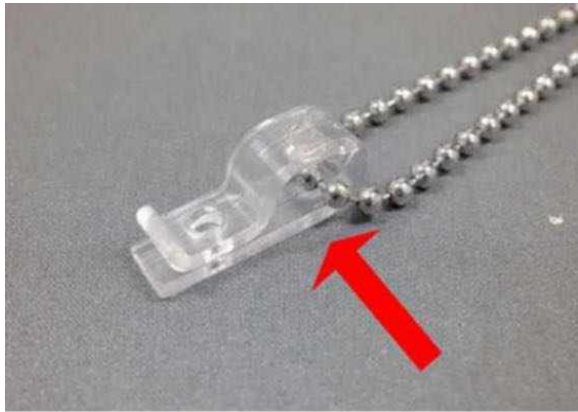
Building:	Main Building
Location:	All Areas
Finding:	Curtain & Blind - Safety Cord
Information:	Looped curtain and blind cords pose a significant strangulation hazard for children as they can place the loop over their head and/or get tangled in the loose cords.

Check all the rooms in your house for any blinds or curtains with long cords that are either loose or looped. This includes any cords that are within children's reach at floor level or near furniture they can climb on.

Secure any loose or looped cords with cleats or tension devices – these can be purchased from your local curtain and blind retailer or hardware store. Do not put furniture such as cots, beds, highchairs, playpens, couches, chairs, tables or bookshelves near a window where children can reach the blind or curtain cord.

It is recommended that this defect be resolved immediately to avoid harm to occupants.

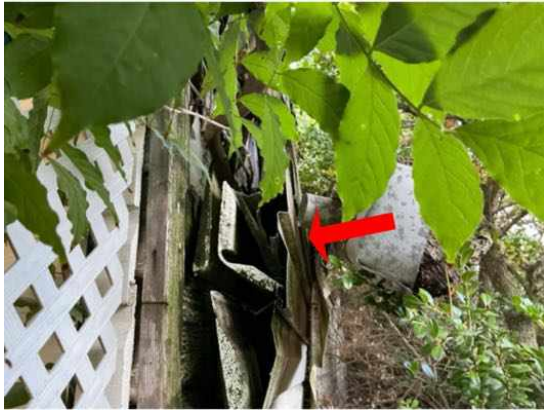
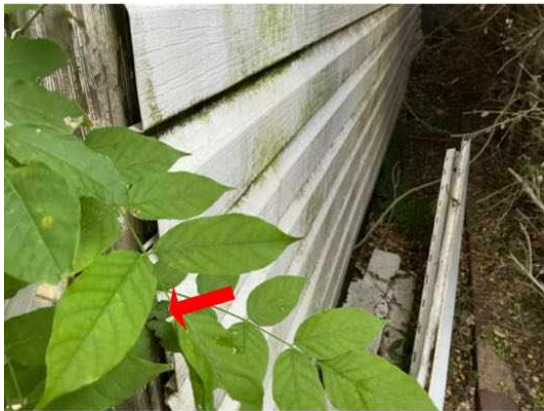
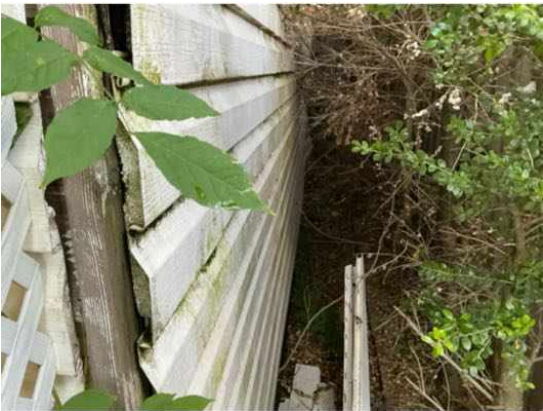
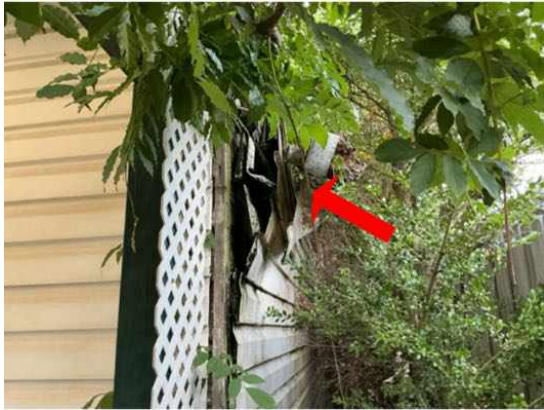
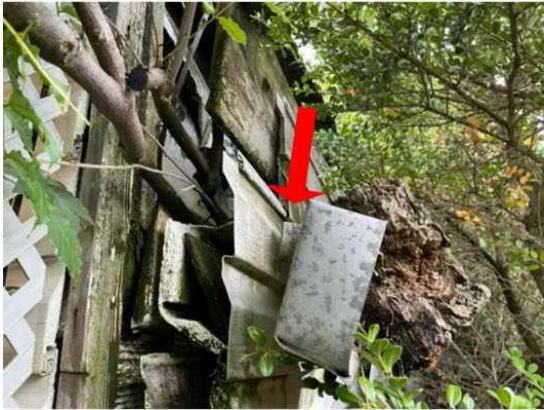
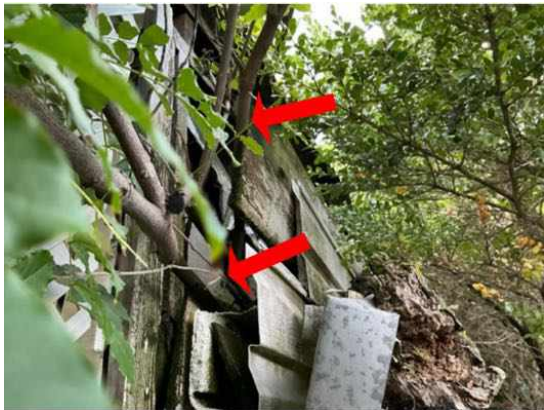
## Finding 2.01

Building: Main Building  
Location: Bedroom 4  
Finding: Wall - Damaged Extensive  
Information: The wall cladding shows visible damage, including to the weatherboard. The area appears to have been affected by tree growth between the stud wall and the external cladding, as well as damage to the gutter and downpipe.

The blocked gutter and the growing tree caused water to overflow, resulting in high soil moisture. This caused the soil to shrink, compromising the stump's load-bearing capacity. Consequently, the downpipe has collapsed.

The section requires urgent repair, including the removal of the tree, re-stumping the affected corner, replacing the affected studs and external cladding.

It is highly recommended that the engagement of structure engineer and registered building professionals to repair the affected area.

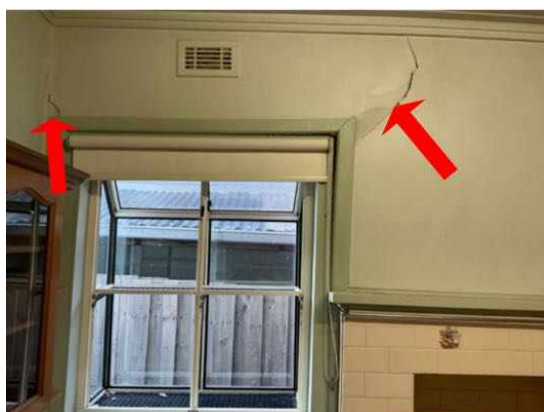
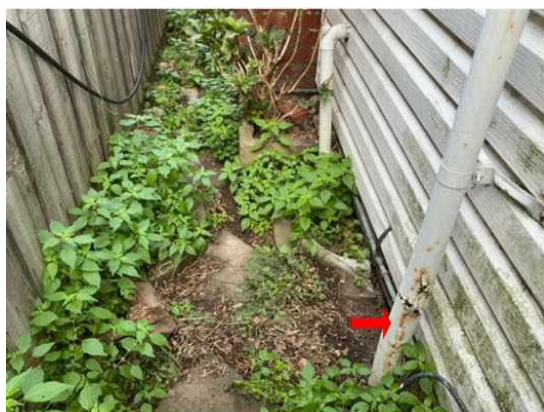
**Finding 2.02**

Building: Main Building  
 Location: Kitchen  
 Finding: Cracking - Extensive Repair Required  
 Information: Extensive repair work is generally required when managing cracking of this degree. This may involve breaking out and replacing wall sections. The property may already be affected by leaning or bulging walls, and loss of some load bearing in the beams. This may also result if the source of the cracking is unmanaged.

The area appears to have been affected by damaged down pipe caused the water pooling under the subfloor. resulting in high soil moisture. This caused the soil to shrink, compromising the stump’s load-bearing capacity. Consequently, the wall

suffered extensive damage.

The section requires urgent repair, including the replacement of the down pipe , re-stumping the affected area, replacing the affected studs and internal/external cladding.

A structural engineer should be appointed immediately to inspect the structural integrity of the affected areas and to assess the safety of the associated structures. The engineer can also nominate a scope of works required for rectification.

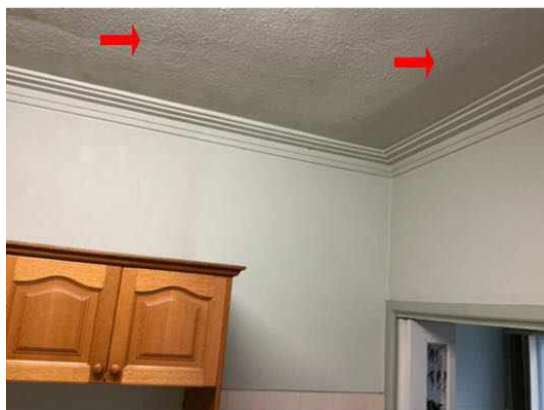
### Finding 2.03

Building:	Main Building
Location:	Kitchen
Finding:	Ceiling - Sagging/Major
Information:	Sections of the ceiling were found to be sagging at the time of inspection. Sagging to the fixed ceiling structure generally indicates that the building materials have swollen, due to contact with water, or that fixings (e.g. nails or glue) have become loose and require reattachment.

ceiling sheets, may be required. Such works may be performed by relevant tradespeople, such as plasterers and painters. Where excessive moisture has caused the roofing structure to swell and sag, the source of the water leak should primarily be identified prior to any remedial works being performed.

In some cases, sagging ceiling linings may also indicate that there are structural issues, causing surfaces to warp, twist or sag. Where sagging appears to be major, appointment of a structural engineer is advised to further inspect the property and identify the source and rectification works required.

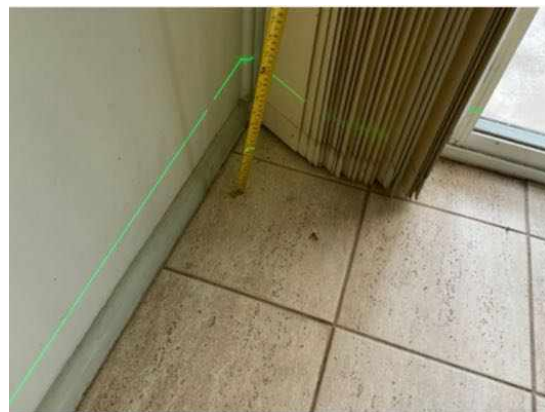
### Finding 2.04

Building: Main Building  
 Location: Bedroom 3/ Sunroom  
 Finding: Finished Floor Levels - Defective due to Variation in Plane/ Bedroom 3/ Sunroom  
 Information: The floor exhibits a horizontal level variation of up to 50mm over a 2 m span, exceeding the allowable standards and tolerances for timber floors.

This issue is caused by stumps being sunk. To rectify the problem, the subfloor structure requires re-stumping.

Structural engineers and re-stumping specialists should be involved urgently to address this matter.

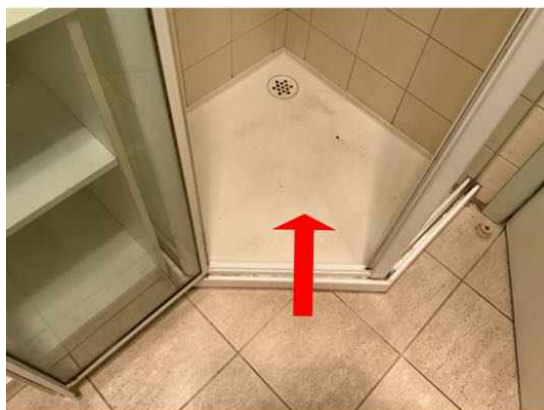
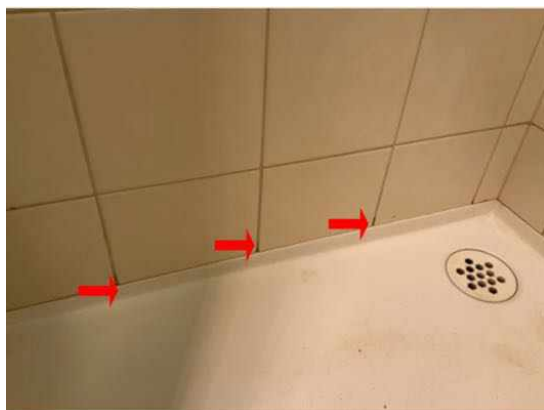
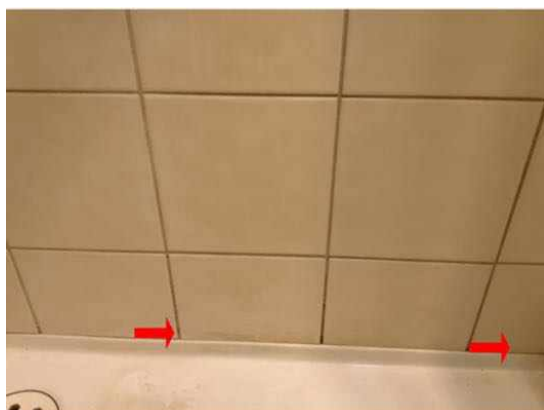
### Finding 3.01

Building:	Main Building
Location:	Bathroom
Finding:	Sealant and grouting - Missing or damaged
Information:	During inspection, it was observed that the sealant or grout has degraded to the tiled shower wall. A flexible sealant is necessary to accommodate the anticipated

The absence of sealant between tiles can cause water to seep into the wall behind it.

Consultation with a sealant specialist is advised immediately to perform remedial works as necessary. Epoxy grout is highly recommended

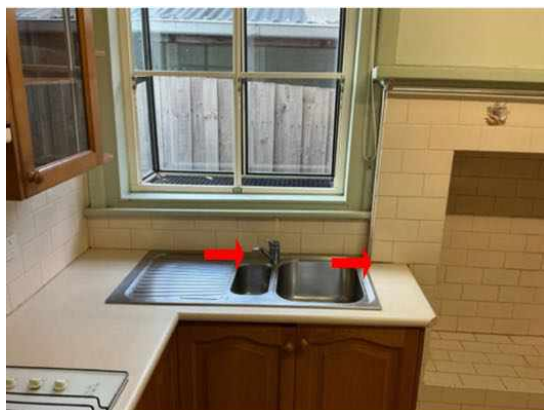
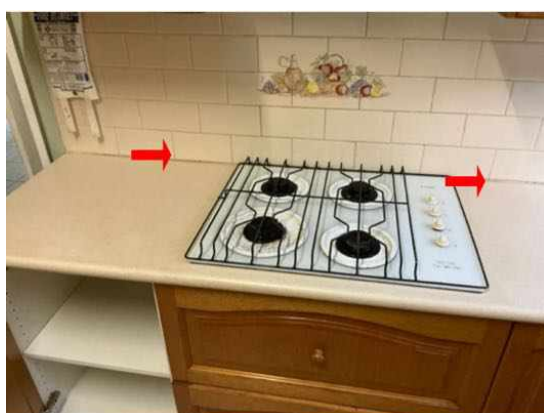
### Finding 3.02

Building:	Main Building
Location:	Kitchen
Finding:	Sealant- Missing
Information:	The lack of sealant between splash back and sink can cause water damp to the wall behind it.

Consultation with a sealant specialist is advised immediately to perform remedial works as required.

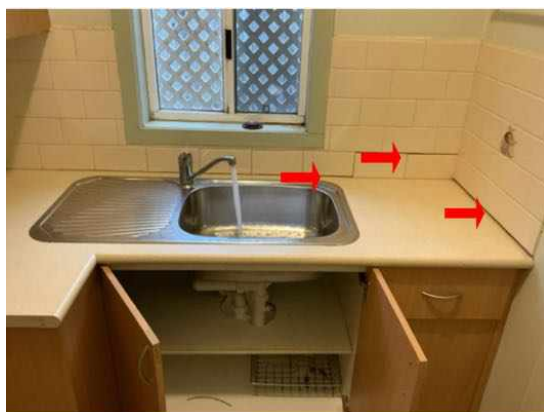
### Finding 3.03

Building:	Main Building
Location:	Laundry
Finding:	Sealant and grouting - Missing or damaged
Information:	During inspection, it was observed that the sealant or grout has degraded to the tiled splashback and bench top in the kitchen. A flexible sealant is necessary to accommodate the anticipated expansion and contraction while maintaining the joint water-tight and protective of all associated building materials.

The absence of sealant between tiles can cause water to seep into the wall behind it.

Consultation with a sealant specialist is advised immediately to perform remedial works as necessary.

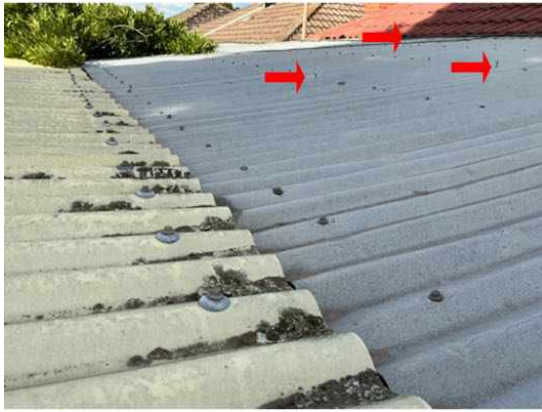
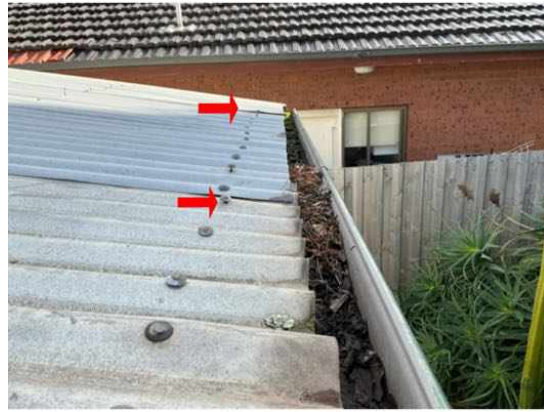
Building:	Main Building
Location:	Roof Exterior
Finding:	Roof sheets - Loose
Information:	Upon inspection of the exterior roof covering, it was noted that numerous roof sheets have become loose from their original fixings. It is suspected that this defect has developed as a result of a lack of adequate maintenance, but may also have been caused by inappropriate fixings being used in the construction process.

Loose roof sheeting detracts from the weather tightness of the roof covering, making the internal roofing structure susceptible to water penetration and subsequent damage. If left unaddressed, it is likely that secondary damage to associated building elements will develop, potentially necessitating remedial works to these structures.

A roofing restoration contractor should be appointed to advise on rectification options and on the cost of repair. It is advised that remedial works be performed as soon as possible to prevent any further damage.

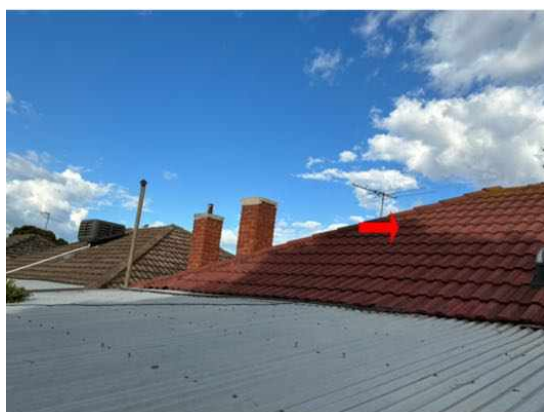
### Finding 3.06

Building:	Main Building
Location:	Roof Exterior
Finding:	Roof tiles - Weathered
Information:	Upon inspection of the exterior roofing, the majority of roof tiles were considered to be in a fair condition. While weathering of the tiles is consistent with the age of the property, maintenance works are required.

Isolated areas of mortar have come loose in the valleys and minor cracking is also present. Re-pointing and re-sealing the may be considered as an interim solution by the client to help preserve and extend the life span of the tiles.

Consultation with a roofing contractor is highly advised to gain advice on cost of remedial works that may be required in the short to medium term. Remedial works are likely to increase the longevity of the exterior roofing structure.

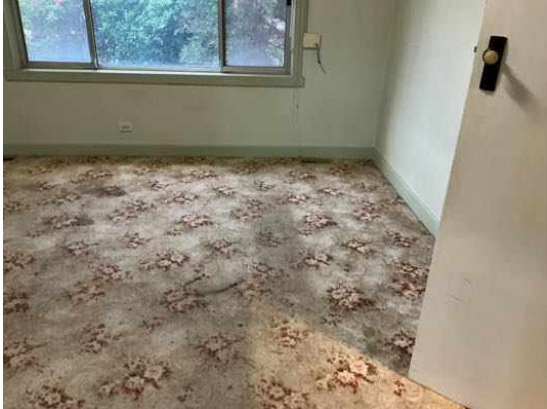
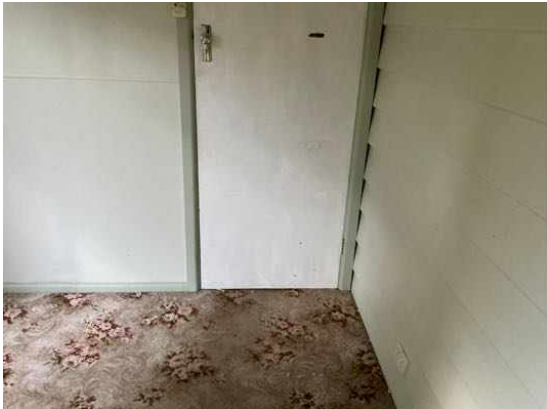
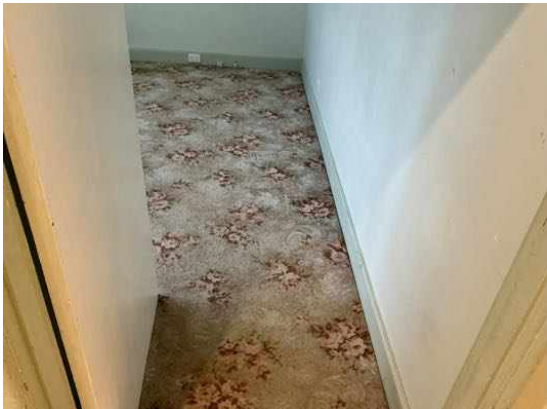
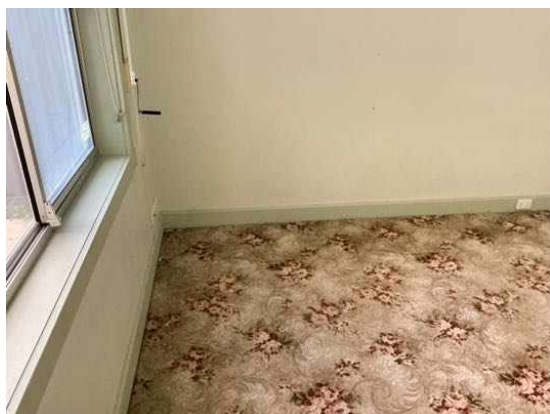
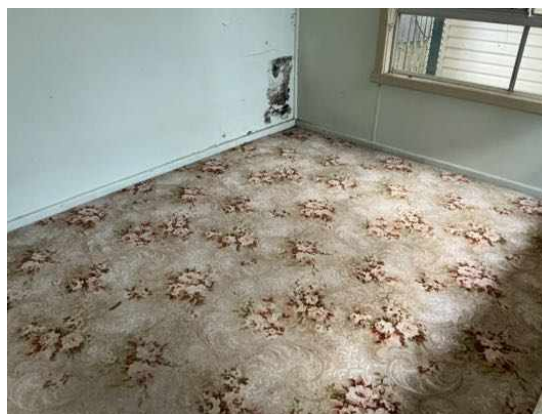
Location: All Areas  
Finding: Carpet - Deteriorated  
Information: The carpet floor covering exhibited signs of deterioration, likely attributed to ageing.  
Replacement of the carpet is recommended at the client's discretion.

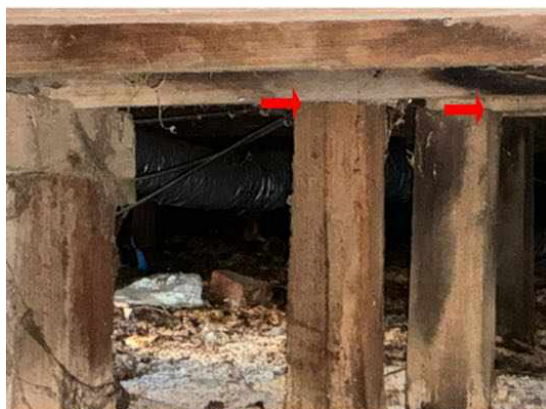
Also minimum or no gaps were noticeable around the edges of the decking. These gaps serve the purpose of preventing termites from accessing the timber, Moisture and humidity creates ideal environment to termites infestation and having timber that is close to the soil will provide ideal environment to termites.

Where ant caps have not been installed, or no gaps at the edge of the decking a frequent monitoring of these areas should be carried out in order to identify any sign of termites or timber pest working is highly advised, appointment of a Registered Builder specialising in re-stumping is required immediately to assess the condition of the stumps and provide advice on remedial works.

Also termite management system to be installed by qualified Pest Control specialist . This defect should not be left unmanaged.

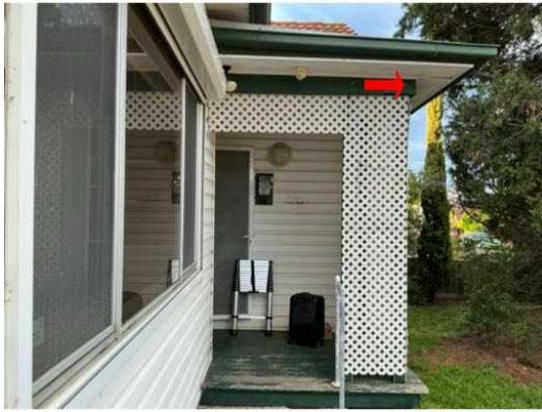
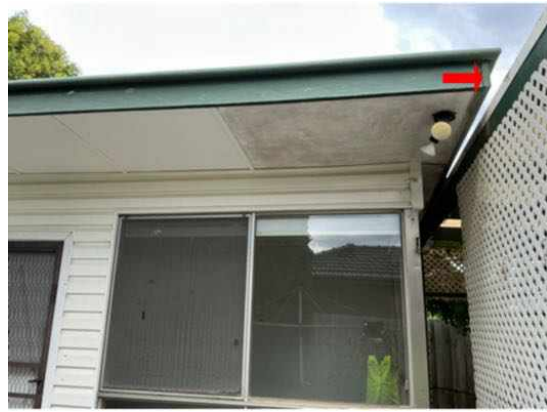
Building:	Main Building
Location:	All External Areas
Finding:	Fascias - Wood rot
Information:	Wood rot was found to be affecting fascias and barges in this area, evidenced by the presence of mould on the surface in some areas. Wood rot, also known as Fungal Decay, occurs when timbers and other cellulose building materials are exposed to damp conditions on an ongoing basis.

It is likely that this wood rot has developed as a result of faults in the roof plumbing, creating excessive moisture in this areas. Frequent exposure to rain and other weather conditions also make fascias and barges susceptible to accelerated deterioration.

A qualified plumber may be appointed to assess the cause of excessive moisture and to provide advice on any remedial works as required. A qualified carpenter or registered builder may also be required to replace affected building materials.
