# Building and Timber Pest Inspection Report

Inspection Date: Thu, 19 Feb 2026

Property Address: 8 Jane Ct, Nambour QLD 4560, Australia

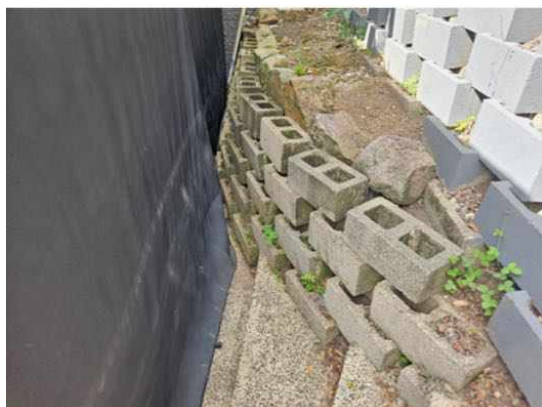
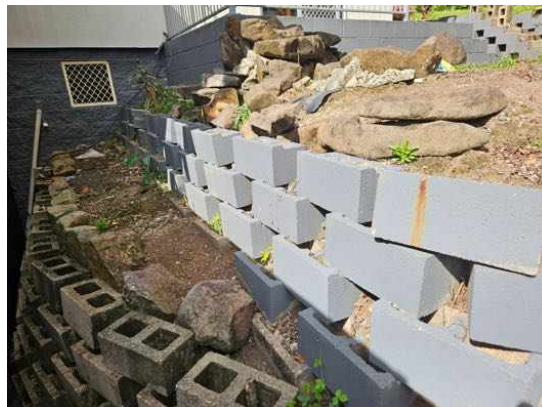
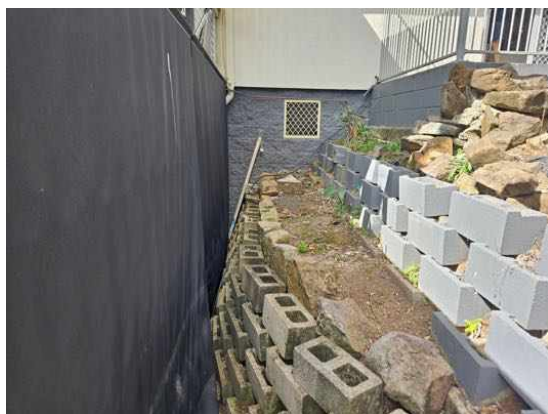
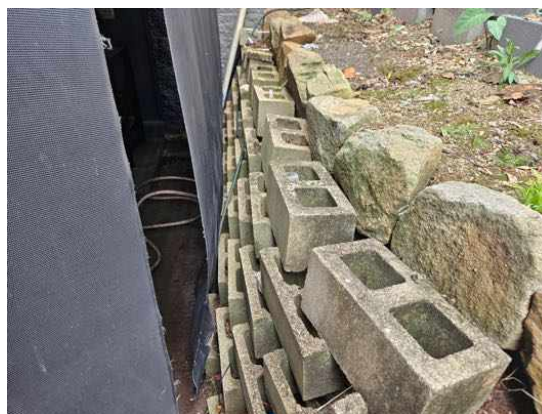
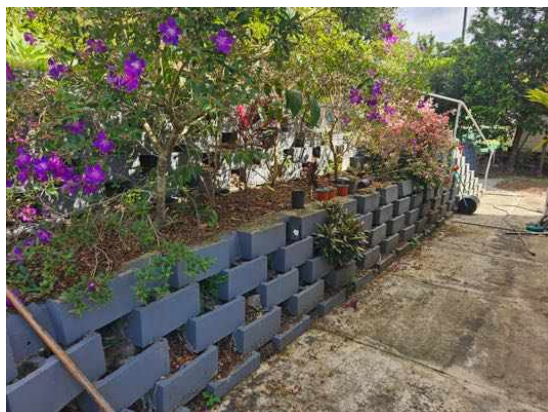
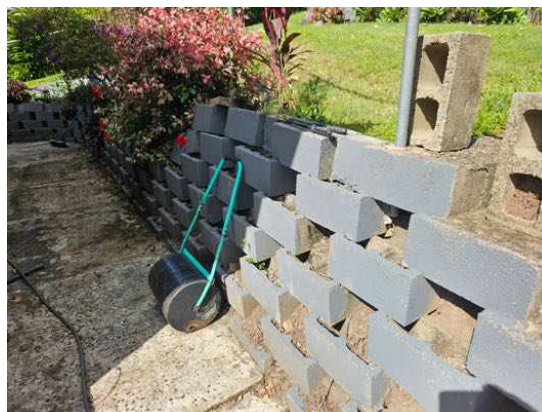
Building:	Yard
Location:	As shown
Finding:	Retaining walls - monitor
Information:	The retaining walls of the garden areas shown at the front and rear of the property are showing signs of movement. These should be monitored and if required have repairs carried out. The materials used may not be traditionally utilised for this function. It appears that they are performing moderately and should be reinforced to provided continued service.

Long term, the client should consider an alternative style of retaining wall.

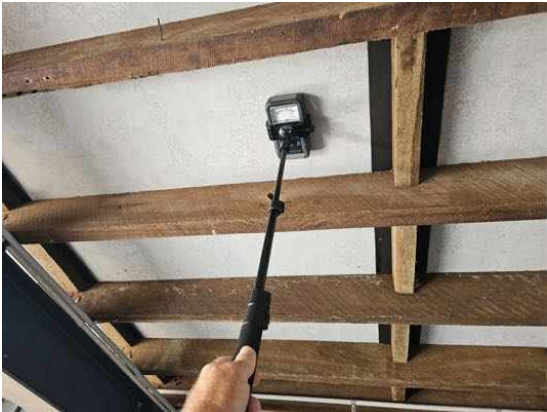
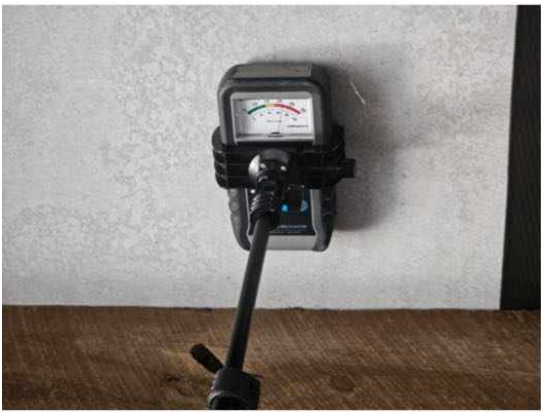
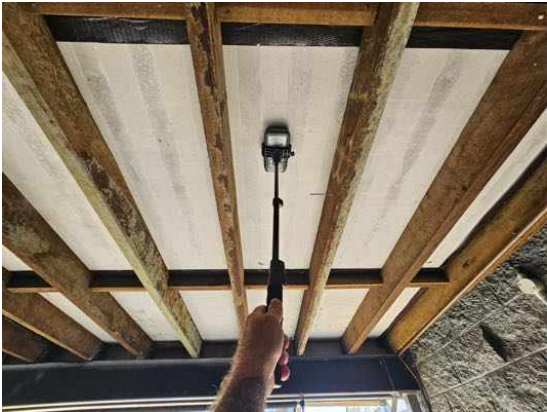
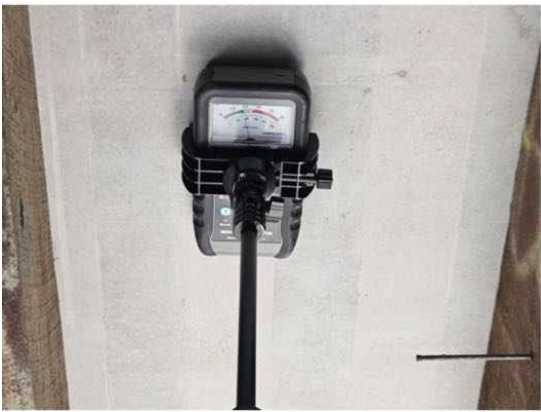
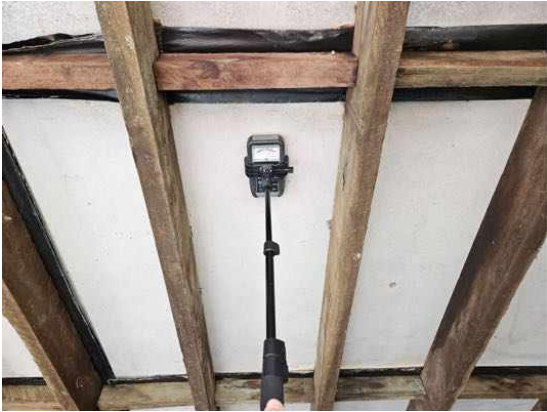
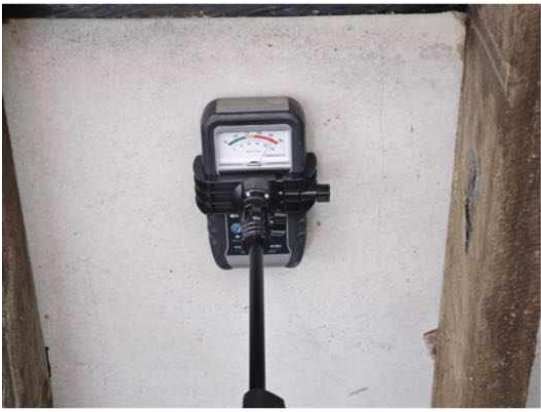
### Finding 3.02

Building:	Main Building
Location:	Deck
Finding:	Evidence of excessive moisture - upper floor deck
Information:	Evidence of elevated moisture readings were noted during the inspection in the carport ceiling / deck floor sheets. It is likely that the moisture is from continued weather exposure on the unwaterproofed surfaces of the compressed fibre cement sheets being used as flooring.

Fibre cement sheets are not designed to be exposed to water over a long term without adequate protection. If the sheets are to only have a membrane as a covering, it must be a UV stable, trafficable product. This will need to be rectified for any long term usage to continue.

It is recommended that the structure be assessed by a licensed waterproofer / tiler/ builder at the clients discretion.

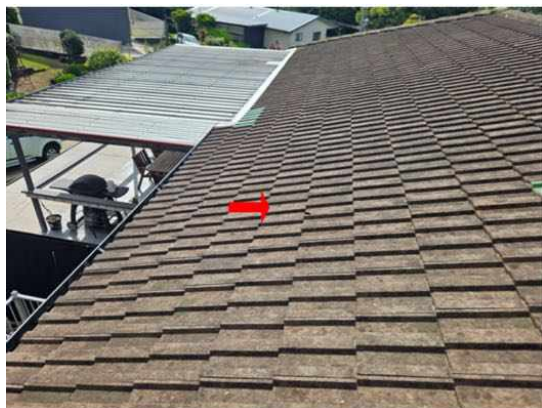
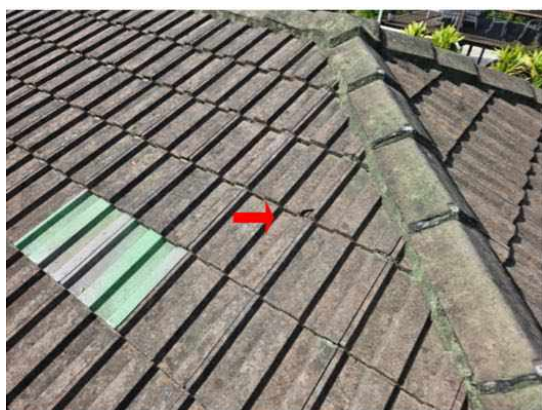
Finding 3.03

Building: Main Building  
Location: As shown.  
Finding: Roof tiles - Broken  
Information: Upon inspection of the exterior roof covering, broken roofing tiles were identified. Broken and friable roof tiles are generally the result of ageing and weathering of what is essentially a porous material.

If left to further deteriorate, broken and brittle roof tiles are likely to lead to water penetration via the roof into the ceiling space, causing secondary damage to ceiling linings, insulation and roof structures. Broken roof tiles are also likely to detract from the effectiveness of the roof drainage system, creating potential for secondary damage to the exterior roof covering and roof plumbing.

The roof condition is noted as a minor defect ; however it should be made a priority to maintain the surface condition and prevent possible leaks and further deterioration.

Replacement of broken tiles is required and should be performed by a roofing contractor as soon as possible.

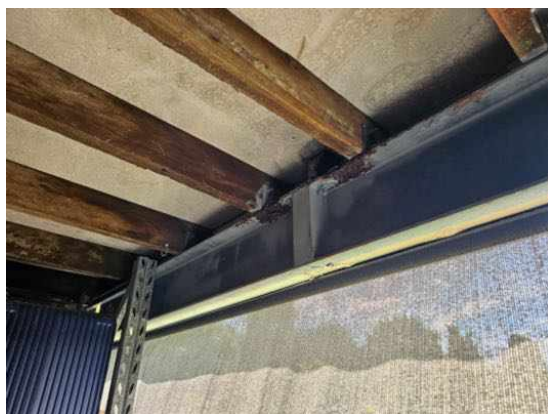
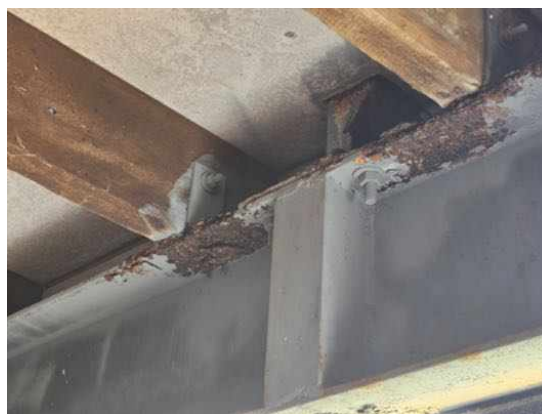
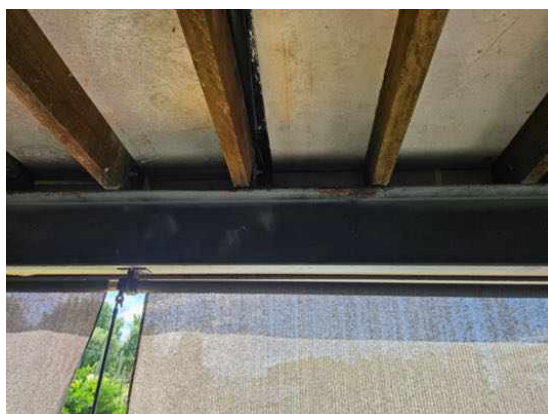
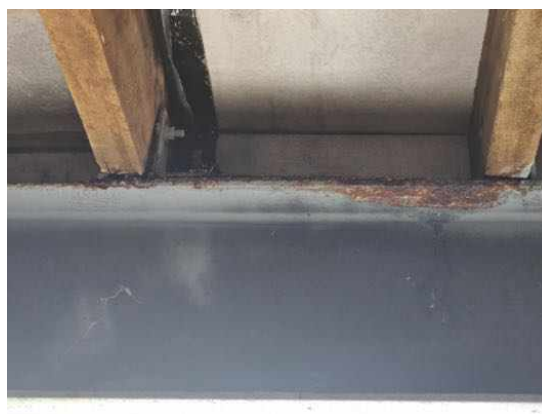
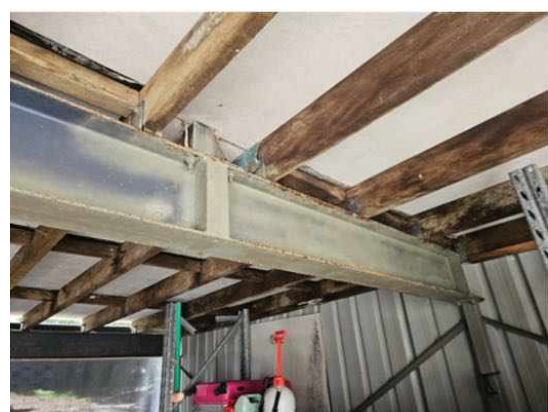
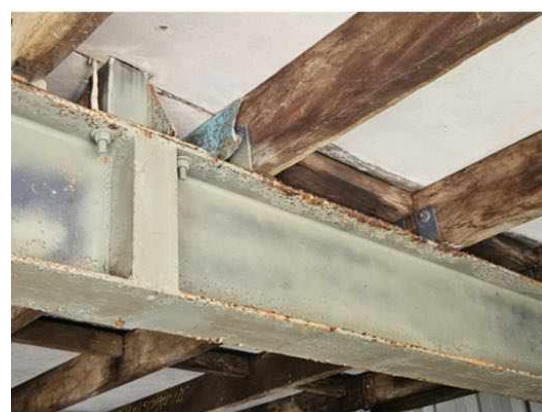
**Finding 3.04**

Building: Main Building  
Location: Carport  
Finding: Rusted structural floor frame.  
Information: At the time of inspection it was noted, that the steel bearers of the upper floor deck structural floor frame / roof of the carport had surface to varying degrees. This is most likely due exposure to weathering over a prolonged period of time.

A licensed painter may be appointed to assess the level treatment required and provide the necessary repairs.

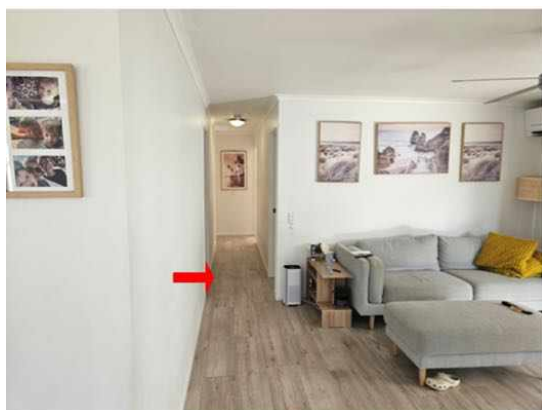
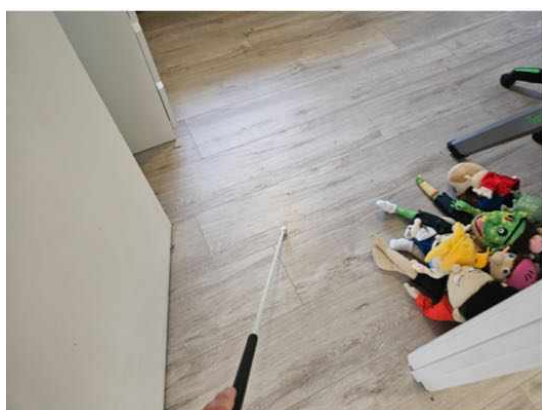
### Finding 3.05

Information: The internal flooring in the hallway / bedroom doorways shown are out of level. Uneven flooring is likely to indicate minor defects such as expected movement of the foundations of the property, but may also indicate subsidence of the associated subfloor stumps.

It should be noted, this is an information statement of an observation only, in buildings of moderate to significant age, subfloor movement can be expected and floor levels can be less than true. These can be part of the character of a period building. It is likely

that the steel stumps are not original and at the time when they were replaced, some settlement may have occurred.

It is advised that the flooring be closely monitored to identify any further movement. Where flooring remains relatively unchanged for an extended period of time (i.e. several months), it is likely that this defect has been caused by expected movement of the foundations of the property.

If no further movement is experienced, a licensed builder could be engaged to Re level the sub floor. It is not considered as anything other than minor at this time.

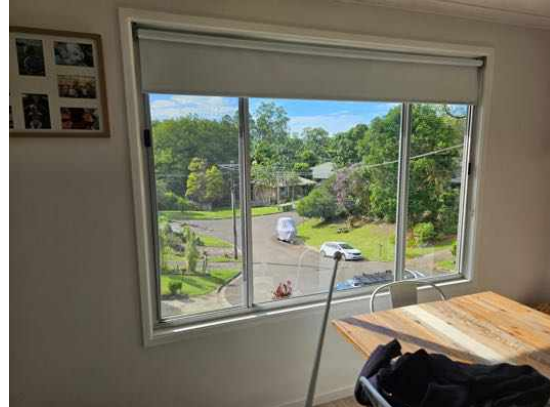
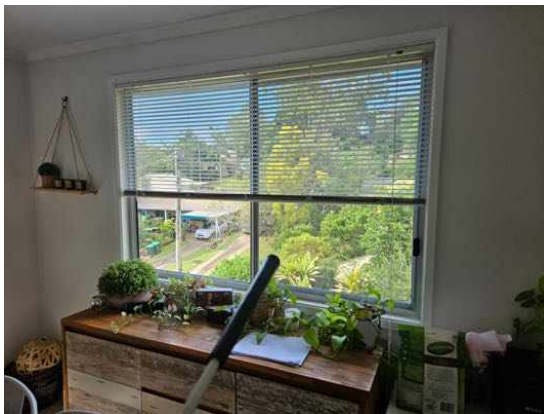
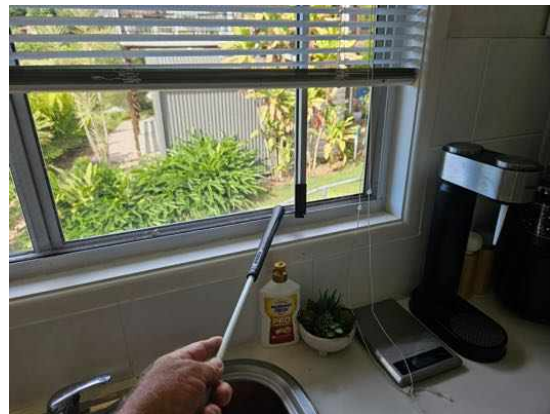
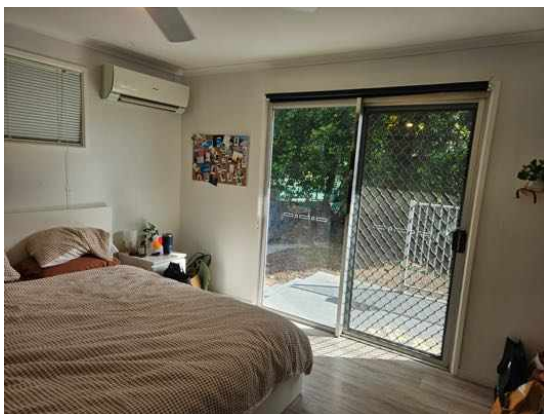
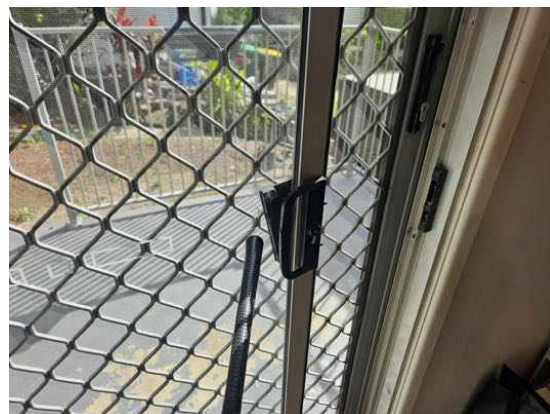
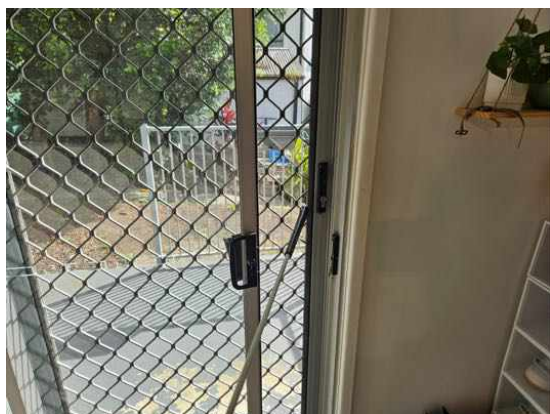
### Finding 3.06

Building:	Main Building
Location:	As shown
Finding:	Aluminium windows, sliding doors - Binding/jamming
Information:	Binding and/or jamming of the aluminium windows and sliding doors was evident during standard operation. This defect inhibits the functionality of the affected windows and doors as well as creating potential for secondary defects to associated building elements, such as damage to the window frames / jambs. A window or door that binds to reveals / jambs or to the associated frame may have several causes, ranging from minor defects.

Where door binding/jamming appears to indicate major structural issues, a licensed builder specialising in re-stumping should be appointed to provide an estimate on the cost of rectification.

For minor causes, a qualified carpenter or glazier should be appointed to perform minor rectification works at client discretion.

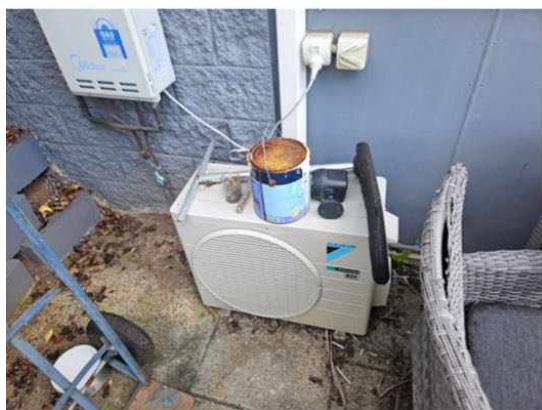
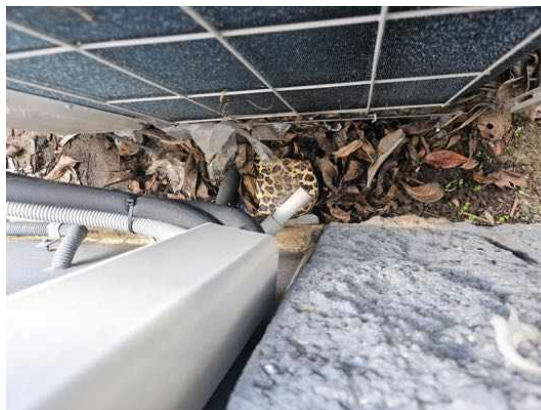
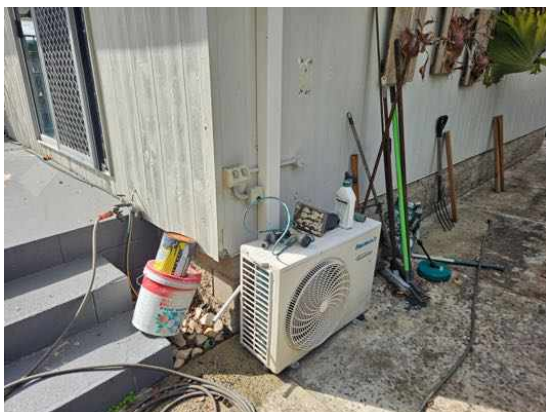
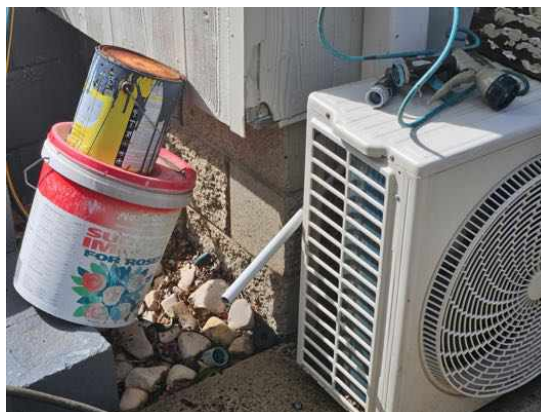
Building:	Main Building
Location:	As shown
Finding:	Air conditioner - Disconnected drain
Information:	The Air Conditioner (A/C) overflow was found to be disconnected from storm water drainage and could create excessive moisture in the surrounding area.

Such leaking creates an environment which is conducive to an array of defects, including water damage to associated building elements and the attraction of termite or timber pest infestation.

It is recommended that a licensed plumber be appointed to connect the A/C overflow to a drainage source in order to prevent such an environment from being created. An alternative is to extend the overflow further into the garden away from the building perimeter.

These minor works should be carried out in the short term.

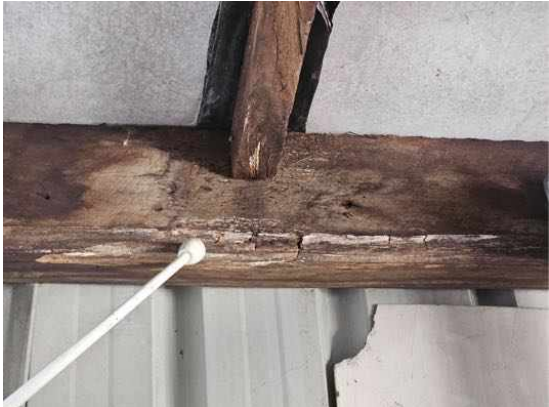
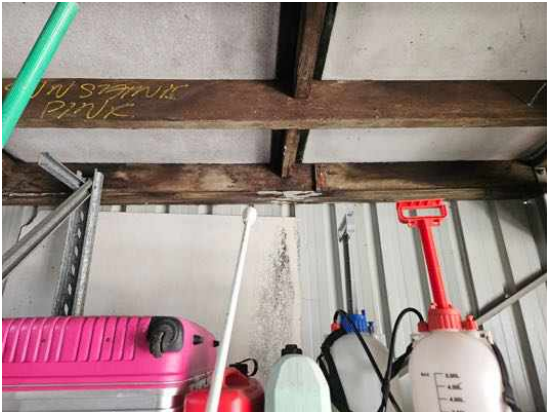
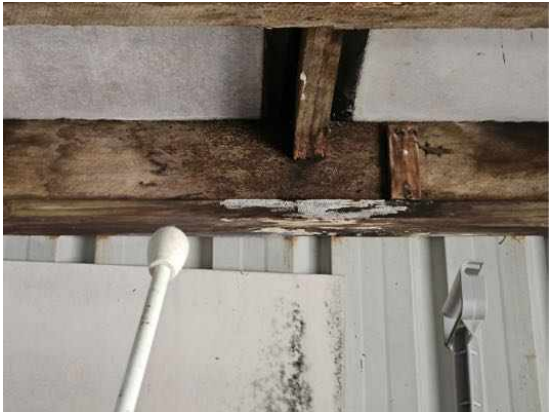
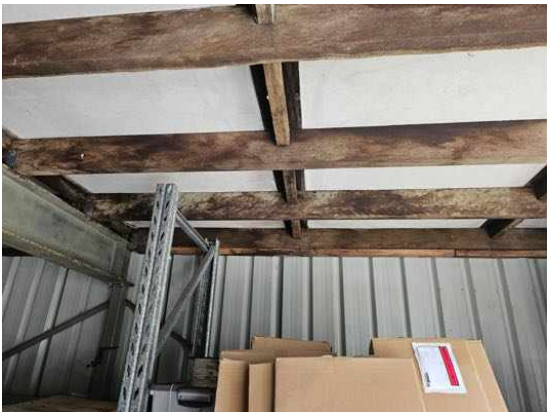
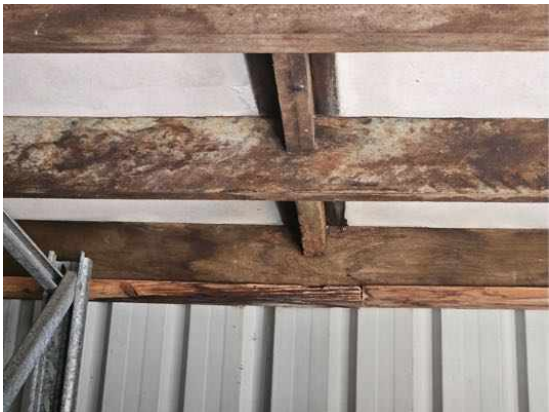
### Finding 6.02

Building:	Main Building
Location:	Carport
Finding:	Wood rot / fungal decay
Information:	The timber framing trims of the carport show evidence of wood rot in various sections of the timber.

Wood rot, also known as Fungal Decay, occurs when timbers and other cellulose building materials are exposed to damp conditions on an ongoing basis. This could be the result of exposure to weathering over a prolonged period of time, or the attraction of excessive moisture from other abutting building materials.

Early intervention and regular maintenance, particularly of exterior timbers, will prolong the useful life of these building elements. Prior to any works being performed, the cause of the moisture that has created the visible wood rot should be identified and addressed in a suitable manner. Replacement of affected timbers may then be a necessary step in protecting surrounding building elements from such deterioration.

A licensed carpenter or licensed builder should be consulted to advise on a solution for the affected building materials.

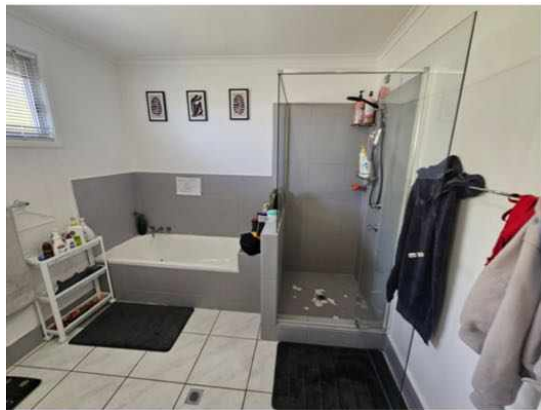
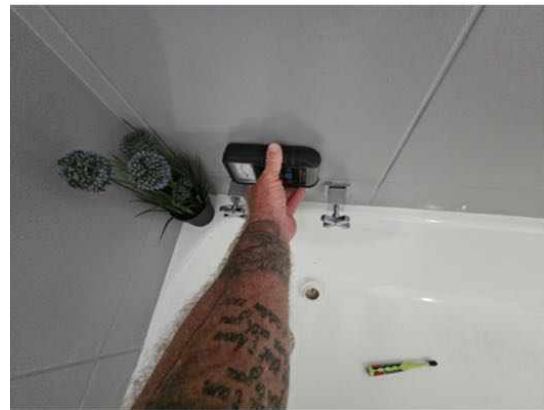
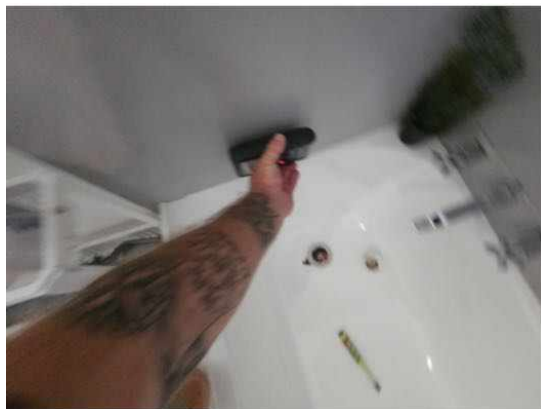
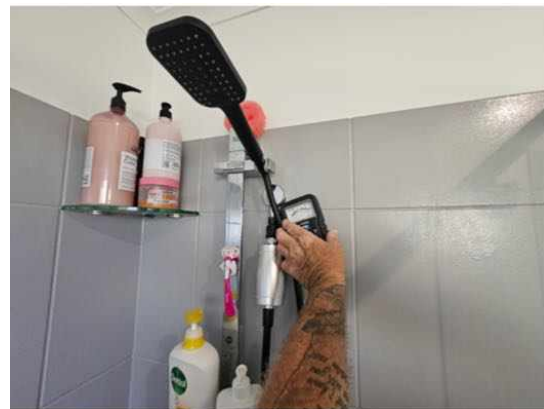
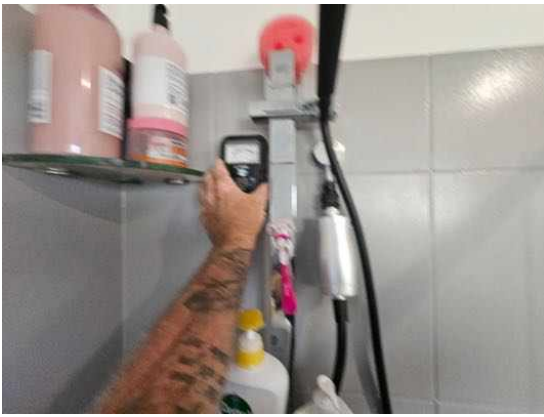
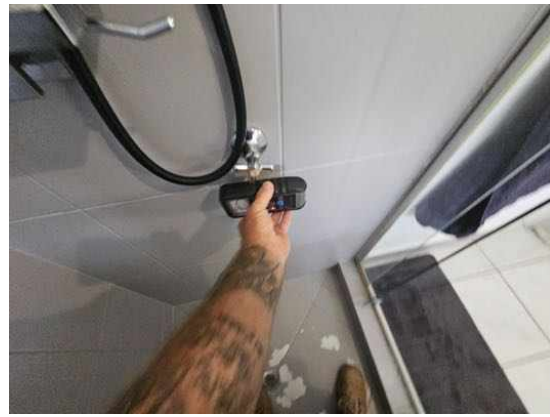
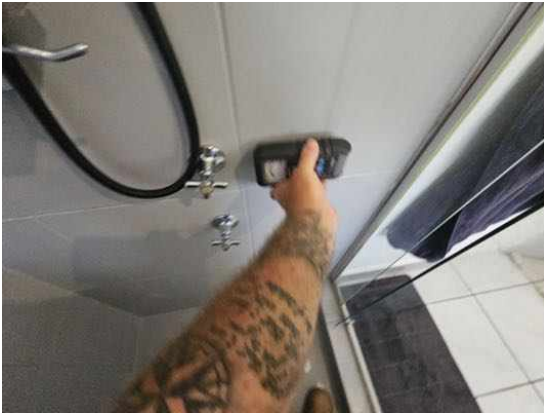
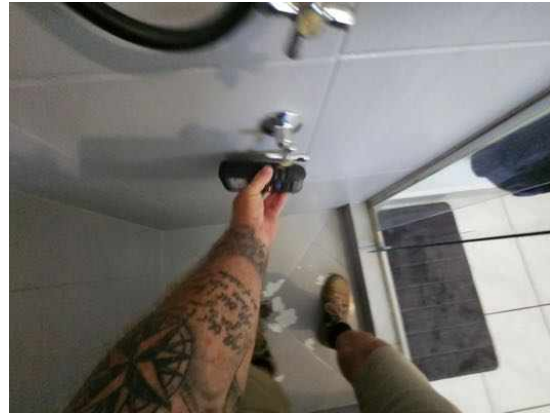
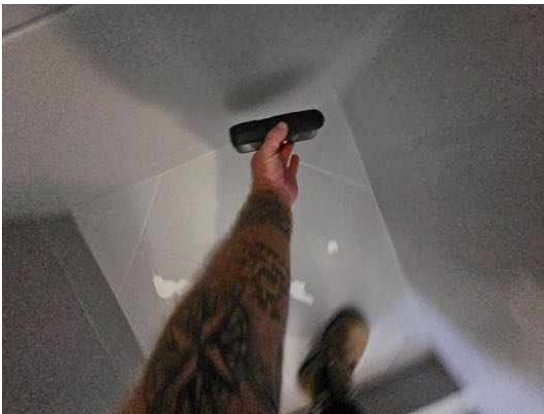
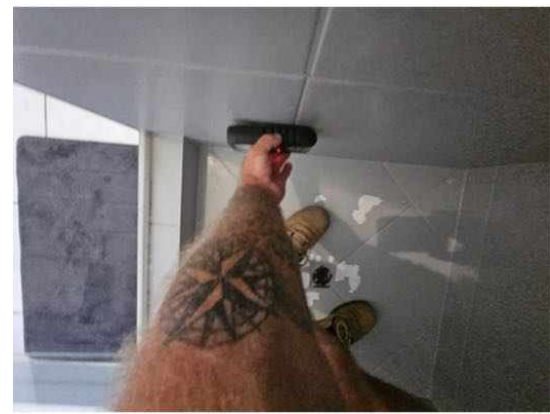
Building: Main Building  
Location: Bathroom, house  
Finding: No moisture detected in bathroom  
Information: On the day of inspection the shower in the main bathroom was measure for moisture using a "Tramex" moisture meter. During this inspection no moisture was detected in this areas and the tiled / sheeted surfaces appear to be in good order.

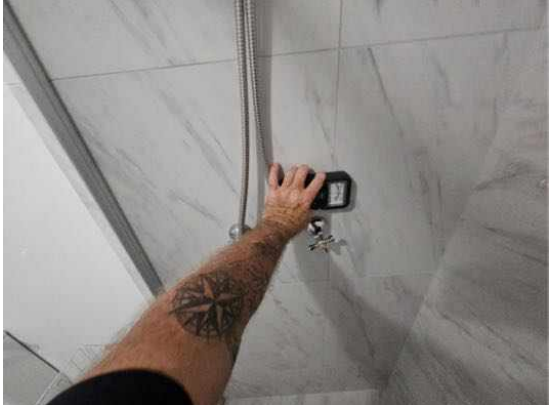
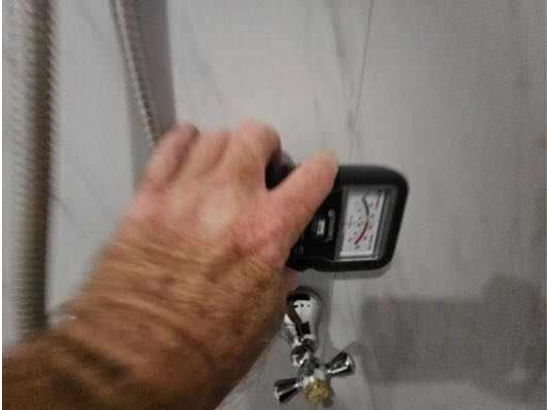
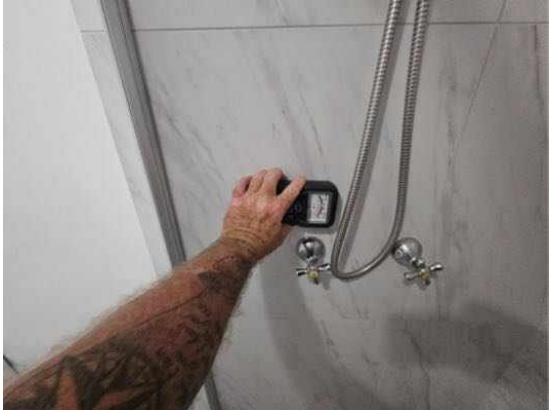
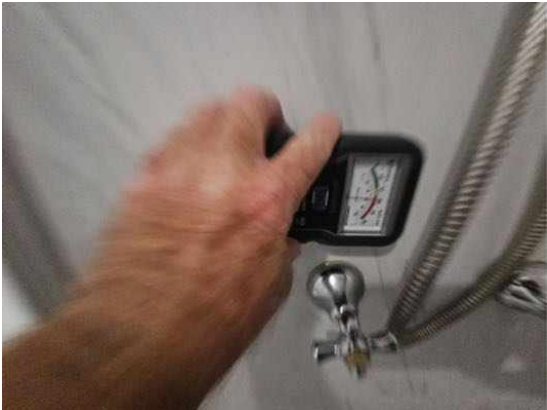
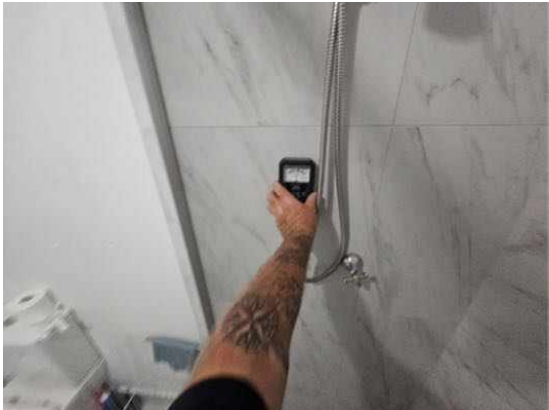
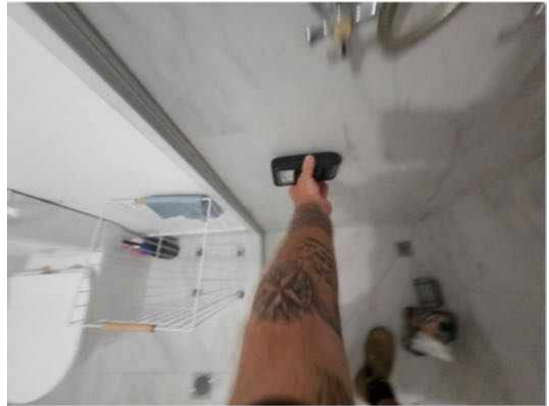
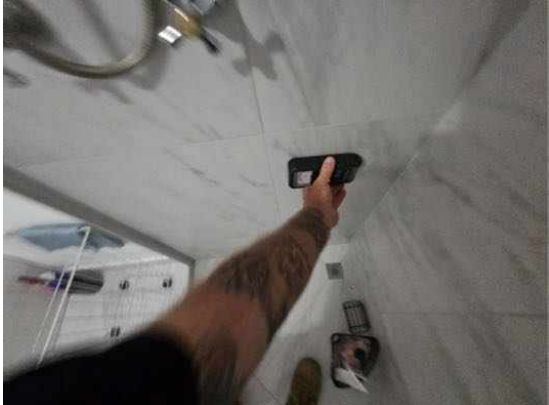
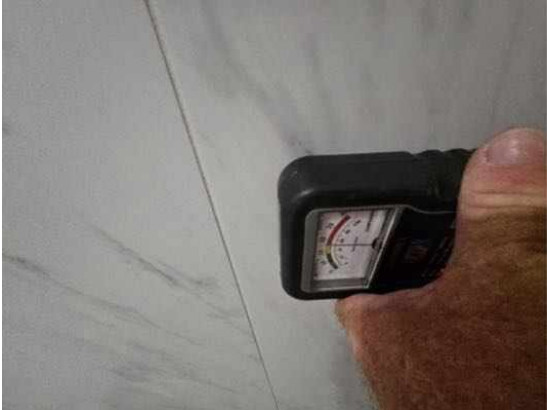
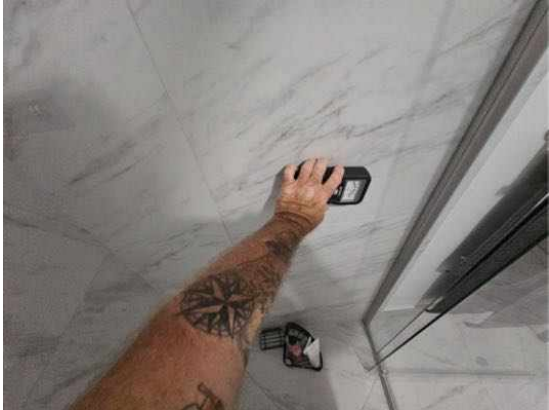
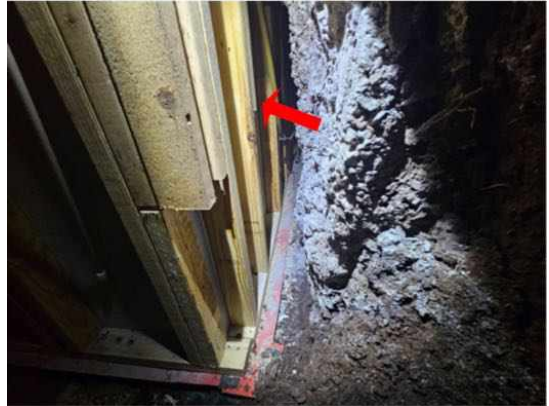
The moisture readings in the granny flat shower recess are believed to be the result of residual moisture absorption from the subfloor area. Monitor, and if there are changes have the shower re-assessed.

Building:	Main Building
Location:	Bathroom, granny flat
Finding:	Elevated moisture present - ensuite shower
Information:	Elevated moisture was noted in the tiled wall surfaces of the granny flat shower; however, moisture was also detected on the opposite site of the walls facing the subfloor area. This is most likely due to the humid conditions of the subfloor area and the fact that the granny flat walls are only sheeted on the inside, exposing the bare internal wall sheeting.

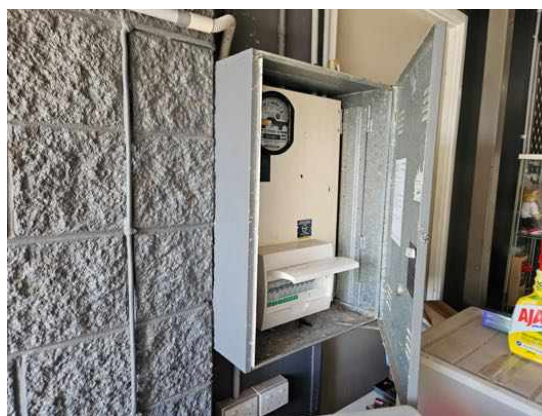
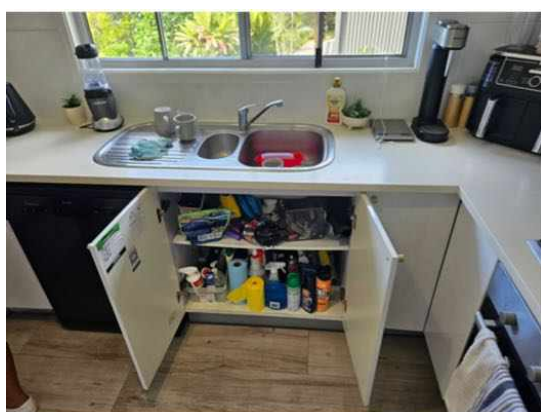
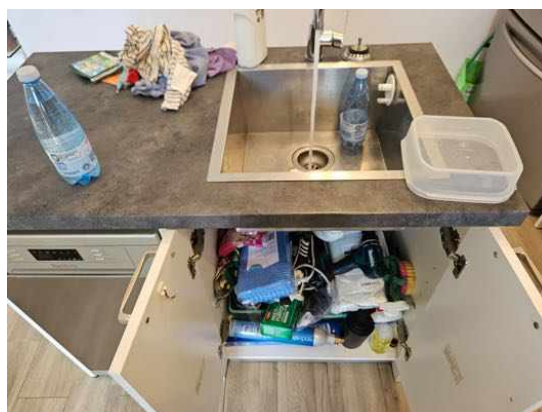
Building: Main Building  
 Location: Meter box, kitchen cupboard  
 Finding: Durable pest inspection notice - not assessable  
 Information: On the day of inspection it was noted that the durable timber pest inspection / treatment notice was missing, not visible or out of date. These notices / stickers are to verify the timber pest inspection dates, the inspector, the currency and type of timber pest system / barrier in place or being used in and around the property.

Annual, or more regular, inspections are crucial in maintaining and managing the properties timber pest risk profile. By not having regular inspections of the property raises the properties risk of undetected defects and damage. Without regular inspection at intervals of not greater than annually the buildings risk profile will

It is recommended that a licensed timber pest controller be contacted to assess the properties needs and provide costings for an annual inspection programme.

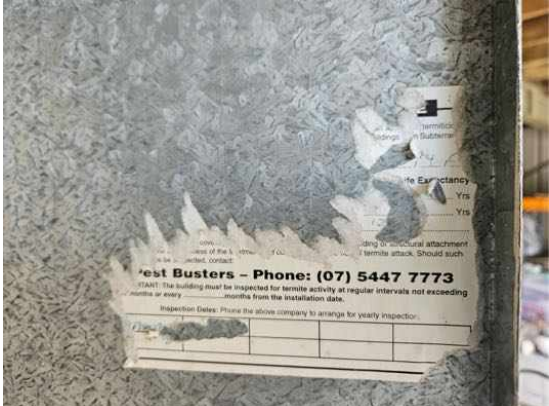
The building employs a physical barrier system to the perimeter of the granny flat bathroom. There is evidence of a previous system in place; however, it is not possible to ascertain the type or date of install. It is recommended that a licensed timber pest controller be engaged to provide a proposal for a current barrier system.

In order for a barrier system to be effective, the property must have regular inspections at intervals of not greater than 12 months. Depending on the risk profile attributed to the property, these inspections may be recommended at lesser time periods.
