## Building Inspection Report

Inspection Date: Mon, 12 Jan 2026

Property Address: 10 Feathertop Wy, Nar Nar Goon North VIC  
3812, Australia

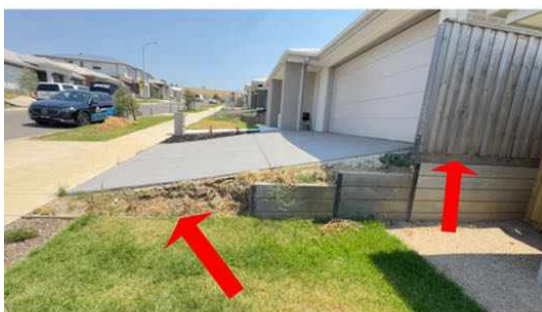
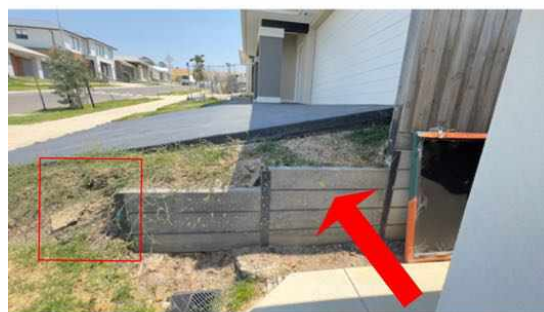
#### Defects 2.01

Building: Main Building  
 Location: Yard - Front > All Areas  
 Finding: Retaining Wall Masonry - Missing & Inadequate Height - Retaining Walls  
 Information: Sections of the retaining wall were observed to be missing and / or at an inadequate height in these areas. This can compromise the structural function of the retaining walls, reducing its ability to restrain soil and manage ground loads. This condition may lead to soil movement, erosion, drainage issues, and potential instability of adjoining ground or structures.

The defect is likely attributable to substandard construction.

A suitably qualified licensed builder or structural engineer should be engaged immediately to assess the retaining walls along all boundaries of the property and specify what appropriate remedial works are required. Repairs or reconstruction should be carried out as soon as practicable to reinstate structural performance, manage soil retention, and reduce the risk of further ground movement or damage to nearby structures.

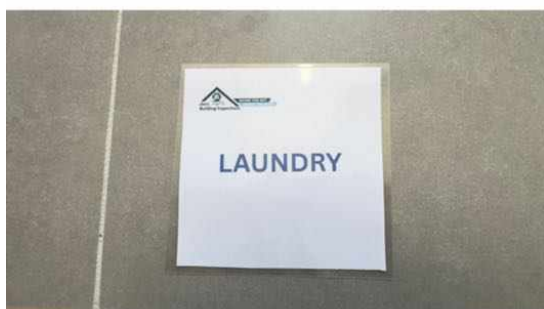
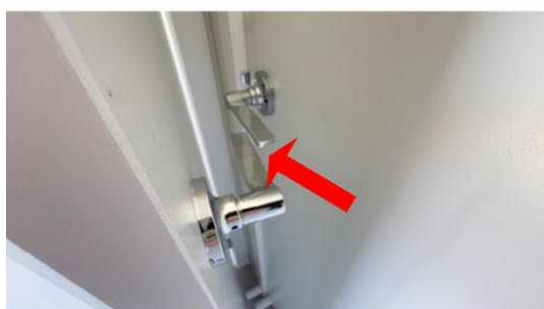
### Defects 3.01

Building: Main Building  
Location: Laundry >  
Finding: Doors - Inadequate Door Stops  
Information: The inspection identified inadequate door stops in this area. Inadequate door stops can lead to damage to walls or doors and may impair the proper operation of the doors.

The inadequate door stop may be due to an oversight by the builder.

It is recommended that a qualified carpenter or competent handyman be engaged promptly to install an adequate door stop. Correct installation will protect doors and walls and ensure proper door functionality.

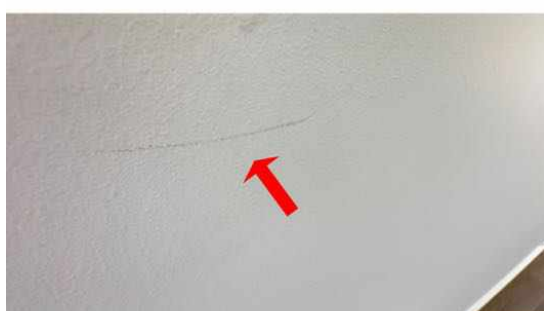
### Defects 3.04

Building:	Main Building
Location:	Entry Hall
Finding:	Walls - Paint Finishes Discolouration
Information:	The walls were inspected for paint condition, and discolouration was observed in this area.

While primarily a cosmetic issue, the affected paint may indicate age-related wear, poor surface preparation, or previous repairs.

When practical, a qualified painter should be engaged to prepare and repaint the affected areas. Addressing paint deterioration will improve the appearance of the ceilings and help protect the surfaces from further wear.

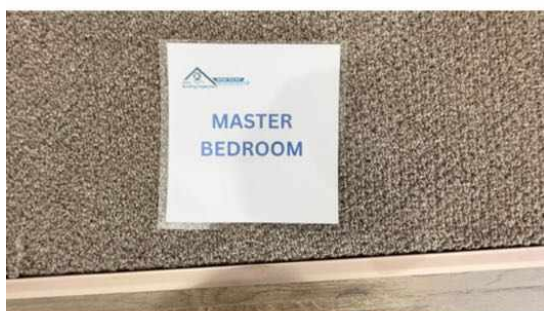
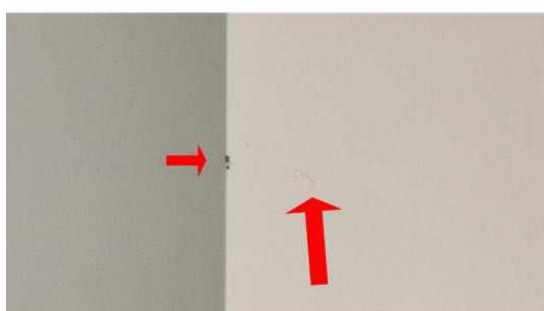
### Defects 3.05

Building:	Main Building
Location:	Bedroom - Master >
Finding:	Walls - Plaster Walls Damaged
Information:	Minor damage to plaster wall surfaces was observed in this area, including small dents, chips, and surface imperfections. This type of damage is commonly associated with general wear and tear, minor impact, or movement over time.

While the damage is not considered structural in nature, it detracts from the overall presentation and finish of the property. Ongoing deterioration may occur if left unattended.

A suitably qualified plasterer or competent handyman should be engaged, at the client's discretion, to carry out minor patching, sanding, and repainting as required to

restore the affected areas to an acceptable standard.

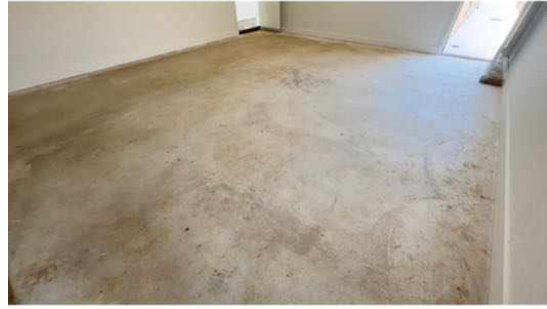
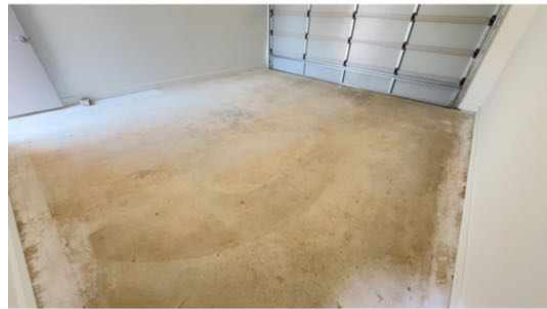
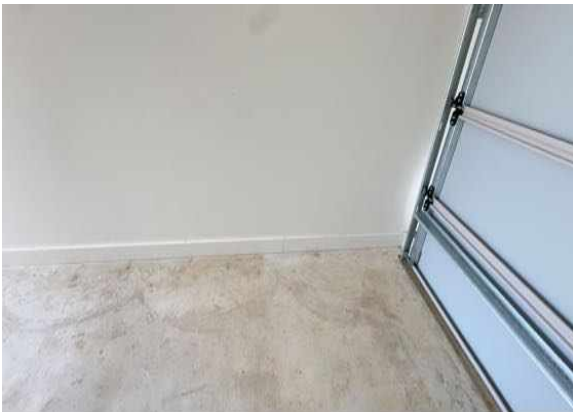
### Defects 3.06

Building:	Main Building
Location:	Garage
Finding:	Concrete - Discolouration
Information:	Concrete surfaces were visually inspected and discolouration was observed in this area. Discolouration may affect the aesthetic appearance of the surface and could indicate exposure to environmental factors, staining, and wear.

Possible causes include weathering, sun exposure, water staining, or contact with chemicals or organic matter.

A qualified cleaning specialist should be engaged when practical to clean or treat the affected areas. Prompt attention will improve appearance and maintain the surface condition.

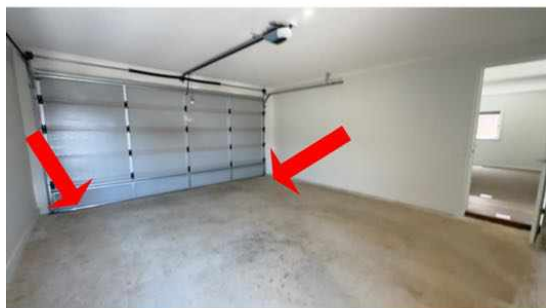
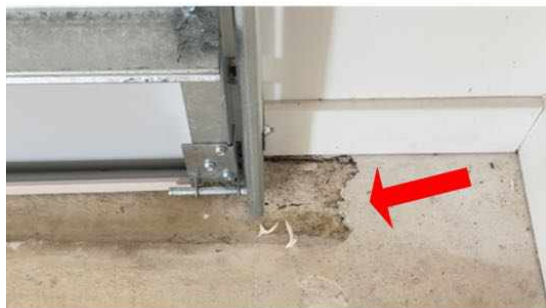
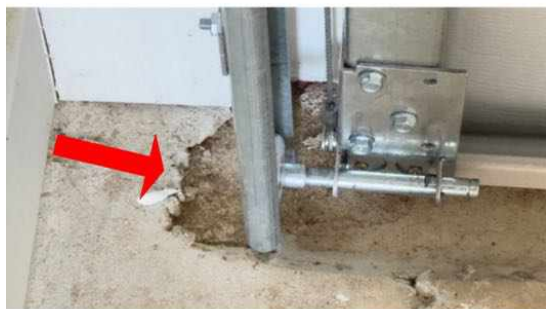
### Defects 3.07

Building: Main Building  
 Location: Garage >  
 Finding: Concrete - Damaged Surfaces  
 Information: Concrete Surfaces were visually inspected in this area. Damaged surfaces were observed, including chipping, spalling and surface abrasion.

Damaged concrete surfaces can reduce durability, aesthetic appearance, and may increase susceptibility to further deterioration over time. Possible causes include age-related wear, impact, weathering, or substandard original construction.

A qualified concreter should be engaged when practical to repair or resurface affected

areas. Prompt attention will restore a smooth surface, improve durability, and maintain presentation.

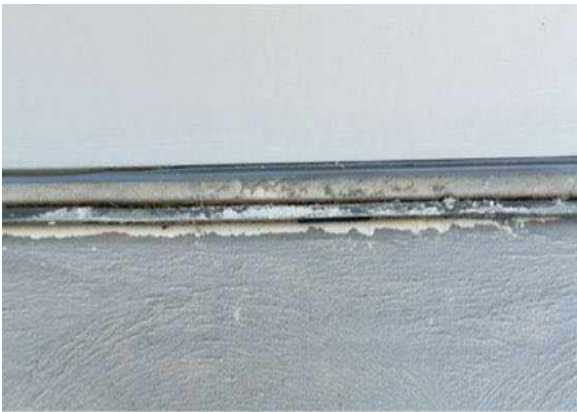
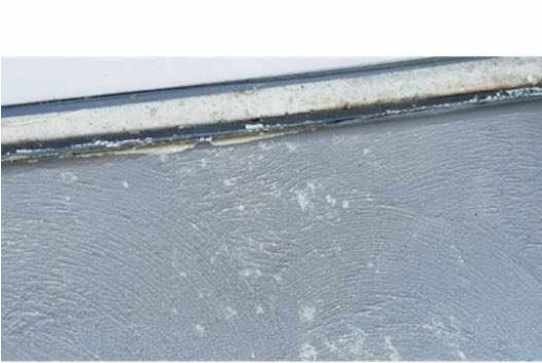
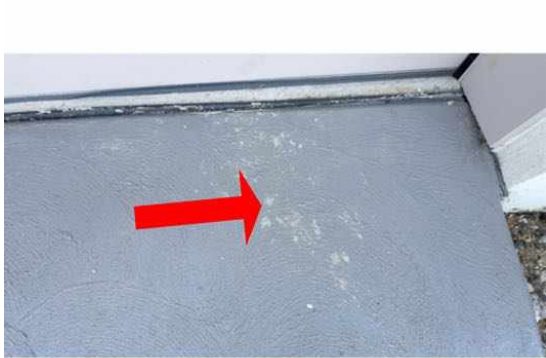
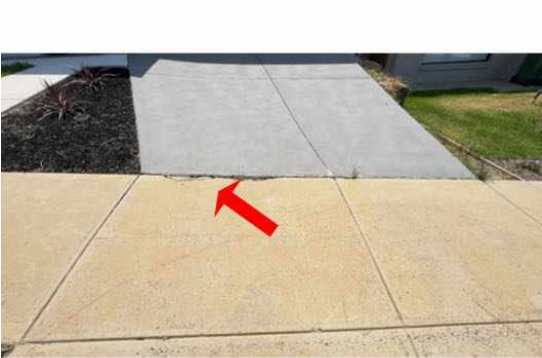
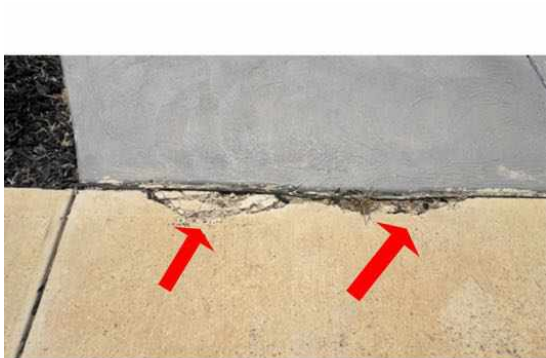
**Defects 3.13**

Building: Main Building  
Location: Driveway  
Finding: Concrete - Poor Surface Finish  
Information: Concrete surfaces were visually inspected and poor surface finishing was observed in this area, including rough textures, uneven troweling and inconsistent concrete painted surface profiles.

While primarily cosmetic, these defects reduce aesthetic appeal, and increase susceptibility to surface wear or deterioration over time. This condition may be caused by rushed or substandard finishing during construction, inadequate curing, or poor quality concrete mix.

A qualified concreter should be engaged when practical to treat affected areas. Prompt attention will improve appearance, durability, and long-term performance of the driveway.

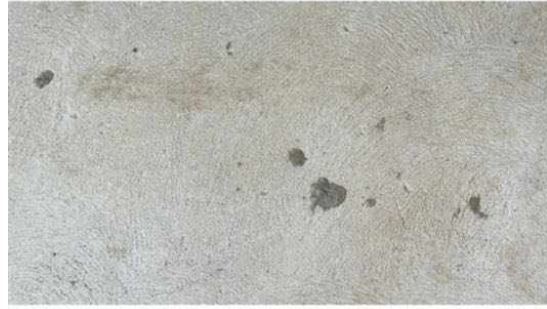
**Defects 3.14**

Building: Main Building  
Location: Yard - Back  
Finding: Concrete - Poor Surface Finish  
Information: Concrete surfaces were visually inspected and poor surface finishing was observed in this area, including rough textures, uneven troweling and inconsistent concrete surface profiles.

While primarily cosmetic, these defects may allow water pooling, reduce aesthetic appeal, and increase susceptibility to surface wear or deterioration over time. This condition may be caused by rushed or substandard finishing during construction, inadequate curing, or poor quality concrete mix.

A qualified concreter should be engaged when practical to grind, resurface, or treat affected areas. Prompt attention will improve appearance, durability, and long-term performance of the driveway.

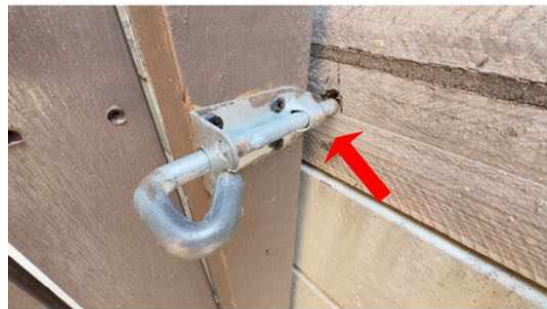
### Defects 3.15

Building:	Main Building
Location:	Inside of the Fencing Side Gate >
Finding:	Gates - Gate Binding
Information:	Binding or jamming of the gate was observed in this area. This affects functionality and may cause secondary damage to surrounding building elements.

Binding can result from minor issues, including poor installation, worn hinges, or misalignment.

When practical, a qualified carpenter should be engaged to inspect and carry out necessary repairs.

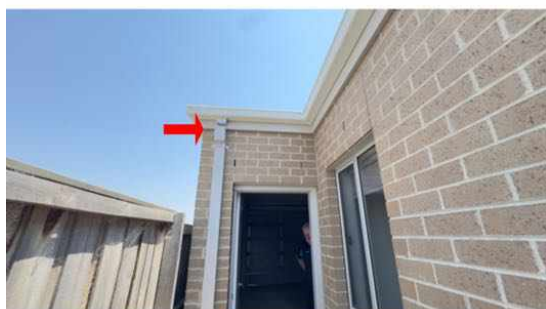
### Defects 3.16

Building:	Main Building
Location:	Side Of House >
Finding:	Roof Plumbing - Downpipes Not Connected To Storm Water
Information:	Downpipes in this area are not connected to the stormwater drainage system, allowing water to discharge directly onto surrounding ground.

This has likely occurred due to missing connections, poor installation, or design oversight. Uncontrolled water discharge may cause erosion, pooling, water ingress

near the building, and potential damage to landscaping, paving, or foundations.

A licensed roof plumber is required to inspect and connect the downpipes to the stormwater system in this area. This should be rectified immediately to ensure proper drainage and prevent potential water damage.

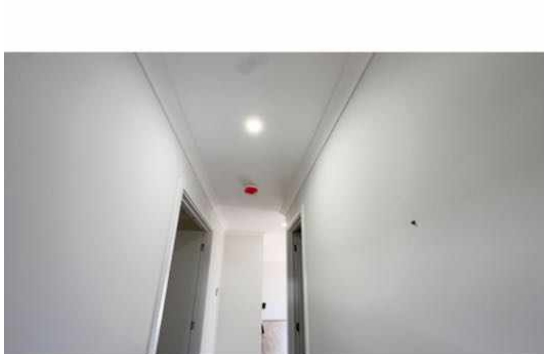
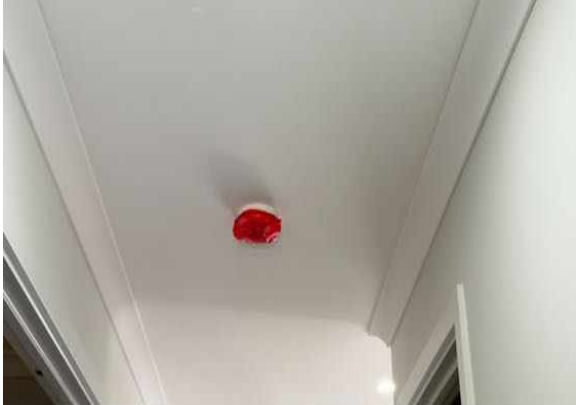
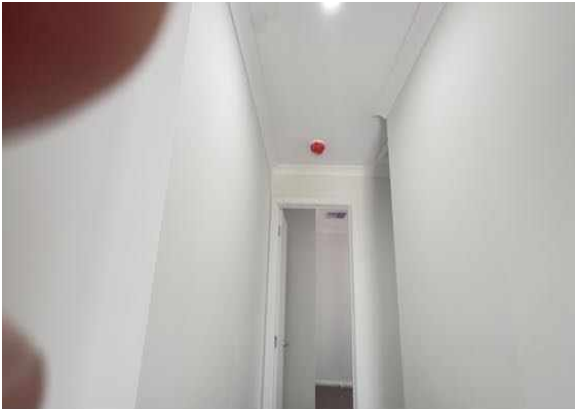
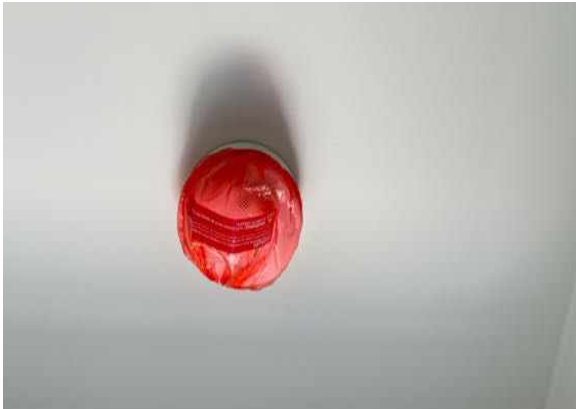
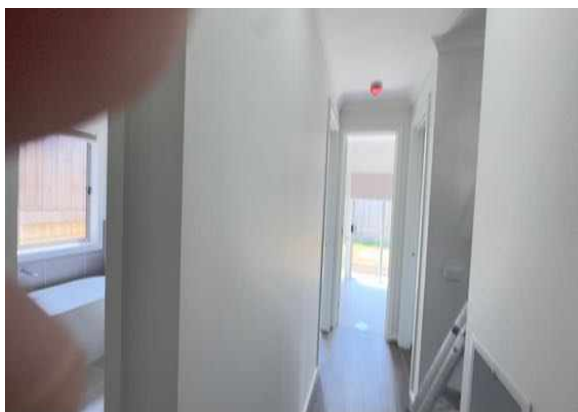
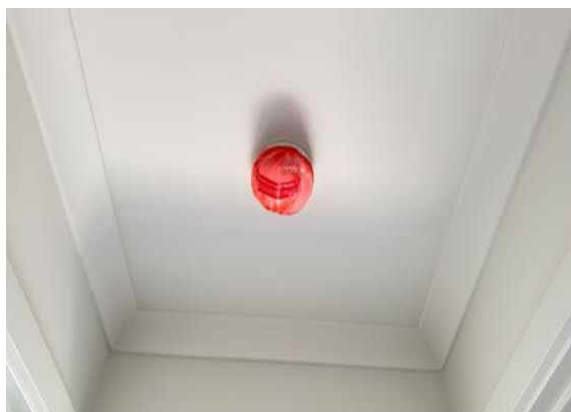
Building: Main Building  
Location: All Internal Areas  
Finding: Smoke Detectors - Advisory  
Information: During the inspection, smoke detectors were noted for advisory purposes only. The operation, age, type, and compliance of smoke detectors could not be fully verified as part of this inspection.

Smoke detectors are critical life-safety devices, and non-compliant, outdated, or non-operational units may not provide adequate warning in the event of a fire.

It is recommended that a licensed electrician be engaged immediately to test, service, and upgrade smoke detectors as required to ensure correct operation and compliance with current safety requirements.

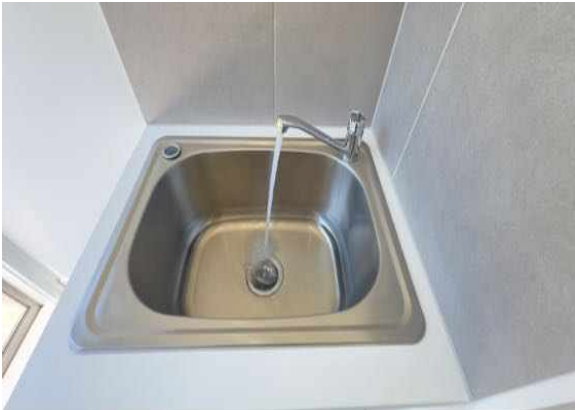
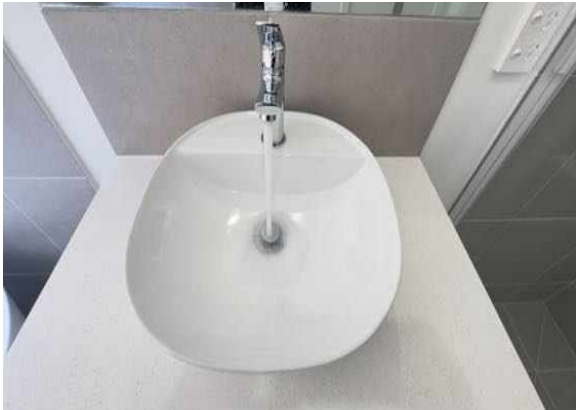
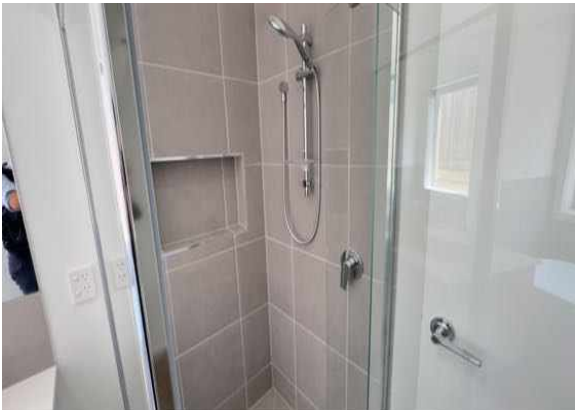
Building: Main Building  
 Location: All Internal Areas  
 Finding: Water Supply & Drainage - Shower, Basins, Toilets, & Plumbing Fixtures  
 Information: The shower recess was tested, and no visible water penetration to surrounding areas was observed at the time of inspection, except where noted as a separate defect elsewhere in this report. Water appeared to flow freely toward the floor waste. Moisture detected to the shower walls is documented separately in the report. The shower floor waste appeared clear during inspection.

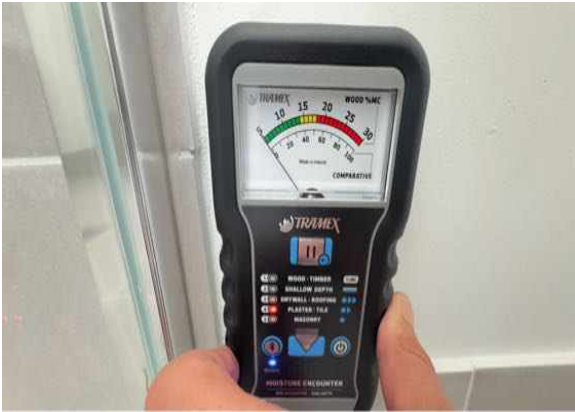
Building: Main Building  
Location: All Areas Interior & Exterior  
Finding: Moisture Levels - Advisory - No Elevated Moisture Levels Present  
Information: At the time of inspection, no elevated moisture levels were detected in these areas. Moisture readings were taken (using a Tramex Moisture Meter) and non-invasive testing methods and reflect conditions present at the time of inspection only. This item is noted for advisory purposes and should not be relied upon as a guarantee that moisture issues are not present elsewhere or may not occur in the future.

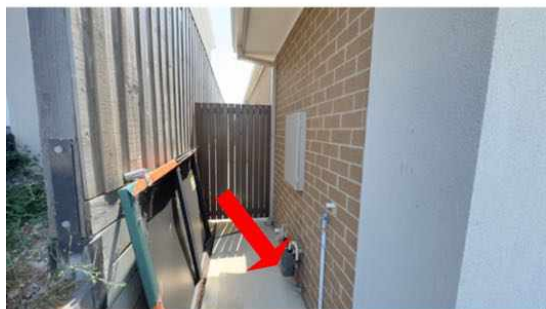
Building: Main Building  
 Location:  
 Finding: Gas Meter - Location For Your Information  
 Information: The gas meter was inspected and photographed for reference and location purposes only.
