Building and Timber Pest Inspection Report

Inspection Date: Fri, 20 Mar 2026

Property Address: 23 Grey St, Glen Innes NSW 2370, Australia

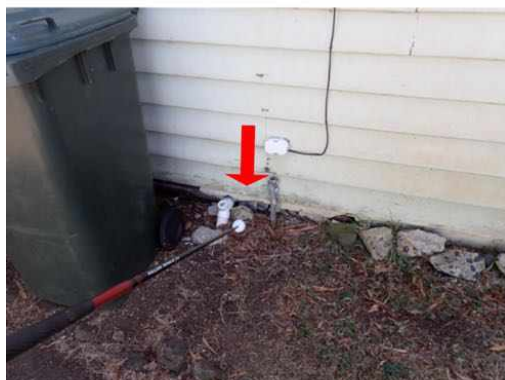
Finding 1.01

Building:	Main Building
Location:	Right hand side of building
Finding:	Damaged External Cladding (Possible Asbestos Containing Material)
Information:	Damage was identified to the external cladding. The material may contain asbestos, which was commonly used in properties of this age. Deterioration or damage to this material may pose a risk if disturbed and can lead to further degradation if not managed appropriately. Possible causes include impact damage, weathering, and general age-related deterioration. It is recommended that a licensed asbestos professional or suitably qualified contractor assess the material to confirm the presence of asbestos prior to any disturbance, and carry out repairs or removal in accordance with relevant regulations. Preventative measures include avoiding disturbance of the material until it has been properly assessed. Assessment and any required works should be carried out prior to any repair, renovation, or disturbance of the material.

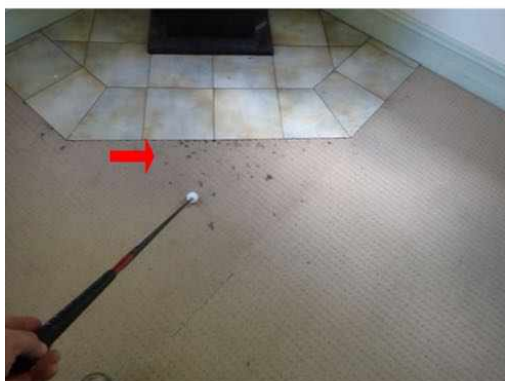
Finding 1.02

Building:	Main Building
Location:	Living room
Finding:	Damage to Carpet in Front of Fireplace
Information:	Damage was identified to the carpet in front of the fireplace, likely caused by embers from the fireplace. This condition may lead to further deterioration of the flooring surface if not addressed. Possible causes include heat exposure and falling embers during use of the fireplace. It is recommended that a licensed flooring contractor assess the affected area and carry out repair or replacement of the damaged carpet as required. Preventative measures include the use of a suitable hearth or protective mat in front of the fireplace to prevent future damage. Repairs should be carried out to

prevent further damage to carpet .

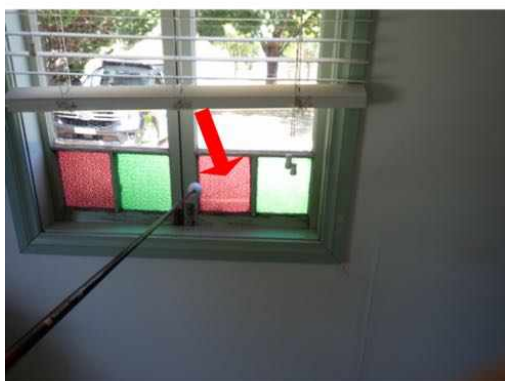
Finding 1.03

Building:	Main Building
Location:	Living room
Finding:	Cracked Window Glass Pane to Front Living Room Window
Information:	A crack was identified to the window glass pane in the front living room window. Cracked glazing can worsen over time and may allow moisture ingress and further deterioration of the window assembly if not addressed. Possible causes include impact damage or general age-related deterioration. This is a relatively common defect. It is recommended that a licensed glazier replace the damaged glass pane and inspect the surrounding frame for any associated damage. Preventative maintenance includes avoiding impact to glazing and ensuring window frames are well maintained. Repairs should be carried out in the short term to prevent further deterioration.

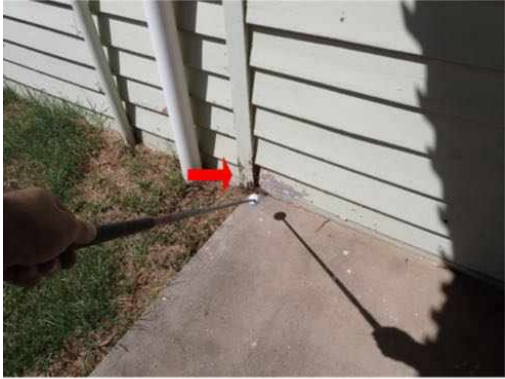
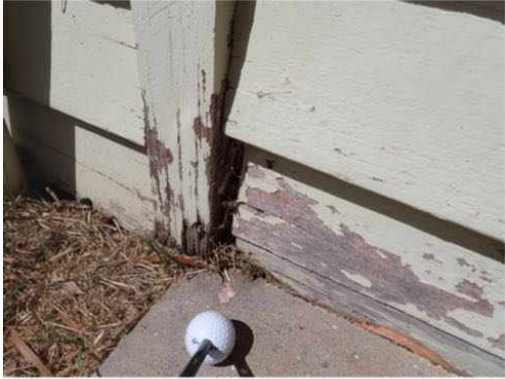
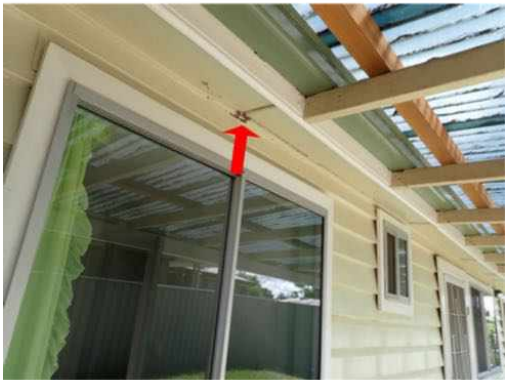
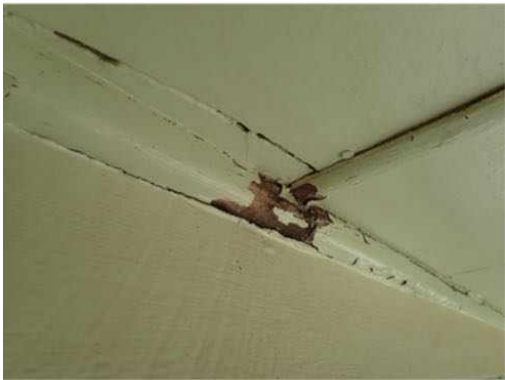
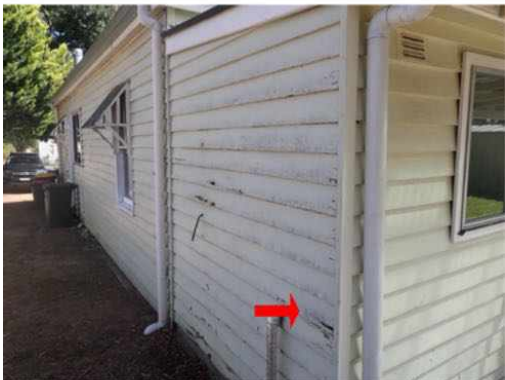
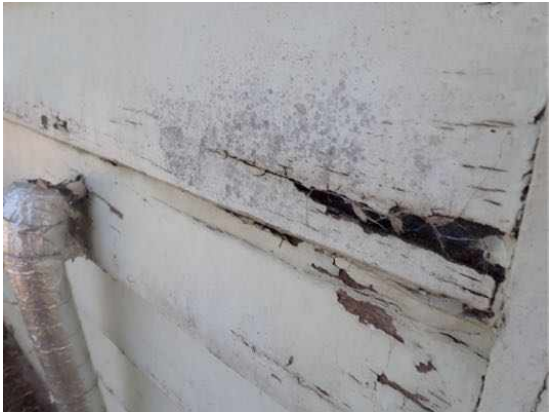
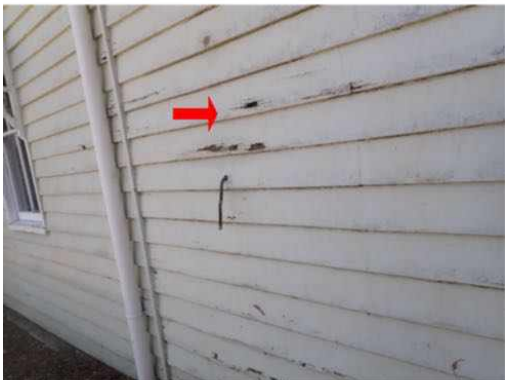
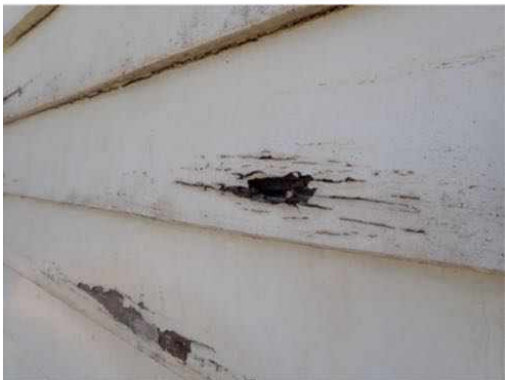
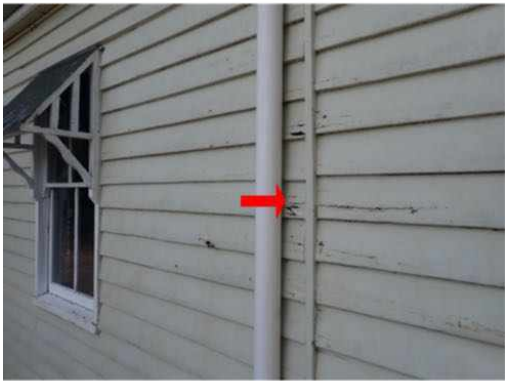
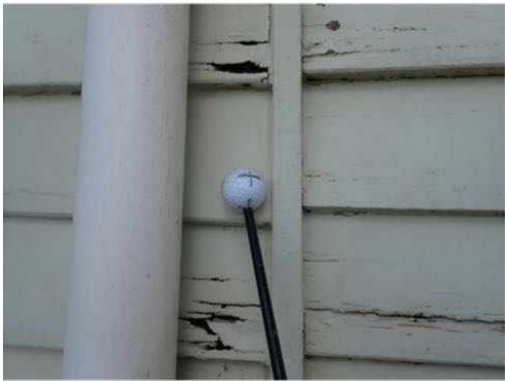
Finding 2.01

Building:	Main Building
Location:	External cladding

Finding: Wood Rot to External Cladding and Timber Trims

Information: Several isolated areas of wood rot were identified to the external cladding and timber trims. This condition may allow moisture ingress and lead to further deterioration of the affected elements and associated building materials if not addressed. Wood rot is also conducive to termite attack. Possible causes include prolonged exposure to weather, failed paint coatings, and general age-related wear and tear. This is a common defect in properties of this age. It is recommended that a licensed carpenter assess the affected areas, carry out repairs or replacement of rotted sections, and repaint/seal the surfaces as required. Preventative maintenance includes regular painting and sealing of external timber elements to protect against moisture. Repairs should be carried out in the short term to prevent further deterioration.

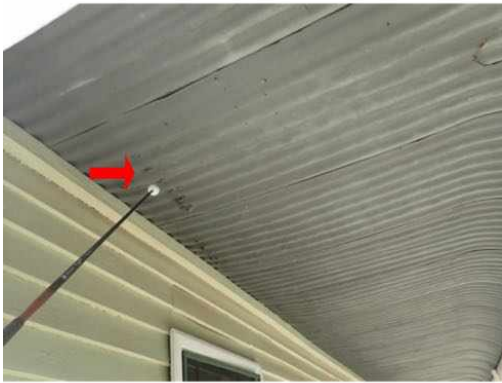
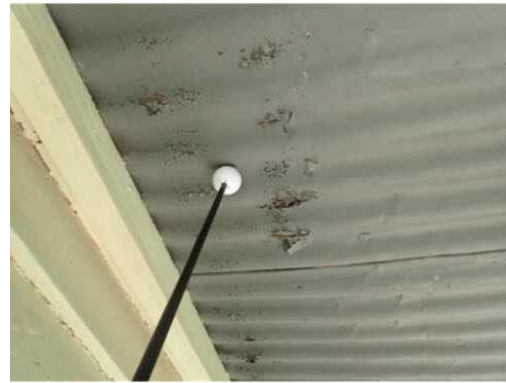
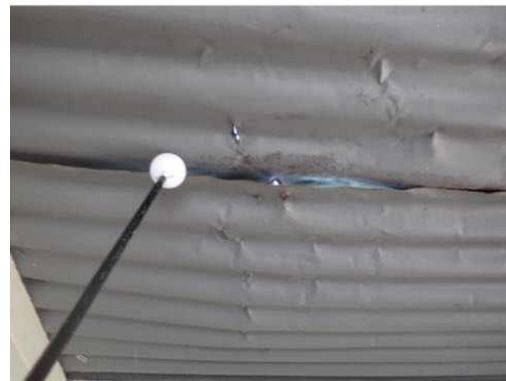
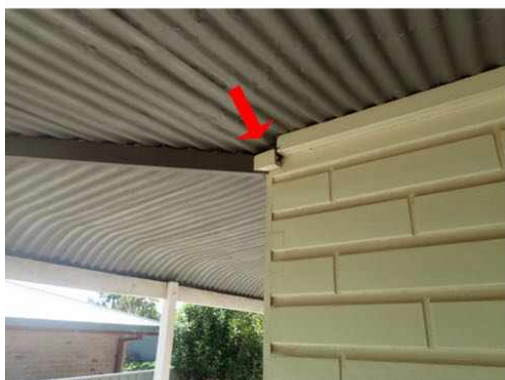
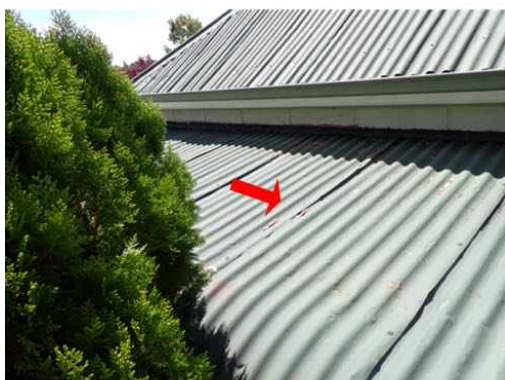
Finding 2.02

Building:	Main Building
Location:	Front porch
Finding:	Damaged Porch Roof Cladding and Timber Roof Framing
Information:	Damage was identified to the porch roof cladding, including damage to the timber roof framing at the left-hand corner of the porch roof junction. This condition may allow moisture ingress and lead to further deterioration of the roof structure and associated building materials if not addressed. Possible causes include weather exposure, previous impact or failure of materials, and general age-related deterioration. It is recommended that a licensed builder or carpenter and roofing contractor assess the extent of the damage, carry out repairs or replacement of the affected cladding and structural timber elements, and ensure the area is properly sealed. Preventative maintenance includes regular inspection and maintenance of roof cladding and timber components. Repairs should be carried out as soon as possible.

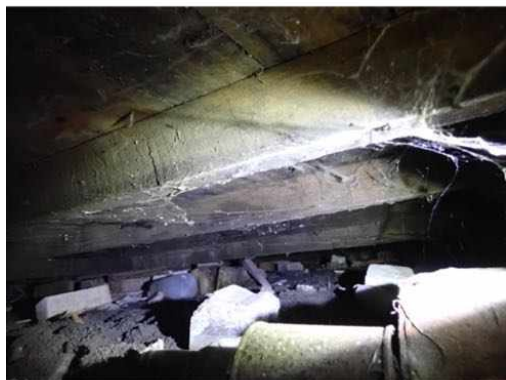
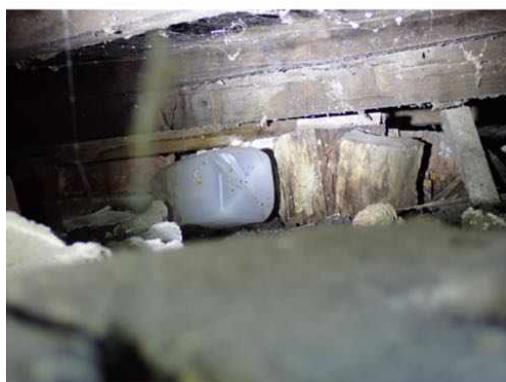
Finding 2.03

Building:	Main Building
Location:	Subfloor
Finding:	Limited Subfloor Access with Suspected Deterioration
Information:	No access was available to the subfloor area at the time of inspection. From a limited visual assessment at the right-hand side, the subfloor appeared to be in poor condition, with indications of inadequate ventilation, wood rot to timber stumps, and damage to brick piers. This condition may indicate deterioration of structural support elements and may lead to further damage if not addressed. Wood rot is also conducive to termite attack. Possible causes include poor ventilation, prolonged moisture exposure, and general age-related deterioration. This is a common defect in properties of this age. It is recommended that a licensed builder, in conjunction with a timber pest inspector, gain full access to the subfloor area, carry out a comprehensive inspection, and undertake repairs or improvements including ventilation upgrades as required. Preventative maintenance includes maintaining adequate subfloor ventilation and managing moisture levels. Further investigation and any required works should be carried out as soon as possible.

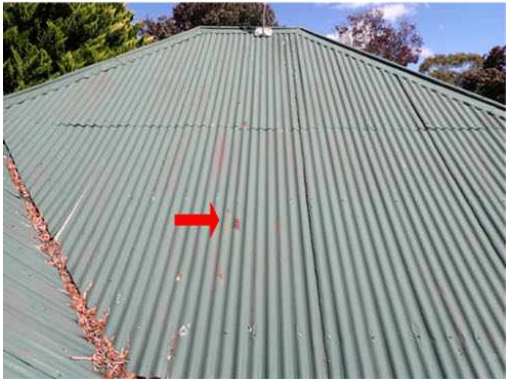
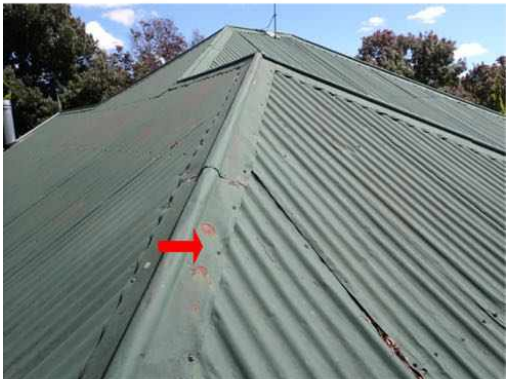
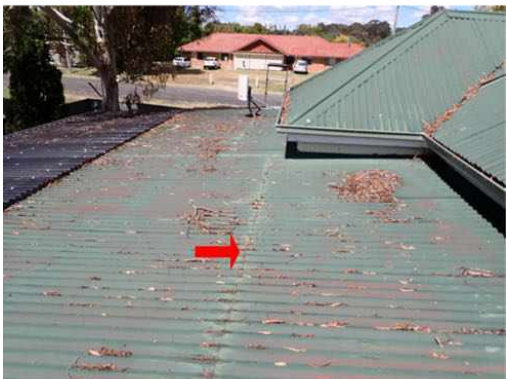
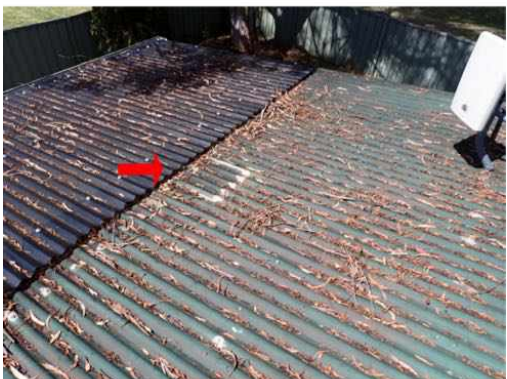
Finding 2.04

Building:	Main Building
Location:	Roof
Finding:	Rust, Impact-Related Damage and Silicone Patch Repairs to Roof Cladding
Information:	Rust and impact-related damage were identified to the roof cladding, along with multiple areas of silicone patch repairs. This condition may allow moisture ingress and lead to further deterioration of the roof cladding and associated building materials if not properly rectified. Possible causes include weather exposure, physical damage, and previous temporary repair works. It is recommended that a licensed roofer assess the roof cladding, remove temporary patch repairs, treat or replace affected sections, and carry out appropriate permanent repairs. Preventative maintenance includes regular roof inspections and ensuring repairs are completed using suitable materials and methods. Repairs should be carried out in the short term to prevent further deterioration.

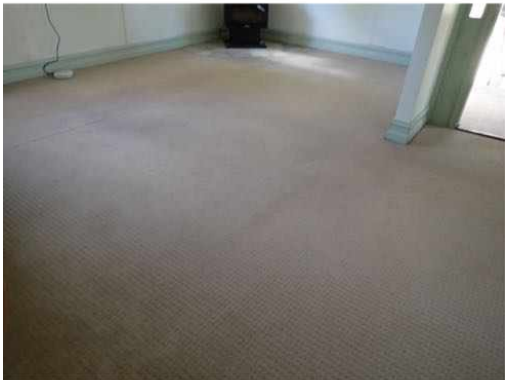
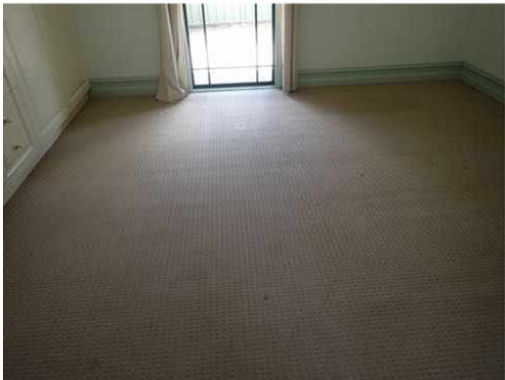
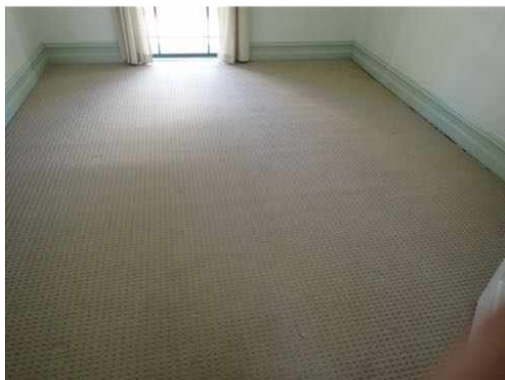
Finding 2.05

Building: Main Building

Location: Floor

Finding: Floor Uneven and Wavy Throughout Building

Information: The floor throughout the building was observed to be uneven and wavy. This condition may indicate movement or deterioration of the subfloor structure and can affect the performance of floor coverings and fixtures if not addressed. Possible causes include subfloor movement, settlement, inadequate support, moisture-related issues, or general age-related deterioration. This is a common defect in properties of this age. It is recommended that a licensed builder assess the subfloor and structural supports, and carry out further investigation and rectification works as required. Preventative maintenance includes maintaining adequate subfloor ventilation and managing moisture levels. Repairs should be carried out in the short term to prevent further deterioration.

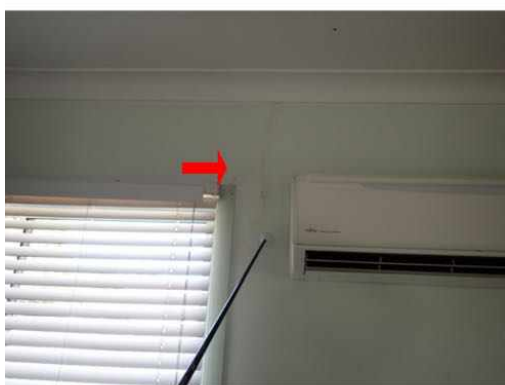
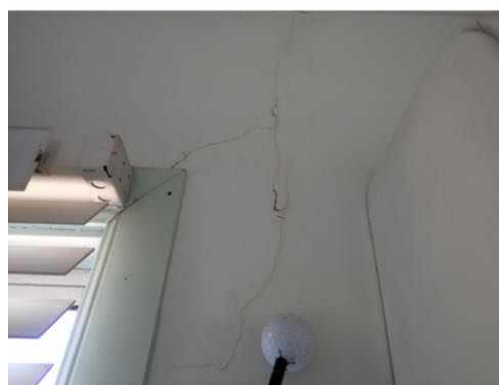
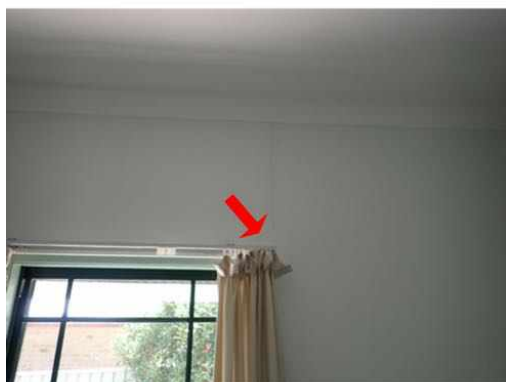
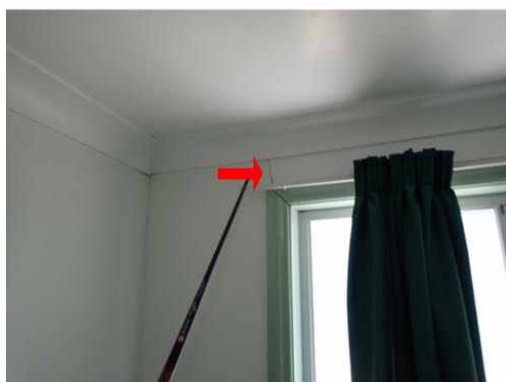
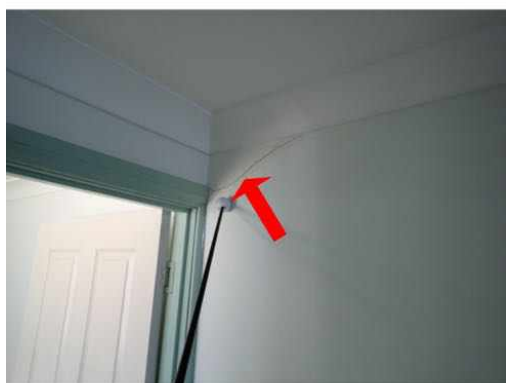
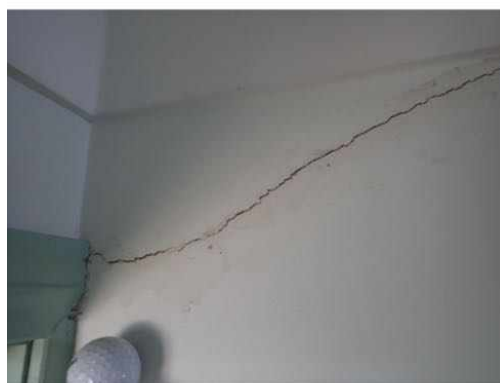
Finding 2.06

Building:	Main Building
Location:	Internal cladding
Finding:	Cracking to Internal Cladding at Multiple Locations
Information:	Minor and some major cracks were identified to the internal cladding at multiple locations throughout the building. This condition may indicate movement or deterioration of the building structure and can lead to further cracking if not addressed. Possible causes include structural movement, settlement, shrinkage of materials, general age-related wear and tear, and may be related to the condition of the subfloor. This is a common defect in properties of this age. It is recommended that a licensed builder assess the extent of the cracking and perform rectification works as required. Preventative maintenance includes monitoring the cracks for any progression over time. Repairs should be carried out in the short term to prevent further deterioration.

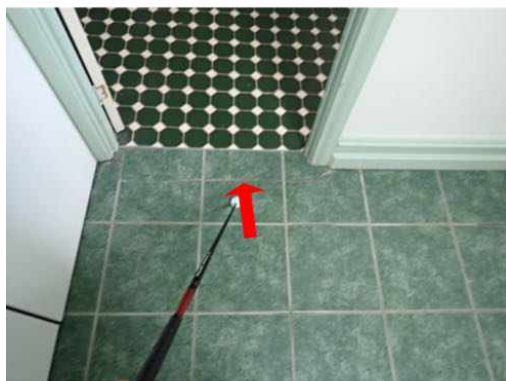
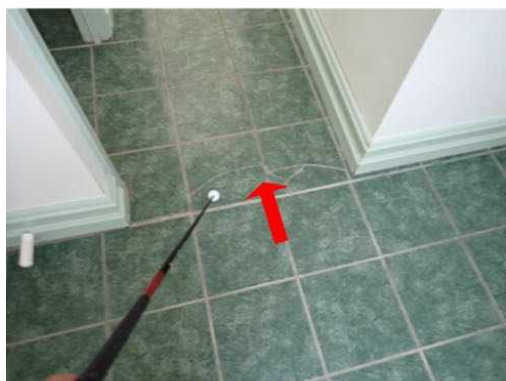
Finding 2.07

Building:	Main Building
Location:	Rear tiled room
Finding:	Major Cracking to Tiles at Entry's to Rear Green Tiled Room
Information:	Major cracking was identified to the tiles at the entry's to the rear green tiled room. This condition may indicate movement or failure of the substrate and can lead to further deterioration of the tiled surface if not addressed. Possible causes include subfloor movement, inadequate substrate preparation, impact damage, or general age-related wear and tear. It is recommended that a licensed tiler, in conjunction with a builder if required, assess the extent of the damage, investigate the underlying cause, and carry out repairs or replacement of the affected tiles and substrate as

necessary. Preventative maintenance includes ensuring a stable substrate and addressing any movement issues. Repairs should be carried out in the short term to prevent further deterioration.

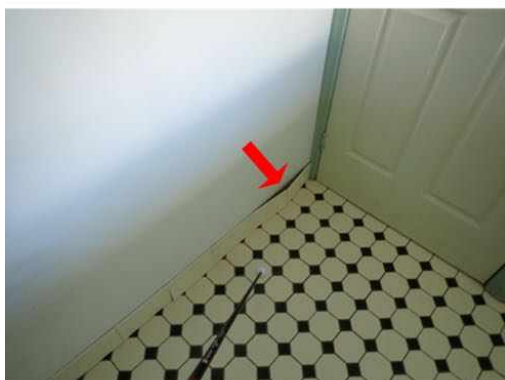
Finding 2.08

Building:	Main Building
Location:	Bathroom and laundry
Finding:	Cracked, Damaged and Loose Wall Tiles to Bathroom/Laundry
Information:	Cracked, damaged, and loose wall tiles were identified to the bathroom/laundry. This condition may allow moisture ingress and lead to deterioration of underlying and adjacent building materials if not addressed. Possible causes include movement in the structure, poor installation, failed adhesive, impact damage, or general age-related wear and tear. It is recommended that a licensed tiler assess the affected areas, remove and replace damaged and loose tiles, and ensure appropriate sealing and waterproofing is in place. A licensed builder may also need to be engaged to assess the underlying cause of the damage and carry out repairs to the substrate as required. Preventative maintenance includes maintaining grout and sealants and addressing damaged tiles promptly. Repairs should be carried out as soon as possible prevent further deterioration.

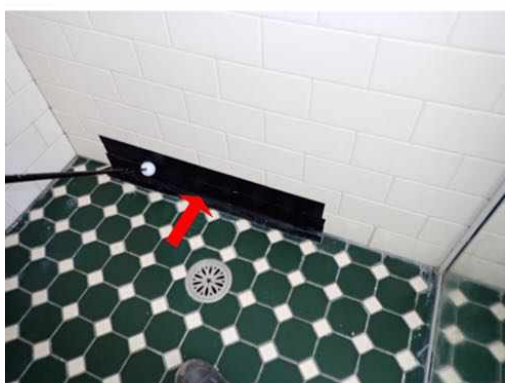
Finding 2.09

Building:	Main Building
Location:	Bathroom
Finding:	Duct Tape Applied to Bottom of Shower
Information:	Duct tape was observed applied to the bottom of the shower as shown in the photos. This appears to be a temporary repair and may indicate underlying issues such as leaks or failed seals. This condition may allow moisture ingress and lead to deterioration of surrounding and underlying building materials if not properly addressed. Possible causes include failed silicone, waterproofing issues, or prior attempts to manage a leak. It is recommended that a licensed plumber, in conjunction with a builder or tiler, assess the shower area, remove temporary repairs, and carry out appropriate permanent repairs including re-sealing or rectification of waterproofing as required. Preventative maintenance includes maintaining effective seals and promptly addressing any leaks. Repairs should be carried out as soon as possible.

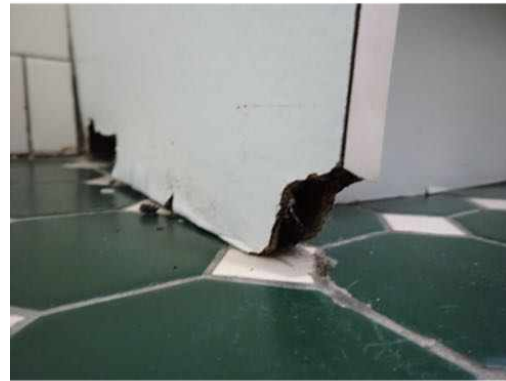
Finding 2.10

Building:	Main Building
Location:	Bathroom
Finding:	Wood Rot to Bathroom End Gable (Possible Shower Leak)
Information:	Wood rot was identified to the bathroom end gable, possibly resulting from a leaking shower. This condition indicates prolonged moisture exposure and may lead to further

deterioration of the affected elements and associated building materials if not addressed. Wood rot is also conducive to termite attack. Possible causes include failed waterproofing, leaking shower components, and ongoing moisture ingress. It is recommended that a licensed builder, in conjunction with a plumber, assess the source of moisture, rectify the leak, and repair or replace the affected timber elements as required. Preventative maintenance includes ensuring shower waterproofing and seals are maintained and promptly addressing any leaks. Repairs should be carried out as soon as possible.

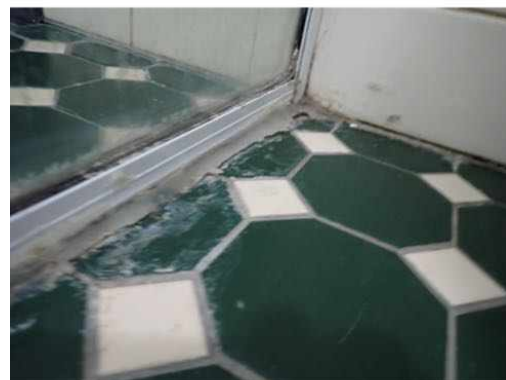
Finding 2.11

Building:	Main Building
Location:	Bathroom
Finding:	Poor Silicone Work to Base of Shower
Information:	Poor silicone application was identified around the base of the shower. This condition may allow moisture ingress and lead to deterioration of underlying and adjacent building materials if not addressed. Possible causes include inadequate installation, deterioration of existing sealant, or previous poor repair work. It is recommended that a licensed plumber or tiler remove the existing silicone and re-apply appropriate sealant to ensure a watertight finish. Preventative maintenance includes regular inspection and maintenance of sealants in wet areas. Repairs should be carried out in the short term to prevent further deterioration.

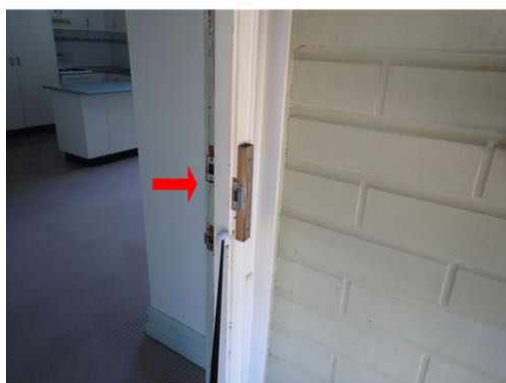
Finding 3.01

Building:	Main Building
Location:	Front entry door
Finding:	Entry Door Jambs Damaged from Previous Lock Installations
Information:	The entry door was operational at the time of inspection; however, the door jambs were observed to have damage from previous lock installations. This condition may affect the integrity of the door frame and security if not addressed. Possible causes include multiple lock changes, poor installation, or removal of previous hardware. It is recommended that a licensed carpenter assess the door jambs and carry out repairs or reinforcement as required to restore integrity and proper function. Preventative maintenance includes ensuring any future hardware installations are carried out correctly. Repairs should be carried out in the short term to prevent further deterioration.

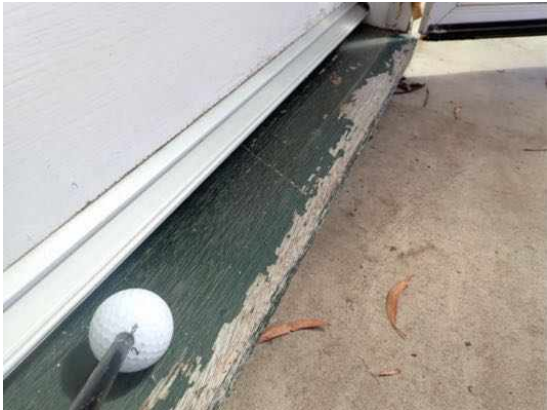
Finding 3.02

Building:	Main Building
Location:	Windows and door
Finding:	Deteriorated Paint to Windows, Doors and Window Hoods
Information:	Deteriorated paintwork was identified to the windows, doors, and window hoods. This condition may allow moisture ingress and lead to deterioration of the underlying materials if not addressed. Possible causes include prolonged exposure to weather, lack of maintenance, and general age-related wear and tear. This is a common defect in properties of this age. It is recommended that a licensed painter prepare and repaint all affected surfaces to provide adequate protection. Preventative maintenance includes regular painting and sealing of external elements. Repairs should be carried out in the short term to prevent further deterioration.

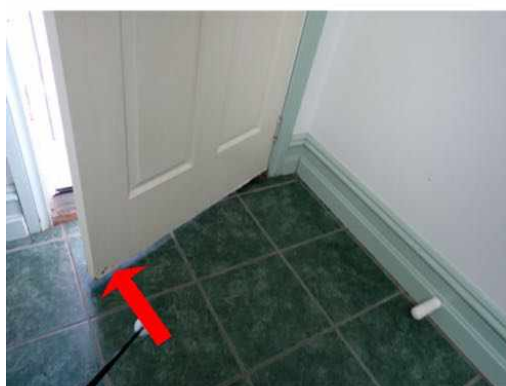
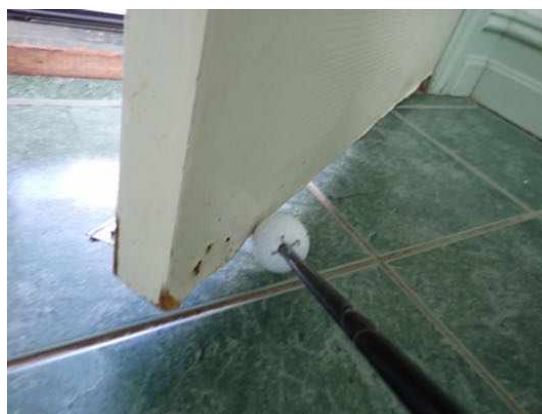
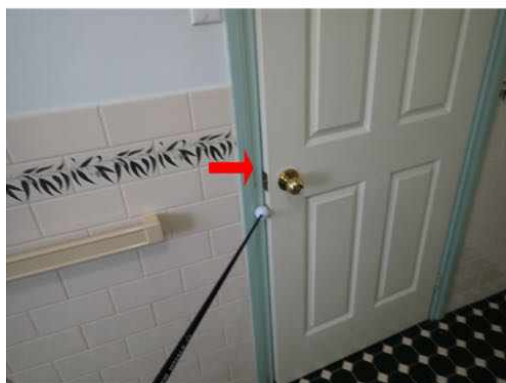
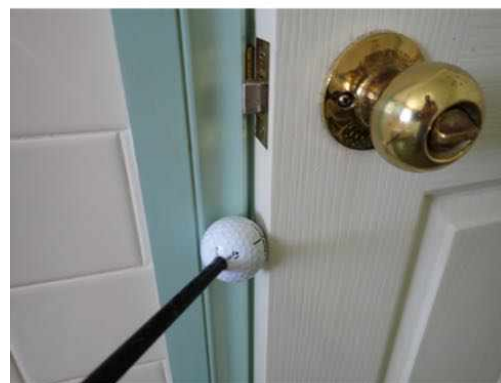
Finding 3.04

Building:	Main Building
Location:	Bathroom
Finding:	Bathroom Door Swollen and Catching on Door Jamb
Information:	The bathroom door was observed to be swollen at the bottom and catching on the door jamb. This condition may lead to reduced functionality and ongoing deterioration if not addressed. Possible causes include moisture ingress, high humidity, and general age-related wear and tear. It is recommended that a licensed carpenter assess the door, carry out adjustments, and repair or replace affected components as required. Preventative maintenance includes managing moisture levels and ensuring adequate ventilation in wet areas. Repairs should be carried out in the short term to prevent further deterioration.

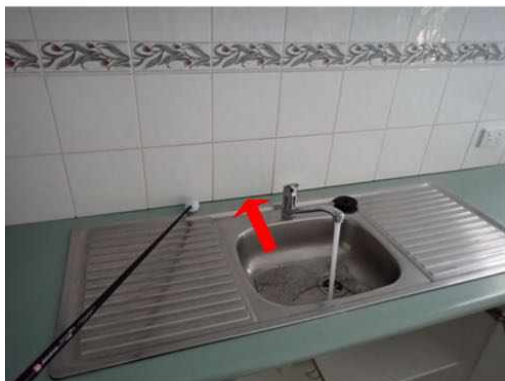
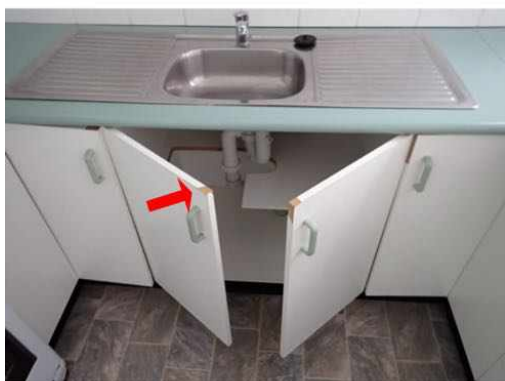
Finding 3.05

Building:	Main Building
Location:	Kitchen
Finding:	Kitchen in Good Condition with Minor Defects Identified
Information:	The kitchen was observed to be in good condition for its age, with minor defects noted including damaged edge tape to cupboard doors and deteriorated silicone to the tile splashback junction. These conditions may allow minor moisture ingress and lead to gradual deterioration of associated materials if not addressed. Possible causes include general age-related wear and tear and ongoing use. This is a common condition in kitchens of this age. It is recommended that a licensed carpenter or

cabinet maker, in conjunction with a tiler if required, carry out minor repairs including replacement of edge tape and re-application of silicone as required. Preventative maintenance includes maintaining effective seals and promptly addressing minor defects. Repairs should be carried out as part of routine maintenance.

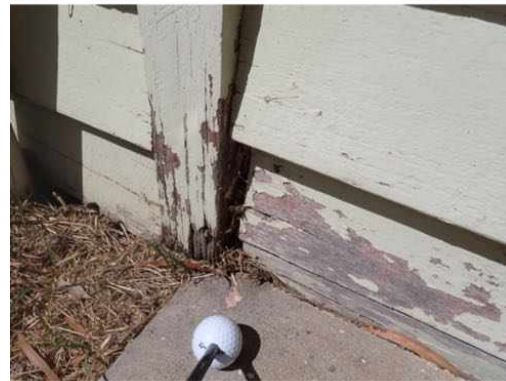
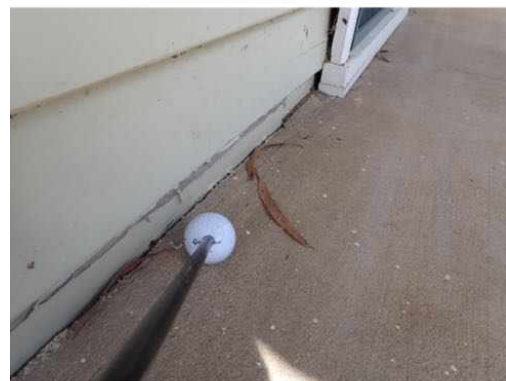
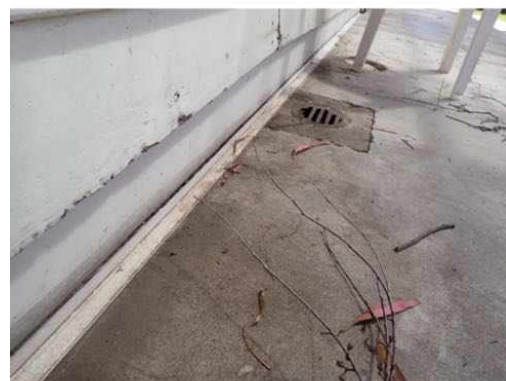
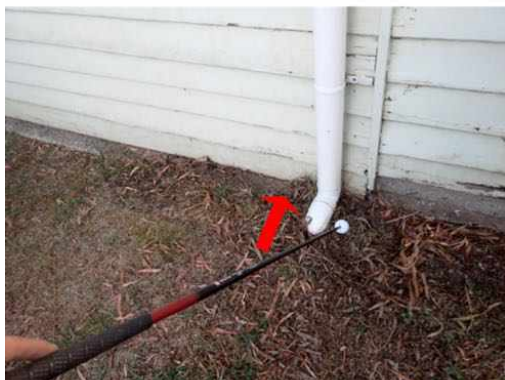
Finding 6.01

Building:	Main Building
Location:	Perimeter of building
Finding:	Conditions Conducive to Termite Attack – Concealed Entry and Timber in Contact with Ground
Information:	Conditions conducive to termite attack were identified around the building, including

areas allowing concealed entry and timber elements in direct contact with the ground. These conditions increase the risk of termite activity and potential damage to structural timber elements if not addressed. Possible causes include inadequate clearance, poor maintenance, and construction elements bridging inspection zones. This is a common issue in properties of this age. It is recommended that a licensed timber pest inspector assess the property, identify all risk areas, and implement appropriate termite management and protection measures. Preventative maintenance includes maintaining clear inspection zones, ensuring adequate clearances, and removing or isolating timber from ground contact. Works should be carried out in the short term to reduce the risk of termite attack.

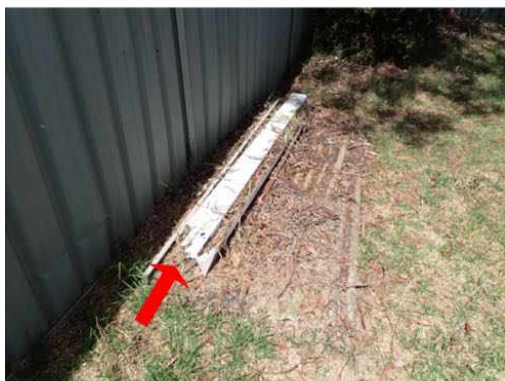
Finding 6.02

Building:	Yard
Location:	Rear yard
Finding:	Stored Timber in Yard Conducive to Termite Attack
Information:	Stored timber was identified in the yard, which is conducive to termite attack. This condition may attract termite activity and increase the risk of infestation to the main building if not addressed. Possible causes include storage of untreated or waste timber in contact with or close to the ground. This is a common issue in properties of this age. It is recommended that all stored timber be removed from the yard or stored appropriately off the ground and away from the building. Preventative maintenance includes keeping the site clear of timber debris and maintaining separation between timber and soil. Works should be carried out in the short term to reduce the risk of termite attack.

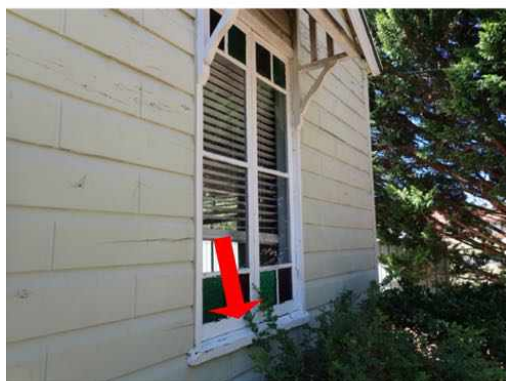
Finding 7.01

Building:	Main Building
Location:	Front living room window
Finding:	Wood Rot to Front Living Room Window

Information: Wood rot was identified to the front living room window. This condition may allow moisture ingress and lead to further deterioration of the window and associated building materials if not addressed. Wood rot is also conducive to termite attack. Possible causes include prolonged exposure to weather, failed paint coatings, and general age-related wear and tear. This is a common defect in properties of this age. It is recommended that a licensed carpenter assess the window and carry out repairs or replacement of affected timber components as required. Preventative maintenance includes regular painting and sealing of timber elements to protect against moisture. Repairs should be carried out in the short term to prevent further deterioration.

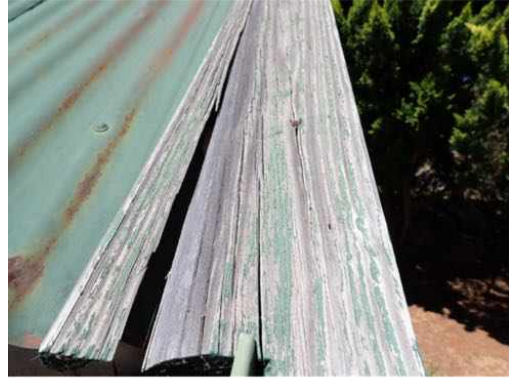
Finding 7.02

Building: Main Building
 Location: Roof
 Finding: Wood Rot to Roof Timber Trims Above Front Living Room Window
 Information: Wood rot was identified to the timber trims to the roof above the front living room window. This condition may allow moisture ingress and lead to further deterioration of the affected elements and associated building materials if not addressed. Wood rot is also conducive to termite attack. Possible causes include prolonged exposure to weather, failed paint coatings, and general age-related wear and tear. This is a common defect in properties of this age. It is recommended that a licensed carpenter assess the affected timber trims, carry out repairs or replacement of rotted sections, and repaint/seal the area as required. Preventative maintenance includes regular painting and sealing of timber elements to protect against moisture. Repairs should be carried out in the short term to prevent further deterioration.

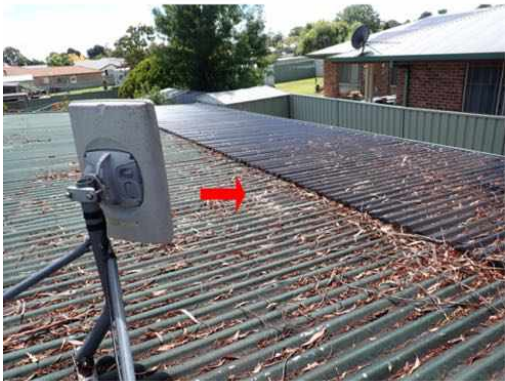
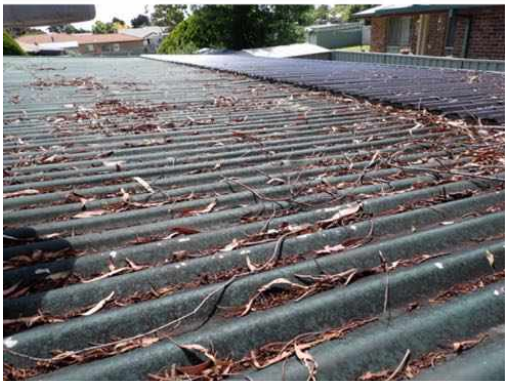
Building: Main Building
Location: Roof
Finding: Blocked Gutters and Debris to Roof
Information: Blocked gutters and the presence of leaves and debris on the roof were identified. This condition may impede proper drainage and lead to water overflow, moisture ingress, and deterioration of associated building elements if not addressed. Possible causes include lack of regular maintenance and surrounding vegetation. This is a common defect in properties of this age. It is recommended that a licensed roofer or suitable contractor clean the gutters and remove debris from the roof, and check the system is functioning correctly. Preventative maintenance includes regular gutter cleaning and roof inspections, particularly in areas with nearby trees. Works should be carried out as part of routine maintenance.

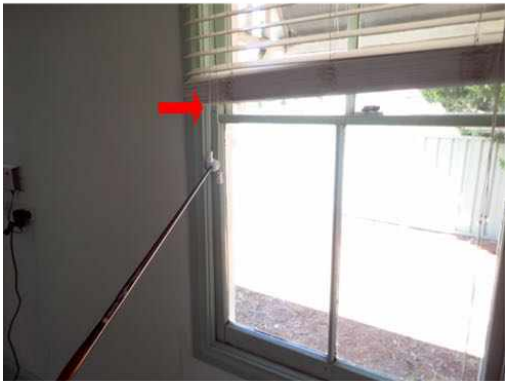
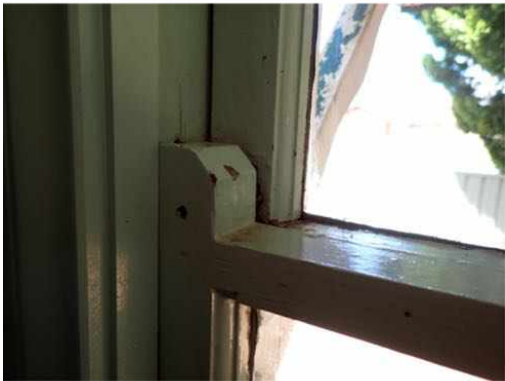
Building: Main Building
Location: Living room and bedroom
Finding: Bedroom and Living Room Windows Nailed Shut
Information: Windows to the bedroom and living room were observed to be nailed shut and unable to be opened. This condition restricts normal operation and may lead to further damage to window components if forced or left unaddressed. Possible causes include previous attempts to secure the windows, faulty hardware, or movement of the frames. It is recommended that a licensed carpenter assess the windows, remove fixings, and carry out repairs or adjustments to restore proper operation as required. Preventative maintenance includes ensuring window hardware is functional and regularly maintained. Repairs should be carried out in the short term to restore functionality.

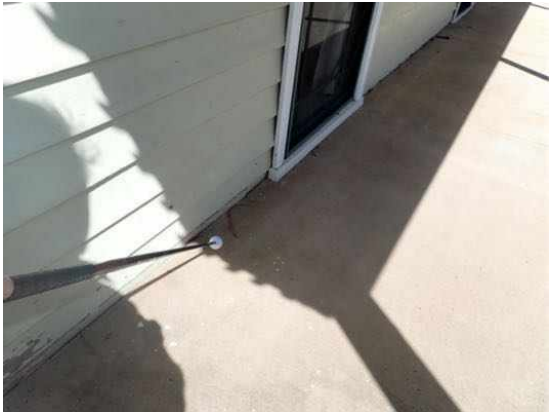
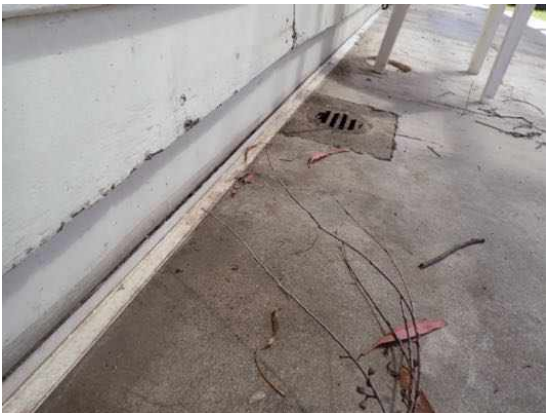
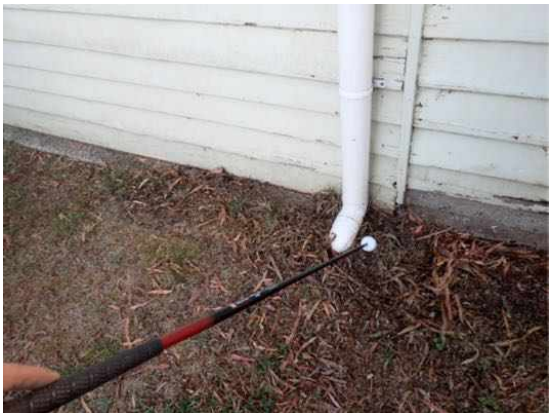
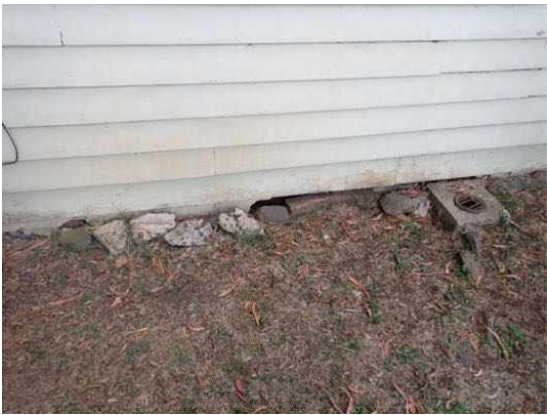
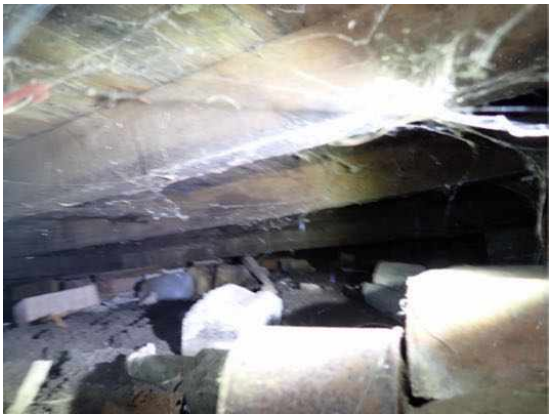
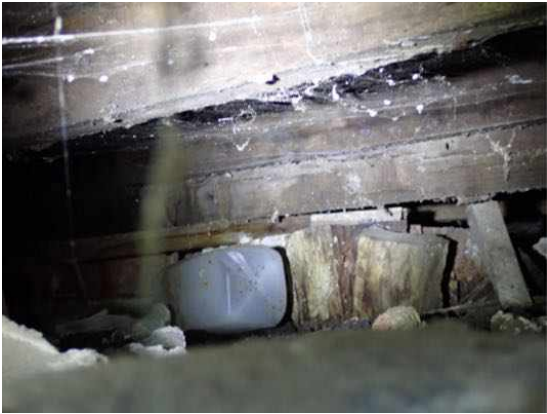
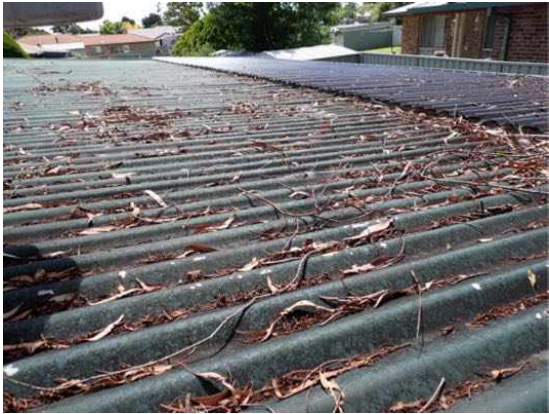
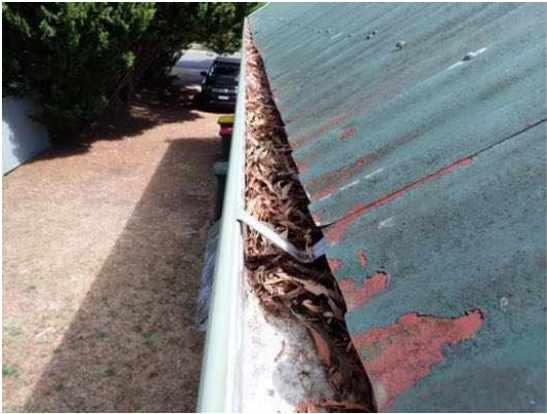
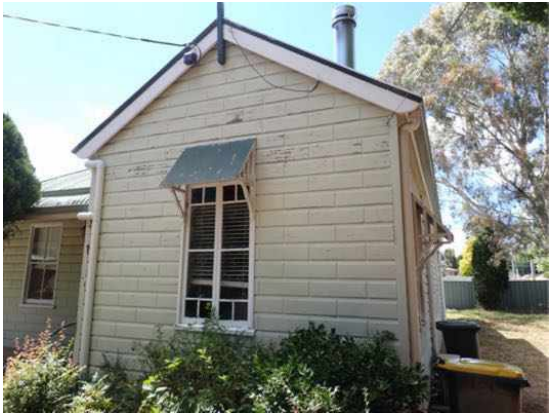
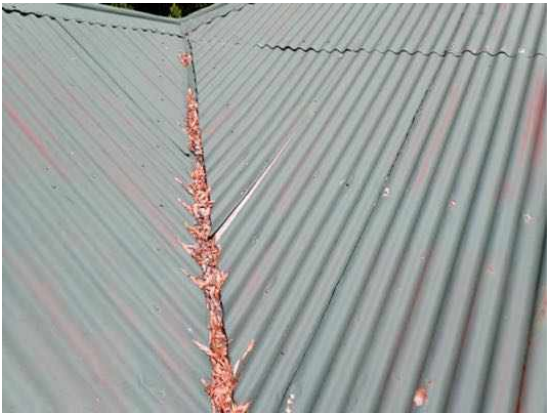
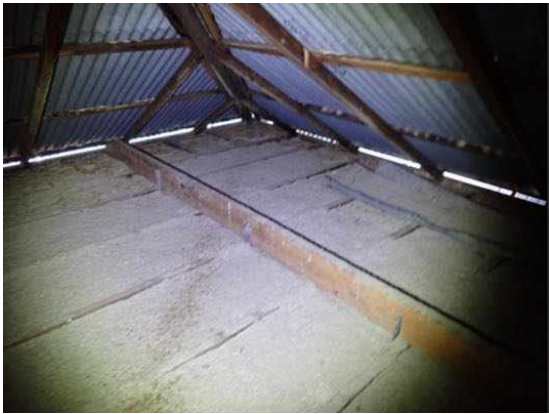
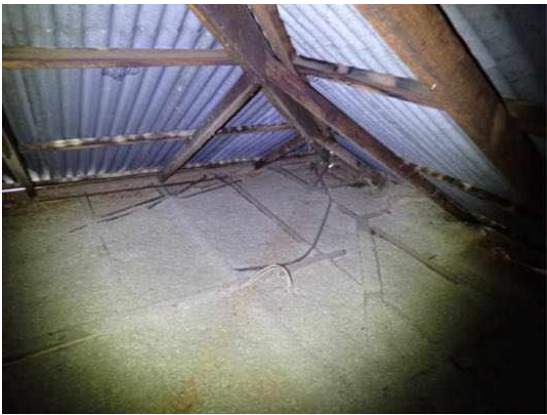
Building: Main Building
Location: All Areas
Finding: Additional Photos - Obstructions and Limitations
Information: These photographs are an indication of the obstructions and limitations which impeded full inspection of the area at the time of inspection. These obstructions can hide an array of defects and should be removed to allow full inspection to be carried out. A re-inspection is recommended once the areas are made accessible.
