Building Inspection Report

Inspection Date: Wed, 18 Feb 2026

Property Address: 2/548 Pennant Hills Rd, West Pennant Hills
NSW 2125, Australia

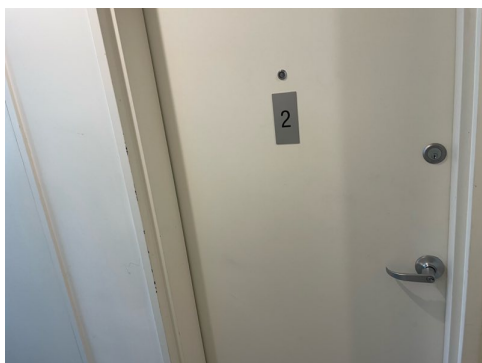
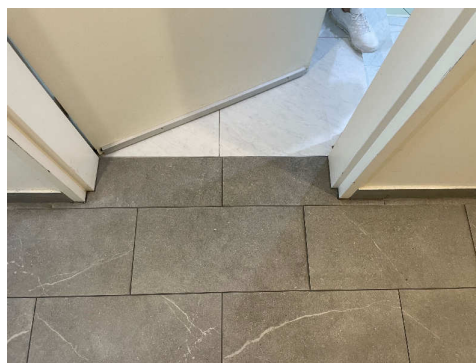
Defects 3.01

Location: Entry

Information: Binding and/or jamming of this door is evident during standard operation. This defect inhibits the functionality of the affected door as well as creating potential for secondary defects to associated building elements, such as damage to the floor covering.

A door that binds to flooring or to the associated door frame may have several causes, ranging from minor defects, such as poor installation of the door or deteriorated hinges, through to major structural issues, such as damage to subfloor structures.

Where door binding/jamming appears to indicate major structural issues, a registered builder specialising in re-stumping should be appointed to provide an estimate on the cost of rectification.

For minor causes, a qualified carpenter or general handyperson should be appointed to perform minor rectification works at client discretion.

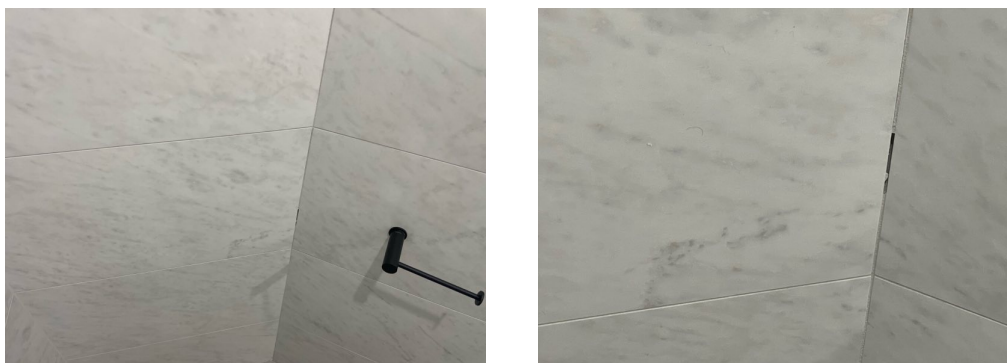
Defects 3.02

Finding: Tiles - Missing Sealants and/or Grouts

Information: During the inspection, sections of the existing tiled surfaces were observed with missing, cracked, or deteriorated grout and/or sealant. These gaps were visible along tile joints and at junctions where tiles meet adjoining walls, skirtings, or fixtures.

The deterioration has likely occurred over time due to general wear, building movement, or ongoing moisture exposure. Missing or damaged grout and sealant allow water to penetrate behind tiles, which can lead to staining, mould growth, or damage to the substrate and surrounding finishes.

It is recommended that the affected areas be re-grouted and re-sealed by a qualified tiler or trade as a short-term priority to maintain a watertight finish and prevent further deterioration.

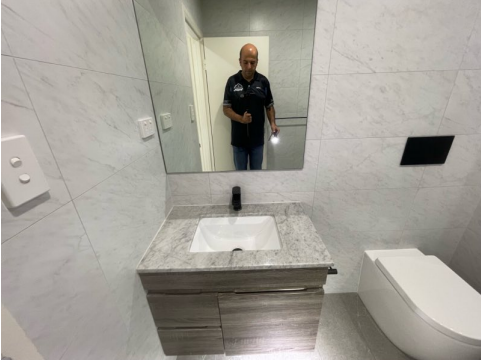
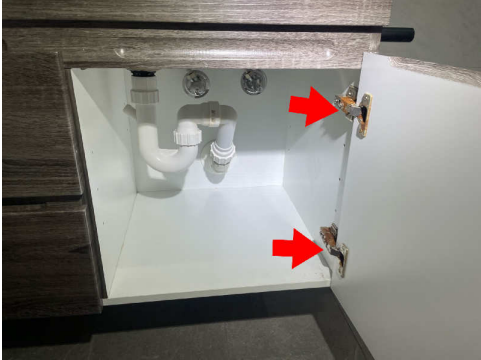
Defects 3.03

Finding: Building element - Rusted or corroded

Information: This building element shows evidence of rusting and corrosion, which is likely to have developed as a result of excessive exposure to moisture and or inadequate coatings.

As surface rust provides no protection to the underlying iron, the deteriorating condition is likely to worsen if not addressed in the short-term future.

Where possible, the use of galvanized (treated) metals or aluminium coated metals aid in rust prevention, as does regular general maintenance. Rust formation can be controlled with coatings, such as paint, that isolate the iron from the environment.

Rusting and corrosion should be managed by ideally removing or limiting the affected surface from exposure to moisture. A registered builder may be appointed to replace any building elements that have been severely affected by rust or water damage.

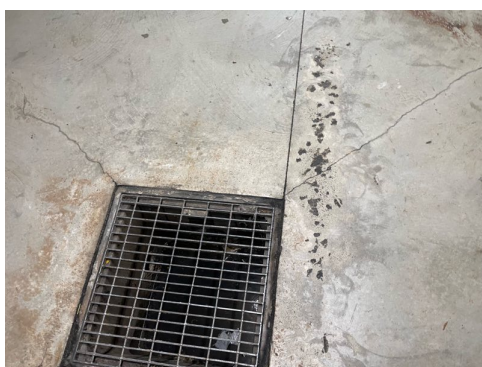
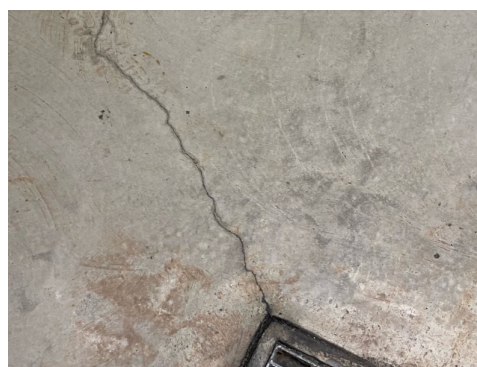
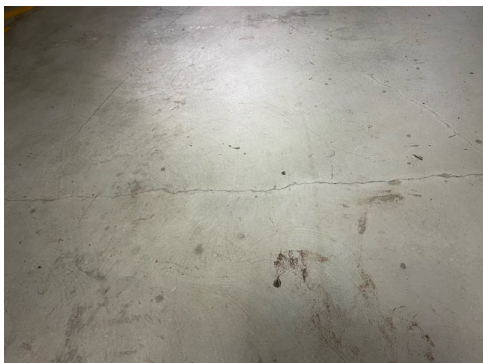
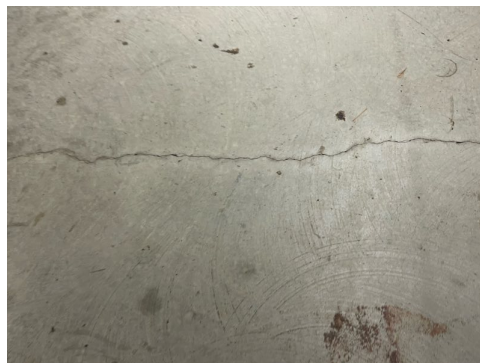
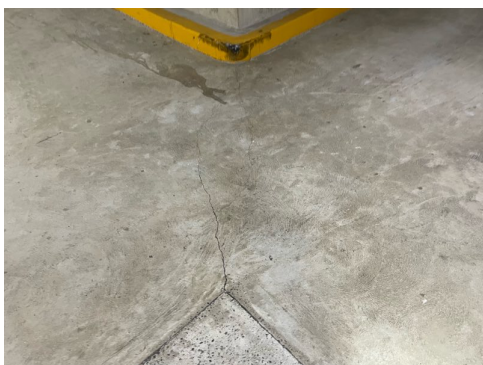
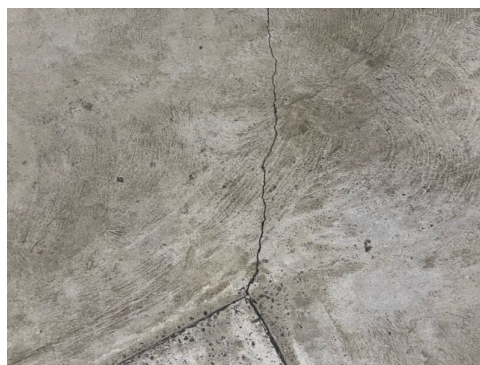
Building:	Main Building
Location:	Strata / Common Area Basement
Finding:	Cracking - External Concrete Paving Damage Category 2 - Distinct (less than 3mm)
Information:	Distinct cracks were identified in external concrete paving. Distinct cracks are generally found in older concrete paving, and may also present as a trip hazard as consequence of an uneven or curved surface.

General age and expected deterioration of the paved areas is a common cause of this type of cracking. However, expansion and contraction of the slab may also have occurred due to environmental factors. Such factors include variable moisture and weather conditions, the presence of trees and their roots having a settling or lifting affect on the soil, or the effect of load bearing, e.g. heavy vehicles over a sustained period of time.

Cracking to this degree may also be due to poor original installation of the concrete. Factors such as poor compaction of the sub surface and/or inadequate reinforcing of the slab may create cracking and other secondary defects.

Repairs are likely to be required to prevent further cracking and to reduce hazards associated with cracking, such as tripping. Monitoring of all cracking should be conducted frequently. Always contact a building inspector should cracks widen, lengthen, or become more numerous.

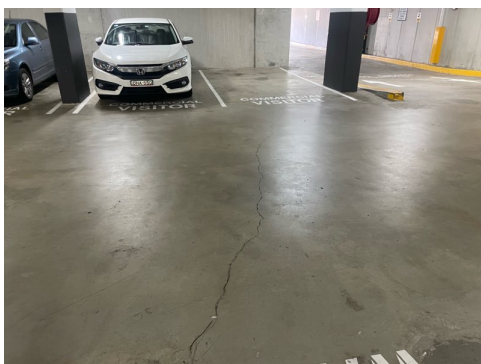
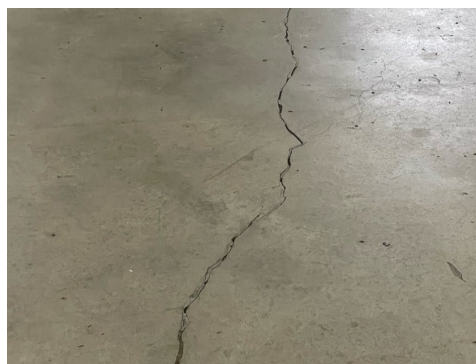
Building: Main Building
Location: Strata / Common Area Ground Level
Finding: Crack in concrete slab - Category 4

Information: During the inspection, a crack previously classified as Category 4 was identified within the concrete slab. A Category 4 crack is defined as a crack presenting as an open gap within the slab, typically accompanied by noticeable curvature, differential movement, or a change in level across the affected area. Such cracking is generally characterised by a crack width in the order of approximately 4–10 mm, or a vertical offset exceeding 25 mm when assessed using a 3-metre straight edge.

At the time of this inspection, the crack had been filled and surface remedial works had been undertaken. While the applied repair appears to have addressed the visible opening, the presence of a previously Category 4 crack indicates that the slab experienced movement beyond the acceptable limits prescribed under the Guide to Standards and Tolerances and relevant performance requirements of the National Construction Code (NCC).

Category 4 cracking to slabs exceeds allowable tolerances and is classified as a major defect due to the extent of movement involved. Accordingly, confirmation should be obtained from the responsible builder or a suitably qualified structural engineer that the underlying cause of movement has been adequately assessed and rectified, and that the slab now performs in accordance with the relevant structural performance requirements. Supporting documentation for the remedial works should be requested and retained for records.
