Building Inspection Report

Inspection Date: Thu, 26 Mar 2026

Property Address: 3/646 Warrigal Rd, Oakleigh South VIC
3166, Australia

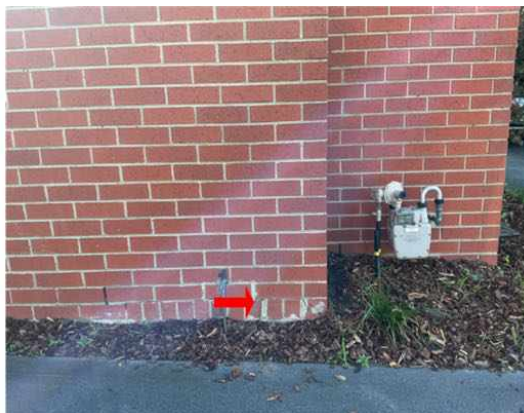
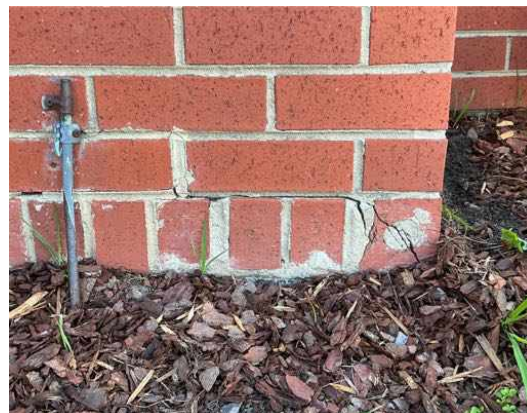
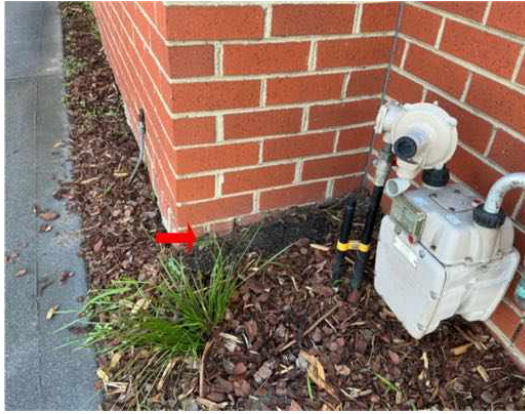
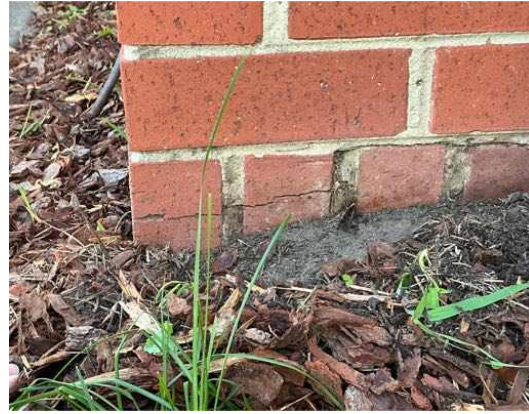
Defects 3.01

Building: Main Building
Location: Exterior walls - front
Finding: Brickwork - Cracking noticeable
Information: There were several cracks and or crack repairs evident to external brickwork.

Noticeable cracks are a common occurrence in external brickwork and are a likely result of age expected building movement, general expansion, and/or contraction of building materials in different weather conditions. Noticeable cracks in brickwork may develop if left unattended, with potential for necessitating major remedial works or replacement of the brickwork.

It is highly advised that a qualified bricklayer be appointed to provide necessary works to cracked brickwork to prevent any further damage. Such works should be conducted as soon as possible.

Always monitor these cracks and contact a building inspector should cracks widen, lengthen, or become more numerous.

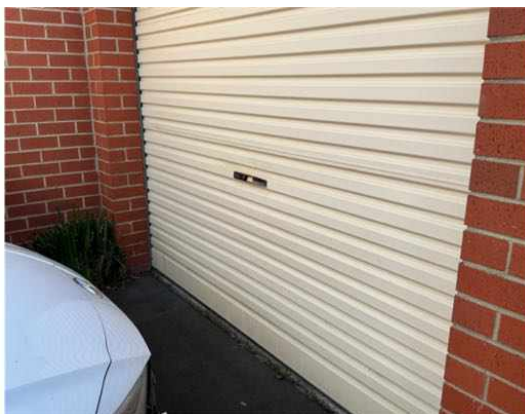
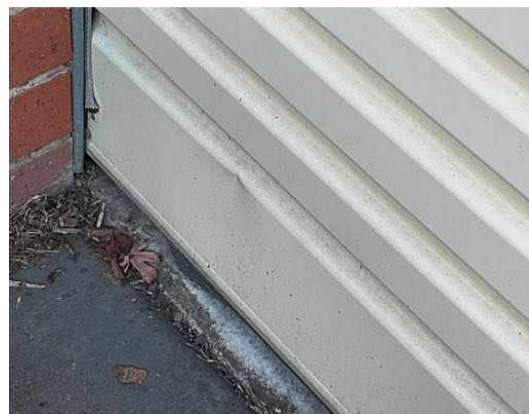
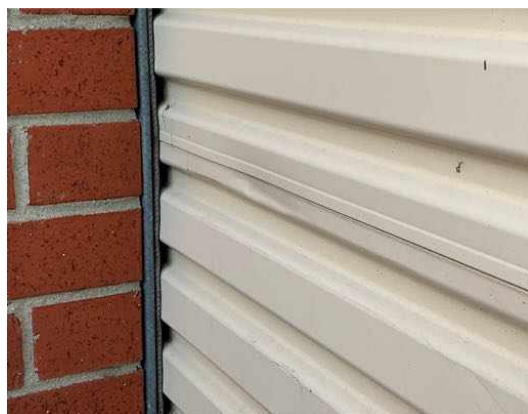
Defects 3.02

Building:	Main Building
Location:	Garage
Finding:	Garage door - Superficial markings
Information:	The garage roller door has a number of marks and dents likely to have resulted from impact damage be it accidental or deliberate impact at sometime.

Garage roller doors can fail when the building materials have aged but may be indicative of impact damage (accidental or deliberate). While superficial markings detract from the aesthetics of the building element, the functionality has not been hindered in any way.

Repair and/or replacement of the two garage doors would improve the condition of the garage but certainly not an urgent item

A qualified roller door installer or supplier should be engaged to check out the operation and overall condition of the doors to determine if repair is an option otherwise replacement may need to be considered.

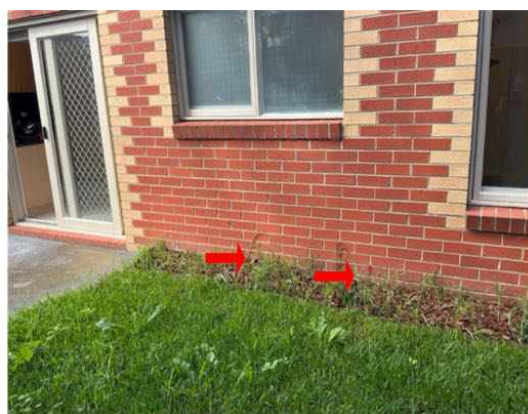
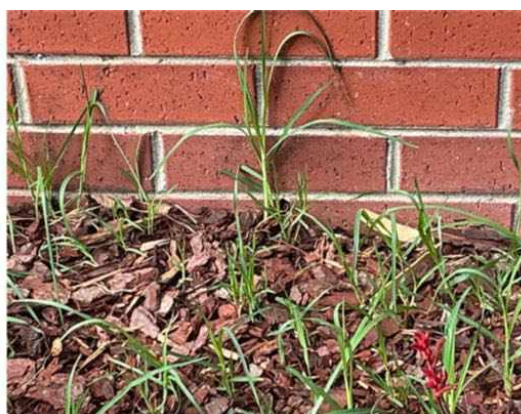
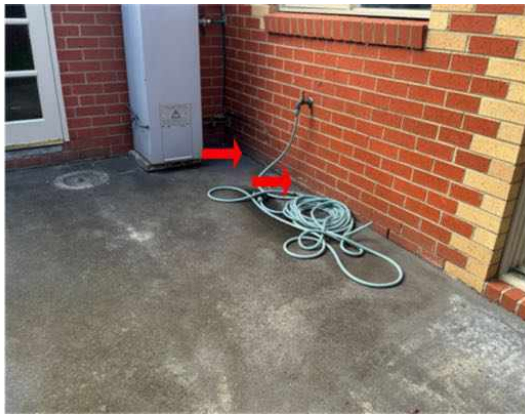
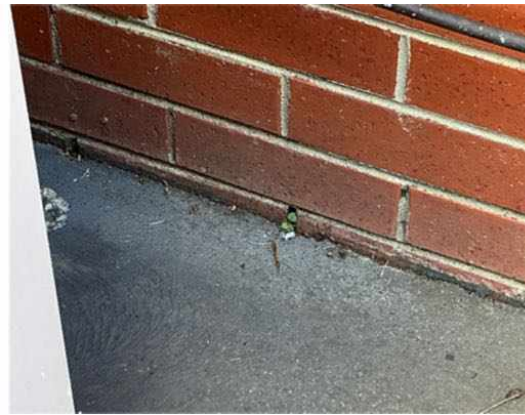
Defects 3.03

Building:	Main Building
Location:	Exterior walls - rear
Finding:	Weep holes - Blocked
Information:	It was noted during the time of inspection that some of the weep holes to the brickwork were blocked. Weep holes are designed to allow water from leaks or seepages in brickwork to be directed to the external environment, prior to entering the wall cavity or associated building materials. Weep holes should therefore be kept clean and free of debris or blockages.

Blocked weep holes are likely to result in the presence of excessive moisture within the brickwork and associated structures, creating potential for water damage and moisture problems.

Depending on the nature of the blockage, the homeowner may be able to undertake remedial works to remove blockages. Alternatively, appointment of a registered builder may be required to remove blockages. Preventative works are necessary in ensuring the structural integrity of the affected brickwork and should be performed as soon as possible.

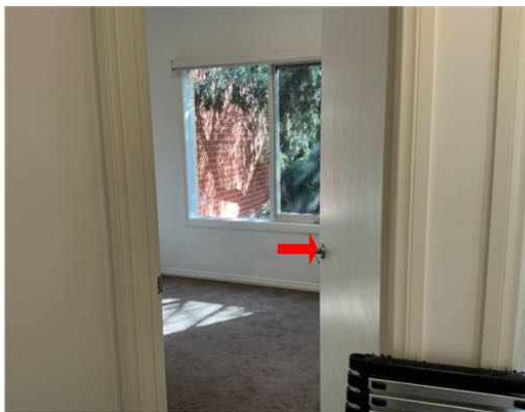
Defects 3.04

Building: Main Building
 Location: Bedroom
 Finding: Door handle - Not latching
 Information: It was noted that the door in this area was not latching during operation at the time of inspection. Whilst detracting from the functionality of this building element, this minor defect may also be a security risk, and may therefore have serious implications if left unattended.

It is suspected that this defect has occurred due to minor issues with the associated hinges. Such damage is identified as general wear and tear, which is expected for building elements of this age.

A qualified carpenter or general handyperson may be appointed to perform rectification works as necessary, at client discretion. If left unattended, further functional impairment is likely to occur.

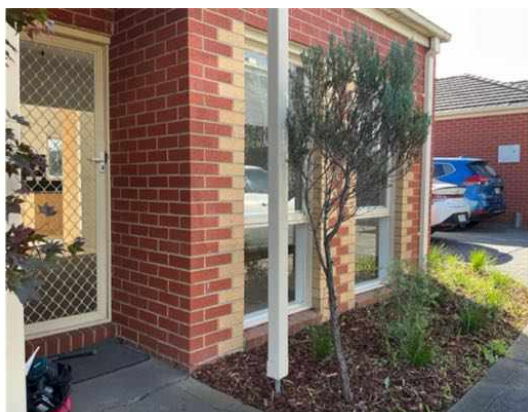
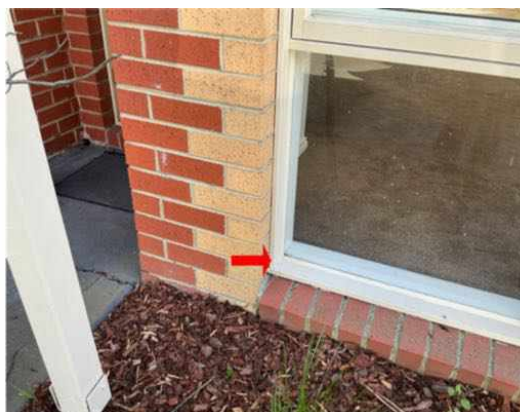
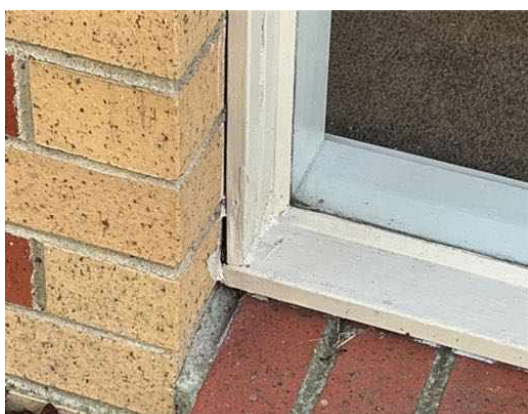
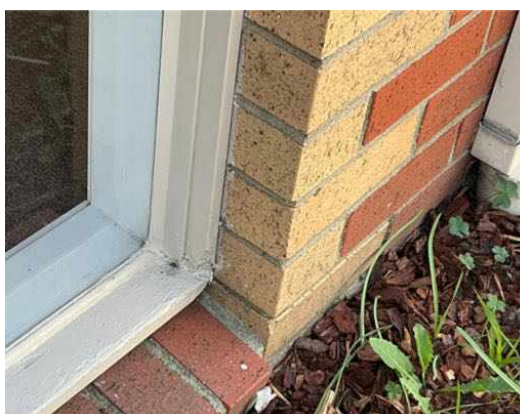
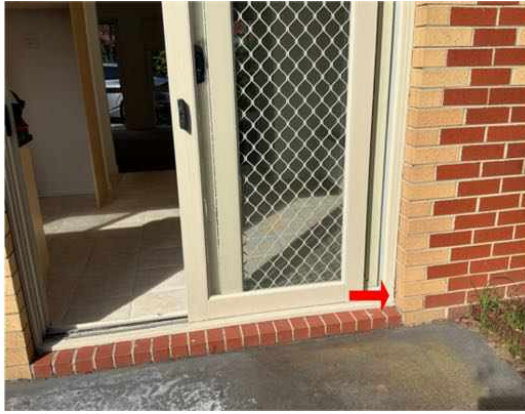
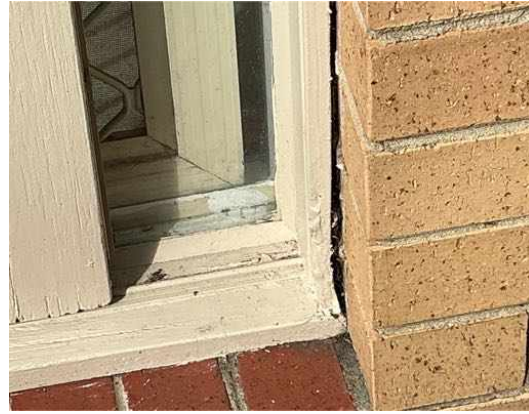
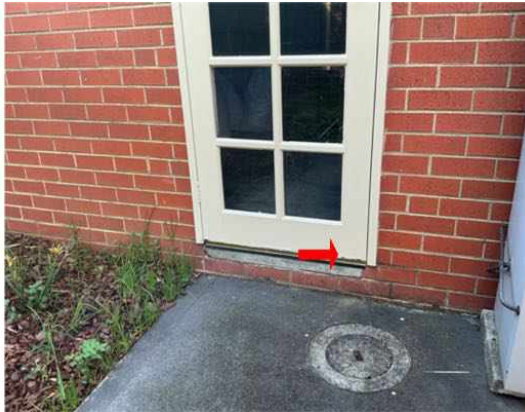
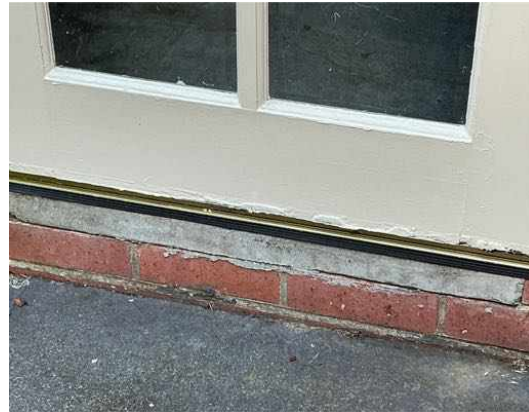
Defects 3.05

Building: Main Building
 Location: Exterior windows and rear sliding and garage doors
 Finding: Windows and doors- Wood rot

Wood rot was found to be affecting external windows and doors. Wood rot, also known as Fungal Decay, occurs when timbers and other cellulose building materials are exposed to damp conditions on an ongoing basis.

It is likely that this wood rot has developed as a result of frequent exposure to rain and other weather conditions. It is suspected that failure to maintain the window frames over a prolonged period has resulted in them deteriorating at an accelerated rate, increasing their susceptibility to the development of wood rot. Leaks in roof plumbing or associated pipework may have also contributed to the formation of the wood rot in this area.

Early intervention and regular maintenance will prolong the useful life of these building elements. Prior to any works being performed, any associated pipework or roof plumbing should be inspected by a licensed plumber for faults or leaks.

Repair and/or replacement of affected window frames may be a necessary step in protecting surrounding building elements from such deterioration. Remedial works should be performed by a qualified carpenter or registered builder as soon as possible to prevent any further damage.

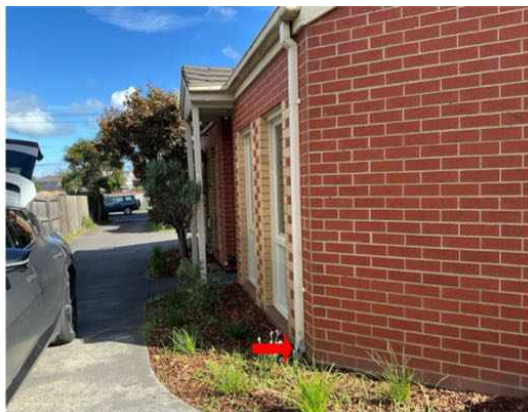
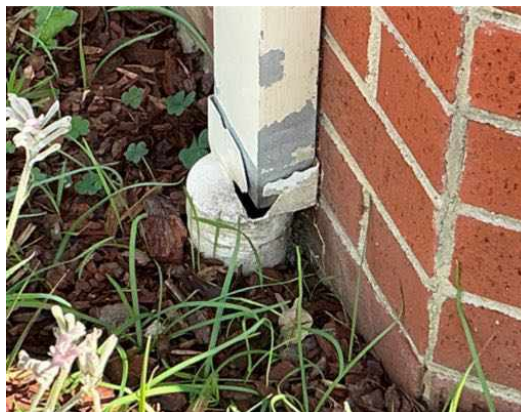
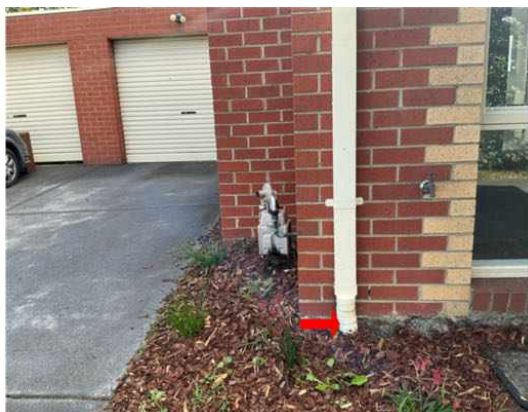
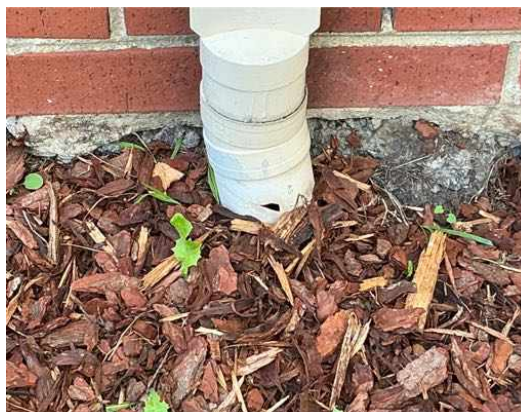
Defects 3.06

Building:	Main Building
Location:	Exterior walls - front
Finding:	Stormwater drain - Not connected
Information:	The roof plumbing is not adequately connected to stormwater drainage on the site due to the fact that it is broken. This disconnection negatively impacts the functional capacity of the roof plumbing.

Where roof plumbing doesn't drain adequately, the area at the base perimeter can become excessively damp, potentially creating an environment that is susceptible to rust and corrosion of surrounding building elements, as well as attracting termites and other pests.

It is highly recommended that a plumber be appointed to further inspect the area and to install adequate drainage equipment where necessary.

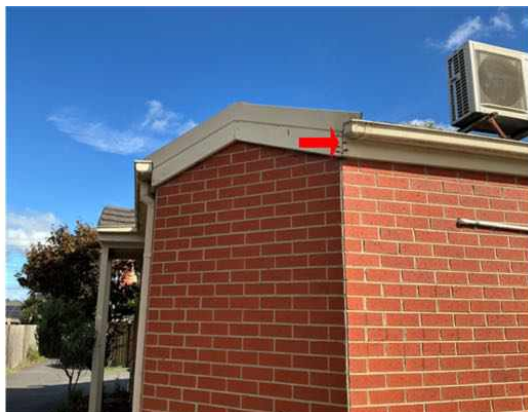
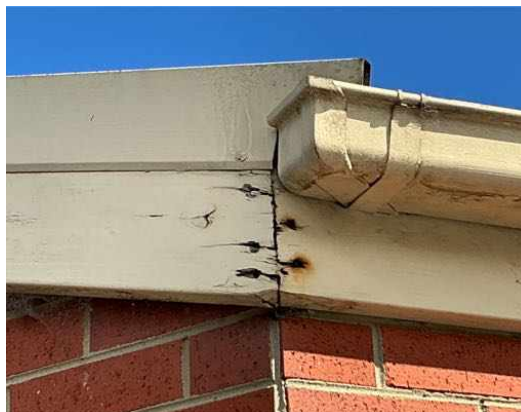
Defects 3.07

Building:	Main Building
Location:	Fascias
Finding:	Fascias - Wood rot
Information:	Wood rot was found to be affecting fascias and barges in this area, evidenced by the presence of mould on the surface in some areas. Wood rot, also known as Fungal Decay, occurs when timbers and other cellulose building materials are exposed to damp conditions on an ongoing basis.

It is likely that this wood rot has developed as a result of faults in the roof plumbing, creating excessive moisture in this areas. Frequent exposure to rain and other weather conditions also make fascias and barges susceptible to accelerated deterioration.

Early intervention and regular maintenance will prolong the useful life of these building elements. Prior to any works being performed, the cause of the moisture that has created the visible wood rot should be identified and addressed in a suitable manner.

It is advised that a roof plumber be appointed to inspect all roof plumbing and subsequently identify the cause of the wood rot. Replacement of affected fascias and barges may then be a necessary step in protecting surrounding building elements from such deterioration.

A qualified plumber may be appointed to assess the cause of excessive moisture and

to provide advice on any remedial works as required. A qualified carpenter or registered builder may also be required to replace affected building materials.

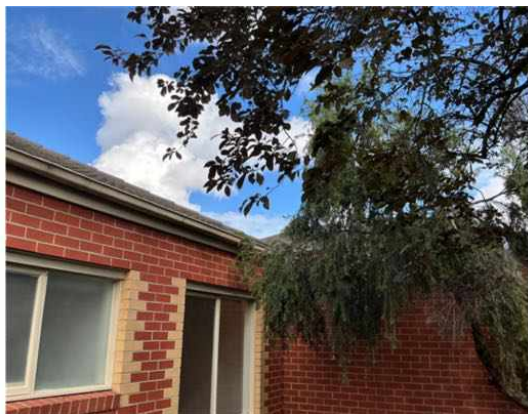
Defects 3.08

Building:	Main Building
Location:	Roof Exterior
Finding:	Trees - Overhanging and filling gutters
Information:	Overhanging trees often result in excessive amounts of leaf debris accumulating in gutters.

Gutters are a critical part of the building's management of storm water and rain. It is therefore important that they be kept clear to prevent secondary damage to associated building elements, including exterior and interior walls, ceiling linings and any adjoining building elements. Where gutters are blocked, pooling of rainwater is likely to occur, fast-tracking rust and corrosion of the roof plumbing elements.

It is highly advised that all overhanging tree branches be removed as soon as possible to prevent any further damage. Repair and/or replacement of sections of damaged guttering may also be required where the extent of the damage necessitates.

Such works should be performed by the homeowner; however, appointment of a landscape contractor or an arborist may be required. Consultation with a licensed roof plumber is required where guttering has been damaged.

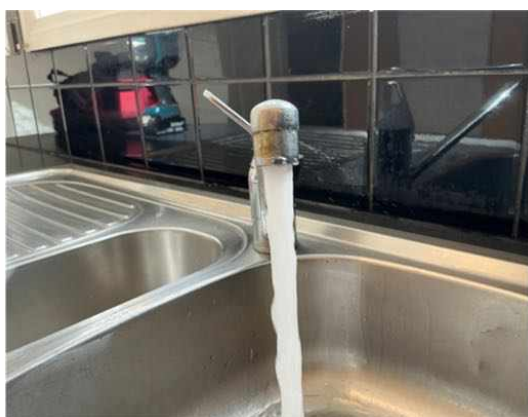
Defects 3.09

Building:	Main Building
Location:	Kitchen
Finding:	Kitchen tap broken
Information:	This kitchen tap was found to be faulty at the time of inspection and may need to be replaced or repaired by qualified plumber

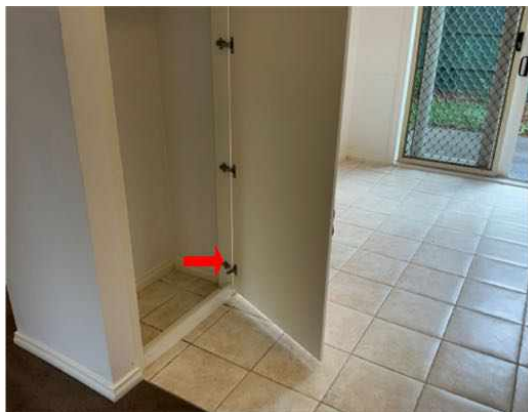
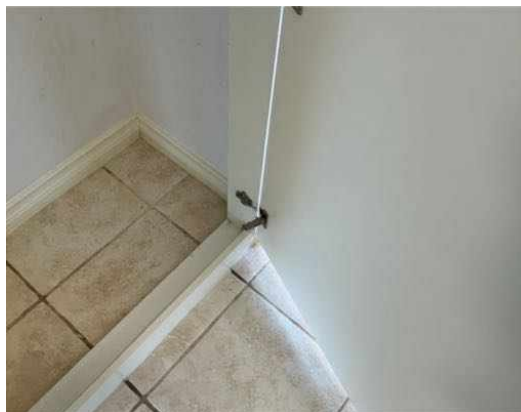
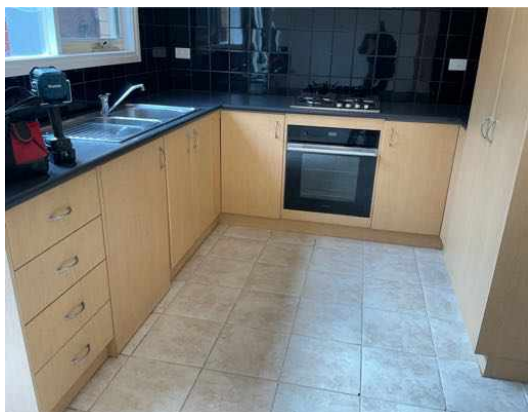
Defects 3.10

Building:	Main Building
Location:	Kitchen
Finding:	Cabinetry - Loose hinges
Information:	Several cupboard doors are not level and detract from the operational state of the cabinetry. Upon further inspection, it was noted that the hinges to the cupboard doors have deteriorated over time and, as a result, have come loose from their original fixing. To improve operation of the affected cupboard doors, a general handyman may be appointed to replace the faulty hinges. Such works should be completed at discretion of the client.

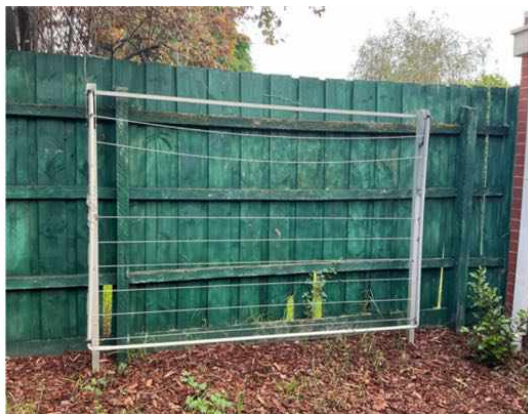
Defects 3.11

Building:	Main Building
Location:	Exterior walls - rear
Finding:	Fencing - Deteriorated
Information:	It was noted at the time of inspection that sections of the fencing throughout the property have deteriorated. Typically fencing deteriorates due to age and or wear, rot and or rust which is generally expected for a structure of this age, due to prolonged exposure to weather conditions. Sometimes inadequate installation or maintenance can be to blame.

If left unattended, it is likely that further damage will occur. It is suspected that repair of several elements of the fencing may be required however replacement may be a consideration of the client also.

A licensed fencing contractor should be appointed to provide further advice and perform rectification works as necessary.

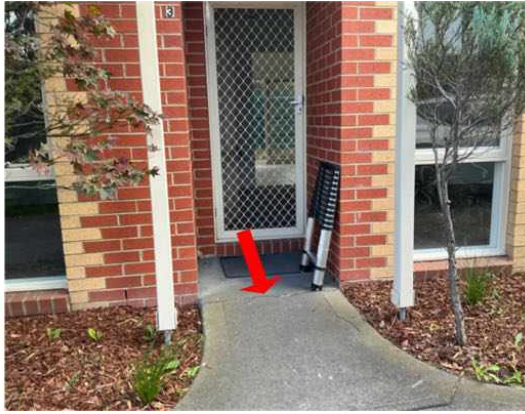
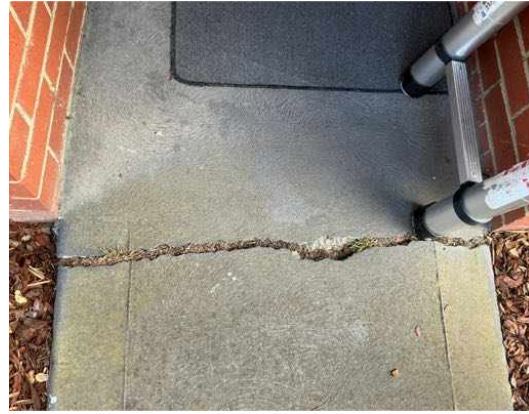
Defects 3.12

Building:	Main Building
Location:	Exterior - front
Finding:	Cracking - External Concrete Paving Damage Category 4 - Gaps in Slab (4mm - 10mm +)
Information:	Gaps in the slab were identified in external concrete paving. Gaps in the slab are significant and are likely to lead to the development of safety hazards and secondary defects if left unmanaged, such as the creation of a trip hazard.

General age and expected deterioration of the paved areas is a common cause of this type of cracking. However, expansion and contraction of the slab may also have occurred due to environmental factors. Such factors include variable moisture and weather conditions, the presence of trees and their roots having a settling or lifting affect on the soil, or the effect of load bearing, e.g. heavy vehicles over a sustained period of time.

Cracking to this degree may also be due to poor original installation of the concrete. Factors such as poor compaction of the sub surface and/or inadequate reinforcing of the slab may create cracking and other secondary defects. Gaps in the concrete paving may also have a more significant structural cause, such as subsidence of soils.

Where gaps in the concrete paving are adjacent to structural elements of the building, the advice of a Structural Engineer is advisable before undertaking repairs. Significant repair and likely replacement of the concrete paving is probable.

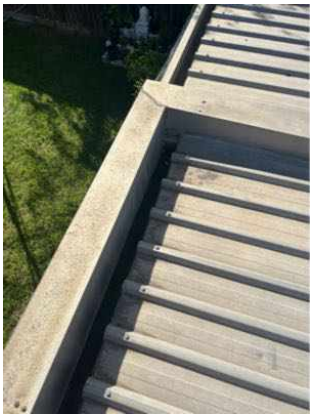
Defects 3.14

Blocked gutters are likely to lead to high levels of moisture in the affected areas. Such moisture will not only cause rust and decay of the associated building materials, but can also provide conditions that are conducive to termite and timber pest activity. Blockages in gutters should therefore be removed immediately to ensure dry conditions are maintained.

Consult a Licensed Plumber for further specific advice on remedial works that may be required. In the interim, it is highly advised that blocked gutters be removed by the homeowner or a general handyperson as a matter of urgency.

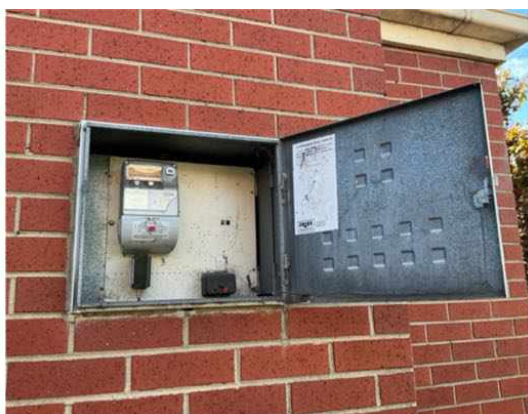
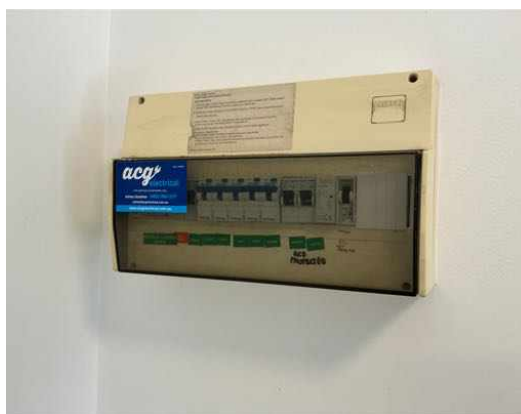
Building: Main Building
 Location: Electrical Switchboard
 Finding: Termite Management System - no evidence of a chemical installation
 Information: The application of a post-construction chemical termite barrier is highly recommended for all properties, particularly if live termite activity has been found on the site previously. Such barriers are highly effective in preventing termite attack on any timber building elements throughout the property.

A durable notice should be placed in the switchboard unit to indicate current termite barriers. At the time of inspection, it appeared as though no termite management system has been installed, with no evidence to suggest preventative works taking place.

The client may consider gaining further advice from a pest controller as to the costs and procedures involved with this application. It is recommended that obtaining such advice be a short-term priority.

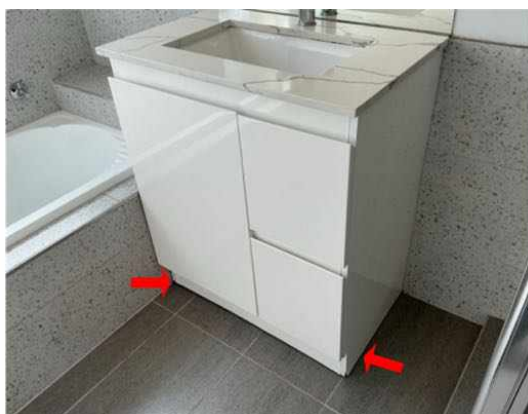
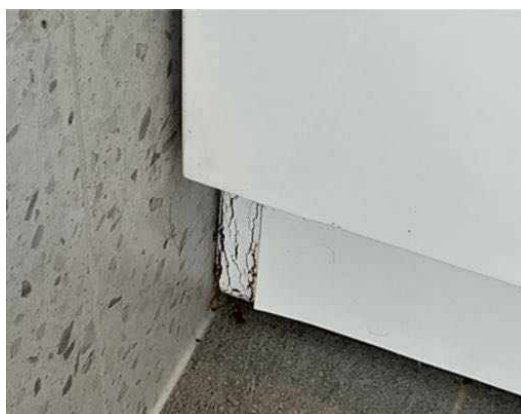
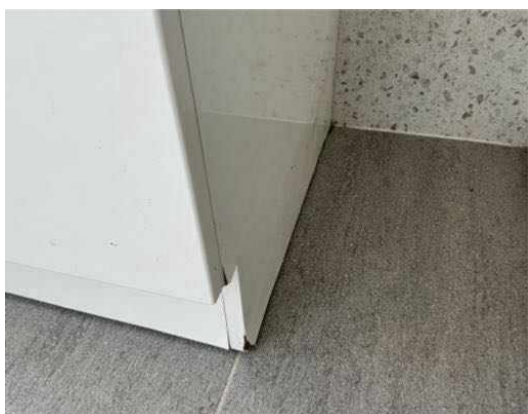
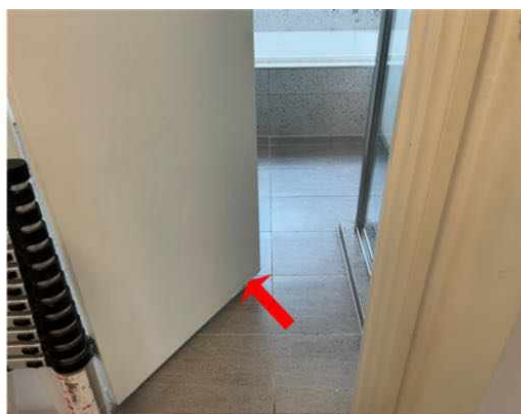
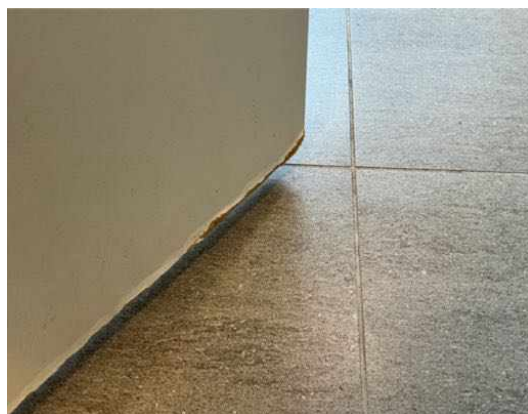
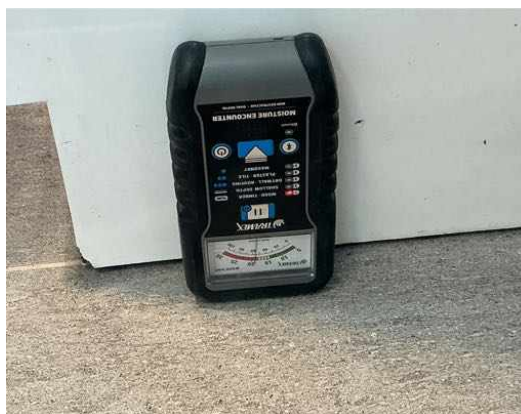
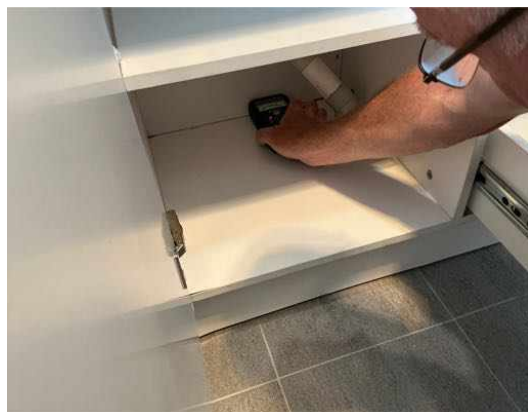
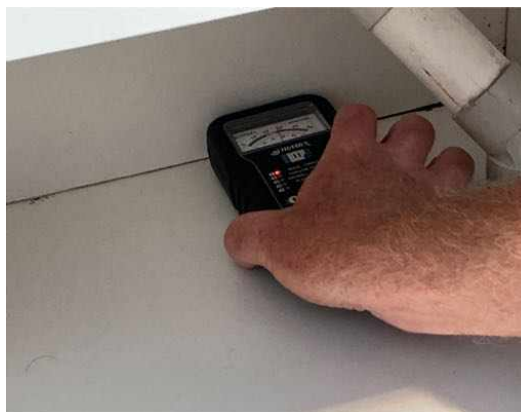
Information: Swollen building elements generally indicate that the building materials have been affected by excessive moisture over a prolonged period of time, and have swollen as a result. The formation and development of mould/fungi or mildew is also a likely consequence of excessive moisture, which may pose major respiratory issues for occupants, particularly the elderly, the very young and those with existing illnesses and could be potential health safety hazards. In these cases an appropriately qualified inspector/tester should also be contacted for advice and/or technical assistance.

The structural integrity of swollen building elements can not be guaranteed, and further damage is likely to develop if left unmanaged. Excessive moisture is likely to lead to the development of secondary damage to any associated building elements, which may necessitate major reparation works if prolonged.

Rectification of the cause of the water leak should be addressed prior to any remedial works to the swollen building elements. A licensed plumber should be appointed immediately to identify the cause of the leak and provide advice on remedial works as necessary, Repair and/or replacement of swollen building elements should be conducted as a matter of urgency by a registered builder or qualified carpenter.

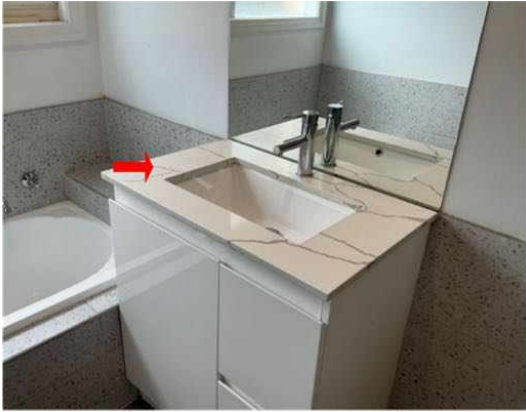
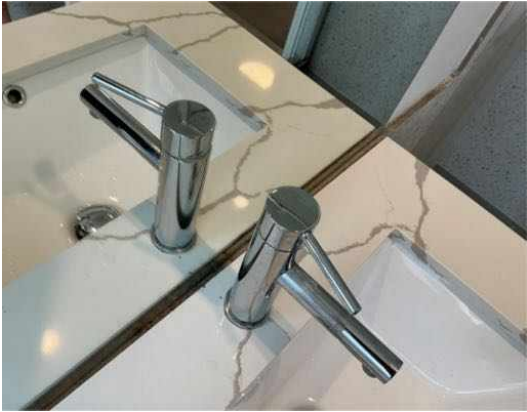
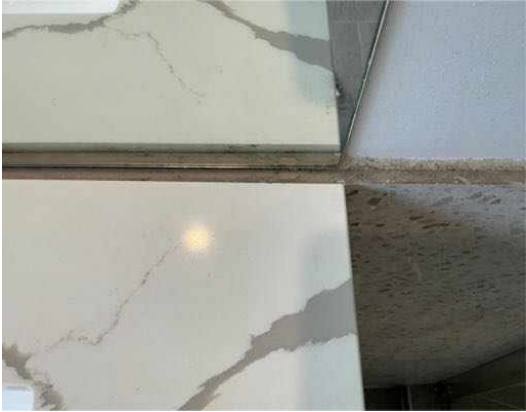
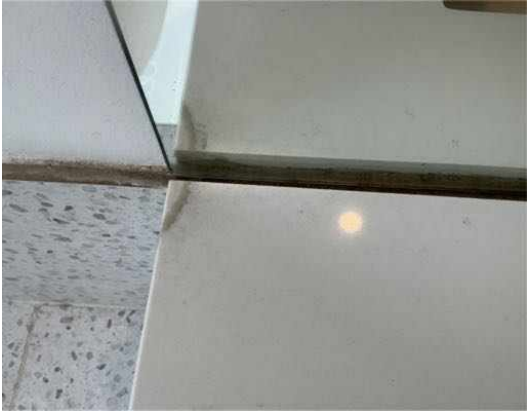
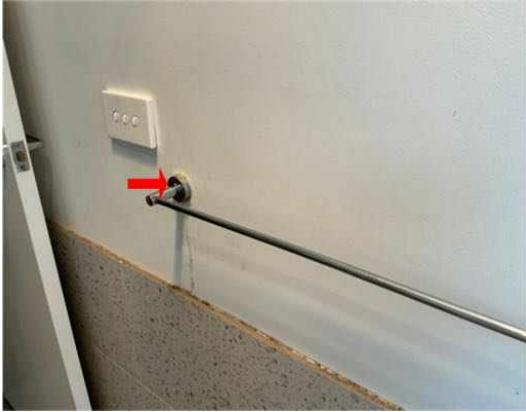
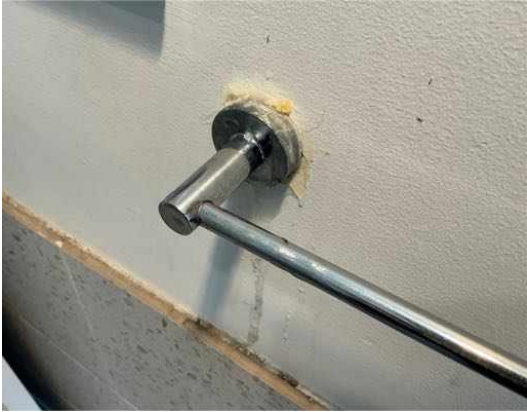
Building: Main Building
 Location: Bathroom
 Finding: Unconventional handyman work
 Information: This handyman work appears to have been completed to a substandard level and does not comply with regular building practices. Where handyman work is not completed satisfactorily, accelerated deterioration of the associated building elements is likely to occur and secondary defects to surrounding structures may develop.

It is highly recommended that the substandard work be rectified by professional services. Works to improve this area are likely to increase the safety and the operation of the associated building elements.

The client should exercise care when coming into the immediate vicinity of the substandard works. Rectification works are advised as soon as possible by the appropriate trades.

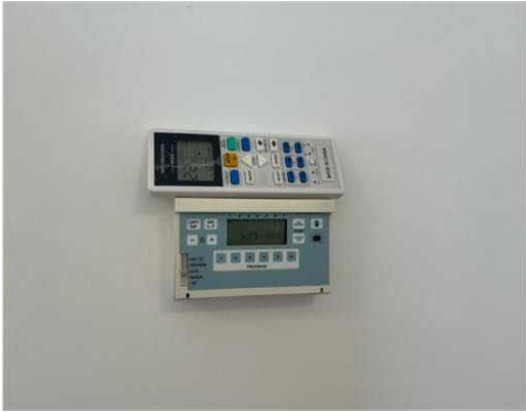
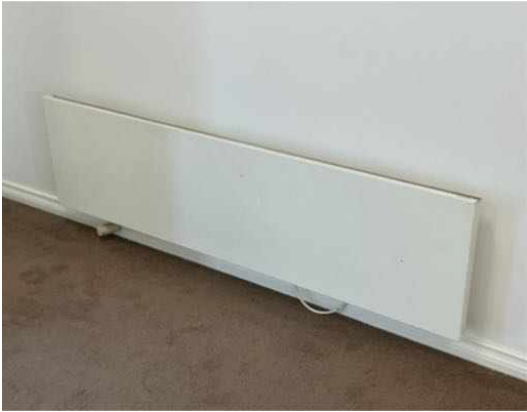
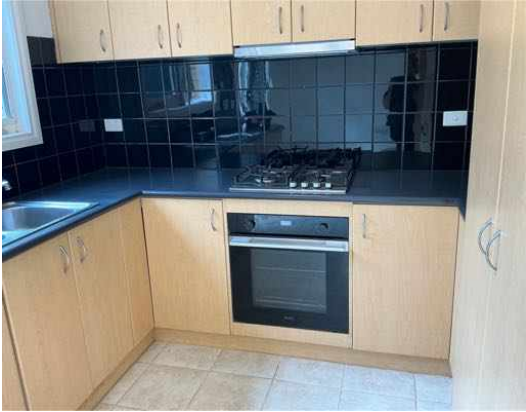
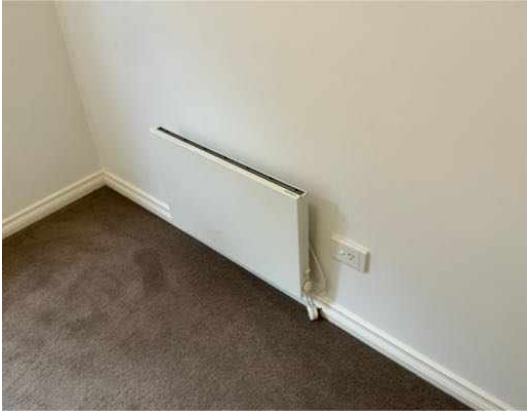
Building: Main Building
Location: Appliances
Finding: Warranty - Expired
Information: Where appliances are beyond their warranty period, the owner should be prepared to meet the cost of replacement or repair of the item at any time. The operation of the appliance can not be guaranteed and further inspection by an appropriately qualified tradesperson may be required.
