Building and Timber Pest Inspection Report

Inspection Date: Tue, 17 Mar 2026

Property Address: 28 Cornelia St, Wiley Park NSW 2195,
Australia

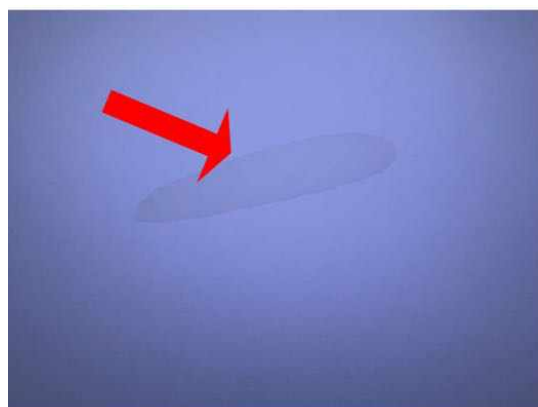
Building:	Main Building
Location:	Family Room
Finding:	Ceiling - Water damaged
Information:	Water damage to the ceiling lining is generally an indication of excessive moisture being present in the roof void, usually via a leak to the roof covering.

Where water damage is evident to the ceiling, the primary requirement is to identify and rectify the source of the leak. A roofing plumber should be appointed as soon as possible to identify the leak and perform rectification works as necessary, ensuring the water damage is restricted.

Once the leak is repaired, consultation with relevant tradespeople, including plasterers and painters, is advised. Rectification works may include replacement of ceiling lining or minor repainting, depending on the extent of the damage.

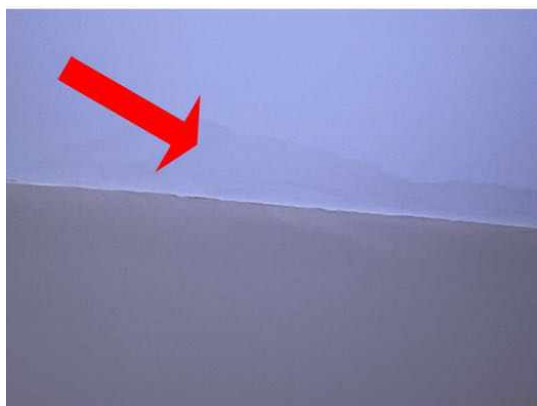
Building:	Main Building
Location:	Dining Room
Finding:	Ceiling - Water damaged
Information:	Water damage to the ceiling lining is generally an indication of excessive moisture being present in the roof void, usually via a leak to the roof covering.

Where water damage is evident to the ceiling, the primary requirement is to identify and rectify the source of the leak. A roofing plumber should be appointed as soon as possible to identify the leak and perform rectification works as necessary, ensuring the water damage is restricted.

Once the leak is repaired, consultation with relevant tradespeople, including plasterers and painters, is advised. Rectification works may include replacement of ceiling lining or minor repainting, depending on the extent of the damage.

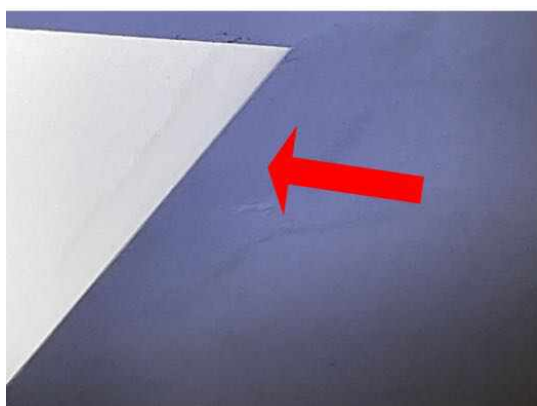
Building: Main Building
 Location: Stairs - Internal
 Finding: Ceiling - Water damaged
 Information: Water damage to the ceiling lining is generally an indication of excessive moisture being present in the roof void, usually via a leak to the roof covering.

Where water damage is evident to the ceiling, the primary requirement is to identify and rectify the source of the leak. A roofing plumber should be appointed as soon as possible to identify the leak and perform rectification works as necessary, ensuring the water damage is restricted.

Once the leak is repaired, consultation with relevant tradespeople, including plasterers and painters, is advised. Rectification works may include replacement of ceiling lining or minor repainting, depending on the extent of the damage.

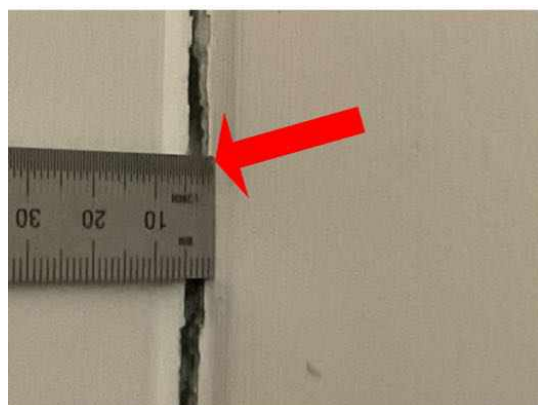
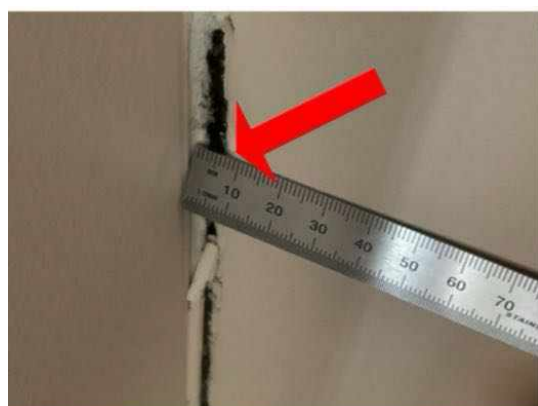
Building: Main Building
 Location: All External Areas
 Finding: Cracking - Damage Category 3 - Repair Required (5mm-15mm or a grouping or cluster of cracks of 3mm or more)
 Information: Cracks of this type are likely to have been caused by minor, expected movement of building elements, but may also have a structural cause that is more significant. Cracking of this degree may result in doors and windows sticking or jamming, but may have more serious implications, such as fracturing service pipes. Weather tightness (the ability to resist rain and wind) is also often impaired, creating potential for the development of secondary defects.

A crack of this size may be repaired. However, these repairs may also include further works, such as easement of associated window and door frames that are jamming, as well as more extensive filling, sanding and/or repainting.

It is highly recommended to gain quotations on repair and restoration works that are required. Always contact your building inspector should cracks widen, lengthen or become more numerous.

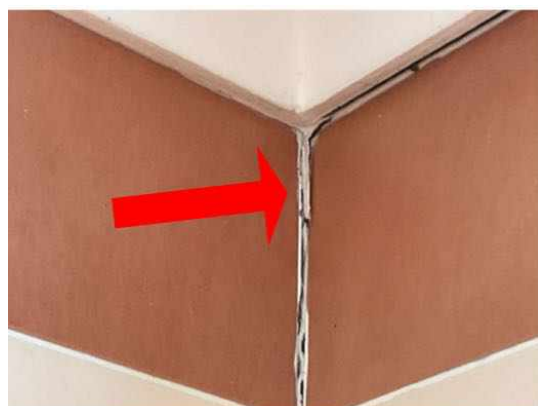
Finding 2.09

Building: Main Building
Location: All Internal Areas
Finding: Significant Structural Cracking to Internal Wall Corners
Information: It was noted at the time of inspection that significant cracking is present at the internal wall junctions, particularly at wall corners. The cracks are measured to be greater than 5mm in width, which is considered major cracking.

The cracking appears to be continuous vertically and is indicative of structural movement, which may be associated with:

- Foundation movement or settlement
- Structural frame movement (e.g. timber shrinkage or load transfer)
- Inadequate jointing or movement allowance at wall junctions

Cracks of this magnitude exceed acceptable tolerances outlined in the Guide to Standards and Tolerances 2017 and are considered Category 3–4 damage (moderate to severe).

- Additional cracking
- Misalignment of wall elements
- Possible impact on structural integrity over time

It is recommended that:

- A qualified structural engineer be engaged to assess the cause and extent of movement; and
- Appropriate rectification works be carried out, which may include structural repairs and reinstatement of finishes.

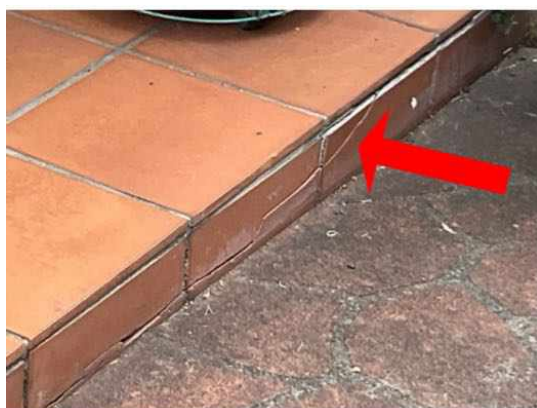
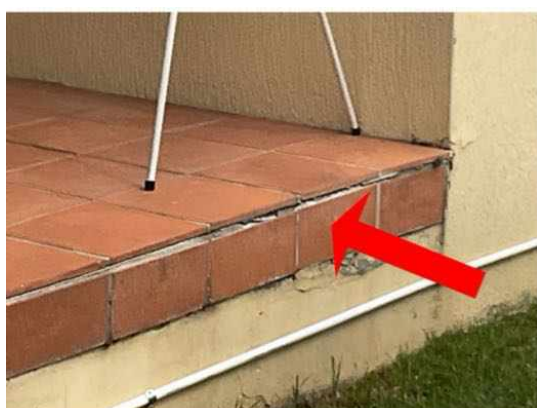
Building: Main Building
 Location: All External Areas
 Finding: Tiles - Cracked or damaged
 Information: Cracking was evident to the tiling in this area at the time of inspection. While the cracking appears to be minor, this area is frequently exposed to water, allowing potential for water penetration into adjoining sections of walls or flooring.

If left unmanaged, water penetration to these areas may lead to subsequent water damage, which is likely necessitate repair work to affected building elements.

A tiling contractor should be appointed to ensure that no further water damage occurs. The re-application of silicone and grouting throughout remaining tile work is also advised, to further protect the area against water penetration.

Where water penetration has led to water damage, appointment of a relevant tradesperson may be required to repair damaged building elements.

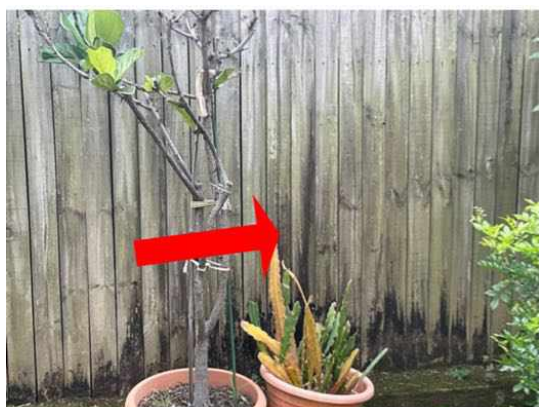
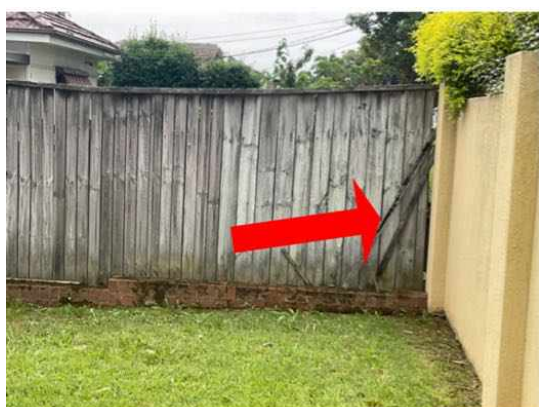
Finding 3.03

Building: Main Building
 Location: All External Areas
 Finding: Fencing - Deteriorated
 Information: It was noted at the time of inspection that sections of the fencing throughout the

property have deteriorated. Typically fencing deteriorates due to age and or wear, rot and or rust which is generally expected for a structure of this age, due to prolonged exposure to weather conditions. Sometimes inadequate installation or maintenance can be to blame.

If left unattended, it is likely that further damage will occur. It is suspected that repair of several elements of the fencing may be required however replacement may be a consideration of the client also.

A licensed fencing contractor should be appointed to provide further advice and perform rectification works as necessary.

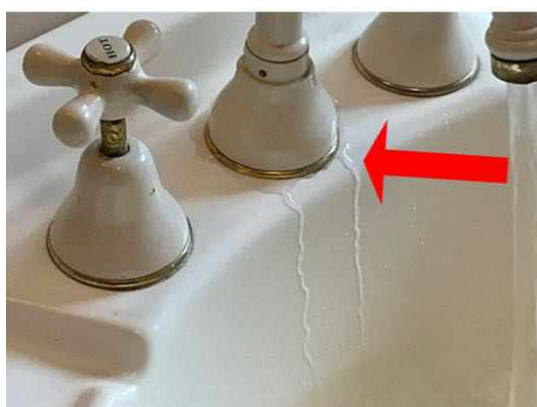
Building:	Main Building
Location:	Powder Room
Finding:	Vanity Tap - leaking
Information:	The vanity tap is leaking at the base connection to the wall plate. Water leakage may cause damage to wall finishes and cabinetry over time, and indicates that the plumbing fitting is not properly sealed or installed.

Licensed plumber to inspect and rectify the leaking connection to ensure watertight installation and compliance with AS/NZS 3500 Plumbing and Drainage Standards.

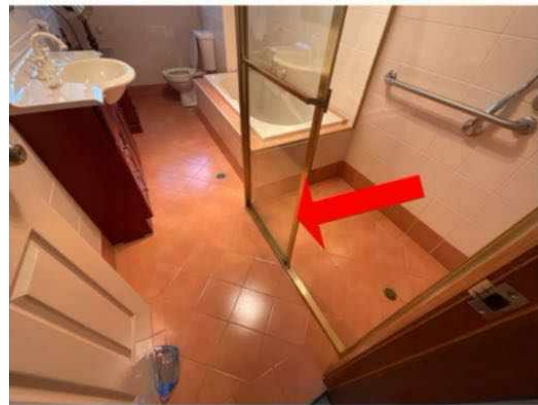
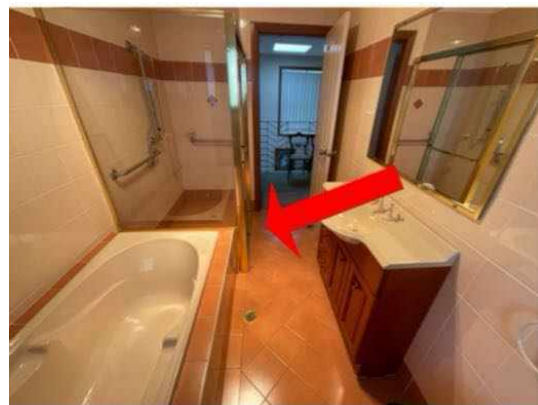
Cracked tiles throughout the household detract from the overall appearance of the affected areas, as well as creating potential for water penetration to adjoining building elements. If left unmanaged, water damage may occur as a result of constant water penetration over a prolonged period of time.

While not considered a matter of urgency, replacement of cracked floor tiles is advised as a solution. A tiling contractor or general handyperson may be appointed to perform these works at client discretion. Where cracks become more numerous, consultation with a registered builder specialising in re-stumping may be required.

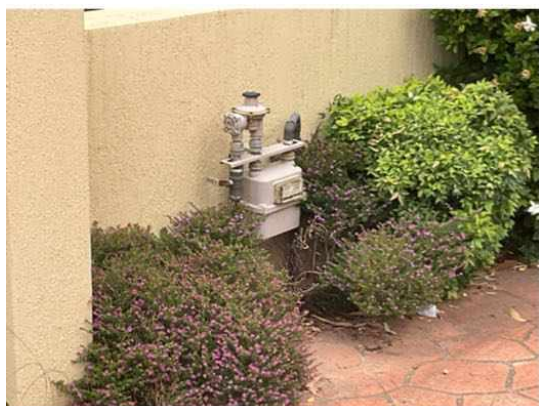
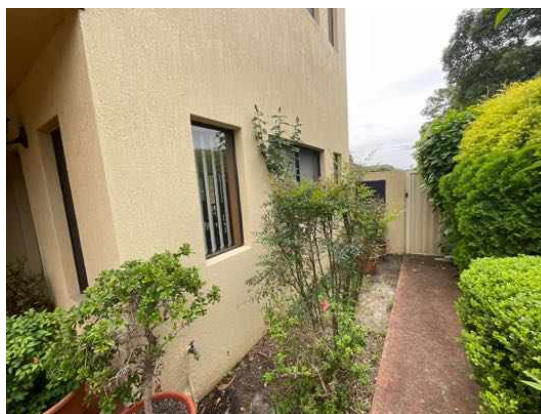
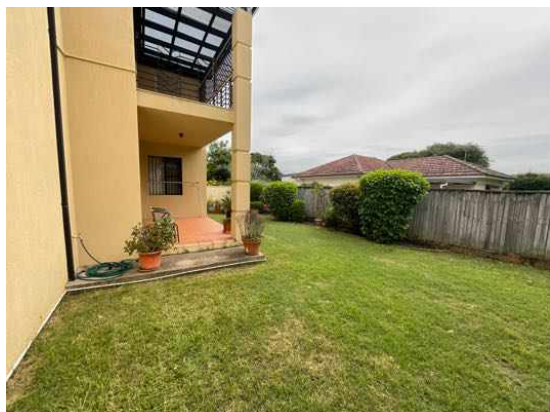
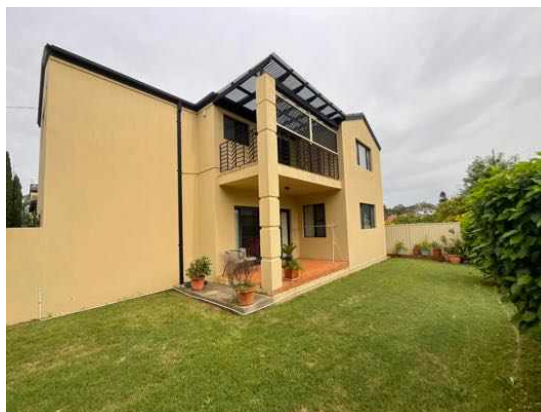
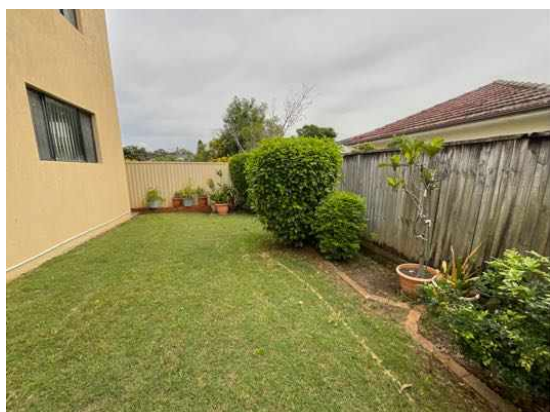
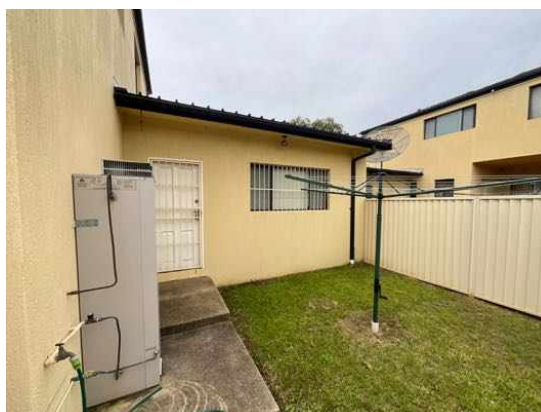
Finding 6.01

Building: Main Building
 Location: All Areas
 Finding: Garden Beds - Conditions Conducive to Termites
 Information: Garden beds were found to be evident in the garden area. These garden beds can include untreated timber, and with a combination of moisture from watering hosing can make conditions conducive to termite activity and termite ingress.

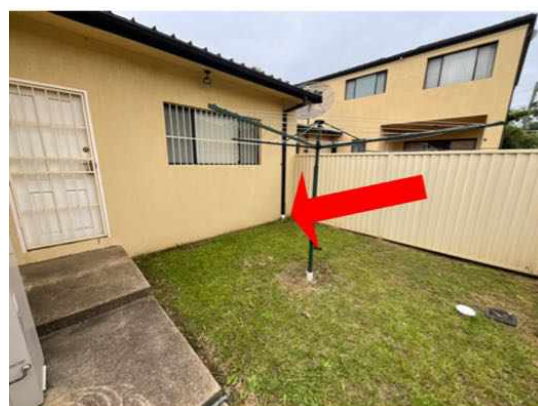
Finding: Overflow - Not plumbed for drainage

Information: The overflow is not plumbed or connected to suitable drainage, which has resulted in the surrounding area becoming excessively damp. These damp conditions can lead to secondary defects such as rot, rust or corrosion of associated building elements, the formation of fungal decay, or even the creation of potential slip hazards. When coupled with poor site drainage, pooling of water may also attract termite activity to this area. It is highly recommended that a qualified plumber be appointed to install adequate drainage to the overflow. These works will ensure that the area remains dry and free of any secondary defects.

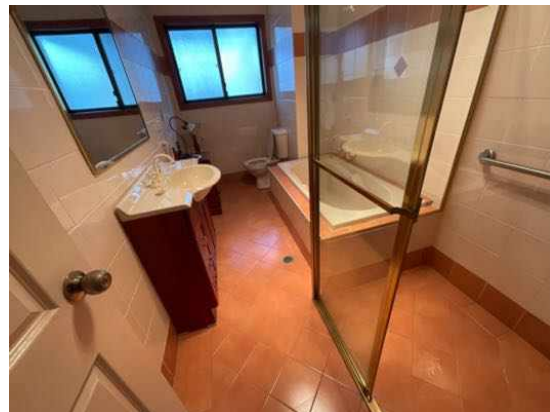
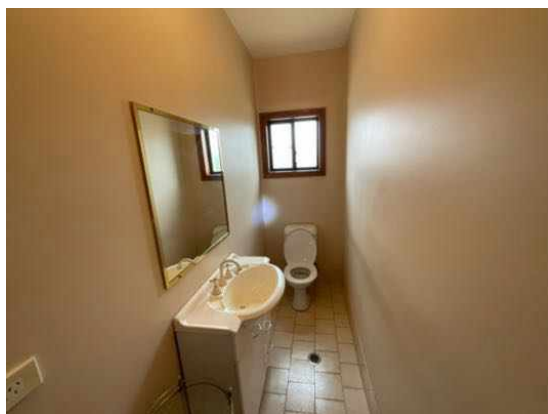
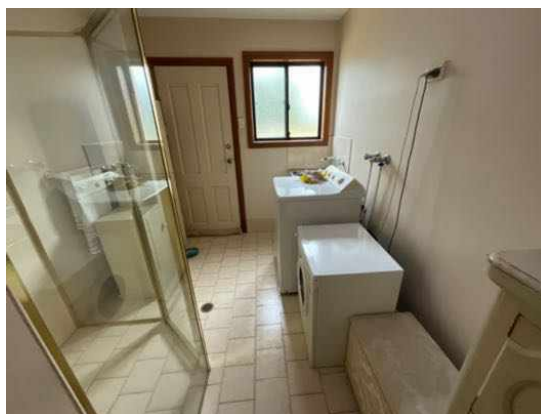
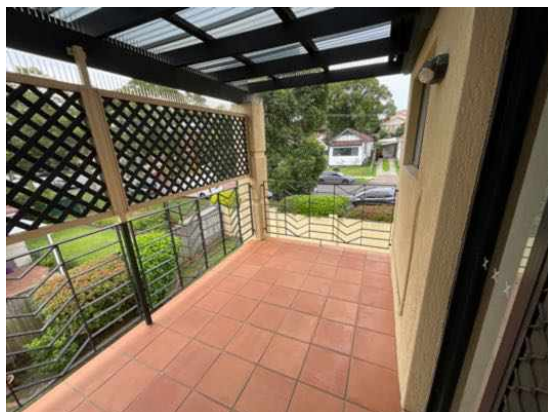
Building:	Main Building
Location:	All Areas
Finding:	Water Proofing Membranes - Information Only
Information:	Internal Water Proofing Membranes, are crucial in preventing water ingress into the property is important to know that the Membrane System used is to Australian Standards and has been installed correctly. Please refer to the original Building Documents or Maintenance Schedule for the relevant information including; - Membrane used and Manufacturers Specifications. - The Installer and Installation Certification. Especially with older property's where this information is unavailable, all wet areas should be monitored. Generally new waterproofing with a certificate may only have a guarantee of 8yrs. If any leaks, water staining, peeling or bubbling of the paint become evident to any adjacent walls or ceilings below a licensed builder or waterproofing specialist is recommended to investigate further.

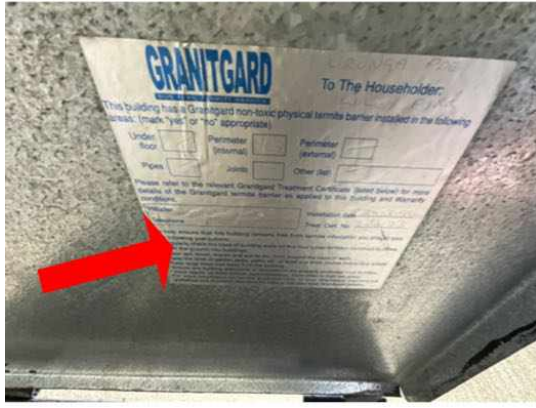
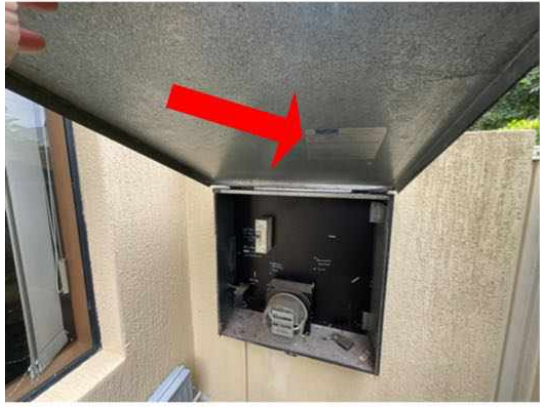
Building:	Main Building
Location:	All Areas
Finding:	Evidence of a chemical treated zone barrier was identified
Information:	During inspection of the property, it was noted that works to install a chemical treated zone barrier had previously been completed. A chemical treated zone barrier is likely to ensure effective protection against termites.

Where a Termite Management System has been identified, the client should identify to the type of barrier, date of installation, warranty conditions and any documentation provided by a builder or past owner. Consult the company who installed the barrier to confirm whether the system is still under warranty.

Most chemical termite management systems expire and require replenishment. All physical systems are primarily designed to prevent concealed entry.
