Building and Timber Pest Inspection Report

Inspection Date: Tue, 3 Feb 2026

Property Address: 94 Wollie Ave, Earlwood NSW 2206,
Australia

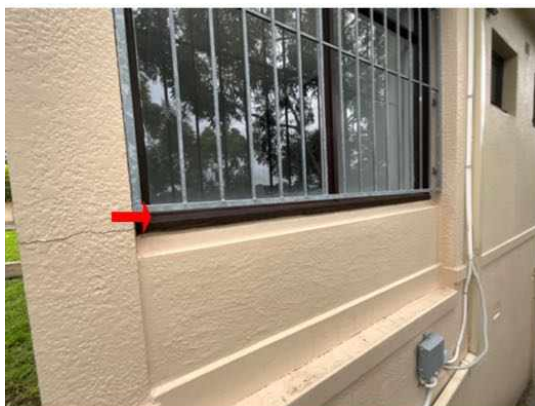
Finding 3.01

Building:	Main Building
Location:	External Areas
Finding:	Wood rot
Information:	This building element shows evidence of wood rot. Wood rot, also known as Fungal Decay, occurs when timbers and other cellulose building materials are exposed to damp conditions on an ongoing basis. This could be the result of exposure to weathering over a prolonged period of time, or the attraction of excessive moisture from other abutting building materials.

Early intervention and regular maintenance, particularly of exterior timbers, will prolong the useful life of these building elements. Prior to any works being performed, the cause of the moisture that has created the visible wood rot should be identified and addressed in a suitable manner. Replacement of affected timbers may then be a necessary step in protecting surrounding building elements from such deterioration.

A qualified carpenter or registered builder may also be required to replace affected building materials.

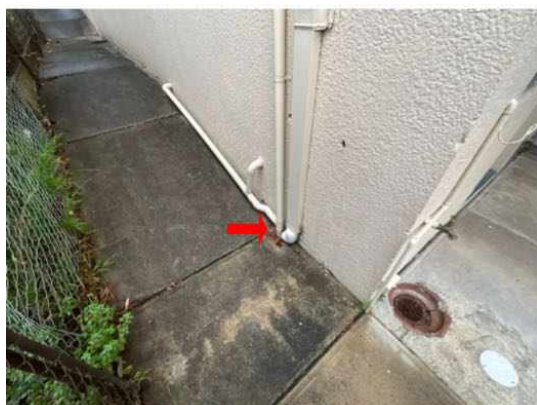
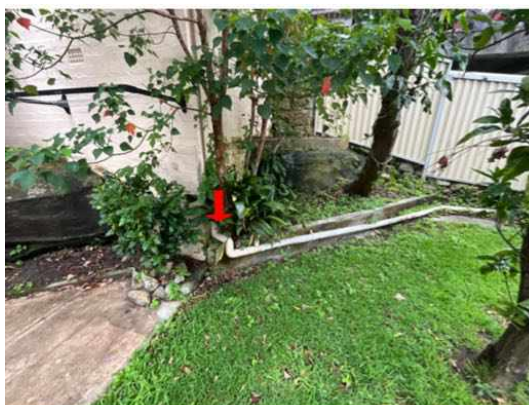
Finding 3.02

Building:	Main Building
Location:	Exterior walls
Finding:	Stormwater drain - Not connected
Information:	The roof plumbing is not adequately connected to stormwater drainage on the site. This disconnection negatively impacts the functional capacity of the roof plumbing. Where roof plumbing doesn't drain adequately, the area at the base perimeter can become excessively damp, potentially creating an environment that is susceptible to rust and corrosion of surrounding building elements, as well as attracting termites and other pests. It is highly recommended that a plumber be appointed to further inspect the area and to install adequate drainage equipment where necessary.

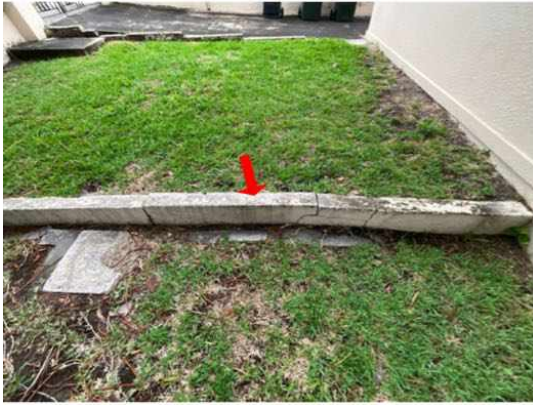
Finding 3.03

Building:	Yard
Location:	Exterior walls
Finding:	Brickwork - Cracking noticeable
Information:	There were several cracks and or crack repairs evident to external brickwork.

Noticeable cracks are a common occurrence in external brickwork and are a likely result of age expected building movement, general expansion, and/or contraction of building materials in different weather conditions.

It is highly advised that a qualified bricklayer be appointed to provide necessary works to cracked brickwork to prevent any further damage.

Always monitor these cracks and contact a building inspector should cracks widen, lengthen, or become more numerous.

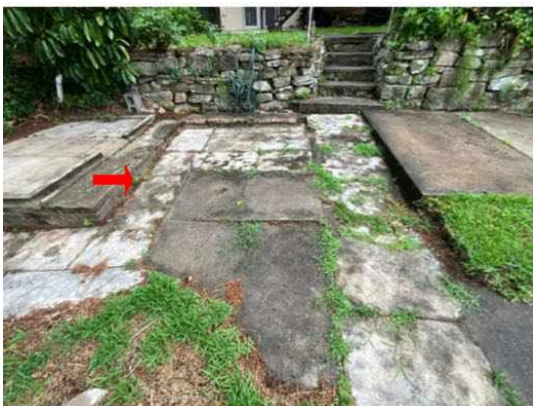
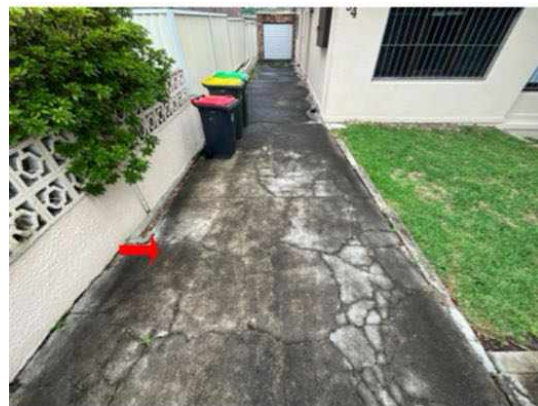
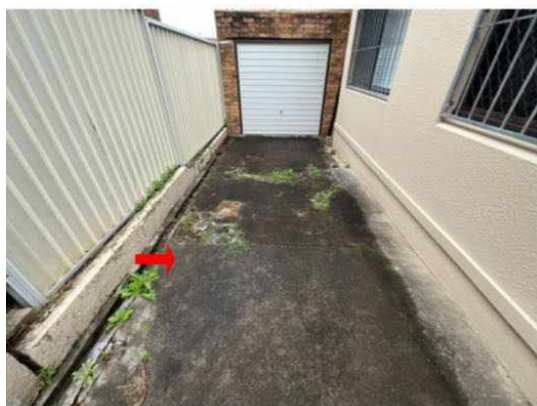
Finding 3.04

Building:	Yard
Location:	Pathway
Finding:	Cracking - External Concrete Paving Damage Category 1 - Fine (less than 2mm)
Information:	Fine cracks were identified in external concrete paving. Although fine cracks are quite noticeable, they are often only considered to be an appearance defect, and usually do not indicate any structural damage. To be considered a Category 1 or fine crack, the crack is found to be less than 2mm in width.

Generally the cause of a hairline crack in existing concrete paving such as driveways and pathways is indicative of the expansion and contraction of the concrete. Such causes are generally due to environmental factors, such as moisture levels, weather conditions, root systems of nearby trees or the soil types on which they are laid.

Fine cracks may also be due to poor original installation of the concrete. Factors such as poor compaction of the sub surface and/or inadequate reinforcing of the slab may create cracking and other secondary defects.

Monitoring of all cracking should be conducted frequently. Always contact a building inspector should cracks widen, lengthen, or become more numerous.

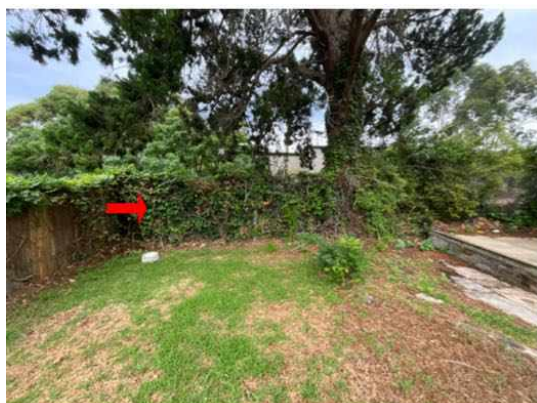
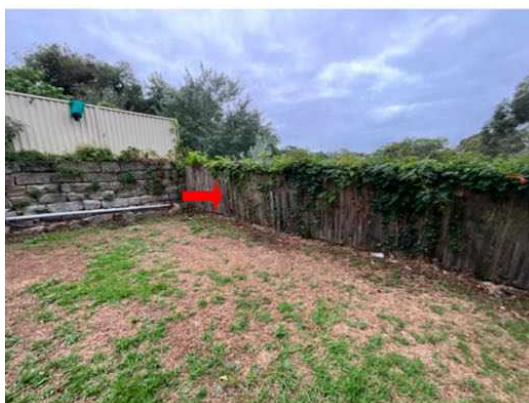
Finding 3.05

Building:	Yard
Location:	Fencing
Finding:	Fencing - Deteriorated
Information:	It was noted at the time of inspection that sections of the fencing throughout the property have deteriorated. Typically fencing deteriorates due to age and or wear, rot and or rust which is generally expected for a structure of this age, due to prolonged exposure to weather conditions. Sometimes inadequate installation or maintenance can be to blame.

If left unattended, it is likely that further damage will occur. It is suspected that repair of several elements of the fencing may be required however replacement may be a consideration of the client also.

A licensed fencing contractor should be appointed to provide further advice and perform rectification works as necessary.

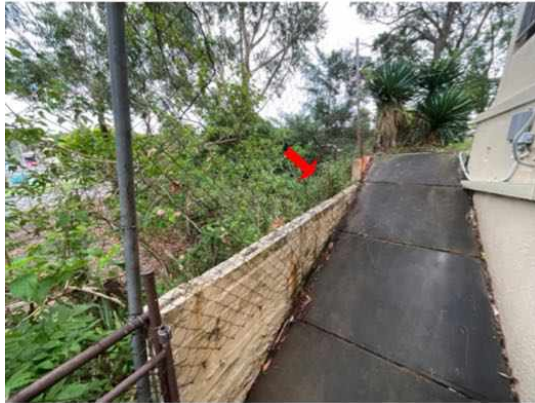
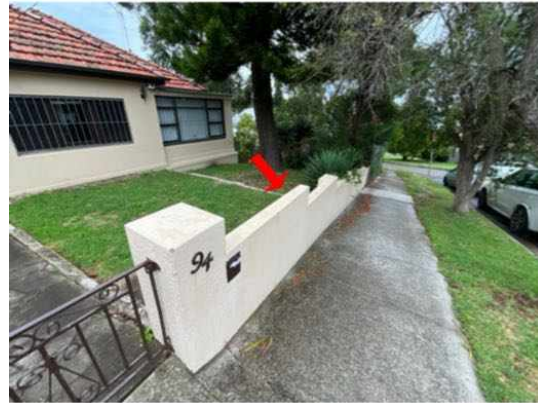
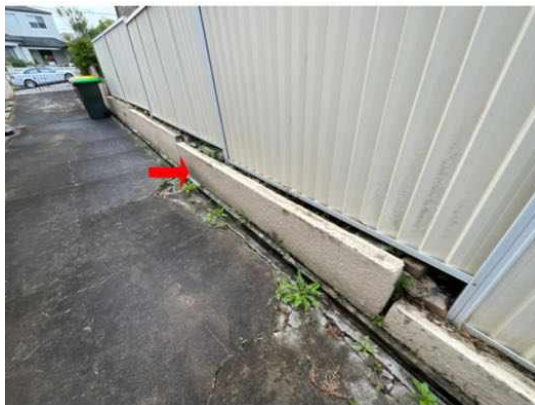
Finding 3.06

Building:	Yard
Location:	Exterior walls
Finding:	Brickwork - leaning

Information: The exterior brick work in this area was leaning.

Although the wall does appear be stable works will need to be done to the brickwork in the area.

I recommend appointing a bricklayer to see what necessary works are required.

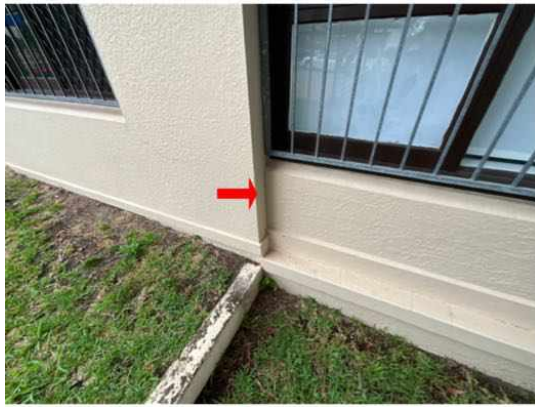
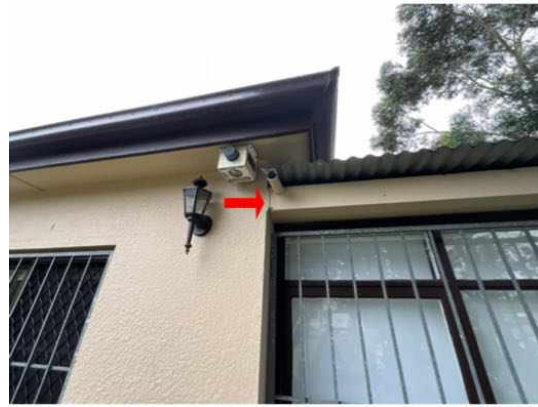
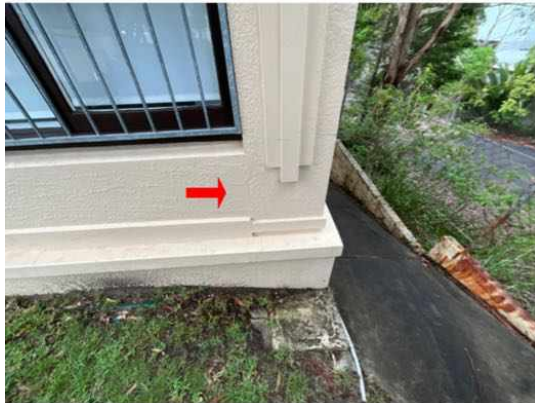
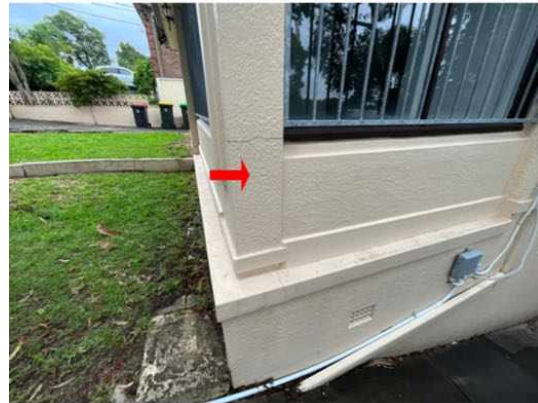
Finding 3.07

Building: Main Building

Location: Exterior walls

Finding: Cracking - Damage Category 2 - Noticeable (up to 5mm)

Information: Noticeable cracks are a common occurrence as a result of many primary defects. Such causes may include age, general wear and tear, expected building movement, general expansion/contraction of building materials in different weather conditions, and/or minor failings in the installation or application of building materials.

I recommend monitoring and if further cracking is evident appoint a bricklayer to see what works are required.

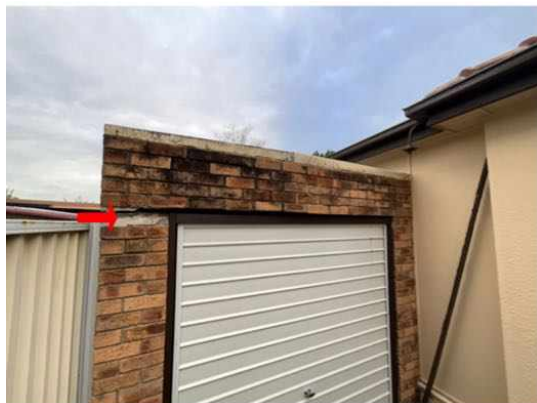
Finding 3.08

Building:	Main Building
Location:	Exterior walls
Finding:	Lintel - Rusted or corroded
Information:	This building element shows evidence of rusting and corrosion, which is likely to have developed as a result of excessive exposure to moisture and or inadequate coatings.

Where possible, the use of galvanized (treated) metals or aluminium coated metals aid in rust prevention, as does regular general maintenance. Rust formation can be controlled with coatings, such as paint, that isolate the iron from the environment.

I recommend appointing a bricklayer to see what necessary works are required. Replacement will most likely be required.

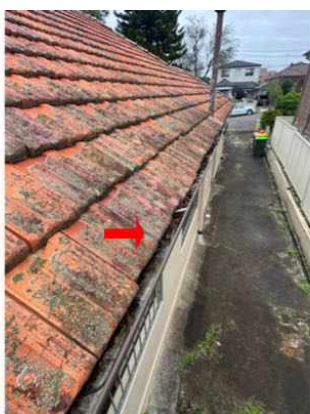
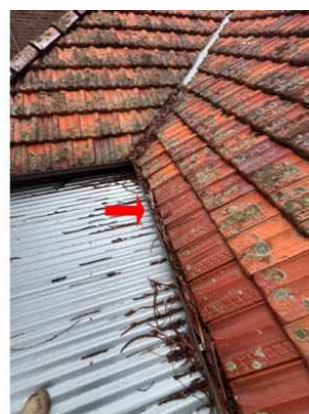
Finding 3.09

Building:	Main Building
Location:	Roof Exterior
Finding:	Gutters - Blocked
Information:	Roof plumbing structures, such as guttering and downpipes, should be free of all debris to prevent blockages. Blockages of the guttering and downpipes will lead to pooling and accumulated water overflows, which is likely to subsequently flood eaves and exterior walls.

Blocked gutters are likely to lead to high levels of moisture in the affected areas. Such moisture will not only cause rust and decay of the associated building materials, but can also provide conditions that are conducive to termite and timber pest activity. Blockages in gutters should therefore be removed to ensure dry conditions are maintained.

Consult a Licensed Plumber for further specific advice on remedial works that may be required. In the interim, it is highly advised that blocked gutters be removed by the homeowner or a general handyperson as a matter of urgency.

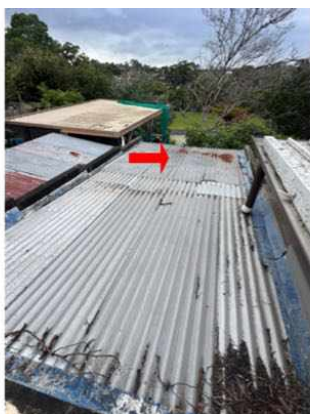
Finding 3.10

Building:	Main Building
Location:	Roof Exterior

Finding: Roof sheets - Rusted
 Information: Metal roofs generally comprise numerous individual sheets, which join and overlap. These intersections are particularly prone to lift at the edge and consequently rust at these points.

Upon inspection of the exterior roofing structure, evidence of rust to these sections was identified.

A roofing contractor should be appointed to assess the damage to the roofing sheets and to perform remedial works as necessary.

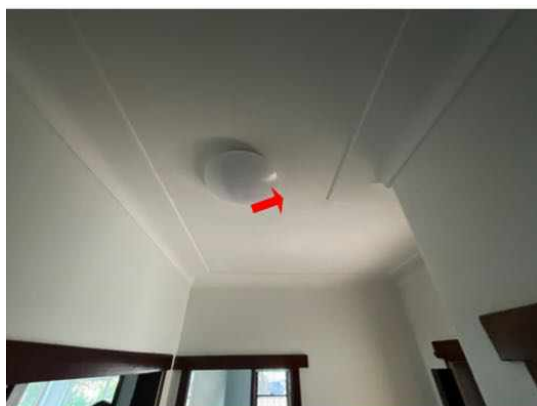
Finding 3.11

Building: Main Building
 Location: Hallway
 Finding: Ceiling - Water stained
 Information: Water staining to ceiling linings in this area was evident at the time of inspection. Water staining indicates that surfaces have been exposed to excessive moisture over time. The minerals and other elements in the water lead to staining, which may graduate to corrosion and deterioration if left unmanaged.

Although there was no moisture detected in the ceiling I would recommend monitoring and acting on one of the following.

Where water staining is active, a licensed plumber must be consulted to identify the cause of the staining and to provide advice on any reparation works that may be required. Replacement of any damaged structures is advised.

Conversely, where water staining is old and inactive, affected building materials may be repaired or replaced at client discretion.

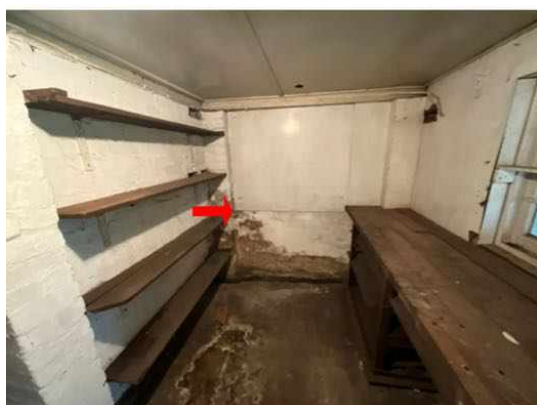
Finding 3.12

Building:	Main Building
Location:	Workshop
Finding:	Interior walls - Lateral damp
Information:	Lateral penetrating damp refers to the sideways movement of moisture. The implications of unmanaged damp range from mould fungi growth, wood rot and decaying building materials, to finishes including lifting, bubbling, peeling and staining of paint, plaster and wallpaper.

Structural waterproofing barriers or tanking barriers are often used to protect internal surfaces against the affects of lateral penetrating dampness. These types of work are generally undertaken where the source of the penetrating damp cannot be prevented.

Consultation with a damp proofing contractor is advised to address the cause of the damp and to perform remedial works as necessary.

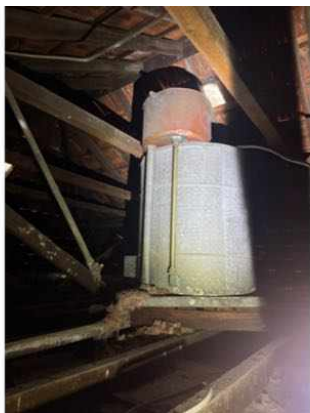
Finding 3.13

Building:	Main Building
Location:	Roof Void
Finding:	Gravity-Fed HWS - Disconnected
Information:	It was noted at the time of inspection that a disconnected gravity-fed hot water

system (HWS) remains in this area.

I recommend appointing a plumber to see what necessary works are required to remove the unit from the area.

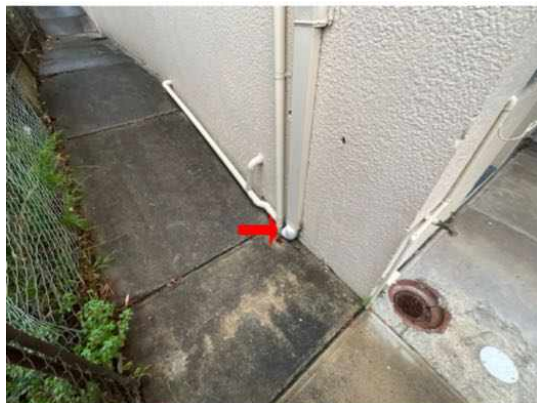
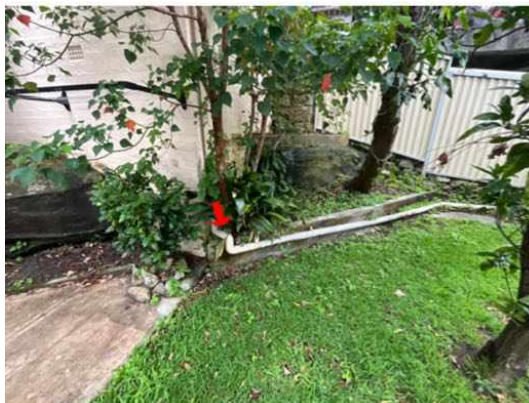
Finding 6.01

Building:	Main Building
Location:	Exterior walls
Finding:	Excessive moisture - identified
Information:	Excessive moisture can attract termites and produce conditions that promote fungal growth and wood decay. Prior to any remedial works being performed a qualified plumber should be appointed to further inspect the property and to identify the cause of the excessive moisture.

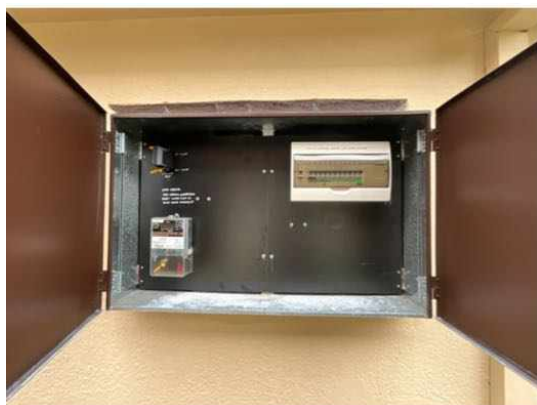
Finding 7.01

Building:	Main Building
Location:	All Areas
Finding:	Termite Management System - no evidence of a chemical installation
Information:	The application of a post-construction chemical termite barrier is highly recommended for all properties, particularly if live termite activity has been found on the site previously. Such barriers are highly effective in preventing termite attack on any timber building elements throughout the property.

A durable notice should be placed in the switchboard unit to indicate current termite barriers. At the time of inspection, it appeared as though no termite management system has been installed, with no evidence to suggest preventative works taking place.

The client may consider gaining further advice from a pest controller as to the costs and procedures involved with this application. It is recommended that obtaining such advice be a short-term priority.

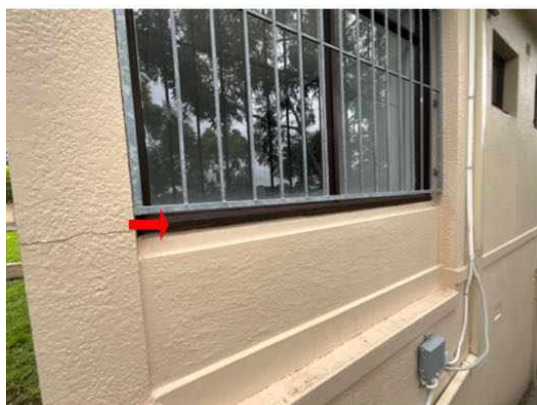
Finding 7.02

Building:	Main Building
Location:	External Areas
Finding:	Fungal decay - present (localised)
Information:	Fungal decay also known as wood decay or wood rot generally refers to the deterioration of timber elements when in contact with excessive levels of moisture for a prolonged period of time.

The development of fungal decay is accelerated by temperatures in the range of 5degreeC to 40degreeC as well as the presence of oxygen. Generally fungal decay develops on timber elements that are in use in an external environment which are exposed to rain penetration.

In this case although the affected timber element is in a decaying state the extent of any visible damage appears to be localised to a specific area and is yet to spread to other parts of the building element or affect adjoining structures. The fungal decay is therefore likely to be of a relatively superficial nature with minimal impact on the structural integrity or tensile strength of the timber element.
