Building Inspection Report

Inspection Date: Mon, 16 Mar 2026

Property Address: 23A Olive St, Hampton VIC 3188, Australia

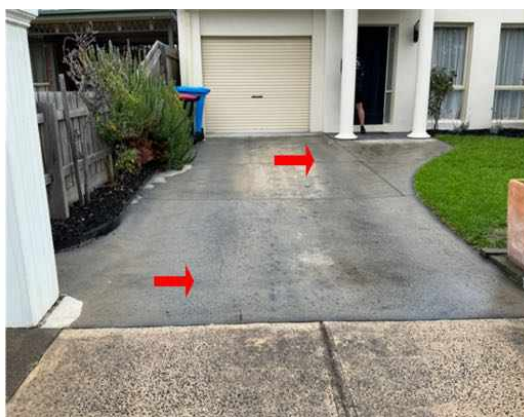
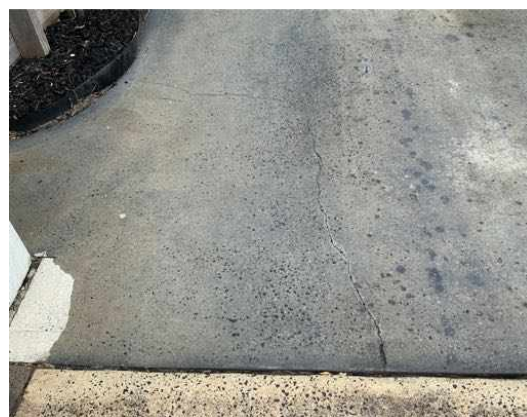
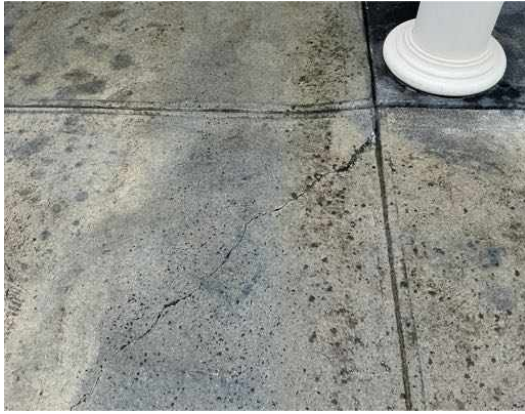
Defects 3.01

Building: Yard
 Location: Driveway and rear
 Finding: Cracking - External Concrete Paving Damage Category 1 - Fine (less than 2mm)
 Information: Fine cracks were identified in external concrete paving. Although fine cracks are quite noticeable, they are often only considered to be an appearance defect, and usually do not indicate any structural damage. To be considered a Category 1 or fine crack, the crack is found to be less than 2mm in width.

Generally the cause of a hairline crack in existing concrete paving such as driveways and pathways is indicative of the expansion and contraction of the concrete. Such causes are generally due to environmental factors, such as moisture levels, weather conditions, root systems of nearby trees or the soil types on which they are laid.

Fine cracks may also be due to poor original installation of the concrete. Factors such as poor compaction of the sub surface and/or inadequate reinforcing of the slab may create cracking and other secondary defects.

Monitoring of all cracking should be conducted frequently. Always contact a building inspector should cracks widen, lengthen, or become more numerous.

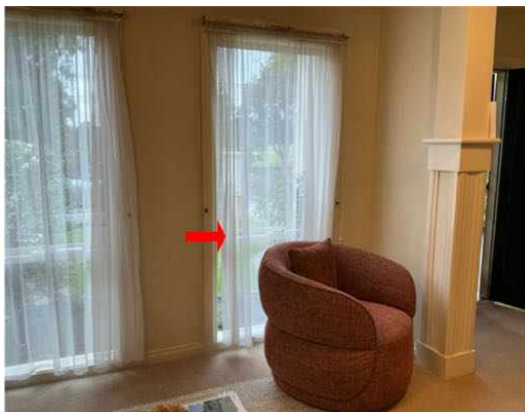
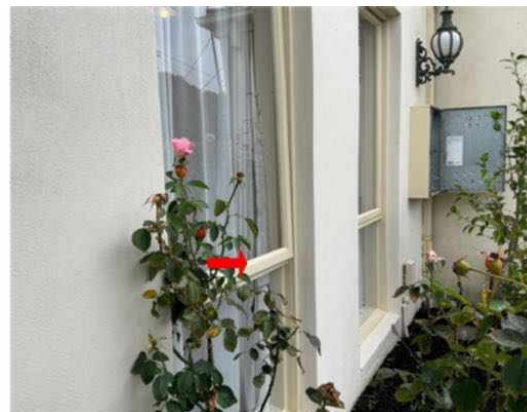
Defects 3.02

Building:	Main Building
Location:	Lounge Room
Finding:	Sticking or jamming
Information:	Building elements which are sticking or jamming are difficult to operate and don't function as intended. There are a variety of causes for sticking and jamming.

The most usual causes are swelling of timbers due to moisture, bulging or bowing of metal frames, or general material deterioration. Generally, sticking and jamming building elements indicate that their frames are uneven or out of level, generally as result of movement to surrounding walls and floors.

Easement will be required, which usually depends on the building materials used. This may involve some sanding and/or application of a lubricant. It will almost always include ensuring the areas are cleaned and free of any debris that may be detrimental to their operational state.

Appointment of a carpenter or general handyman is recommended to rectify any sticking/jamming building elements.

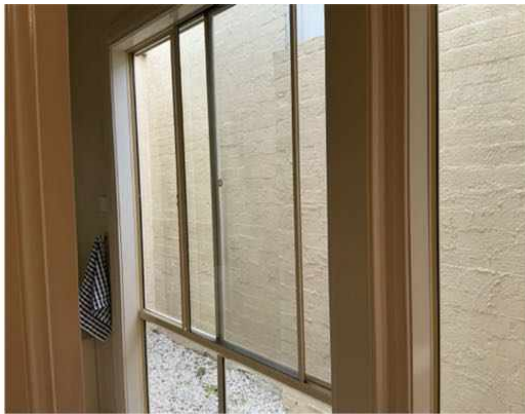
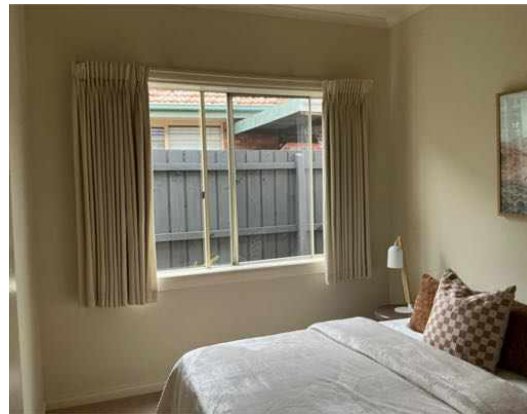
Defects 3.03

Location: All Areas
 Finding: Windows- stiff to slide
 Information: The windows to this area was difficult to operate at the time of inspection.

Windows provide ventilation and exits to the adjoining area and should be at a fully operational level to ensure user comfort and safety. Restricted function may also pose as a potential safety hazard if required for emergency egress from the building.

Generally, factors such as general age of the building element and a lack of maintenance are the usual causes for this type of defect.

Replacement of windows running hardware may be required, as well as minor repairs and cleaning. A registered builder or general handy person will be required to repair the windows

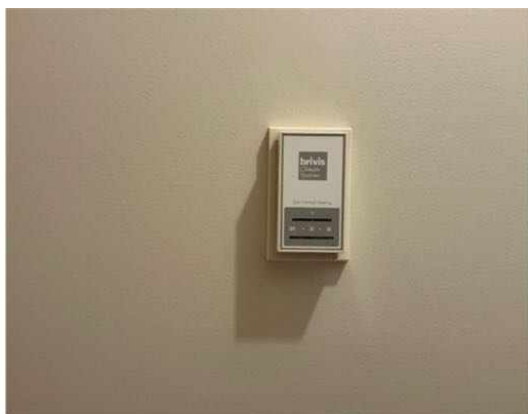
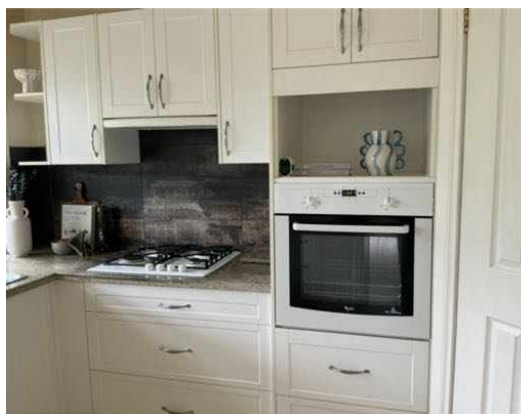
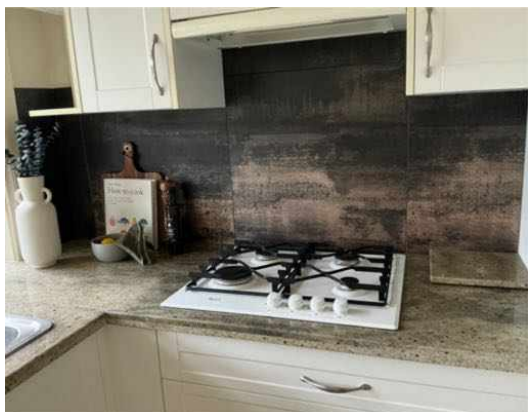
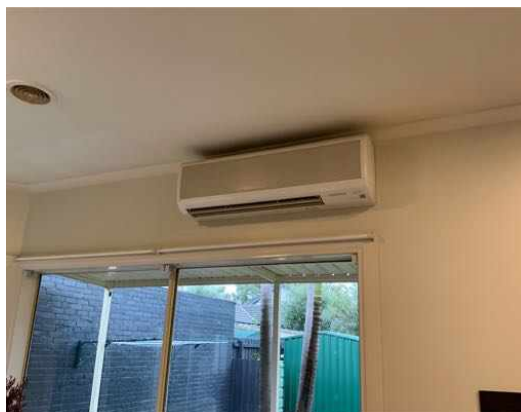
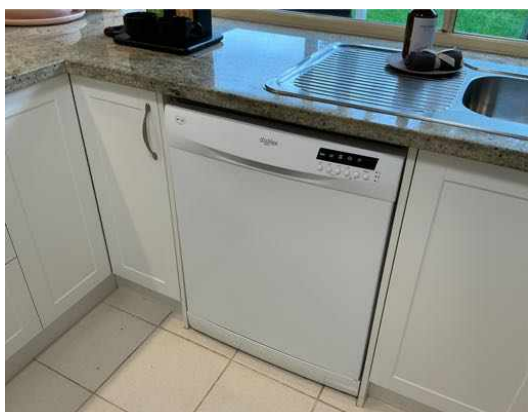
Defects 3.04

Building: Main Building
 Location: All Appliances
 Finding: Warranty - Expired
 Information: Where appliances are beyond their warranty period, the owner should be prepared to meet the cost of replacement or repair of the item at any time. The operation of the appliance can not be guaranteed and further inspection by an appropriately qualified tradesperson may be required.

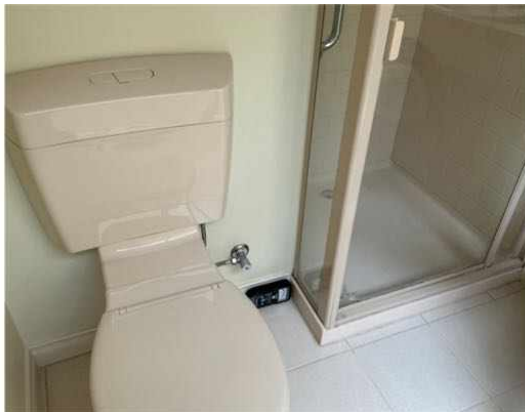
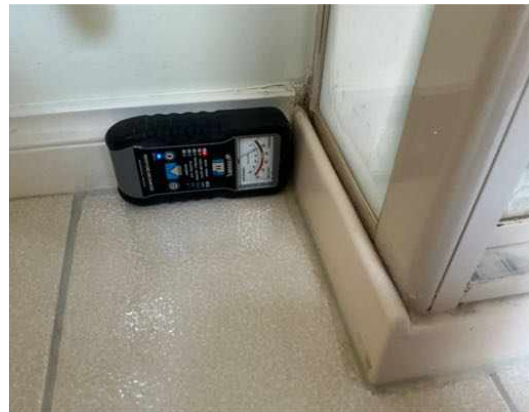
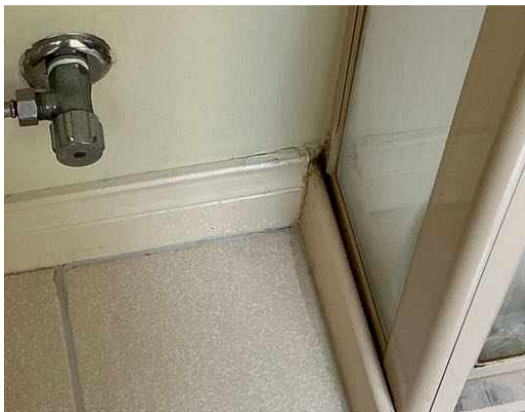
Defects 3.05

Building:	Main Building
Location:	Bathroom
Finding:	Building element - Swollen
Information:	Swollen building elements generally indicate that the building materials have been affected by excessive moisture over a prolonged period of time, and have swollen as a result. The formation and development of mould/fungi or mildew is also a likely consequence of excessive moisture, which may pose major respiratory issues for occupants, particularly the elderly, the very young and those with existing illnesses and could be potential health safety hazards. In these cases an appropriately qualified inspector/tester should also be contacted for advice and/or technical assistance.

The structural integrity of swollen building elements can not be guaranteed, and further damage is likely to develop if left unmanaged. Excessive moisture is likely to lead to the development of secondary damage to any associated building elements, which may necessitate major repair works if prolonged.

Rectification of the cause of the water leak should be addressed prior to any remedial works to the swollen building elements. A licensed plumber should be appointed immediately to identify the cause of the leak and provide advice on remedial works as necessary, Repair and/or replacement of swollen building elements should be conducted as a matter of urgency by a registered builder or qualified carpenter.

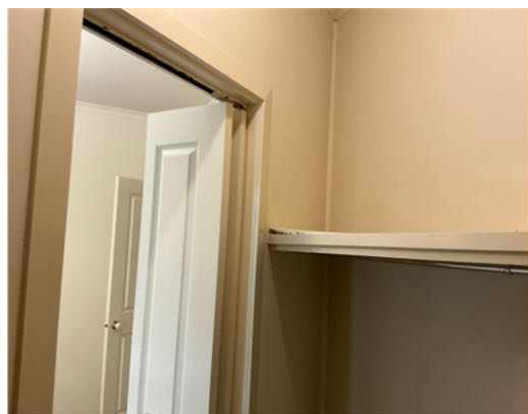
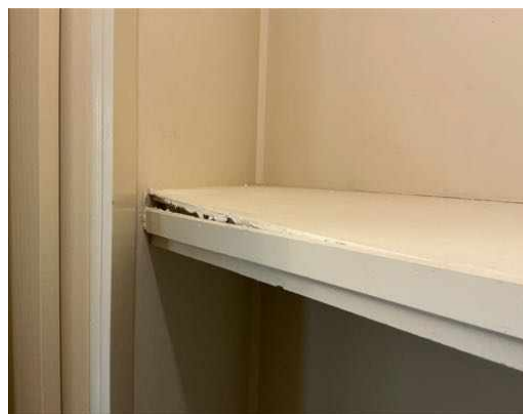
Defects 3.06

Building: Main Building
Location: Walk In Robe
Finding: Building element - Damaged
Information:

Evidence of damage was identified to the shelf in the walk-in robe, this damage shelf may be rectified at the client's discretion.

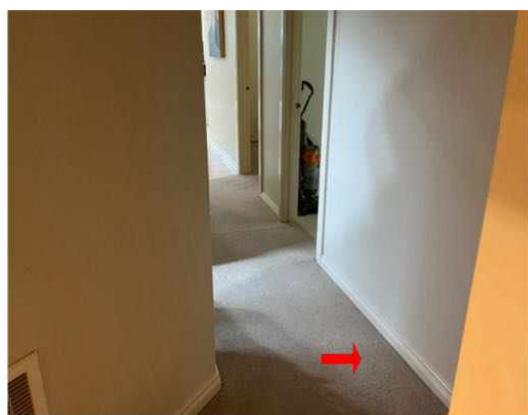
Defects 3.07

Building:	Main Building
Location:	Hallway
Finding:	Flooring discrepancies
Information:	There is a discrepancy in the flooring in this area, without an invasive inspection under the carpet it is impossible to determine the cause

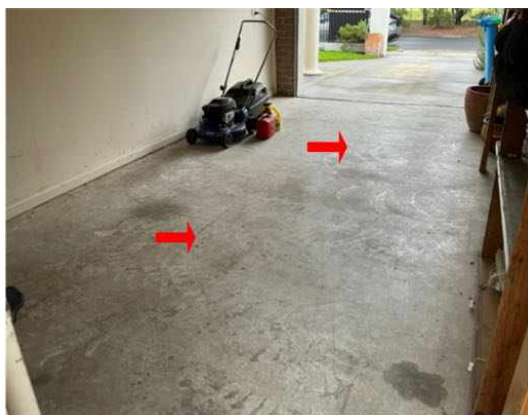
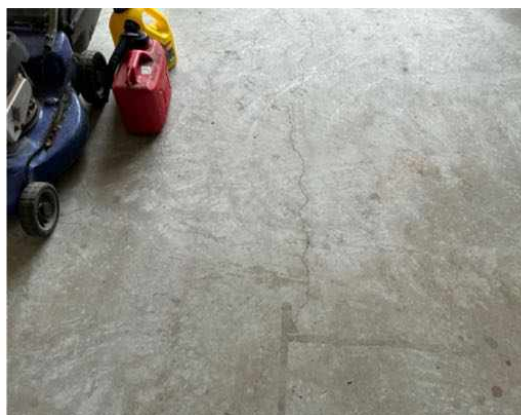
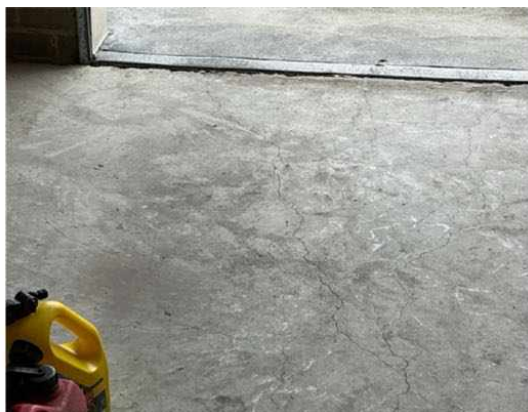
Defects 3.08

Building:	Main Building
Location:	Garage
Finding:	Crack in concrete slab - Category 1
Information:	A crack coded as Category 1 was identified in the slab. A Category 1 crack is described as a fine but noticeable crack, with the slab at an otherwise reasonable level.

To be considered Category 1, the approximate width of the crack is less than 1.0mm, or a less than 10mm change in offset when a 3m straight edge is placed over the defect.

Category 1 cracks should be monitored for a period of 12 months. At the end of the monitoring period, identified cracks that are rated greater than Category 2 are

considered defects, and require rectification.

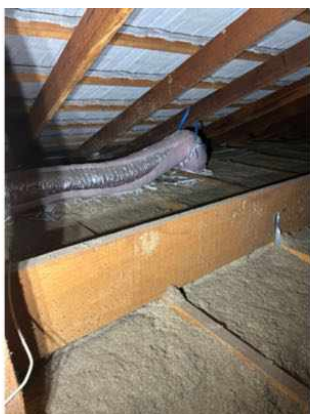
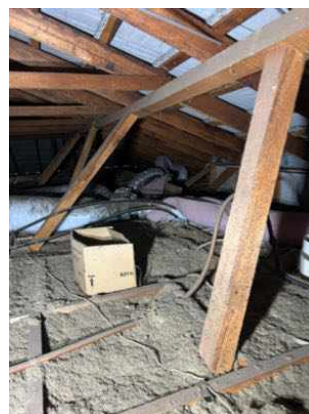
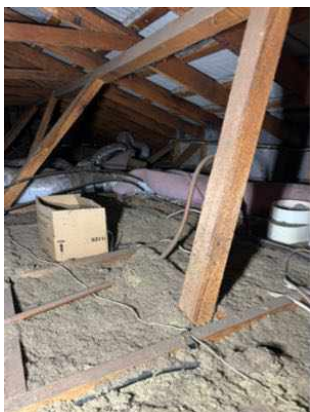
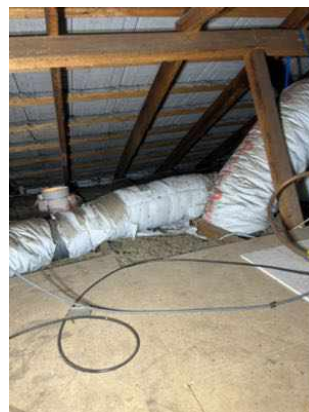
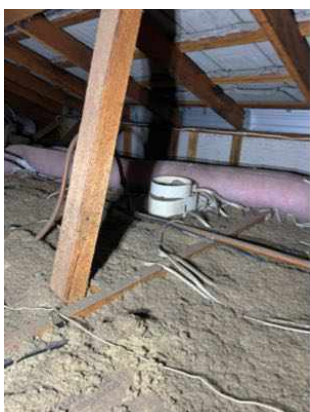
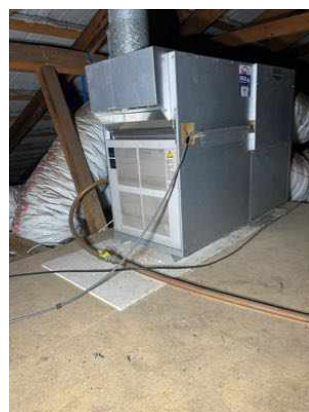
Defects 3.09

Building:	Main Building
Location:	All Areas
Finding:	Heating / Cooling Ducts - damaged
Information:	The heating/cooling ducts were found to be damaged and not at a fully operational level. Generally, damage to ducts occurs as a result of aging and material deterioration, but impact damage or pest damage may also be the underlying cause.

The damage sustained by the ducts detracts from the energy efficiency of the property. The airflow within the property is likely to be restricted, particularly in areas where ducting shows signs of major damage.

A heating/cooling specialist should be appointed to provide further advice on remedial work options and to perform any works deemed necessary.

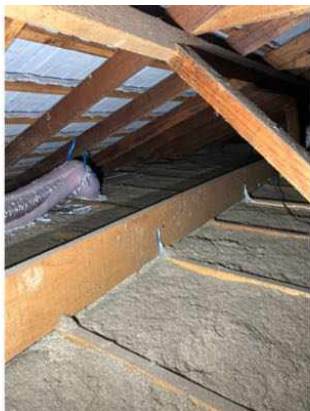
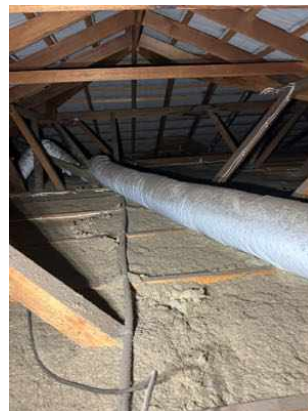
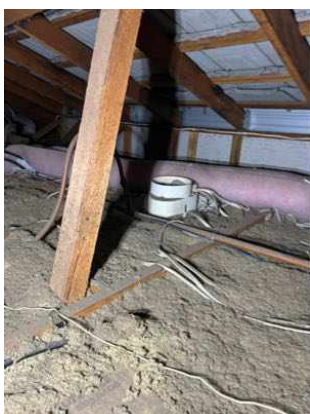
Defects 3.10

Building:	Main Building
Location:	All Areas
Finding:	Insulation - Reduced in volume
Information:	Insul-fluff is common in many older homes and is a loose form of insulation that is 'blown' into roof voids. While this type of insulation was considered effective at the time of installation, modern materials have surpassed it as the preferred insulator.

This type of insulation is susceptible to settling and reducing in volume, detracting from its effectiveness and resulting in an overall loss of energy within the household. Additionally, the reduction in volume has led to an uneven distribution of insulation within the ceiling void, further detracting from its effectiveness.

It is highly advised that this insulation be removed and replaced with a more appropriate material. This will ensure that the property is adequately insulated and will promote an increase in energy efficiency within the property. An insulation contractor should be appointed to provide further advice on replacement options and to perform works as necessary.

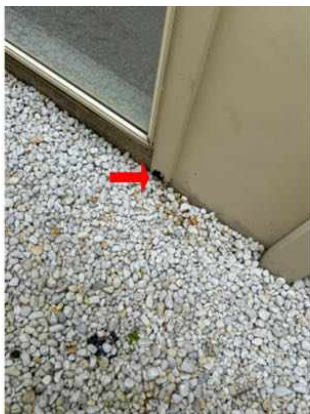
Defects 3.11

Building:	Main Building
Location:	Courtyard
Finding:	Wood rot
Information:	This building element shows evidence of wood rot. Wood rot, also known as Fungal Decay, occurs when timbers and other cellulose building materials are exposed to damp conditions on an ongoing basis. This could be the result of exposure to weathering over a prolonged period of time, or the attraction of excessive moisture from other abutting building materials. Contributing factors also include poor air ventilation in the area.

Wood rot is often associated with general damp problems and is evidenced by a 'musty' smell or mould and mildew occurring on surfaces. If left unmanaged, damp conditions can lead to further health problems and the decay of timbers will continue.

Early intervention and regular maintenance, particularly of exterior timbers, will prolong the useful life of these building elements. Prior to any works being performed, the cause of the moisture that has created the visible wood rot should be identified and addressed in a suitable manner. Replacement of affected timbers may then be a necessary step in protecting surrounding building elements from such deterioration.

A qualified plumber may be appointed to assess the cause of excessive moisture and to provide advice on any remedial works as required. A qualified carpenter or registered builder may also be required to replace affected building materials.

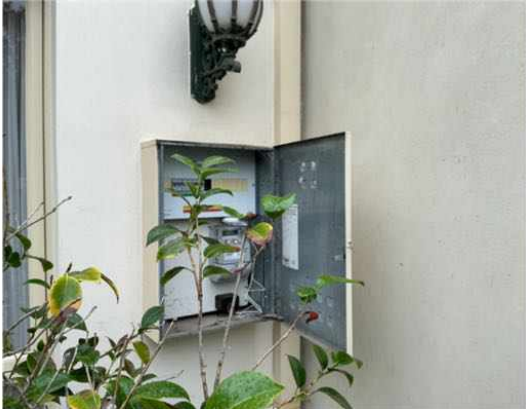
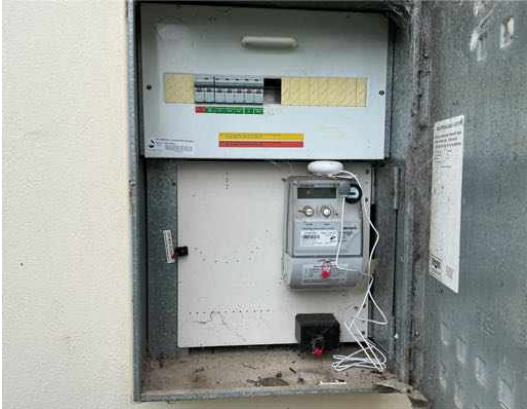
Noted Item

Building: Main Building
 Location: Electrical Switchboard
 Finding: Termite Management System - no evidence of a chemical installation
 Information: The application of a post-construction chemical termite barrier is highly recommended for all properties, particularly if live termite activity has been found on the site previously. Such barriers are highly effective in preventing termite attack on any timber building elements throughout the property.

A durable notice should be placed in the switchboard unit to indicate current termite barriers. At the time of inspection, it appeared as though no termite management system has been installed, with no evidence to suggest preventative works taking

place.

The client may consider gaining further advice from a pest controller as to the costs and procedures involved with this application. It is recommended that obtaining such advice be a short-term priority.
