Building and Timber Pest Inspection Report

Inspection Date: Mon, 9 Feb 2026

Property Address: 13 Wirbill St, Cobram VIC 3644, Australia

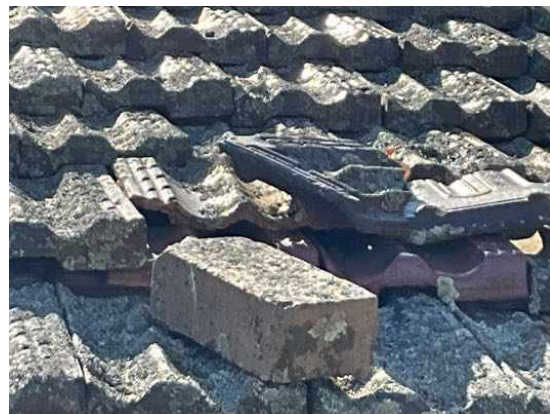
Building: Building 1
Location: Roof Exterior
Finding: Roof tiles - Broken
Information: Upon inspection of the exterior roof covering, broken roofing tiles were identified. Broken and friable roof tiles are generally the result of ageing and weathering of what is essentially a porous material.

If left to further deteriorate, broken and brittle roof tiles are likely to lead to water penetration via the roof into the ceiling space, causing secondary damage to ceiling linings, insulation and roof structures. Broken roof tiles are also likely to detract from the effectiveness of the roof drainage system, creating potential for secondary damage to the exterior roof covering and roof plumbing.

Replacement of broken tiles is required and should be performed by a roofing contractor as soon as possible.

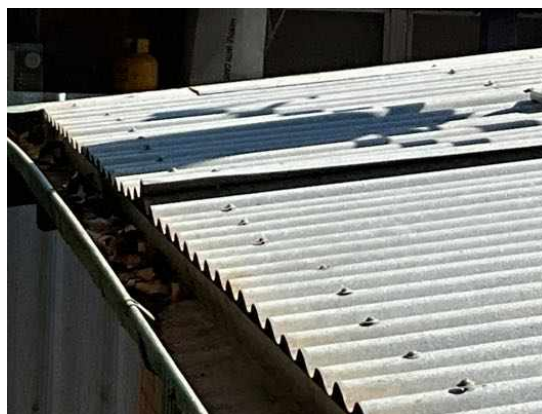
Finding 3.02

Building: Building 1
Location: Roof Exterior

Finding: Roof sheets - Loose

Information: Upon inspection of the exterior roof covering, it was noted that numerous roof sheets have become loose from their original fixings. It is suspected that this defect has developed as a result of a lack of adequate maintenance, but may also have been caused by inappropriate fixings being used in the construction process.

Loose roof sheeting detracts from the weather tightness of the roof covering, making the internal roofing structure susceptible to water penetration and subsequent damage. If left unaddressed, it is likely that secondary damage to associated building elements will develop, potentially necessitating remedial works to these structures.

A roofing restoration contractor should be appointed to advise on rectification options and on the cost of repair. It is advised that remedial works be performed as soon as possible to prevent any further damage.

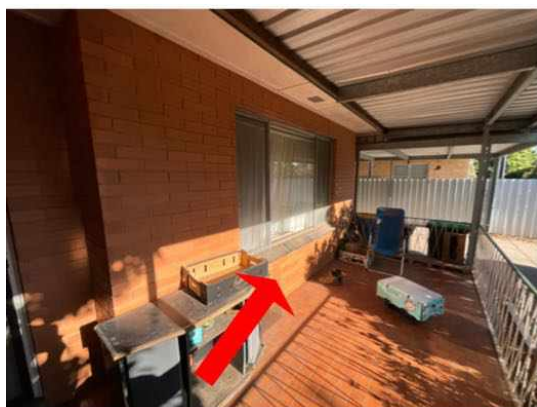
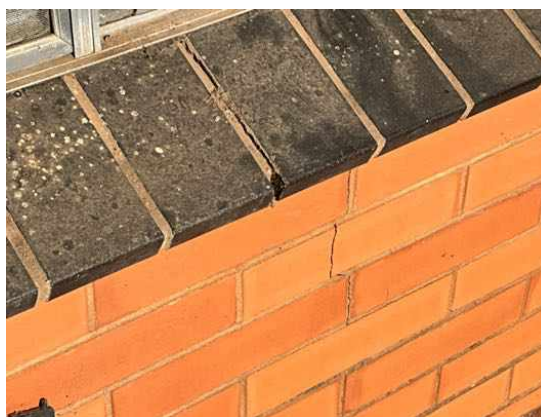
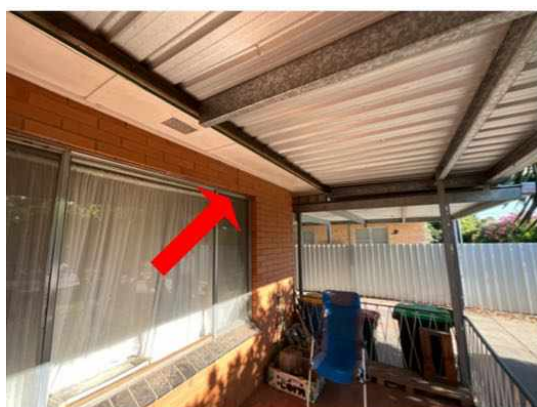
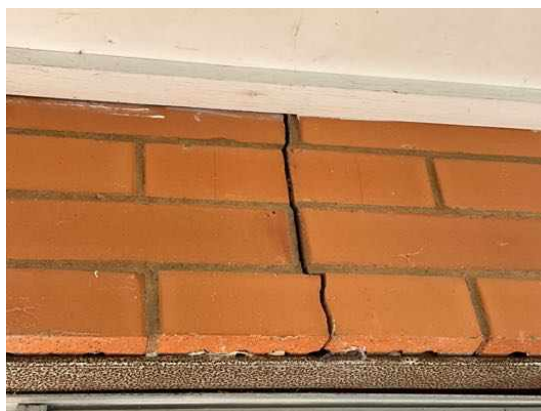
Finding 3.03

Finding: Brickwork - Cracking noticeable

Information: There were several cracks and or crack repairs evident to external brickwork.

Noticeable cracks are a common occurrence in external brickwork and are a likely result of age expected building movement, general expansion, and/or contraction of building materials in different weather conditions. Noticeable cracks in brickwork may develop if left unattended, with potential for necessitating major remedial works or replacement of the brickwork.

It is highly advised that a qualified bricklayer be appointed to provide necessary works to cracked brickwork to prevent any further damage. Such works should be conducted as soon as possible.

Always monitor these cracks and contact a building inspector should cracks widen, lengthen, or become more numerous.

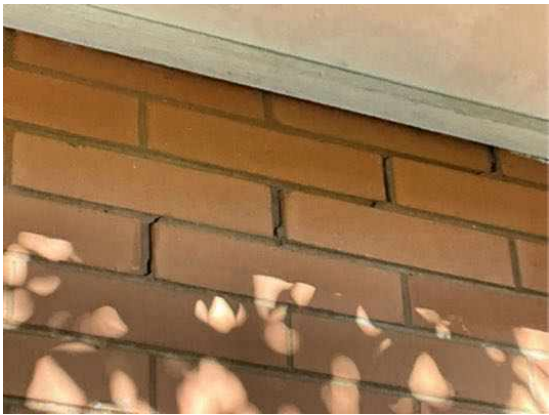
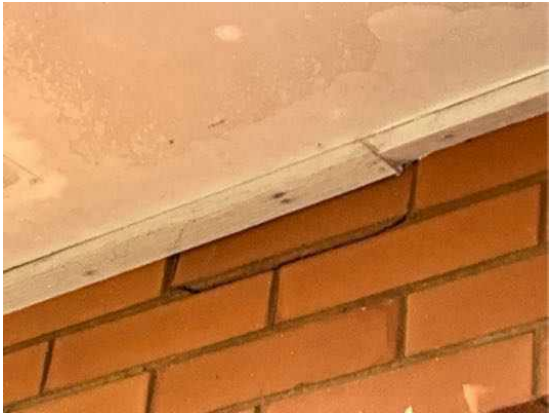
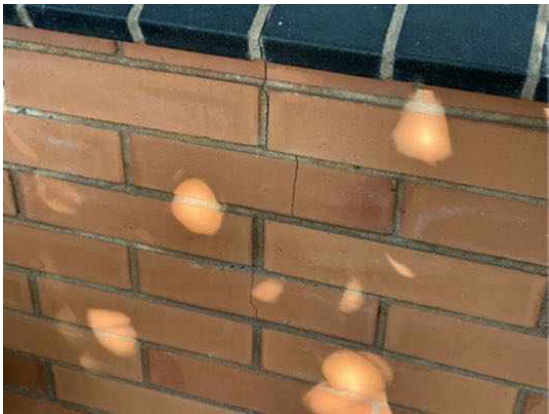
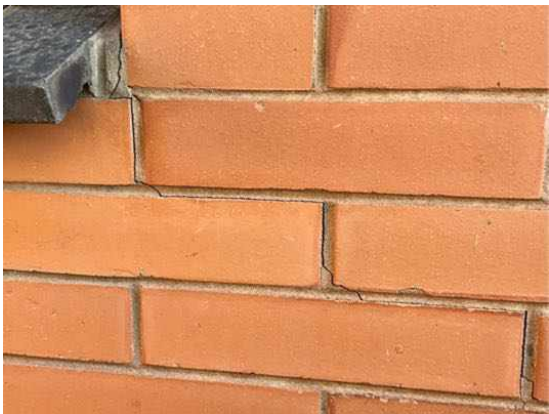
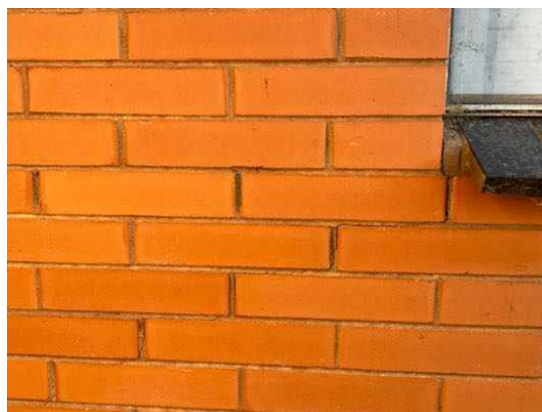
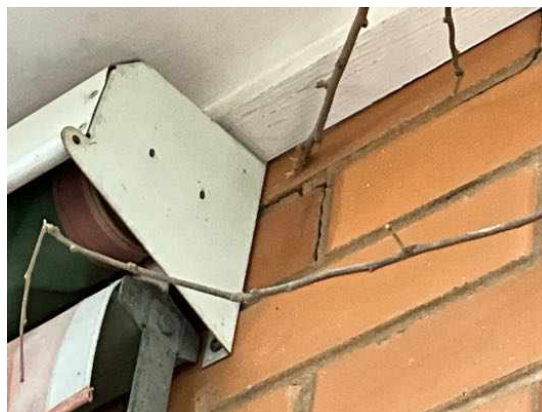
Finding 3.04

Building:	Building 1
Location:	Front, side, rear wall
Finding:	Brickwork - Step cracking
Information:	Step cracking was identified to the brickwork in this area at the time of inspection. Step cracking, which is similar to other forms of cracking, has a variety of possible causes. However, the most common is the subsidence of adjacent footings.

Step cracking is a relatively common defect, and is most likely to occur adjacent to windows, doors and other openings. Mortar failure in the gaps between affected bricks indicates the stresses and tensions affecting the wall.

Where step cracking is extensive or severe, the client is advised to consult a structural engineer. Minor step cracking can be used as a warning sign to address factors causing stress to the wall, which can include the effect of surrounding trees, water leaks, soil erosion, or even the presence of reactive soils in the surrounding area.

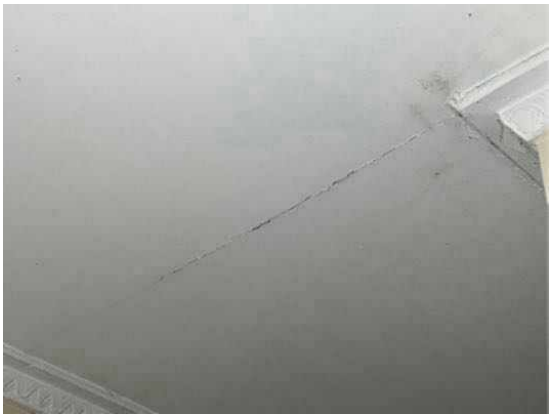
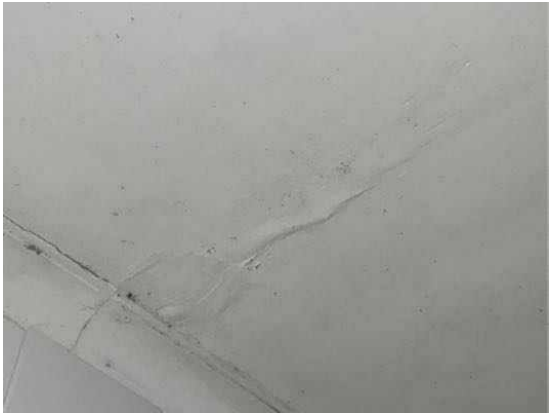
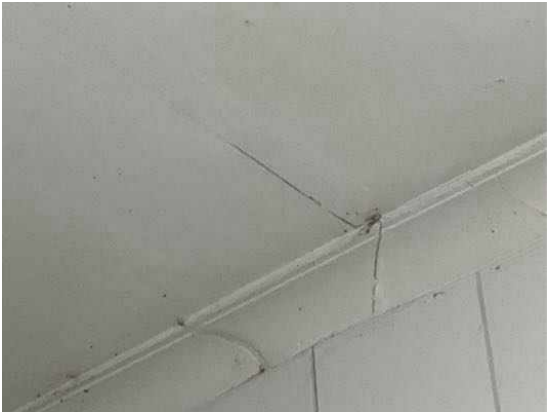
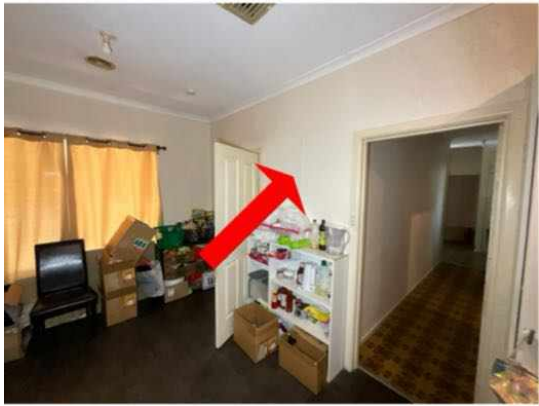
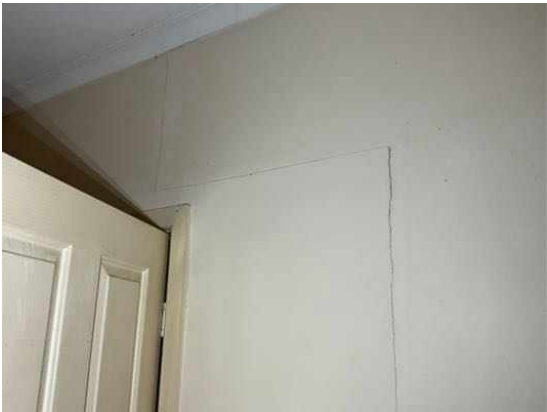
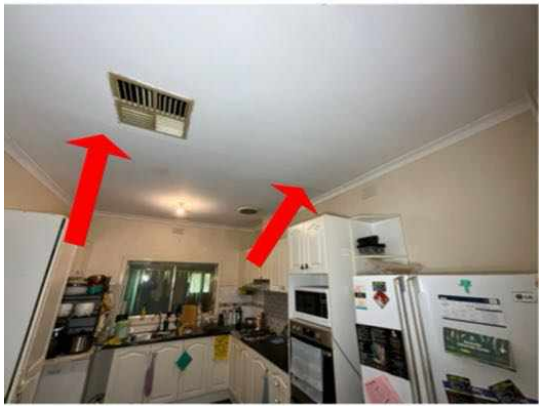
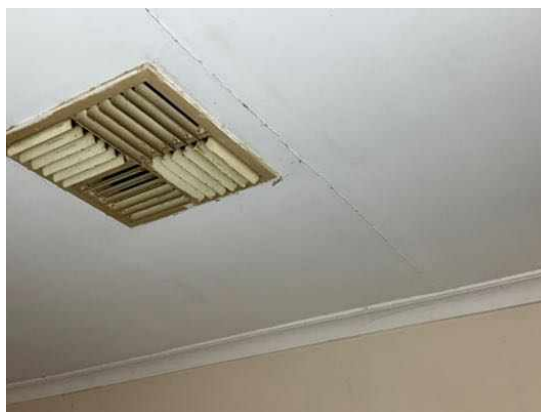
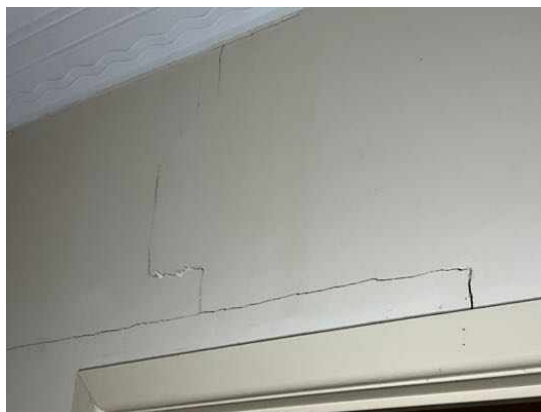
Finding 3.05

Building:	Building 1
Location:	Hall, bathroom, kitchen, living
Finding:	Cracking - Damage Category 1 - Fine (up to 1mm)
Information:	Although fine cracks are quite noticeable, they are often only considered to be an appearance defect, and usually do not indicate any structural damage. Generally, the cause of a fine crack is indicative of a separation between building materials and finishes (e.g. paint, plaster, etc.) along joins.

Cracking of this nature can generally be repaired with minor sanding, filling and/or repainting. Such works should be performed by a qualified painter or a general handyman.

Monitoring of all cracking should be conducted frequently. Always contact a building inspector should cracks widen, lengthen, or become more numerous.

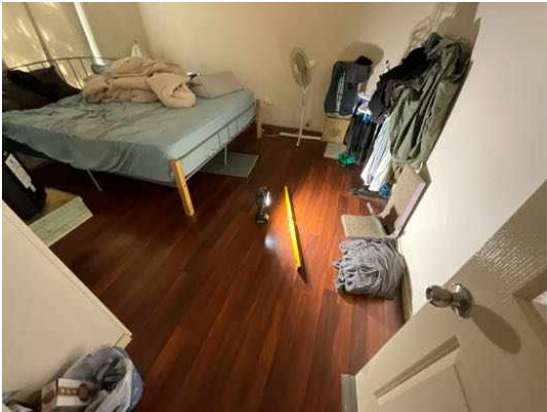
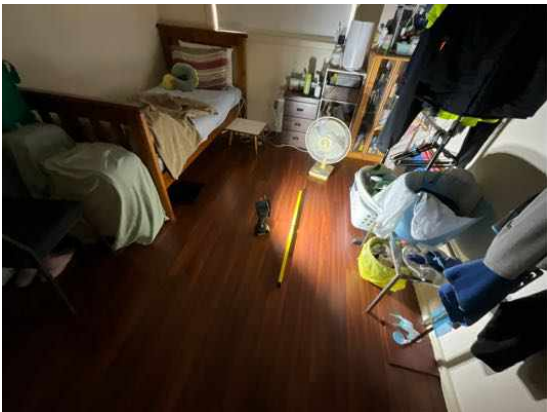
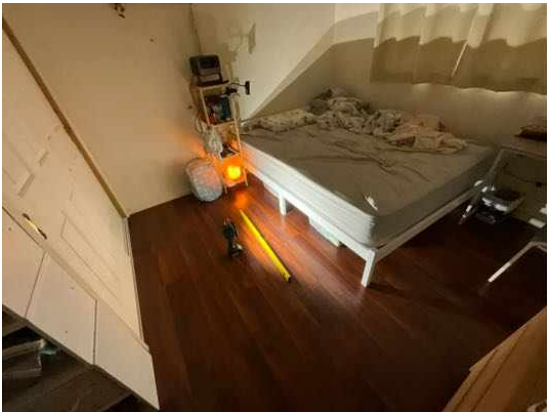
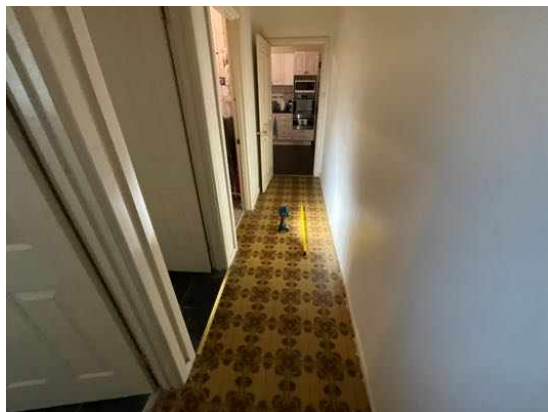
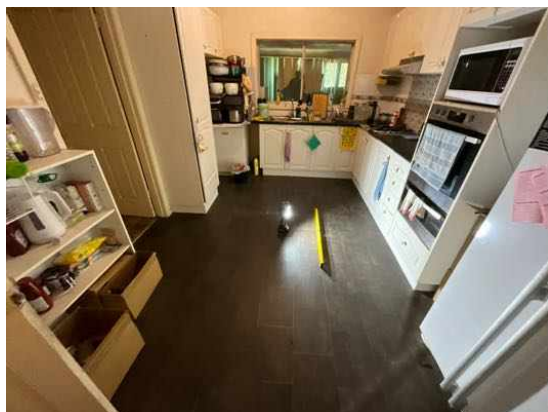
Finding 3.06

Building:	Building 1
Location:	All Internal Areas
Finding:	Flooring - Uneven
Information:	The internal flooring in this area is out of level and uneven. Uneven flooring is likely to indicate minor defects such as expected movement of the foundations of the property, but may also indicate subsidence of the associated subfloor stumps.

It is advised that the flooring be closely monitored to identify any further movement. Where flooring remains relatively unchanged for an extended period of time (i.e. several months), it is likely that this defect has been caused by expected movement of the foundations of the property.

However, where flooring is uneven further, potentially invasive inspection of the subfloor structures and stumps in this area is required. In this case, works to repair are likely to be required, and would be carried out by a registered builder specialising in re-stumping.

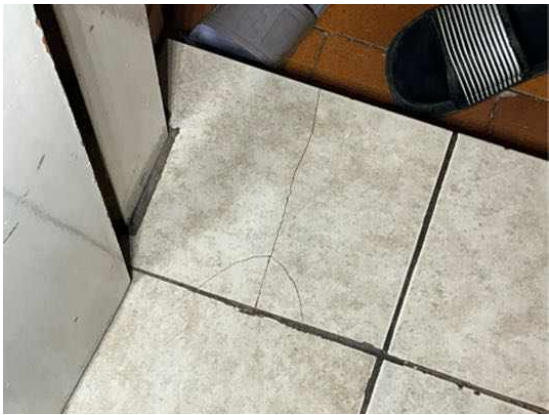
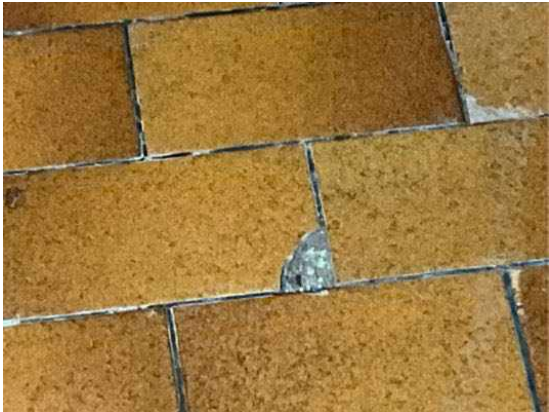
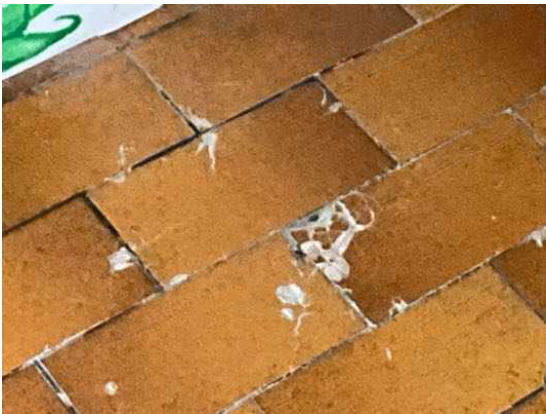
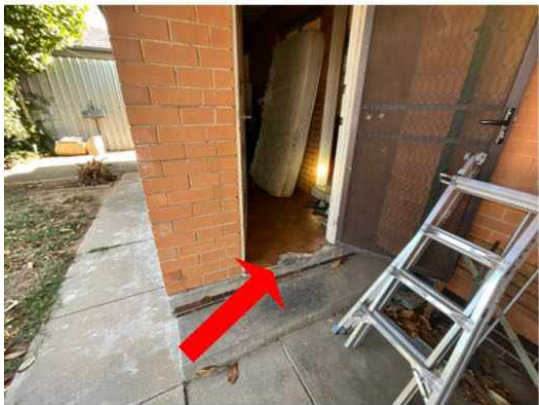
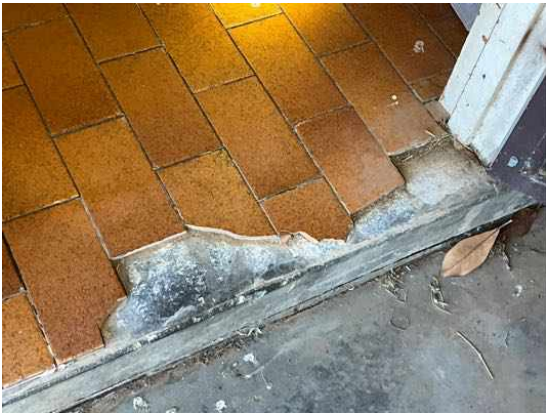
Finding 3.07

Building:	Building 1
Location:	Laundry area
Finding:	Cracked floor tiles
Information:	Cracking in the floor tiles was evident in this area at the time of inspection. It is suspected that this cracking has occurred as a result of minor settlement or impact damage.

Cracked tiles throughout the household detract from the overall appearance of the affected areas however it is unlikely to create or lead to any secondary defects.

While not considered a matter of urgency, replacement of cracked floor tiles is recommended at the clients discretion. A tiling contractor may be appointed to perform these works. Where cracks become more numerous, contact a licensed building inspector for further investigation.

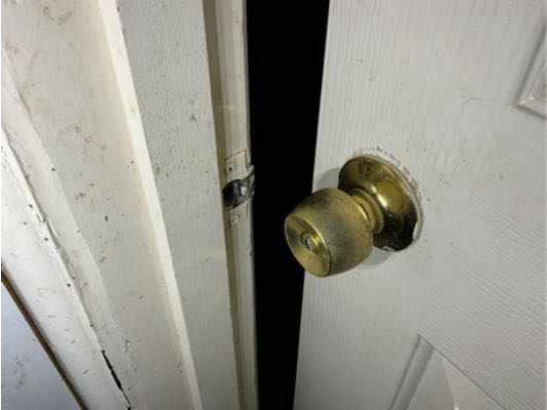
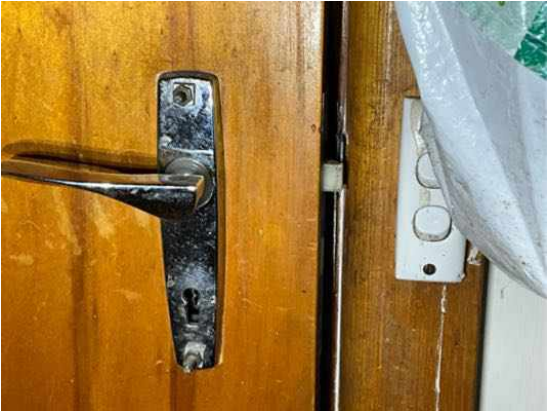
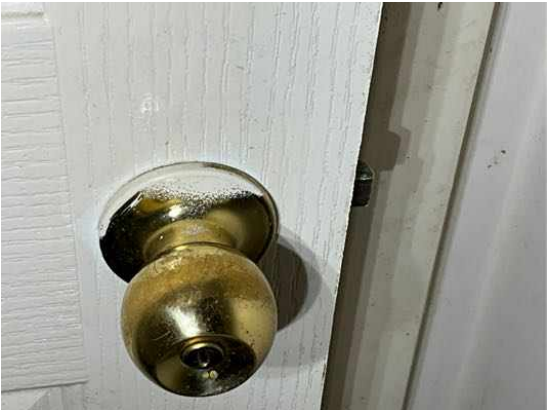
Finding 3.08

Building: Building 1
Location: Bathroom, laundry, hall
Finding: Door - Striker plate misaligned
Information: The striker plate to this door appears to have become misaligned and has consequently resulted in the door's operation being compromised.

This is a common defect and is expected in a property of this age, whether being due to substandard installation or general deterioration of the door hardware.

Readjustment of the striker plate is recommended at client discretion. Works such as these can be completed by a general handyman or qualified carpenter.

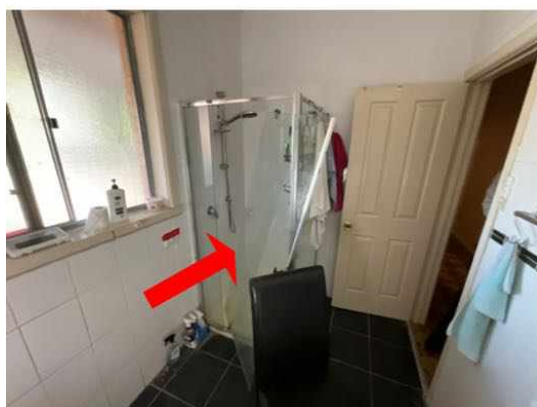
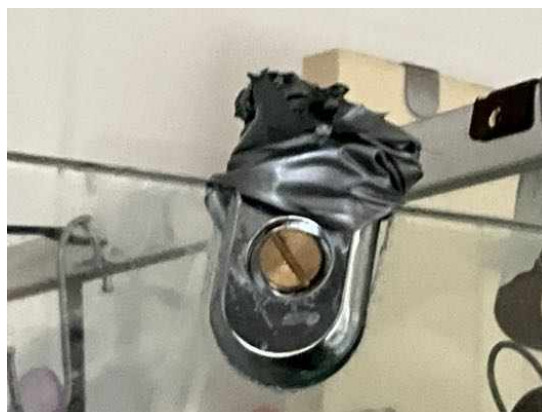
Finding 3.09

Building:	Building 1
Location:	Bathroom
Finding:	Shower Door- jamming/ damaged
Information:	The door to the shower alcove is disconnected during normal operation. Poor operation of building elements is inconvenient and potentially dangerous to the elderly or younger members of the home.

A Handy person or bathroom specialist should be contacted soon to adjust the door to prevent any further deterioration.

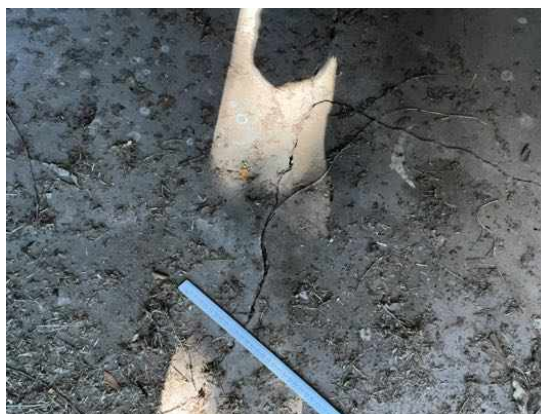
Finding 3.10

Building:	Building 1
Location:	Shed
Finding:	Cracking - External Concrete Paving Damage Category 3 - Wide Cracks (2mm - 4mm)
Information:	Wide cracks were identified in external concrete paving Wide cracks are significant and are likely to lead to the development of safety hazards and secondary defects if left unmanaged.

General age and expected deterioration of the paved areas is a common cause of this type of cracking. However, expansion and contraction of the slab may also have occurred due to environmental factors. Such factors include variable moisture and weather conditions, the presence of trees and their roots having a settling or lifting affect on the soil, or the effect of load bearing, e.g. heavy vehicles over a sustained period of time.

Cracking to this degree may also be due to poor original installation of the concrete. Factors such as poor compaction of the sub surface and/or inadequate reinforcing of the slab may create cracking and other secondary defects. Wide cracks may also have a more significant structural cause, such as subsidence of soils.

Where the crack is located adjacent to structural elements of the building, the advice

of a Structural Engineer is advisable before undertaking repairs. Significant repair and likely replacement of the concrete paving is probable.

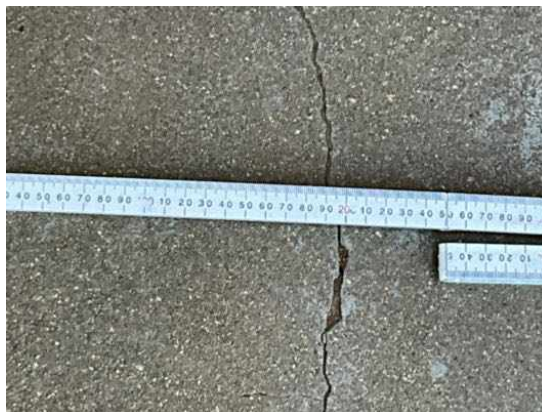
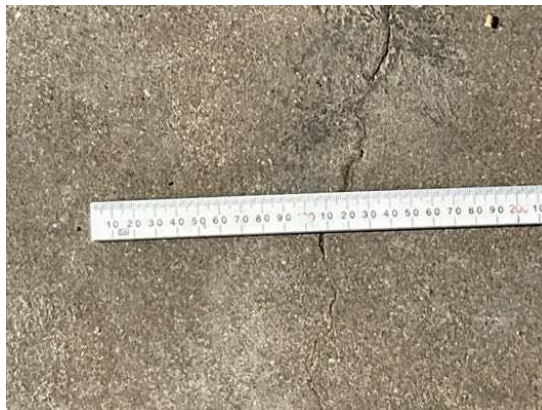
Finding 3.11

Building:	Building 1
Location:	Yard - Back, driveway
Finding:	Cracking - External Concrete Paving Damage Category 1 - Fine (less than 2mm)
Information:	Fine cracks were identified in external concrete paving. Although fine cracks are quite noticeable, they are often only considered to be an appearance defect, and usually do not indicate any structural damage. To be considered a Category 1 or fine crack, the crack is found to be less than 2mm in width.

Generally the cause of a hairline crack in existing concrete paving such as driveways and pathways is indicative of the expansion and contraction of the concrete. Such causes are generally due to environmental factors, such as moisture levels, weather conditions, root systems of nearby trees or the soil types on which they are laid.

Fine cracks may also be due to poor original installation of the concrete. Factors such as poor compaction of the sub surface and/or inadequate reinforcing of the slab may create cracking and other secondary defects.

Monitoring of all cracking should be conducted frequently. Always contact a building inspector should cracks widen, lengthen, or become more numerous.

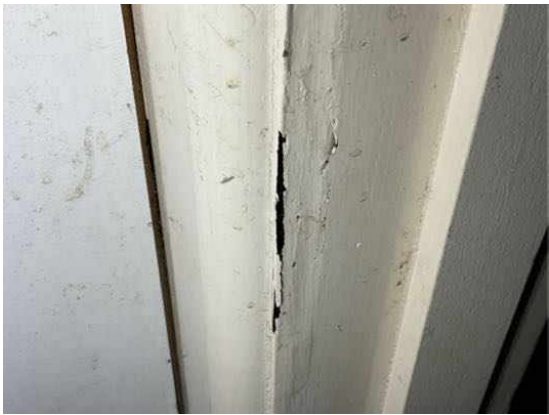
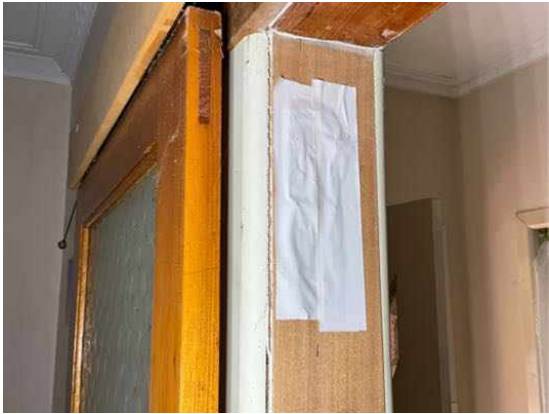
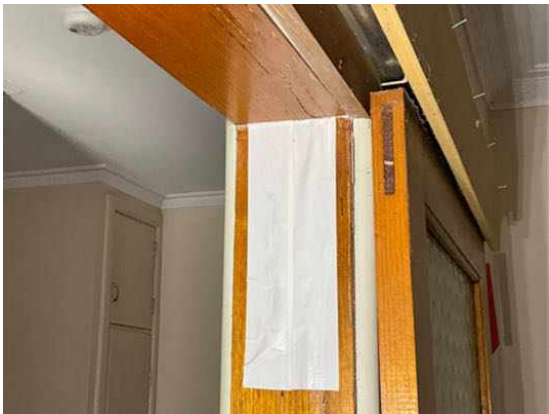
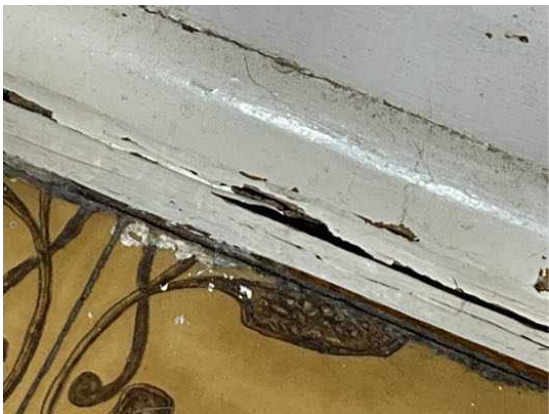
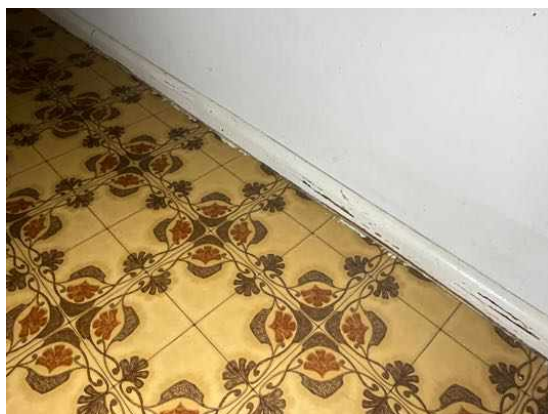
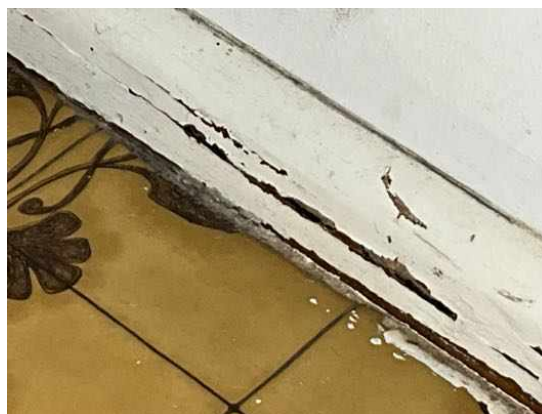
Building:	Building 1
Location:	Bathroom, living, hall
Finding:	Evidence of termite damage- minor
Information:	Despite no live termite or timber pest activity being indicated, previous termite damage was found to have affected this area. This damage is considered to be inactive and is minor in nature.

There is evidence of previous Termite Management services. The property has factors that are Conducive to Termite attack. Previous repair can be seen in the living room door frame that has then been damaged by termites. A Licensed Pest controller should be contacted soon to advise on a Termite Management Plan and avoid potentially costly repairs.

It is advised that the area be visually inspected frequently to ensure that the condition of affected building materials does not worsen. At the time of inspection, damage is not structural and is only considered to be superficial.

A building contractor may be appointed to provide a further invasive inspection if further damage is evident.

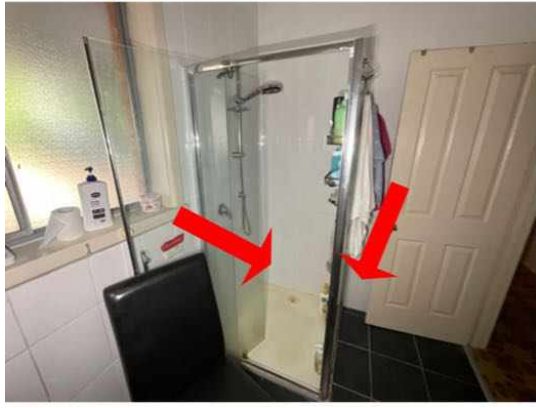
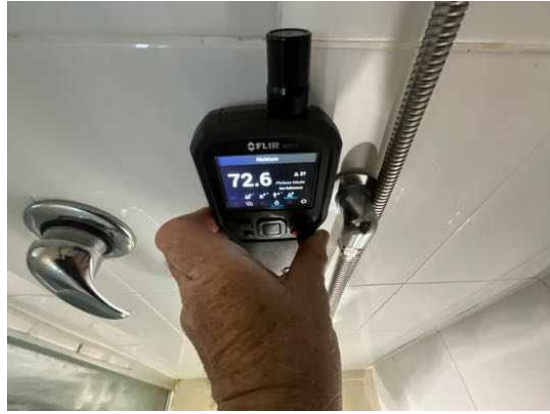
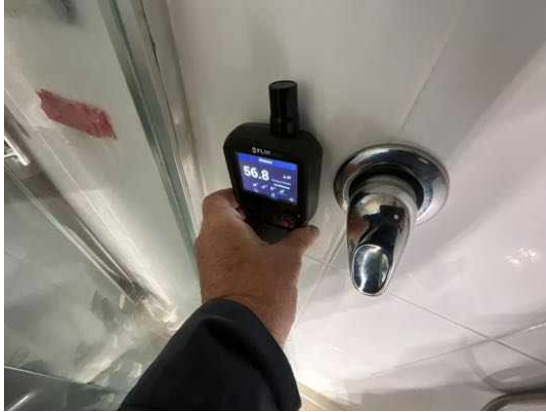
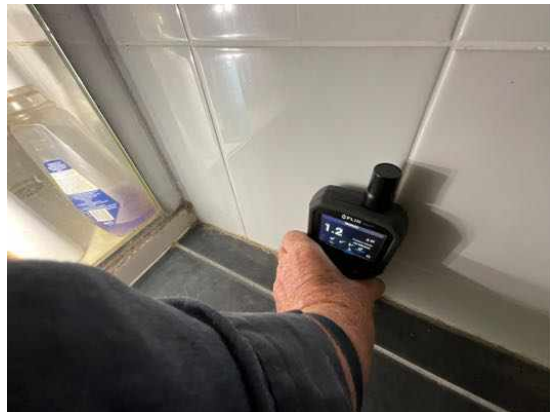
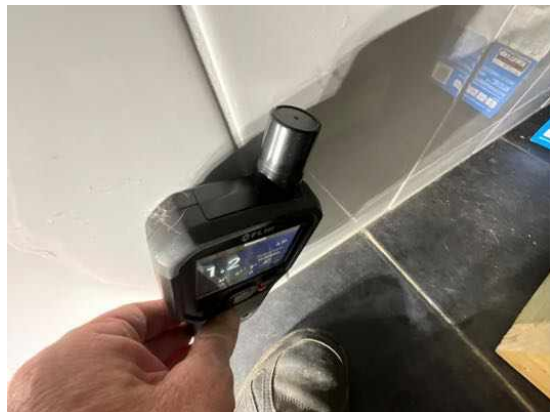
Finding 6.01

This defect is quite common, and is suspected to have been caused by moisture permeating or leaching through the grouting and perhaps gaps in the sealant prior to repair.

Damp (or structural damp) refers to the presence of unwanted moisture in the structure of a building, either as the result of intrusion from outside, or condensation from within the structure. In the shower area, internal water leaks or other sources of excessive moisture are generally the cause of damp.

Monitoring the area is advised and if any visual signs of excessive moisture appear (peeling paint, mould) then consultation with a qualified plumber or bathroom specialist would be advised to identify the cause of damp and to perform remedial works as required.

Always ensure that sealant and grout is in good condition to prevent any moisture issues occurring in the future.

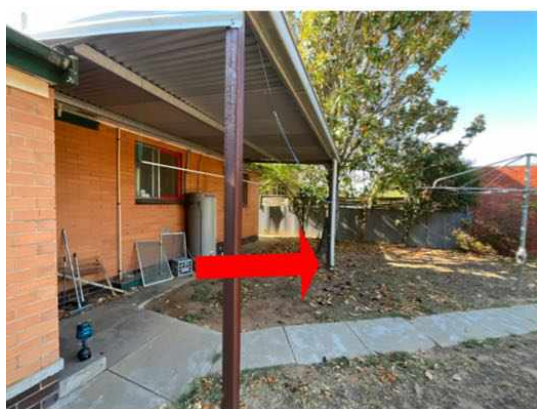
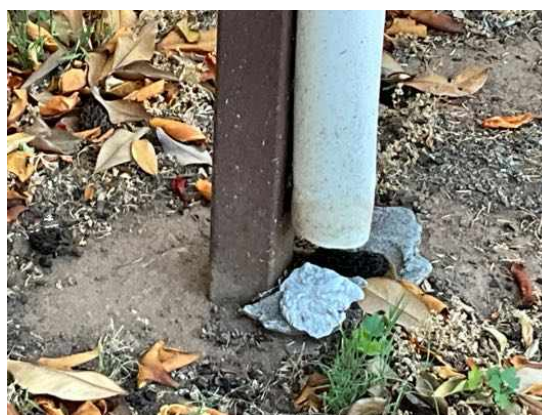
Finding 6.02

Building: Building 1
 Location: Yard - Back
 Finding: Stormwater drain - Not connected
 Information: The roof plumbing is not adequately connected to stormwater drainage on the site. This disconnection negatively impacts the functional capacity of the roof plumbing.

Where roof plumbing doesn't drain adequately, the area at the base perimeter can become excessively damp, potentially creating an environment that is susceptible to rust and corrosion of surrounding building elements, as well as attracting termites and other pests.

It is highly recommended that a plumber be appointed to further inspect the area and to install adequate drainage equipment where necessary.

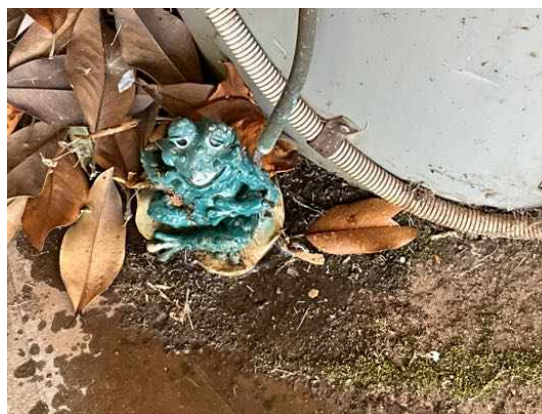
Finding 6.03

Building: Building 1
 Location: Yard - Back
 Finding: HWS Overflow - Not Connected
 Information: The Hot Water System (HWS) overflow was found to be disconnected from storm water drainage and is creating excessive moisture in the surrounding area.

These damp conditions can lead to secondary defects such as rot, rust or corrosion of associated building elements, the formation of fungal decay, or even the creation of potential slip hazards. When coupled with poor site drainage, pooling of water may also attract termite activity to this area.

It is highly recommended that a licensed plumber be appointed to connect the HWS overflow in order to prevent such an environment from being created. These minor works should be carried out as soon as possible.

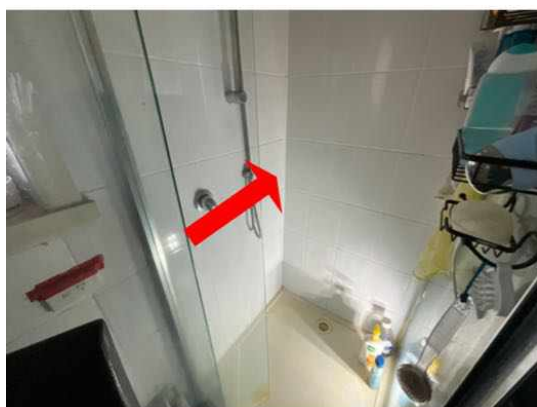
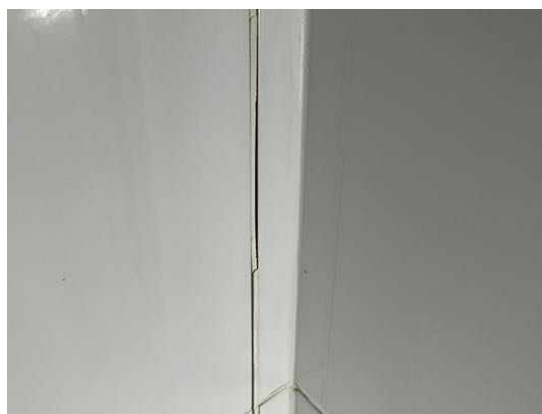
Finding 6.04

Building: Building 1
 Location: Bathroom
 Finding: Inadequate sealant or Grout
 Information: This area has a lack of effective Sealant or Grout. This is allowing the ingress of water to the structure inside the wall.

The presence of water encourages Termite attack, Mould and Fungal Decay.

A Tiler or General Handy person must be contacted as soon as possible to effect repairs and prevent further deterioration.

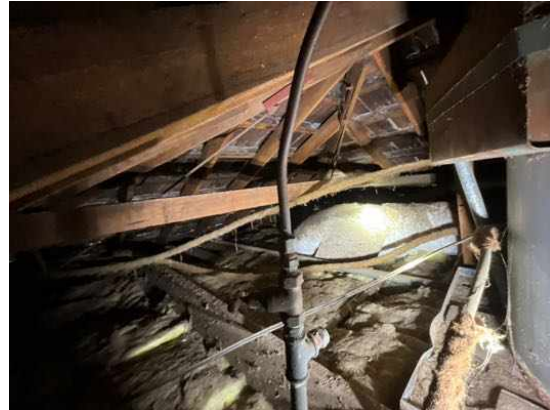
Finding 6.05

Building: Building 1
 Location: Roof Void
 Finding: Gravity-Fed HWS - Disconnected
 Information: It was noted at the time of inspection that a disconnected gravity-fed hot water system (HWS) remains in this area.

Despite this plumbing structure being unused, it is likely to be storing residual water, and is therefore susceptible to rust and corrosion. If allowed to continue, rust and corrosion is likely to lead to damage to adjoining building elements, and may also

make the area susceptible to termite or timber pest activity.

While it is a costly exercise to remove the disused gravity-fed HWS, it is advisable in the short-term future to prevent any further damage to the area. Further consultation with a licensed plumber is required to gain further advice on removal of the structure.

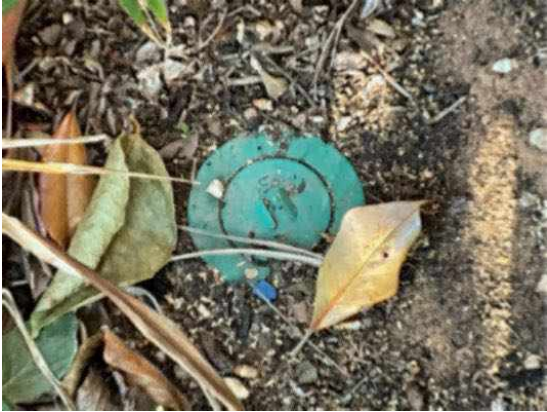
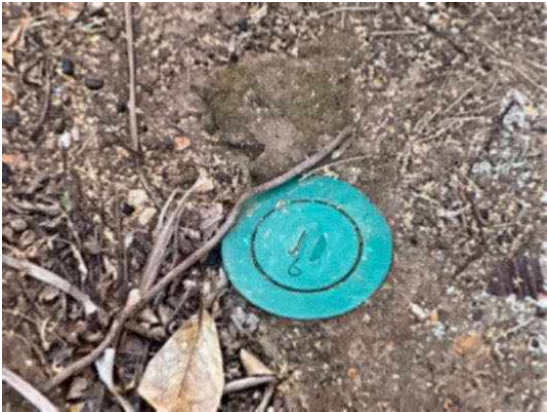
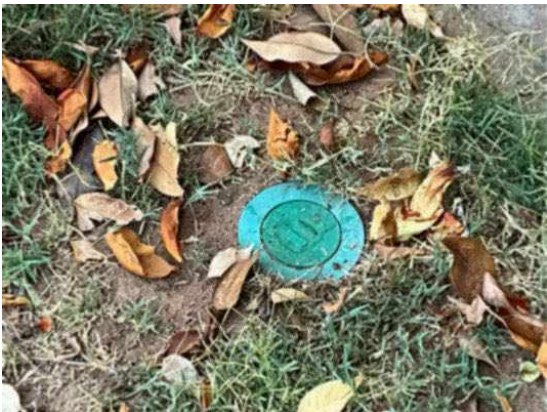
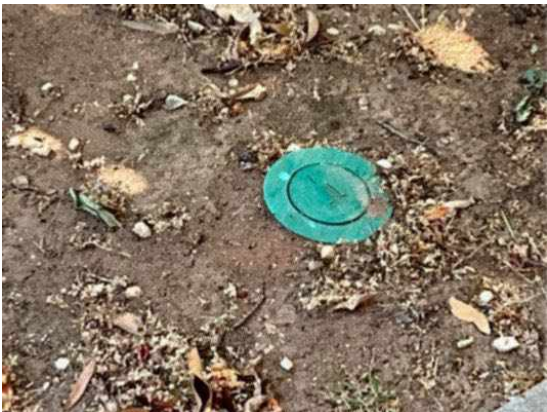
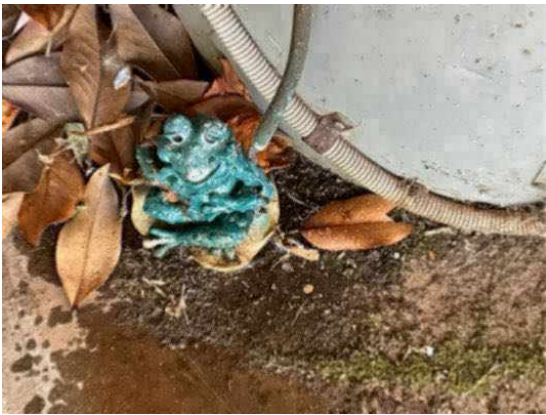
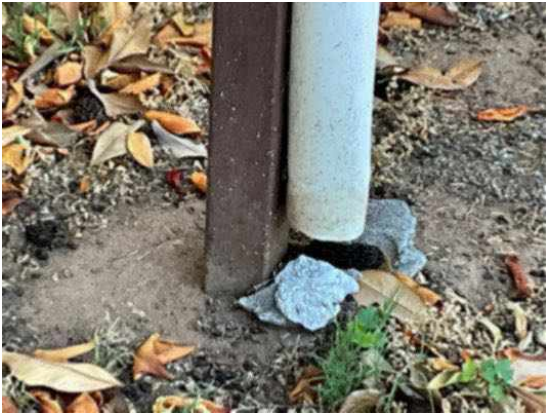
Finding 6.06

Building:	Building 1
Location:	All External Areas
Finding:	Termite Management System- evidence of a chemical installation
Information:	The application of a post-construction chemical termite barrier is highly recommended for all properties, particularly if live termite activity has been found on the site previously. Such barriers are highly effective in preventing termite attack on any timber building elements throughout the property.

The client may consider gaining further advice from a pest controller as to the costs and procedures involved with this application. It is recommended that obtaining such advice be a short-term priority.

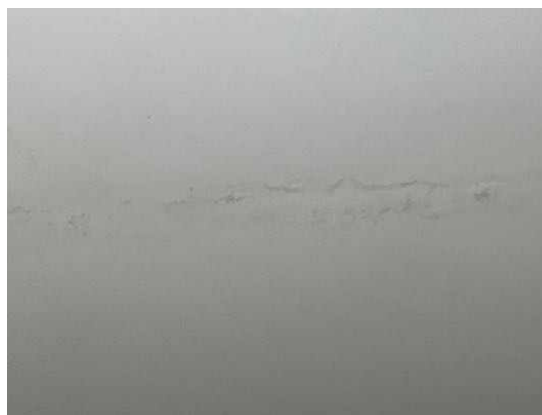
Building: Building 1
Location: Hall
Finding: Ceiling - Water stained
Information: Water staining to ceiling linings in this area was evident at the time of inspection. Water staining indicates that surfaces have been exposed to excessive moisture over time. The minerals and other elements in the water lead to staining, which may graduate to corrosion and deterioration if left unmanaged.

While mostly an appearance defect, water staining can be indicative of more serious defects, which may be currently concealed by interior ceilings.

Where water staining is active, a licensed plumber must be consulted to identify the cause of the staining and to provide advice on any reparation works that may be required. Replacement of any damaged structures is advised.

Conversely, where water staining is old and inactive, affected building materials may be repaired or replaced at client discretion.
