Building and Timber Pest Inspection Report

Inspection Date: Wed, 4 Feb 2026

Property Address: 44 Wideview Rd, Berowra Heights NSW
2082, Australia

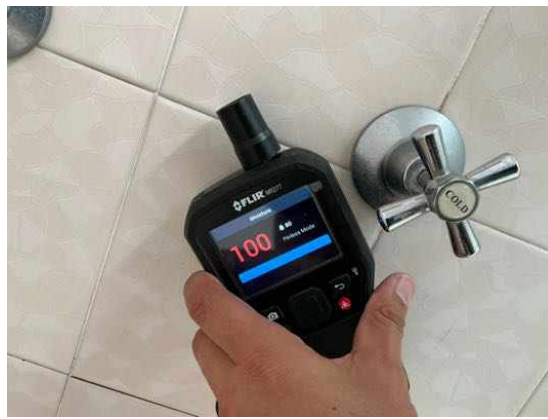
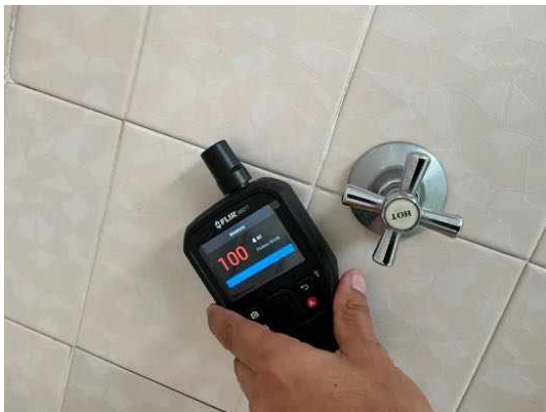
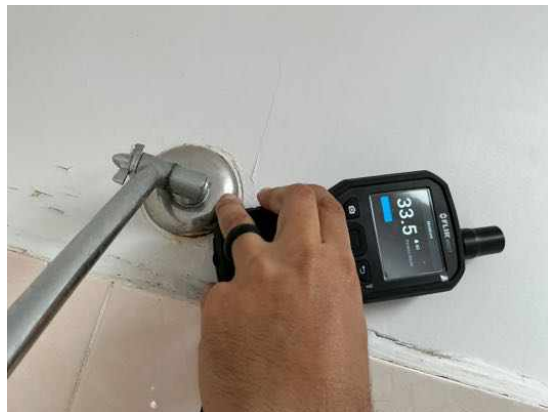
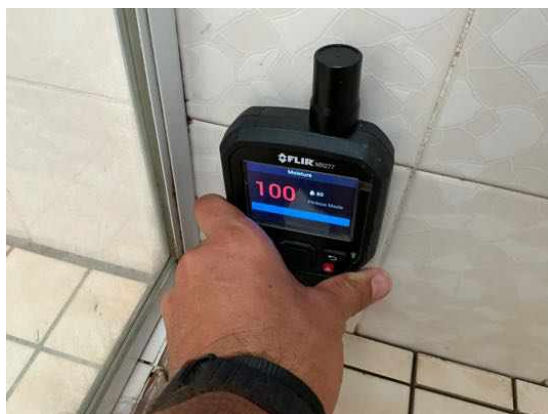
Building:	Main Building
Location:	Bathroom
Finding:	Excessive Moisture - Adjacent to Bathroom Wall W
Information:	At the time of the inspection, excessive moisture was observed at the base of the wall in the specified area. This issue is particularly concerning due to the presence of a shower on the opposite side of the wall, which may be contributing to the moisture infiltration due to the possibility of waterproofing failure.

Excessive moisture can lead to the deterioration of wall materials, including paint, plaster, and timber elements. If left untreated, it has the potential to cause significant

structural damage over time.

Furthermore, the moisture creates an environment conducive to mould growth, posing potential health risks to the occupants.

It is highly recommended that a more invasive inspection be carried out to this area immediately, in order to determine the cause of the excessive moisture.

It is strongly recommended to reseal the shower area and improve waterproofing measures to address the problem effectively.

A professional plumber or waterproofing specialist should be engaged to ensure the issue is properly resolved, preventing further damage and safeguarding the property.

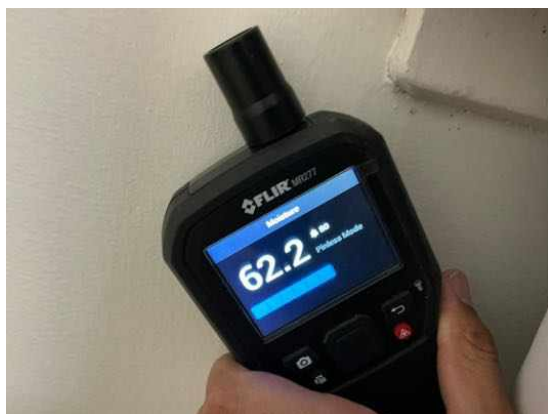
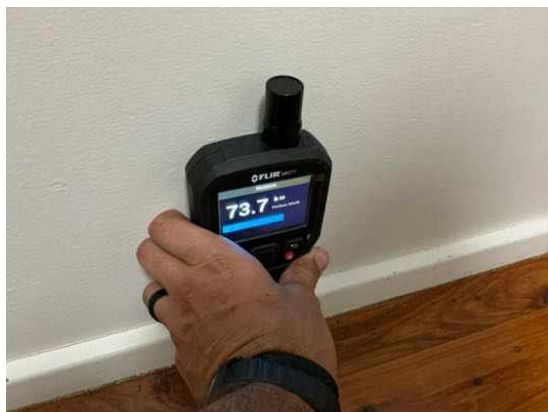
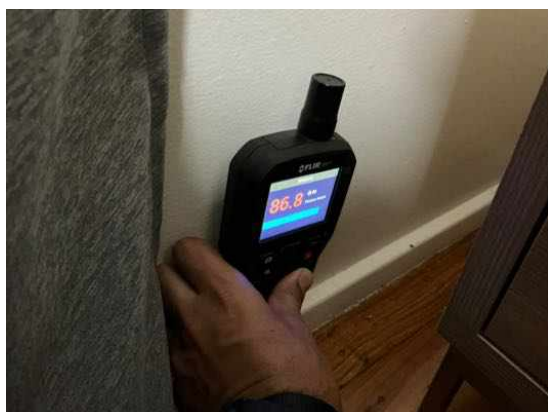
Building:	Main Building
Location:	Front Bedrooms
Finding:	Excessive Moisture - Rising Damp Due to Subfloor Conditions
Information:	At the time of the inspection, excessive moisture has been identified to the wall in this area using a moisture meter, indicating potential water ingress or high humidity levels within the wall structure. This may be caused by plumbing leaks, rising damp, condensation buildup, high humidity levels in the room or external water penetration due to inadequate weatherproofing around windows and openings. Common indicators of damp issues include peeling paint, efflorescence, musty odors, and damage to skirting boards or internal finishes.

Upon further inspection, excessive moisture was noted in the subfloor area, accompanied by poor drainage and likely inadequate ventilation. These conditions significantly increase the risk of moisture being drawn upward into the timber-framed walls through capillary action and rising damp.

Prolonged exposure to elevated moisture levels can compromise the integrity of the building structure, leading to timber rot, mould growth, termite attraction, and degradation of internal wall materials. If the damp-proof course is bridged, damaged, or insufficient, the likelihood of moisture intrusion into wall cavities is further increased.

It is recommended that a licensed builder or drainage specialist assess the subfloor area as soon as possible to improve drainage, verify the condition and placement of the damp-proof course, and ensure adequate subfloor ventilation is provided to prevent ongoing moisture-related issues.

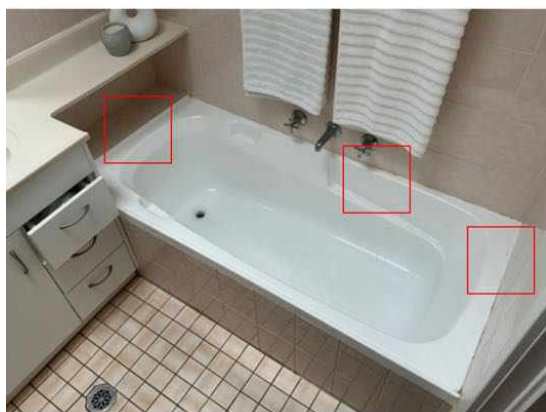
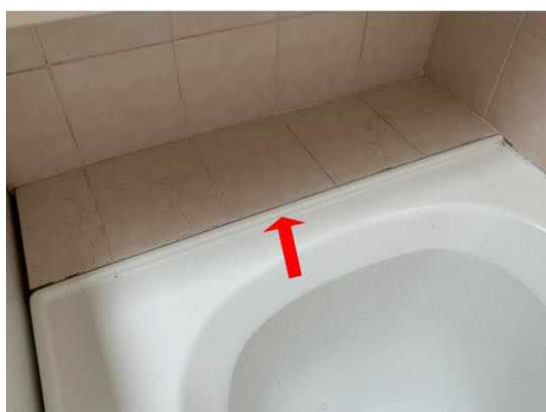
Building:	Main Building
Location:	Bathroom
Finding:	Sealant - Missing or Damaged/Inadequate
Information:	At the time of the inspection, it was noted that the sealant was missing and/or damaged/inadequate in this area.

Flexible and mould resistant materials should be applied to affected areas to prevent any subsequent water damage that is likely to occur. Regular maintenance and replacement of missing or damaged sealant is highly recommended to the wet areas, as this is a regular wear and tear defect. Sealant in areas that come into regular

contact with water should be maintained for the long term care of your property.

A sealant specialist or tiling contractor should be appointed to complete these works as soon as possible. If left unattended, this minor defect can develop into a MAJOR defect.

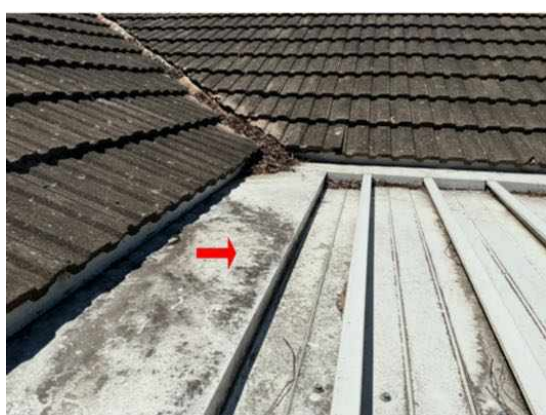
- Prolonged exposure to sunlight can cause the roofing material to degrade over time,

- Older or lower-quality roofing materials may be more susceptible to weathering compared to newer or higher-grade materials.

It is recommended that a qualified roofing contractor be engaged as soon as possible in order to conduct a detailed inspection to evaluate the extent of the weathering and determine whether the roof sheeting has been structurally compromised. Removal of debris, moss, or algae growth from the roof surface, which may contribute to further damage or deterioration.

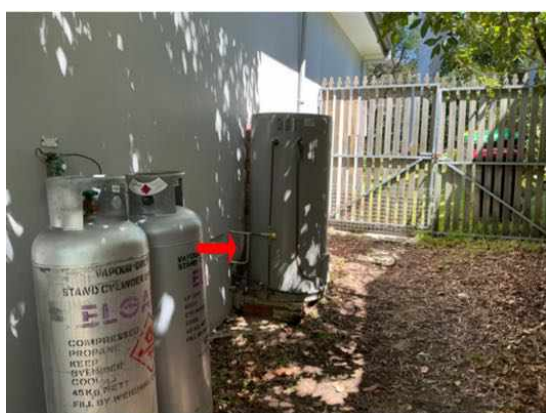
Building:	Main Building
Location:	All Areas
Finding:	Site Drainage Inadequate - Conducive Condition
Information:	The site drainage in this area was found to be inadequate at the time of inspection, creating potential for subsequent water damage to associated building elements and water pooling and ponding up against the buildings foundations. This in turn can create conducive conditions for termite activity and infestation.

It is strongly recommended that these areas be reviewed by a licensed pest management professional, and that steps be taken to improve accessibility and reduce conducive conditions, in line with AS 3660.2 – Termite Management in and Around Existing Buildings and Structures.

Regular, ongoing termite inspections are also recommended to help detect activity as early as possible.

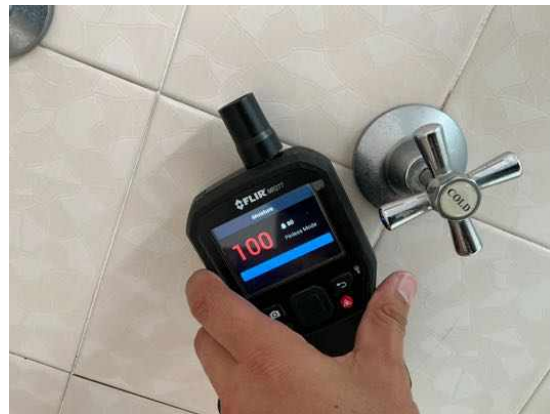
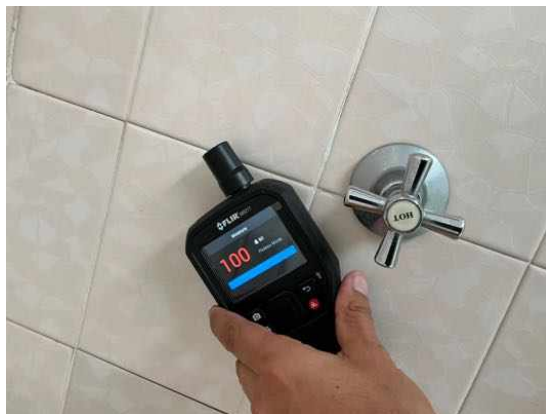
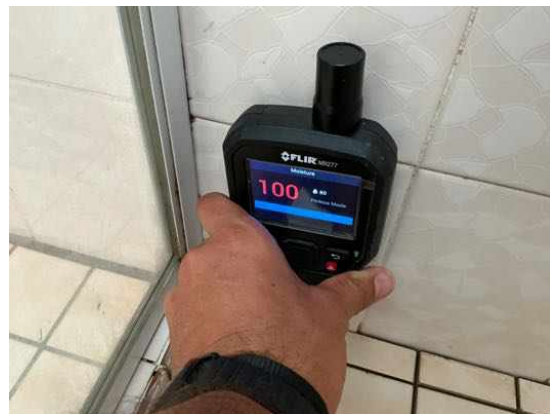
Building:	Main Building
Location:	All Areas
Finding:	Excessive Moisture - Conducive Condition to Termites
Information:	Excessive moisture was detected in the mentioned areas of the property, creating a conducive environment for termite infestation.

Termites are attracted to damp and humid conditions, as moisture softens wood and other cellulose-based materials, making them easier for termites to consume. The presence of excessive moisture in these areas significantly increases the risk of termite activity, which can lead to extensive structural damage if not promptly addressed.

It is strongly recommended that the source of the moisture be identified and rectified immediately, such as by improving ventilation, repairing leaks, or addressing any damp-proofing issues. By doing so, the property will be better protected against the threat of termite infestation and the associated risks.

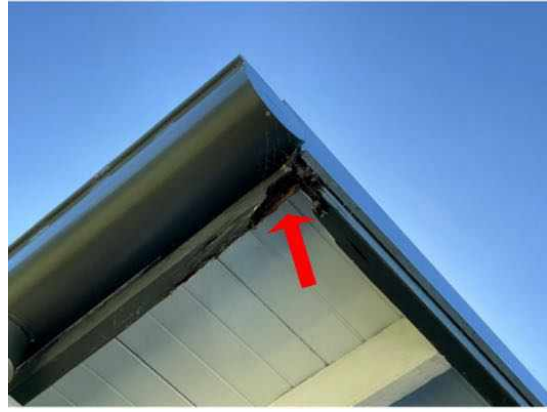
In this case although the affected timber element is in a decaying state the extent of any visible damage appears to be localised to a specific area and is yet to spread to other parts of the building element or affect adjoining structures. The fungal decay is therefore likely to be of a relatively superficial nature with minimal impact on the structural integrity or tensile strength of the timber element.

It is recommended that a qualified carpenter, painter or handy person be appointed to either replace or treat the timbers from further decaying as soon as possible.

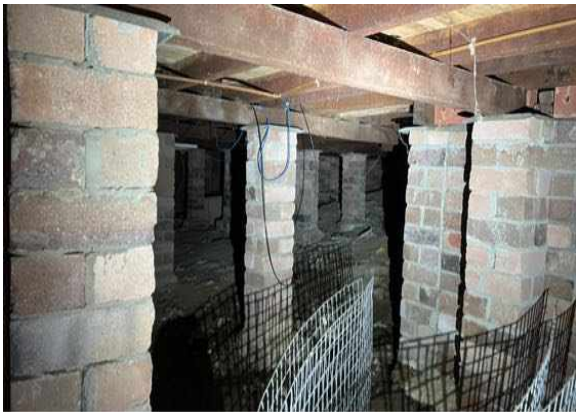
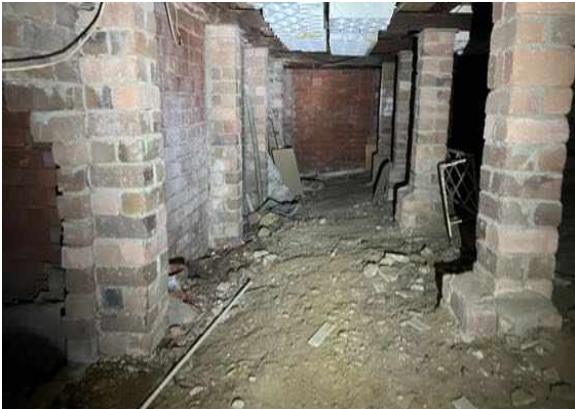
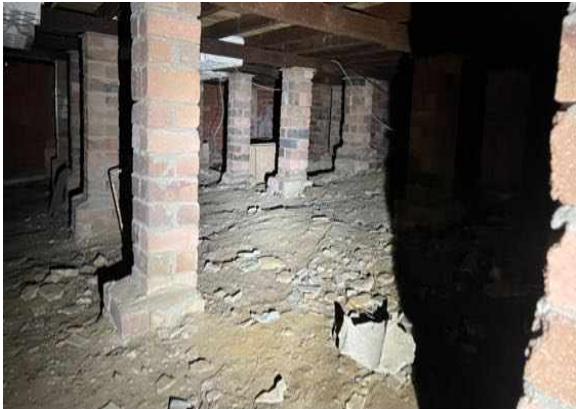
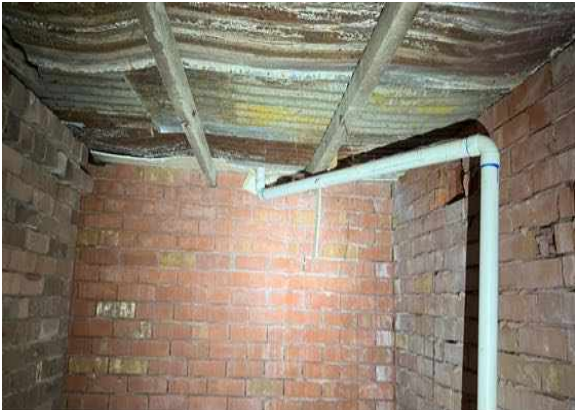
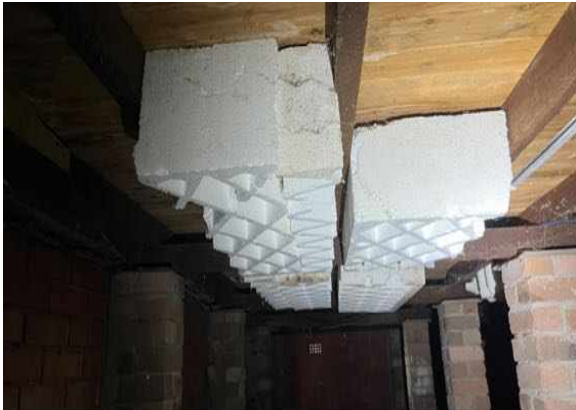
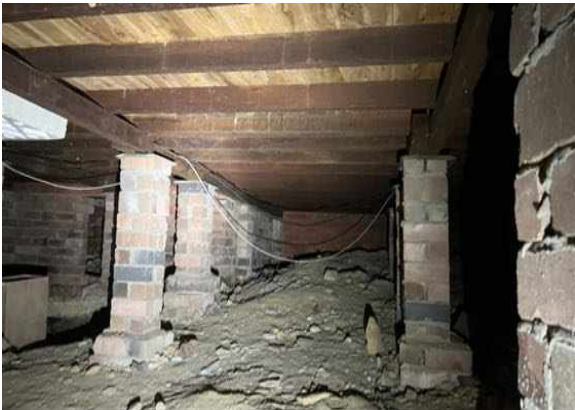
Building: Main Building
 Location: All Areas
 Finding: Obstructions and Limitations - Subfloor
 Information: These photographs are an indication of the obstructions and limitations which impeded the inspection of the subfloor area of the property at the time of inspection. These obstructions, which may include stored items, construction debris, low-hanging pipes, or insulation materials, restricted access to significant portions of the subfloor.

These obstructions can hide an array of defects and should be removed to allow full inspection to be carried out.

A re-inspection is recommended once the areas are made accessible.
