Building and Timber Pest Inspection Report

Inspection Date: Thu, 19 Feb 2026

Property Address: 5A Dunk Cl, Green Valley NSW 2168,
Australia

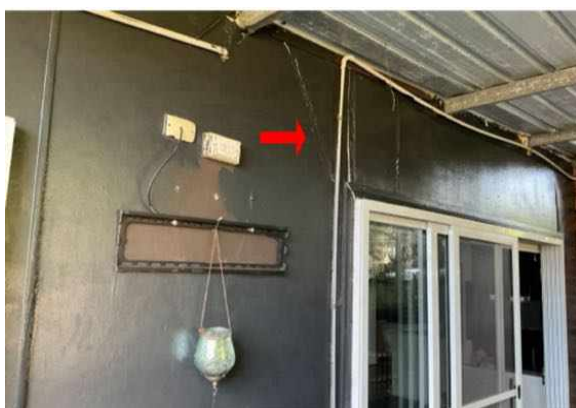
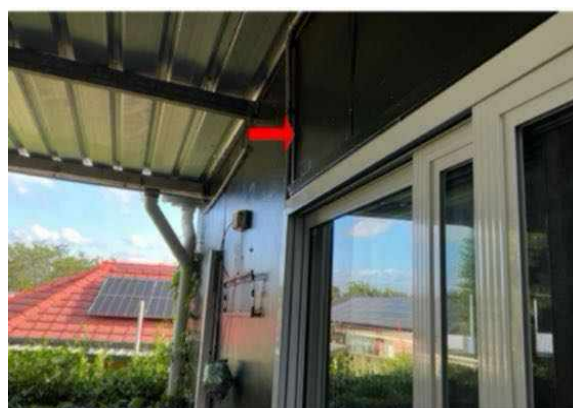
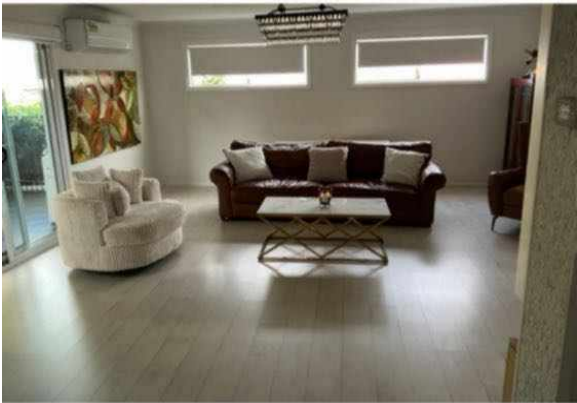
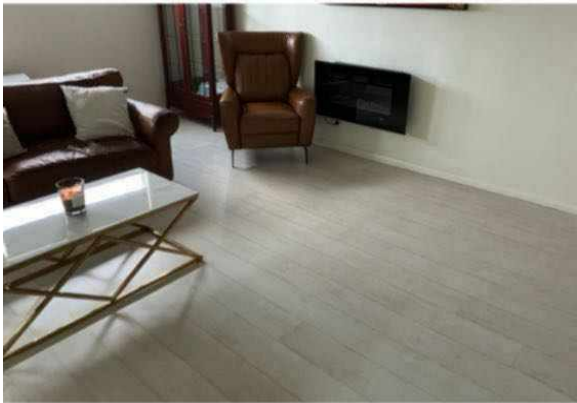
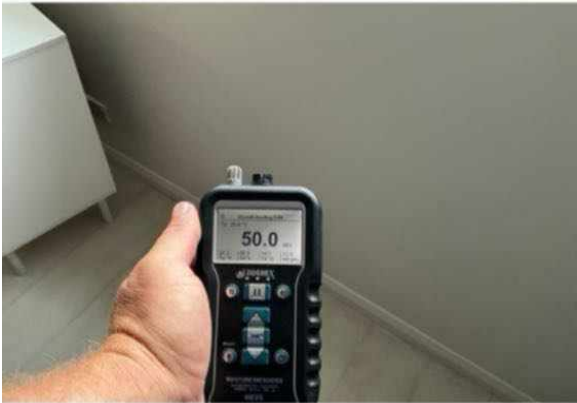
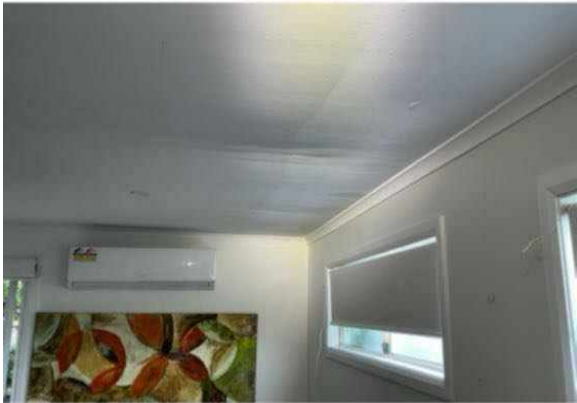
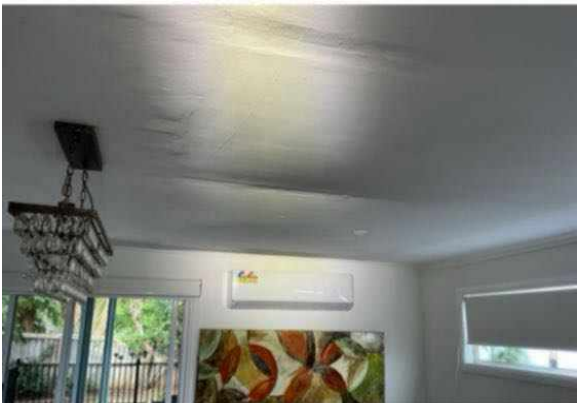
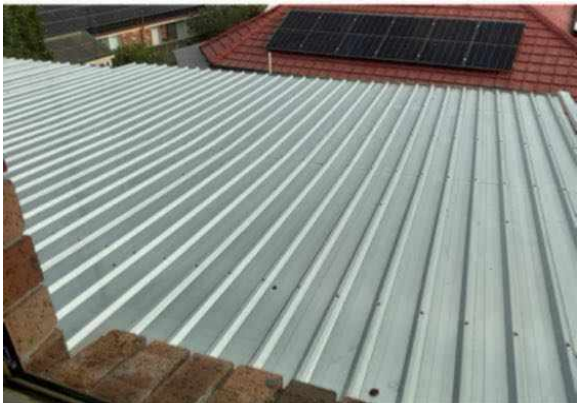
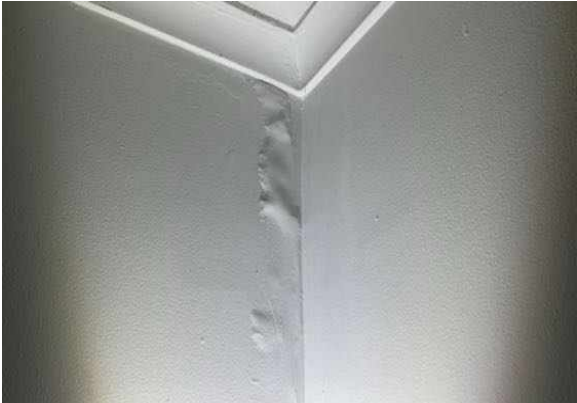
Building: Main Building
Location: Exterior walls
Finding: Rear Extension Significant Structural and Moisture Concerns (Unsafe Condition) Major structural repairs required.

During the inspection, the rear extension of the building was found to be in poor condition. The walls were observed to be bowed, the floor felt unstable under body weight, and both the ceiling and roof structure were sagging. These conditions indicate significant structural inadequacy and deterioration of supporting elements.

Elevated moisture levels were recorded within the internal walls, and peeling paint was observed, indicating prolonged or ongoing moisture intrusion. The combination of structural movement and moisture presence raises serious concerns regarding the integrity and safety of the extension.

The area is considered unsafe, and caution should be exercised when accessing or using this section of the building.

Immediate assessment by a qualified structural engineer and licensed builder is strongly recommended to determine the extent of structural failure and to implement appropriate remedial works prior to continued occupation or use.

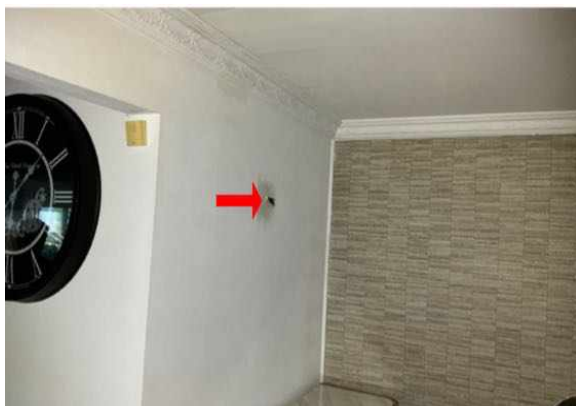
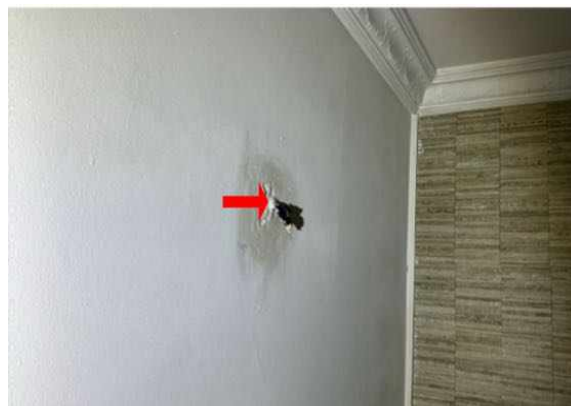
Finding 1.02

Building:	Main Building
Location:	Dining Room
Finding:	Electrical Wiring (Exposed)
Information:	Exposed electrical wiring was identified, posing a significant safety hazard, including risks of fire and personal injury. It is crucial to contact a licensed electrician immediately for further inspection, investigation, and rectification to address the potential danger.

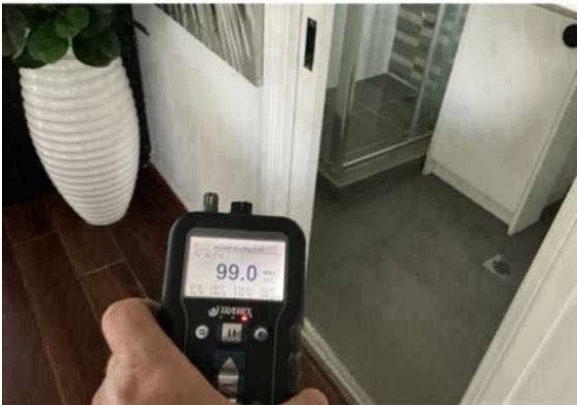
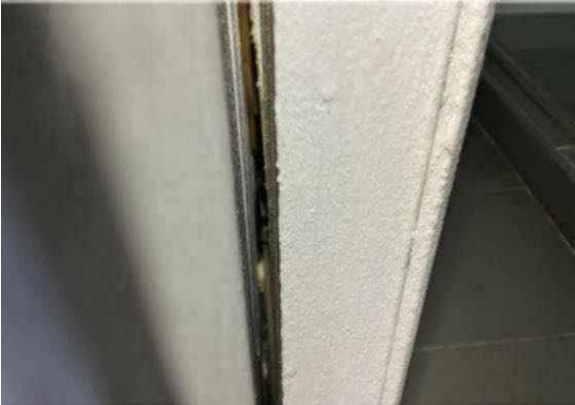
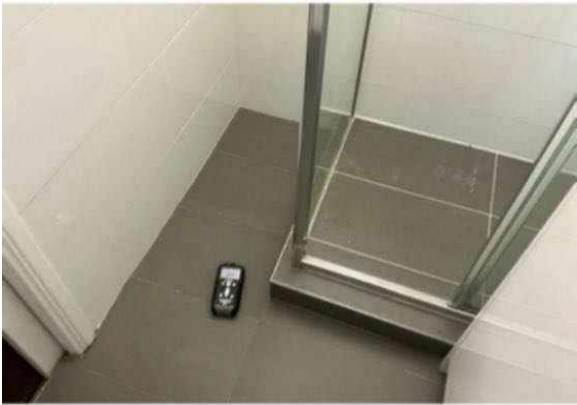
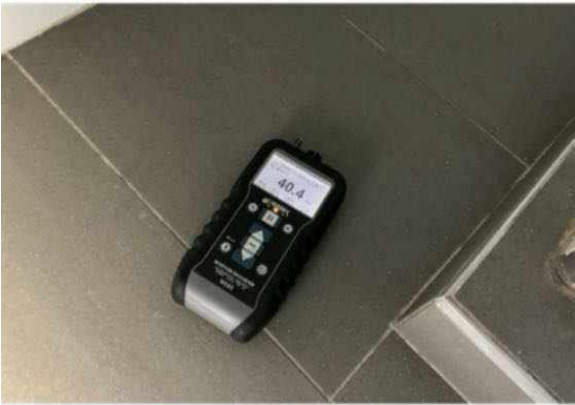
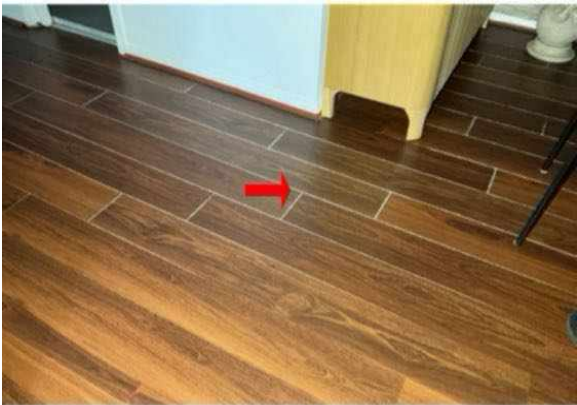
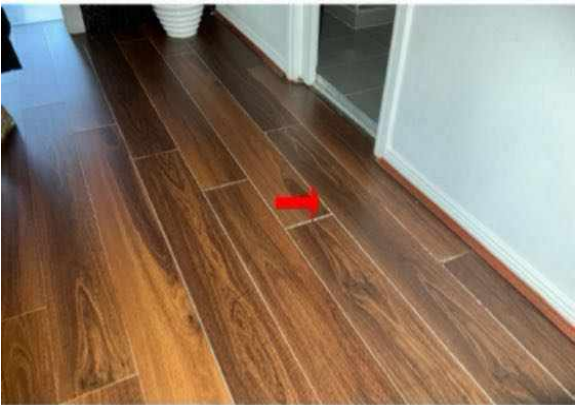
Finding 2.01

Building:	Main Building
Location:	Ground floor Bathroom and En-suite
Finding:	Showers (Elevated Moisture Efflorescence / water damage and wood rot found)
Information:

General ageing of the shower areas has resulted in deterioration of the sealant and grout, increasing the risk of water penetration behind the tiles.

Moisture testing confirmed elevated moisture levels beneath the tiled surface, both within the shower and extending beyond the immediate shower zone, indicating active water ingress into concealed spaces. Water damage and wood rot was also found in the sliding door and to the door jambs of the ground floor bathroom, confirming that moisture has migrated into adjacent building elements. In addition, damage to the internal flooring outside the bathrooms was identified on the ground floor and within the ensuite area, indicating that moisture has extended beyond the wet areas and is affecting surrounding finishes.

Prolonged moisture exposure in these areas can create conditions conducive to termite and timber pest activity, as well as fungal growth, timber decay, and potential structural deterioration of surrounding components.

It is recommended that a qualified bathroom renovation specialist or licensed builder be engaged to assess the full extent of moisture-related damage and undertake the

necessary remedial works, including renewal of waterproofing systems and replacement of affected materials. Timely intervention is strongly advised to prevent further deterioration and to ensure the long-term safety and integrity of the wet areas.

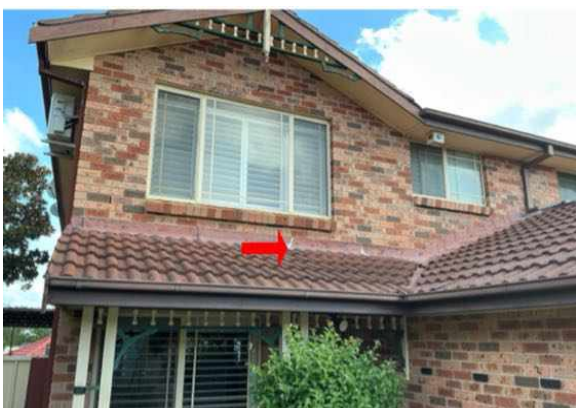
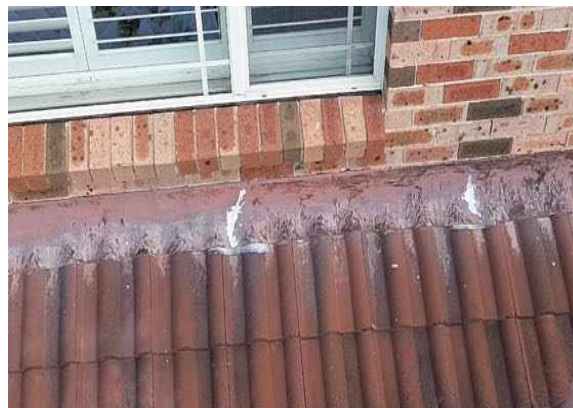
Finding 3.01

Building:	Main Building
Location:	Lower Roof
Finding:	Roof Flashing (Deteriorated)
Information:	<p>During the inspection, deterioration was evident in sections of the lower roof flashing. Flashings play a crucial role in weatherproofing roof joints and require regular inspection and maintenance due to their susceptibility to deterioration. To address this issue, repairs or remediation of the deteriorated flashings are recommended to ensure adequate roof protection against water penetration. Neglecting these repairs may lead to water damage and accelerated deterioration of associated building elements. It is advisable to appoint a roofing contractor or roofing plumber to adequately rectify this issue or potential leak.</p>

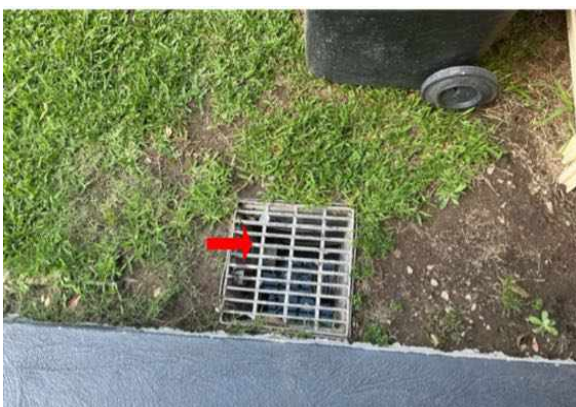
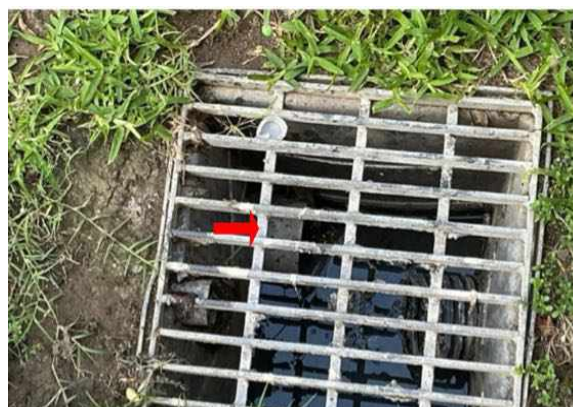
Finding 3.02

Building:	Main Building
Location:	Exterior walls
Finding:	Stormwater Pits Not Sealed
Information:	During the inspection, it was observed that the pipes entering the stormwater pit were not properly sealed or watertight. This condition may lead to water seepage, soil erosion, and the accumulation of moisture around the building's foundations, creating conditions conducive to termite activity and structural deterioration over time. It is recommended to engage a qualified plumber to assess and seal the stormwater pit connections appropriately. Ensuring a watertight stormwater system is essential to maintaining proper site drainage and protecting the property from moisture-related issues.

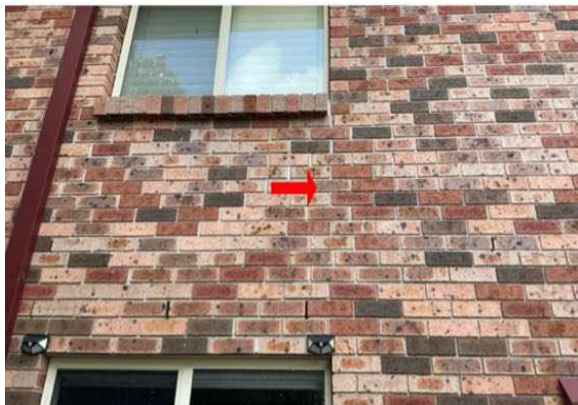
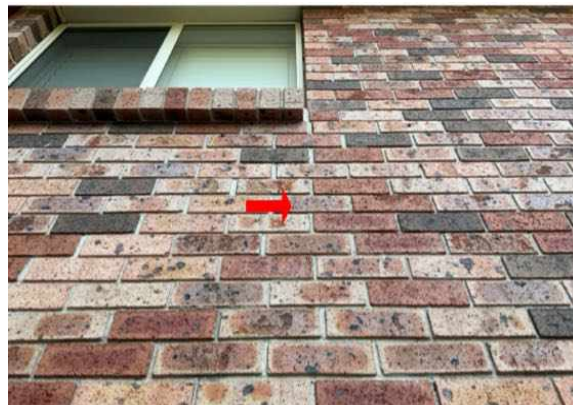
Finding 3.03

Building:	Main Building
Location:	Exterior walls
Finding:	Step Cracking to Exterior Brickwork
Information:	During the inspection, step cracking was observed in the exterior brickwork. This type of cracking is commonly associated with foundation movement or settlement and may result from factors such as environmental wear, nearby tree activity, or drainage issues contributing to soil movement over time.

It is recommended that the cracks be monitored and recorded over a period of several months, or up to one year (in consultation with a qualified professional), to assess whether progression is occurring. Monitoring will provide valuable information to assist a structural engineer in accurately determining the underlying cause and recommending appropriate remedial works to prevent further deterioration.

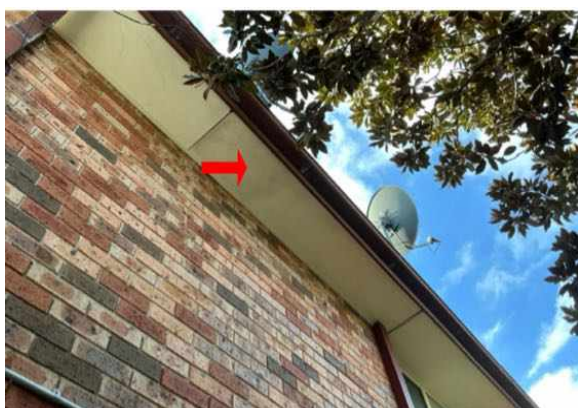
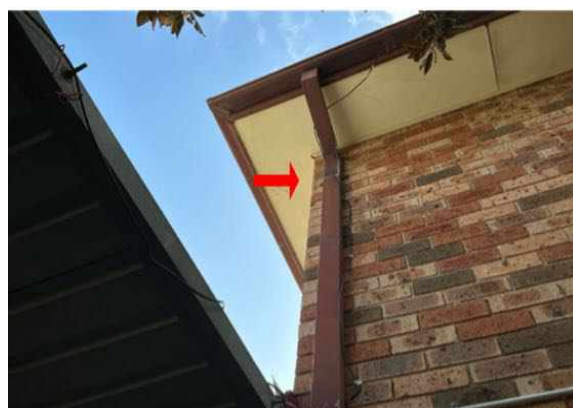
Finding 3.04

Building:	Main Building
Location:	Exterior walls
Finding:	Eaves (Water Damaged)
Information:	Evidence of water damage was observed on the eaves during the inspection, potentially stemming from various causes such as inadequate roof drainage or leaking roof plumbing. To address this issue effectively, it is recommended to schedule a consultation with a licensed plumber. They can provide expert advice on any necessary remedial works that may be required to mitigate further damage. On the other hand, in cases where water staining is old and inactive, clients have the option to repair the affected building materials at their discretion. This allows for flexibility in addressing cosmetic concerns without the urgency associated with active water intrusion.

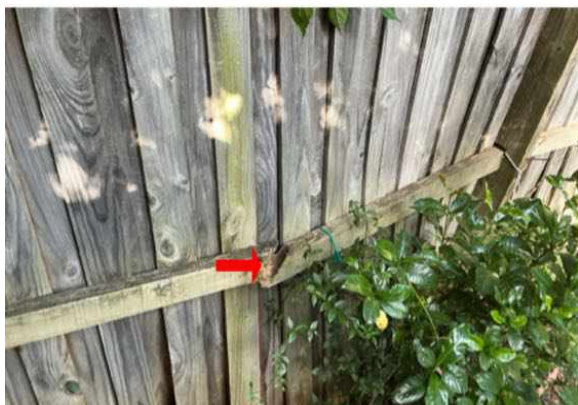
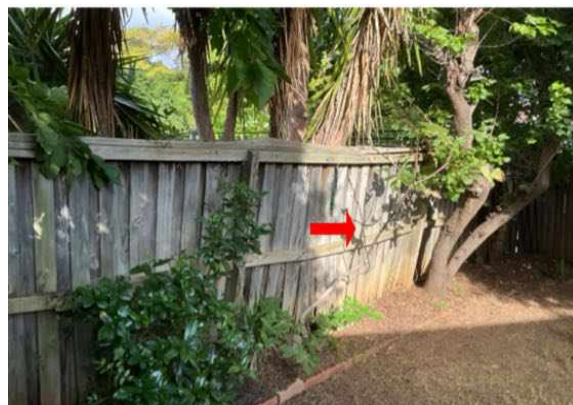
Finding 3.05

Building:	Main Building
Location:	All Areas
Finding:	Fencing (Deterioration Observed)
Information:	During the inspection, the property fencing was found to be in generally fair condition, however, some sections show signs of wear. This is likely due to factors such as the original design, material selection, environmental exposure, or the natural aging of the fence. Regular assessment and maintenance are advised to prevent further deterioration. It is also recommended to consult with a qualified fencing contractor for further advice.

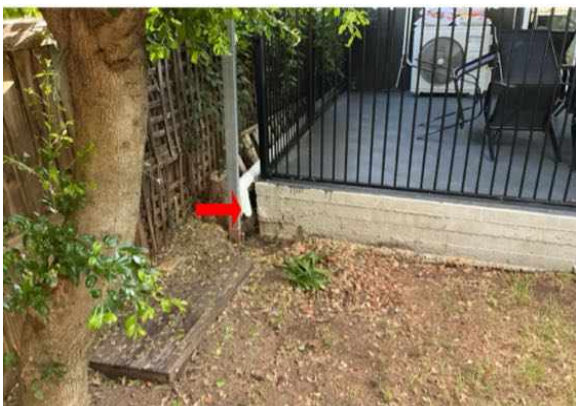
Finding 3.06

Building:	Main Building
Location:	Exterior walls
Finding:	Down Pipe (Disconnected)
Information:	Unfinished downpipes were observed during the inspection, posing a risk of water damage to the building under stormwater conditions. Proper management of rainwater is critical to prevent overflow and pooling against the base of walls, which can lead to issues such as rising damp. Moisture also creates an environment conducive to termite and timber pest activity, potentially compromising the integrity of the building.

To address these concerns, it is recommended to engage a qualified roof plumber to assess and perform the necessary remedial works. These works should ensure that downpipes effectively direct stormwater away from the building, maintaining dry conditions around the foundation and preventing secondary defects.

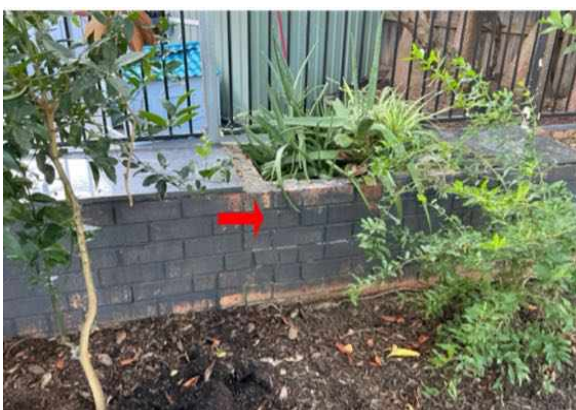
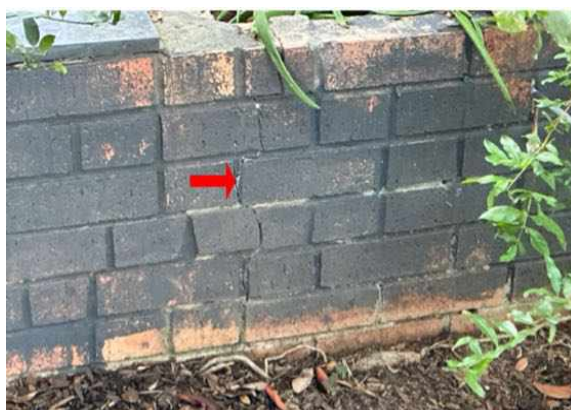
Finding 3.07

Building:	Main Building
Location:	Exterior walls
Finding:	Garden Bed (Step Cracking)
Information:	Step cracking or deterioration was observed in the garden bed brickwork, which is often a result of foundation movement. This can be due to poor installation or an inadequate foundation under the brickwork, or it may be caused by settling due to various factors such as environmental wear or drainage issues leading to soil erosion. It is recommended to monitor and record these cracks over several months, or up to a year (consult a qualified expert for guidance), to assess any progression before proceeding with repairs. This observation period will provide essential data to accurately determine the cause and recommend appropriate remedial actions to prevent further deterioration.

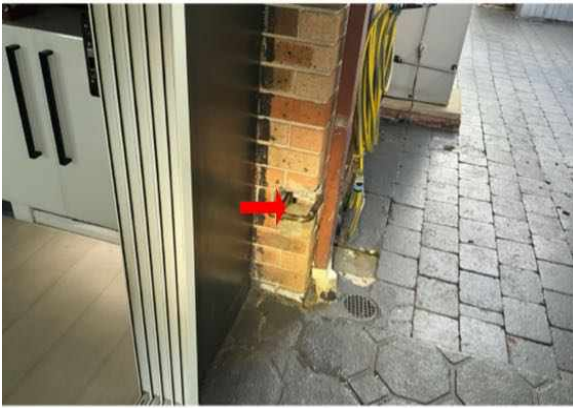
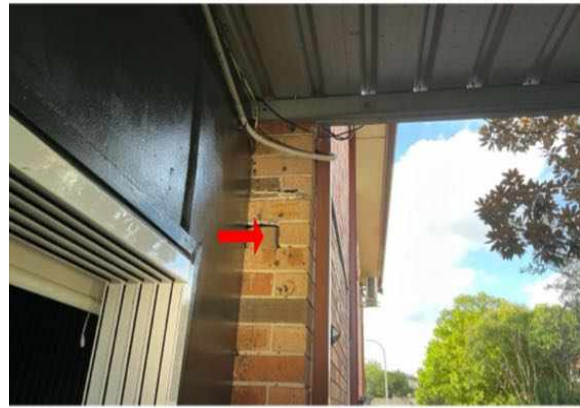
Finding 3.08

Building:	Main Building
Location:	Exterior walls
Finding:	Bricks Removed for Services
Information:	During the inspection, bricks were observed to have been removed to accommodate additional services. The affected areas have been left unfinished, exposing openings

within the masonry.

Unfinished brickwork can compromise the weather resistance and integrity of the wall and may allow moisture ingress or pest entry. It is recommended that a qualified bricklayer reinstate and properly finish the affected sections to restore the integrity and appearance of the masonry.

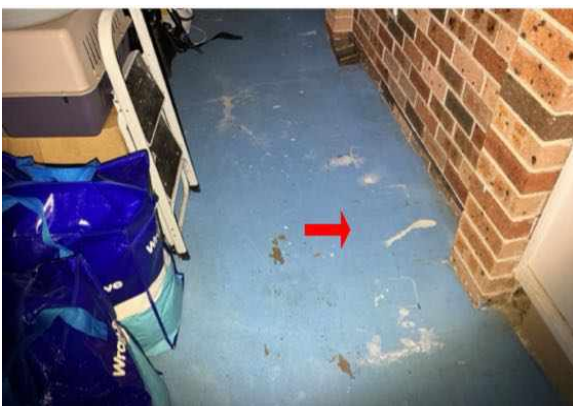
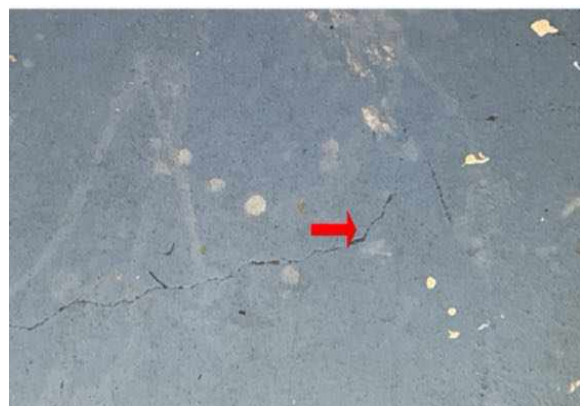
Finding 3.09

Finding: Garage Concrete Slab Cracks (Category 0)

Information: A Category 0 crack, characterised as hairline crack indicating minimal movement of the slab from its original level, was observed in the garage slab. To be classified as Category 0, a crack typically requires an approximate width of 1mm or less. At this point, immediate rectification is not necessary. However, it is recommended to monitor all cracks over a 12-month period to identify any further movement. This monitoring is essential to ensure that any changes in the slab's condition are promptly recorded and addressed if necessary.

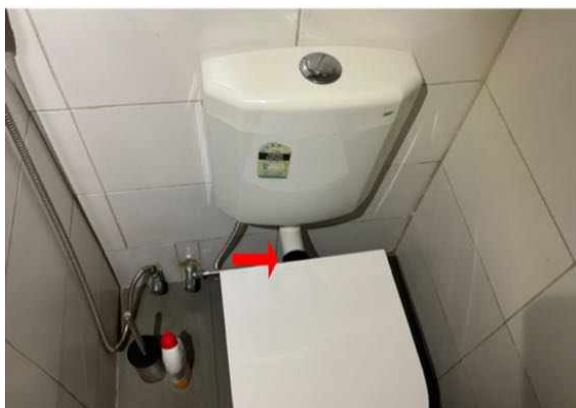
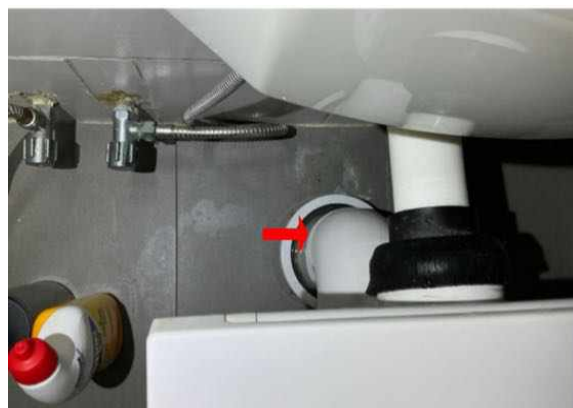
Finding 3.10

Location: Bathroom > Ground Level
 Finding: Leaking Toilet
 Information: The toilet was observed to be leaking during operation, with visible water around the tiles surrounding the toilet. To address this issue, it is essential to schedule an appointment with a licensed plumber. Until the leak is repaired, it is advisable to minimize the use of the toilet to prevent further water damage.

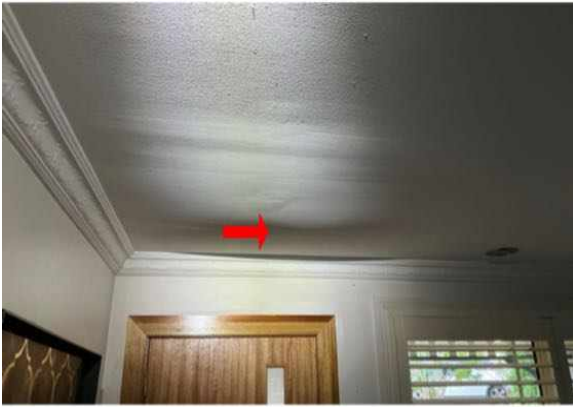
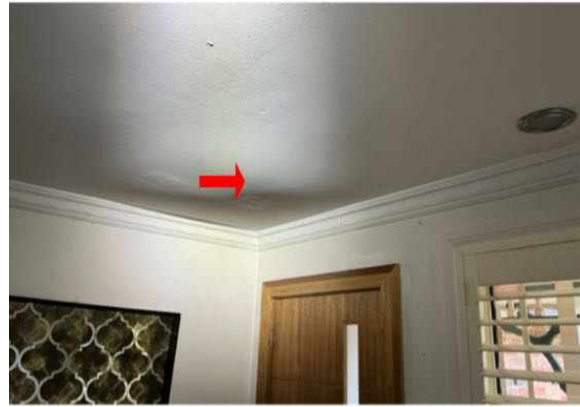
Finding 3.11

Building: Main Building
 Location: Family Room
 Finding: Sagging Ceiling Above Entry Door
 Information:

During the inspection, the ceiling above the entry door was observed to be sagging. An external assessment identified that the flashing on the lower roof in this area is deteriorated, which may have contributed to water ingress and subsequent ceiling damage.

Deteriorated flashing can compromise the weatherproofing of the roof and allow moisture to penetrate internal linings. It is recommended that a qualified roofing contractor repair or replace the affected flashing to prevent further water ingress. Once the source of moisture has been rectified, repairs to the sagging ceiling should be carried out by a qualified tradesperson. Monitoring is also advised to ensure no ongoing moisture issues remain.

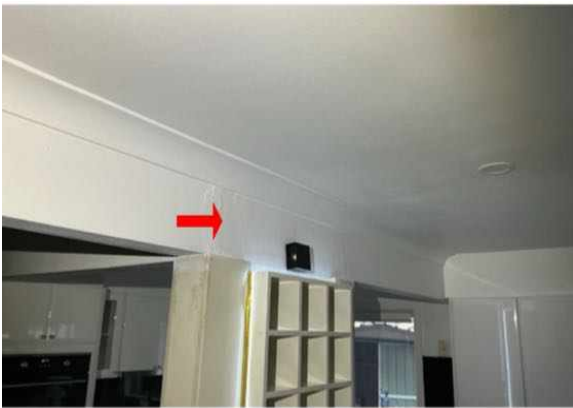
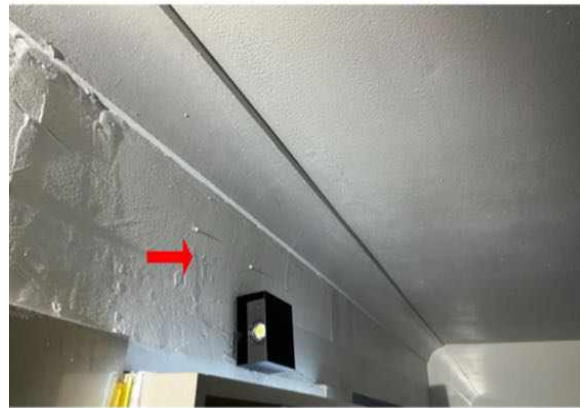
Finding 3.12

Building:	Main Building
Location:	All Areas
Finding:	Cosmetic Paint Defects
Information:	Incomplete paint coverage, minor blemishes, over-painting, missing paint finish, and colour variations are generally considered cosmetic defects. These irregularities are common in many properties and may be more noticeable under certain lighting conditions, while being less apparent in low light.

This is a straightforward maintenance task. To improve the overall appearance and achieve a consistent finish, it is advisable to engage a qualified painter to address the affected areas, enhancing both the visual appeal and the durability of the painted surfaces.

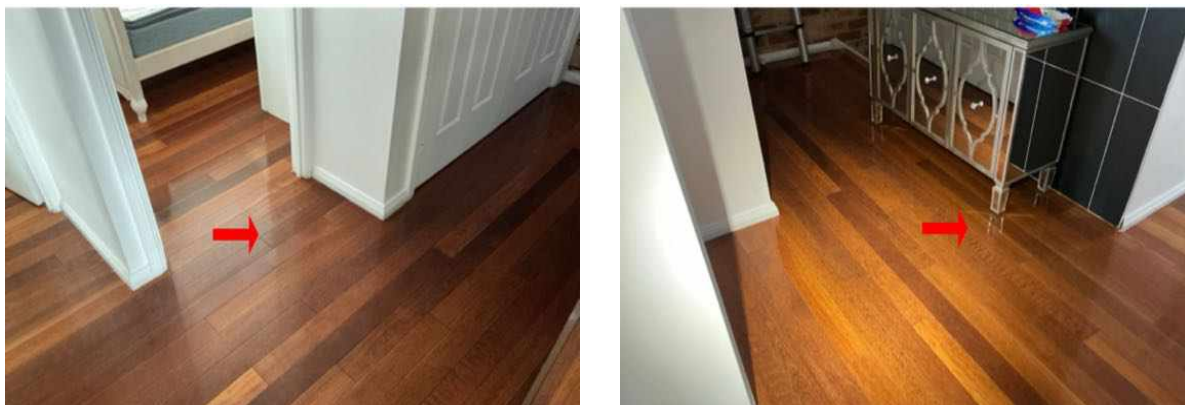
Finding 3.13

Building:	Main Building
Location:	All Areas
Finding:	Uneven Internal Flooring (Upstairs)
Information:	During the inspection, noticeable unevenness and out-of-level conditions were observed in the internal flooring of the bedrooms, as depicted in the photos provided. It is recommended that the flooring be closely monitored over an extended period,

such as several months, to detect any further movement or deterioration. Should the unevenness become more pronounced, a more invasive inspection may be required to thoroughly assess the underlying building structures. This could involve removing ceiling and wall linings beneath the affected areas to identify and rectify the root cause of the issue.

In cases where structural issues are confirmed, repairs should be undertaken by a registered builder to ensure compliance with building standards and to restore the integrity and functionality of the flooring.

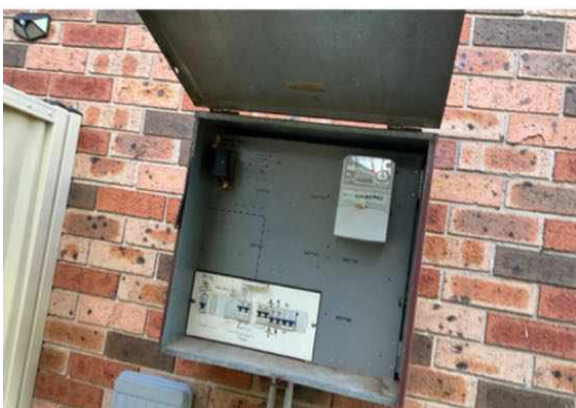
Finding 6.01

Building:	Main Building
Location:	Meter Box
Finding:	Termite Management (No Evidence of a Chemical Installation)
Information:	During the inspection, it was noted that no termite management system had been installed, and there was no evidence of preventative works. Applying a post-construction chemical termite barrier is essential for all properties, as these barriers are highly effective in preventing termite attacks on timber building elements. A durable notice should also be prominently displayed in the meter box to ensure awareness of the termite barriers in place. It is important for the client to seek further professional advice on implementing a termite management system. Failure to address this leaves the property vulnerable to potential termite infestations.

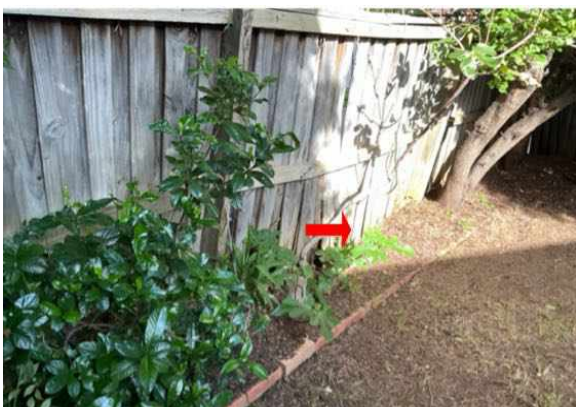
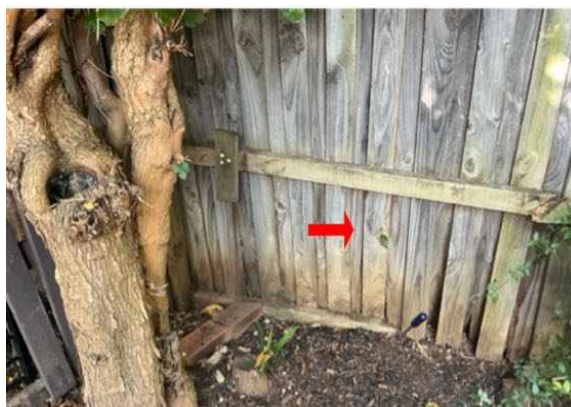
Finding 6.02

Building:	Main Building
Location:	All Areas
Finding:	In Contact With The Ground
Information:	During the inspection, wood and timber materials were observed in direct contact with the ground. This condition is highly conducive to timber pest activity, particularly termites, as it provides an ideal environment for infestation and timber decay due to elevated moisture levels, concealment, and direct access to cellulose material. Untreated or inadequately protected timber in ground contact significantly increases the risk of concealed termite entry and potential structural damage.

To reduce the risk of infestation, all ground-contacting timber should be promptly removed. It is recommended to engage a qualified pest control to assess the subfloor and implement appropriate termite management system, in accordance with AS 3660.2. Regular timber pest inspections, ideally every 90 days, are advised until all conducive conditions have been fully addressed.

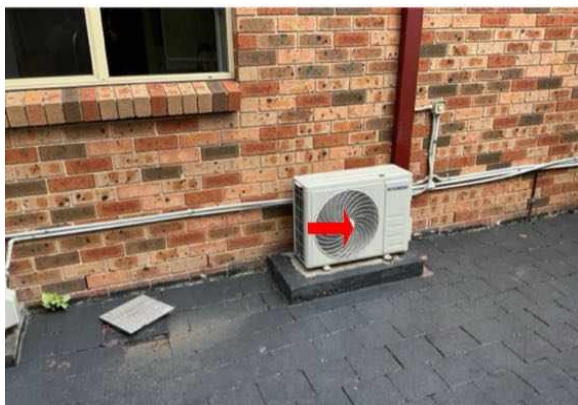
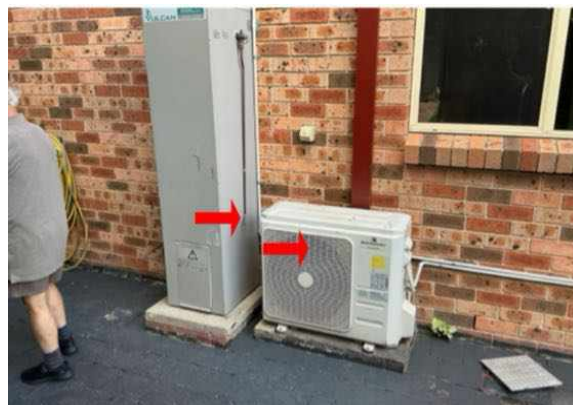
Finding 6.03

Building:	Main Building
Location:	Exterior walls
Finding:	Overflows Not Connected

Information: During the inspection, it was observed that the overflows are not connected to the stormwater drainage system. This condition may result in moisture accumulation around the property and creating conditions conducive to termite activity. To mitigate these risks, it is recommended to engage a qualified plumber to connect the overflows to the stormwater drainage system. This will prevent excessive moisture accumulation, reduce the risk of termite infestations, and protect the surrounding structures from potential water-related deterioration.

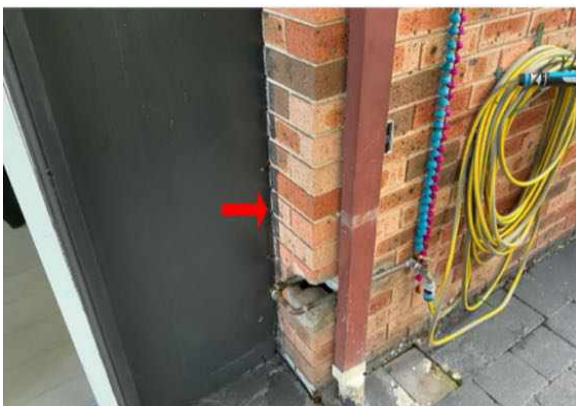
Finding 6.04

Information: Bridging of a termite physical barrier occurs when termites bypass a preventative measure designed to block or expose their access to a structure. This can happen when soil, vegetation, or debris accumulates against exterior walls above the barrier level. Appliances such as hot water units and air conditioning systems, or wooden structures like decks and porches that touch the ground and connect to the main building, can also contribute to bridging. Even structural modifications may unintentionally create pathways that allow termites to bypass barriers or inspection zones. These breaches provide termites with a direct and often undetectable route into the property, increasing the risk of substantial and unnoticed infestations that can cause extensive structural damage.

To safeguard your property from termite infestations, it is essential to maintain a minimum clearance of 75mm from the exposed slab edge. This clearance forces termites into the open, where they can be more easily detected during regular inspections. If this clearance is not achievable, it is crucial to conduct consistent timber pest inspections every 30 days or implement a post-construction termite management system compliant with Australian Standard AS 3660. Taking these precautionary measures helps ensure the property remains protected from termite threats and allows for early detection and intervention.

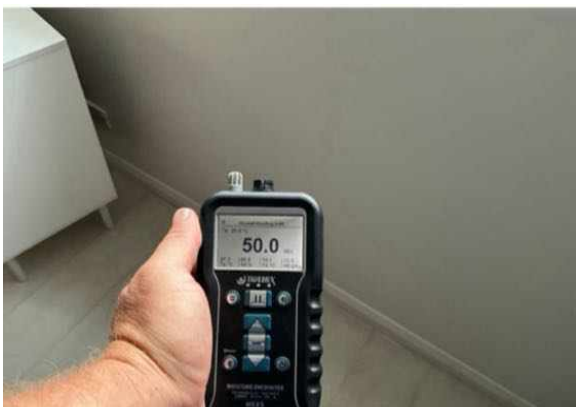
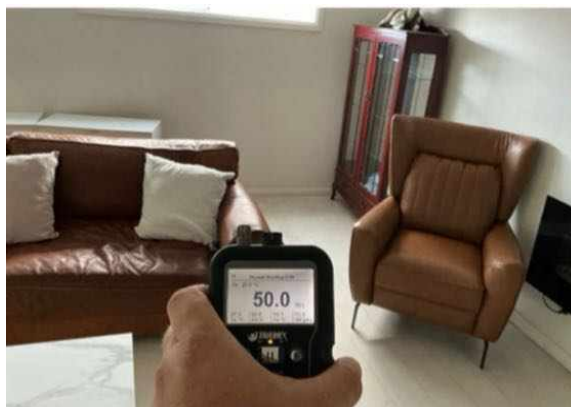
Finding 6.05

Building: Main Building
 Location: All Areas
 Finding: Elevated Moisture Levels Rear Extension (Termite Risk)
 Information:

During the inspection, elevated moisture levels were recorded within the rear extension of the building. Persistent damp conditions can accelerate material deterioration and create an environment conducive to termite and timber pest activity.

It is recommended that the source of moisture be identified and rectified promptly. Improving drainage, ventilation, and repairing any water ingress points is advised. A timber pest inspection is also recommended to assess any existing or potential termite activity in the affected area.

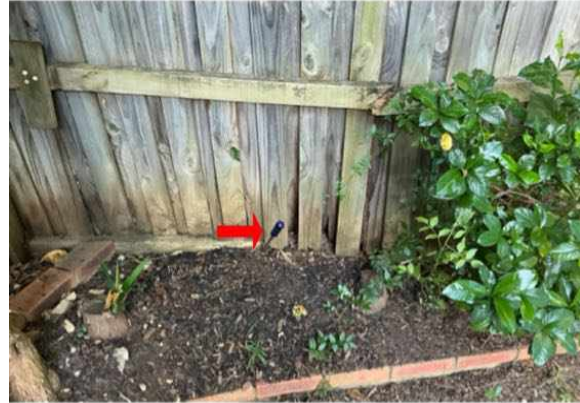
Finding 7.01

Building: Main Building
 Location: All Areas
 Finding: Wood Rot / Fungal Decay

Information: Wood rot was found in the exterior timbers, a condition commonly caused by prolonged moisture exposure. This accelerates the decay process and creates an environment conducive to termite activity and fungal growth. To prevent further deterioration and reduce the risk of termite infestations, it is essential to replace the affected timber with treated or moisture-resistant alternatives. It is recommended to engage a qualified carpenter or landscaper to undertake the necessary replacements and ensure the long-term durability of the building materials.

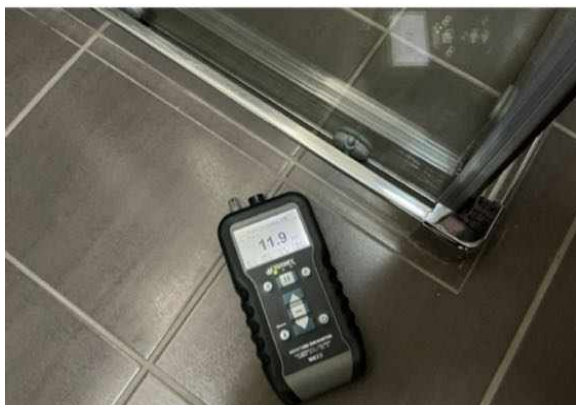
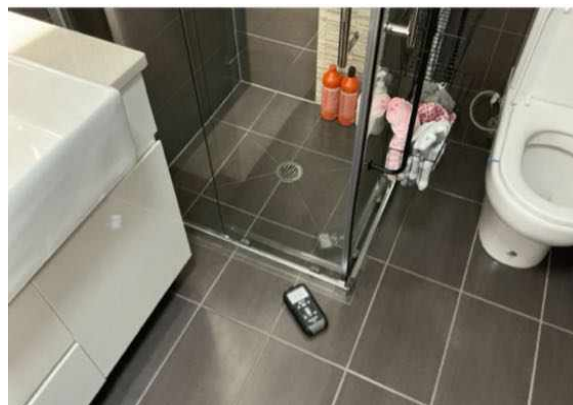
Building:	Main Building
Location:	Main Bathroom
Finding:	Shower (For Your Information)
Information:	The shower was inspected by assessing the moisture content of the surrounding floor and walls, and no signs of moisture or moisture damage were detected in the accessible and visible areas at the time of inspection. To maintain the integrity of these areas, periodic inspections and routine maintenance of wet areas are essential. If any remedial work is needed, addressing it promptly will help prevent minor issues from escalating into more significant problems. This proactive approach ensures the long-term durability and functionality of the shower areas.
