Building and Timber Pest Inspection Report

Inspection Date: Tue, 10 Feb 2026

Property Address: 52 Ridgeline Dr, The Ponds NSW 2769, Australia

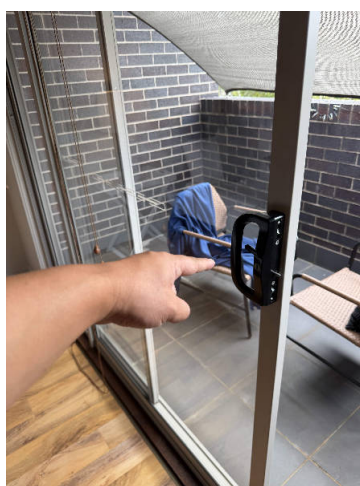
Information: The door in this area was jammed and difficult to slide along the associated tracks at the time of the inspection. Restricted function of the affected door may pose as a potential safety hazard if required for emergency egress from the building.

Generally, factors such as general age of the building element and a lack of maintenance are the usual causes for this type of defect.

Replacement of door hardware or tracks may be required, as well as minor repairs and cleaning. A registered builder or general handy person will be required to repair the affected doors.

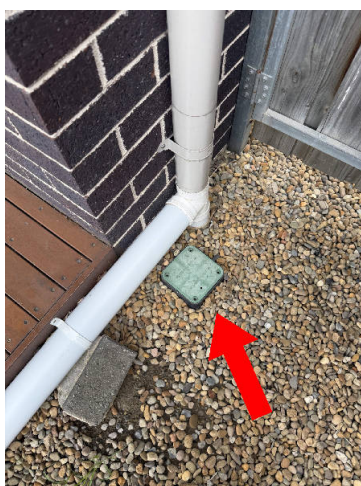
Finding: Garden Beds - Conditions Conducive to Termites

Information: Garden beds were found to be evident in close proximity to the building. Garden beds immediately adjacent to the perimeter of the building block the visual inspection of these areas providing a concealed termite entry point.

Garden beds can include untreated timber and a combination of moisture from watering produce conditions conducive to termite activity and ingress.

Further advice from a Timber Pest Technician is required to ensure appropriate Termite Management systems are implemented.

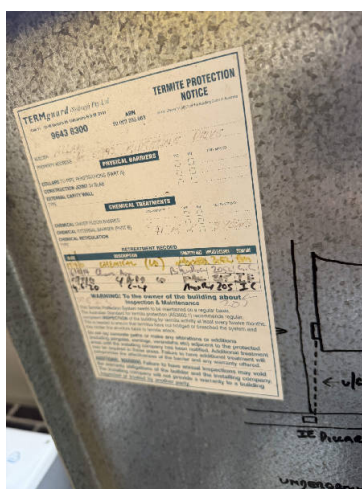
Noted Item

Building:	Main Building
Location:	Electrical Switchboard
Finding:	Evidence of a previous termite management system was identified

Where a Termite Management System has been identified you should refer to the type of barrier date of installation warranty conditions and any documentation provided by a builder or past owner. Consult the company who installed the barrier to confirm whether the system is still under warranty.
