Building and Timber Pest Inspection Report

Inspection Date: Tue, 17 Feb 2026

Property Address: 23 Corkwood Pl, ACACIA GARDENS, NSW,
2763, Australia

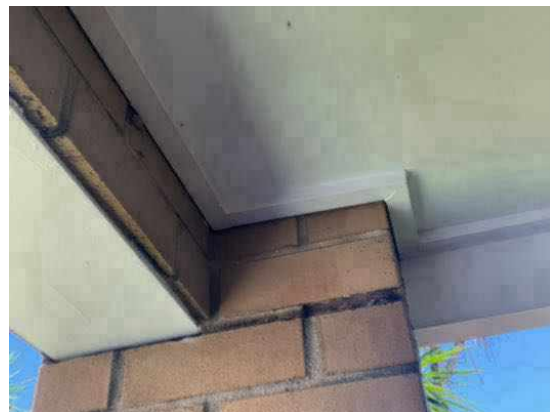
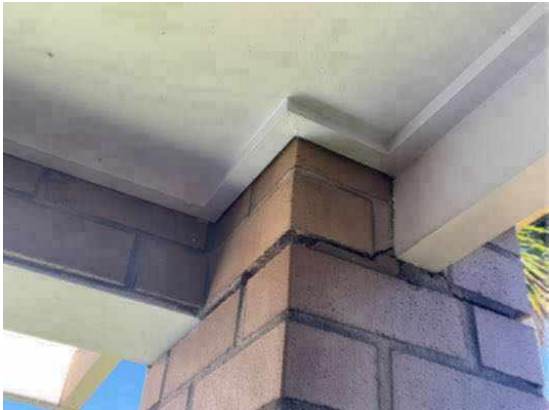
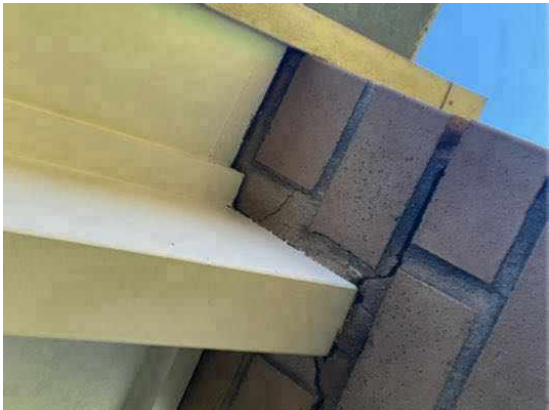
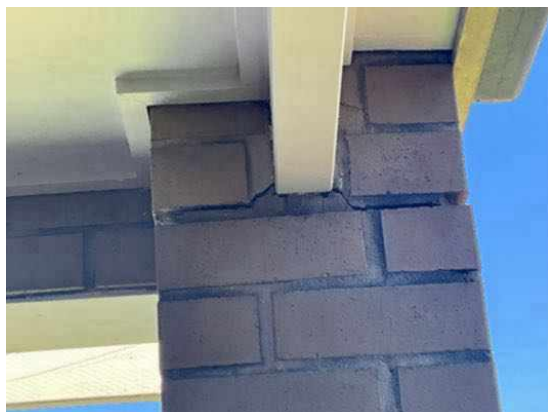
Building: Main Building
Location: Front Elevation
Finding: Movement and Mortar Deterioration – Brick Pier (Front Porch)
Information: Deterioration of mortar joints and displacement of bricks were observed to the brick pier at the front porch at the point where the roof beam bears onto the masonry support. The condition is consistent with structural movement and affects a loadbearing element.

As the pier supports roof framing, further movement may impact structural stability. Assessment by a qualified structural engineer or experienced builder is recommended to determine the cause and appropriate rectification.

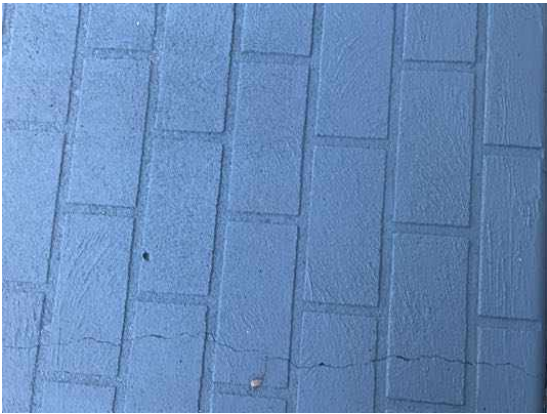
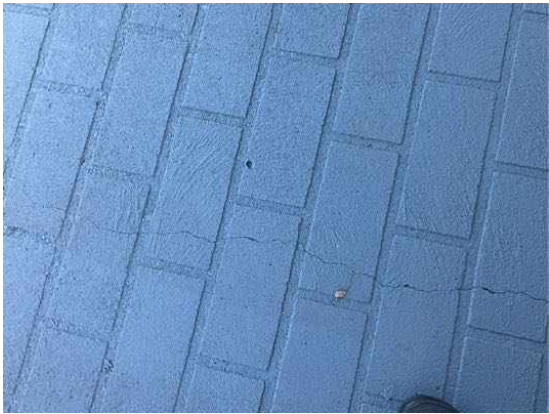
Finding 3.01

Building:	Main Building
Location:	All Areas
Finding:	Crack in concrete slab - Category 2
Information:	A crack coded as Category 2 was identified in the slab. A Category 2 crack is described as a distinct crack, with the slab being noticeably curved or changed in level.

To be considered Category 2, the approximate width of the crack is less than 2.0mm, or a change in offset of less than 15mm when a 3m straight edge is placed over the defect.

Category 2 cracks to slabs should be monitored for a period of 12 months. At the end of the monitoring period, cracks rated greater than Category 2 are considered defects that require rectification.

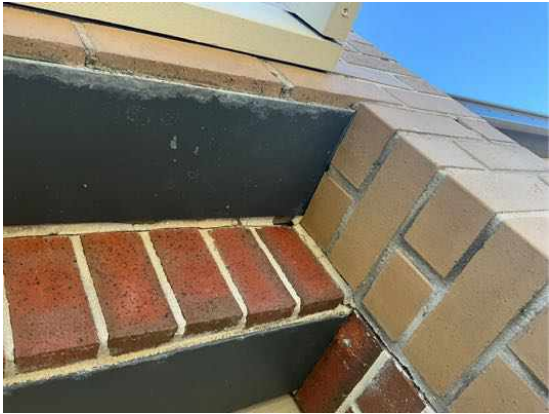
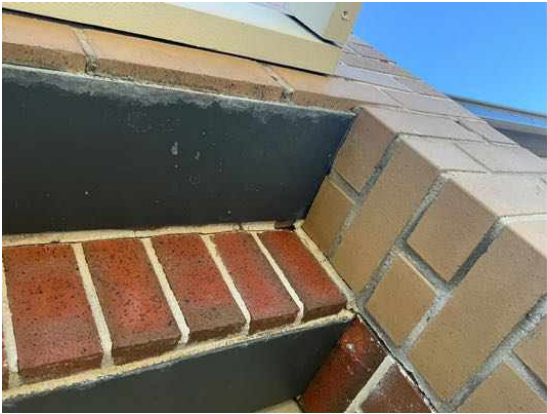
Finding 3.02

Building: Main Building
Location: All Areas
Finding: Brickwork - Deteriorated mortar
Information: Mortar, or 'bedding', is the material which fills joints and intersections between bricks in masonry walls and structures. Sections of mortar in this brickwork were identified as having deteriorated, which is generally expected for a property of this age and condition.

Mortar may deteriorate as a result of age of building materials, minor movement of bricks, or frequent exposure to weathering. Mortar should be replaced to ensure that bricks remain in their intended location and to prevent gaps, which would allow water or moisture ingress and secondary damage as a result.

Mortar deterioration can be addressed by a bricklayer where areas of deterioration are localised and easily accessible. Alternatively, appointment of a registered builder is advised, to repoint large areas of decaying mortar. Where secondary structural defects have become evident, consultation with a structural engineer may be required.

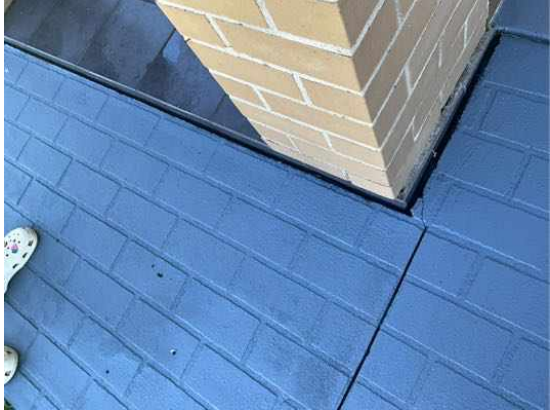
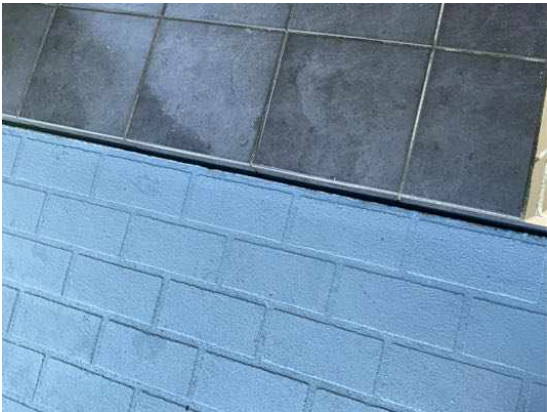
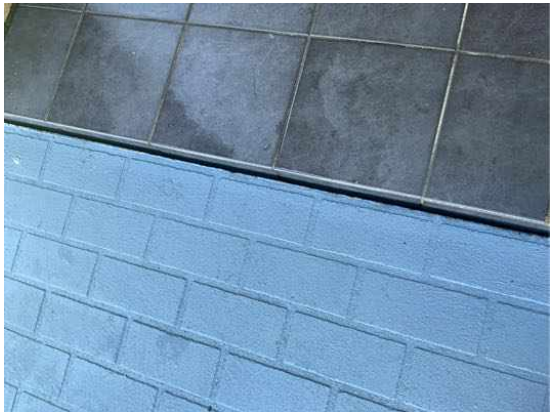
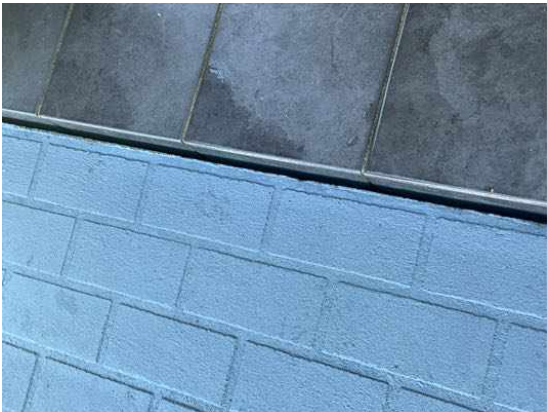
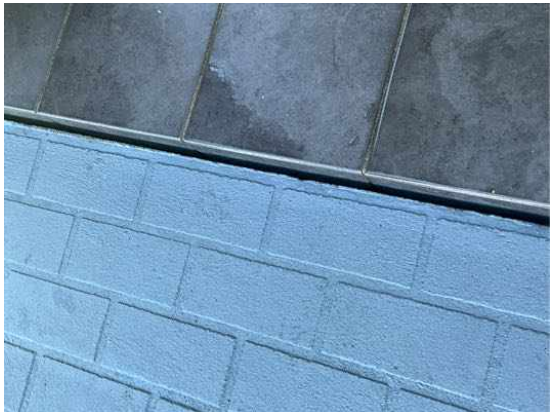
Building:	Main Building
Location:	Yard - Front
Finding:	Gaps in perimeter pavement
Information:	Gaps in the external concrete paving were identified at the time of inspection. Gaps in the slab are significant and are likely to lead to the development of secondary defects if left unmanaged, such as the creation of a trip hazard and water entry points.

With reactive clay soils, it is extremely important to ensure that all stormwater flows including roof and ground flows, contained and continually maintained. High moisture also creates an environment that is conducive to termite attack.

A licensed Plumber should be appointed immediately to ensure that the stormwater pipework is intact and adequate, and all gaps to concrete, driveways and paths should be sealed by a licensed builder or a general handy person to keep moisture from entering.

A licensed concretor may be required to replace pavements that are beyond repair.

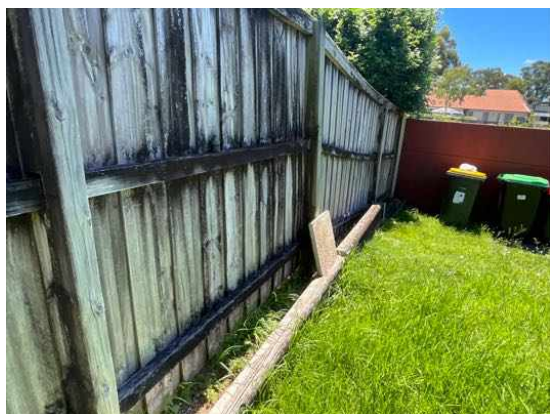
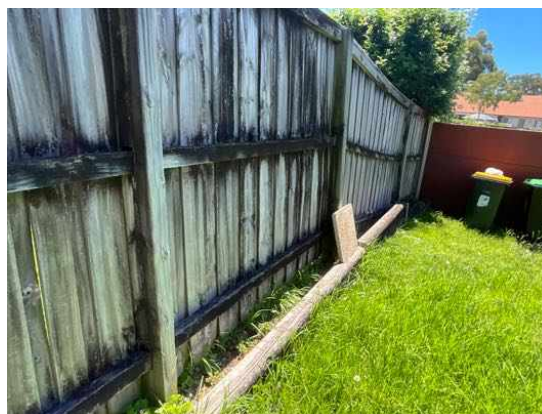
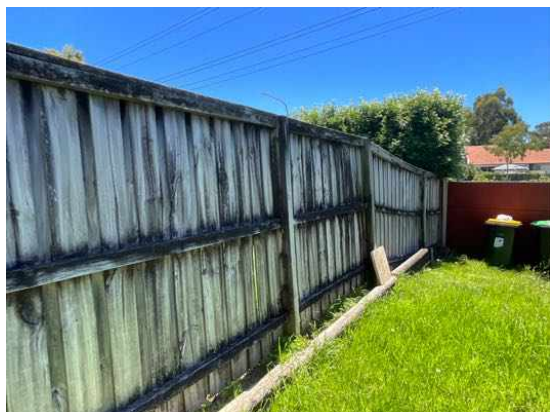
Finding 3.05

Building:	Main Building
Location:	All Areas
Finding:	Detoriated fence
Information:	The fence along the property boundary has deteriorated significantly, showing signs of rot, rust, and structural weakness. Several sections are leaning or have become detached, compromising the integrity of the fence and its ability to perform its intended function.

The deteriorated fence poses multiple risks:

1. **Safety Hazard:** The unstable fence may collapse, posing a risk of injury to residents, visitors, and passersby.
2. **Security Concern:** The compromised fence may allow unauthorized access to the property, increasing the risk of theft, vandalism, or trespassing.
3. **Property Damage:** Falling sections of the fence could damage nearby structures, plants, or other property features.
4. **Legal Liability:** If the fence were to fail and cause injury or damage to neighboring properties, the property owner may be held liable.

- **Licensed Fencing Contractor:** A professional fencing contractor should be hired to assess the extent of the damage and either repair or replace the deteriorated sections.
- **Handyman Services:** For minor repairs, a qualified handyman could be engaged to reinforce or repair specific sections of the fence.
- **Landscaper (if the fence is part of a larger garden feature):** If the fence is integrated into the landscape design, a landscaper with experience in fencing could be involved in the repair or replacement process.

It's important to ensure that whoever is hired is experienced and qualified to ensure the fence is restored to a safe and functional condition, compliant with local regulations.

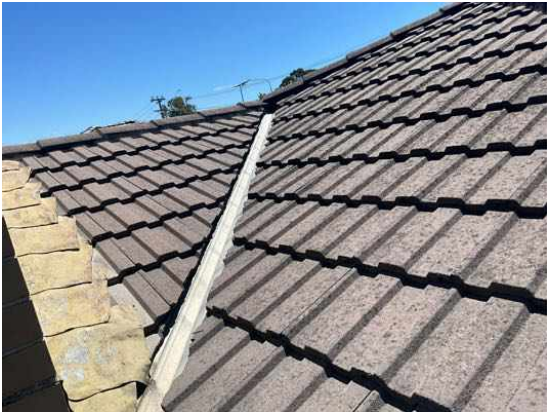
Information: Inspection of the roof revealed widespread weathering to the tiled roof surface. The tiles show loss of surface finish, colour fading, and age-related deterioration typical of older roof coverings. Although no significant cracking was noted, weathering can lead to increased porosity, reduced water-shedding capability, and a higher risk of future cracking or displacement during adverse weather conditions.

A licensed roofer should be engaged to undertake a closer inspection, carry out routine maintenance, and replace any tiles that may be compromised. Ongoing monitoring is recommended due to the age and condition of the roof covering.

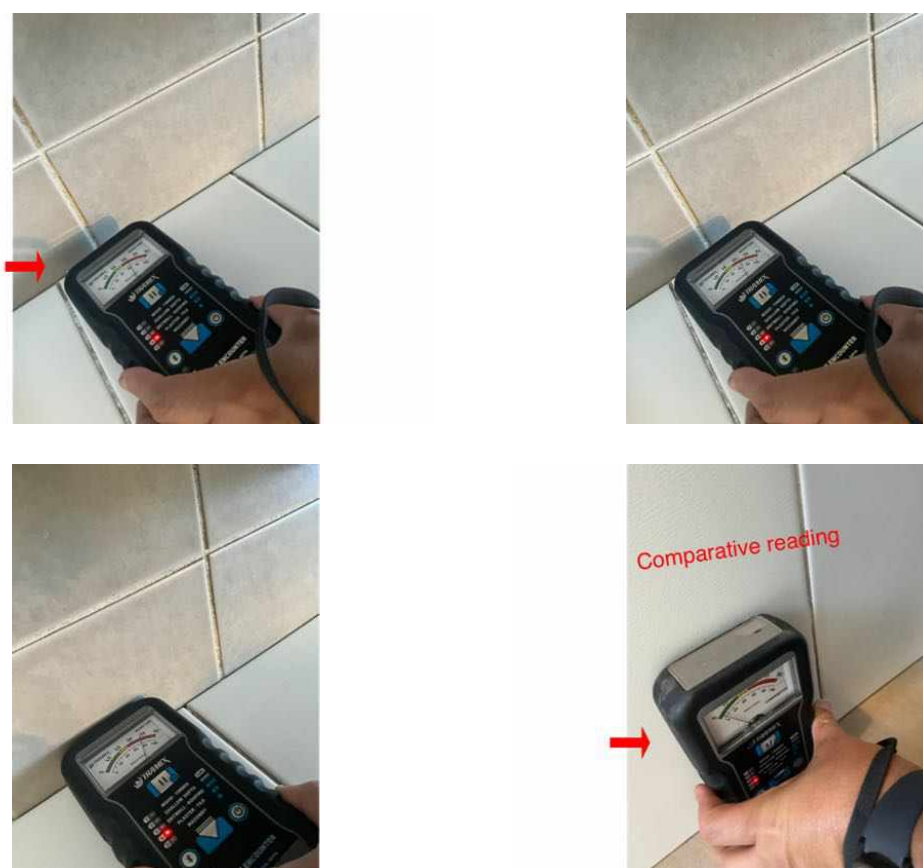
Building:	Main Building
Location:	Ensuite
Finding:	Shower - Damp
Information:	Damp is evident to the lower 300mm of wall to the shower alcove. This defect is quite common, and is suspected to have been caused by moisture permeating through the grouting in this area, which shows evidence of deterioration. Leaking pipes within the adjoining wall is also a possible cause.

Damp (or structural damp) refers to the presence of unwanted moisture in the structure of a building, either as the result of intrusion from outside, or condensation from within the structure. In the shower area, internal water leaks or other sources of excessive moisture are generally the cause of damp.

Unmanaged damp in the shower recess is likely to facilitate the formation and development of mould and fungi growth, decaying associated building materials and compromising their structural integrity. It is important to address damp conditions, as

Consultation with a qualified plumber or bathroom specialist is advised immediately to identify the cause of damp and to perform remedial works as required. Where excessive mould growth is present, further inspection by a specialist environmental health inspector should also be considered.

Always ensure that sealant and grout is in good condition to prevent any moisture issues occurring in the future.

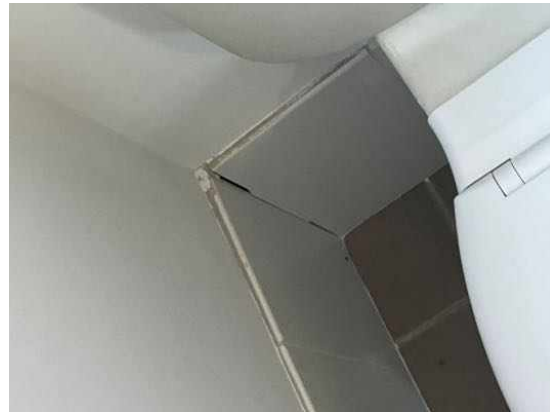
Finding 3.15

Building:	Main Building
Location:	Ensuite
Finding:	Sealant and grouting - Missing or damaged
Information:	It was noted on inspection that sealant or grout is degraded to the tiled shower alcove and or other areas of the bathroom.

Different materials and floor areas move at different rates, generally causing cracking to grout or sealant at this point. A flexible sealant is required to allow for expected

There appears to be excessive mould to the sealant and grout which will likely require scraping out and replacement.

Flexible and mould resistant materials should be applied to affected areas to prevent any subsequent water damage that is likely to occur. Regular maintenance and replacement of damage or missing or damaged sealant and grout is highly recommended to the wet areas, as this is a regular wear and tear defect. Sealant and grouting in areas that come into regular contact with water should be maintained for the long term care of your property.

A sealant specialist or tiling contractor should be appointed to complete these works as soon as possible

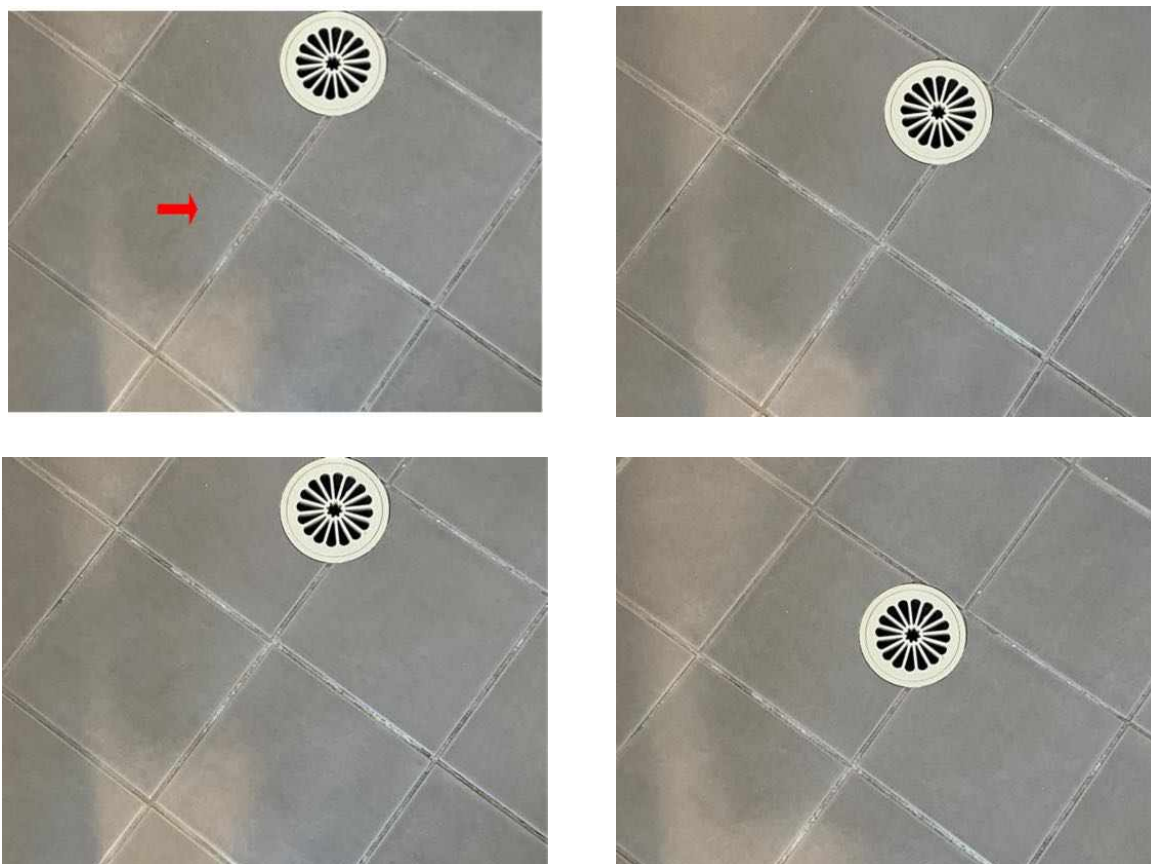
Finding 3.20

Building:	Main Building
Location:	Bathroom
Finding:	Sealant and grouting - Missing or damaged
Information:	It was noted on inspection that sealant or grout is degraded to the tiled shower alcove and or other areas of the bathroom.

Flexible and mould resistant materials should be applied to affected areas to prevent any subsequent water damage that is likely to occur. Regular maintenance and replacement of damage or missing or damaged sealant and grout is highly recommended to the wet areas, as this is a regular wear and tear defect. Sealant and grouting in areas that come into regular contact with water should be maintained for the long term care of your property.

A sealant specialist or tiling contractor should be appointed to complete these works as soon as possible

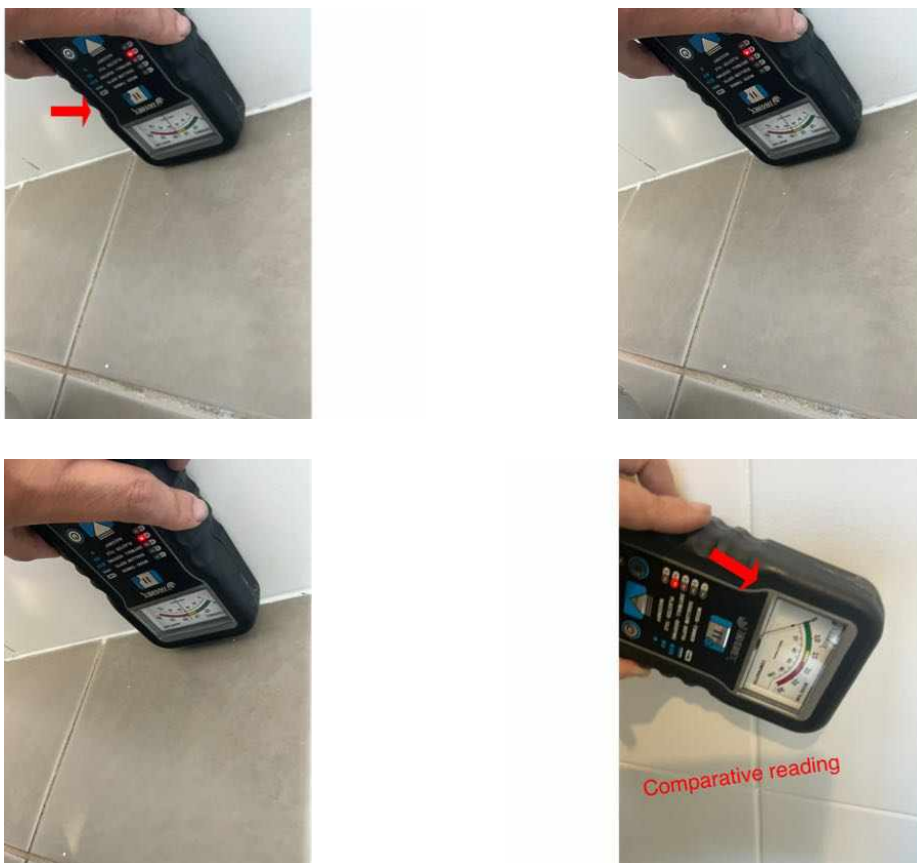
Finding 3.21

Building:	Main Building
Location:	Bathroom
Finding:	Shower - Damp
Information:	Damp is evident to the lower 300mm of wall to the shower alcove. This defect is quite common, and is suspected to have been caused by moisture permeating through the grouting in this area, which shows evidence of deterioration. Leaking pipes within the adjoining wall is also a possible cause.

Consultation with a qualified plumber or bathroom specialist is advised immediately to identify the cause of damp and to perform remedial works as required. Where excessive mould growth is present, further inspection by a specialist environmental health inspector should also be considered.

Always ensure that sealant and grout is in good condition to prevent any moisture issues occurring in the future.

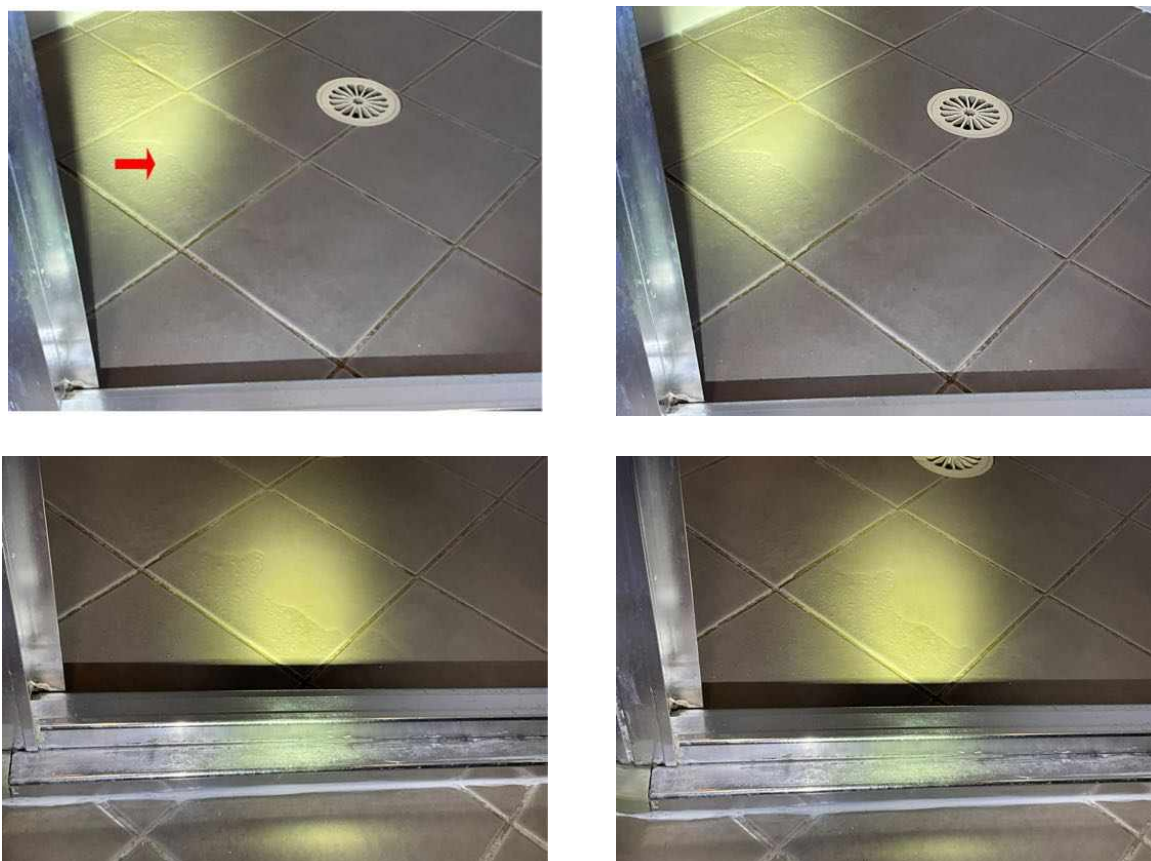
This pooling is minor overall but is still considered unsatisfactory, as standard tiling practices would not permit this situation to occur. Pooling water around floor wastes can create a slip hazard in extreme cases and create conditions that are conducive to mould growth over time. Where left unmanaged, the degradation of sealant and grouting is also likely to occur, possibly necessitating further repair works.

Remedial works may involve some sections of tiling and flooring repair and replacement. A tiling contractor or bathroom specialist should be appointed to provide further advice on reparation options and to perform works as necessary.

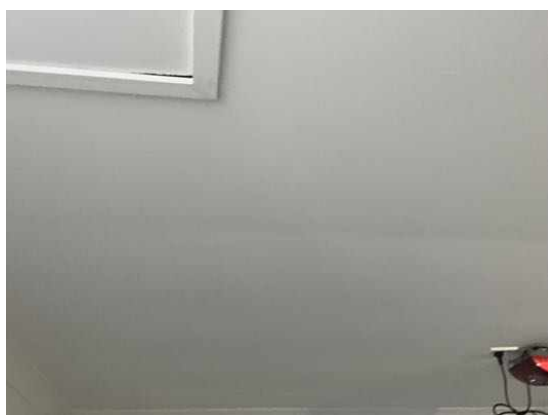
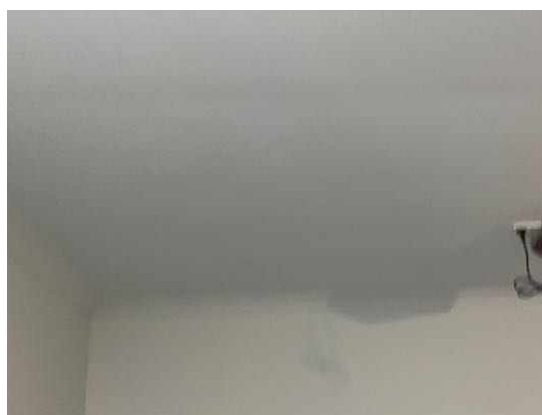
Finding 3.23

Building: Main Building
 Location: Garage
 Finding: Sagging ceiling
 Information: The ceiling exhibits noticeable sagging, characterized by visible dips or bulges in the surface.

Risk: Sagging ceilings pose several risks, including potential collapse or detachment of ceiling materials, which can lead to property damage and serious injuries to occupants. Additionally, sagging ceilings may indicate underlying structural issues, such as water damage or compromised support beams, which could worsen over time if left unaddressed.

A qualified and licensed Builder or structural engineer should be consulted to assess the extent of the sagging and identify the underlying cause. Depending on the severity and cause, repairs may involve reinforcing support structures, addressing water damage, or replacing damaged ceiling materials to ensure safety and structural integrity.

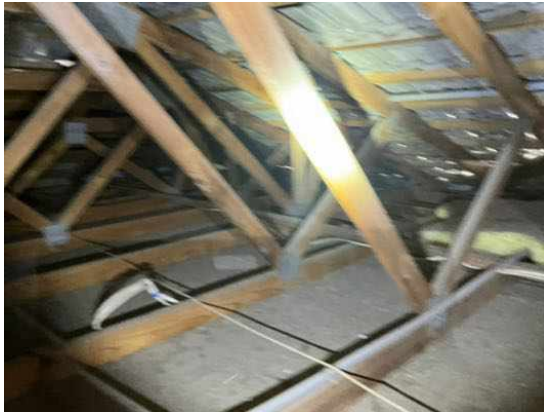
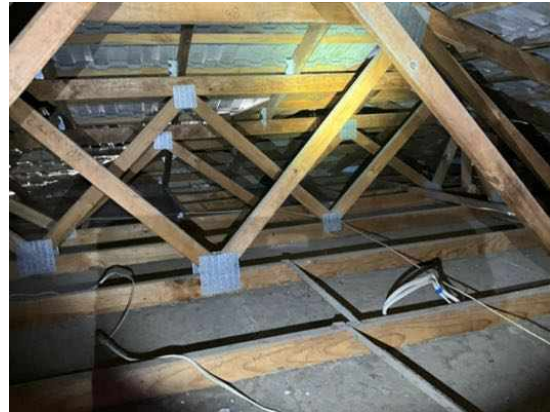
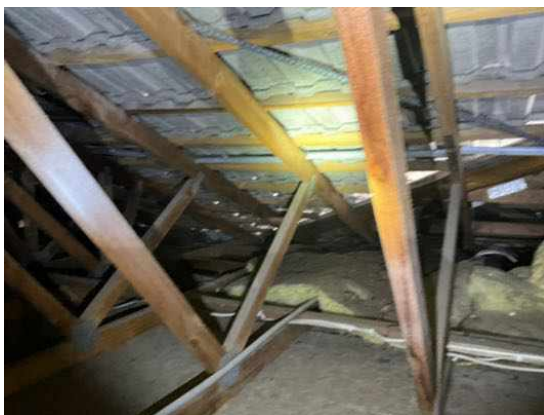
Finding 3.24

Building:	Main Building
Location:	Roof Void
Finding:	Sarking - Missing
Information:	Sarking is missing under the roof sheeting. Sarking acts as an insulator that helps with noise reduction and protects against water penetration. Sarking plays a key role in the operation and function of the overall roofing structure and its performance.

of construction). Where sarking is missing, regular inspections of the roof tiles for cracking and potential moisture penetration is required.

Sarking may be retrospectively fitted by a registered builder at the discretion of the client.

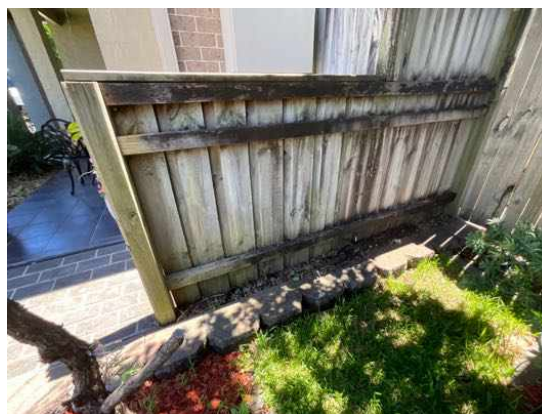
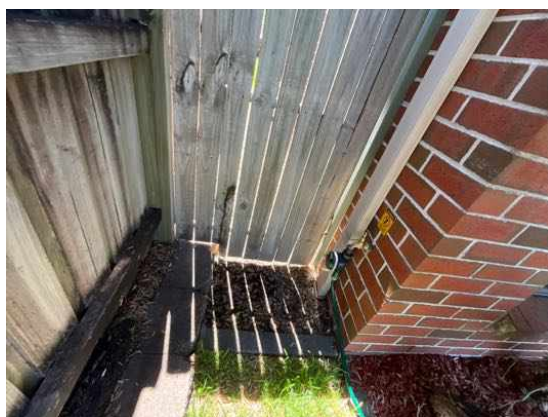
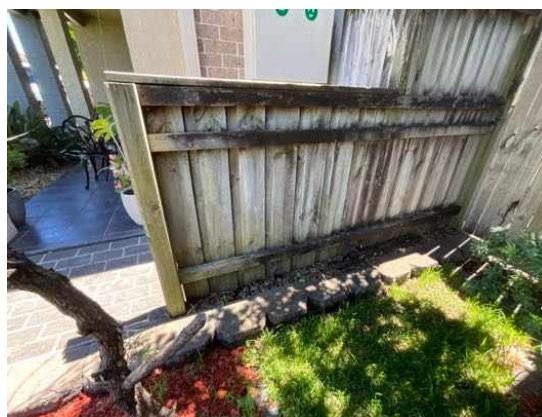
Finding 6.02

Building:	Main Building
Location:	All Areas
Finding:	Timber on ground / conducive conditions to termite damage
Information:	Timber on the ground is indeed conducive to termite damage. Termites are known to thrive in moist environments, and wood in contact with soil or moisture is more susceptible to infestation.

To prevent this, it's important to keep timber elevated and away from direct ground contact. Regular inspections and proper termite control measures are also essential to protect your wooden structures from termite damage.

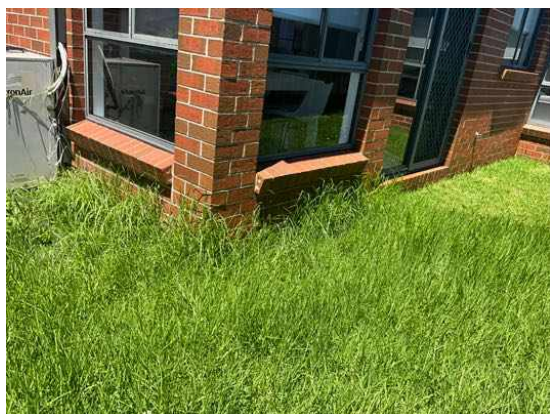
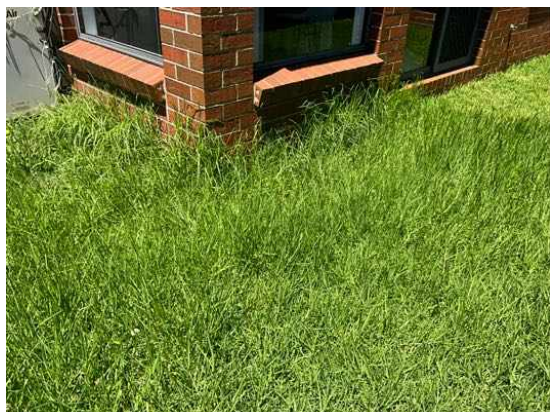
Finding 6.03

Building:	Main Building
Location:	All Areas
Finding:	Dense vegetation around a property can increase the risk of termite infestation
Information:	The presence of dense vegetation around a property can increase the risk of termite infestation, as it provides a conducive environment for them. To address this, consider maintaining a clear space between the vegetation and your home. If you suspect a termite issue, it's advisable to consult with a licensed pest control professional for inspection and treatment.

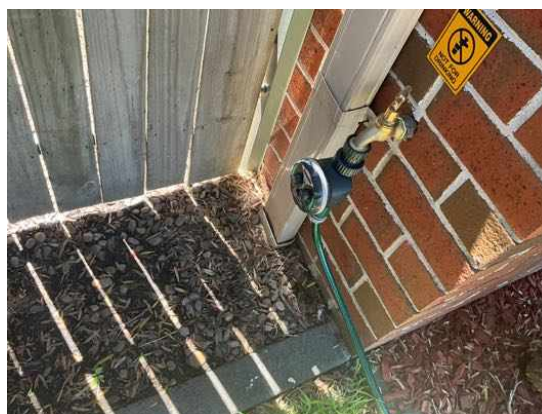
Finding 6.04

Building:	Main Building
Location:	All Areas
Finding:	No Drain under tap
Information:	There is no drain installed under the tap, leading to water accumulation and creating conducive conditions for timber pests. This defect needs immediate attention to prevent potential damage and pest infestation.

1. Assessment: Evaluating the area to determine the best approach for installing a proper drainage system under the tap.
2. Installation: Installing a drain that effectively channels water away from the base of the tap, preventing water accumulation and dampness.
3. Repair and Prevention: Inspecting and repairing any existing water damage and implementing measures to prevent future water accumulation and pest infestations.

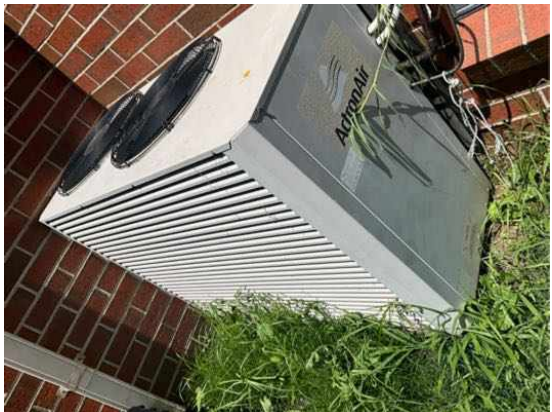
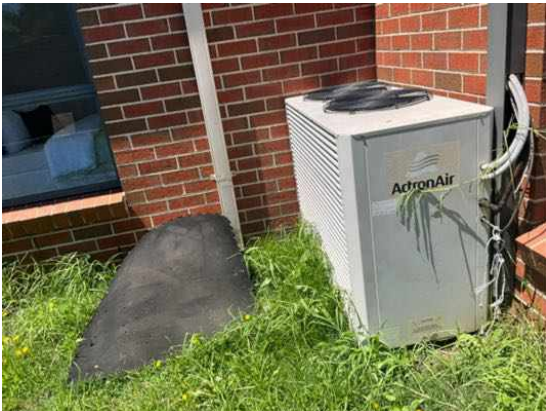
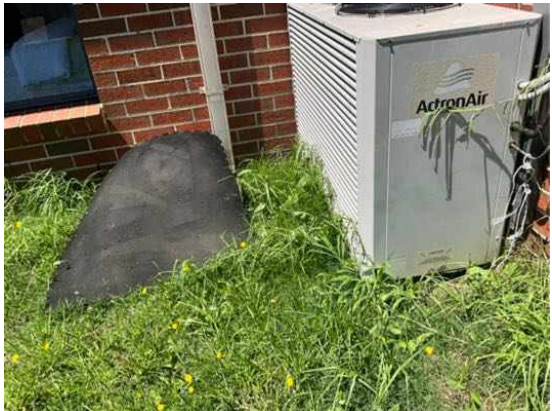
Finding 6.05

Building:	Main Building
Location:	All Areas
Finding:	Bridging or Obstruction Conducive environment for Termites
Information:	Bridging of termite barriers occurs when termites bridge (usually by building a mud tunnel) a termite barrier or inspection inspection zone or where termites have a passage, allowing them to bridge the barrier.

Recommended moving obstructions away from the external walls for further and future inspections.

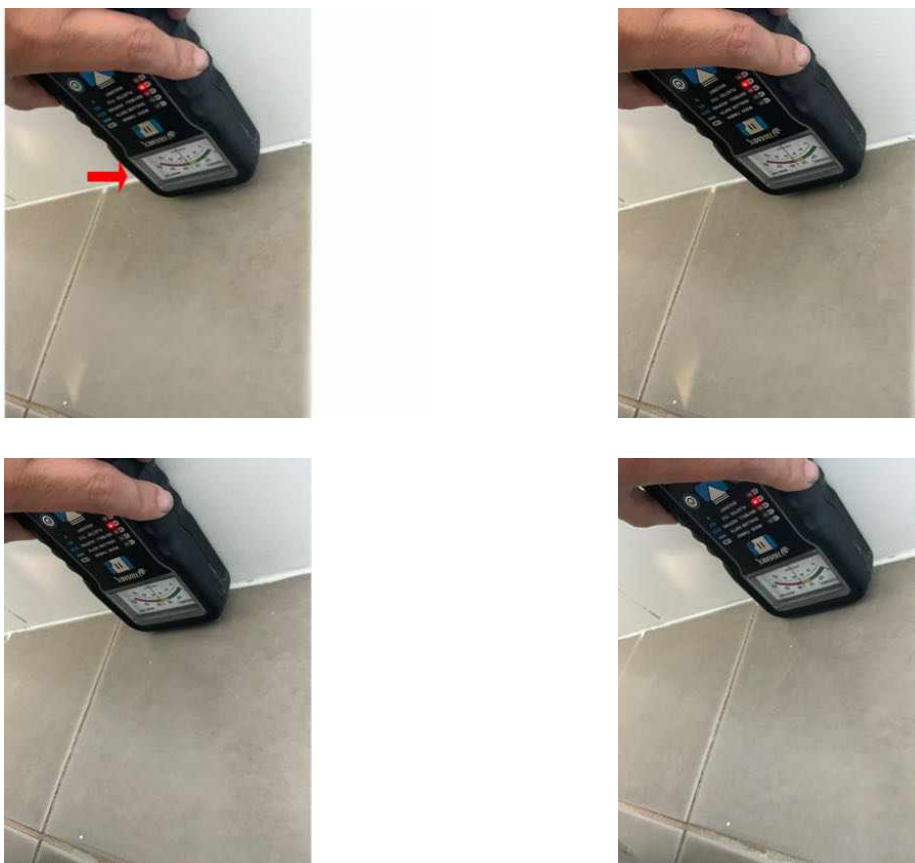
Finding 6.08

Building:	Main Building
Location:	Bathroom
Finding:	Excessive moisture - Conducive to Timber pest
Information:	Excessive moisture can attract termites and produce conditions that promote fungal growth and wood decay.

Prior to any remedial works being performed a qualified plumber should be appointed to further inspect the property and to identify the cause of the excessive moisture. Works to remove affected building elements may then be necessary and should be performed by an appropriate tradesperson.
