Building and Timber Pest Inspection Report

Inspection Date: Wed, 18 Feb 2026

Property Address: 4 Small Crescent, Glenmore Park NSW
2745

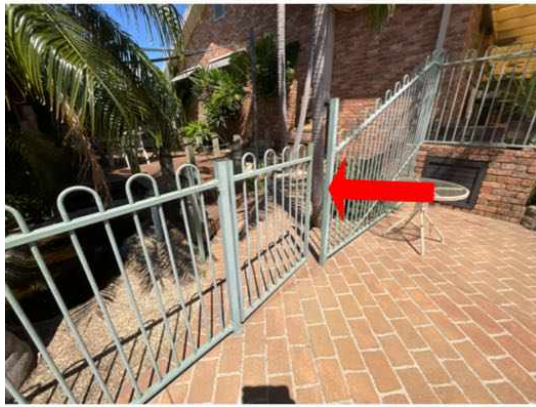
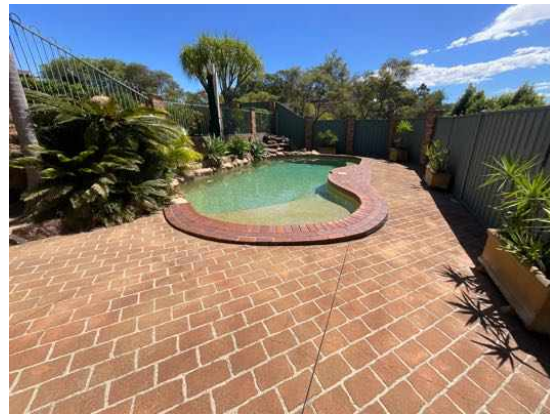
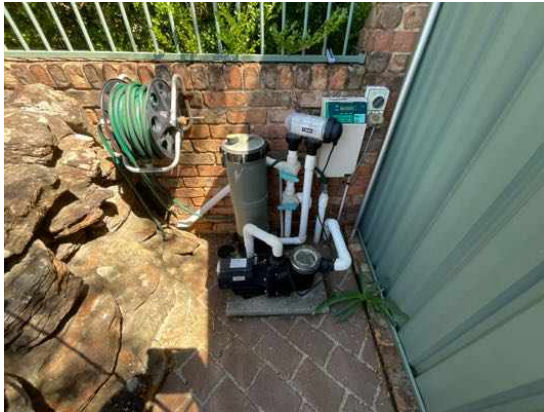
Building:	Yard
Location:	Pool Area
Finding:	Safety Hazard – Defective Pool Gates.
Information:	Observation:

During the inspection, it was noted that the pool gates appeared to be defective and may not comply with current pool safety standards.

Defective or non-compliant pool gates can pose a serious safety risk, particularly to children, and may result in non-compliance with local council regulations and relevant pool safety legislation.

Recommendation:

- It is strongly recommended that a licensed pool safety inspector be engaged to conduct a comprehensive inspection of:
 - The pool gates and barriers
 - The pool structure
 - All associated equipment and surrounds
- Any identified safety or compliance issues should be rectified without delay to ensure the area meets current safety requirements and minimises risk.

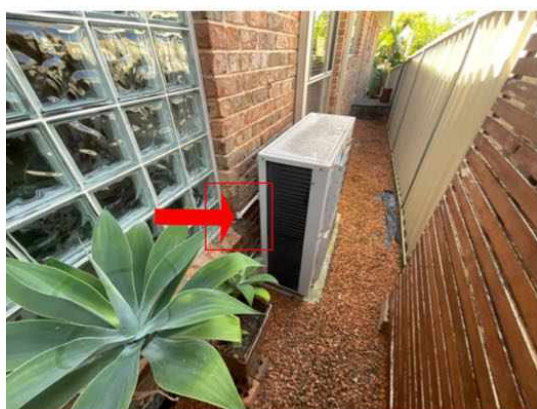
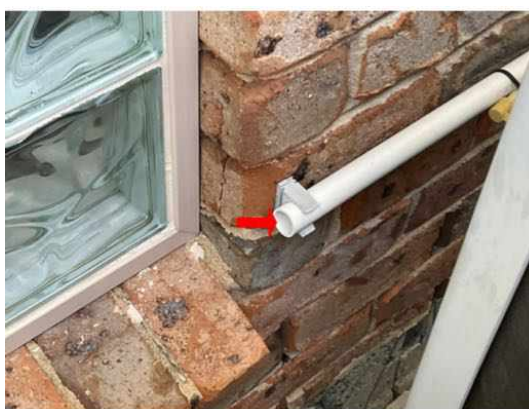
Finding: Overflow Management – Risk of Termite Activity..
 Information: Observation: Water Pooling from HWS and Air Conditioning Overflows

Water discharge from the Hot Water System (HWS) pressure relief valve and air conditioning unit overflows was observed discharging close to the base of the structure, contributing to water pooling around the building perimeter.

Persistent moisture near the foundation or subfloor area significantly increases the likelihood of termite activity. Termites are highly attracted to damp environments, and stagnant water near structural elements provides ideal conditions for foraging and infestation.

- Moisture Conducive to Infestation: Termites require moisture for survival, and pooled water can soften timber materials, making them more accessible.
- Structural Risk: Prolonged dampness may also contribute to timber decay, further increasing vulnerability.

It is highly recommended that all overflows from the HWS and air conditioning units be redirected away from the building, preferably via fixed drainage or extension piping, to prevent water accumulation near the structure.

These minor corrective works should be undertaken promptly to minimise the risk of both termite ingress and potential structural damage due to ongoing moisture exposure.

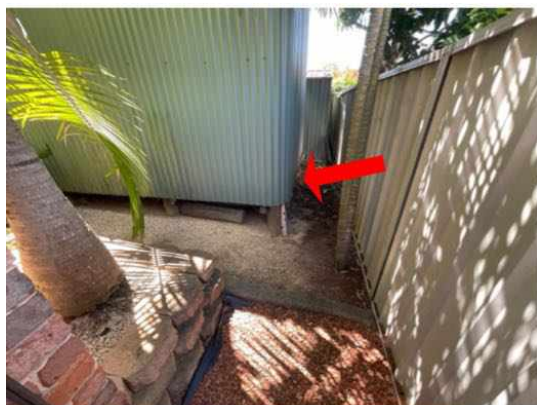
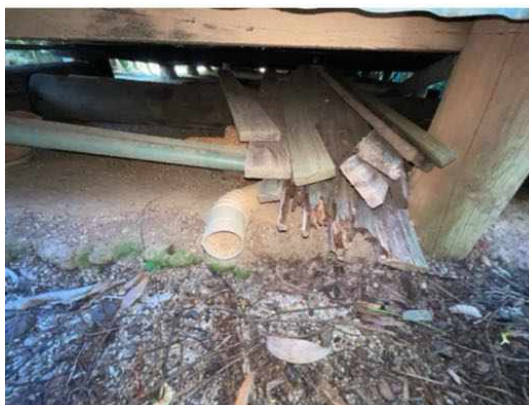
Finding 6.02

Building: Shed
 Location: Subfloor
 Finding: Stored timbers - External Area..
 Information: Observation:

Timber materials stored under the cabana were observed to the property.

- Stored timbers in contact with the ground or exposed to moisture are highly conducive to timber pest activity, particularly subterranean termites.
- Prolonged exposure to moisture can also lead to wood rot or fungal decay, further increasing the risk of termite attraction.

It is strongly recommended that all stored or unused timbers be immediately removed from around the building perimeter and yard areas. Reducing conducive conditions is a critical part of termite risk management.

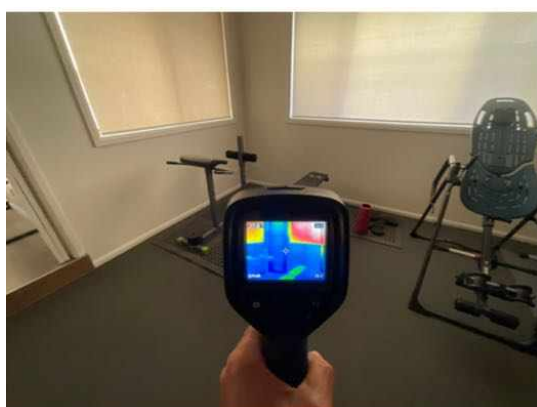
Termites release heat in the form of carbon dioxide and build mud tubes with high moisture content, which can create irregular heat patterns on surfaces such as walls, ceilings, and floors.

At the time of the inspection, no abnormalities indicating live termite activity were observed. However, it's important to note that various factors—such as obstructions, ambient temperature, and wall material/thickness—can impact the accuracy of thermal readings. In cases where surfaces are visually restricted or obstructed, a comprehensive thermal scan may not always be feasible.

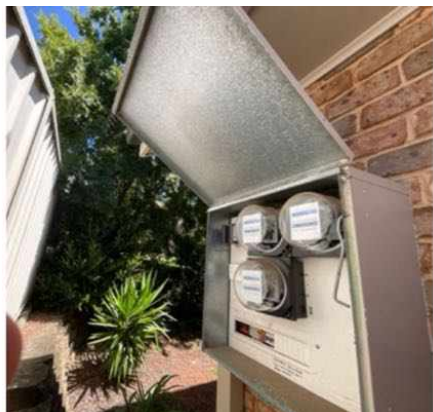
Building:	Main Building
Location:	All Areas
Finding:	Termite Management System - Missing Durable Notice..

Information: Observation: Missing Durable Notice for Termite Management System

Proper maintenance and documentation are essential to ensure continued protection. Without a visible durable notice, there is no clear indication of what system (if any) is in place, which may limit the effectiveness of future termite inspections and hinder warranty claims.

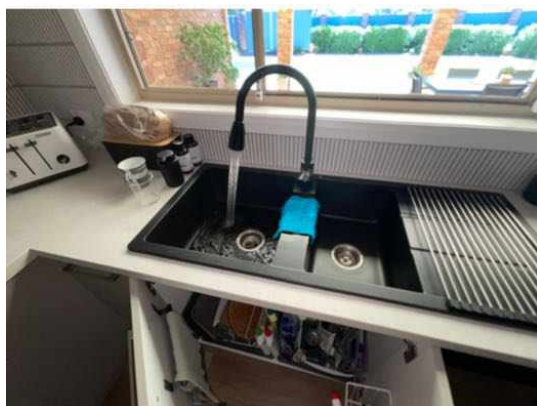
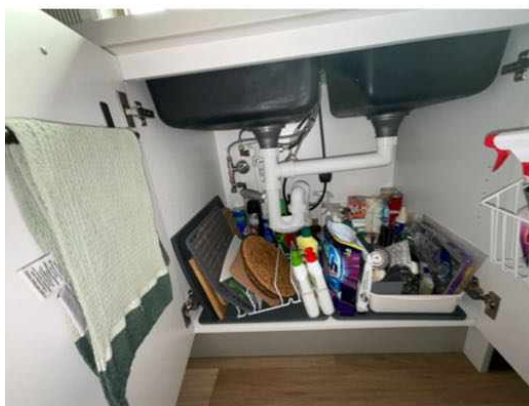
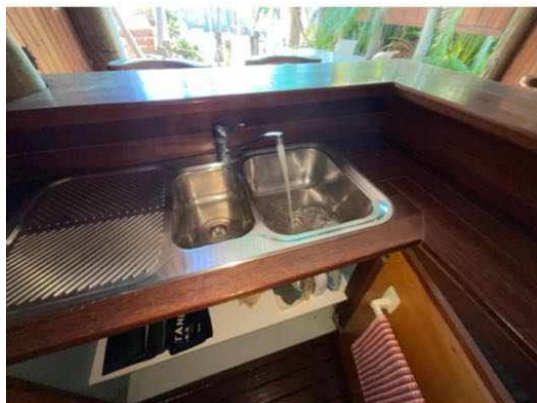
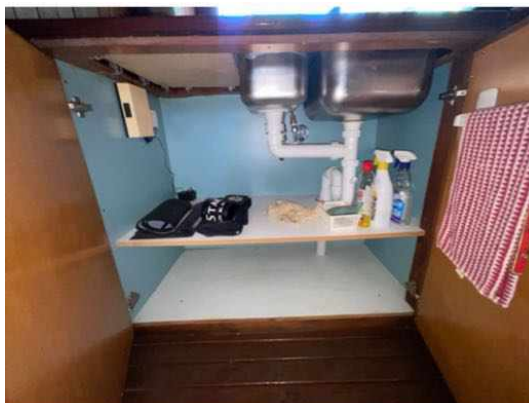
Building: Main Building
Location: Kitchen / Cabana
Finding: Kitchen Sink – Overall Condition & Recommendations.
Information: Observations:

- Further monitoring and testing are recommended once the tap(s) are in constant use, to identify any drainage issues or signs of slow leaks not evident during the limited inspection.
- It is recommended that the stored items beneath the sink be removed to allow for a full re-inspection of the plumbing and cabinetry, ensuring no concealed defects are present.

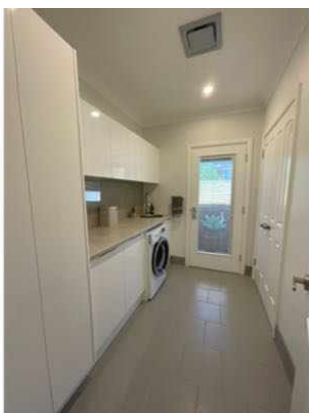
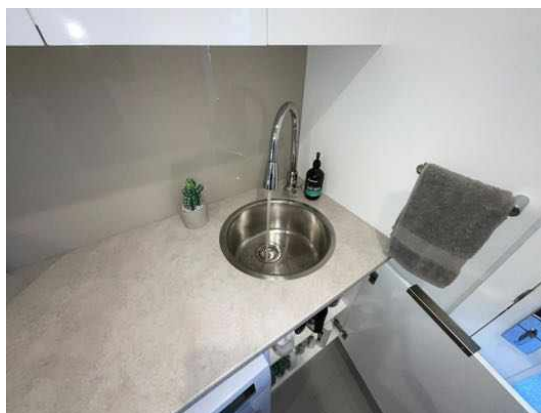
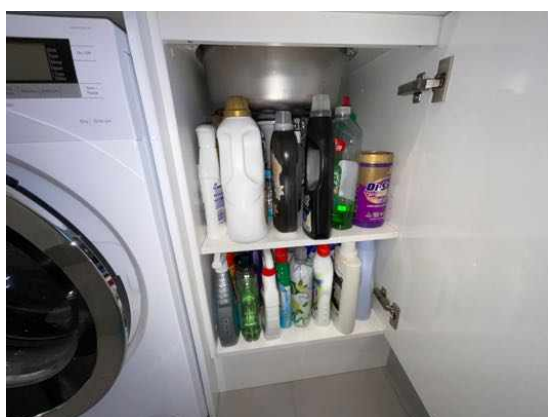
Building: Main Building
 Location: Laundry
 Finding: Laundry - Taps/Plumbing/Drainage.
 Information: Observation: Laundry Tub – Taps, Plumbing, and Cabinetry

highly recommended, as this is a common wear-and-tear issue.

- Sealant and grouting in wet areas should be maintained as part of the long-term care and upkeep of the property.

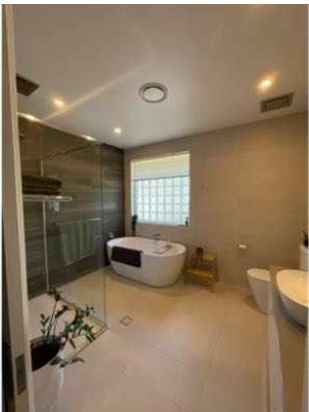
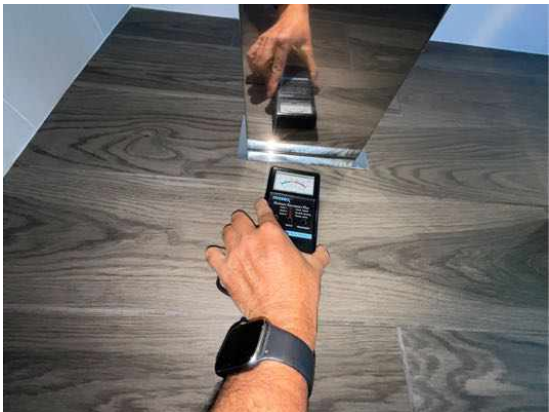
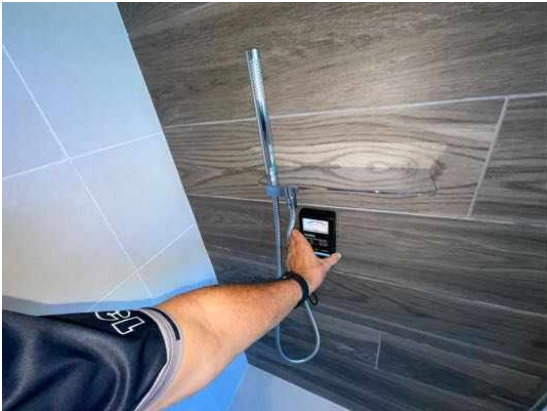
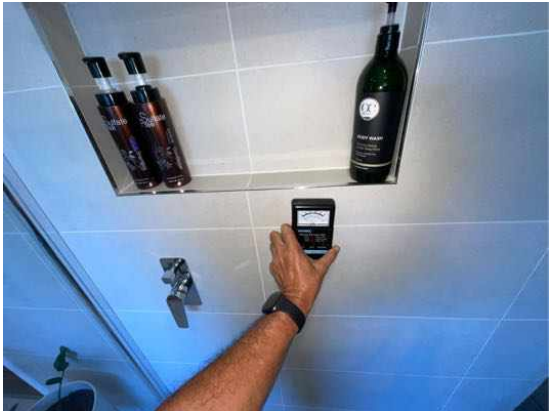
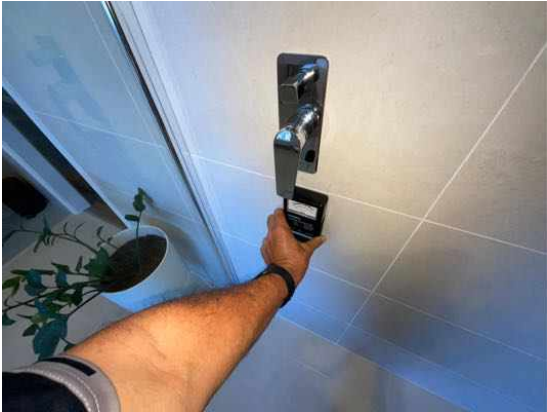
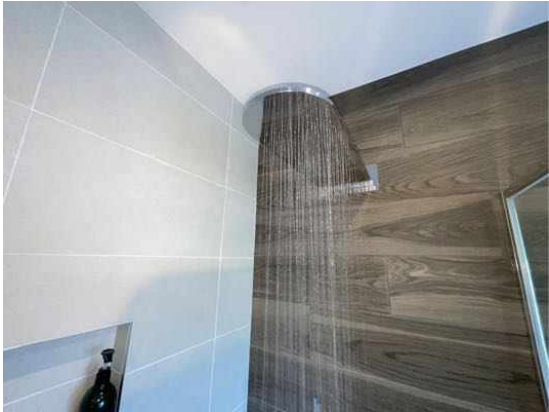
Building: Main Building
 Location: Bathroom
 Finding: Wet Areas - Bathroom(s) - Overall Condition & Recommendations.
 Information: Overall Condition & Recommendations

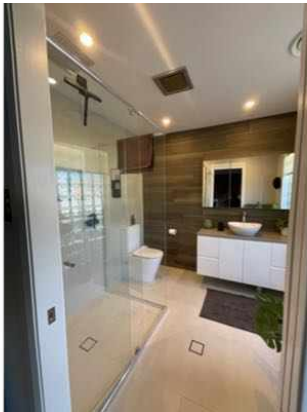
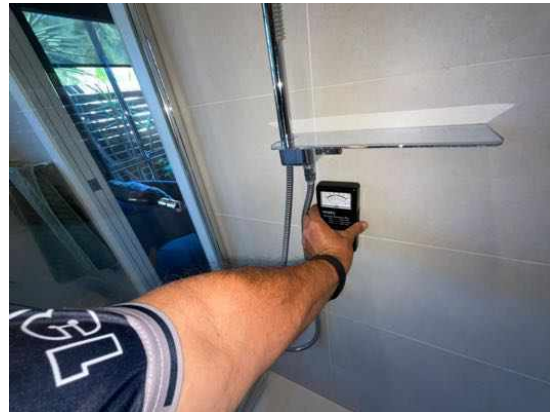
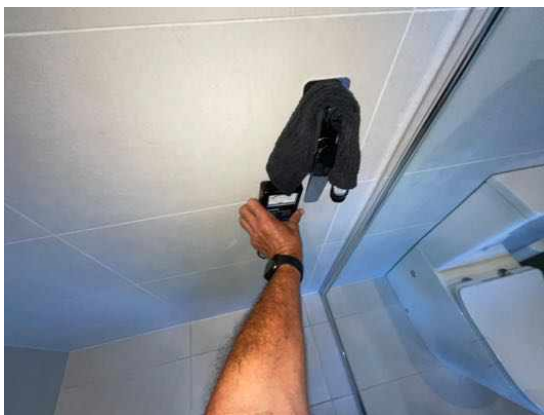
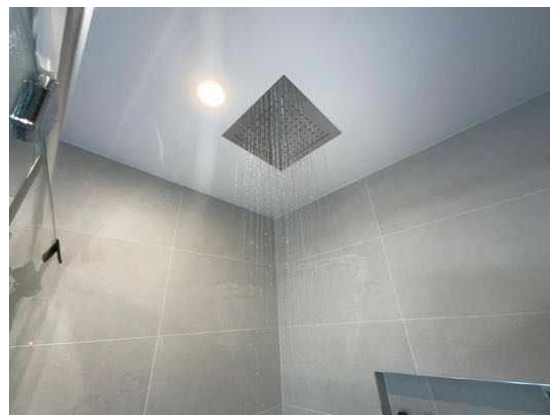
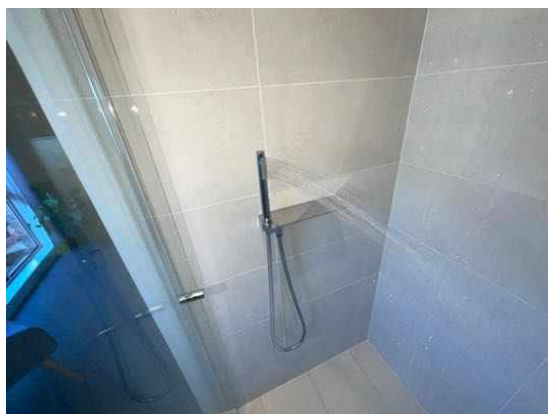
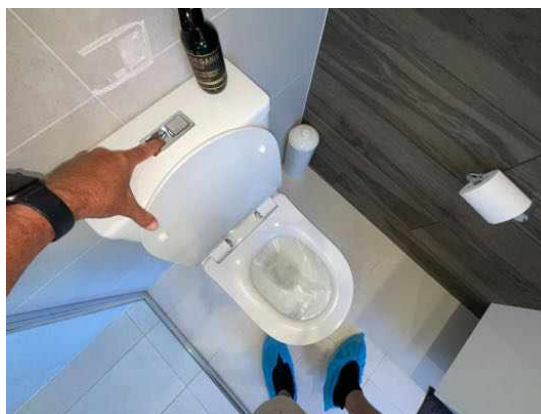
Building: Main Building
Location: Ensuite
Finding: Wet Areas - Bathroom(s) - Overall Condition & Recommendations.
Information: Overall Condition & Recommendations

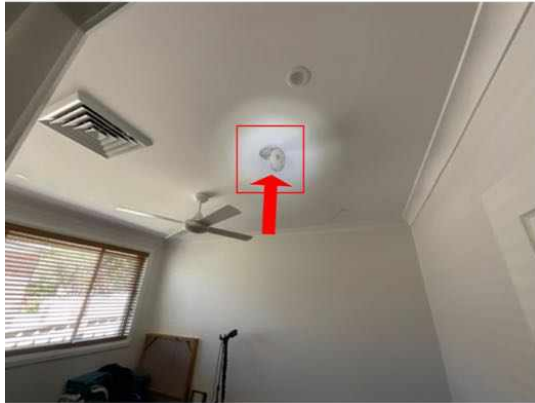
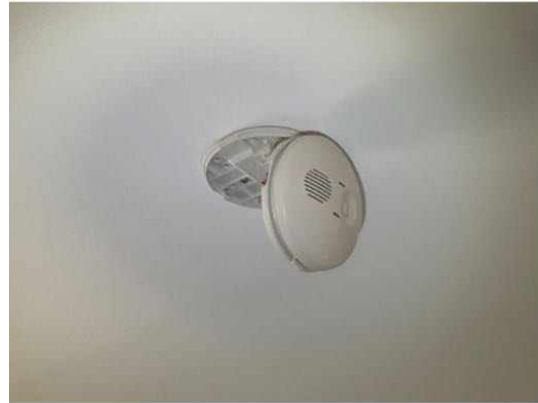
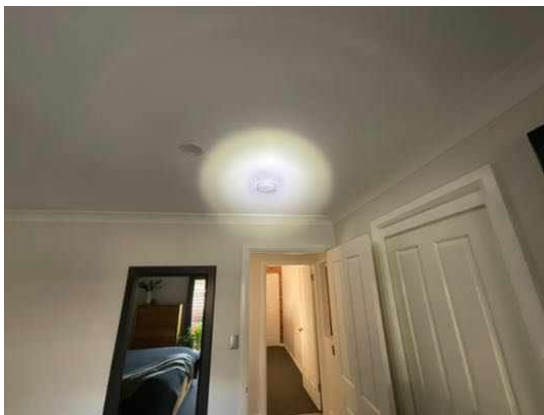
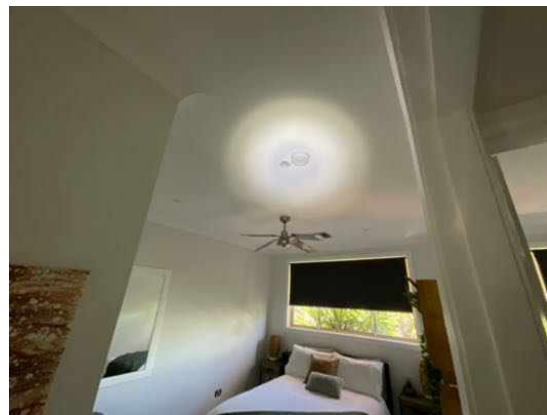
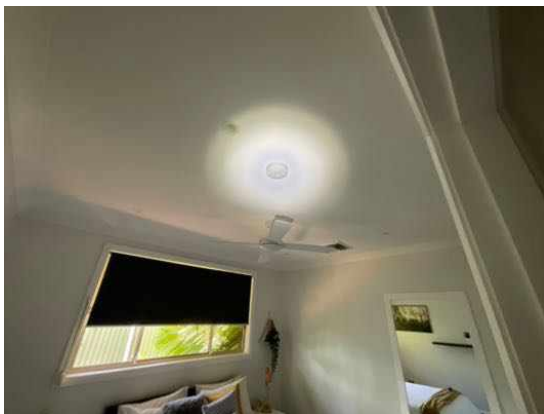
Building:	Main Building
Location:	All Areas
Finding:	Smoke Detectors / Alarms.
Information:	Reporting on the presence, type, location, or compliance of smoke detectors or alarms, including hard-wired smoke detection systems and their legislative requirements, is outside the scope of this inspection report.

Failure to comply with these requirements may pose a serious risk to occupant safety.

- All smoke detectors be tested monthly by the homeowner.
- All systems comply with the requirements of AS 3786 and any applicable state-based legislation.
