Building and Timber Pest Inspection Report

Inspection Date: Tue, 31 Mar 2026

Property Address: Woodburn St, Evans Head NSW 2473,
Australia

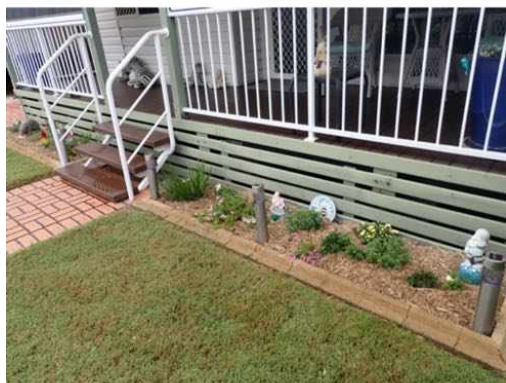
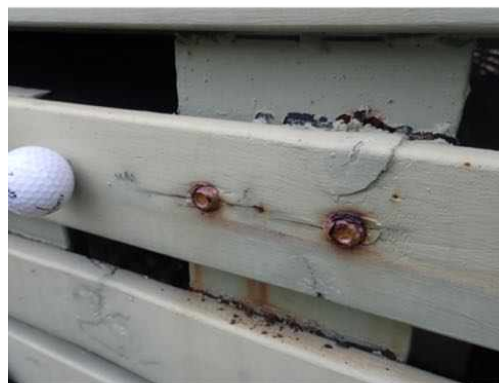
Finding 3.01

Building:	Main Building
Location:	Around base of building
Finding:	Rusted Steel Fixings To Timber Screening At Base Of Building
Information:	Rusted steel fixings have been identified at several locations to the timber screening around the base of the building. This is typically associated with age-related deterioration and prolonged exposure to moisture. If left untreated, corrosion may lead to weakening of the fixings and reduced stability of the screening. It is recommended that a carpenter or suitably experienced handyman replace the affected fixings with corrosion-resistant alternatives and carry out any necessary repairs. Repairs can be carried out at the owner's discretion.

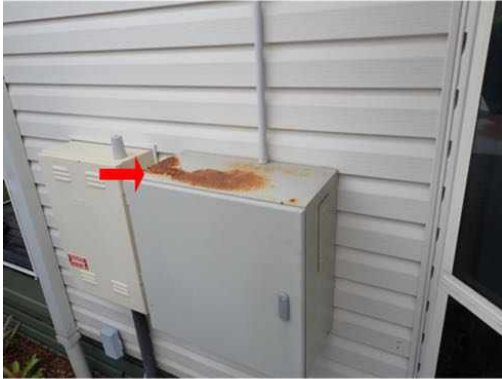
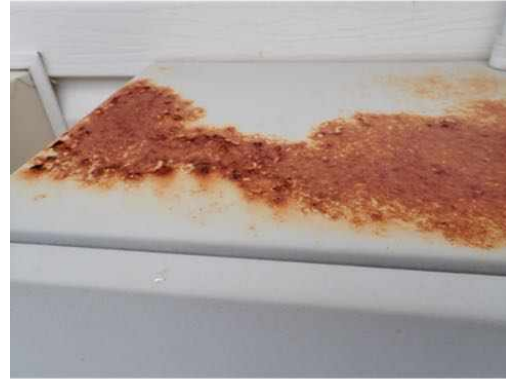
Finding 3.02

Building:	Main Building
Location:	Right hand side of building
Finding:	Rust Identified To Electrical Meter Box
Information:	Rust has been identified to the electrical meter box. This is typically associated with age-related deterioration and exposure to the elements, leading to breakdown of protective coatings. If left unaddressed, corrosion may worsen and potentially affect

the integrity of the enclosure. It is recommended that a licensed electrician or suitably experienced handyman assess the condition, treat or replace the affected components, and ensure the enclosure remains compliant and adequately protected. Repairs can be carried out at the owner's discretion.

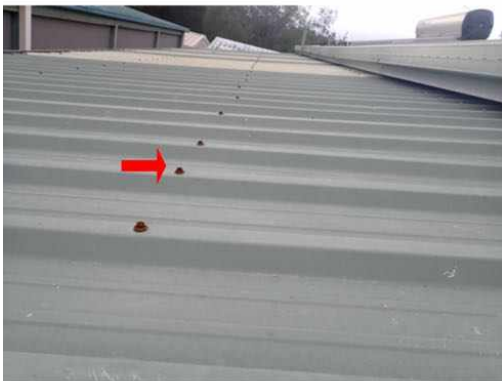
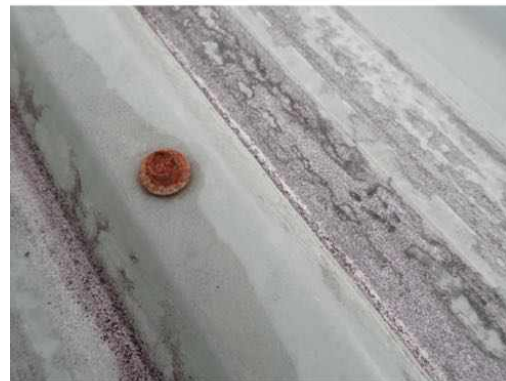
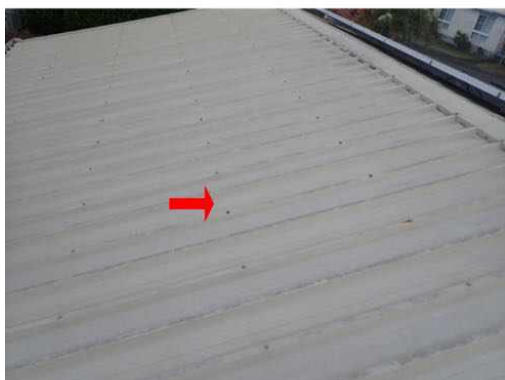
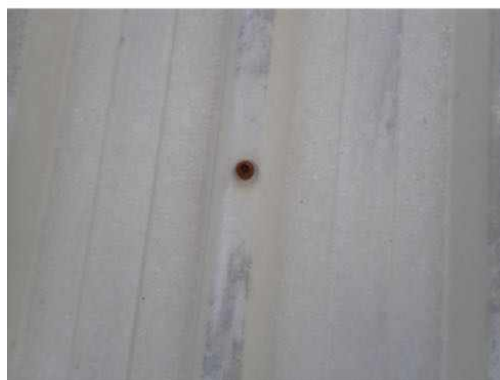
Finding 3.03

Finding: Rusted Screws To Roofing Cladding

Information: Rusted screws have been identified to the roofing cladding. This is typically associated with age-related deterioration, weather exposure, and breakdown of protective coatings. If left unaddressed, corrosion may lead to loosening of fixings and potential water ingress. It is recommended that a licensed roofer replace the affected screws with appropriate corrosion-resistant fixings and ensure all penetrations are adequately sealed. Repairs can be carried out at the owner's discretion.

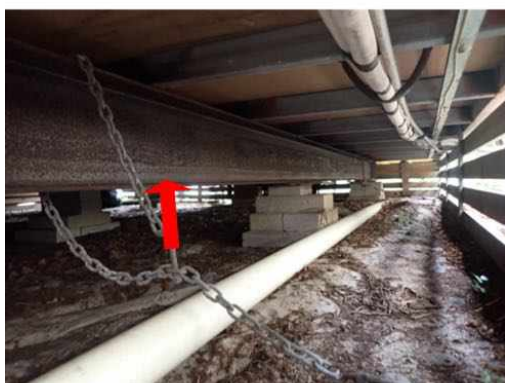
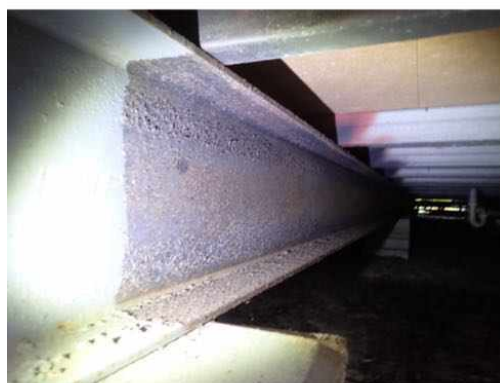
Finding 3.04

Building:	Main Building
Location:	Subfloor
Finding:	Surface Rust To Steel Floor Bearers
Information:	Surface rust has been identified to the steel floor bearers. This is typically associated with age-related deterioration, moisture exposure, and breakdown of protective coatings and is a common defect with a property of this type of construction. If left untreated, corrosion may progress and lead to further deterioration of the steel components. It is recommended that a builder, metal fabricator, or suitably experienced handyman clean, treat, and apply protective coatings to the affected areas, or replace components as required. Repairs can be carried out at the owner's discretion.

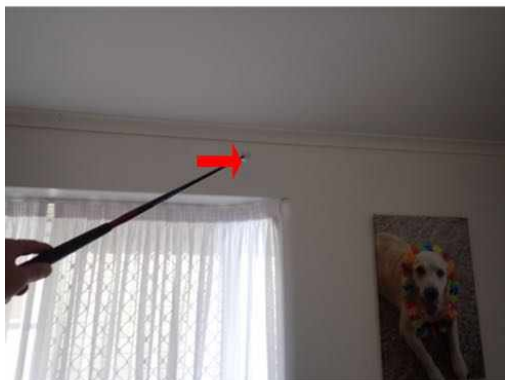
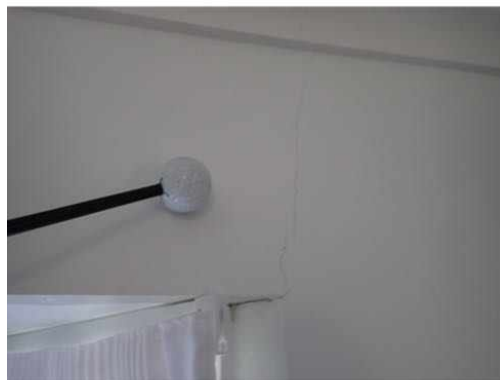
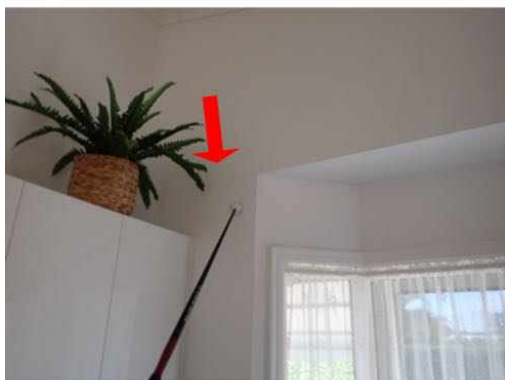
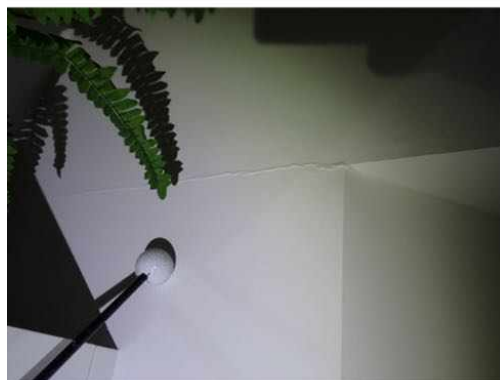
Finding 3.05

Building:	Main Building
Location:	Kitchen and living room
Finding:	Minor Cracking To Internal Cladding In Living Room And Kitchen
Information:	Minor cracks have been identified to the internal wall cladding within the living room and kitchen. This is typically associated with normal settlement, minor movement, or age-related deterioration and is considered a common defect. If cracks increase in size over time, further assessment may be required. It is recommended that a plasterer

or suitably experienced handyman repair and make good the affected areas as required. Repairs can be carried out at the owner's discretion.

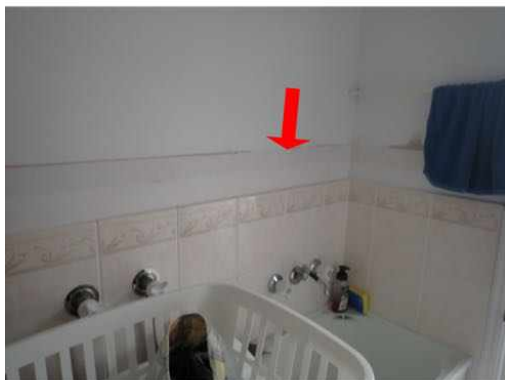
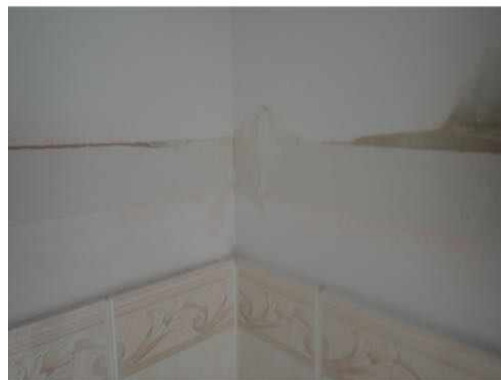
Finding 3.06

Building:	Main Building
Location:	Laundry
Finding:	Damage To Plasterboard Wall In Laundry
Information:	Damage has been identified to the plasterboard wall in the laundry, possibly due to the removal of a previously installed fixture or fitting. This has resulted in localised surface damage to the wall lining. If left unaddressed, the damage may worsen or affect the finish of the wall. It is recommended that a plasterer or suitably experienced handyman repair and make good the affected area and repaint as required. Repairs can be carried out at the owner's discretion.

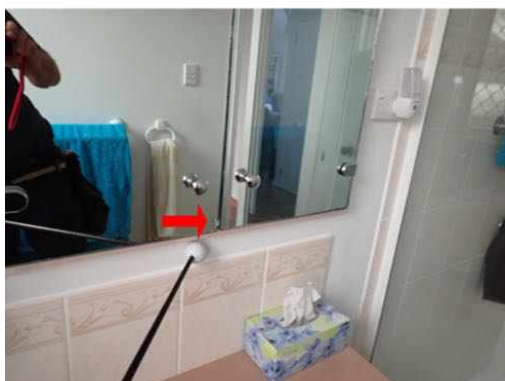
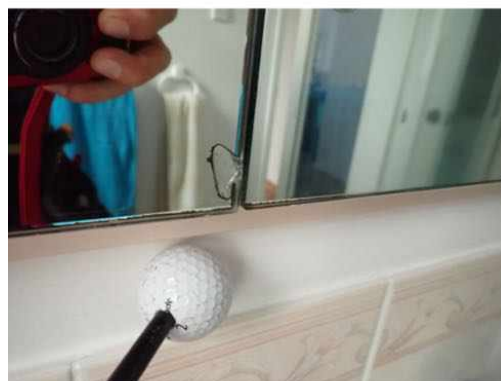
Finding 3.07

Finding: Chip To Bathroom Mirror Shaving Cabinet

Information: A chip has been identified to the bathroom mirror shaving cabinet. This is likely due to impact damage or general wear and tear. Damaged mirror surfaces may worsen over time and can present a minor safety risk due to sharp edges. It is recommended that a glazier or suitably experienced handyman repair or replace the affected mirror or cabinet as required. Repairs can be carried out at the owner's discretion.

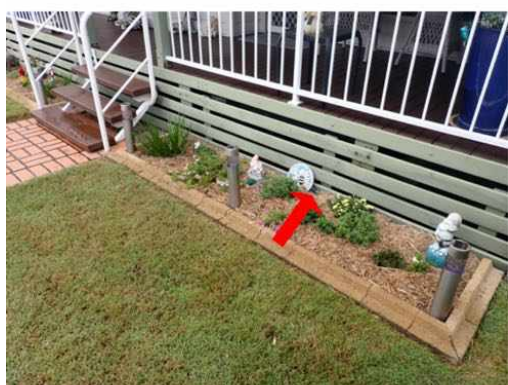
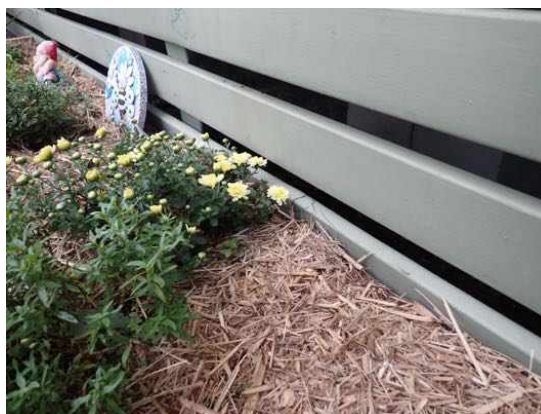
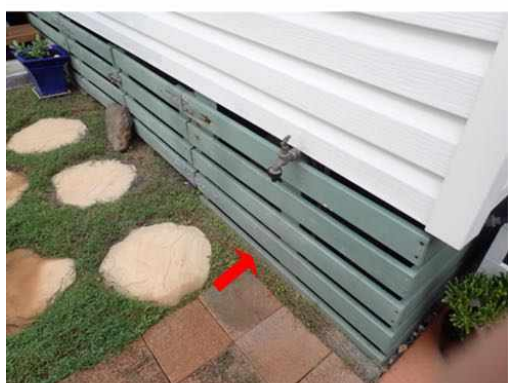
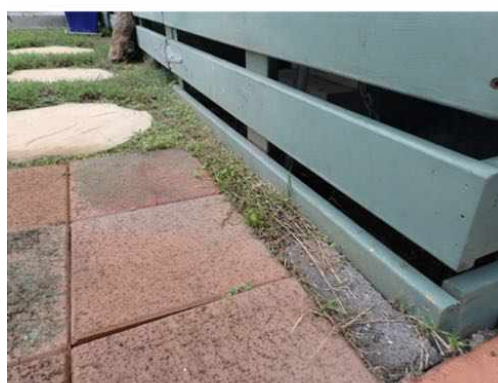
Finding 6.01

Building:	Main Building
Location:	Around base of building
Finding:	Timber Screening In Contact With Ground Conducive To Termite Attack
Information:	Timber screening around the base of the building has been installed in contact with the ground, which is conducive to termite attack. This is a common defect with homes of this type of construction. Ground contact can allow concealed termite entry and may lead to timber deterioration over time if left unaddressed. It is recommended that a carpenter or suitably experienced handyman modify the installation to provide adequate clearance from the ground and implement appropriate termite management measures. Repairs can be carried out at the owner's discretion.

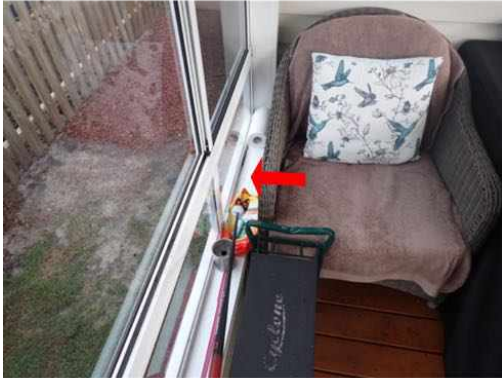
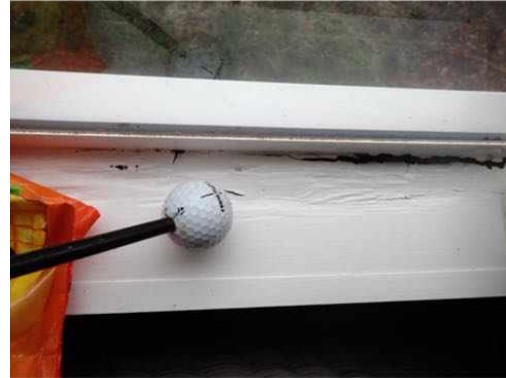
Finding 7.01

Building:	Main Building
Location:	Window for rear decked area
Finding:	Wood Rot To Window Frame At Rear Decked Area
Information:	Wood rot has been identified to the window frame in the rear decked area. This is typically associated with prolonged moisture exposure and breakdown of protective coatings. Timber in this condition is susceptible to further deterioration and may be

conducive to termite attack if left unaddressed. It is recommended that a carpenter or suitably experienced handyman repair or replace the affected timber and apply appropriate protective finishes to prevent recurrence. Repairs can be carried out at the owner's discretion.

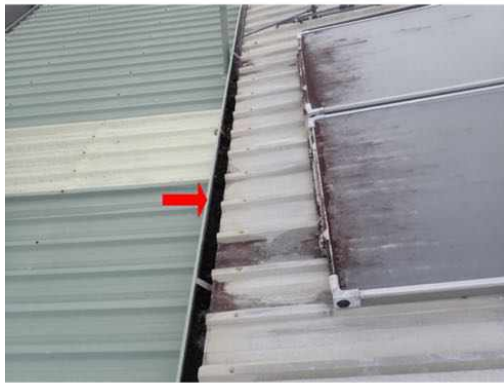
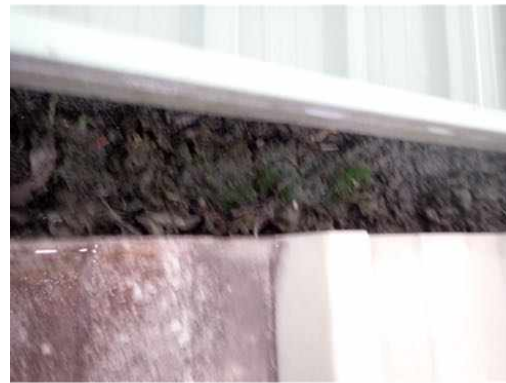
Building:	Main Building
Location:	Roof
Finding:	Gutters Require Cleaning
Information:	The gutters were observed to require cleaning due to the accumulation of debris. Blocked gutters can impede proper water flow and may lead to overflow, moisture ingress, or damage to surrounding building elements. It is recommended that a suitably experienced handyman or gutter cleaning service remove debris and ensure the system is functioning correctly. Maintenance can be carried out at the owner's discretion.
