# Building and Timber Pest Inspection Report VR

Inspection Date: Tue, 24 Mar 2026

Property Address: 226 Farmborough Rd, Farmborough Heights NSW 2526, Australia

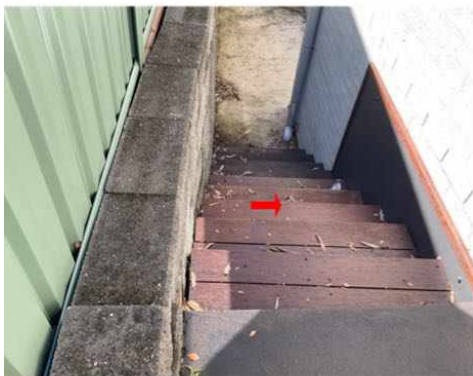
Building: Building 1  
 Location: Exterior walls - left side  
 Finding: Handrail - Suspected Non-Compliance  
 Information: This staircase is missing a handrail. This may not have been required at the time of construction but is highly recommended.

(Ref - National Construction Code. - 11.3.5 Handrails)

A builder or carpenter should install a handrail for the safety of all users.

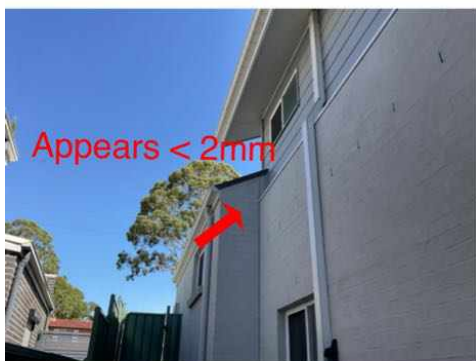
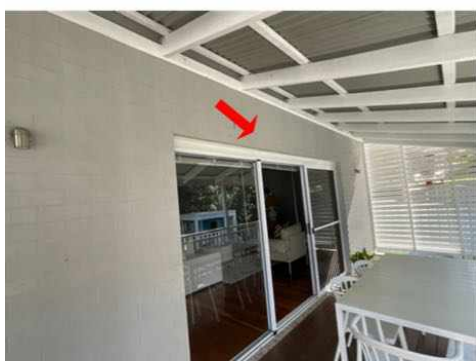
Building: Building 1  
 Location: Exterior garage and rear walls  
 Finding: Step cracking to brickwork (minor under 2mm)  
 Information: Step cracking was identified to the brickwork in this area at the time of inspection. Step cracking, which is similar to other forms of cracking, has a variety of possible causes. However, the most common is the subsidence of adjacent footings.

Step cracking is a relatively common defect, and is most likely to occur adjacent to windows, doors and other openings. Mortar failure in the gaps between affected bricks indicates the stresses and tensions affecting the wall.

Where step cracking is extensive or severe, the client is advised to consult a structural engineer. This minor step cracking can be used as a warning sign to address factors causing stress to the wall, which can include the effect of surrounding trees, water leaks, soil erosion, or even the presence of reactive soils in the surrounding area.

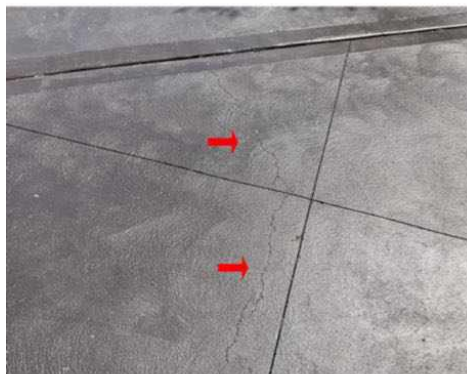
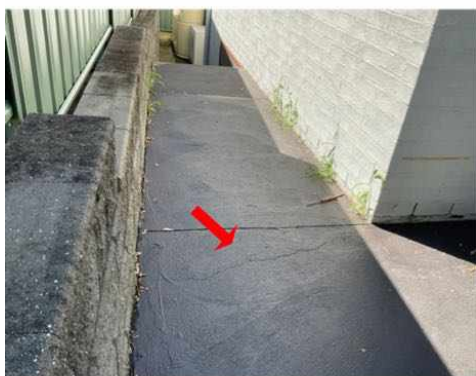
**Finding 3.02**

Building: Building 1  
 Location: Yard - front  
 Finding: Crack in concrete slabs - Category 1  
 Information: Cracks coded as Category 1 was identified in these pictured slabs. A Category 1 crack is described as a fine but noticeable crack, with the slab at an otherwise

reasonable level. To be considered Category 1, the approximate width of the crack is less than 1.0mm, or a less than 10mm change in offset when a 3m straight edge is placed over the defect.

Category 1 cracks should be monitored for a period of 12 months. At the end of the monitoring period, identified cracks that are rated greater than Category 2 are considered defects, and require rectification.

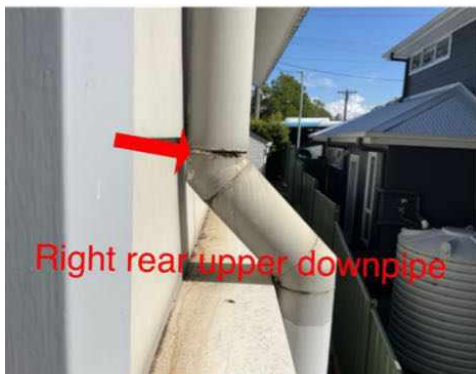
Building: Building 1  
Location: Pictured external areas  
Finding: Building elements - loose or damaged  
Information: Evidence of minor missing or damaged areas was identified at the time of the inspection. These include -

1. The master verandah railing east bolt requires tightening.
2. The right rear upper downpipe has a small leak requiring repair.

A carpenter and plumber would be the trades responsible for rectification of these areas when convenient.

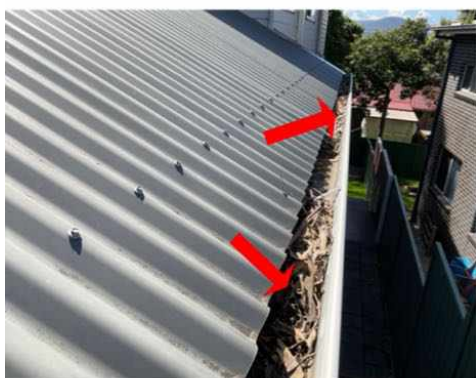
### Finding 3.05

Building: Building 1  
Location: Roof exterior  
Finding: Gutters - Full and blocked  
Information: The guttering on around the roof was found to be blocked at the time of the inspection. Roof plumbing structures, such as guttering and downpipes, should be free of all debris to prevent blockages. Blockages of the guttering and downpipes will lead to pooling and accumulated water overflows, which is likely to subsequently flood eaves and exterior walls.

Blocked gutters are likely to lead to high levels of moisture in the affected areas which can cause rust and decay of the gutters and downpipes and wood rot to adjoining timber areas. Blockages in gutters should therefore be removed immediately to ensure dry conditions are maintained.

It is highly advised that gutters be cleaned by the homeowner or a general handyperson as a matter of urgency.

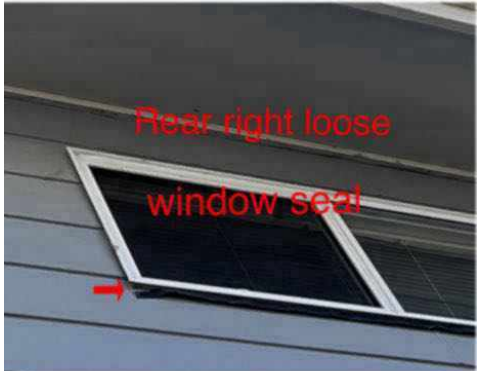
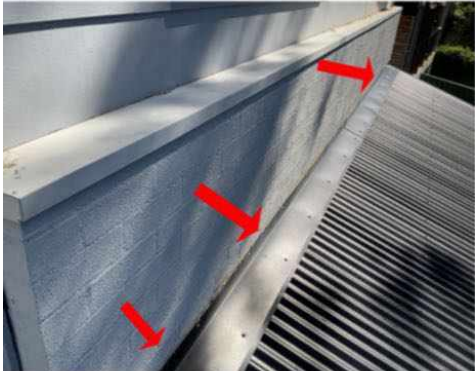
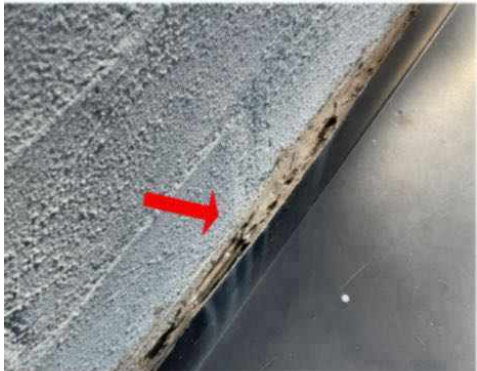
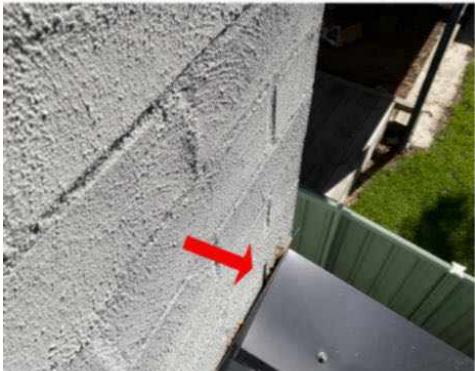
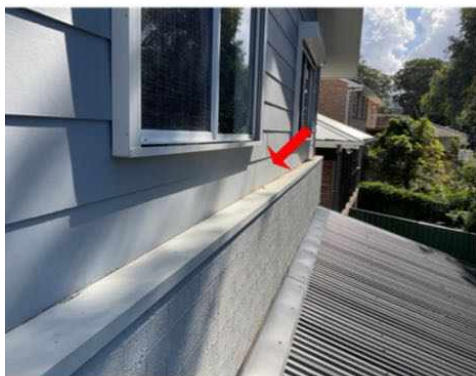
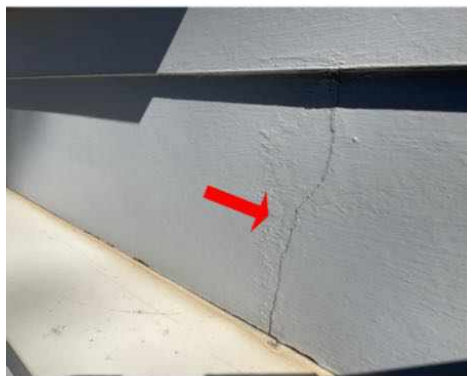
### Finding 3.06

Finding: Sealant (external) - Missing.  
Information: It was noted on inspection that areas of external sealant was missing to small areas of the external walls. One rear cladding board is broken requiring sealing in the crack or replacement. A flexible sealant or flashing is required to protect the associated building materials from rainwater ingress.

Flexible sealants should be applied to these affected areas to prevent any subsequent water damage that is likely to occur.

A sealant specialist or skilled handy person should be appointed to complete these works as soon as possible

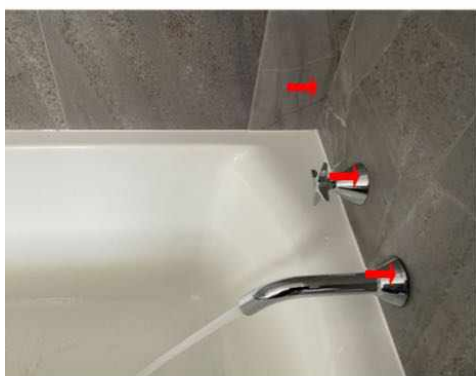
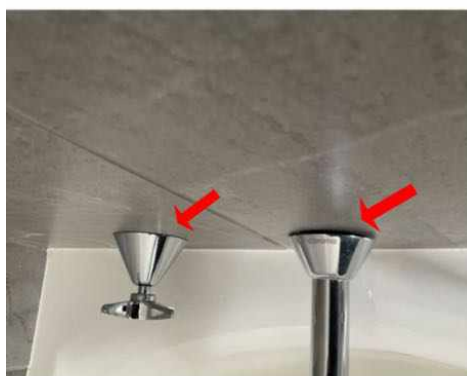
### Finding 3.07

Building:	Building 1
Location:	Kitchen and bathroom
Finding:	Sealant and grouting - Missing or damaged
Information:	It was noted on inspection that sealant or grout is degraded to these pictured wet areas.

Different materials and floor areas move at different rates, generally causing cracking to grout or sealant at this point. A flexible sealant is required to allow for expected expansion and contraction, while keeping the joint water tight and protective of all associated building materials.

Flexible and mould resistant materials should be applied to affected areas to prevent any subsequent water damage that is likely to occur. Regular maintenance and replacement of damage or missing or damaged sealant and grout is highly recommended to the wet areas, as this is a regular wear and tear defect. Sealant and grouting in areas that come into regular contact with water should be maintained for the long term care of your property.

A sealant specialist or tiling contractor should be appointed to complete these works as soon as possible

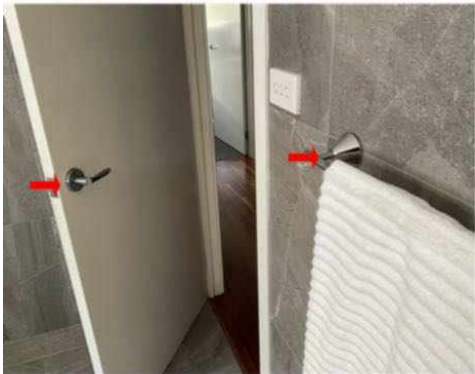
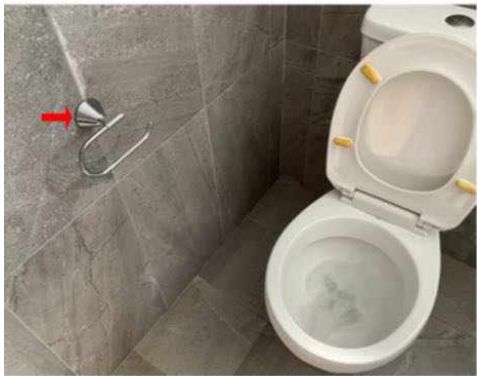
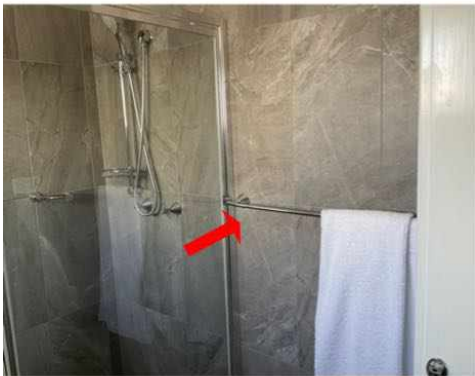
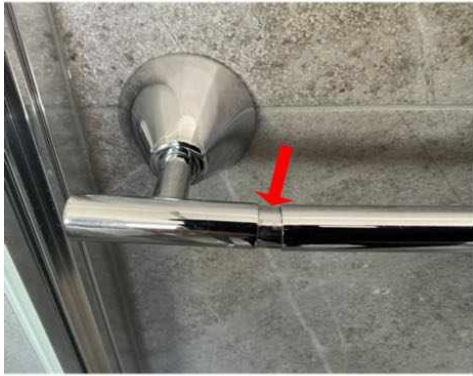
Building: Building 1  
Location: Bathroom  
Finding: Door handle, towel rails, etc loose  
Information: This door handle and other fixtures were found to be loose at the time of the inspection. Tightening of these fixtures is advised to improve the operational state of the associated areas.

A qualified carpenter or general handyman should be appointed to repair the door handle at the client's discretion.

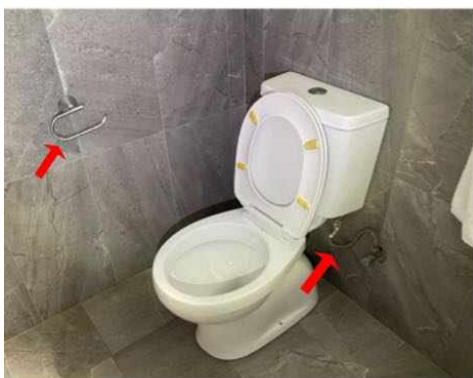
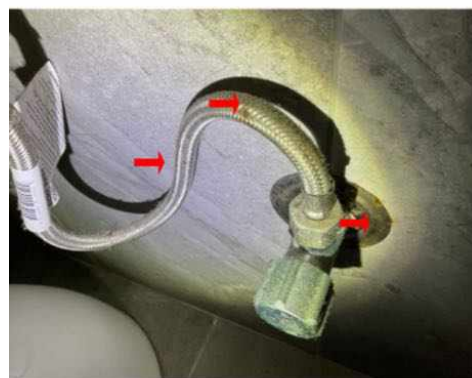
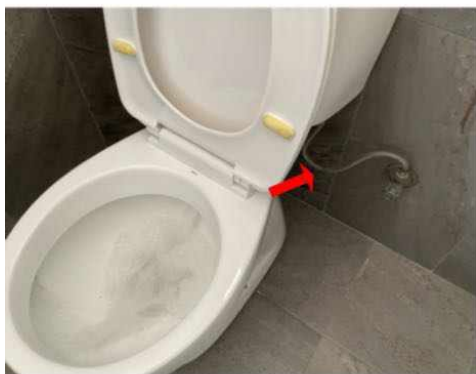
### Finding 3.10

Building:	Building 1
Location:	Bathrooms
Finding:	Some areas rusted or corroded
Information:	This pictured areas shows evidence of rusting and corrosion, which is likely to have developed as a result of excessive exposure to moisture and or inadequate coatings.

As surface rust provides no protection to the underlying iron, the deteriorating condition is likely to worsen if not addressed in the short-term future.

Where possible, the use of galvanized (treated) metals or aluminium coated metals aid in rust prevention, as does regular general maintenance. Rust formation can be controlled with coatings, such as paint, that isolate the iron from the environment.

Rusting and corrosion should be managed by ideally removing or limiting the affected surface from exposure to moisture. A registered builder may be appointed to replace any building elements that have been severely affected by rust or water damage.

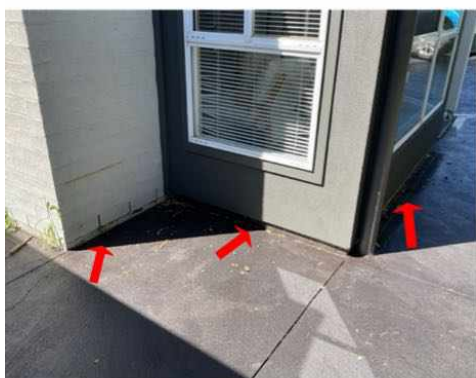
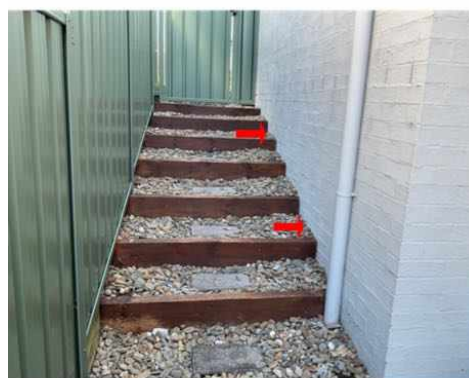
Building:	Building 1
Location:	Yard - front
Finding:	Bridging - decking
Information:	Where decking obstructs inspection of building elements, also known as bridging as it provides a bridging point for the access of termites, full inspection can not be achieved. Consequently moisture or dampness may be present and the areas becomes conducive to termite activity. Decks against or very close to buildings provide cover, shade and can provide an environment that is attractive to termite infestation.

- If the slab edge is not properly exposed there is a high risk of termite attack. Sometimes, in order to determine the type of slab, a suitably qualified person such as an architect or builder may be required to consult the construction plans.

- Where the slab edge cannot be properly inspected, it is highly recommended that termite or timber pest inspections be carried out every 6-12 months to aid protection of the property against infestation.

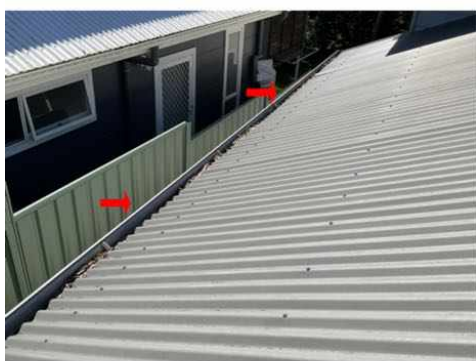
Building:	Building 1
Location:	Roof exterior
Finding:	Gutters - Full and blocked
Information:	The guttering on around the roof was found to be blocked at the time of the inspection. Roof plumbing structures, such as guttering and downpipes, should be free of all debris to prevent blockages. Blockages of the guttering and downpipes will lead to pooling and accumulated water overflows, which is likely to subsequently flood eaves and exterior walls.

Blocked gutters are likely to lead to high levels of moisture in the affected areas. Such moisture will not only cause rust and decay of the associated building materials, but can also provide conditions that are conducive to termite and timber pest activity. Blockages in gutters should therefore be removed immediately to ensure dry conditions are maintained.

It is highly advised that gutters be cleaned by the homeowner or a general handyperson as a matter of urgency.

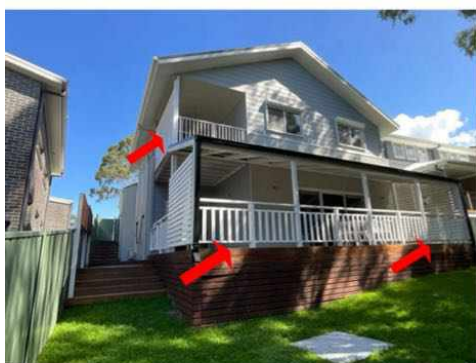
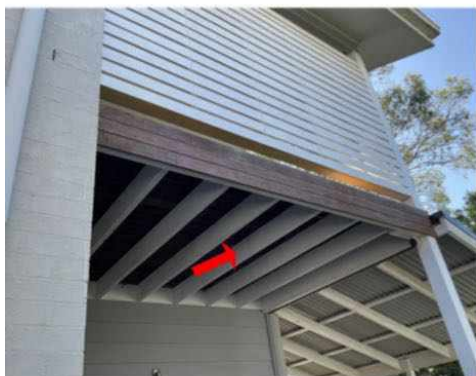
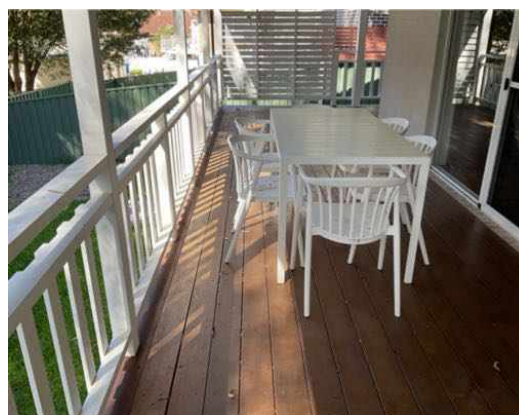
Building: Building 1  
Location: Rear decks and playhouse  
Finding: Elevated structure inspections  
Information: While these decks and cubby house appear in good condition, where any elevated Structure (deck, balcony, verandah etc) is present, and this elevated structure is designed to accommodate people, you MUST have this structure checked by an engineer or other suitably qualified person.

You should also arrange annual inspections of the structure by an engineer or other suitably qualified person to ensure any maintenance, that may become necessary, is identified. Care must be taken not to overload the structure.
