Building and Timber Pest Inspection Report

Inspection Date: Fri, 6 Feb 2026

Property Address: 14 Varna St, Mount Colah NSW 2079,
Australia

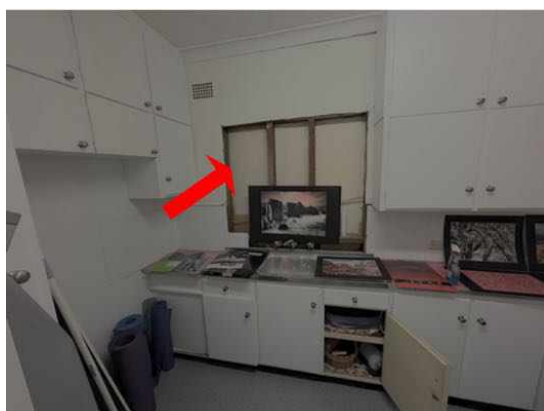
Finding 2.01

Building:	Main Building
Location:	Studio
Finding:	Plasterboard - incomplete
Information:	A section of plasterboard is missing from the wall, likely resulting from previous plumbing or remedial works. The wall lining has not been reinstated, leaving the timber framework exposed. This is considered incomplete workmanship. The plasterboard is required to be reinstated, properly fixed, set and finished, and the affected area painted to match the surrounding wall surfaces to achieve an acceptable standard of finish.

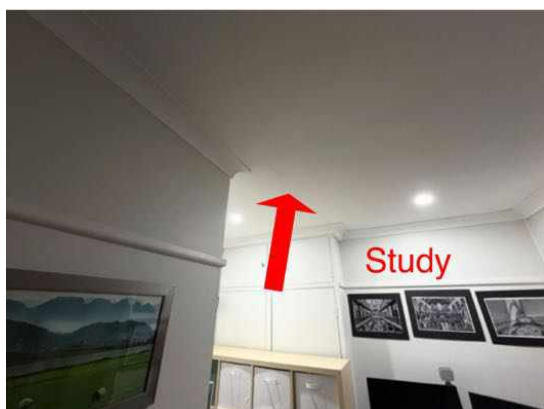
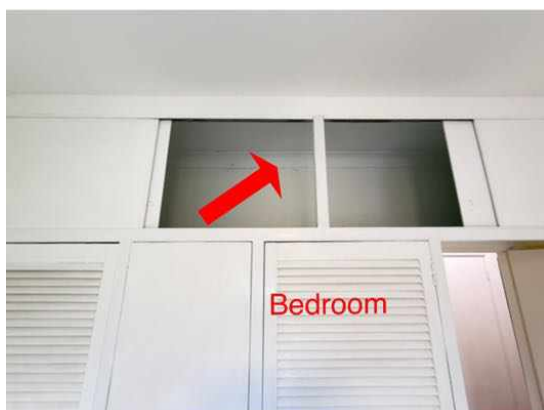
Building:	Main Building
Location:	Study/bedroom
Finding:	Cracking - Damage Category 1 - Fine (up to 1mm)
Information:	Although fine cracks are quite noticeable, they are often only considered to be an appearance defect, and usually do not indicate any structural damage. Generally, the cause of a fine crack is indicative of a separation between building materials and finishes (e.g. paint, plaster, etc.) along joins.

Cracking of this nature can generally be repaired with minor sanding, filling and/or repainting. Such works should be performed by a qualified painter or a general handyman.

Monitoring of all cracking should be conducted frequently. Always contact a building inspector should cracks widen, lengthen, or become more numerous.

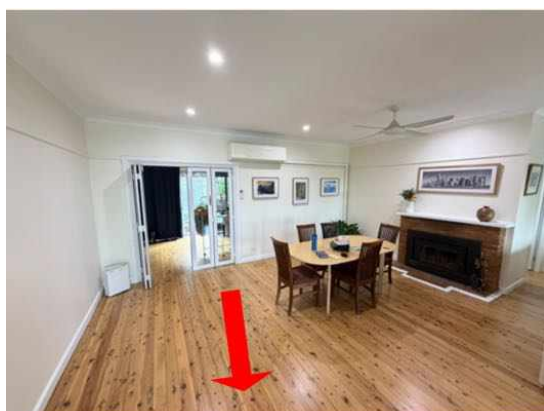
Finding 3.03

Building:	Main Building
Location:	Lounge Room
Finding:	Floors - Squeaking
Information:	Minor squeaking is evident to the timber flooring when walked across in the affected area. This indicates movement within the flooring system, potentially due to inadequate fixing, substrate movement, or installation tolerances. While not considered a major defect, remedial works are recommended to investigate the cause and rectify the issue to minimise noise, improve performance, and ensure the flooring is fixed and performing in accordance with acceptable building standards.

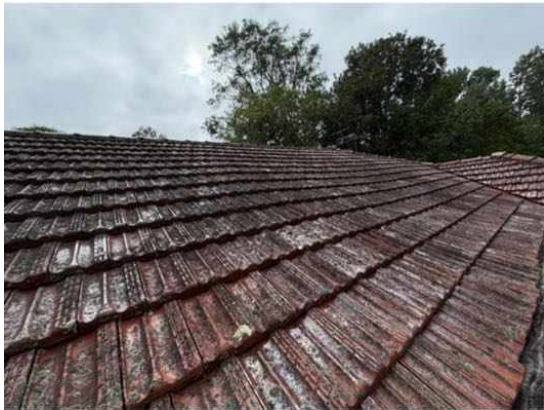
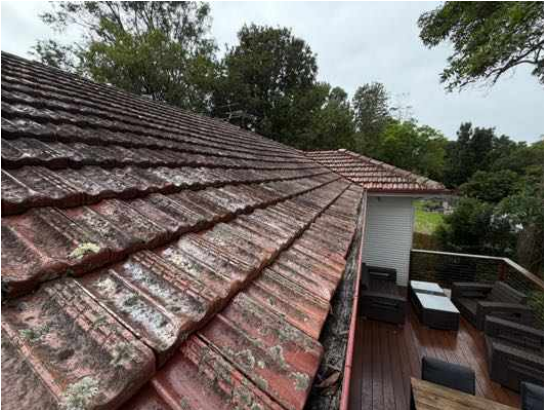
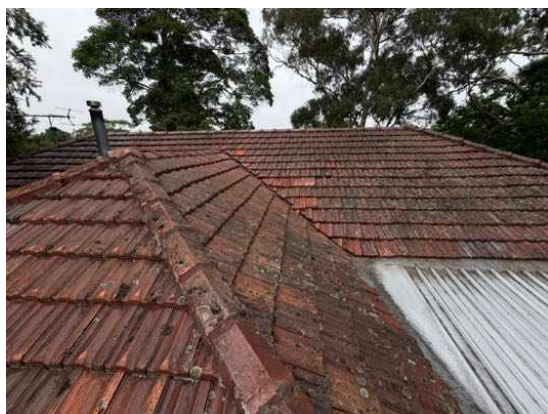
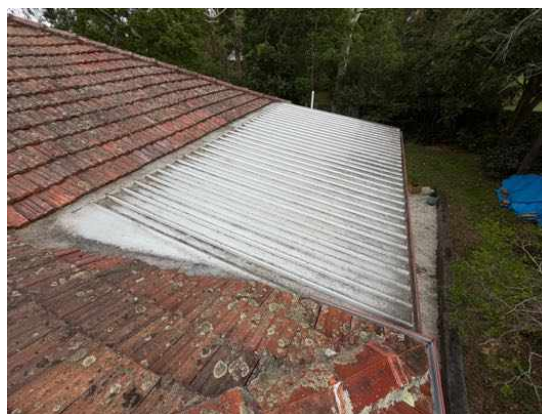
Building: Main Building
Location: Roof Exterior
Finding: Lichen present on roof tiles
Information: Upon inspection of the exterior roofing, the majority of roof tiles were considered to be in a fair condition. While weathering of the tiles is consistent with the age of the property, maintenance works are required. Concrete roof tiles are typically cleaned to have the visible moss and lichen removed. Moss and lichen is attracted to the roof tiles surface, and if left will continue to grow and most likely restrict the flow of rain water over the tiles surface, into the roofs gutters. An application of an environmentally friendly anti-fungal solution should be applied to all moss and lichen, prior to undertaking the roof cleaning process.

A roof restoration company can be contacted for further advice.

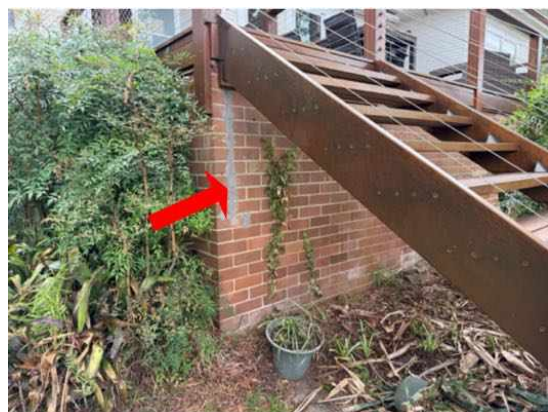
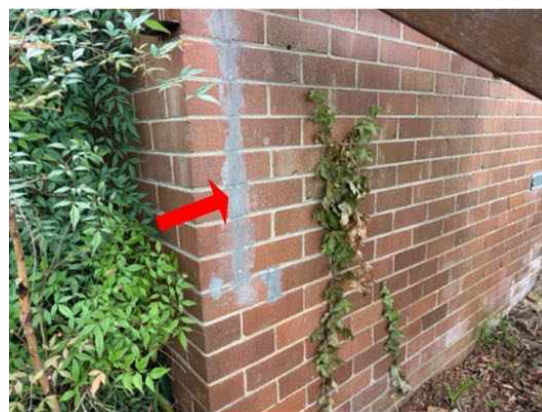
Finding 3.06

Building:	Main Building
Location:	Front Left Decking
Finding:	Brickwork - Cracking [Fine]
Information:	Although fine cracks are quite noticeable, they are often only considered to be an appearance defect and usually do not indicate any structural damage. Generally, the cause of a fine crack is indicative of a separation between brickwork and mortar throughout the structure, but single bricks may also show cracks of this nature.

Cracking of this nature can generally be repaired with minor filling and should be conducted by a qualified bricklayer.

Always contact a building inspector should cracks widen lengthen or become more numerous.

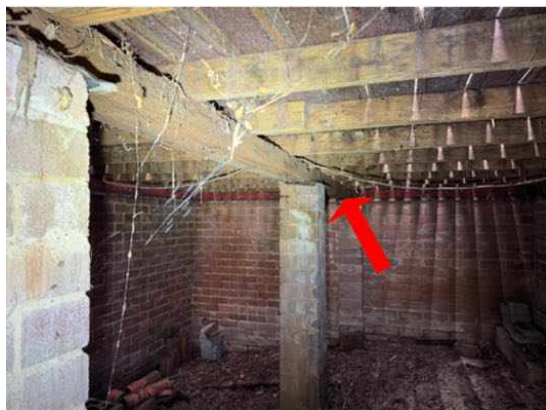
Finding 3.07

Building:	Main Building
Location:	Front Deck lhs
Finding:	Wood Rot - Decking bearers
Information:	One area of structural timber bearers located beneath the front timber decking shows visible signs of wood rot and deterioration. This condition indicates prolonged

exposure to moisture and may compromise the long-term structural integrity of the decking if it continues to deteriorate. While immediate replacement may not be required at this stage, the affected bearers should be regularly monitored, and allowance made for repair or replacement in due course to prevent further degradation and potential structural issues.

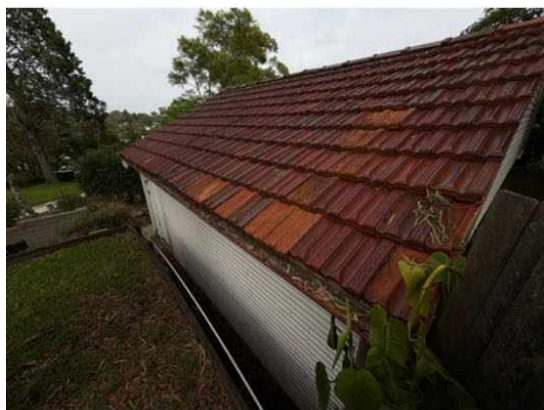
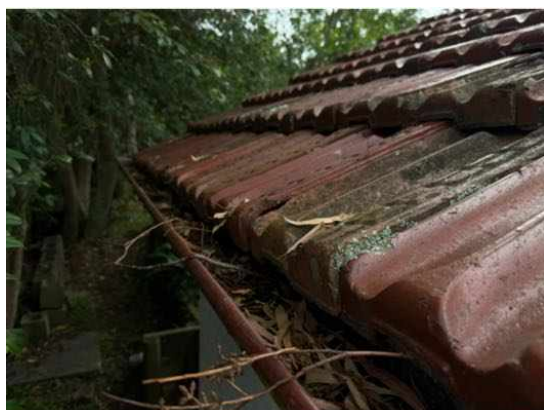
Finding 3.08

Building:	Main Building
Location:	Detached Garage
Finding:	Gutters - Blocked
Information:	At the time of inspection it was found that this gutter was completely blocked with debris, leaves and silt.

The area was checked for high readings of moisture in the area and no high levels were recorded.

Blocked gutters are likely to lead to high levels of moisture in the affected areas. Such moisture will not only cause rust and decay of the associated building materials, but can also provide conditions that are conducive to termite and timber pest activity.

Blockages in gutters should therefore be removed immediately to ensure dry conditions are maintained.

Consult a Licensed Plumber for further specific advice on remedial works that may be required. In the interim, it is highly advised that blocked gutters be removed by the homeowner or a general handyperson as a matter of urgency.

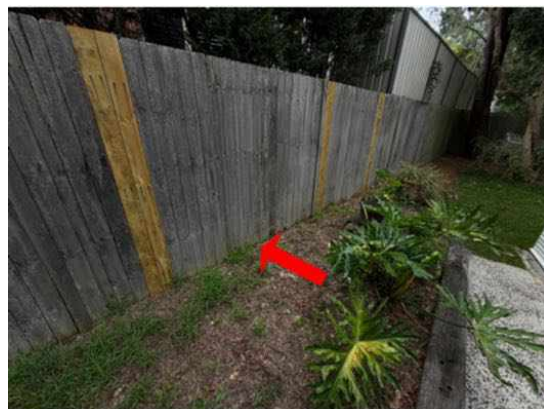
Finding 6.02

Building: Yard

Information: Any timbers in direct ground contact provide opportunity for concealed termite entry and are likely to be subject to premature rot and decay as the soil retains moisture or damp conditions against the timbers.

Treated Timbers can decay or be poorly treated at manufacturing and as they degrade overtime can allow for termite attack.

Remove any timber that is in direct contact with external grounds. Consider replacement with more durable materials i.e. non timber elements. Frequent pest inspections are advised to readily identify any termite activity in these areas.

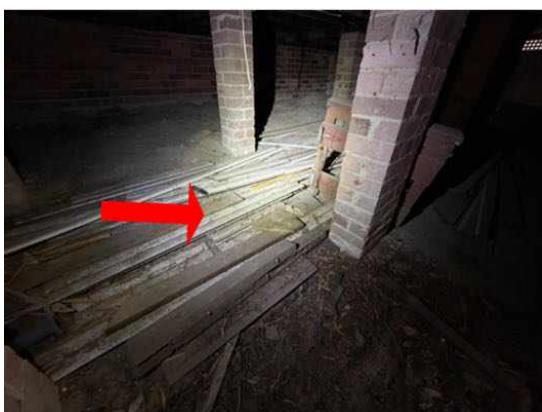
Finding 6.03

Building:	Main Building
Location:	All Areas
Finding:	Stored timbers - subfloor space or external area
Information:	The storing of timbers in the subfloor space or around the external property (including bark mulch) increases the risk of termite activity being present. As they are likely to come into contact with weather conditions or excessive moisture wood rot is likely to develop on timbers that are not treated.

It is highly recommended that any stored timbers be immediately removed from areas in which they may attract any termite / timber pest attack. Minimisation of risk / prevention of termite attack is far more adequate than dealing with the presence of termite activity.

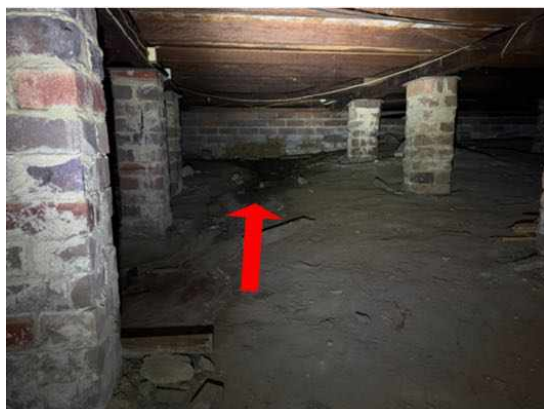
Finding 6.06

Building:	Main Building
Location:	Subfloor
Finding:	Excessive subfloor moisture
Information:	Excessive moisture can attract termites and produce conditions that promote termite attack fungal growth and wood decay.

Excessive moisture is generally caused by inadequate subfloor ventilation and poor site drainage.

There appear to be inadequate vents installed to the perimeter of the building and I would suggest that further solar powered fans or the like be installed to improve cross flow ventilation and aid in keeping the subfloor area relatively dry.

The installation of additional surface drainage to the rear of the property would also be beneficial to keeping the subfloor dry.

It is highly recommended that both subfloor ventilation and site drainage be improved and maintained regularly in order to prevent excessive moisture being present in the external / internal property.

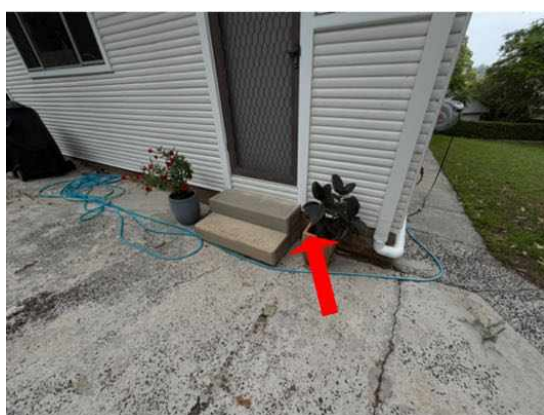
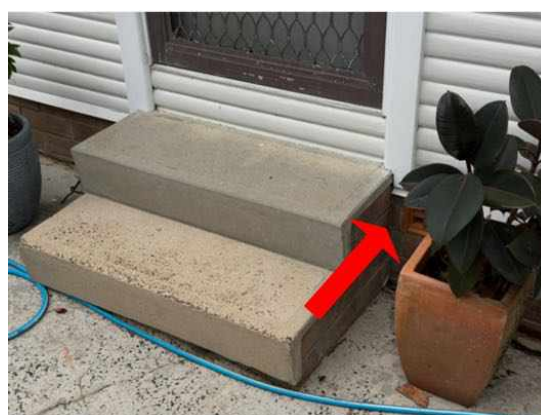
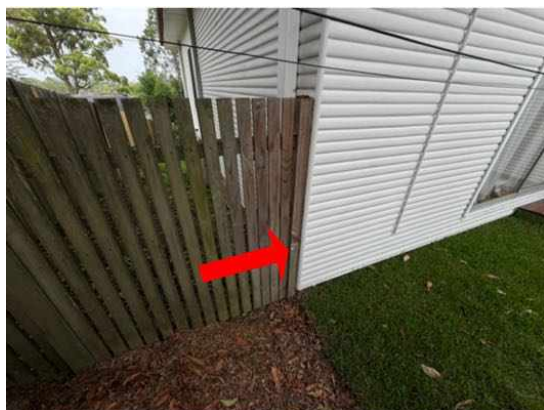
Finding 6.07

Building:	Main Building
Location:	All Areas
Finding:	Bridging or breaching of termite barriers - weep holes
Information:	Bridging is the spanning of a termite barrier or inspection zone so that subterranean termites are provided with passage over or around that barrier.

framework to drain from within the wall hence preventing any deterioration of the timber building elements.

Additionally build-up of moisture is likely to occur if weep holes are covered further attracting termite activity to these areas.

It is highly recommended that weep holes are left exposed in all areas throughout the external property. Therefore if any termite activity leading into weep holes becomes easily detectable during frequent pest inspections.

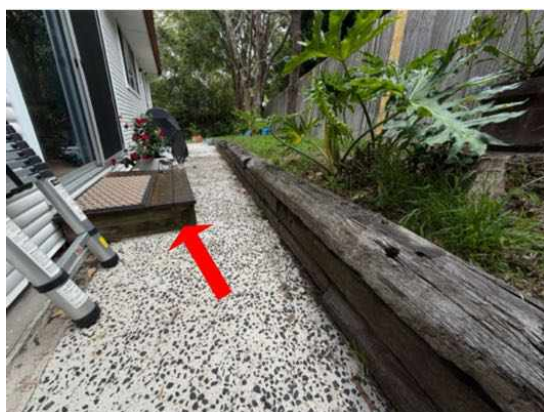
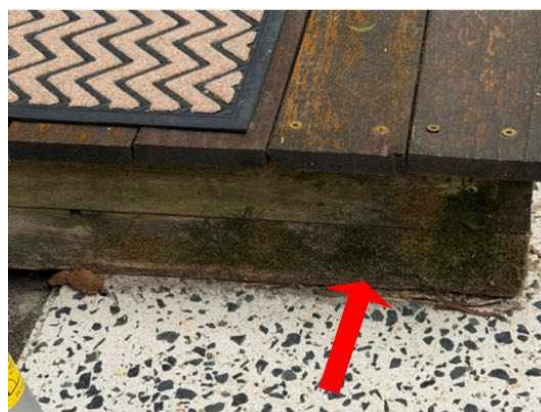
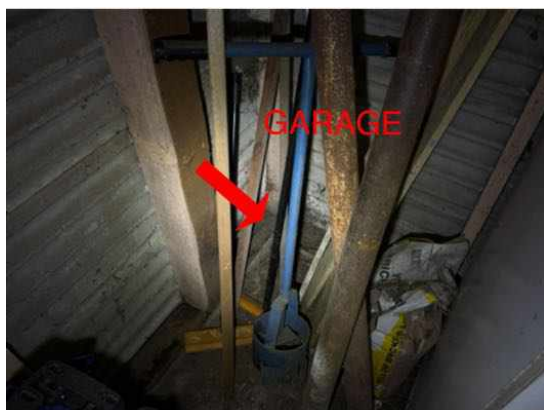
Finding 7.01

Building:	Main Building
Location:	Rear steps/detached Garage
Finding:	Fungal decay - present at the time of inspection
Information:	Fungal decay also known as wood decay or wood rot occurs when timbers and other

cellulose building materials are exposed to damp conditions on an ongoing basis. This could be the result of exposure to weathering in the long term or the pooling of water or absorbed moisture from other abutting building materials or a shower leak. It is advisable to remove these affected timbers to prevent any chance of attack in the future.

Wood decay is more susceptible to termite attack and these timbers should be replaced to limit termite attack.
