# Building and Timber Pest Inspection Report VR

Inspection Date: Fri, 13 Feb 2026

Property Address: 16 Kurrajong St, Durack QLD 4077,  
Australia

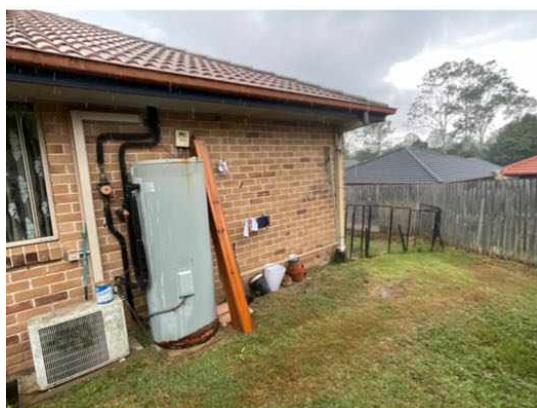
Building: Main Building  
 Location: Exterior walls - right side  
 Finding: Corrosion to Hot Water Service Tank – Rear External Wall  
 Information: Corrosion to Hot Water Service Tank – Rear External Wall

Significant corrosion and rust deterioration were observed to the lower section (base ring) of the hot water service storage tank. Rust staining and active corrosion are evident around the bottom perimeter of the unit, indicating advanced metal degradation. This condition is consistent with prolonged moisture exposure and age-related failure of the tank lining/coating.

Corrosion at the base of a hot water service is a common precursor to sudden tank failure and leakage. If left unaddressed, this may result in water damage to surrounding structures, loss of hot water supply, and potential flooding of the area. The structural integrity of the tank is considered compromised.

Engage a licensed plumber to assess the unit and arrange replacement of the hot water service as required. Given the extent of corrosion observed, replacement is strongly recommended rather than repair.

High priority – recommend replacement within 30 days or sooner if signs of leakage occur.

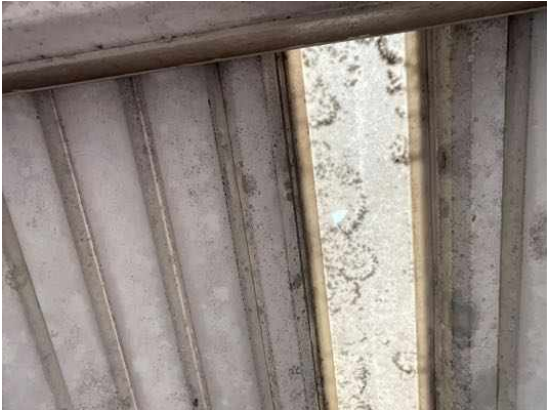
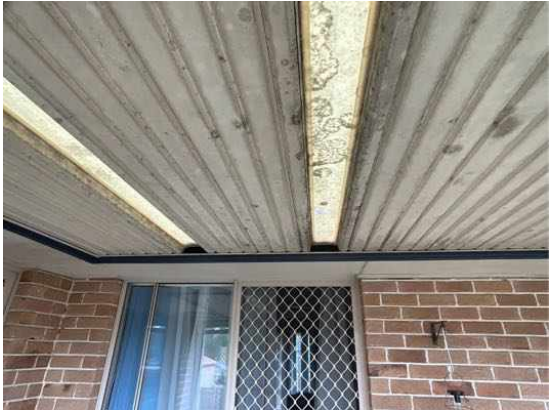
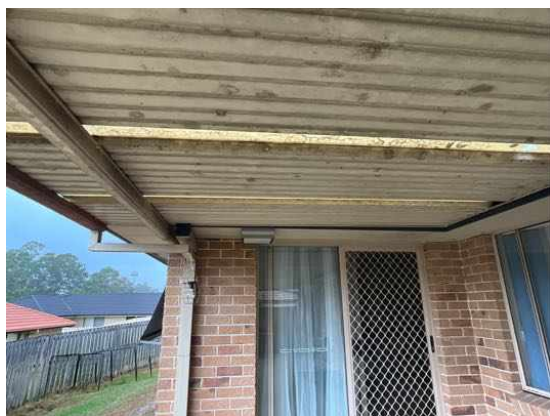
Building:	Main Building
Location:	Rear Elevation
Finding:	Polycarbonate sheeting - Damaged
Information:	The polycarbonate sheeting has deteriorated as a result of exposure to weather conditions over a prolonged period of time. Exposure to elements, such as heavy rain and hailstorms, is likely to damage polycarbonate sheeting, which is not as strong as

Further deterioration of the polycarbonate sheeting is likely to occur if left unmanaged. Such deterioration creates potential for water penetration and secondary damage to the internal roofing structure, accelerating deterioration of all associated building elements.

Repair and replacement of several sections of the sheeting is required. Appointment of a roofing restorer is required to perform these works as soon as possible to prevent any further damage being sustained.

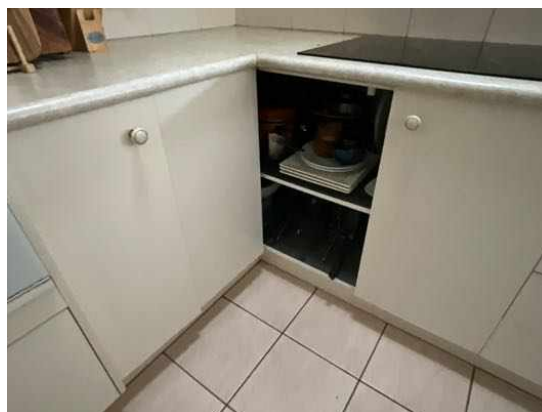
Building: Main Building  
Location: Kitchen  
Finding: Missing Cabinet Door – Kitchen Base Cupboard  
Information: Missing Cabinet Door – Kitchen Base Cupboard

A cabinet door is missing from the base kitchen cupboard, exposing internal shelving and contents. This detracts from the overall presentation of the kitchen and leaves the cupboard cavity open to dust, debris, and potential pest entry.

- Reduced functionality and visual appeal of kitchen cabinetry
- Increased likelihood of dust accumulation and pest ingress
- Potential safety issue due to exposed shelving edges
- May indicate poor maintenance or incomplete prior repairs

Supply and install a matching replacement cupboard door, including hinges and hardware as required. Ensure alignment and operation are satisfactory on completion.

Non-urgent – recommend rectification within 30 days or prior to settlement/tenant occupation.

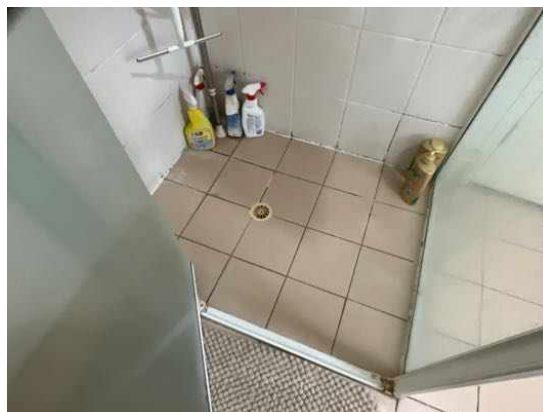
Building:	Main Building
Location:	Bathroom
Finding:	Sealant and grouting - Missing or damaged
Information:	It was noted on inspection that sealant or grout is degraded to the tiled shower alcove and or other areas of the bathroom.

Different materials and floor areas move at different rates, generally causing cracking to grout or sealant at this point. A flexible sealant is required to allow for expected expansion and contraction, while keeping the joint water tight and protective of all associated building materials.

There appears to be excessive mould to the sealant and grout which will likely require scraping out and replacement.

Flexible and mould resistant materials should be applied to affected areas to prevent any subsequent water damage that is likely to occur. Regular maintenance and replacement of damage or missing or damaged sealant and grout is highly recommended to the wet areas, as this is a regular wear and tear defect. Sealant and grouting in areas that come into regular contact with water should be maintained for the long term care of your property.

A sealant specialist or tiling contractor should be appointed to complete these works as soon as possible

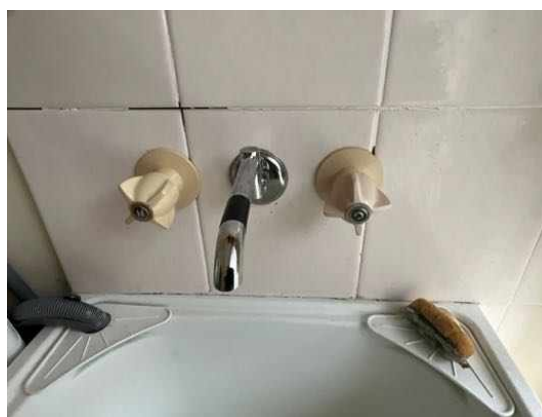
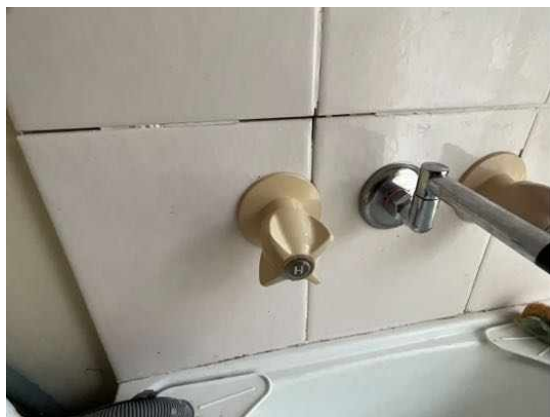
Building: Main Building  
Location: Laundry  
Finding: Laundry – Splashback Tiles Loose / Gaps to Joints

Wall tiles to the laundry splashback area exhibit visible gaps at horizontal and vertical joints, with sections appearing uneven and inadequately grouted. There are open junctions at tile intersections and minor movement evident around tap penetrations. Grout lines are deteriorated in areas, and sealing appears incomplete.

Open tile joints and failed grout allow water ingress behind tiles, which may result in moisture penetration into wall linings and framing. Over time this can contribute to substrate deterioration, mould growth, and loosening of tiles. Continued wetting from regular laundry use may accelerate damage.

A licensed tiler should inspect the splashback area. Remove and re-secure any loose tiles as required, re-grout joints, and seal all penetrations around plumbing fixtures with appropriate waterproof sealant. Ensure adequate waterproofing integrity behind tiles if works are extensive.

Repairs recommended within 30 days to prevent moisture-related deterioration.

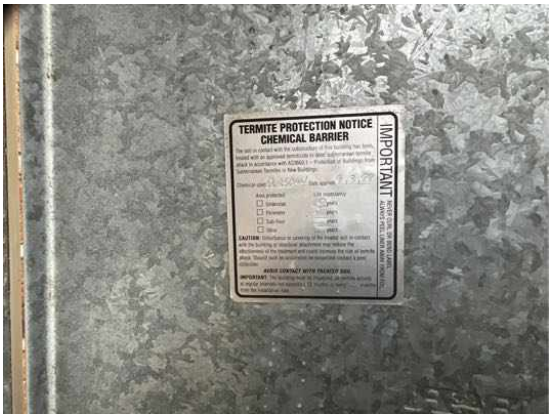
The owner has provided the latest treatment as per photos attached.

The client may consider gaining further advice from a pest controller as to the costs and procedures involved with this application. It is recommended that obtaining such advice be a short-term priority.
